WITNEY; THE WEAVERS 1990  
ARCHAEOLOGICAL ASSESSMENT REPORT

# **THE WEAVERS (PHASE 2)**

## **WITNEY, OXON.**

### **ARCHAEOLOGICAL ASSESSMENT, SEPTEMBER 1990**

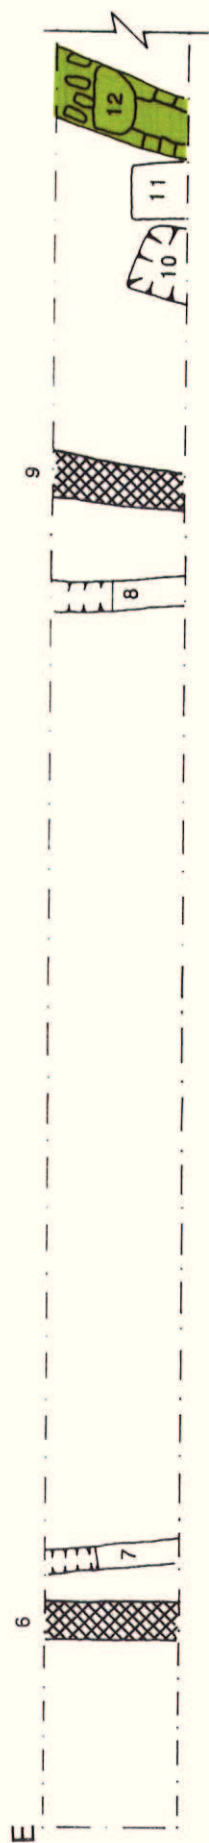
Fig. 4

# WTW 90 Trench 4

## Eastern extent of pond deposits

- Mill building
- Medieval drains
- Medieval walls
- Wall footings
- Floors
- Hearth

**Trench 4**, parallel to the N wall of the site, produced a large number of archaeological deposits (Fig. 4). Two stone footings [4/6, 4/9] in the W end of this trench are the remains of the walls for one of the two Mount Mills buildings along the N edge of the site. The deposit [3/5] formed in the bottom of the pond found in the N end of Trench 3 also occurs in this trench, but is less dark and more clayey [4/4]. A stone-built drain [4/12], which produced no finds, marks the eastern extent of the pond deposit.

In the E end of this trench, a dry-stone wall footing aligned WNW/ESE through an area of disturbed soil, sand and coal [4/28] lies just E of the planned E extent of one of the Mount Mills buildings. This footing and disturbance are probably the surviving deposits of an earlier Mount Mills structure. Under the disturbed soil [4/28] and a layer of loam [4/29], a cobbled surface [4/30] was revealed. The age and extent of this cobbling could not be determined, but it is likely to have been in use at the same time as the medieval structures already discussed.

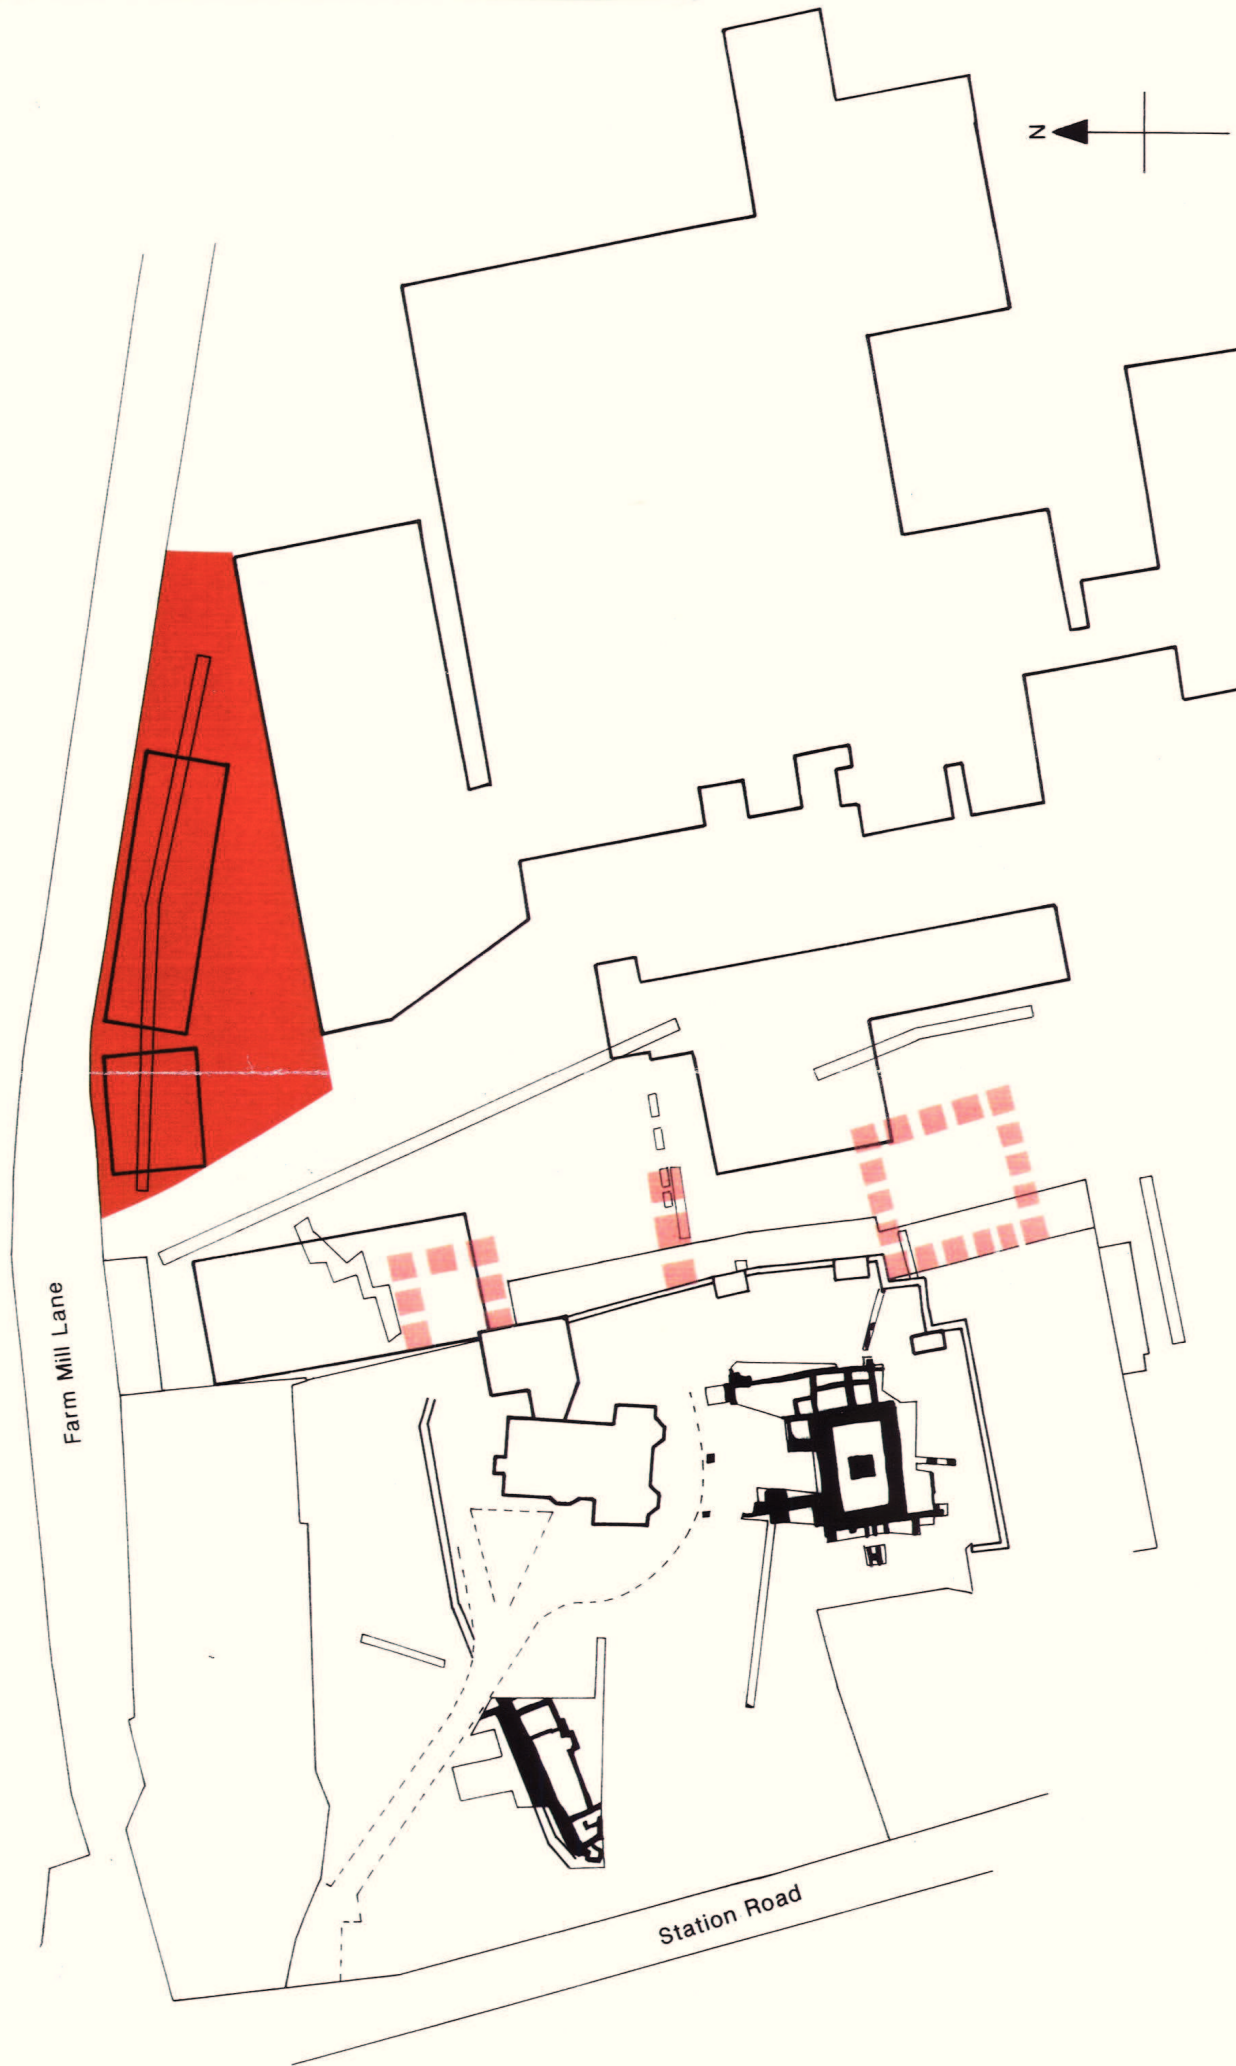
WTW 90 Fig 5

Medieval structures surviving

Course of palace moat

This assessment has therefore identified four areas of the site where important information about the past is preserved (Fig. 5).

- 5.1 The area adjoining Farm Mill Lane contains a sequence of early medieval structures and associated features (Trench 4). The deposits are near the surface and fairly fragile; heavy earthmoving or construction vehicles would almost certainly damage them to the point where they could no longer be

- 5.2 The area immediately NE of Mount House ought to include the NE corner of the palace moat, and failure to find it in Trench 2 of this assessment means either that it cuts back very close to the palace wall, or it is discontinuous: either way it is significant and would repay investigation.

- 5.3 Near the more northerly of the two tower fronts of the palace outer wall the full width of the moat is considerably smaller than previously estimated; there must be a possibility that this was a double moat, which would again repay an investigation.

- 5.4 The inner edge of the moat as observed in 1984 at the SE corner of the palace site was tight up against the terrace wall, and as with the NE corner it needs to be investigated in case it reflects an anomalous relationship with the upstanding terraces. Assuming that this is to be the site of the proposed Interpretation Centre there would be a case for excavating those areas which would be affected by the foundations, which would thereby provide the first full section across the Witney moat, and to judge from the results of the hand excavation on the Mount Mills site in 1984 it would provide some finds worthy of display.
