Swerford Castle Oxfordshire

Topographic Survey Report

September 2012

Client: Natural England

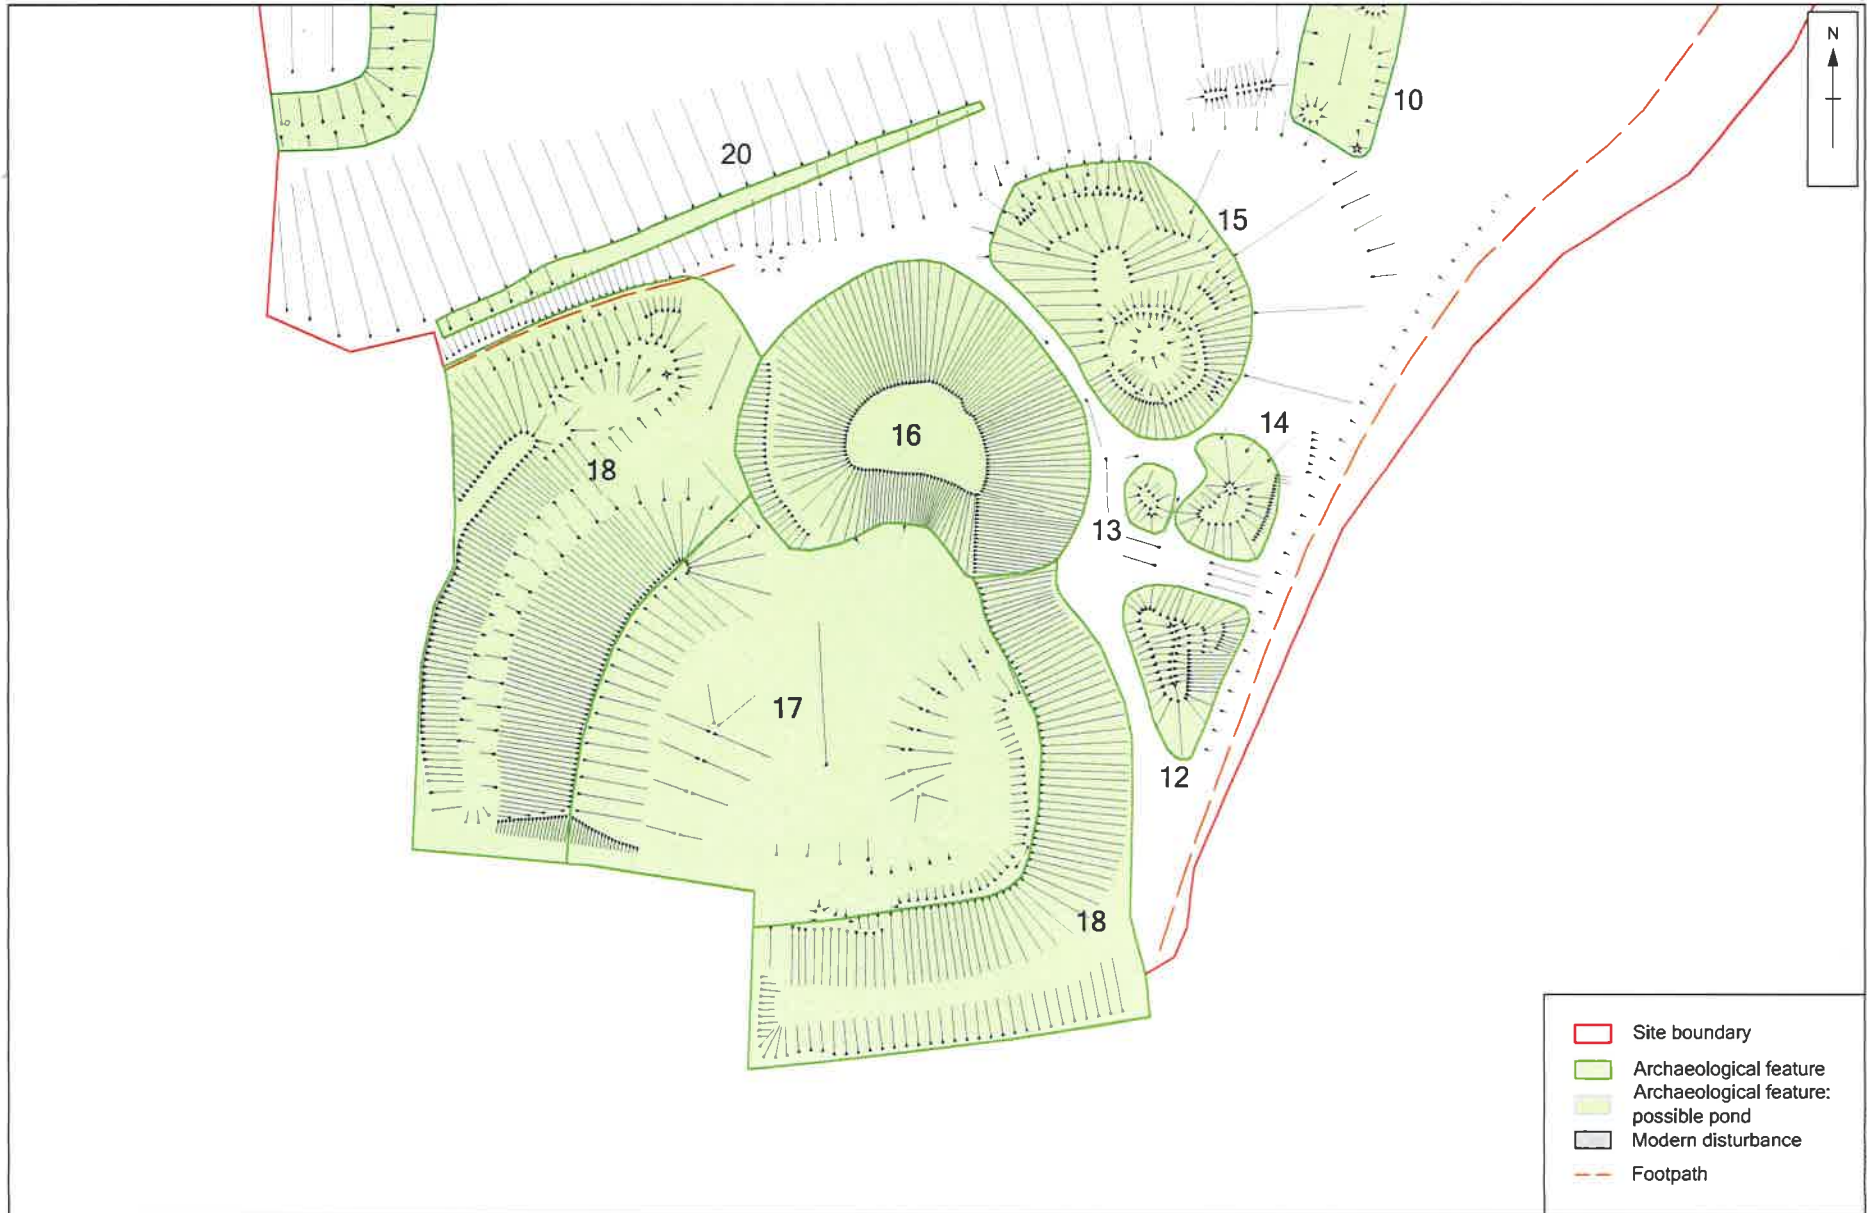
Figure 8: Features identified within Area 1

- 3.1.1 The results are displayed in Figures 8 and 9
- 3.1.2 The features identified in Area 1 were:
- 12: A roughly triangular mound at the south east of the site (photo 1). The narrower end is to the south, with the widest part at the northern end measuring 12m across. The feature measures 17.5m north to south. The southern end has a gradual slope. The northern end has a much steeper and well defined slope. The eastern side of the feature slopes down to a track which runs along the east of the site. On the north-west slope of the feature, occasional stones are visible through the grass, which is of a poor quality, suggesting stones beneath the surface.

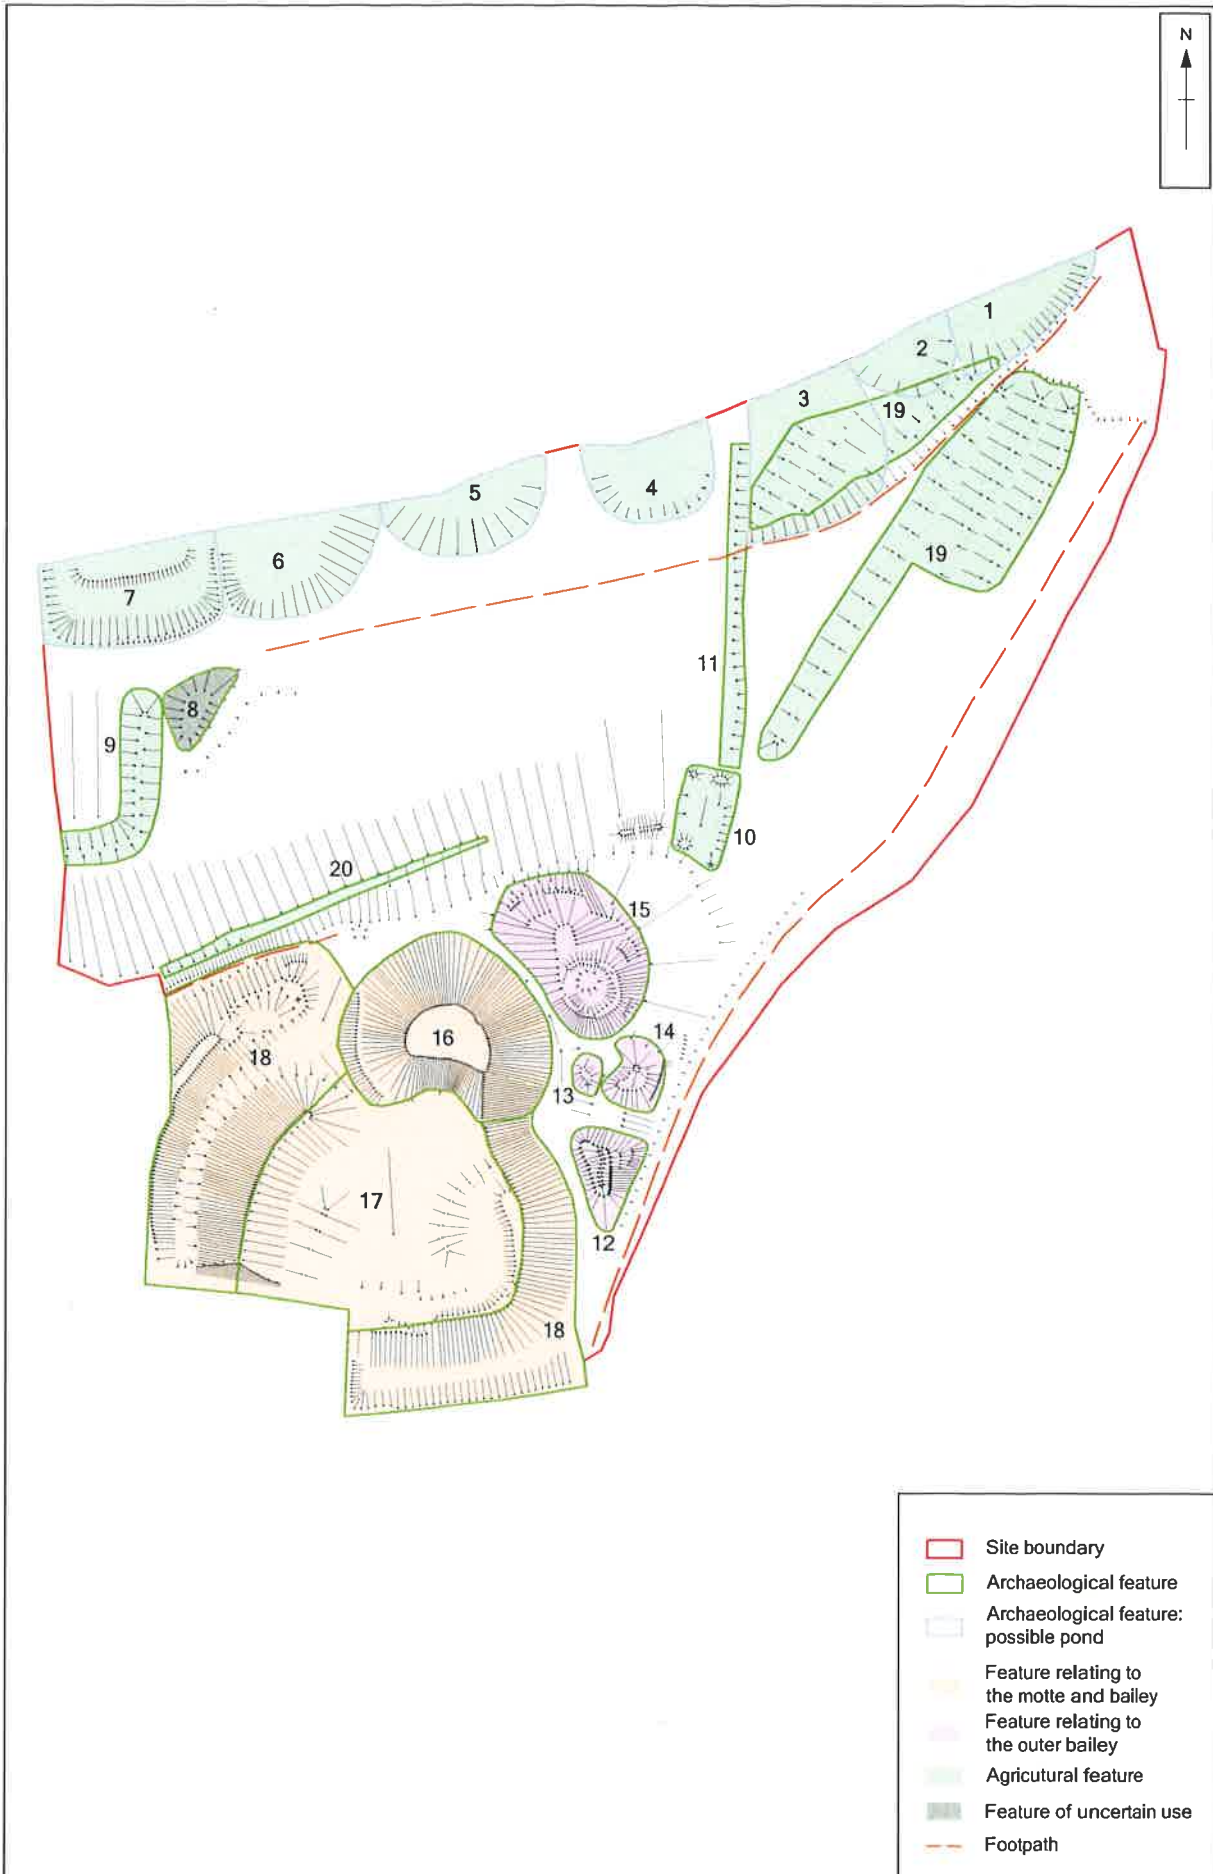
Figure 10: Categories of use of features identified during the survey

3.2.1 The features identified during the survey can be divided into four broad categories (figure 10). Those relating to the motte and bailey, those in the second bailey, those relating to agriculture, and those of unknown use.

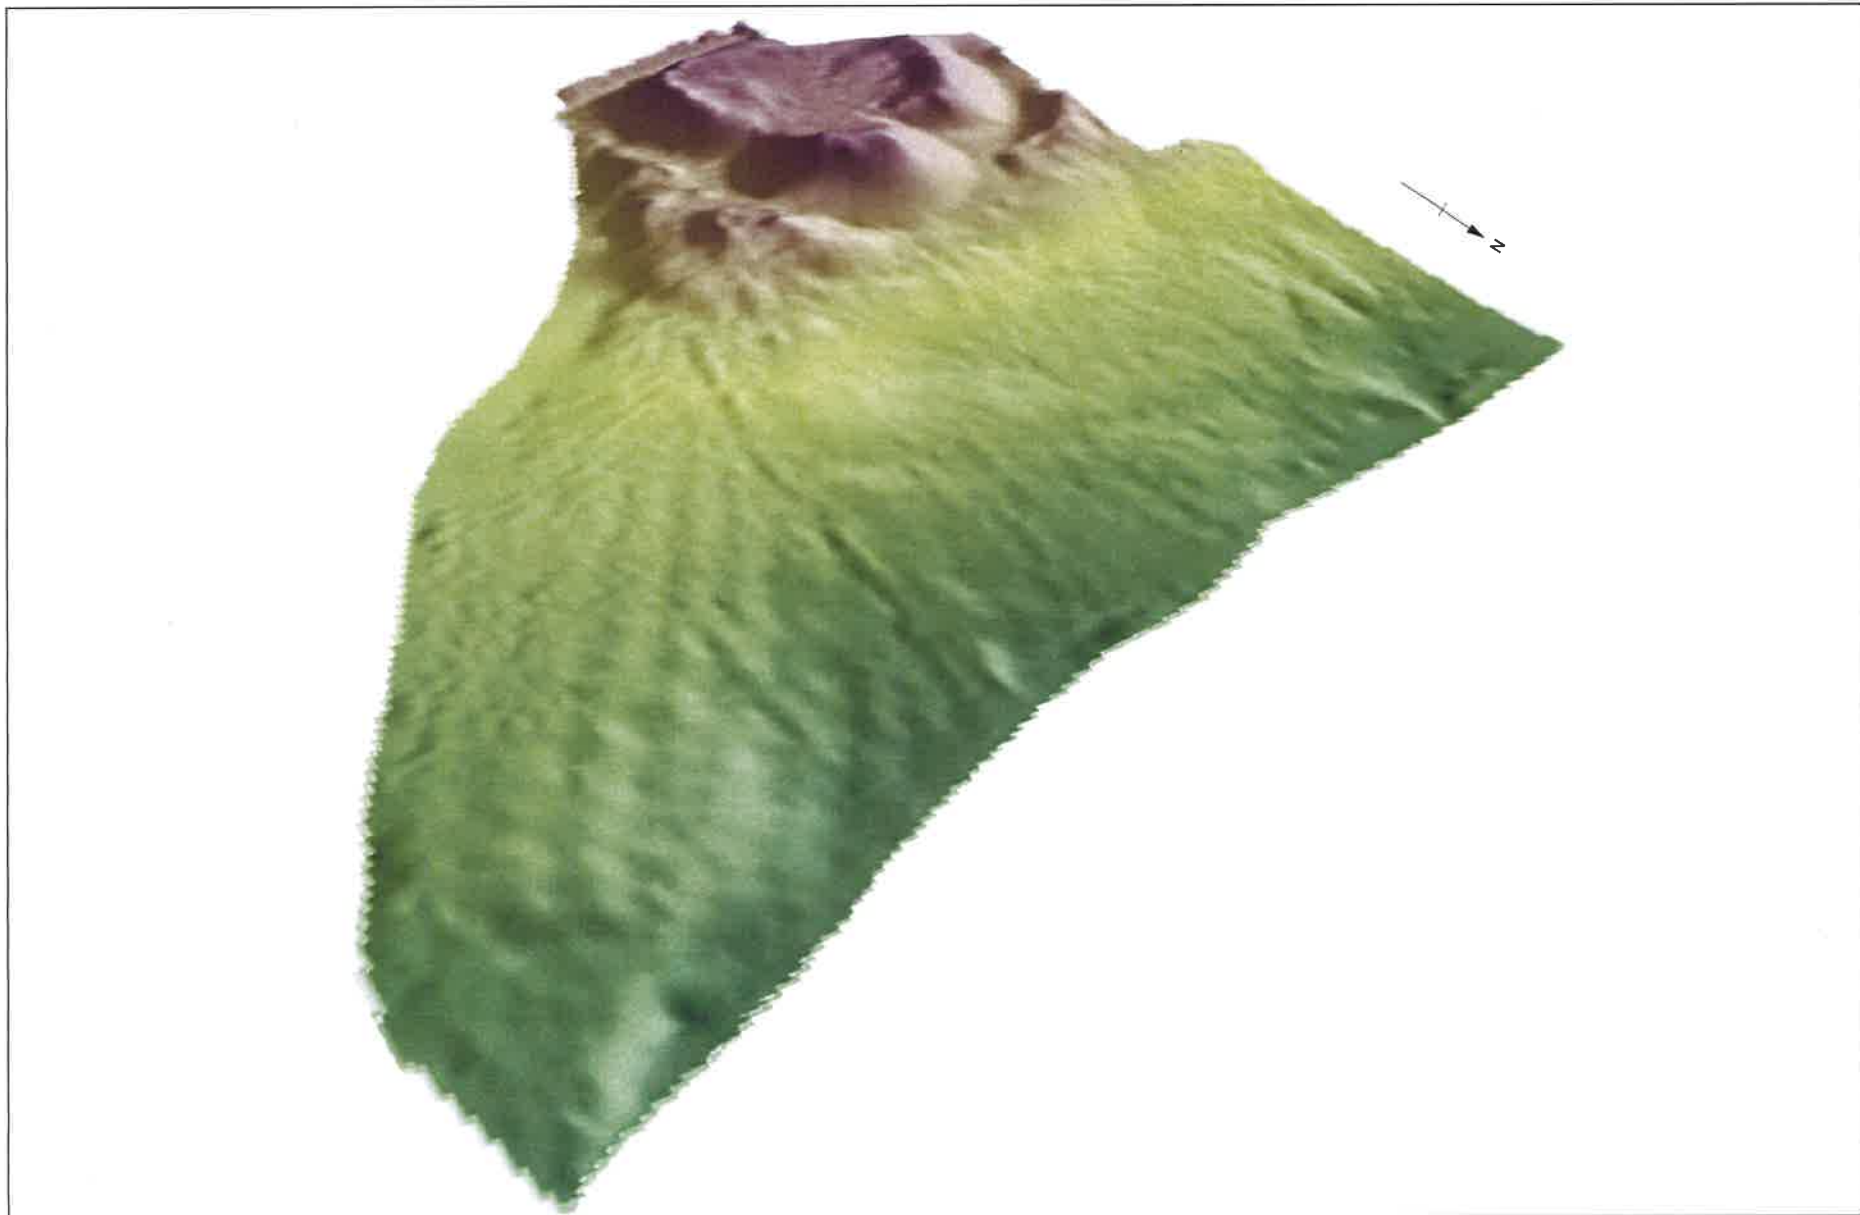
Figure 11: Digital Terrain Model derived from survey data

- 3.2.13 The area of ridge and furrow in the north-east corner of the field is mostly visible on aerial photographs of the site and on the topographic survey data (figure 11). Some of it was not visible on the ground during site visits. The ridge and furrow extends in to one of the possible ponds – feature 3, indicating that this may be as a result of natural pooling of water. The ridge and furrow has been disturbed by feature 10, and by modern works on the site, which can be seen as a line of manholes and a footpath running west to east across the site. It was noted during visits to the site, that this area was warmer and more sheltered than to the south of the site, making it suitable for growing crops.

- 3.2.7 There are reportedly a number of platforms within the bailey marking the possible locations of stables, kitchens, store rooms and other structures (Oxfordshire Historic Environment Record). These were not particularly visible during visits to the site, although some features became apparent once the topographic data had been processed (figure 11).

- 3.2.15 Features 10, 11 and 20 match almost perfectly with former field boundaries seen on the first edition OS map. 10 follows a north-south field boundary, which has some trees indicated on it. 11 sits on the junction of three former field boundaries, including features 10 and 20. The feature is more defined than 10, so the junction may have been of a more substantial construction than the north-south boundary. Feature 20 follows the line of a former east-west field boundary which can be seen on the first and second edition OS maps. Feature 10 truncates the earlier medieval ridge and furrow ploughing, as can be seen on plate 1 and figure 11.

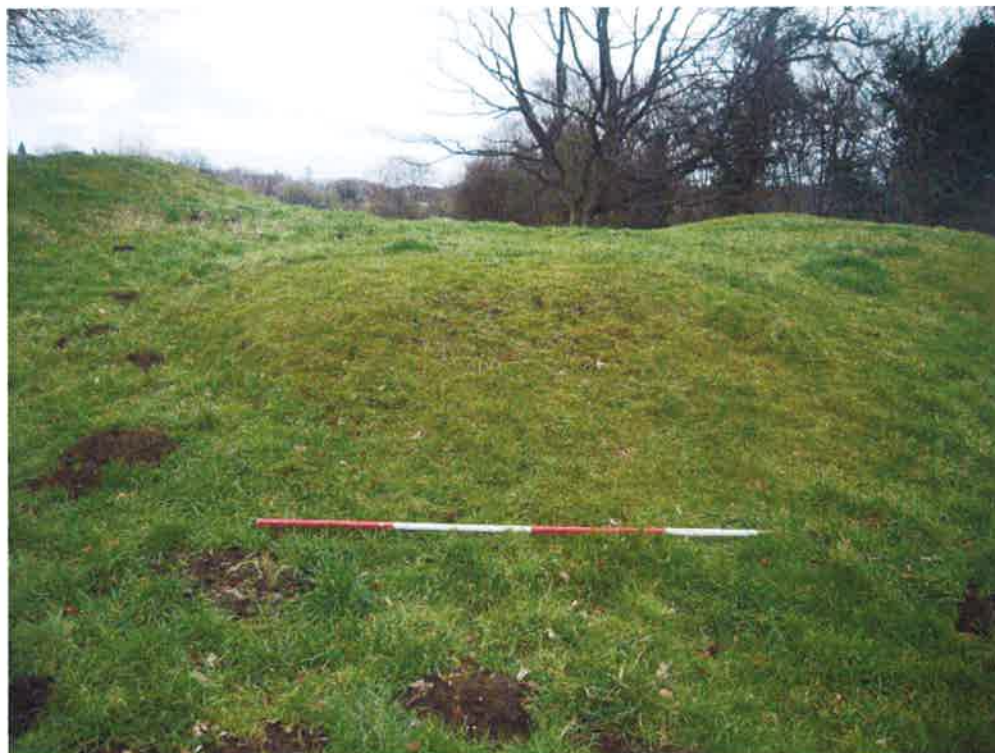
Photograph 2: Feature 13

- 13 and 14: Two features that may be associated. 13 is the western of the two features (photo 2). It is a sub rectangular raised mound, measuring 6.3m by 4.5m with a flat top. It slopes steeply down to the west with a sharp break of slope, and has a more shallow and gentle slope to the east. The grass on the western and southern edges is more yellowed, suggested stonework under the surface. There is mole damage to the north and north-east. 14 is the larger of the two features (photo 3). It is roughly semi-circular, measuring 12.5m by 9m. It has a very steep slope down towards the track to the east with a sharp break of slope. The north-western slope is shallower and more gentle. The top of the mound is moderately flat to the

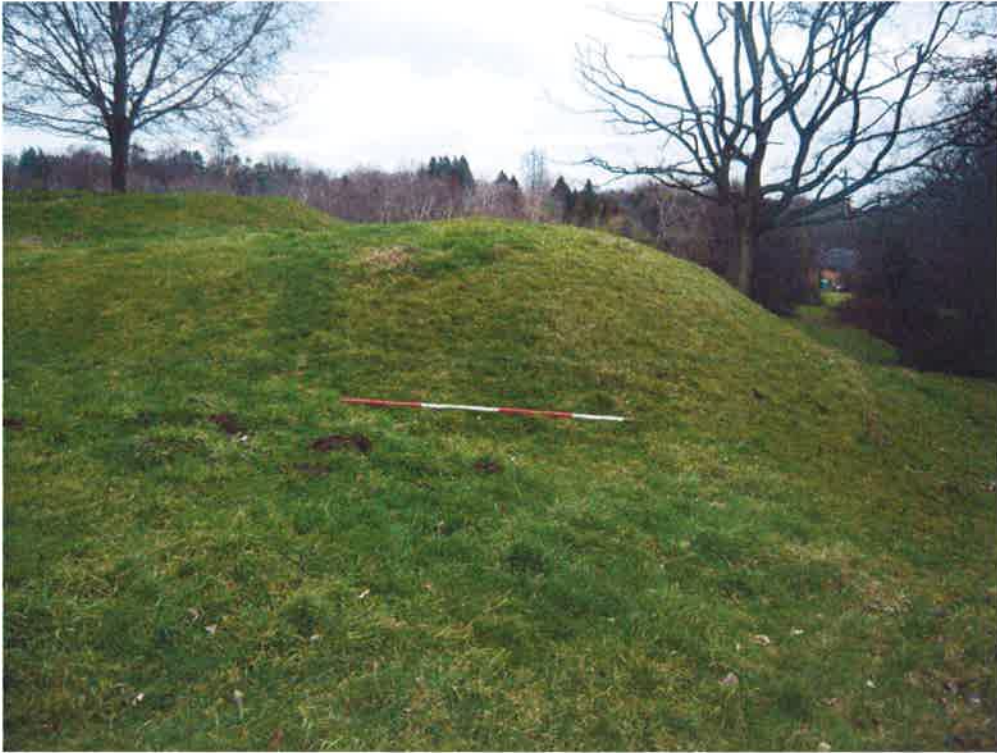
Photograph 3: Feature 14

south and west. The grass on the eastern slope suggests something substantial under the surface, possibly stonework.

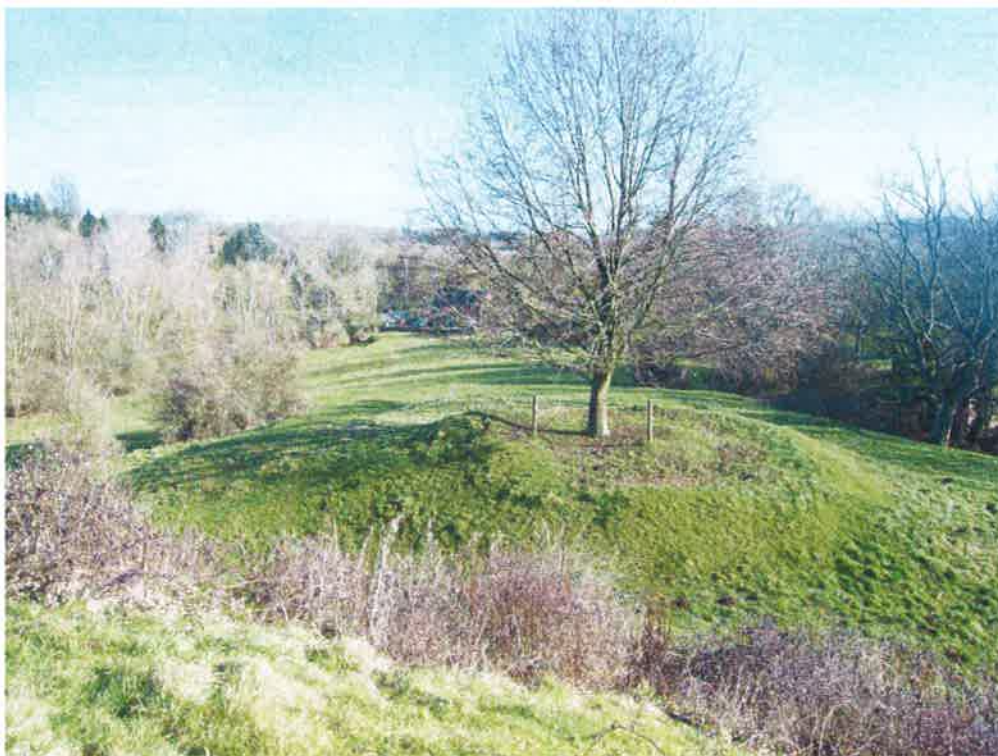
Photograph 4: Feature 15

- 15: A feature consisting of a kidney-shaped mound measuring 28.3m north-west to south-east, and 18.5m at its widest point (photo 4). The mound has steeply sloping sides to the east and west, with a more gentle slope to the north and south. On the south of the mound is a raised embankment roughly 9.5m in diameter and 0.75m wide. The embankment appears to be of stone construction. The area within the embankment drops down slightly, before rising up again. There is a tree on the raised area. The north of the mound is much less well defined and more irregular as it slopes down to the north. This feature will need further monitoring due to possible root damage.

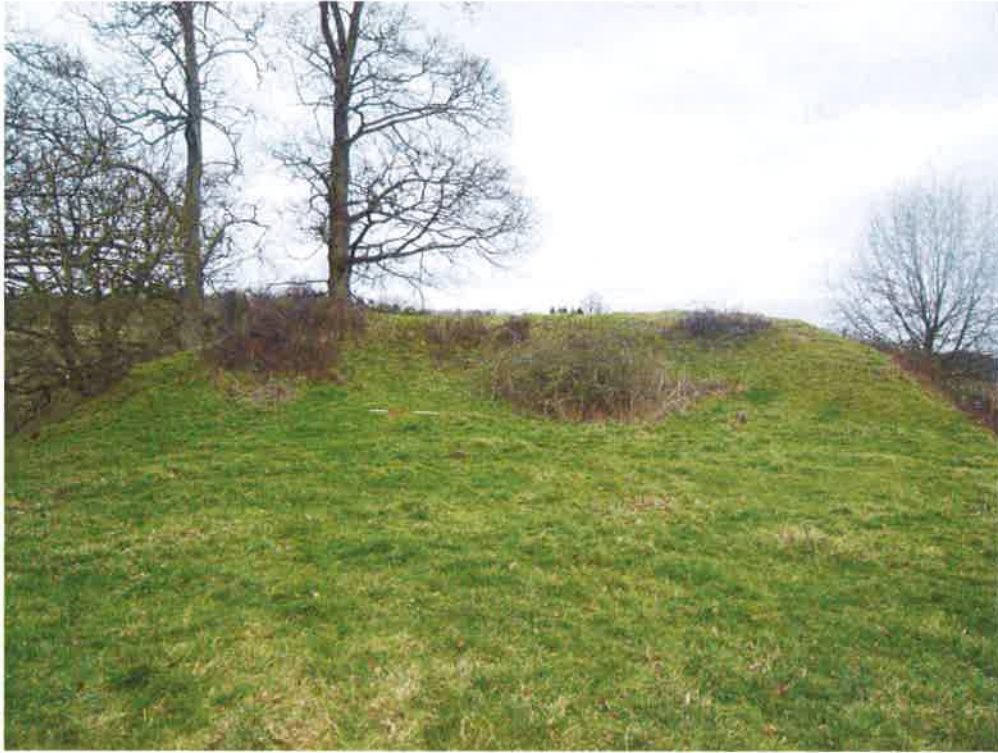
Photograph 5: Feature 16

- 16: A kidney-shaped mound on the north-east of feature 17, measuring 26.3m by 35.4m (photo 5). It has very steeply sloping sides and a flat top, which measures 14m by 9.1m. There is evidence of a footpath winding anti-clockwise up the mound from the north-western edge for about 22m (photo 6). It stops where the bottom of the mound meets the central area of feature 17. There is a large tree growing on the top of the mound on the north-western edge, and the slope to the north has considerable undergrowth cover. There is some erosion of the mound around the tree roots which has exposed stones, indicating an earthen and stone construction. This feature will need further monitoring due to erosion and root damage.

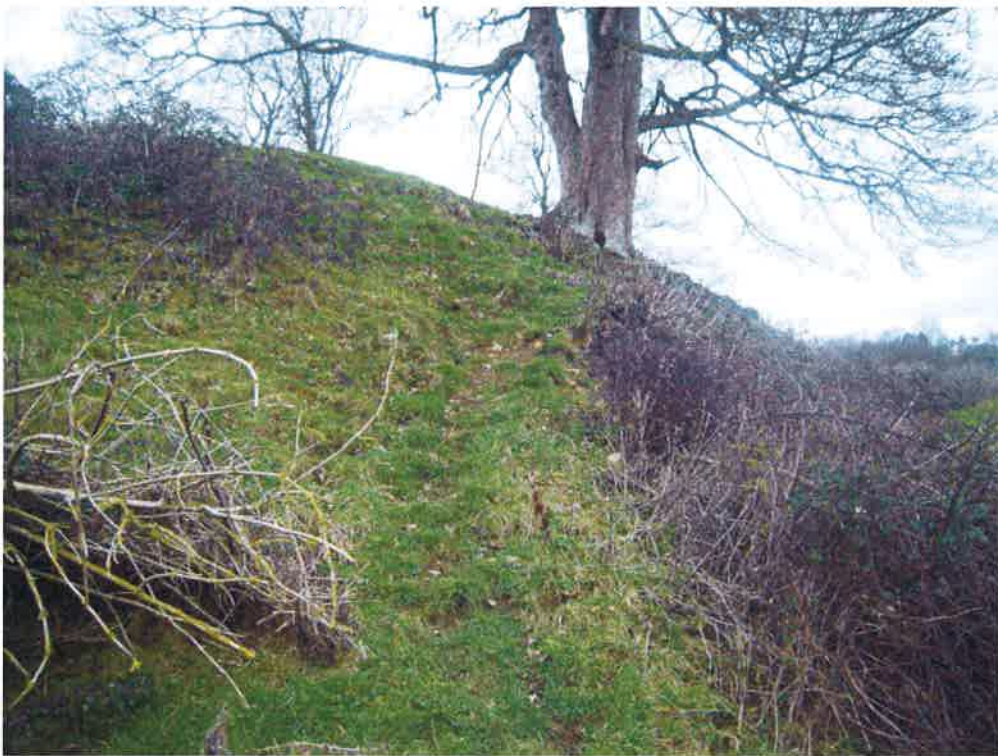
Photograph 6: Footpath on feature 16

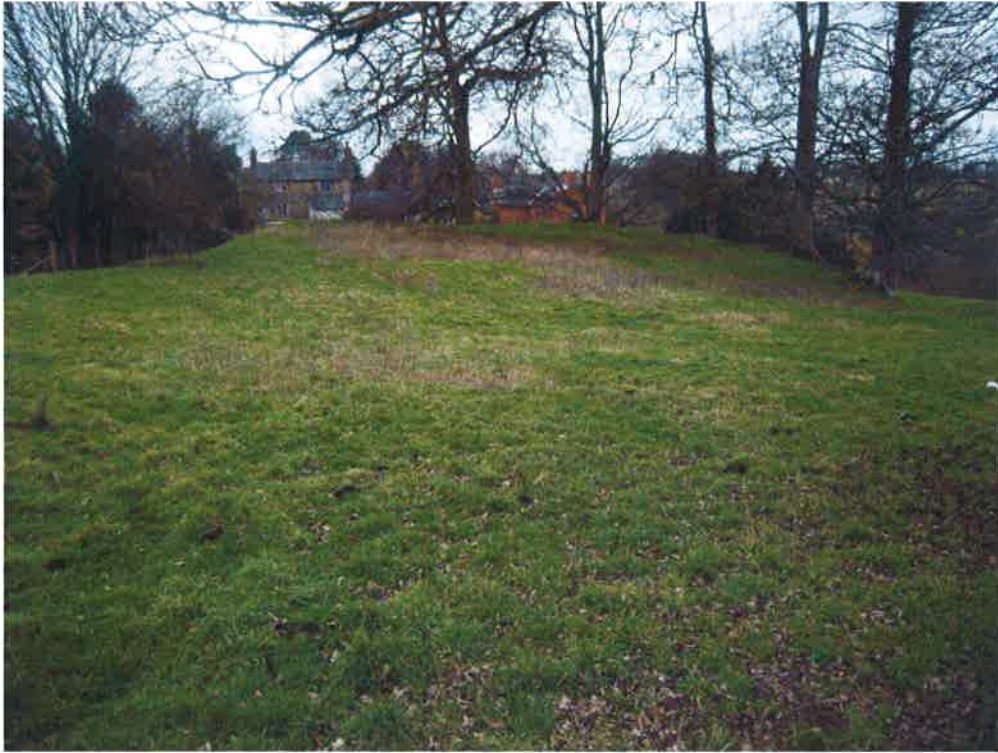
Photograph 7: Feature 17

- 17: An irregular circular shaped raised area in the south-west of the site, enclosing an area roughly 45m from east to west, and 36.5m from north to south (photo 7). It is surrounded by a rampart which measures up to 15m wide and up to 8m from the bottom of the exterior ditch (feature 18) to the top of the rampart. The top of the rampart is flat along most of its course. The outside of the rampart slopes down steeply, whereas the inside has a much shallower and shorter slope. The rampart has tree cover to the north-west, and the east, and has undergrowth cover to the south. The trees have caused erosion with their roots, and where this occurs a considerable amount of stone can be seen (photo 8). Several pathways have been created up the rampart postdating its construction, probably by visitors to the site, or may be indicative of livestock use. On one of these pathways on the north-east of the rampart, some coursed stone can be seen (photo 9). This indicates that the feature is at least partially constructed out of stone. The area within the rampart is flattish, with a few humps and bumps, although no features were discernible among them during site visits. This feature will need further monitoring due to erosion and root damage, and damage from visitors or livestock.

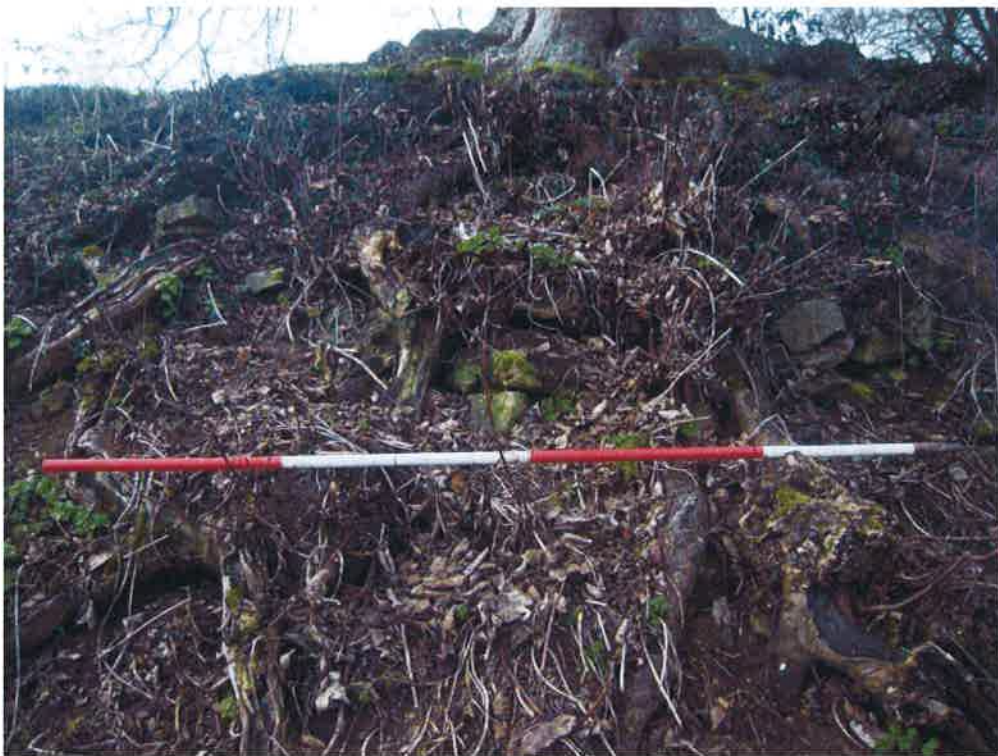
Photograph 8: Tree root erosion revealing a substantial amount of stone on the outside of feature 17

- 3.3.1 Damage has occurred to several features at Swerford castle, due to root activity, trampling by visitors and livestock, weathering, and erosion. Overall, the monument appears to be stable, but it would be worthwhile monitoring features such as the motte, the bailey, and feature 15 - the possible mill site, as they have experienced the greatest root and erosion damage.

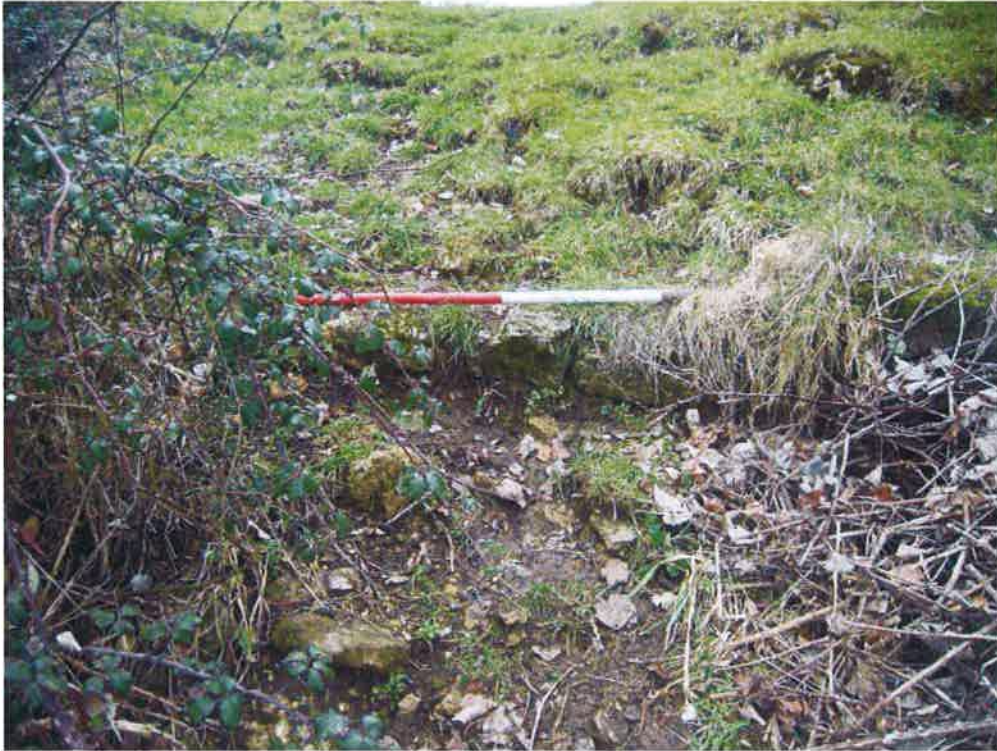
Photograph 9: Pathway erosion on feature 17, revealing coursed stonework.

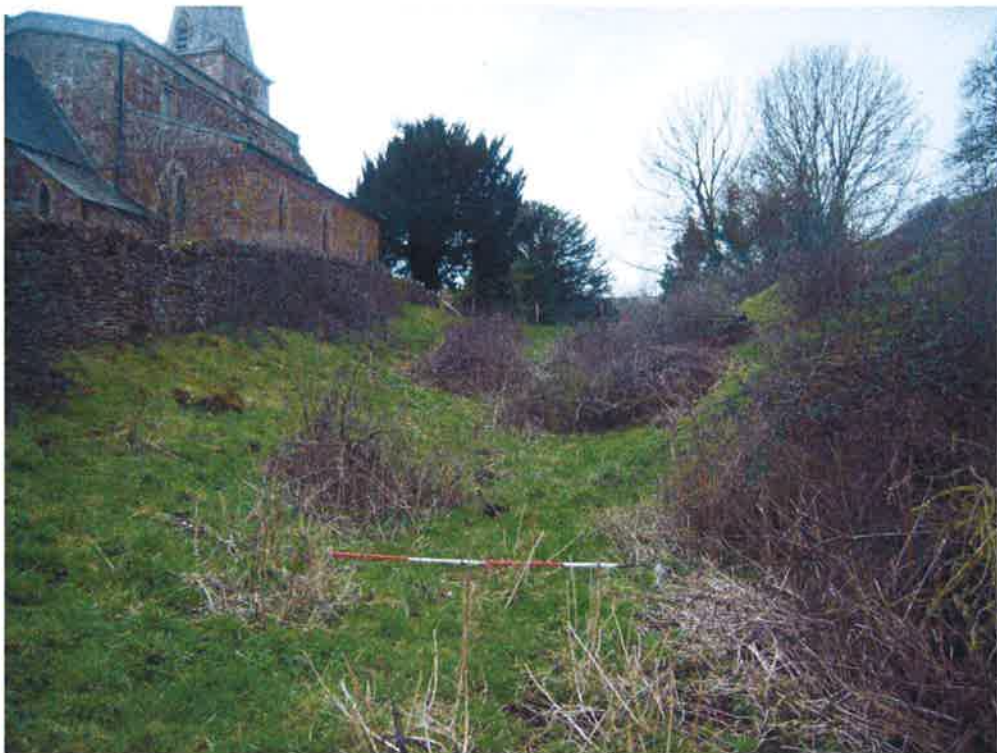
- 18: A bank and ditch around the outside of features 16 and 17 anticlockwise from north-west to south-east (photo 10, 11). It has been truncated to the south-west by the churchyard (photo 12). The distance across the base of the bank is around 18m. The north-western terminus of the bank has a flattened area with stones visible on the surface.

Photograph 10: The ditch of feature 18, to the south of feature 17.

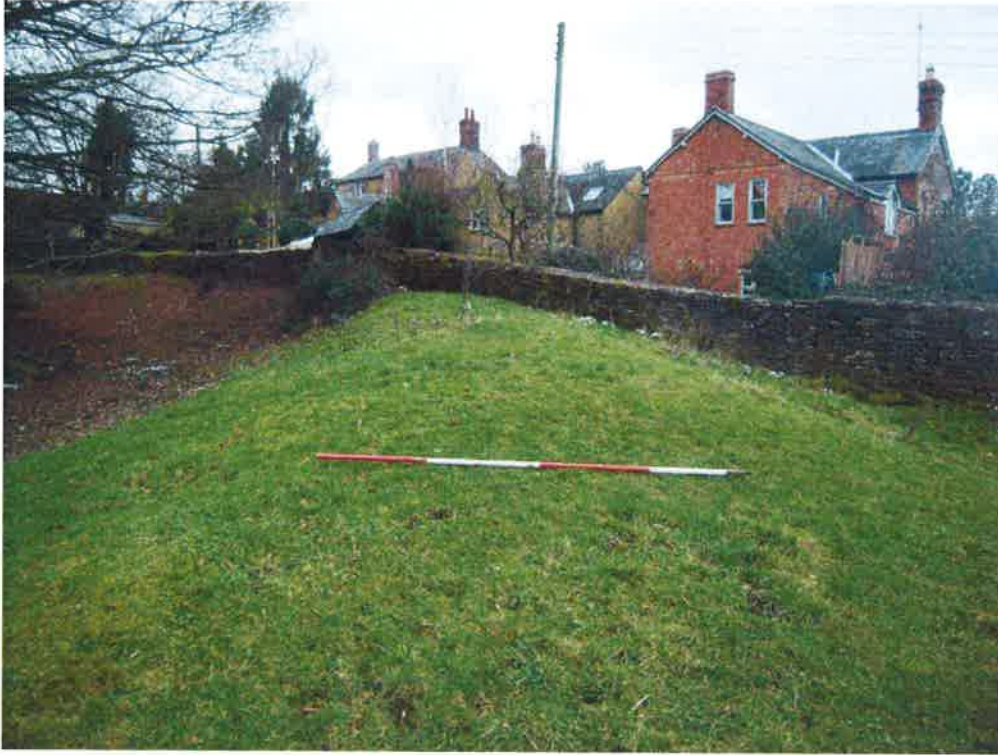
Photograph 11: The bank of feature 18, to the north-west of feature 17

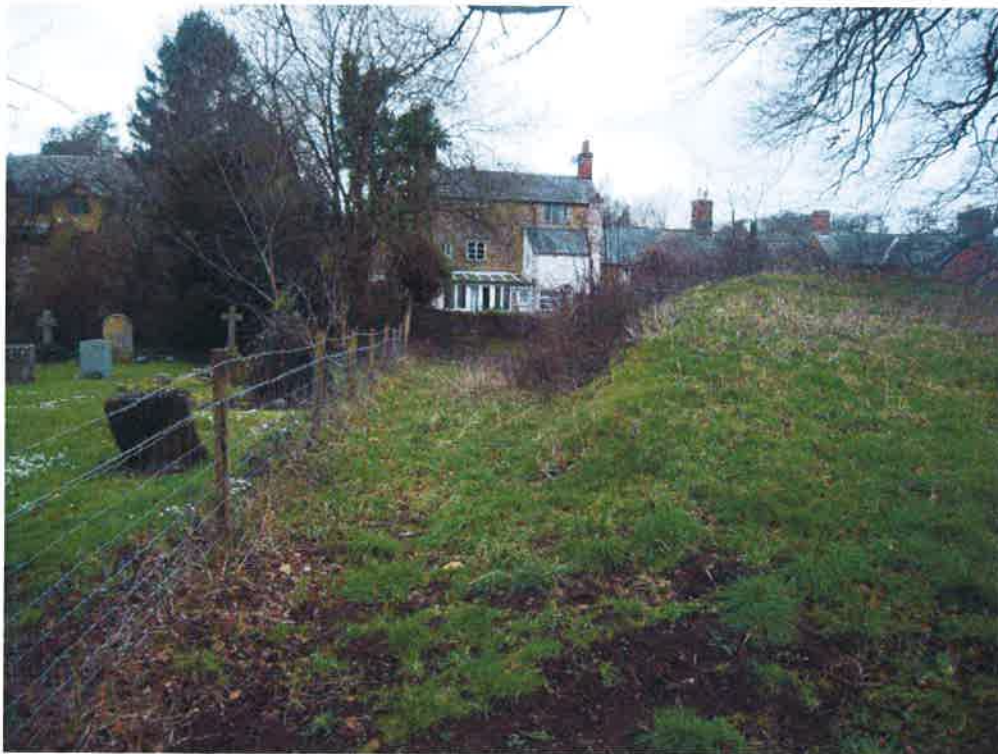
Photograph 12: Truncation of features 17 and 18 by the expansion of the churchyard

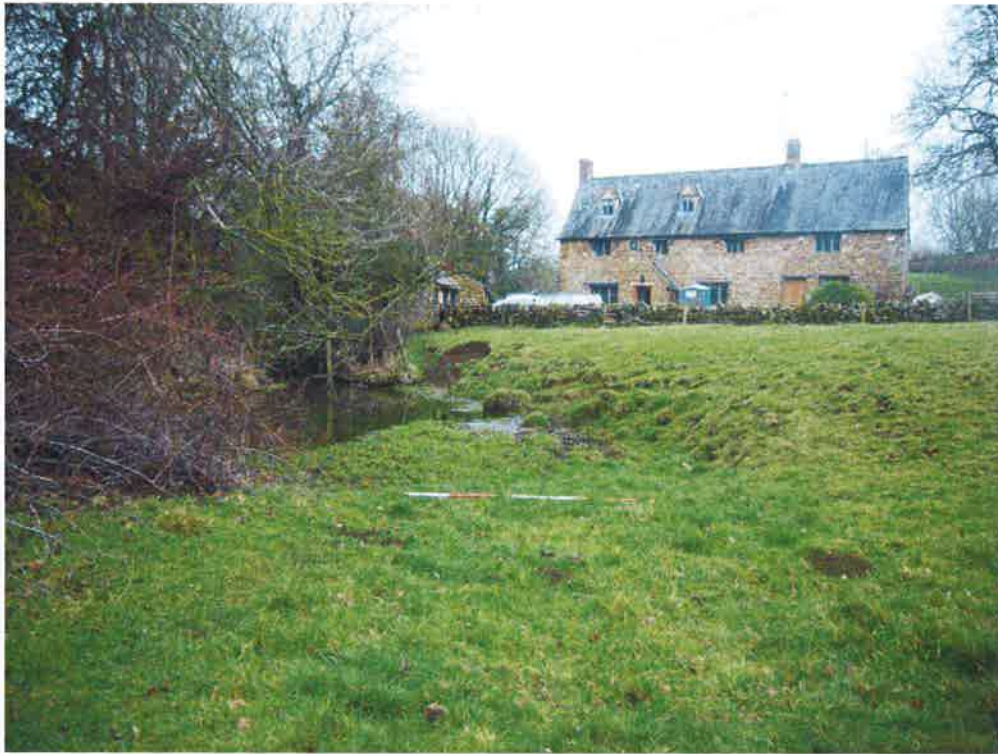
Photograph 13: Pond 1, demonstrating its ability to retain water

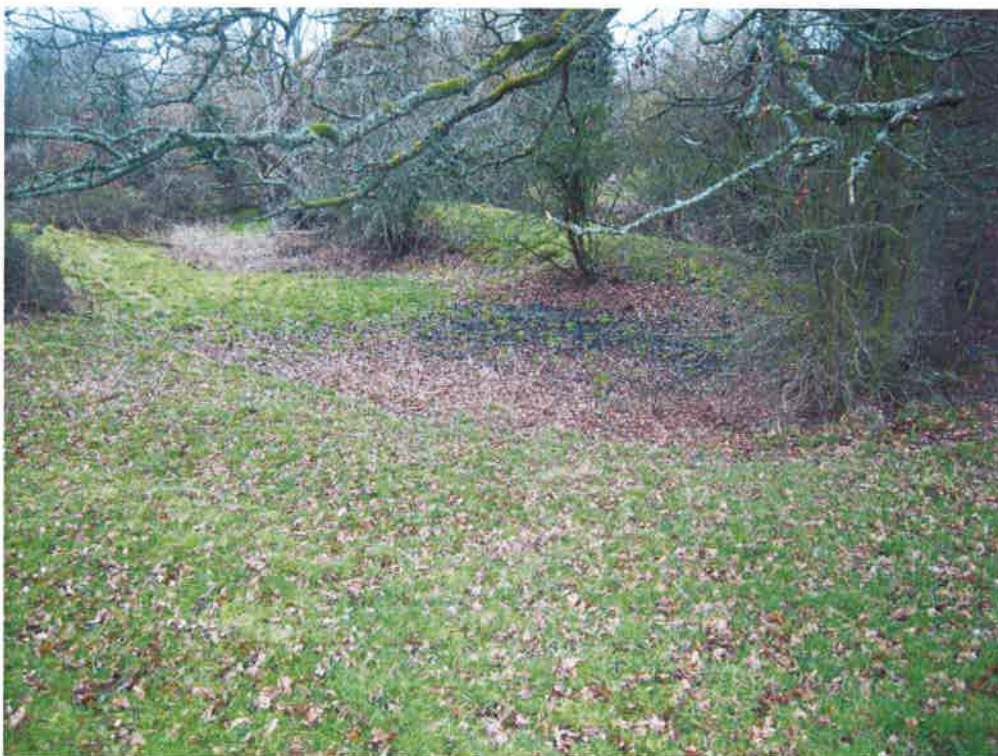
(photo 14). It is semi-oval in shape, and measures 28.7m by 18.3m. It has been cut in to the slope of the hill to the south, and has had banks constructed to form its northern, eastern and western extents. There are two breaks in the northern bank between the pond and the stream, forming inlets for the water when the level of the stream increases (photo 15). They have been constructed so that water can flow into the pond when water levels rise, but not flow out again when levels return to normal. The bottom of ponds 1 and 7 were noted during the site visits to be flooded or waterlogged, and there was an area of recent collapse on the southern bank of pond 7 and the southern bank of pond 1. Ponds 2-6 are much less well defined (photo 16, 17, 18).

Photograph 14: Pond 7, with evidence of waterlogging

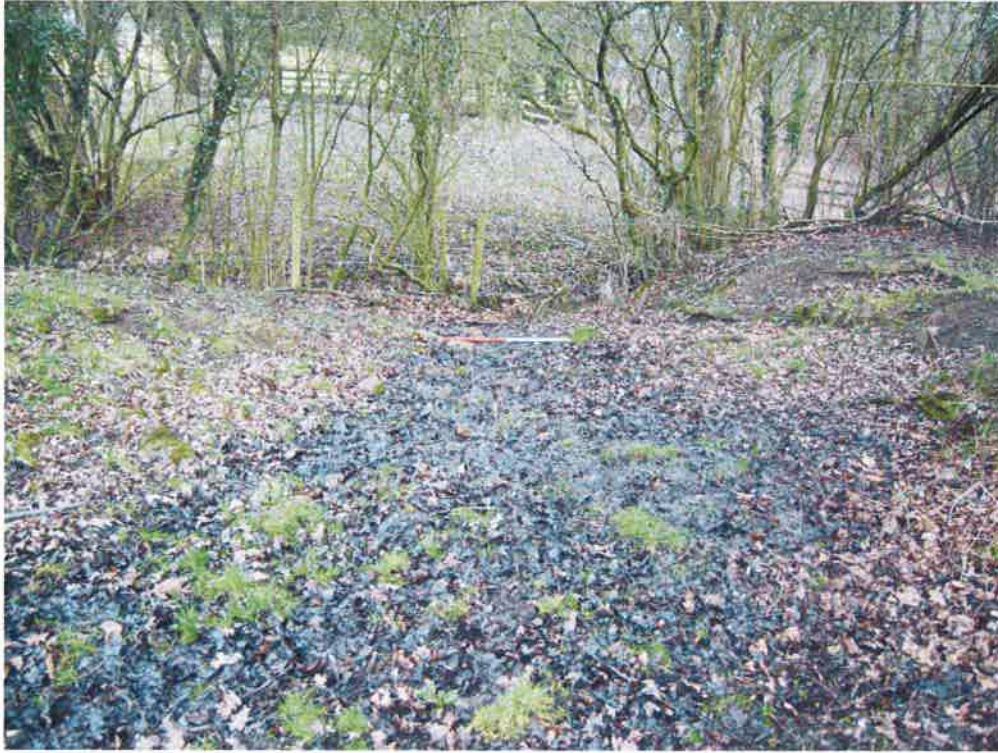
Photograph 15: Inlet between pond 7 and the River Swere

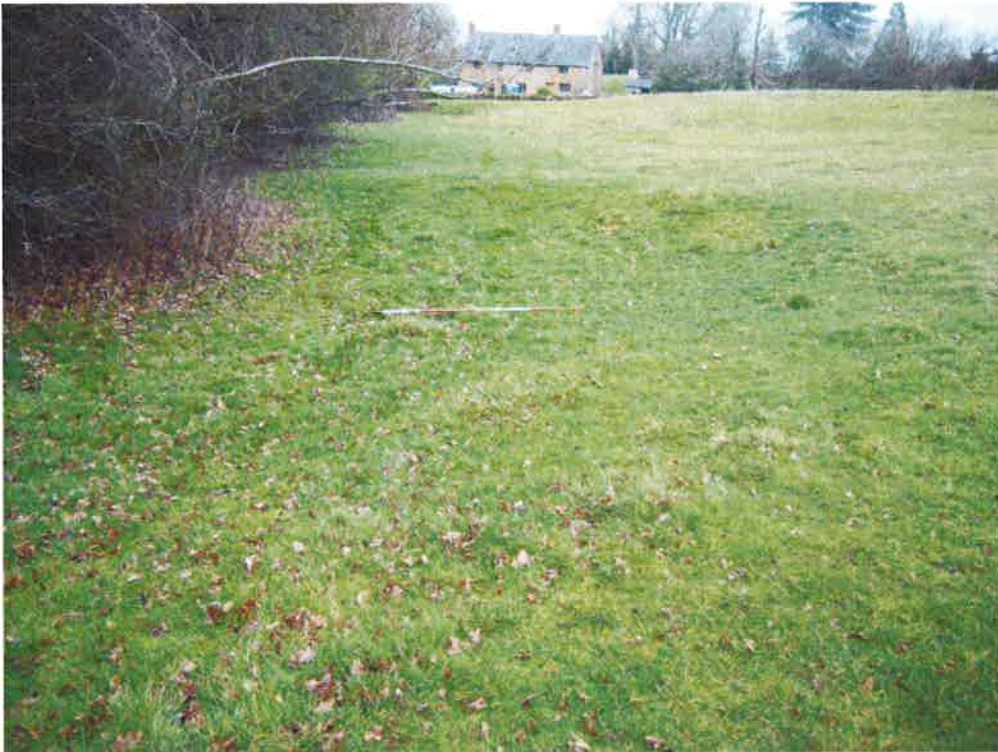
Photograph 17: View across ponds 3 and 2

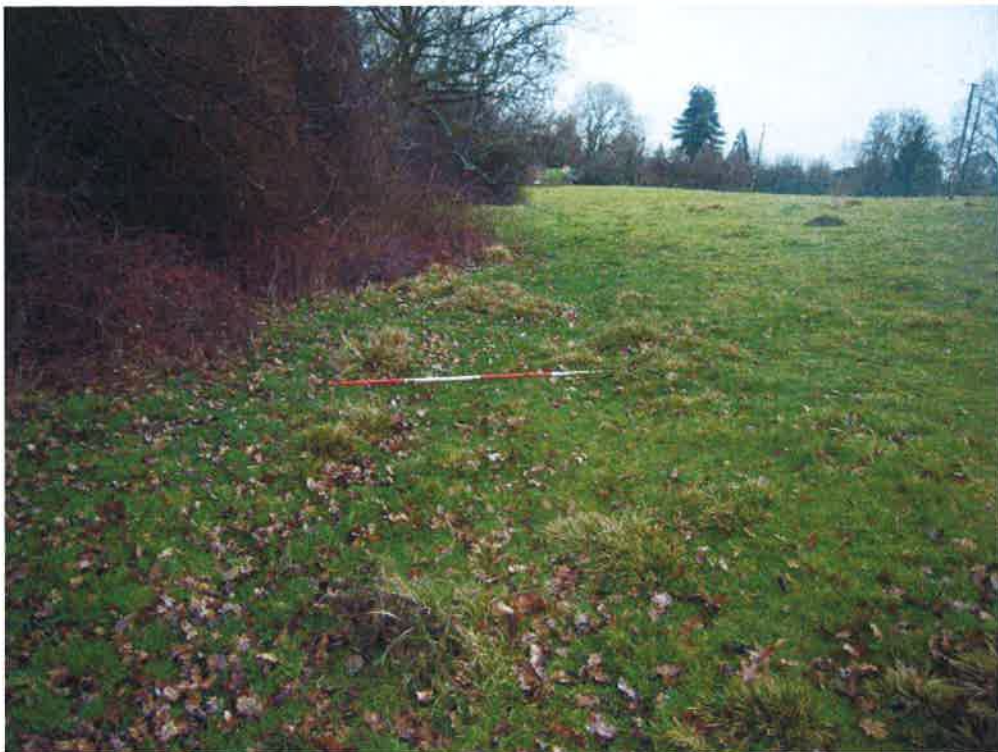
Photograph 18: view across ponds 6 and 5

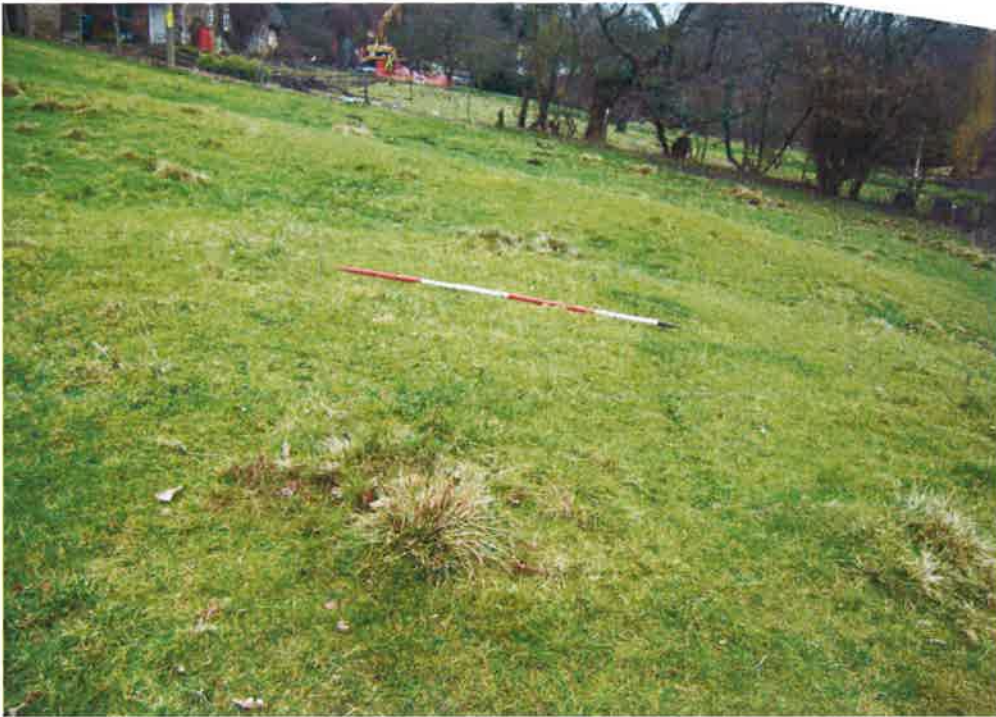
Photograph 19: Feature 9

- 9: A curvilinear raised embankment to the south of pond 7 (photo 19). It runs south from pond 7 for 24m before turning a right angle and running west. The bank is 6.5m wide. The extent of the feature is unknown, as it continues in to the garden of a neighbouring property.

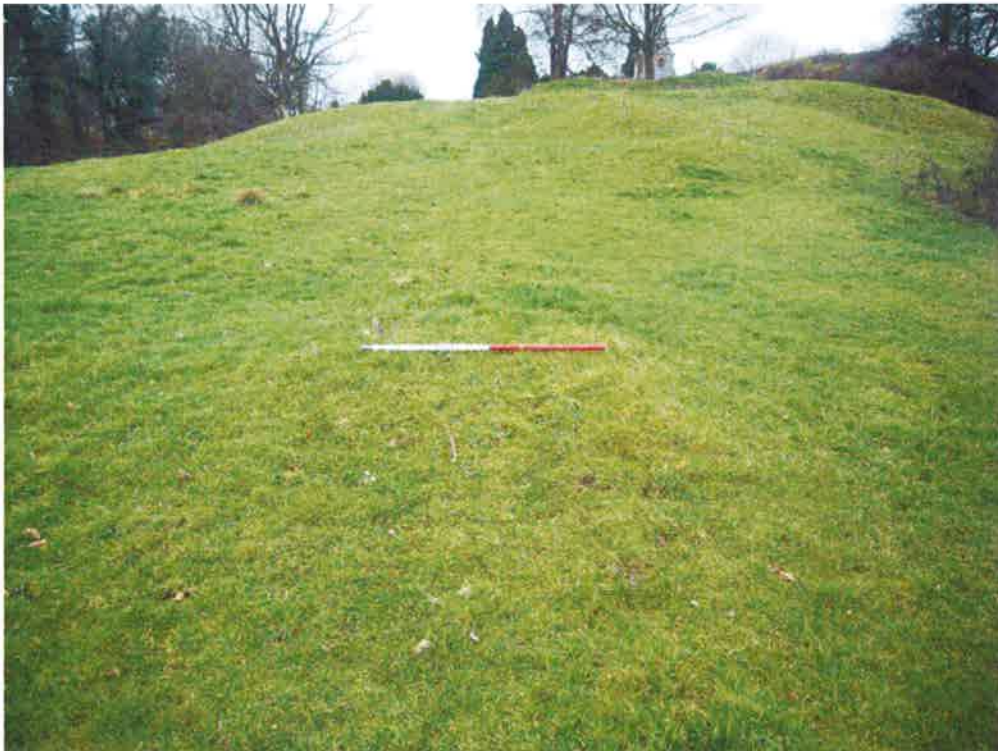
- 11: A possible rectangular structure consisting of four mounds, one at each corner (photo 20). It is aligned north south and is situated at the southern end of feature 10. The north-west mound measures 2.1m by 2.3 has a roughly flat top and well defined edges. The north-east mound measures 2.4m by 3.6m has a roughly flat top and is well defined. The south-east mound measures approximately 3.2m by 2.6m has a roughly flat top and is well defined. The south-west mound measures approximately 3m by 3.1m has a roughly flat top and is well defined. The poor quality of the grass on these mounds indicates that there may be something under the surface, possibly stonework.

Photograph 20: Feature 11, a possible structure
