Swerford Castle Oxfordshire

Topographic Survey Report

September 2012

Client: Natural England

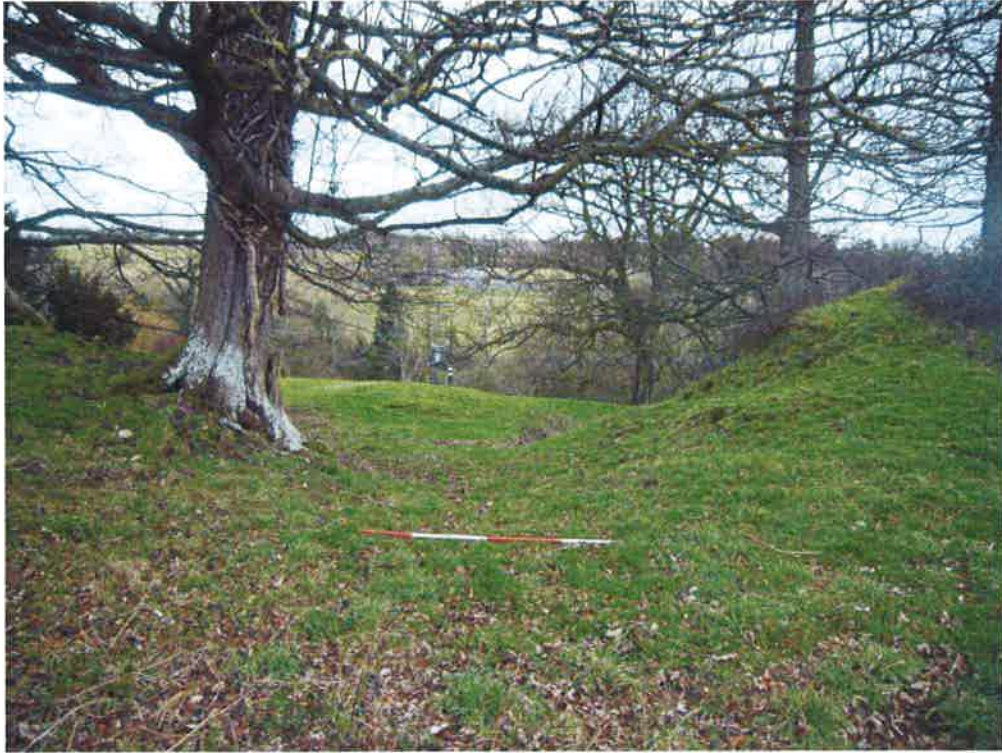
- 3.2.3 The entrance to the bailey is on the north-west, just to the east of the motte (photo 21). At this point the bank and ditch end, and there is an area of disturbance on the bank, which has numerous stones visible on the surface. It may be that some form of entrance structure lay here.

Photograph 21: Entrance in the north-west of feature 17, the bailey

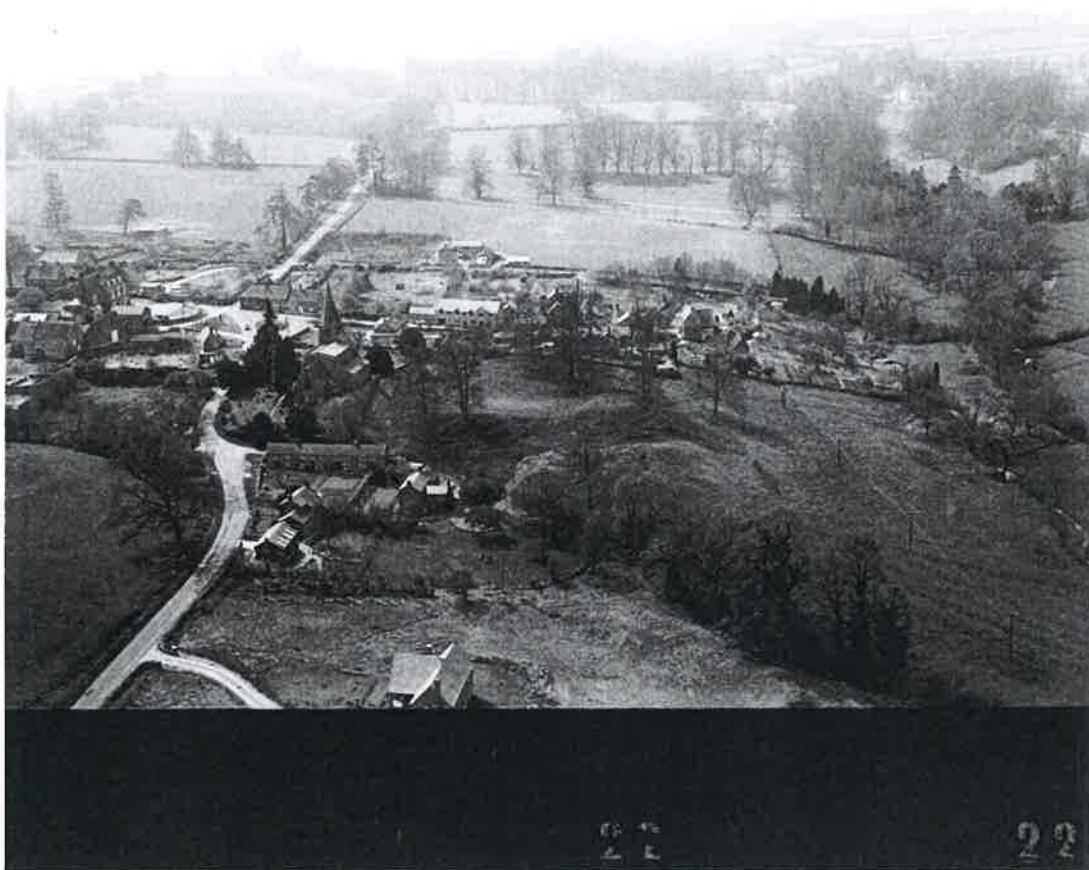
- 20: A linear break of slope, identified during data processing. It runs east-west from the corner of a property boundary on the west of site, and is visible for 60m. It can be seen most clearly on an aerial photograph of the site, taken in 1972-73 (plate 1).

Plate 1: Aerial photograph of Swerford Castle taken in 1972-73 by the Helicopter Training School, based in Netheravon, Wiltshire. The ridge and furrow ploughing can clearly be seen at the bottom right of the picture. Feature 10 shows clearly just above the ridge and furrow.

- 3.2.15 Features 10, 11 and 20 match almost perfectly with former field boundaries seen on the first edition OS map. 10 follows a north-south field boundary, which has some trees indicated on it. 11 sits on the junction of three former field boundaries, including features 10 and 20. The feature is more defined than 10, so the junction may have been of a more substantial construction than the north-south boundary. Feature 20 follows the line of a former east-west field boundary which can be seen on the first and second edition OS maps. Feature 10 truncates the earlier medieval ridge and furrow ploughing, as can be seen on plate 1 and figure 11.

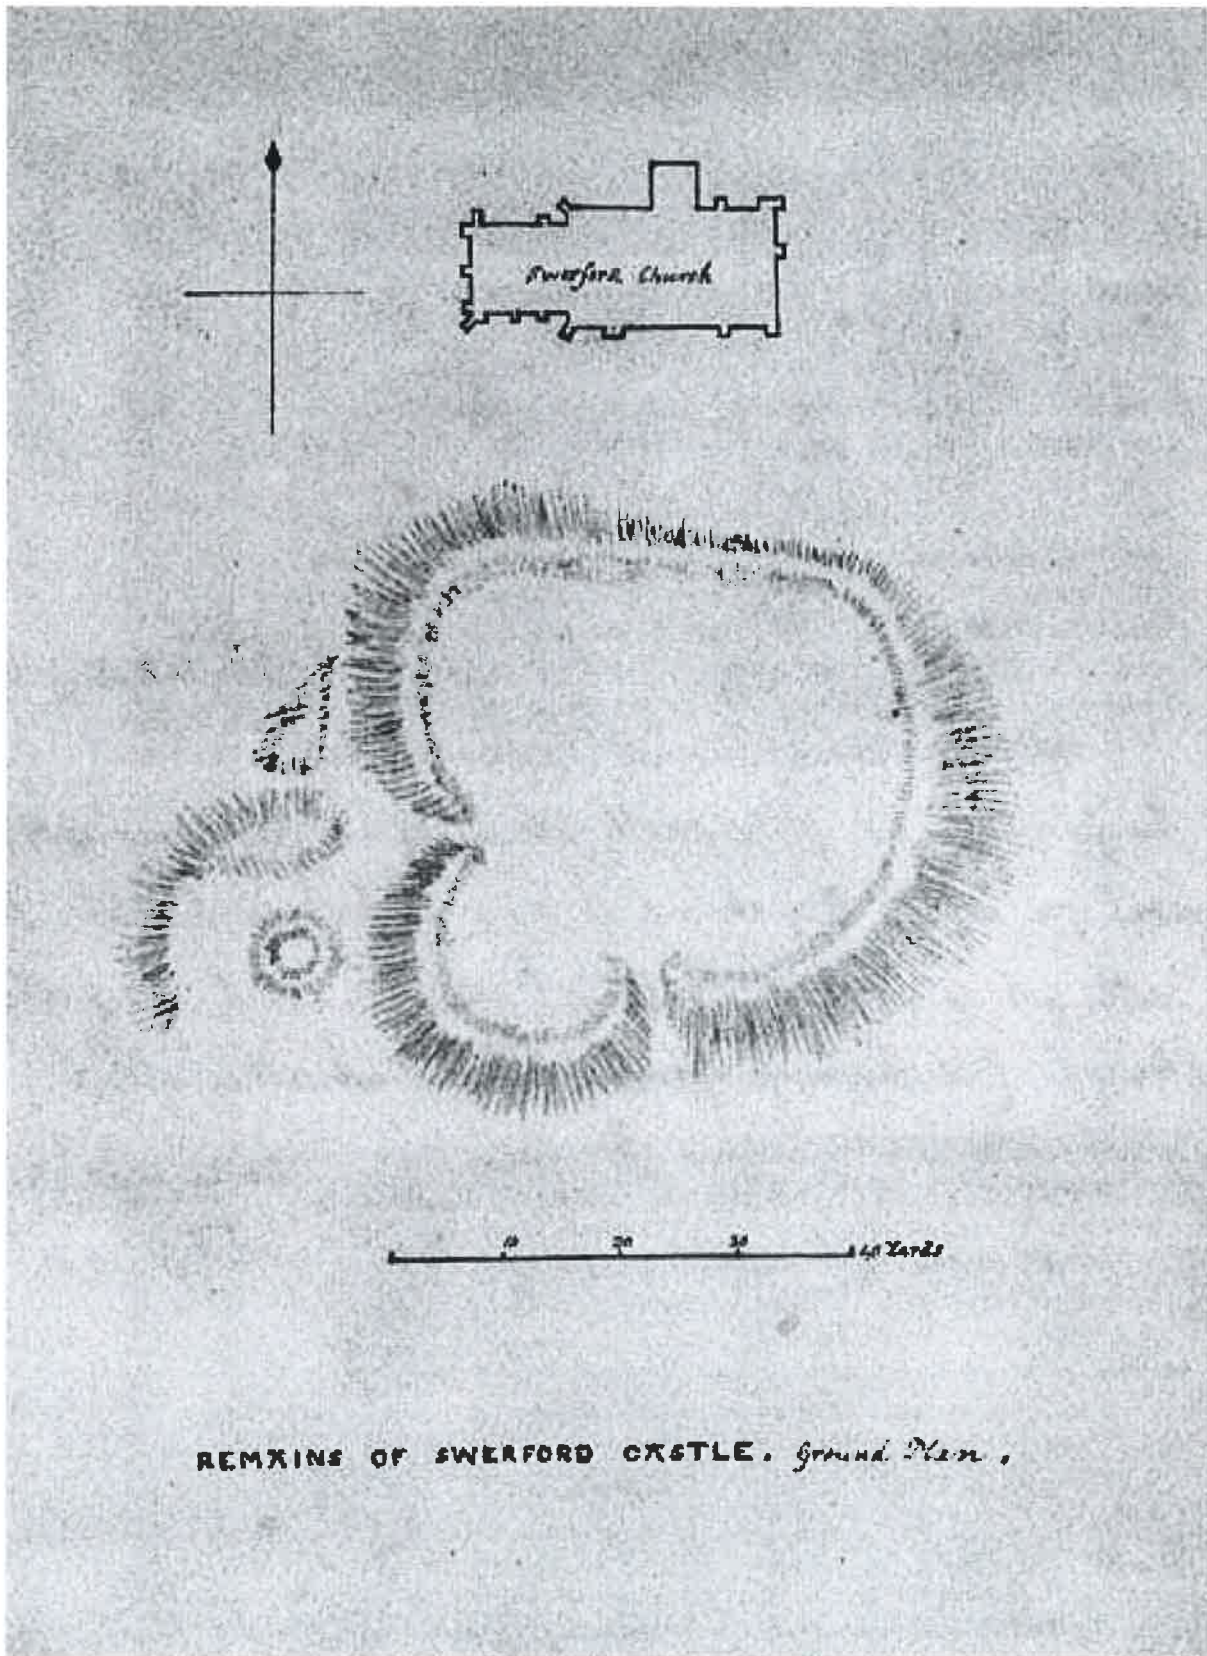
Plate 2: Remains of Swerford Castle, plan from Alfred Beesley's extra illustrated copy of his History of Banbury Vol 3. 1830-1850

The motte and bailey (features 16, 17 and 18) can clearly be seen, as can features 12, 13, 14 and 15 to the west.
