Archaeological Watching Brief Report

OA East Report No: 2353

Land South of Station Road, Barnack, Peterborough

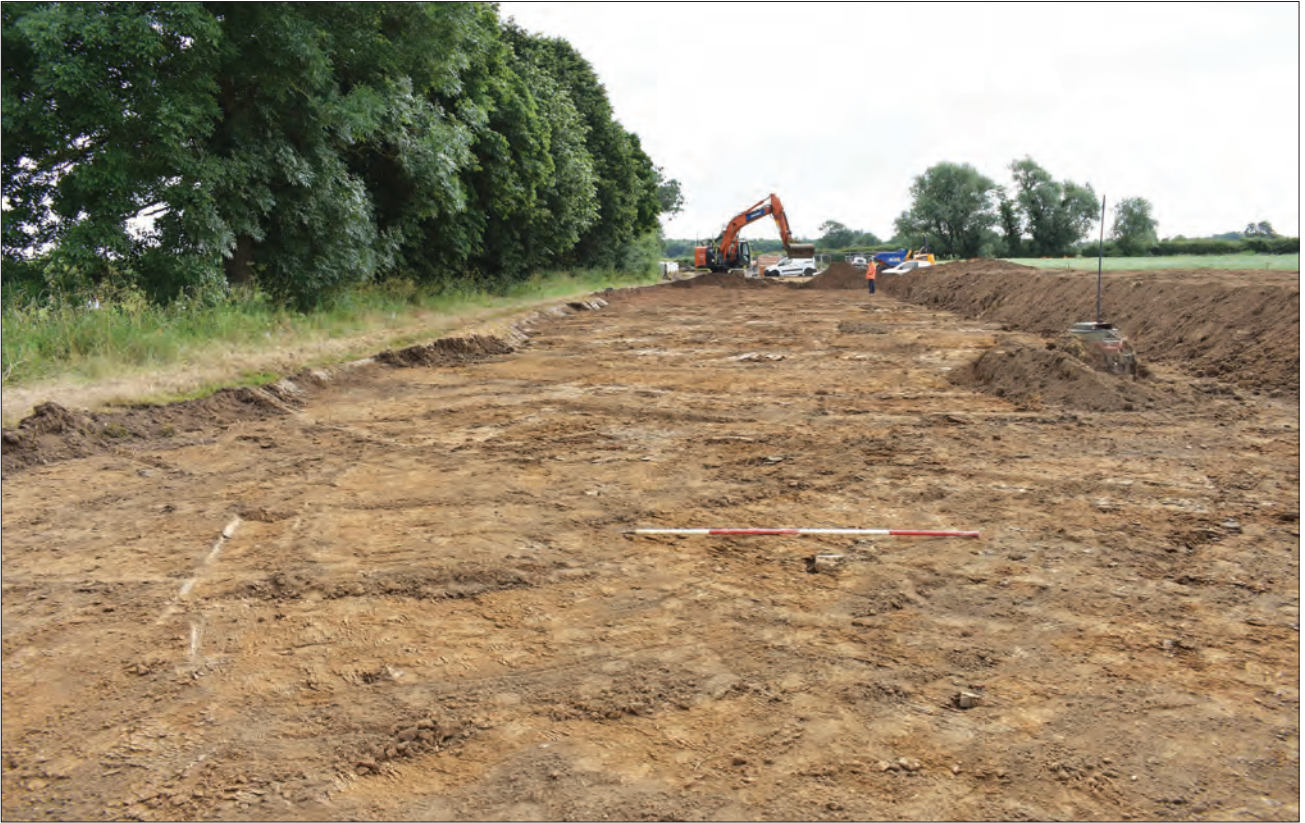
Plate 1: Topsoil stripping

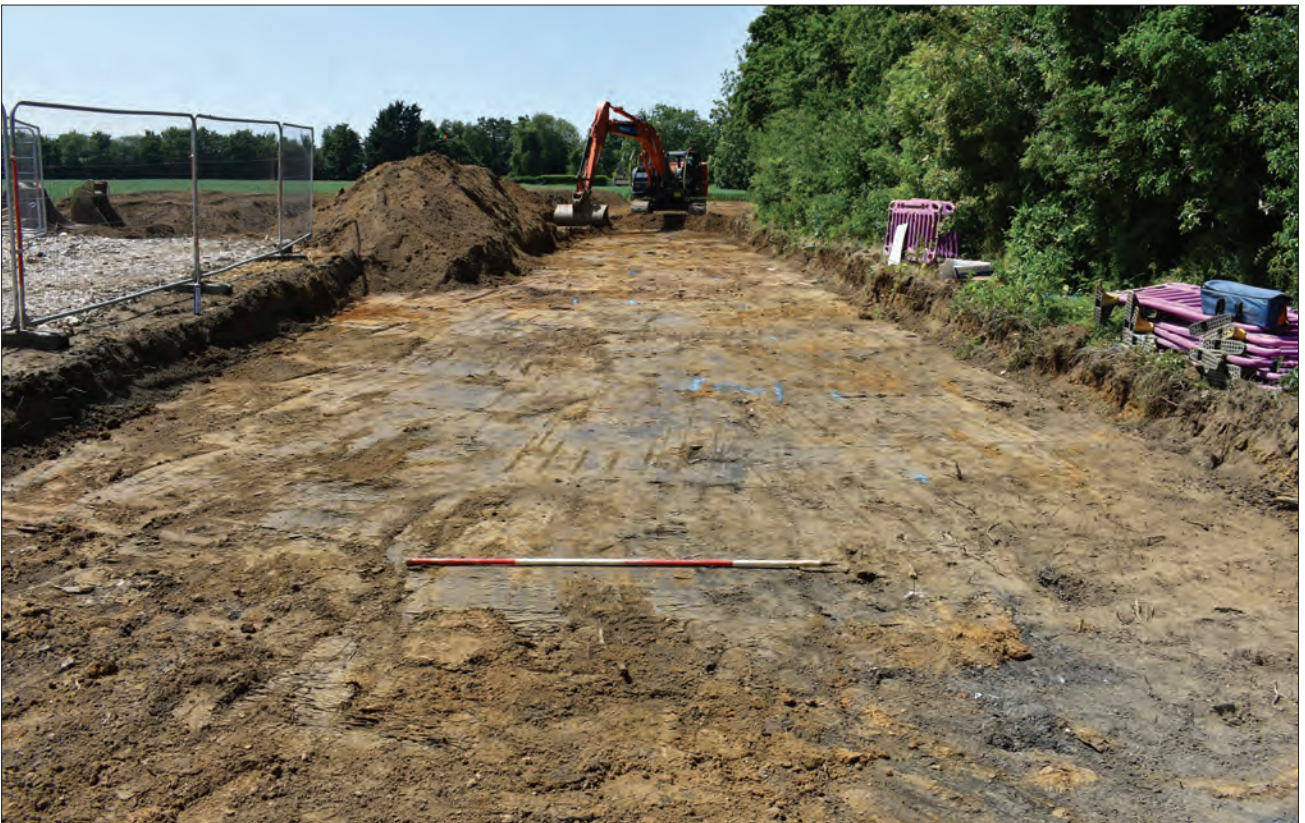
Plate 2: Subsoil stripping

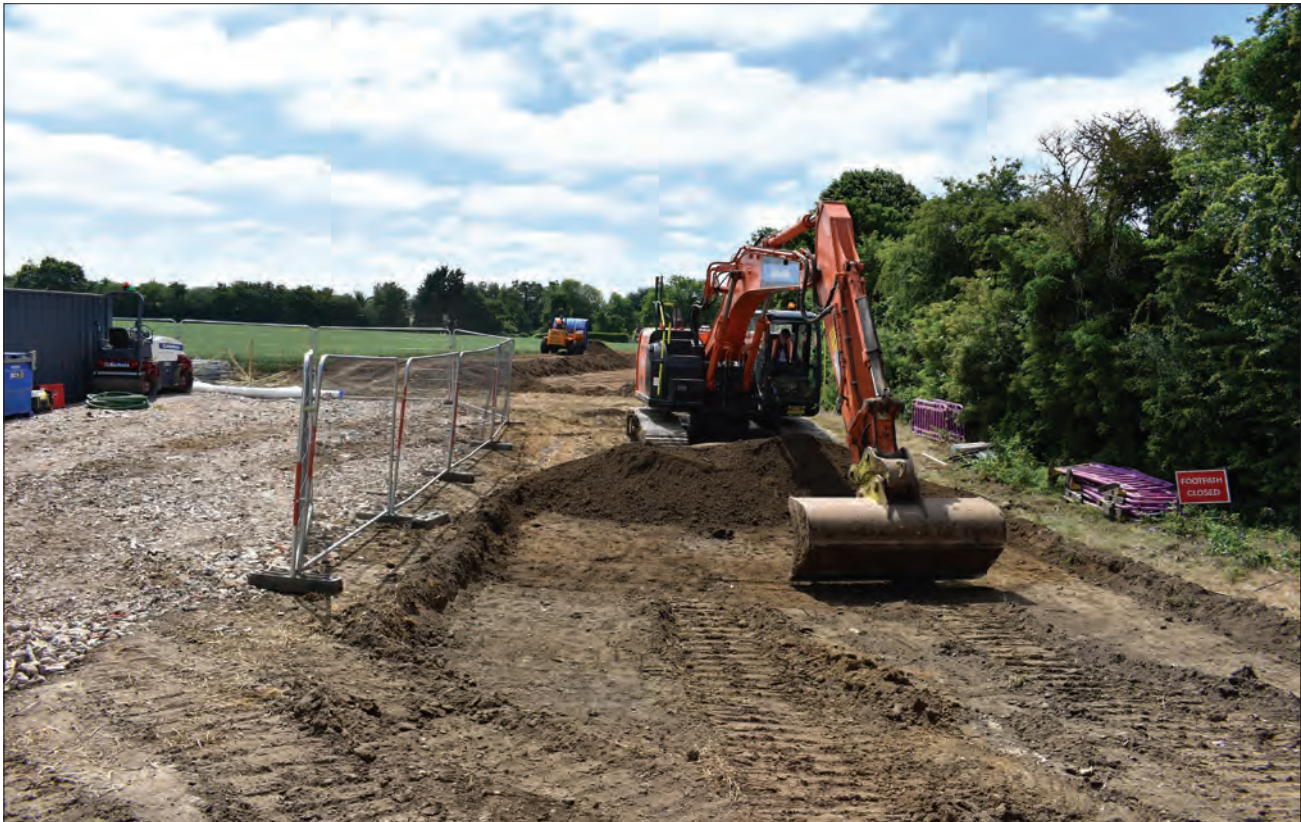
3.3.2 The eastern edge of the trench exposed an extensive layer of friable dark brownish grey clay silt (7; Plate 8) that had an amorphous shape in plan (where its edge was exposed), and was up to 0.3m thick. This deposit spread across the width of the easement and for 15m from the eastern end of the site and contained occasional pieces of modern brick.

Plate 8: Topsoil stripping at the eastern end revealing an area of disturbance 7, looking west

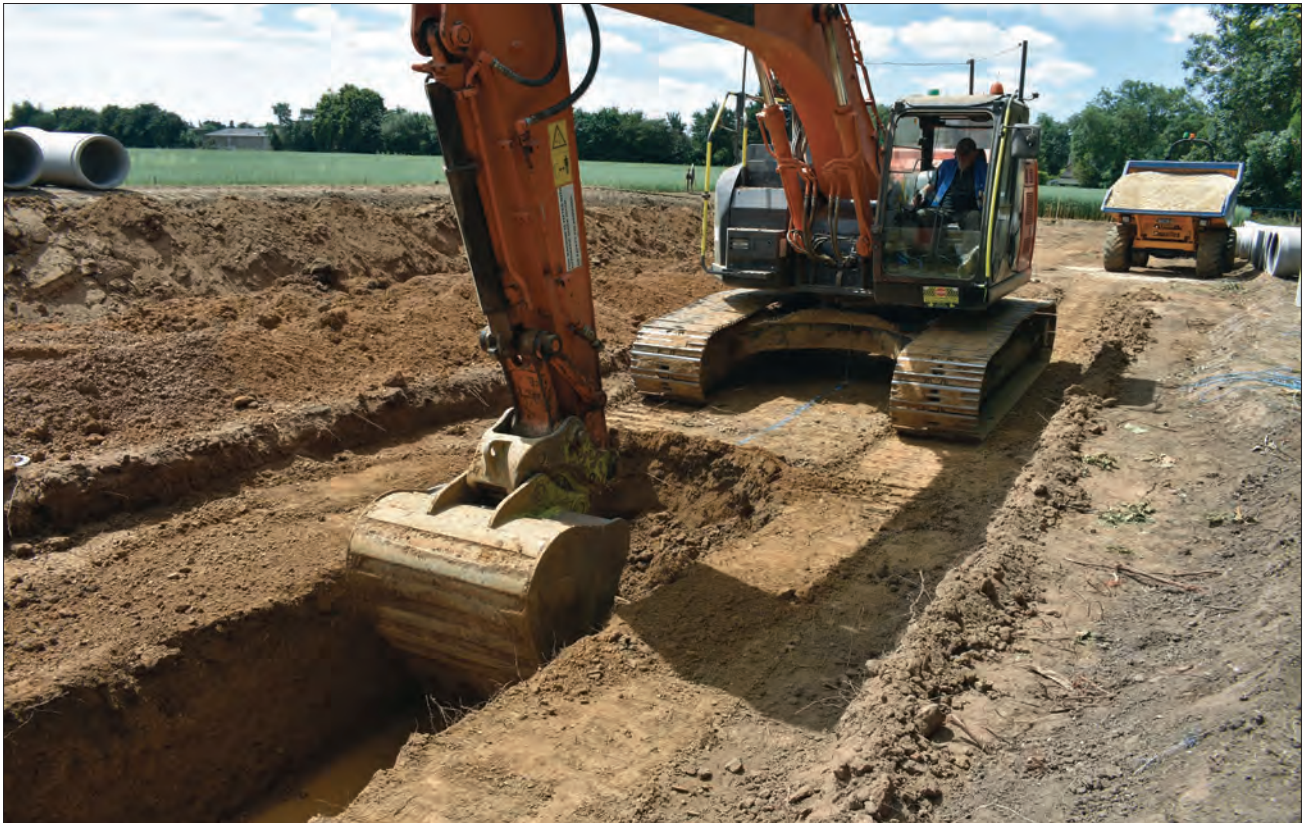
Plate 3: Digging the line of the pipe trench

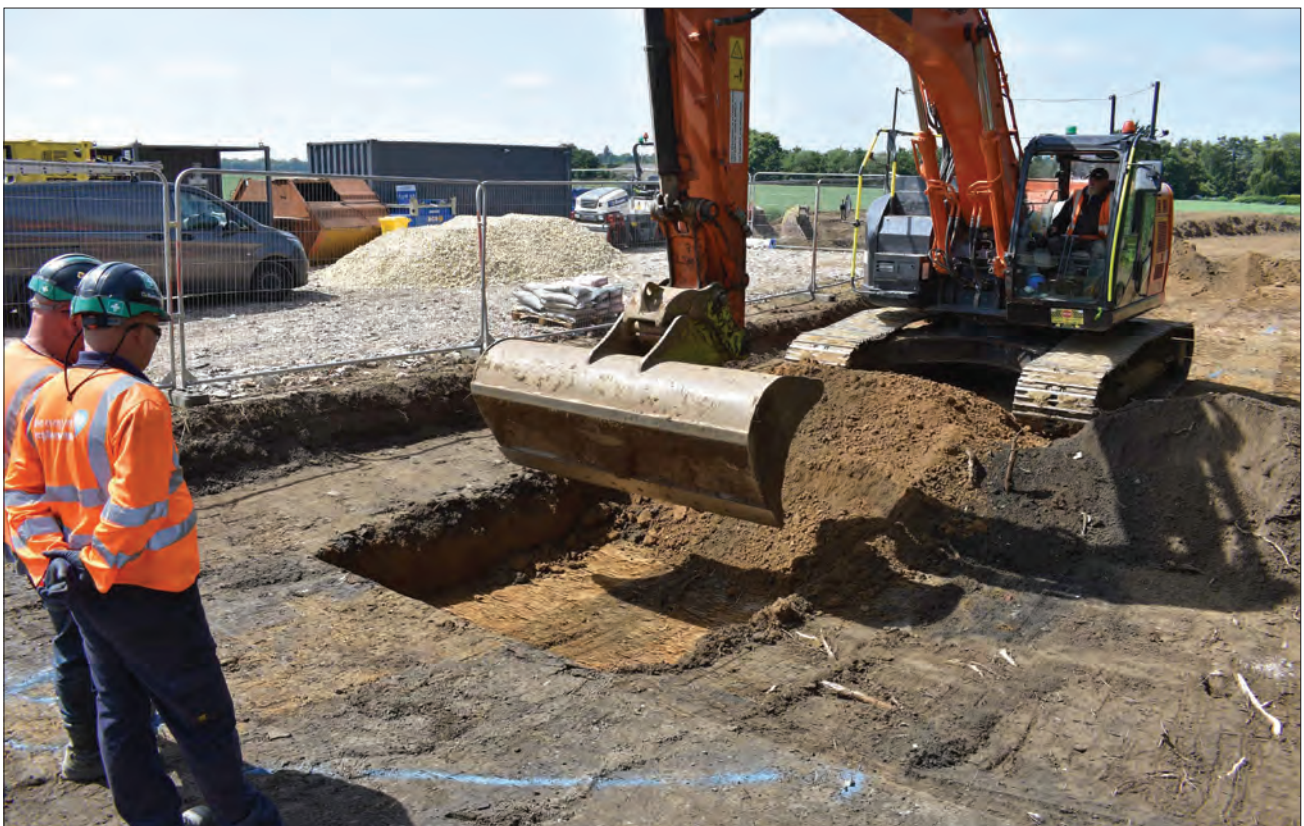
Plate 4: Digging for the manhole

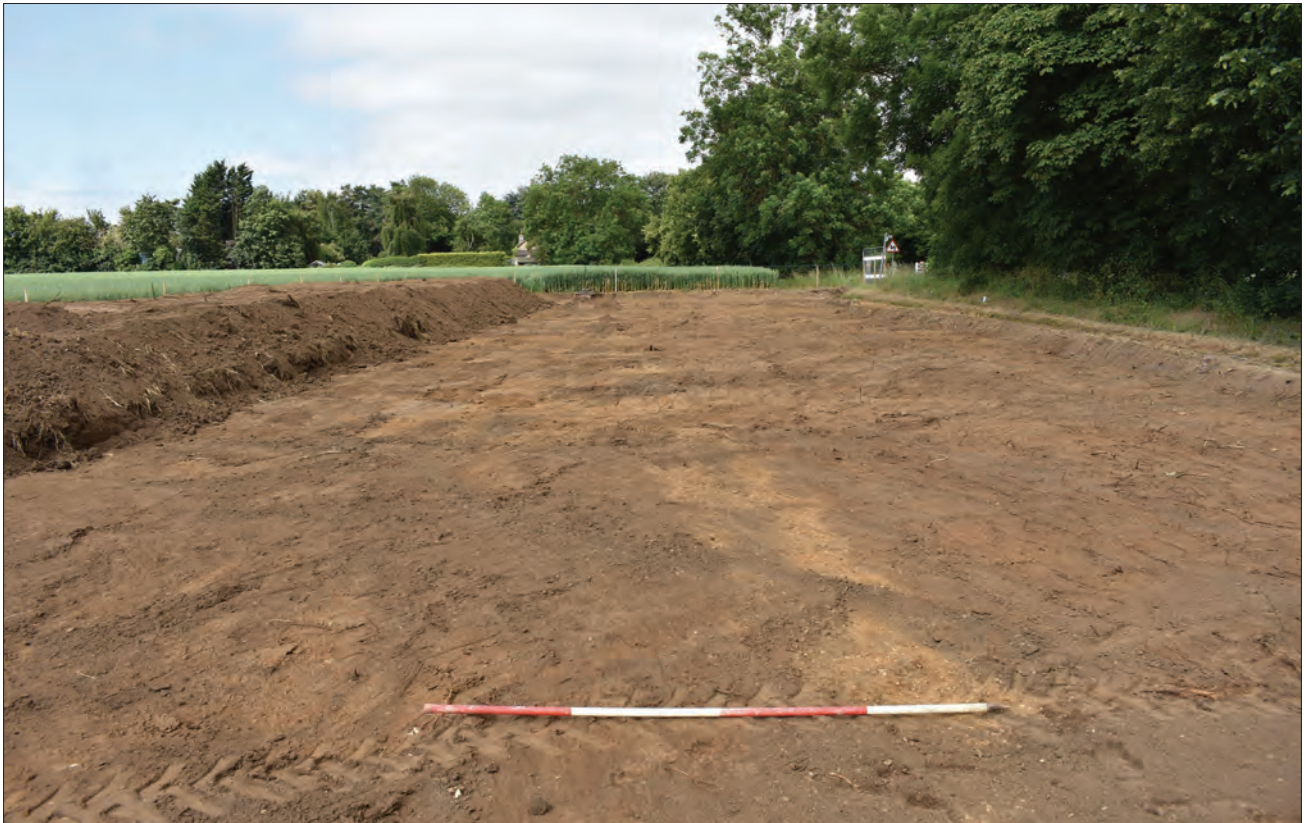
3.2.2 Ground conditions throughout the watching brief were generally good, and the site remained dry throughout. Archaeological features and the existing pipe trench (Plate 5) were easy to identify against the natural geology.

Plate 5: The line of the existing pipe trench
