Twyford Wharf Banbury Oxfordshire

Historic Building Analysis

**Twyford Wharf
Adderbury Banbury**

Historic Building Assessment

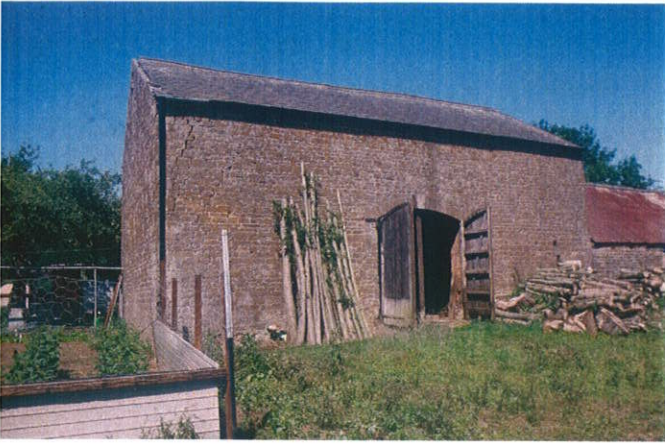
Plate 1: Block A from the south-east

- 3.2.1 **Description:** This large (12.4 m x 7 m) rectangular building sits at the south end of the site. It is a large open rectangular structure with small windows on the eaves (north and south sides) and large double doors on the east and west. The exterior is made up of large blocks of ironstone neatly laid in horizontal courses. The interior is entirely lined with large pink lightly fired bricks apart from a small alcove for a light on the east wall. There are no internal features. The floor is lined in large square slabs and slates cover the roof. The barn is almost all of one phase although the upper part of the west doorway has been rebuilt in recent times. The south doorway has a fine stone shallow arch with

well made voussirs and a pronounced keystone. Some of the ironwork on both doorways may be original. The east door is also somewhat lower than the west. The roof consists of two softwood (probably pine) trusses supporting a single purlin to each slope. Each truss comprises a tie-beam, a pair of principal rafters, an iron king strut between the centre of the tie and the apex of the rafters and two raking struts between the tie and rafters immediately below the purlins. The purlins are notched and rest on top of the principal rafters while the common rafters run over the purlins. The primary roof remains substantially intact although the common rafters appear to be secondary additions. The roof form is strongly suggestive of an early 19th-century date for the barn.

- 3.2.2 **Significance:** This is a well built and elegant building of early 19th-century date built using an interesting and unusual building technique. The possible historical association between this building and the canal increase the importance of this building.

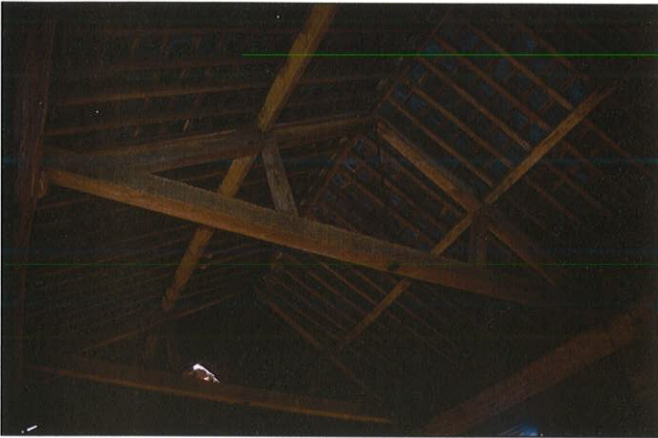
Plate 2: Internal view of Block A truss

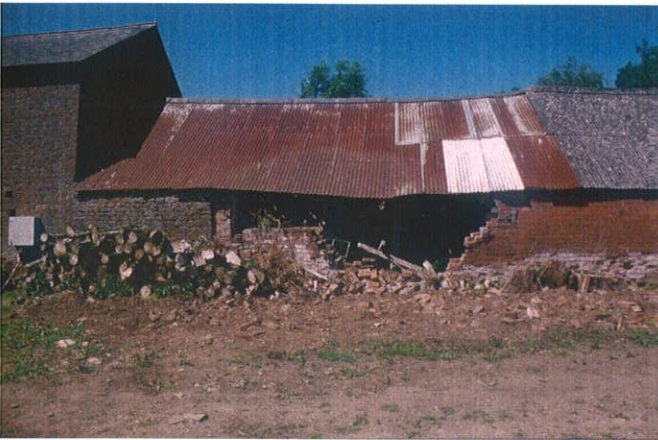
Plate 3: Block B from the east

- 3.3.1 **Description:** A single storey cow shed with a slate, corrugated iron and asbestos roof. The south end is obviously earlier and on the eastern side has a small surviving section of rough stone walling. The rest of the walling is brick of various phases. The north end is much later than the south the western wall is made of modern brick whilst the eastern wall and the internal dividing wall appear to be 19th century. Much of the east brick wall has collapsed destabilising the whole southern part of the building. The doorways are simple openings with rough timber doors of various dates A blocked door with a moulded brick jamb lies at the north end of the east elevation.

- 3.3.2 The roof in the north end is a simple relatively modern structure (mid 20th century). The south end has three simple trusses formed with timbers reused from elsewhere (tie-beam and two principal rafters to each truss) the central truss is particularly rough and is propped in several places. The purlins of the southern roof are set directly into holes in the wall of the adjoining barn, this proves that the cow-shed post-dates the barn. Several types of roofing material are represented. The south end has blue tiles on the west side and corrugated iron on the east whilst the whole north end is covered by asbestos sheeting.

- 3.3.3 The northern end has no fittings apart from a simple hay basket. In the southern part however there are a number of fittings including rough internal fencing and partitions repaired in places with old doors and corrugated iron. There are also the remains of a row of cattle stalls with a crude integral wooden manger trough.

- 3.3.4 **Significance:** Block B is an animal shelter of probable 19th-century date and is now in a structurally unsound condition. It requires substantial renovation/rebuilding but it adds to the group value of the structures at Twyford Wharf and to an understanding of the complex.

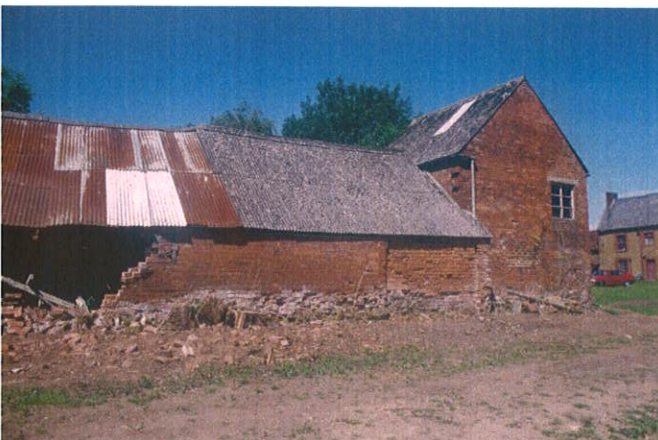
Plate 4: Blocks B and C from the east

3.4.1 **Description:** This building appeared to act as an office for the Twyford brickworks up until the 1930s and since then it has been used for storage. It is a square building of 19th-century date and forms the north element of the block made up of buildings A, B and C. The building is two storey and made of deep red brick with numerous patches and repairs. On the southern side bricks have been left protruding during construction presumably to allow the addition of an upper floor to building B. The roof is of asbestos sheet.

3.4.2 There is a single doorway on the northern facade with a panelled door topped by a shallow brick arch. Another door on the first floor must have been accessed by ladder or used only for loading. There are two windows on the north side one on the east and one on the west. The ground floor windows are all set in shallow brick arches the upper all have concrete lintels. A single blocked window with brick arch lies high on the west gable. The windows themselves are all glazed with iron and wooden frames of an early 20th-century type. The tiny west window is the only exception and this has a wooden frame and decorative iron catch.

3.4.5 **Significance:** Block C is a 19th-century building which has undergone some alteration in the past (roof and windows) but still it retains a number of primary features and is an unusual survival of its type.

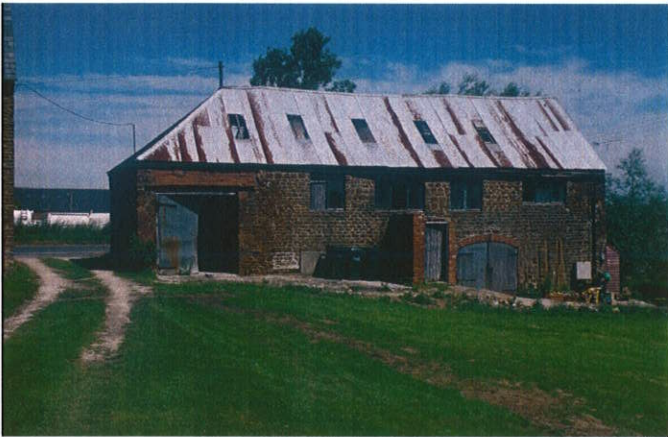
Plate 6: Block F from the south

- 3.7.1 **Description:** A large rectangular open barn or agricultural building built on two levels but currently only the ground floor is intact. The building is deeply

terraced into the canal side bank and is single storied at the west and two storied at the east. The walls are mostly local yellow ironstone on the exterior and much of the interior is lined with the same large pink bricks seen in Building A. The roof is covered in modern corrugated iron and roof lights.

- 3.7.2 The building is entered by two doors on the southern face, the eastern door is on the basement level and has a delicate shallow arch much like that on Building A. The western door gives access to the upper floor and is a simple rectangular opening topped by modern brick. On the north side are two blocked doors the western one is similar to its companion on the opposite side and has again been recently rebuilt. A smaller blocked door or window lies further to the west this is capped by a simple timber lintel. The only other entrance is a door high on the east (canal) side which looked out from the upper floor.

- 3.7.3 The windows are a row of modern iron frames set into the (largely rebuilt) southern side. These are capped by concrete lintels and inserted into the exterior stone wall, which is backed with breeze blocks. These were inserted in the 1980s or early 1990s. The only accretion to this building is a small (and now roofless) room on the southern side. This evidently once contained a privy.

- 3.7.4 The roof is covered with sheets of corrugated iron with Perspex panels only the small west roof retains its slate covering. The roof structure itself has suffered from major alteration and is almost entirely modern and is supported by a number of props. An original truss still survives at the western end this is suspended below the modern rafters with little support, The tie beam has been removed completely and the whole truss has no structural purpose.

- 3.7.6 **Significance:** This barn has many constructional and stylistic similarities with building A. It has however been substantially altered in recent times and this has adversely affected its historic integrity.

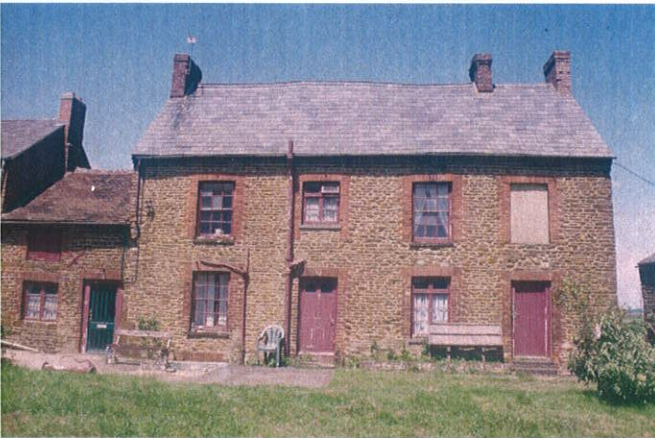
Plate 7: Block G from the south

- 3.8 **Building G Wharf House or The Red Lion**
- 3.8.1 **History:** The red lion was first licensed as a public house in 1832. Its name probably has no significance in that it is traditional and very common pub name (there is a far larger Red Lion public house in Adderbury village). It

- 3.8.2 This public house seemingly utilised the east end of building. It consisted of a number of rooms on the ground floor. Nearly all the fittings of the pub have been removed but some are retained in the small room at the southern end of the house. This includes a late 19th-century cast-iron Art Nouveau fire surround with iron and brass fender. Above this sits an intact gas light with glass shade. The bar counter is painted wood with a hinged flap and door, further counter sits on the west wall complete with a lockable cash drawer.
- 3.8.3 **Significance:** A remarkably intact building which retains a number of interesting features both inside and out. The railings and original fenestration are interesting survivors and some of the fittings including fireplaces and gaslights are also of note.
