Oak Colliery, Hollins Road, Oldham Greater Manchester

Archaeological Evaluation

Oxford Archaeology North

July 2010

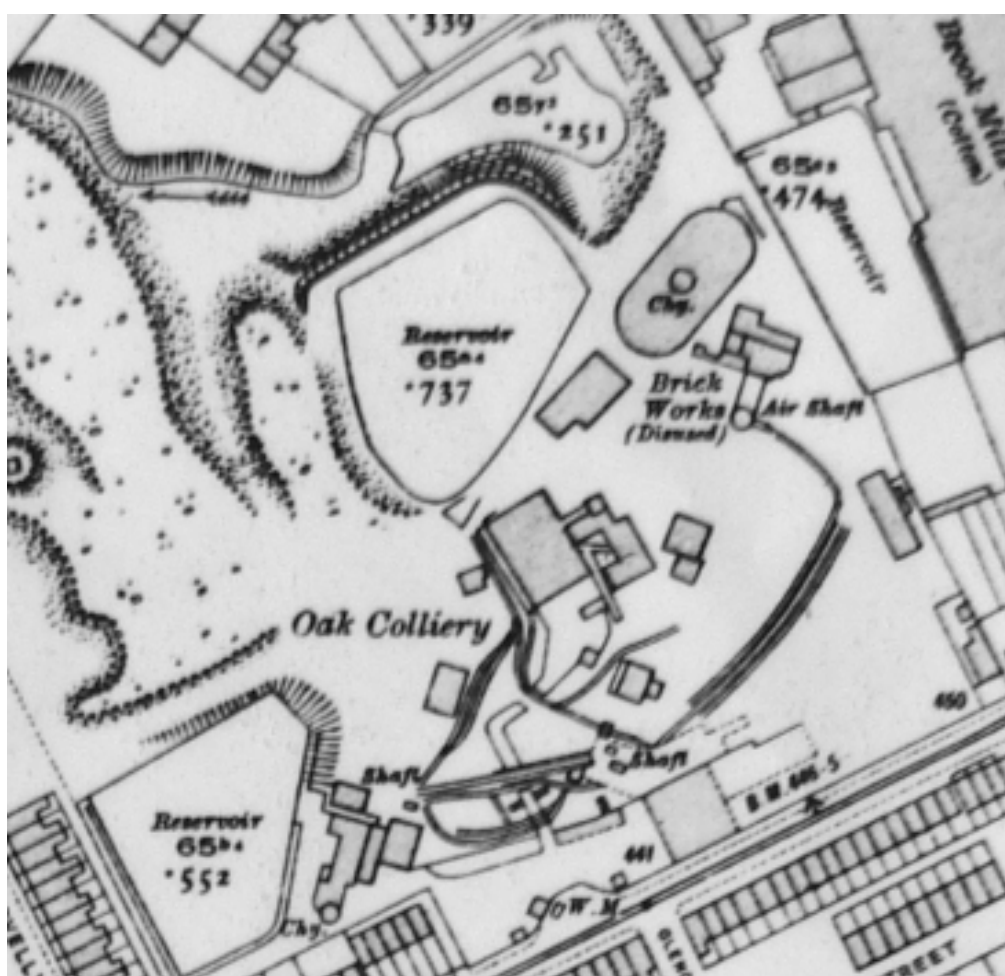
Plate 6: Extract from the Ordnance Survey 25": 1 mile map of 1922 (revised 1916)

- 3.3.22 The Ordnance Survey map of 1922 also shows the buildings on the pit bank at Victoria Pit to have been replaced with a new, large structure erected on the southern boundary of the site. The map also shows new structures to have been erected on the pit bank associated with Albert pit in the south-west corner of the site. These included a chimney, suggesting that the steam-power plant for the winding engine had been replaced; it is possible that this was the building depicted in a photograph dated to the 1920s, thought to be of Albert Pit (Plate 7).

- 3.3.21 The Ordnance Survey 25": 1 mile map published in 1909 (based on revision of the 1894 survey, which was completed in 1906) shows the layout of the colliery as largely unchanged relative to the layout in 1894. However, the next edition of Ordnance Survey mapping, published in 1922, shows several important changes to have been implemented (Plate 6). The brick works is marked as 'disused', although the kiln clearly survived extant. The group of buildings situated to the south of the reservoir, incorporating the putative boiler house, has been remodelled and expanded, with new buildings erected immediately to the south-east of the existing structures; the intended function of these buildings remains uncertain. This group of buildings is shown to have been served by a new network of tramlines, although this appears to have been intended purely for moving coal around the colliery, as there are no connections with railway lines beyond the site boundary; the Oak Incline, which had connected the colliery to the Hollinwood Branch of the Ashton-under-Lyne Canal, is no longer shown, and the tramline to the boiler house of Brook Mill has also been removed.

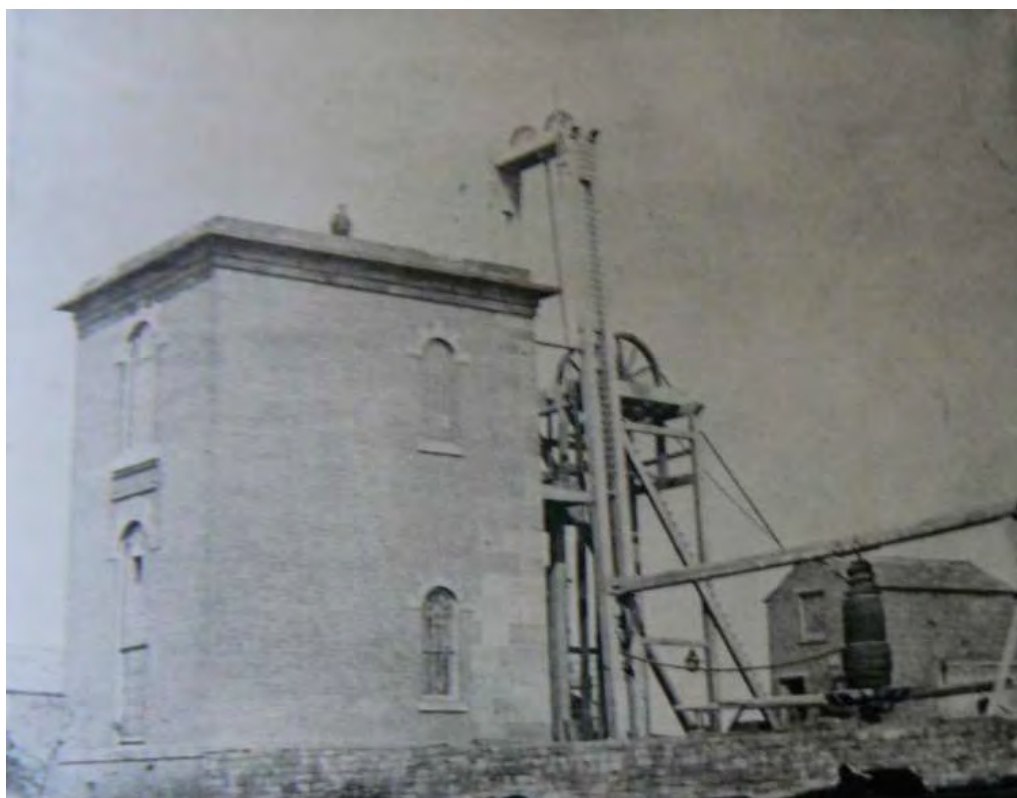
Plate 7: Albert Pit in the 1920s (reproduced from Fanning 2001)

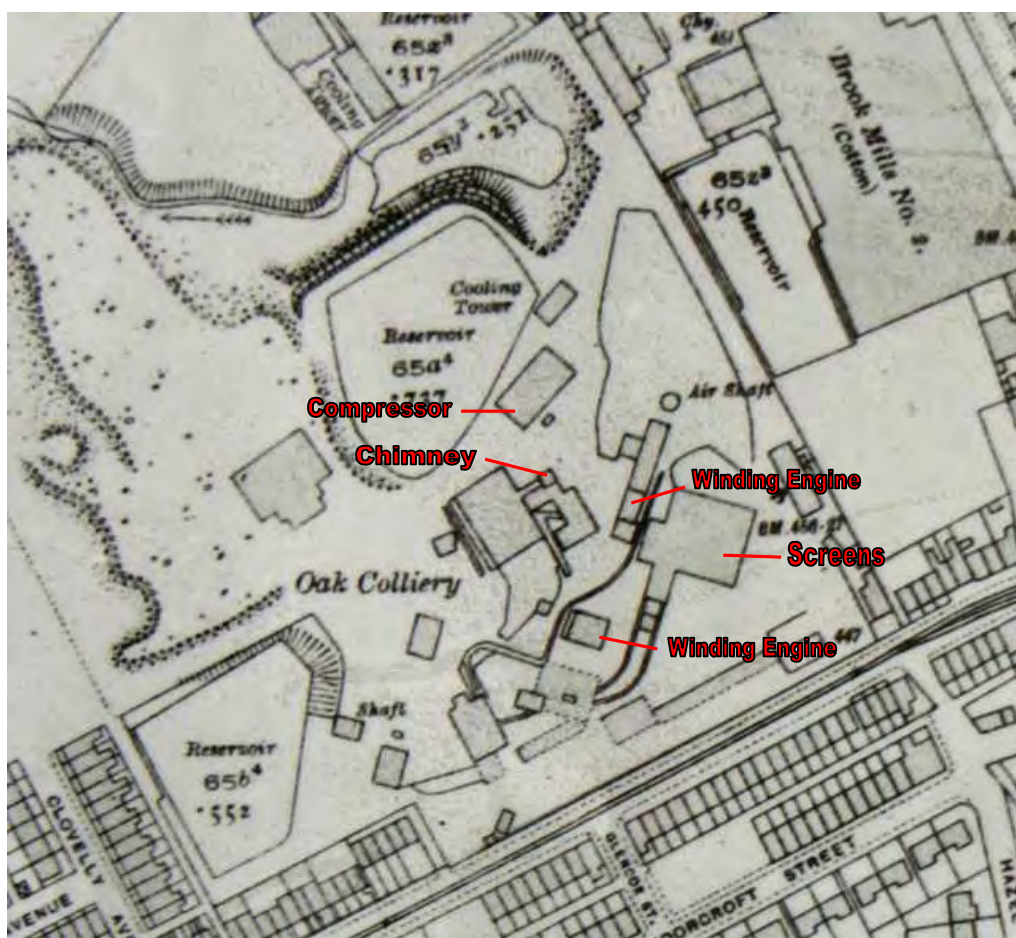
Ordnance Survey 25": 1 mile map of 1936 (Plate 8). This shows the brick kiln in the north-eastern part of the site to have been demolished, together with the buildings immediately to the south-east. The upcast shaft is marked, with an associated range of new buildings situated to the south-west. These are shown on a deposited building plan of 1953 (Plate 9) to have housed the upcast winding engine and the fan motor (CBO 4/11). Immediately to the south-east of the upcast winding engine and fan house is a large new building, which is identified on the deposited building plan of 1953 as screens. The Ordnance Survey map also shows a reduced group of buildings on the pit bank around Albert Pit, although the shaft is still marked.

Plate 8: Extract from the Ordnance Survey 25": 1 mile map of 1938

- 3.3.25 In the List of Mines in Great Britain and the Isle of Man for 1938, the Chamber Colliery Co Ltd is listed as the owner of Oak (Victoria) Colliery, with I Jackson as the manager; the company is also listed as the owner of Ashton Moss Nos 1 and 2. At that date, 366 men were employed underground, and 107 on the surface. The layout of the colliery at that date is depicted on the

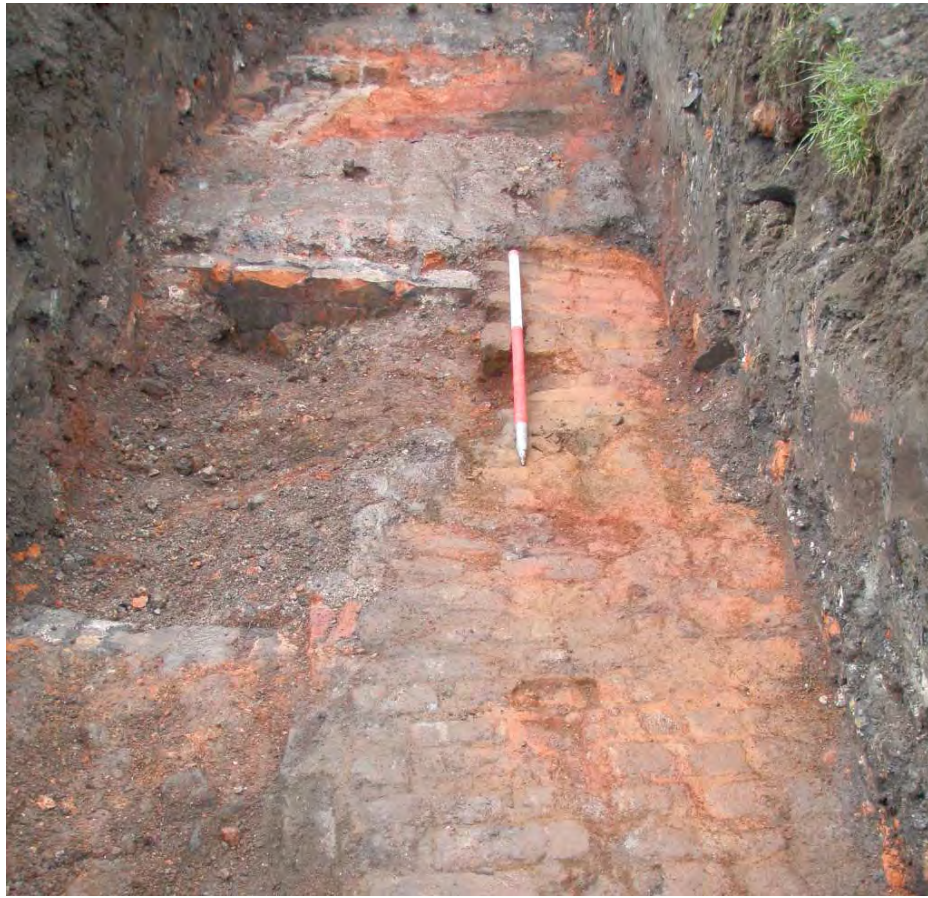
Plate 11: View along Trench 1, showing brick kiln floor 101

4.2.2 Excavation of the north-eastern part of the trench revealed a heavily burned surface of machine-made brick (**101**), clearly representing the *in-situ* remains of the brick kiln (Fig 4). The exposed surface was almost certainly an internal element of the kiln, and had probably formed part of a firing chamber floor (Plate 11). The north-western edge of floor **101** abutted a north-east/south-west-aligned wall, which was similarly composed of machine-made bricks. The location of this wall corresponded broadly with the curtain wall of the brick kiln, as shown on historical mapping (Fig 2).

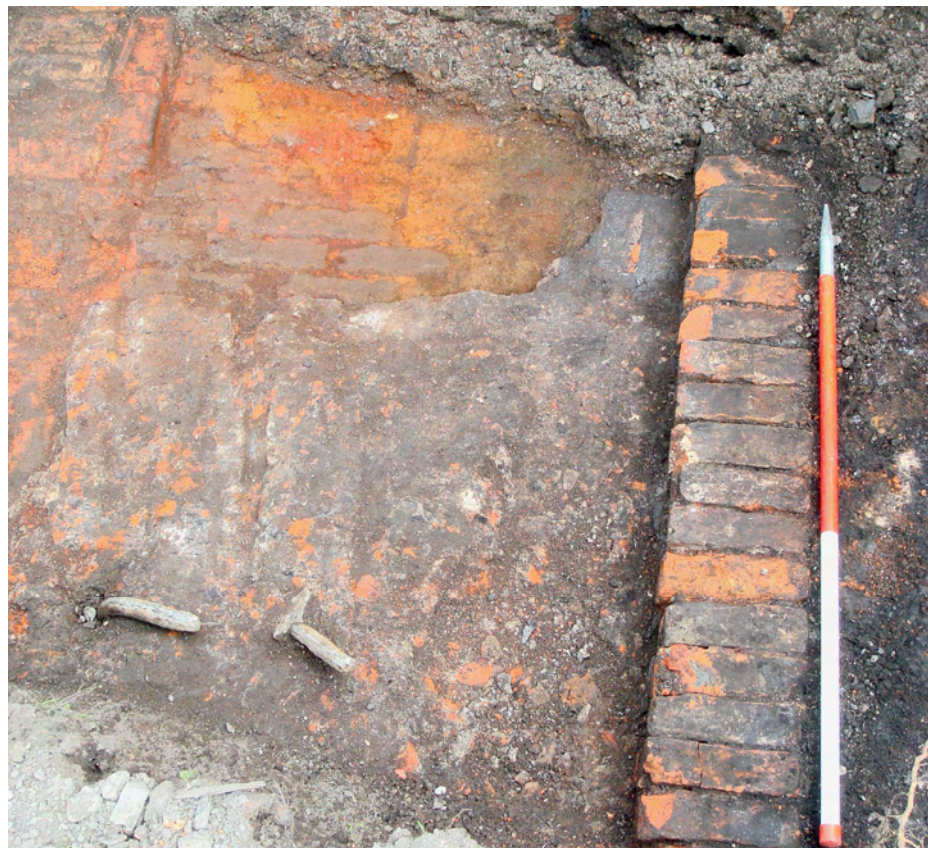
Plate 12: Machine base 102 and wall 103

4.2.3 Excavation to the south of floor **101** exposed a concrete base (**102**). This incorporated two metal tie-down bolts, suggesting that concrete **102** had been intended as a foundation base for an item of heavy machinery (Plate 12).

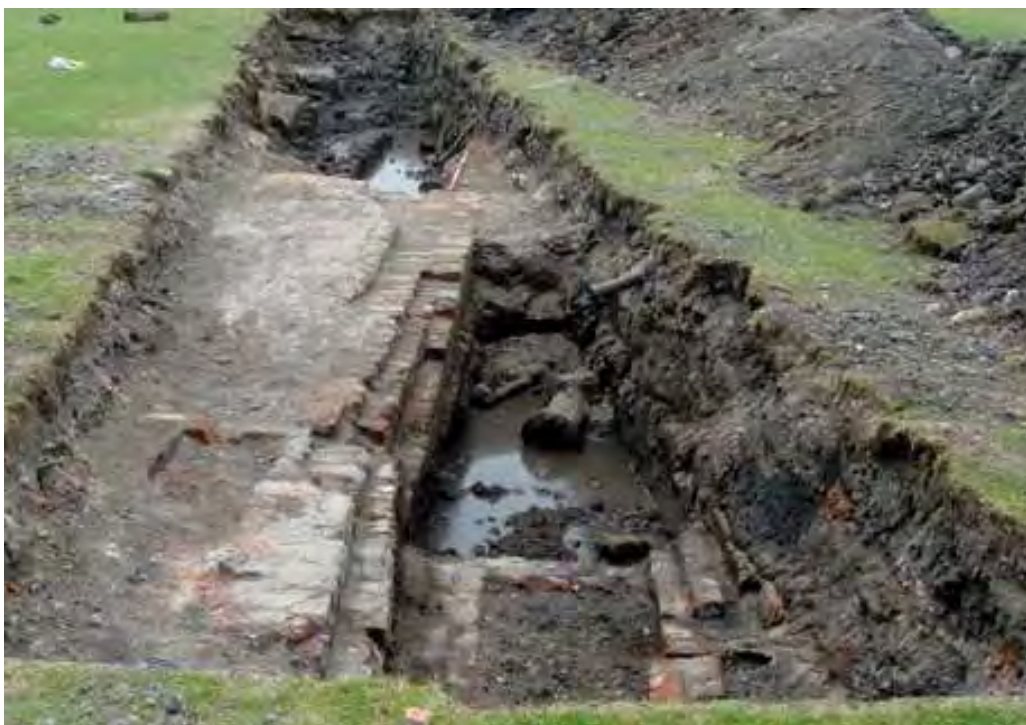
Plate 13: General view of Trench 3, looking south-west

- 4.4.2 Buried archaeological remains in the northern part of the trench had been subject to some disturbance, although a rectangular structure composed of machine-made bricks (**301**) survived *in-situ*. This comprised two parallel walls, aligned north-east/south-west and set 0.4m apart, with a third wall aligned north-west/south-east at the south-western end (Fig 6). A long wall of machine-made bricks (**302**) continued to the south-west. It was two-courses wide, and survived to a height of six courses high above a stone foundation. The wall was excavated to a depth of 0.9m deep, although its base was not exposed as the trench was flooded with water below this depth.

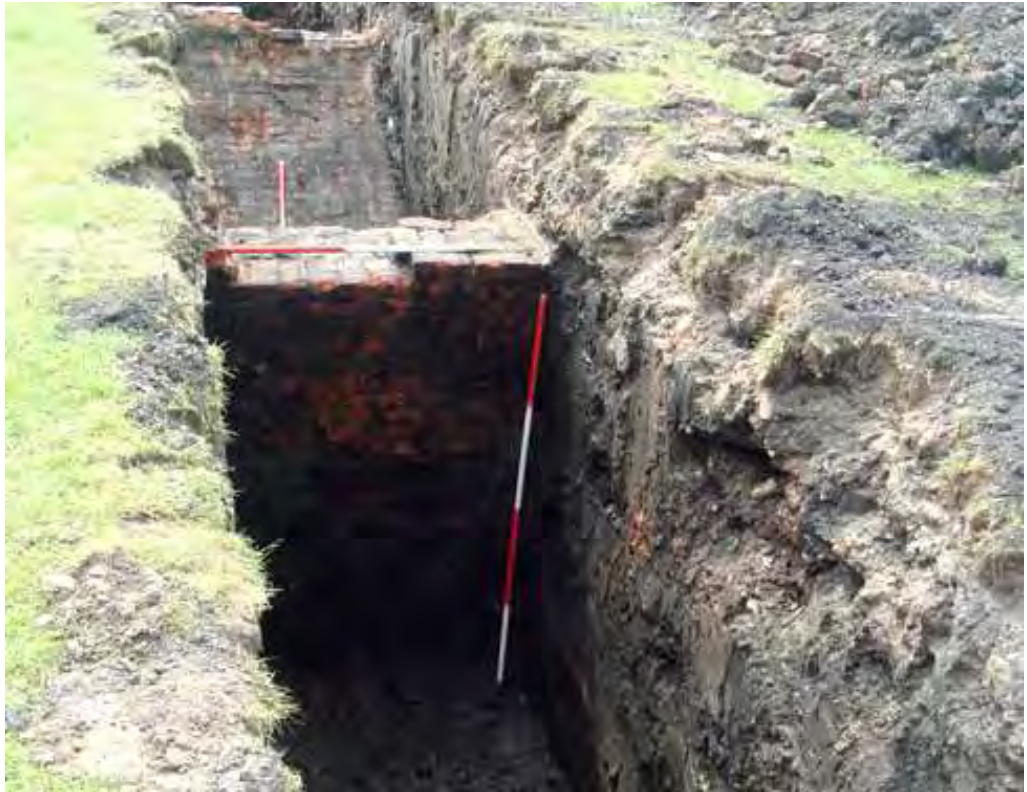
Plate 14: South-western end of Trench 5, showing structures 501 and 503

- 4.6.3 Situated at a distance of 6.2m from the south-western end of the trench were the well-preserved remains of a brick wall (**501**), aligned north-west/south-east and composed of machine-made bricks. The top of the wall was exposed at a depth of 0.52m below the modern ground surface, and was excavated for a depth of 2m, although its foundations were not exposed (Plate 14).

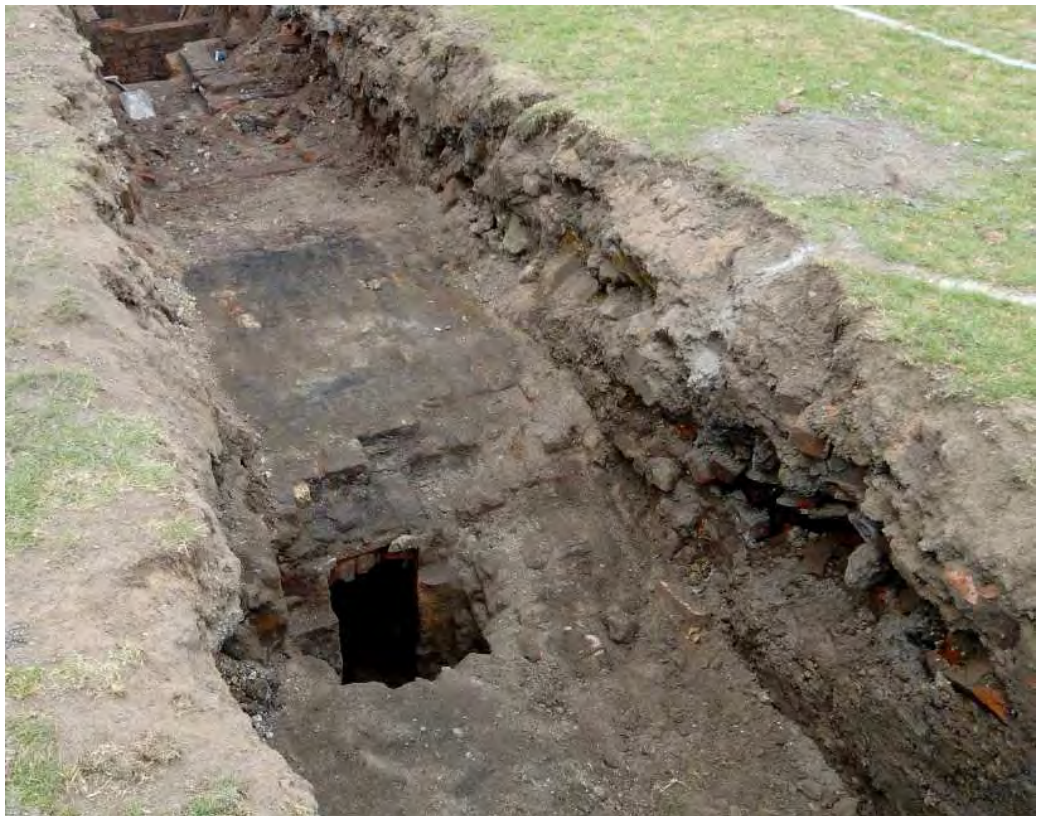
Plate 15: Passage 504 and wall 505 looking north-east

- 4.6.5 Situated some 15.7m to the north-east of wall **503** was another wall (**505**), composed of machine-made bricks. Wall **505** was aligned north-west/south-east across the trench, and incorporated a narrow, 0.37m wide, doorway (**504**) set within a metal frame (Plate 15). The upper portion of the frame had a projecting slot, which had probably housed a retractable wooden or metal gate. The doorway led into a small underground brick chamber with passages leading off it to the north-west and south-east. These passages had both been blocked with brick. The top of the chamber beyond wall **505** comprised a surface of machine-made bricks coated with black tar. The area between walls **503** and **505** contained a thick deposit of mixed ash and rubble, which had a depth in excess of 2.5m.

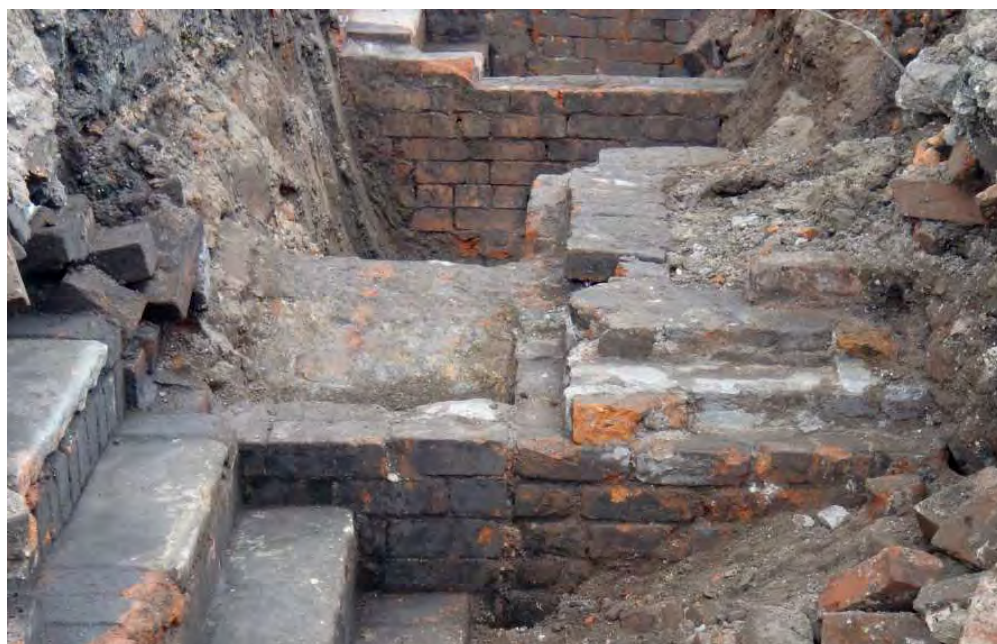
Plate 16: Flue **507** and chimney **508**

- 4.6.6 Situated to the north-east of wall **505** was structure **506**, which comprised two parallel north-west/south-east-aligned brick walls with brick steps in between leading downwards to the south-east. Abutting the eastern corner of steps **506** were the remains of a square brick chimney (**508**), with a brick-arched flue (**507**) extending to the north-west (Plate 16). Situated 1.15m to the north-east was a second set of brick steps (**509**) leading downwards to the south-east (Plate 17). At the north-eastern end of the trench was a wall (**514**) of machine-made bricks, which ran parallel to the south-eastern trench edge and then, at its north-eastern end, returned south-east into the trench edge. Beyond this wall the trench had been disturbed and was filled with mixed rubble and ash.

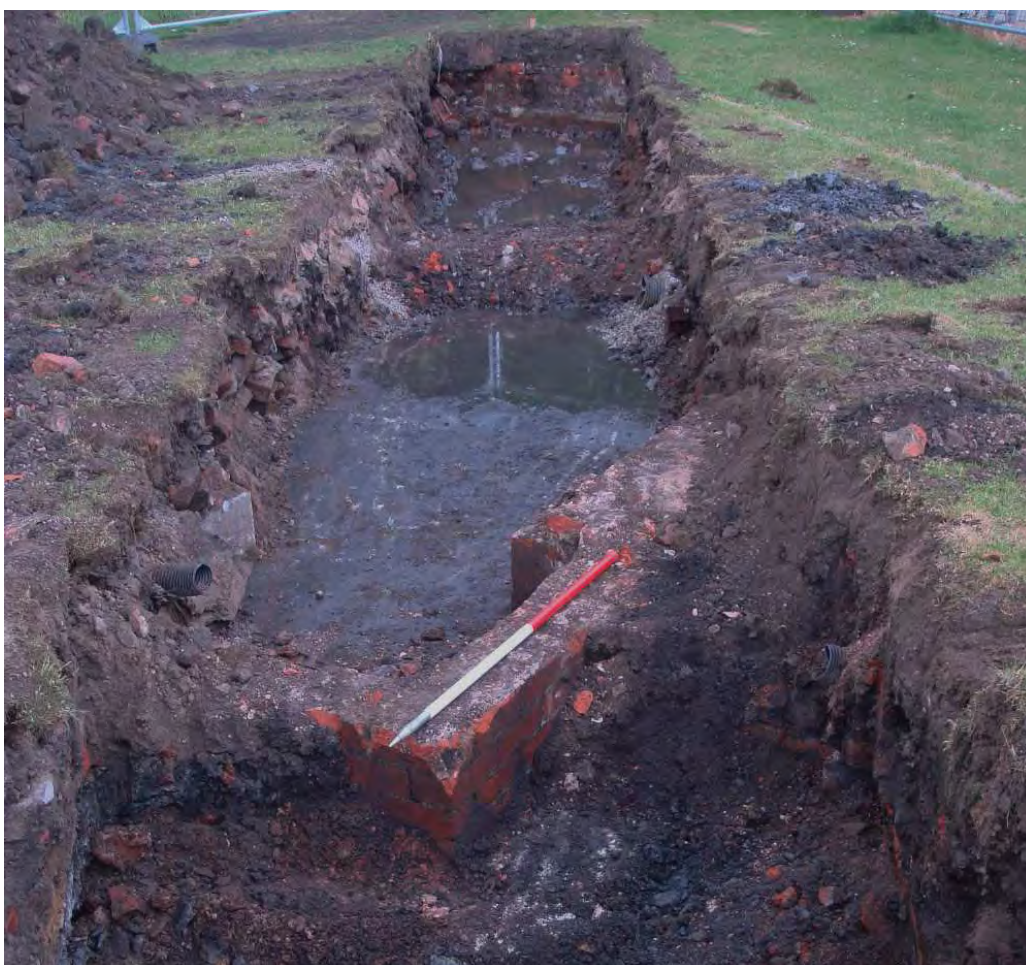
Plate 18: Trench 6 looking east, showing wall **601**

- 4.7.2 A wall (**601**) composed of machine-made bricks bonded with a cement-based mortar, indicative of a twentieth-century construction date, was exposed at the eastern end of the trench. Wall **601** was aligned north-east/south-west, and survived to a height of at least four courses (Plate 18). A similar wall (**603**) was exposed at the western end of the trench (Fig 8). This sat on a concrete foundation (**604**), set within mixed rubble levelling material (**605**).

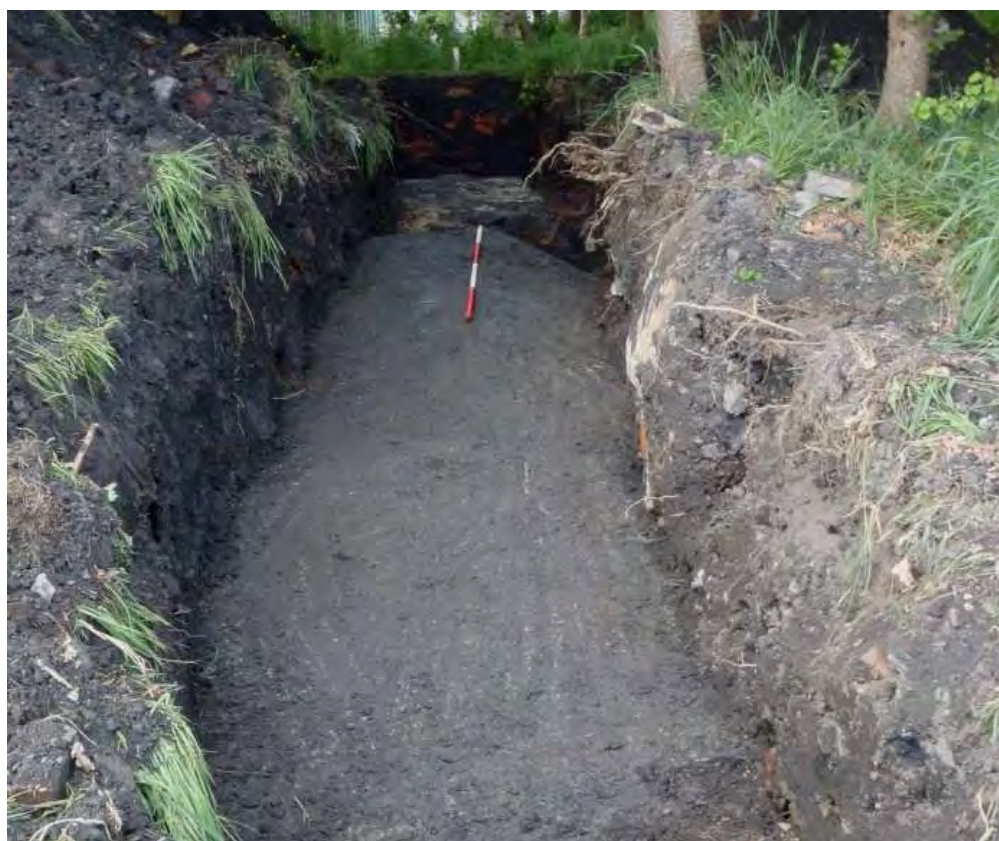
Plate 20: Trench 10, showing surface **1002** at the south-western end of the trench

- 4.11.3 Excavation to the south-west of plinth **1003** revealed a concrete surface (**1002**; Plate 20), although a localised deposit of mortared brick tumble perhaps represented demolition associated with the construction of surface **1002**.

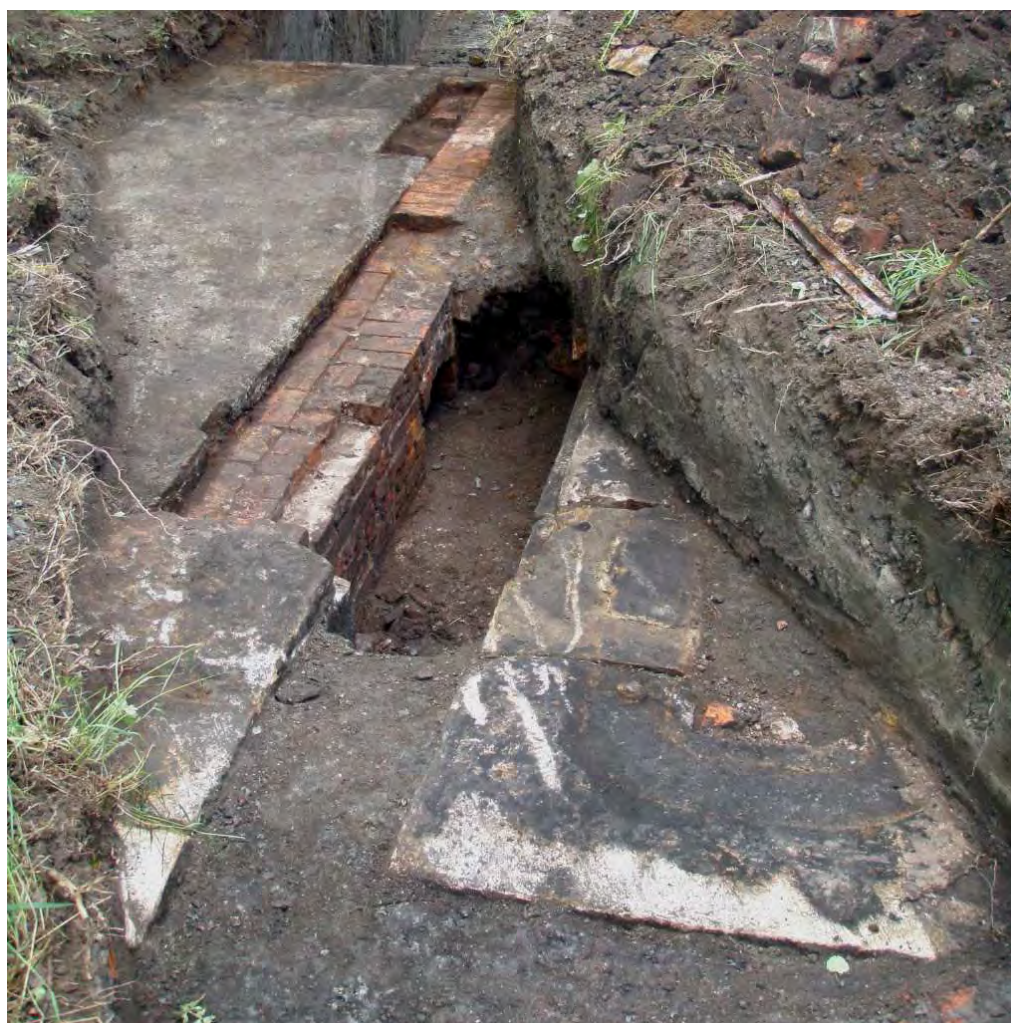
Plate 21: Trench 11, showing **1101** and **1104** at the south-western end of the trench

- 4.12.3 Situated to the north of floor **1104** and wall **1106** was a stone structure (**1101**), which comprised stone blocks forming an 'L'-shape (Plate 21). This had a groove cut along its south-western edge, a small circular hole drilled into it and a cast-iron tying-down bolt at the southern corner. There was also the 'U'-shaped imprint of a machine or engine base stained onto the stone surface. The stone blocks forming the walls of both **1101** and **1104** were of well dressed, slightly rusticated ashlar masonry of varying sizes.

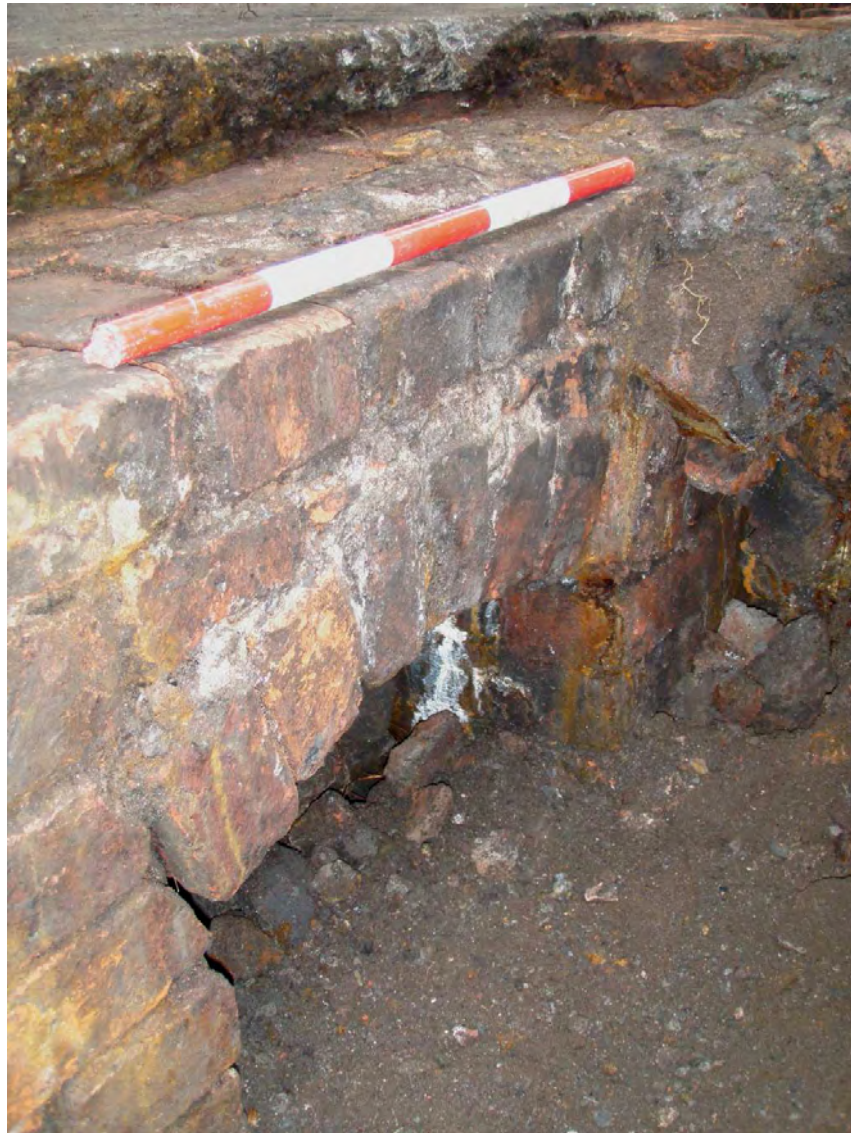
Plate 22: Trench 11, showing arched-brick aperture 1114 within wall 1106

- 4.12.4 Between structures **1101** and **1104/1106** was a channel filled with mixed rubble (**1115**). Excavation of rubble **1115** from the channel exposed a 0.47m wide brick-arched opening (**1114**) through wall **1106**, which had been partially blocked with bricks (Plate 22). Opposite **1114**, and set within stone structure **1101**, was a square opening, measuring 0.48m wide. The rationale for these openings remains unclear.

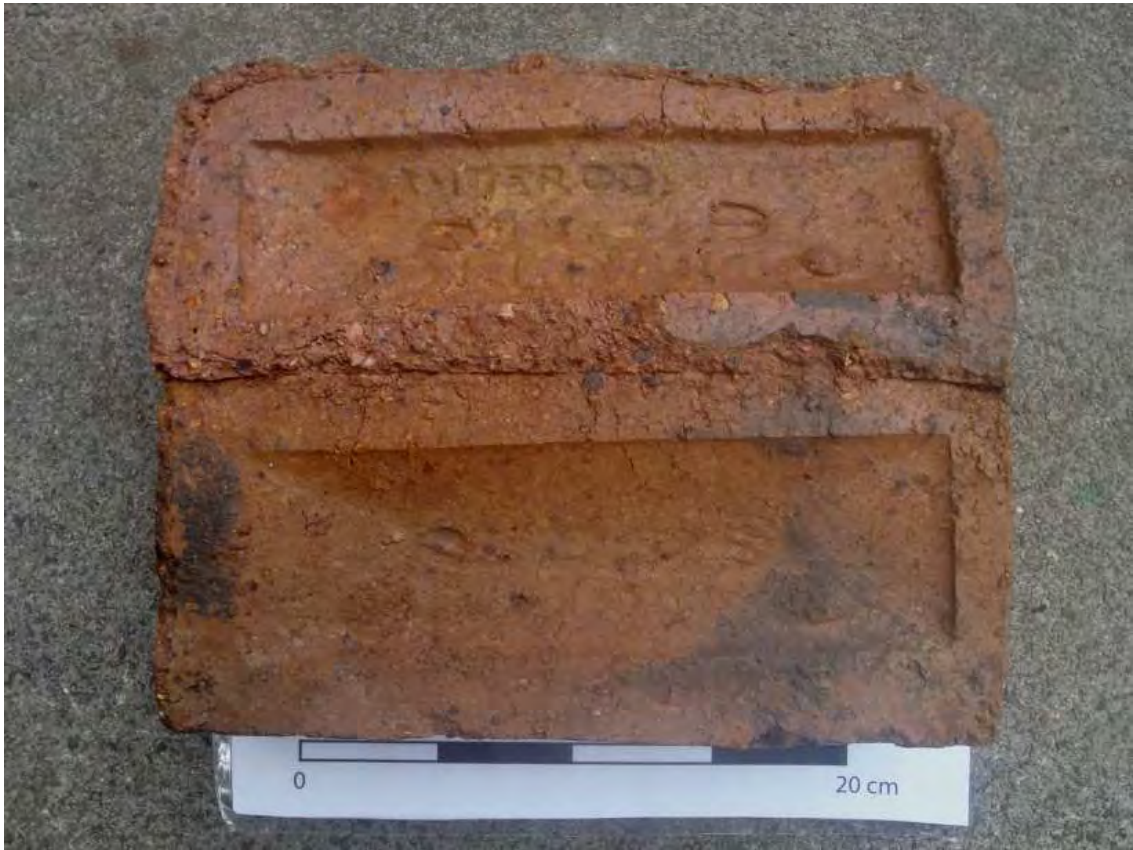
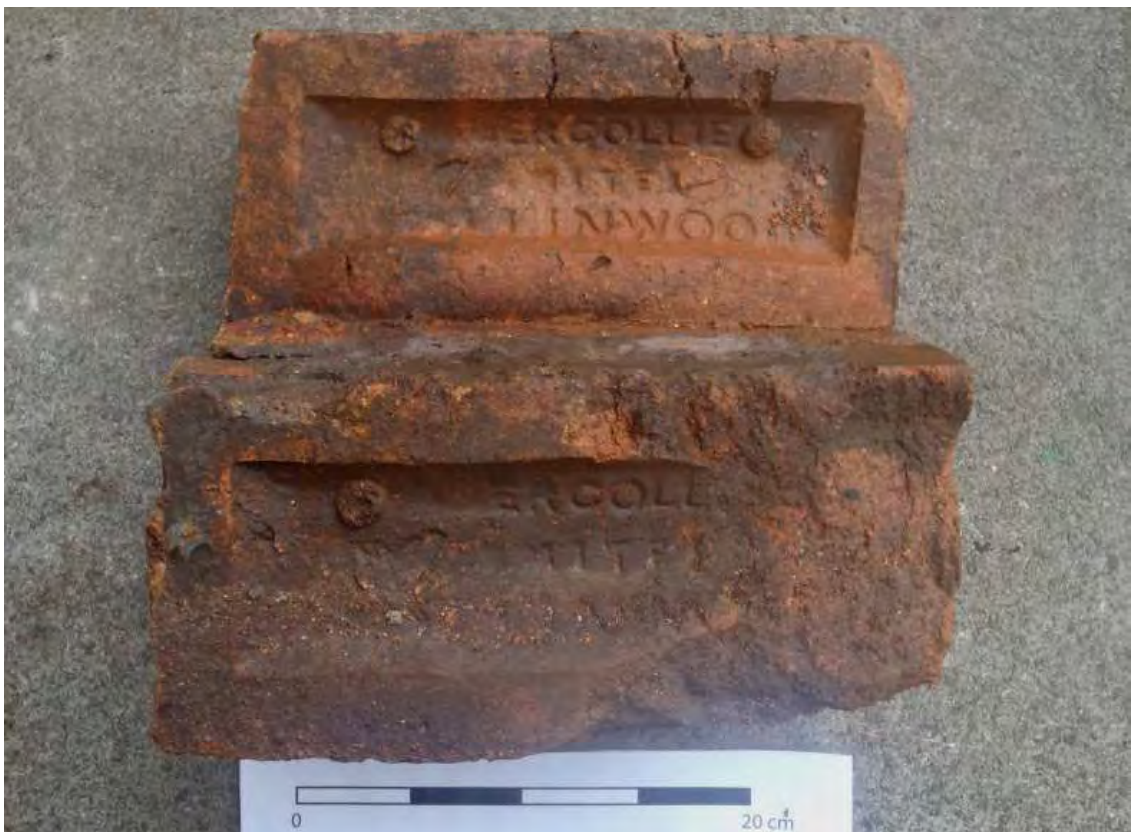
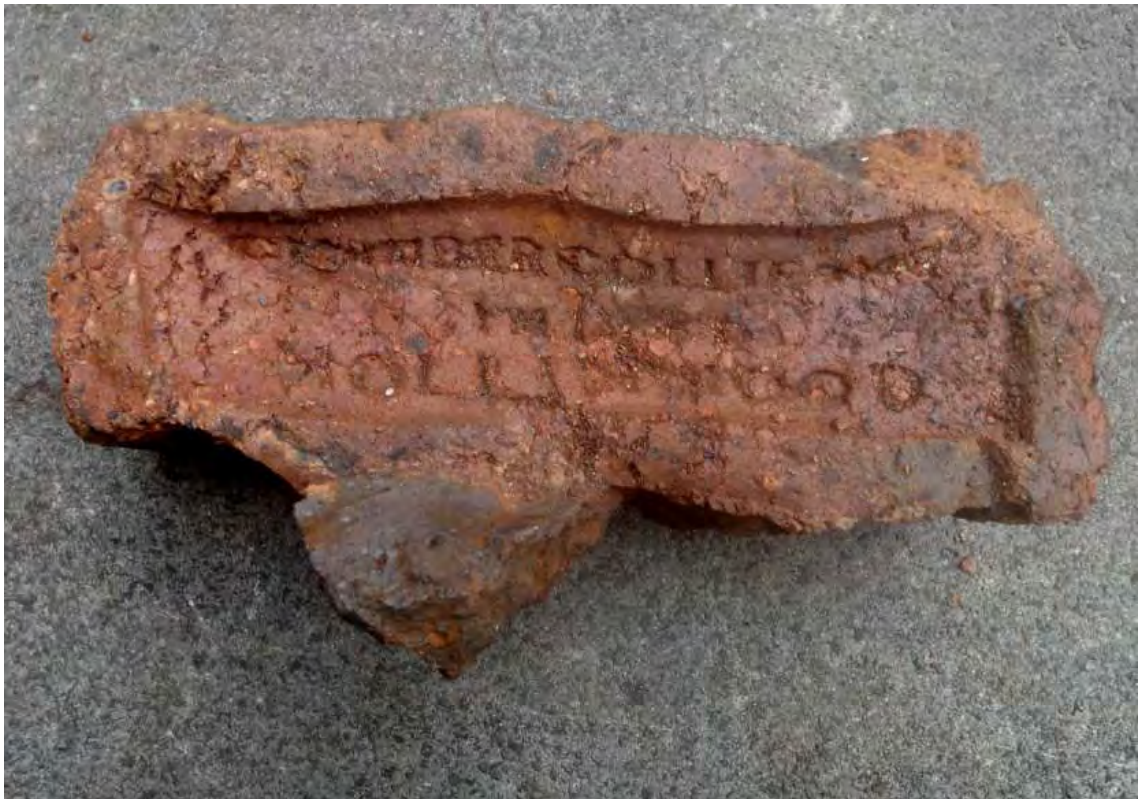
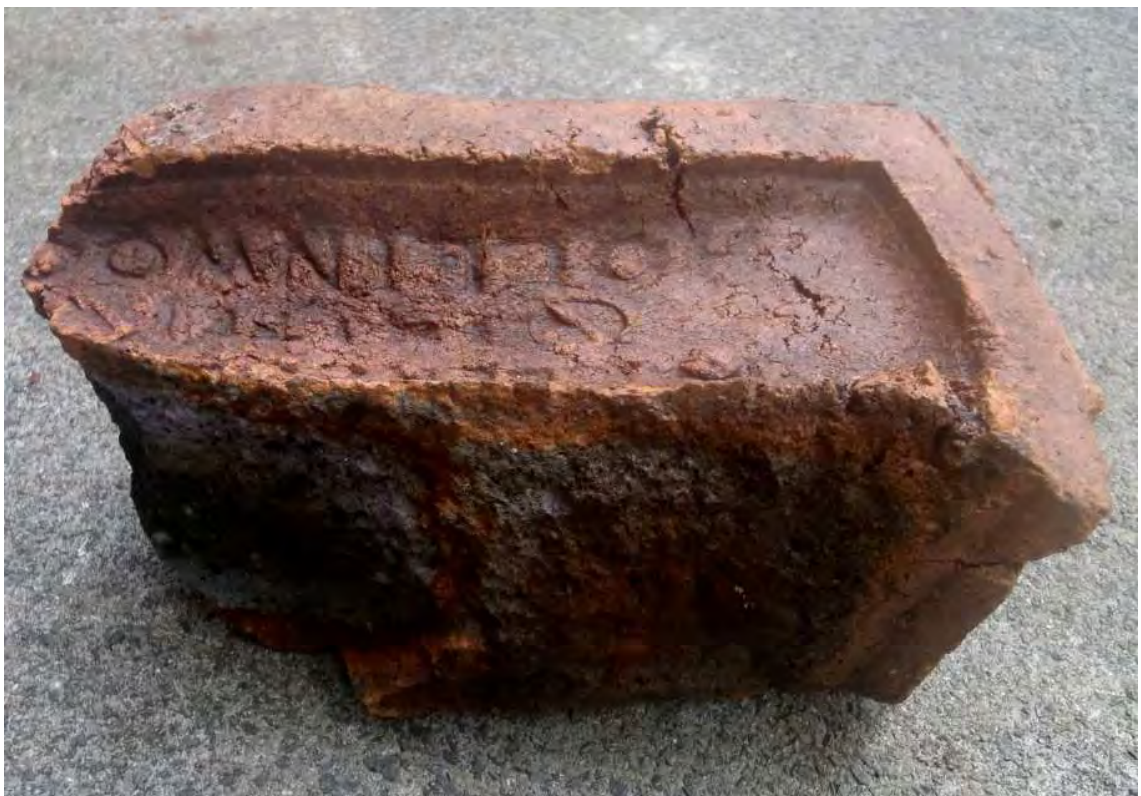
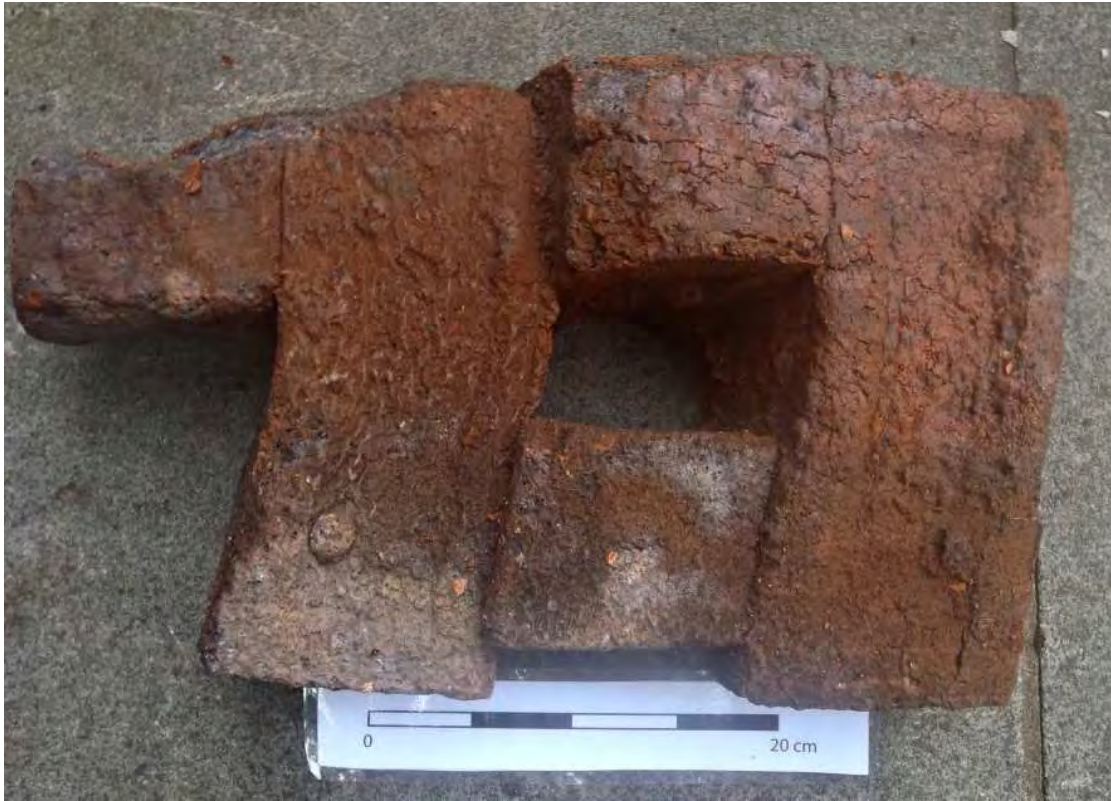
4.13.1 Very artefacts were recovered from the evaluation trenches. The assemblage consisted entirely of misfired bricks, almost certainly discarded from the brick kiln (Plates 23 – 27). These were all recovered from a dump of waste material exposed in Trench 4, and clearly offer some potential to inform an understanding of the type and range of bricks that were manufactured in the kiln.

Plate 23: Sample of waste brick recovered from Trench 4

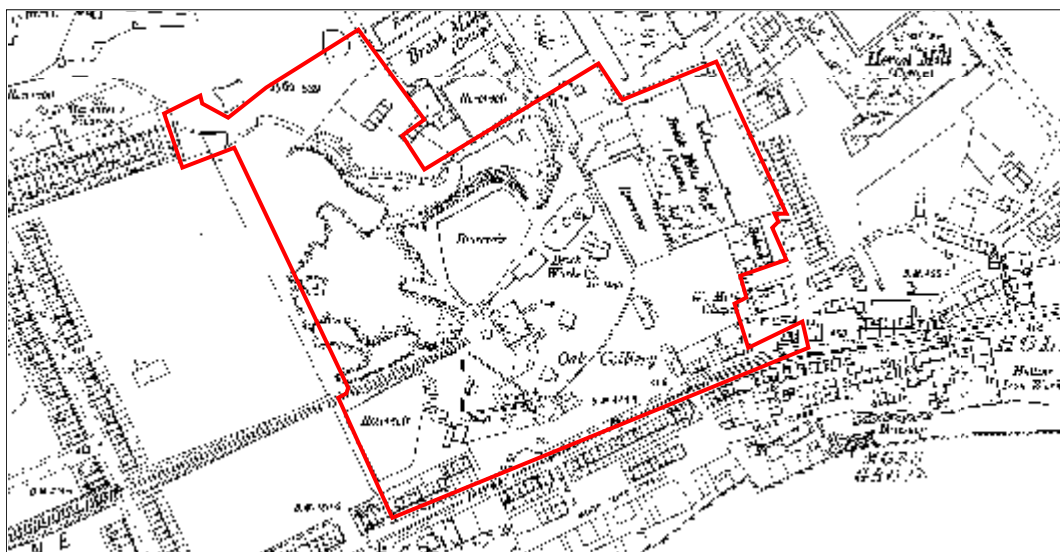
Fig. 3: OS 1907

- 2.5 The Ordnance Survey 25" mapping of the 1890s through to the 1920s (fig. 3) shows what appears to be a very large Hoffman-style brick kiln with a central chimney centred on SD91460296. Such kilns represented a major investment and, judging from the historic mapping, this example was c.40m long and 18m wide. Large areas of the site now used for amenity open space appears to have been either quarried for clay or covered in spoil tips. By 1896 the Oak Colliery brick works was the largest producer in Oldham. However, by the early 1920s the brick works is shown on mapping as 'disused'. It is not known when the kiln was finally demolished. Mapping of the 1950s shows the colliery but no standing kiln (fig. 4) Oak Colliery continued in coal production until the 1960s. The site was landscaped in the 1970s.
