The Mill House Cuddesdon Oxfordshire

Historic Building Analysis

Oxford Archaeology

September 2005

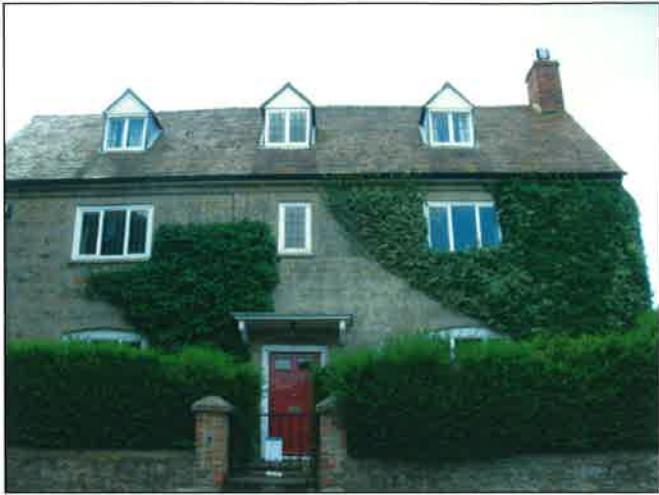
Plate 1: Mill House, front elevation

- 4.2.1 The house faces north-east onto the road on a slight rise and is reached from road level by a flight of six steps. It is a double pile building with double gable roof. Constructed of roughly squared and coursed limestone rubble with ashlar quoins and dressings and brick gable stacks on the north-west gables. There are two main floors and an attic. The front (north-east) elevation (plate 1) is symmetrical with a central door flanked by two three light windows with segmental heads on the ground floor. There is a modern hood over the door. The first floor has two three light windows with flat heads either side of a central single light window above the door. All the original windows have

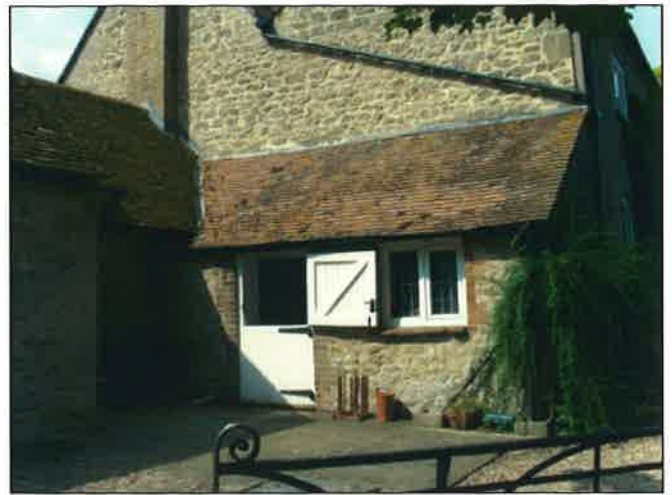
Plate 2: Back porch

- 4.2.3 Adjoining the south-east end of the house are two additional structures, a small lean-to (the 'back porch,' plate 2) is built against the front gable, this is of limestone rubble with red brick door and window jambs and may be later 18th century or 19th century in date. The back porch abuts a single-storey, stone, ridge roofed structure (the lobby or 'back hall') which connects the main house and the 'family room' a single-storey stone built former outbuilding which is thought to have been used as a stable or small barn (plate 3).

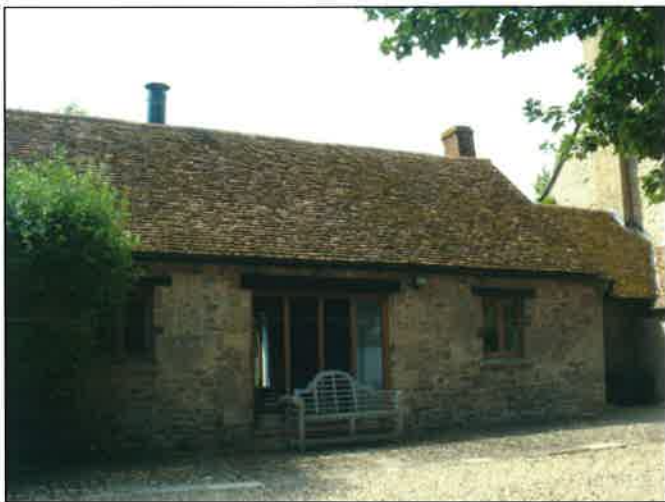
Plate 3: Former barn or stable, front elevation

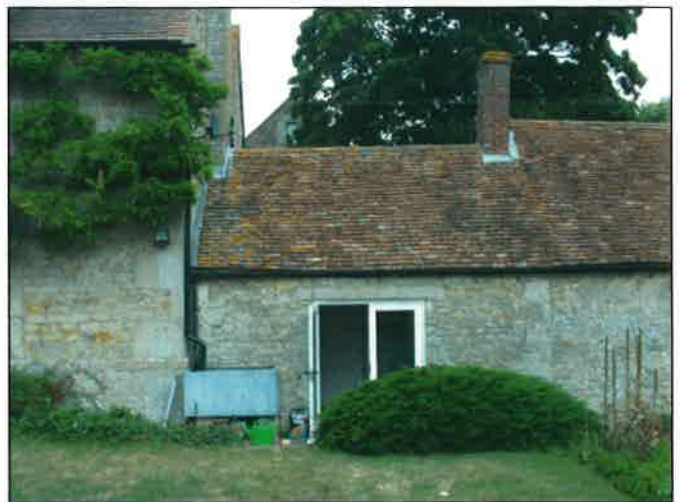
Plate 4: Back hall, rear elevation

- 4.2.4 From the rear elevation (plate 4) it can be seen that the 'stable' abuts the south corner quoins of the back hall and is a later addition. The north end of the back hall appears to abut the main house and one stone is shaped to fit around the house plinth (plate 5), this gives the impression that the back hall may be a later addition to the house but as will be seen the internal evidence generally gives a contrasting view.

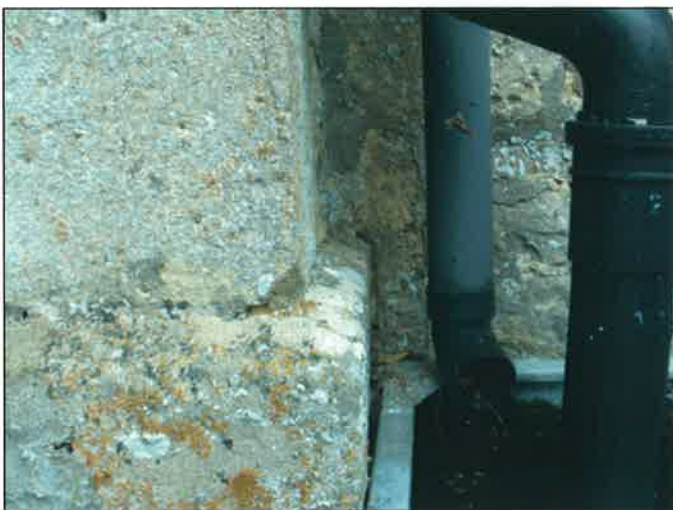
Plate 5: Junction of back hall and house plinth

- 6.1.2 **2). The creation of a new opening from the breakfast room into the back hall.** Creation of an opening here will remove part of the 18th century house wall and plinth but should not affect the fabric of the earlier back hall. There is evidence of an earlier opening at plinth height blocked with brick in this section of wall and there is possibly a stone jamb on the east side of this blocking but with a covering of whitewash it is difficult to identify. If this opening is created the wall should probably be further investigated first to record and understand this feature.

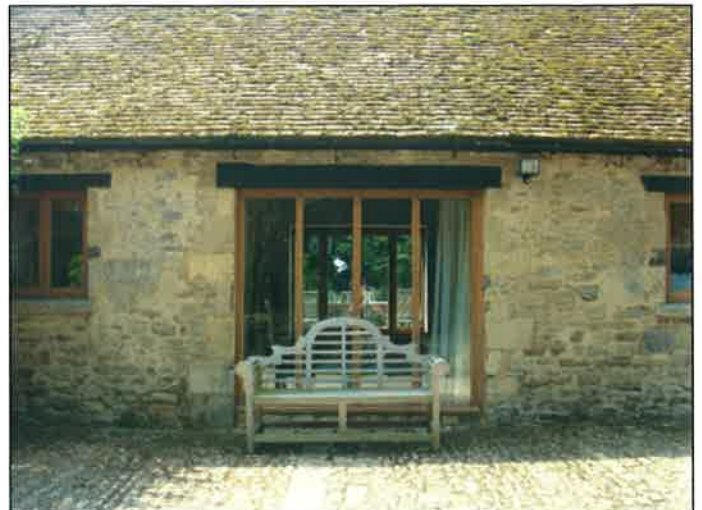
Plate 6: Former barn or stable front door opening

- 4.2.5 The 'stable' has a large central barn door sized opening, now glazed, in the front elevation with ashlar jambs, that on the west is original, the east jamb is of original blocks but has new mortar and may have been rebuilt to widen the door, but possibly was just repointed when other work was done in 2000 (plate 6). There are original stone jamb windows to either side. An upper window has been inserted in the gable end and modern boiler room built onto the end of the rear elevation (plate 7). There is a large opening in the rear wall, also glazed, with double doors and recently constructed jambs. This opening is either a wholly new insertion or a widening of an existing door (plate 8).

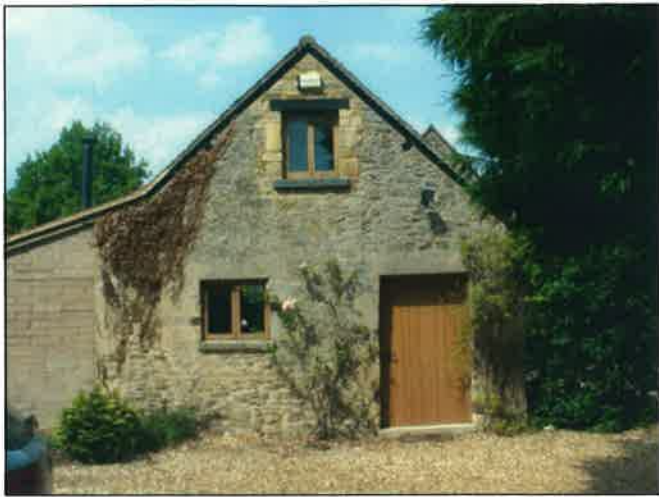
Plate 7: Former barn or stable south-east gable

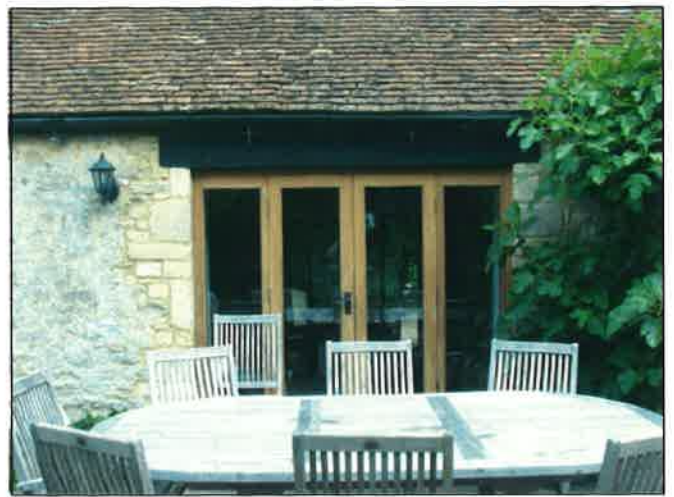
Plate 8: Former barn or stable rear door opening

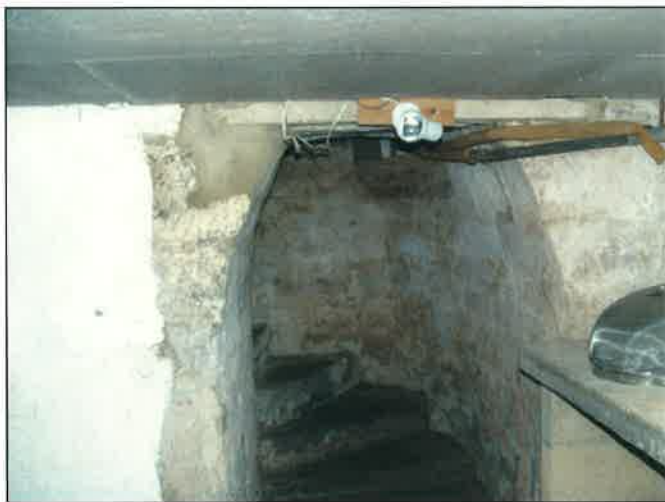
- 4.3.1 The front door of the main house opens onto an internal porch/lobby which leads onto a central hall-passage across the house to the rear door. Two rooms open off each side of the hall and stairs to the first floor are situated at the rear of the hall. The basement is reached by steps down from the rear of the hall, these enter the cellar through a rounded arch in a massively thick stone wall (plate 9). The cellar is of stone and is below the drawing room at the rear of the house. The cellar arch gives the appearance of possibly being earlier than the house but could equally be contemporary, it is almost impossible to be certain of the date and the cellar is not affected by any proposed structural alterations.

Plate 9: Cellar arch

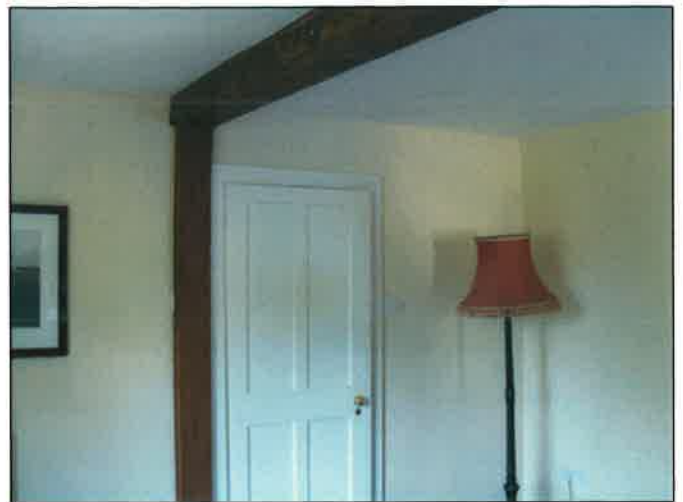
Plate 10: Dining room: wall proposed for removal

- 6.1.5 **5). Loss of wall between dining room and hall.** The wall currently in this position appears to be relatively recent and its removal would not result in the loss of historic fabric. The post and stone plinth supporting the original bridging beam is modern and must replace some earlier support probably a solid wall. The proposals require removal of the wall but the post would be left to support the beam. Although the wall is modern its removal would to some extent change what was probably the original plan form. It is not known when or why the original wall was removed from here and it may be that there was a larger opening in this location before the modern walling was constructed.

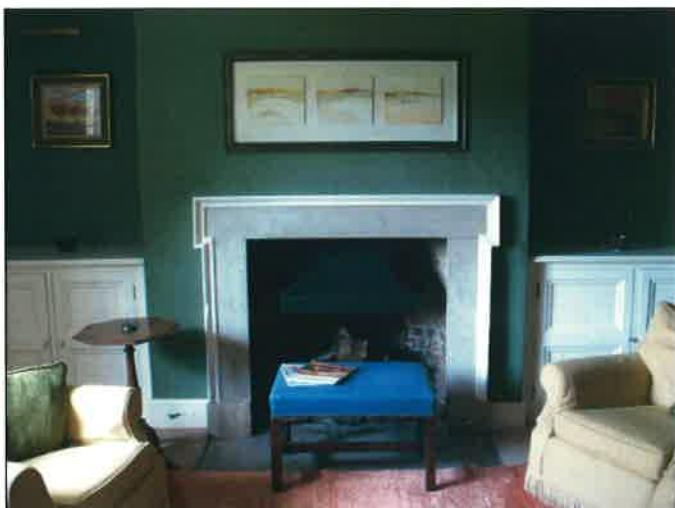
Plate 11: Drawing room fireplace

- 4.3.4 The rear north-west room (the 'drawing room') has a more formal fireplace with a stone surround and a moulded and shouldered wooden edging on the north-west end wall. The ceiling is supported by central bridging beam with plain chamfer. The room appears to be in fairly original condition and is unaffected by the proposed alterations (plate 11).

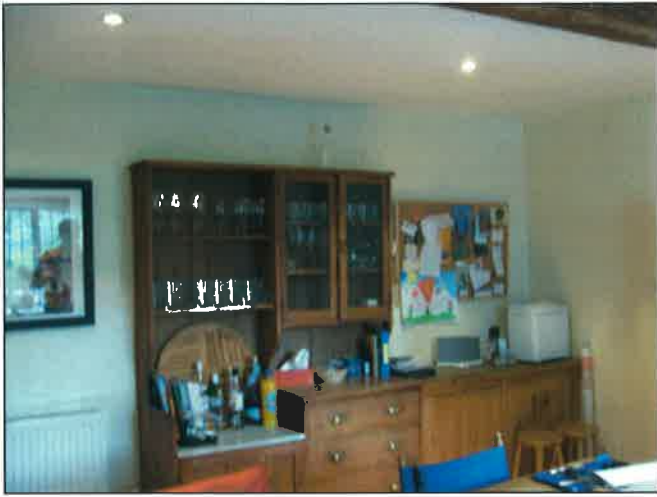
Plate 13: Kitchen, wall proposed for removal

- 4.3.5 The front south-east room, the present kitchen, has an original cross beam and a door into the back porch (plate 12). The rear wall of this room appears to be a solid original wall. This is part of the central spine wall of the house which extends up through the first floor to support the inner slopes of the roof. The proposed alterations involve making a large opening in this wall to join the present kitchen to the breakfast room to create one space and reversing the functions of each of the two rooms (plate 13).

- 6.1.1 **1). Removal of the wall between kitchen and 'breakfast room'.** The proposal is to remove nearly all of this wall to create a modern style larger family eating and dining area but to leave piers about 0.5m wide each side to indicate that the space was originally two rooms. This wall is part of the thick main spine wall of the house and is an integral part of the original plan form. Removal of the wall will change the internal character of the house by connecting these rooms There is existing consent for removal of a smaller portion of this wall for insertion of double doors.

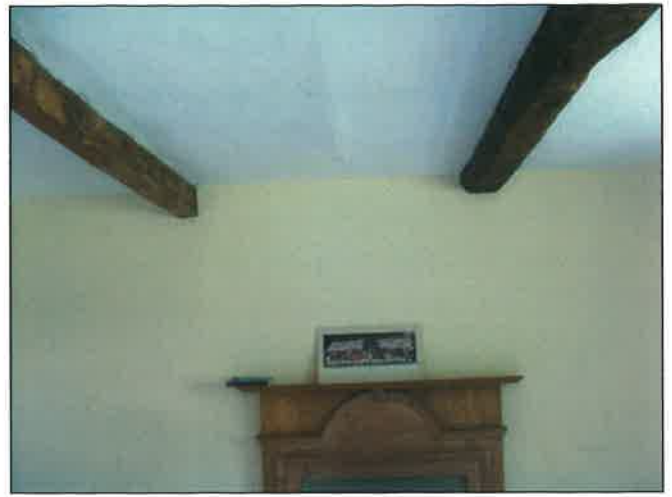
of opening which will utilise the existing chimney. The room has two cross beams, the original beam with plain chamfer which has been moved south-west when the stack was added and a second beam made from a reused timber added at the same time (plate 14). As mentioned above the wall between this room and the kitchen is proposed to have a large opening made in it. The proposals also involve a new opening being made from this room into the back hall on the north-east side of the fireplace (plate 15). This wall as seen from the back hall appears to be part of the main house wall, the plinth runs across here, however in the position of the proposed opening there is a square area of brickwork above the plinth which may indicate a blocked former opening (plate 16). This was not a doorway as it is above the plinth but may have been a connecting opening between this room and the back hall.

Plate 14: Breakfast room, repositioned and inserted beams

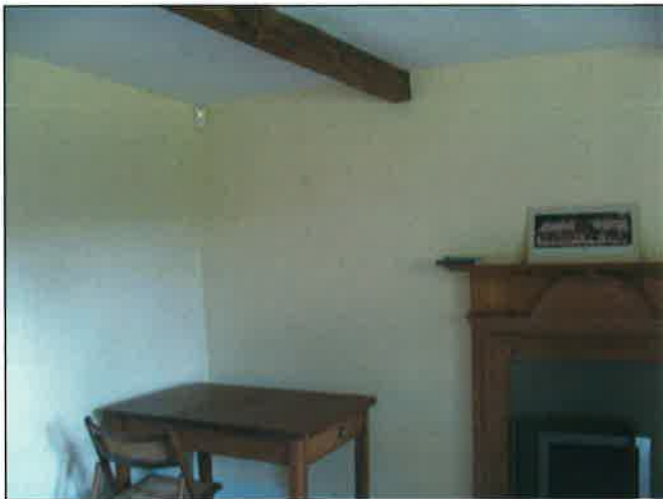
Plate 15: Breakfast room, site of proposed new opening to back hall

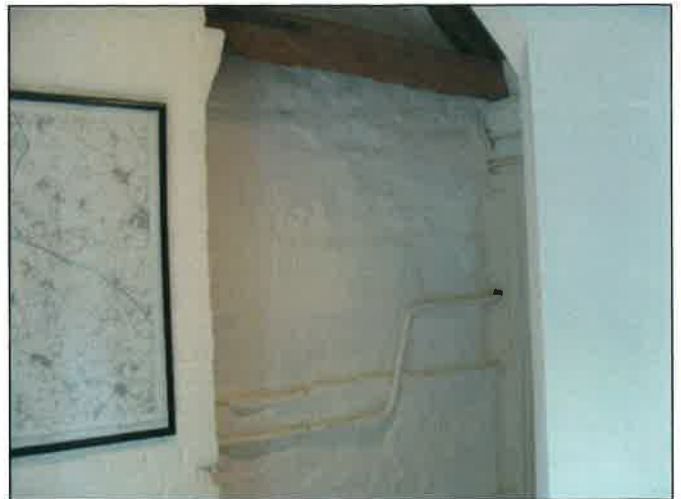
Plate 16: Back hall site of proposed opening from breakfast room

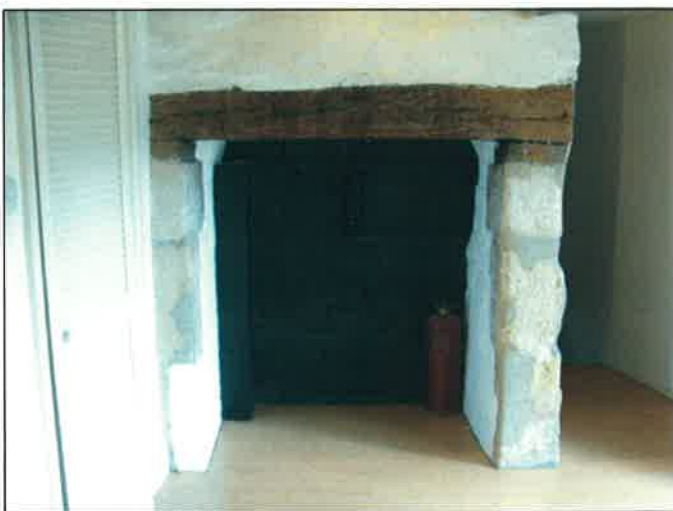
Plate 17: Back hall, stone fireplace and beam

- 4.3.7 The back hall is accessed from the south-west end of the back porch and does not open onto the main house. There is a stone fireplace (plate 17) with timber beam and tapering chimney breast above (plates 18) at the south-east end of the room south-west of the fireplace is an opening into the family room and there is a double door opening in the rear wall modern glazed doors fitted (see plate 4). The north-west wall has a 19th century central gault brick stack built against it to service fireplaces in the house. A modern cupboard and partition to a utility area within the back hall are to be removed as part of the proposed alterations.

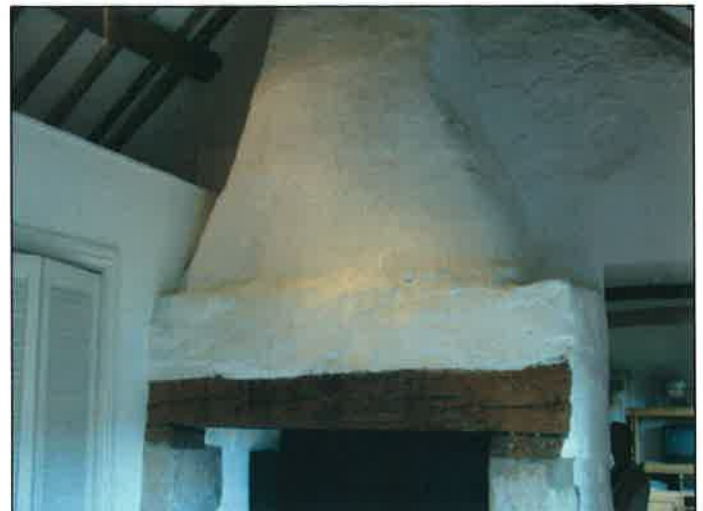
Plate 18: Back hall, tapering chimney breast

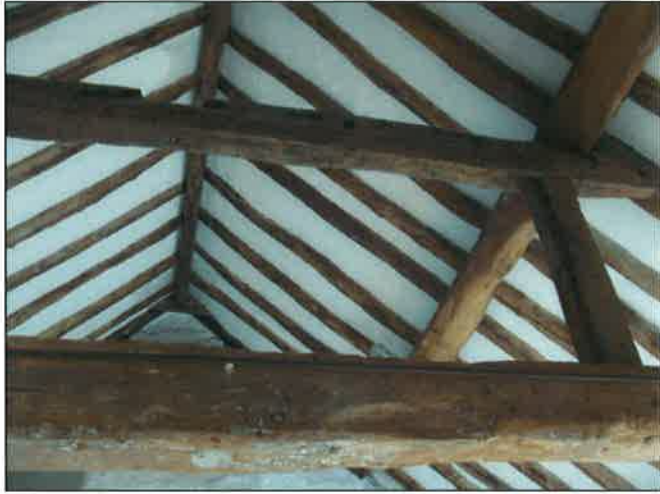
- 4.3.8 The roof of the back hall consists of paired common rafters supported by a large purlin on each slope. The purlins are clasped to the principals by a collar which is supported by queen struts rising from a central tie beam (plate 19). At the south-east end the purlins are supported in the gable wall and at the north-west end the purlins butt up to the wall and are supported by a truss which has been modified by the insertion of the later stack. The central portion of the tie beam has been removed and the two inner ends supported on corbelled courses projecting from the stack. The collar has similarly been reduced and the two inner ends picked up by extended queen struts rising from the shortened ties to the principals which have also been shortened (plate 20).

Plate 19: Back hall, main roof truss

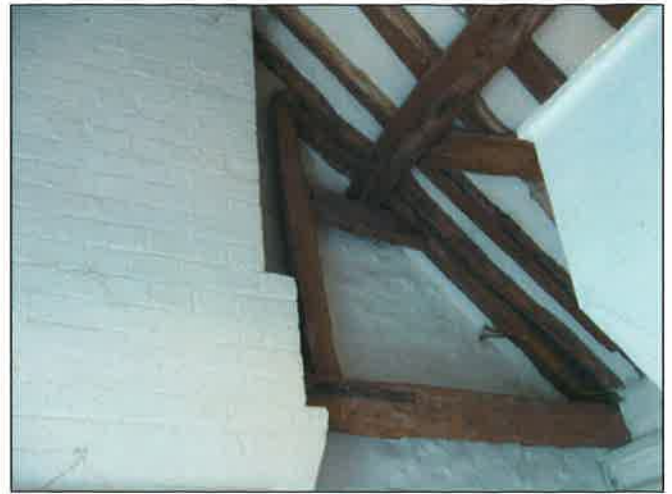
Plate 20: Back hall, later chimney and truncated and altered roof truss

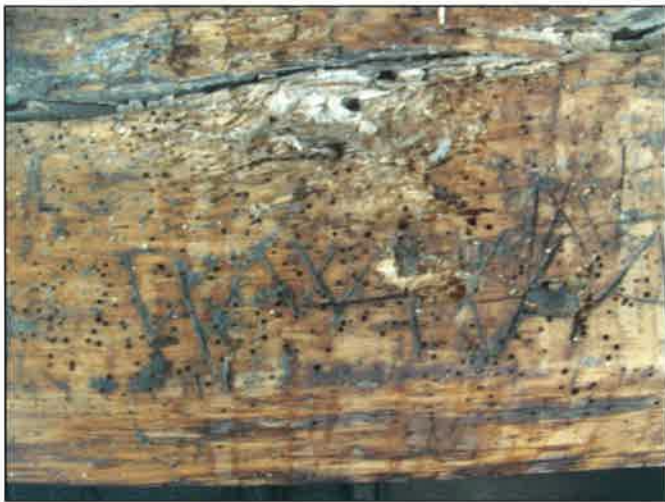
Plate 21: Back hall, fireplace beam with apotropaic symbols

- 4.3.9 The form of the roof and the fireplace indicate a date for the back hall considerably earlier than the main house, possibly later 16th or earlier 17th century. The fireplace beam has marks and letters incised on it some of which have parallels in recorded examples from the 16th and 17th centuries, these are technically called apotropaic symbols and were intended to ward off the influence of the devil or witches. The marks here which fall into this category are repeated W's and M's composed of double V's, these are known as 'Virgin Mary marks', M standing for Mary and the double V's probably standing for Virgo Virginum (Virgin of Virgins), intended to invoke the protection of the Mother of Christ (Easton 1999) (plate 21).

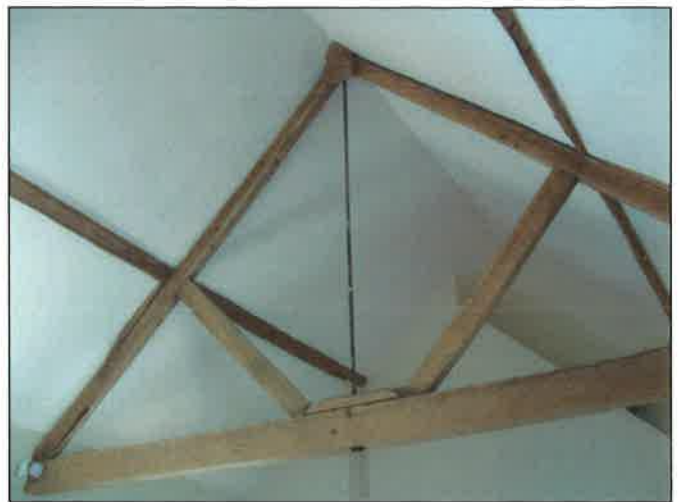
Plate 22: Former barn or stable, roof truss

- 4.3.11 The former 'stable' was built onto the existing end gable of the back hall. The roof trusses are typical of late 18th century or early 19th century farm buildings, consisting of a tie beam from which raking struts support the principals at the point where the single purlins rest on them. The lower ends of the struts are tensioned by a straining sill and an iron king rod runs from tie beam to ridge (plate 22).

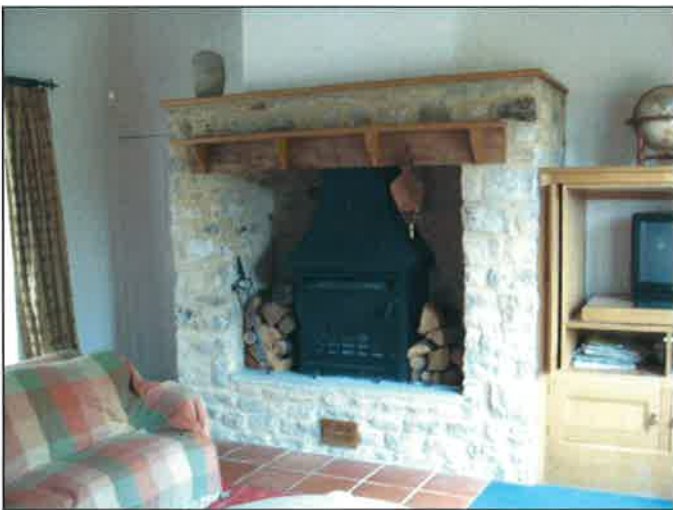
Plate 23: Former barn or stable, modern hearth

- 4.3.12 There is a modern inserted stone hearth and chimney breast at the south-east end of the family room (plate 23) and behind this the south-east end of the stable has been converted into a 'granny flat' by the insertion of an upper floor and fitting of a shower and kitchenette on the ground floor. The proposed changes within the former 'stable' do not affect any of the old structure apart from blocking the opening to the back hall which will not require any removal of fabric.

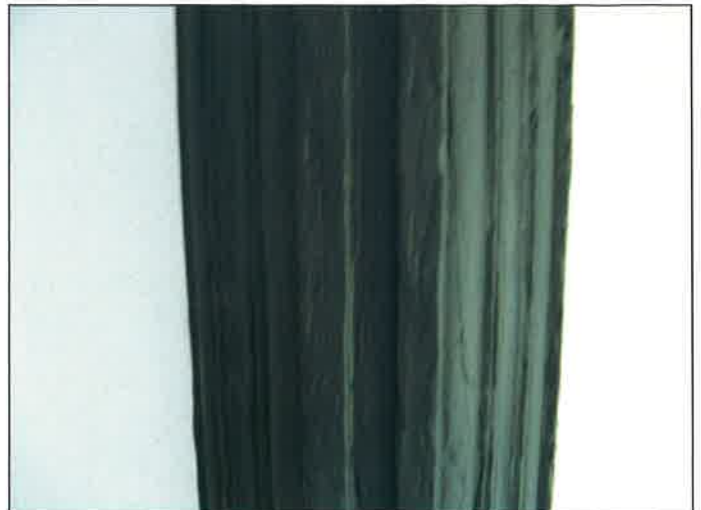
Plate 24: First floor rear north-west bedroom, reused late medieval beam
