CANNING DOCK LIVERPOOL

Phase 2

Archaeological Evaluation

May 2005

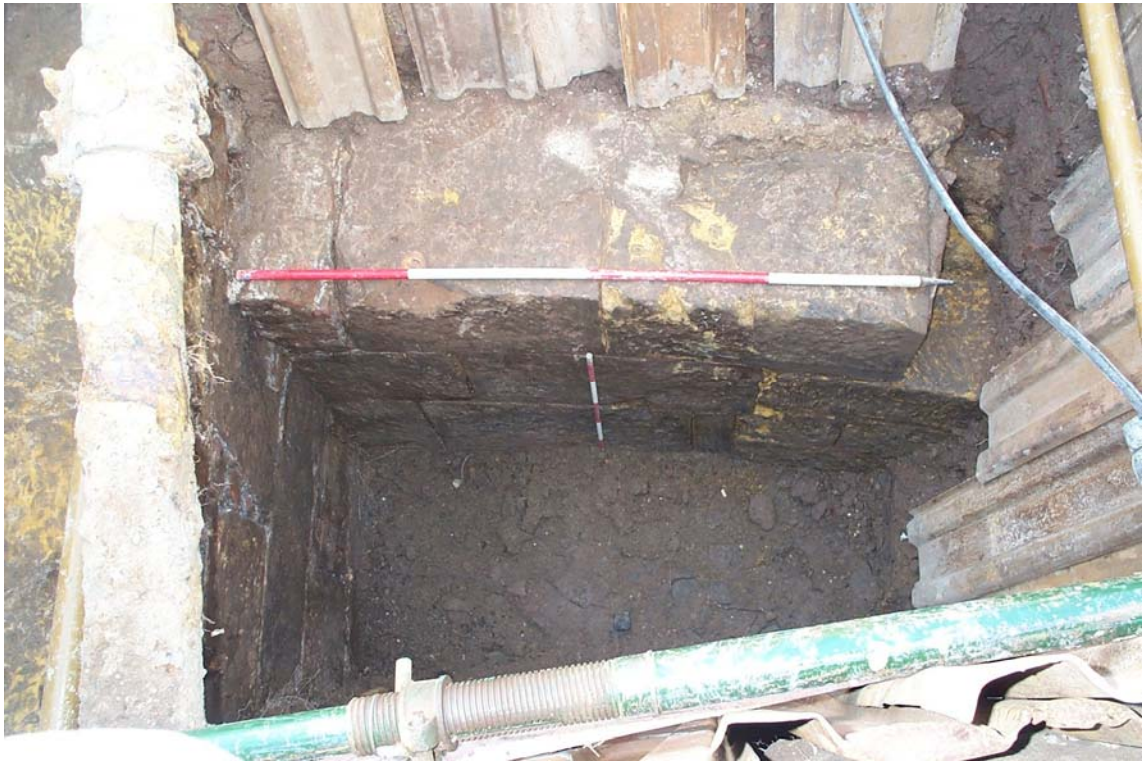
Plate 1: View of walls *1233* and *1234* looking north-north-west

4.2.1 **Trench 137:** this trench was aligned approximately north-east/south-west, and measured 3m by 2.5m, with a maximum depth of 3.2m. The trench revealed a cobbled pavement surface and modern pipe trenches, which overlay a series of deliberate backfill deposits. These in turn overlay two sandstone walls **1233** and **1234** (Fig 3).

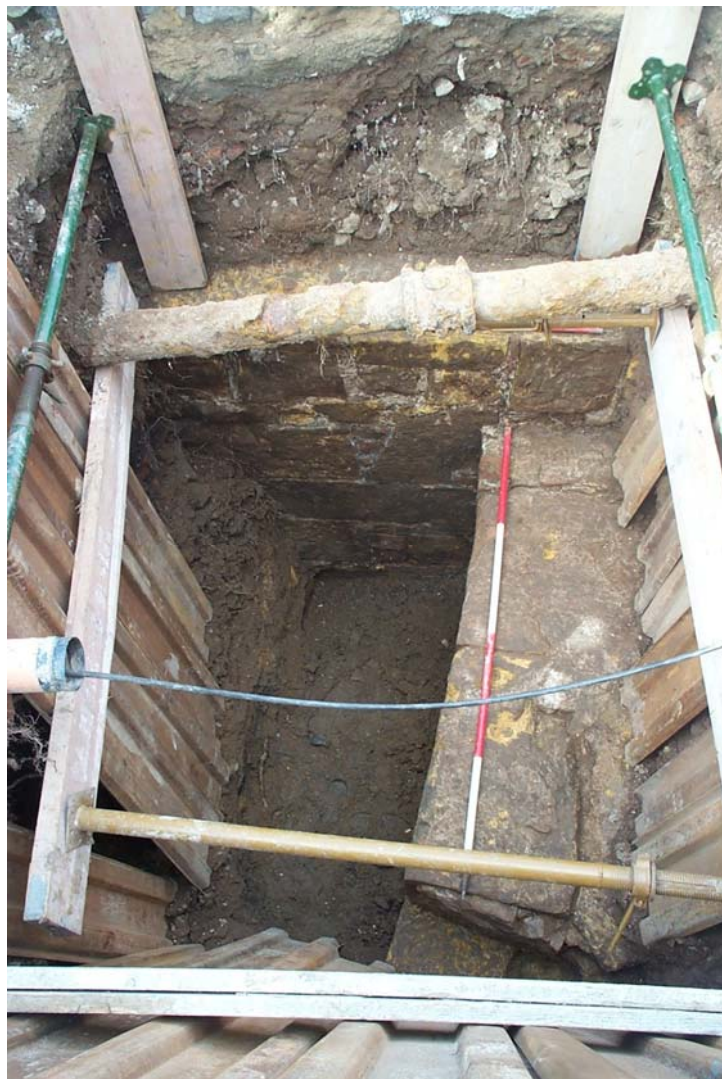
Plate 2: View of walls *1233* and *1234* showing curvature of *1233* looking west

4.2.2 Wall **1234** was aligned west-south-west/east-north-east, roughly at right angles to Canning Dock, and was revealed at a depth of 2.2m. This wall was constructed from dressed square yellow sandstone blocks, with tool marks on the majority of the stones; traces of mortar could be seen at irregular intervals. The wall appeared to be curving towards the north/south aligned wall revealed in earlier evaluation Trenches 1803b and 126, although the alignment was difficult to ascertain given to constricted size of the trench (Plate 2).

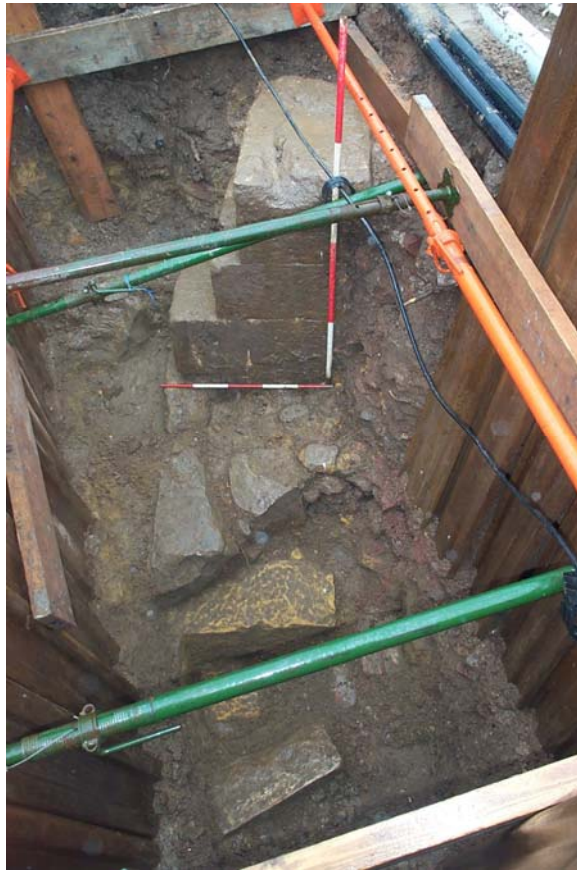
Plate 3: View of wall *1254* looking south

- 4.2.6 The yellow sandstone wall, **1254**, aligned approximately north/south, was revealed at a depth of 1.5m in the south of the trench, stepping down to a depth of 3.2m in the north of the trench (Plate 3). The wall was constructed of roughly-squared sandstone blocks with coarse tooling, and was built using dry-stone construction. The northern section of the wall appeared to have been partially robbed, and damaged, with deliberate packing having been carried out using bricks **1262** to the west of the wall, and to the east of Canning Dock (Fig 6; Plate 4).

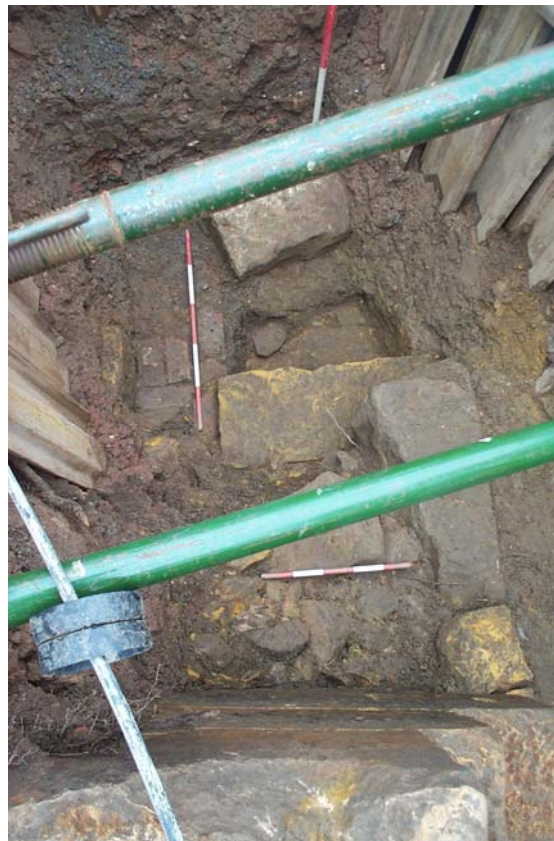
Plate 4: View of wall *1254* (looking north) showing brick packing *1262*

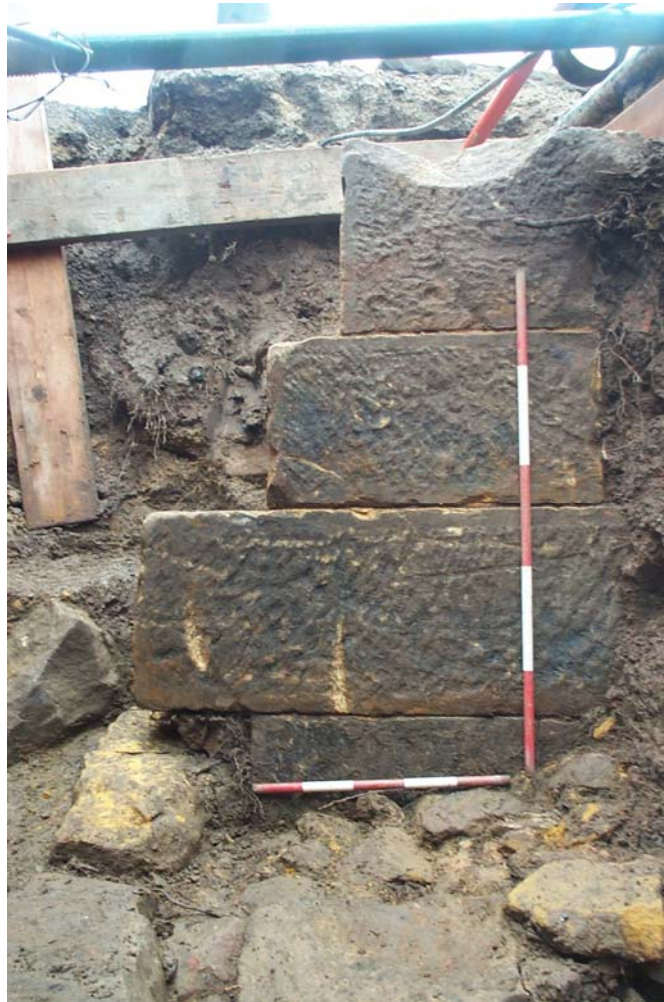
Plate 5: North face of wall *1254*

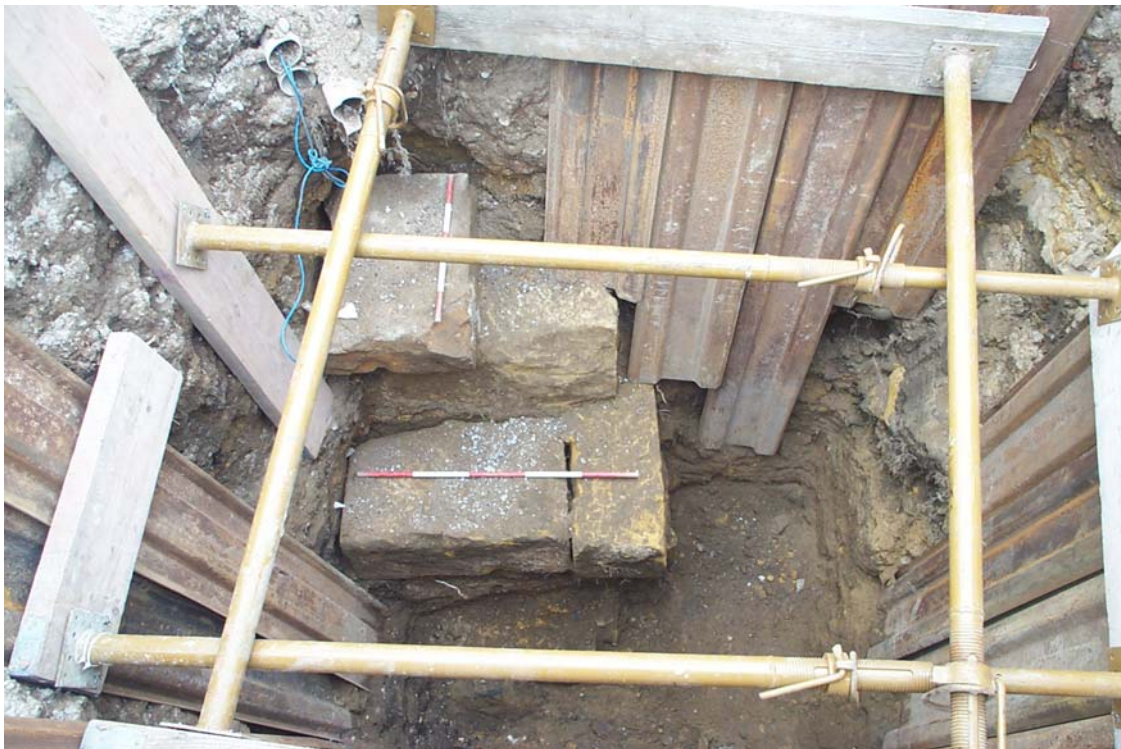
Plate 6: View of wall *1279* looking west

- revealed at a depth of 1.5m, and was constructed of roughly-squared sandstone blocks with coarse tooling, and was bonded using a lime mortar; four courses of the wall were revealed (Plate 6). A linear feature, **1280**, probably a robber trench, was also located directly to the east of **1279**, on an identical alignment. This was backfilled with a loose sand, **1277**.

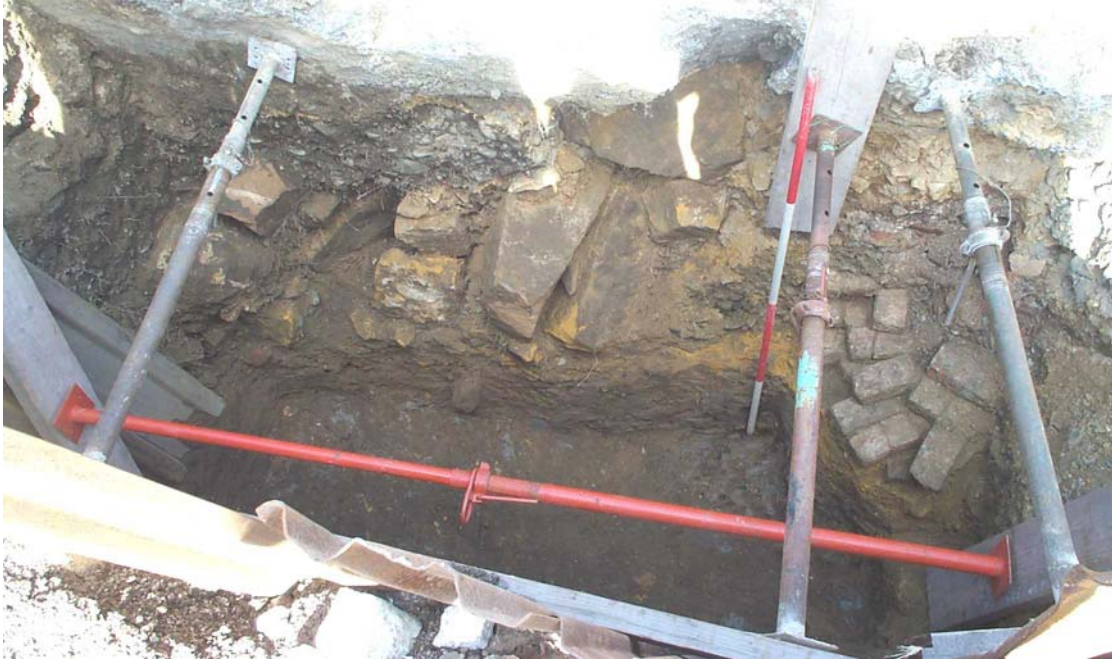
Plate 7: View of wall **1294** looking north

- 4.2.12 These backfill deposits overlay a curved 'structure', **1294**, measuring 0.72m by 0.6m, located within the north-eastern corner of the trench at a depth of 1.5m (Fig 3); it was constructed of bricks, bonded with a sandy lime mortar built on crushed yellow sandstone **1291**. Three courses of brick were revealed, although some had been moved from their original position (Plate 7).

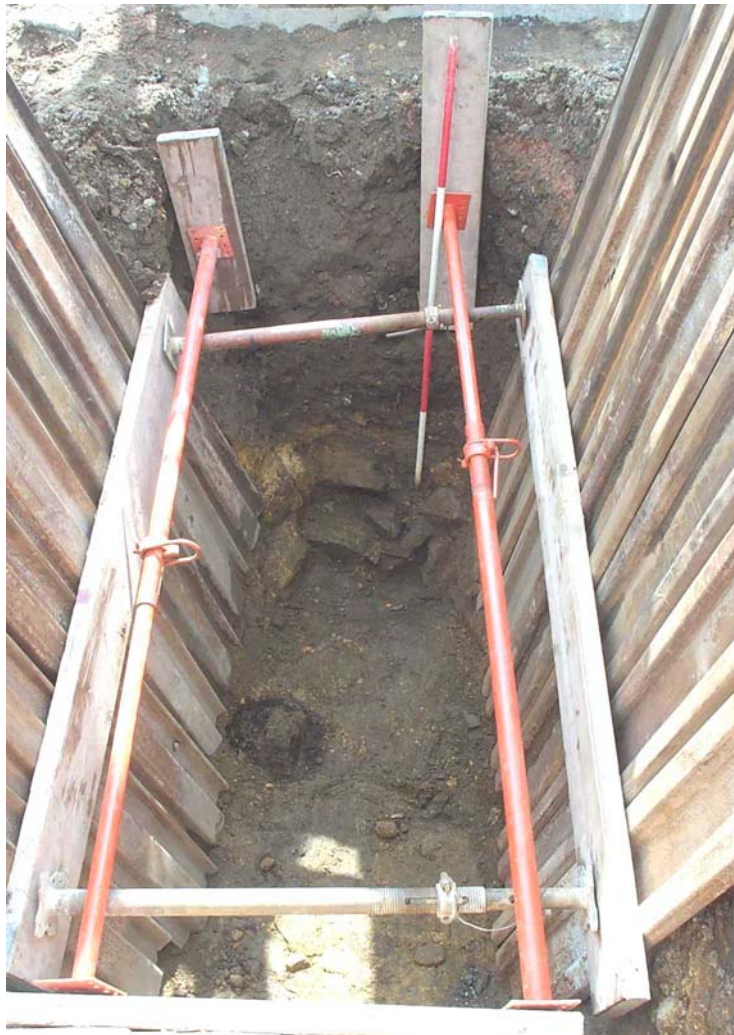
Plate 8: View of timber structure **2314** with east-facing section of wall **2315**

- 4.2.16 A brick structure, **2315**, measuring 0.7m by 0.5m with a thickness of 0.18m (Plate 8), was revealed in the north-eastern corner of the trench at a depth of 2.4m. The structure was constructed of red bricks bonded with sandy lime mortar. Two courses survive built on blue grey clay backfill **2313**, there was no apparent bond pattern.
- 4.2.17 A large vertical timber and a horizontal beam, **2314**, was located along the south edge of the trench (Plate 8). The vertical timber was 0.5m in diameter, 0.75m in height retaining most of the sapwood although it appears to have been squared off towards the east. The horizontal beam is aligned north-west/south-east extending for 0.2m into the trench and 0.35m thick. The horizontal timber has been driven into clay **2313** and was packed around with stones.

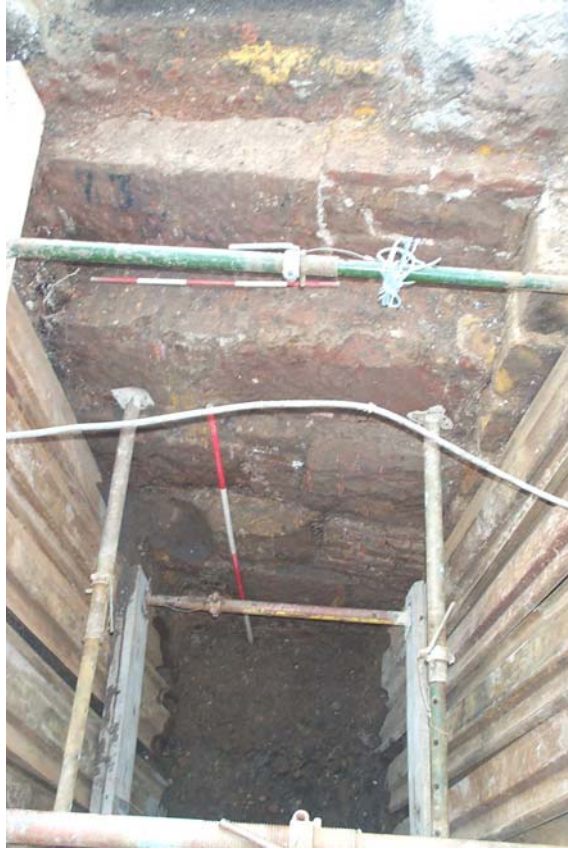
Plate 9: Canning Dock Wall **2317** looking south-west

- 4.3.5 The rear face of Canning Dock was located and appears to have been constructed in two phases, the earlier phase **2325** was constructed of rectangular sandstone blocks with soft yellowish sand/lime mortar and was of a neater construction than the later phase. These blocks were of a varied stretcher bond and stepped out with each course down (Plate 9). The alignment of this face does not run parallel with

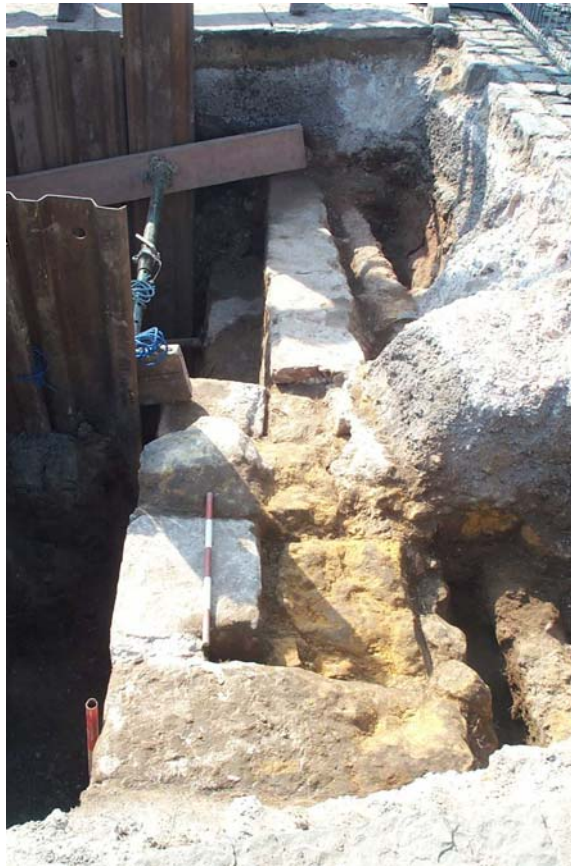
Plate 10: Canning Dock Wall **2317** looking south-east

- 4.3.2 A drain was located within the backfill layer **2321**, constructed with a flagstone base, with brick and sandstone walls at each side 1.15m wide, 0.32m in height and 0.87m deep. This feature was aligned north-west/south-east parallel to Canning Dock. The top was damaged and was truncated to the north only surviving 0.4m into the trench. The portion of drain that extended into the trench was demolished to accommodate the shoring (Plate 10).
