STEETLEY QUARRY, Worksop, Nottinghamshire

Small Building Survey Supplementary Report

November 2011

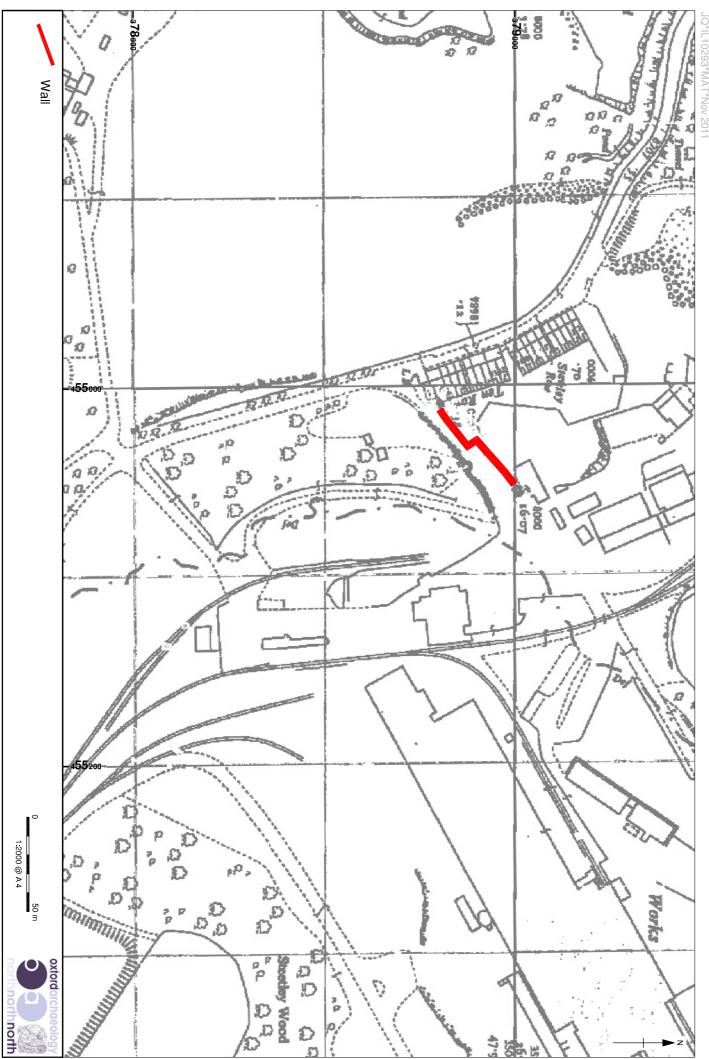
Figure 2: Wall location

- 3.4 The wall is recorded on the 1961 Ordnance Survey map (Fig. 2). It appears to be associated with the former Ten Row Cottages, though its function remains unclear. It may have been a boundary wall.

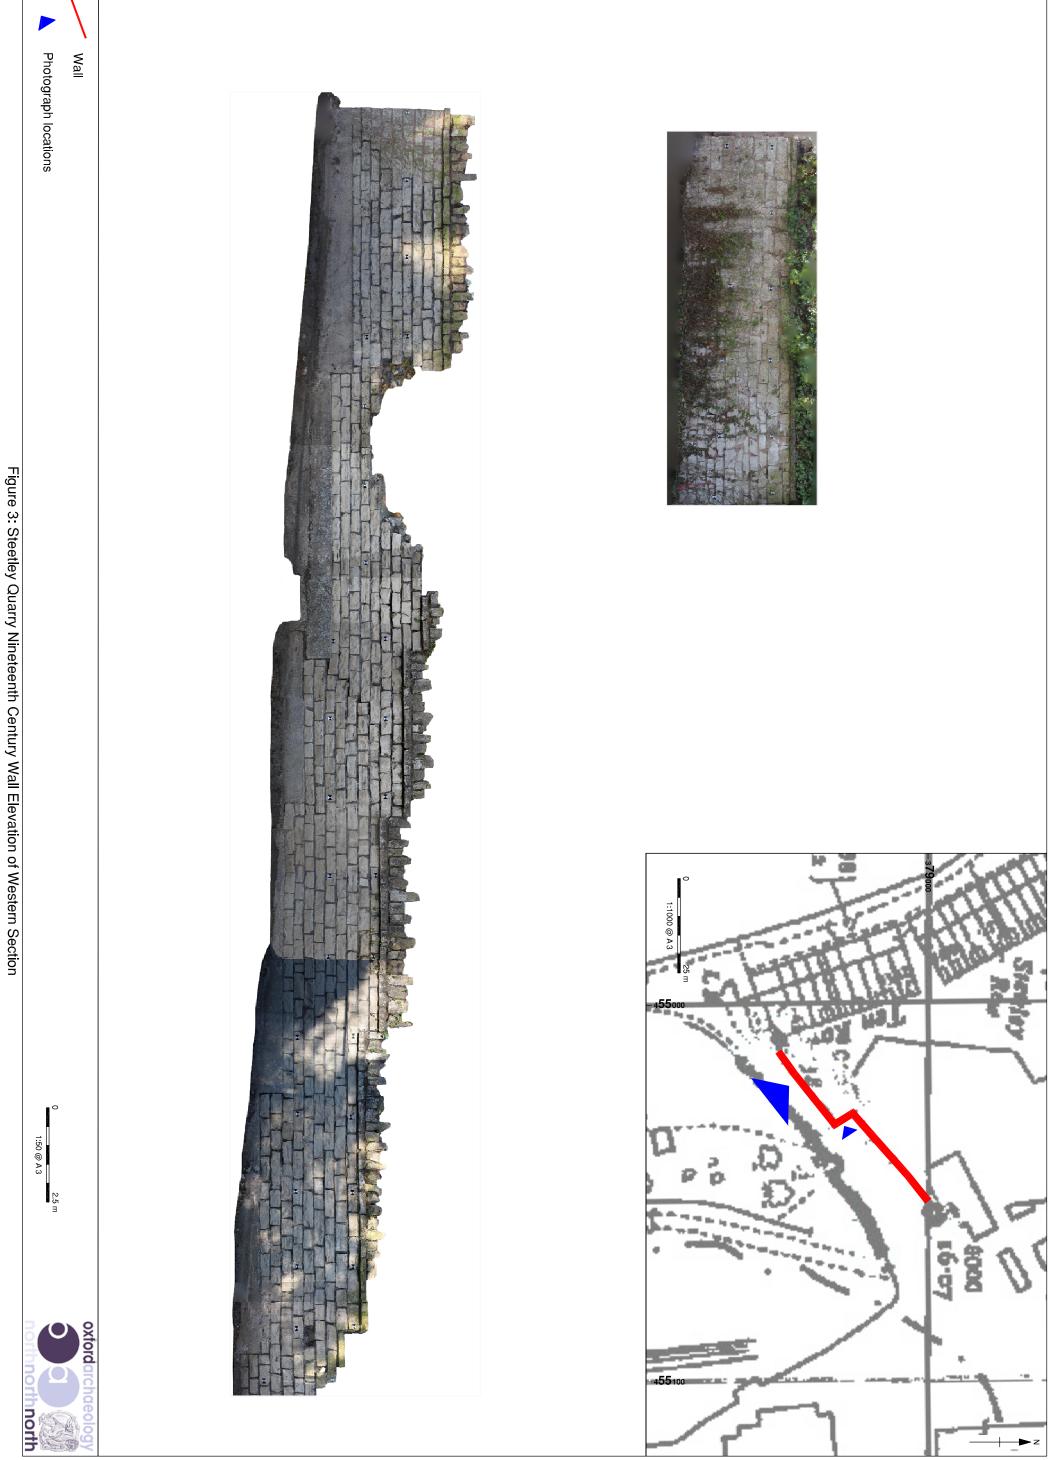
- 3.5 The rectified image of the wall is shown on Figure 3.

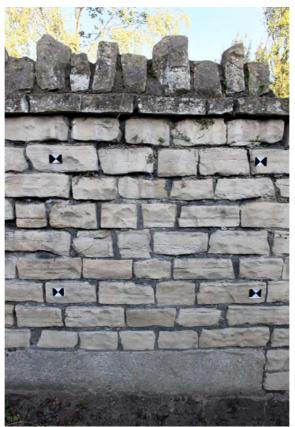
- 3.2 Survey tags were placed on the wall at 1m intervals (Plate 1), except for for the stretch of wall from 16m to where it turns, where the targets were placed at intervals of 0.5m. This was due to restricted access, and inability to move further away from the wall to photograph it. The last 10m of the wall could not be photographed with survey tags as heavy fencing was prevented access to the wall.

Plate 1: Section of wall with survey tags.

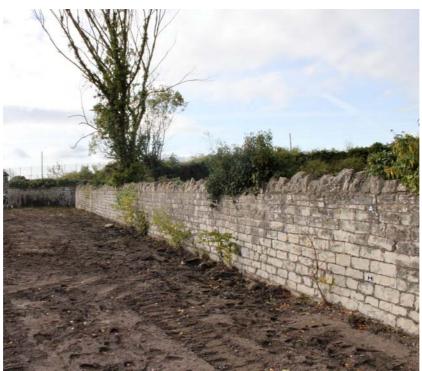
- 3.3 The wall itself is constructed of hand cut, light grey stones of varying sizes, with a grey sandy mortar. The wall sits on top of a concrete foundation, that extends 0.5m above ground level. It was heavily overgrown with ivy and surrounded by trees which were cleared so that the survey could be undertaken (Plate 2).

Plate 2: Wall after vegetation clearance.
