SMITHDOWN LANE, CORPORATION STABLE YARDS

Building Survey Report

Document Title: SMITHDOWN LANE CORPORATION STABLE YARDS,
MERSEYSIDE

Document Type: Building Survey Report

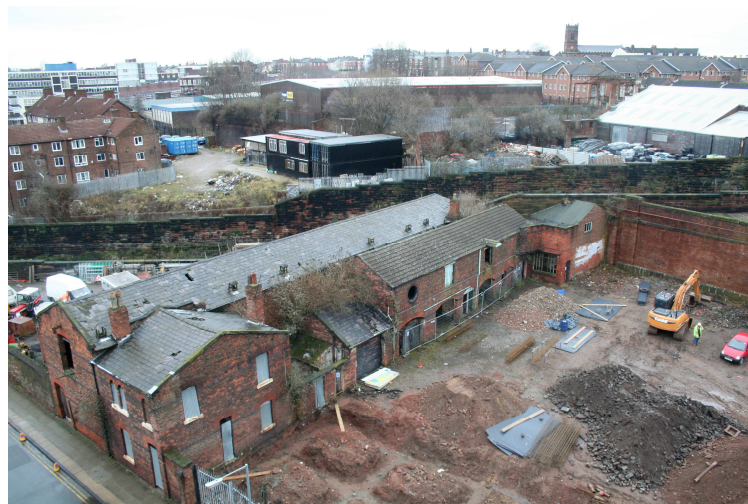
Plate 1: Aerial view showing south- and west-facing elevations of the surviving north block of Smithdown Lane Corporation Stable Yard

3.2.1 The buildings are orientated broadly east/west in a linear arrangement at the north end of the development plot (Plate 1). The north-facing elevation of the stable building also defines the northern limit of the plot. The west-facing elevation of the house and the stable yard both overlook Smithdown Lane, in particular Smithdown Lane Police Station, although when they were originally constructed they would have been located directly opposite the eastern end of Blanche Street (now demolished). The east-facing elevation of the structure butts directly against the sandstone wall which demarcates the line of the Lime Street Tunnel and, consequently, is not visible.

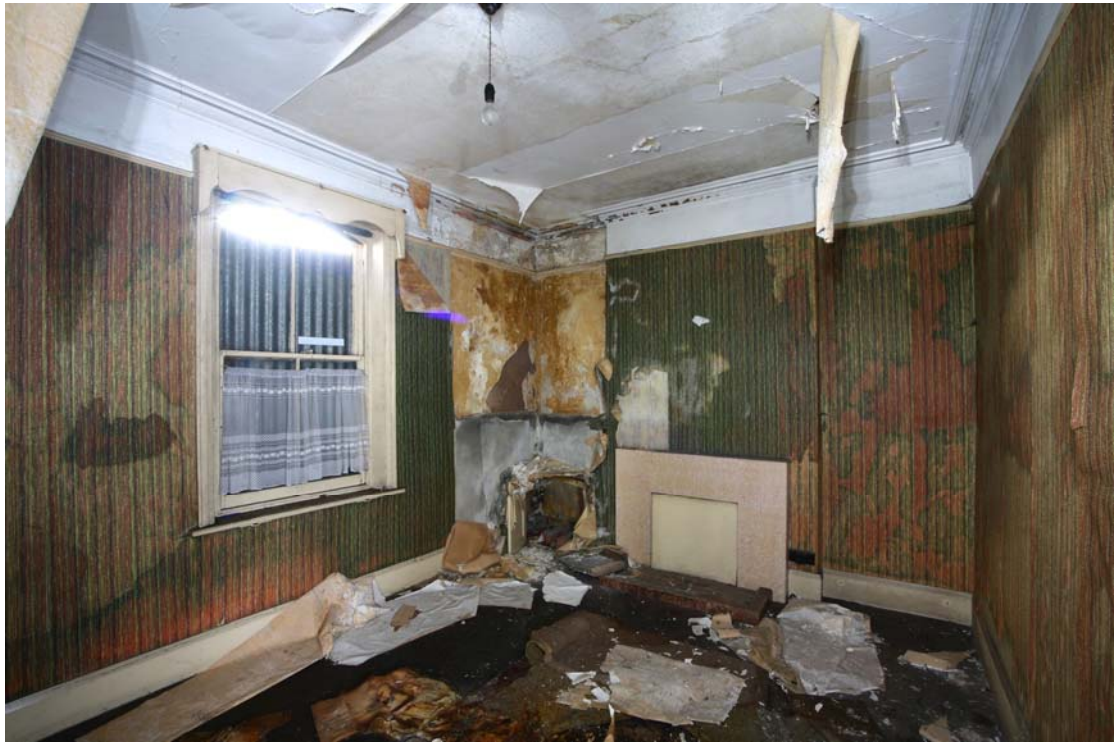
Plate 6: Living Room (1), ground floor, Smithdown Lane

- 3.4.2 **Living Room (1):** this room was accessed via a single door on the south wall leading to hallway (2), the living room is 4.1m by 3.1m in size and is a small rectangular room orientated north/south on its long axis with one window in the western wall (Plate 6). A 1.6m wide chimney breast is present on the north wall, although the original fireplace has been replaced with a 1970s ceramic tiled surround. This would have presumably been accompanied by an electric fire, which has subsequently been removed. The ceiling is decorated with a basic moulded cornice and the floor is a poured concrete slab. There are no other features of note within this room.

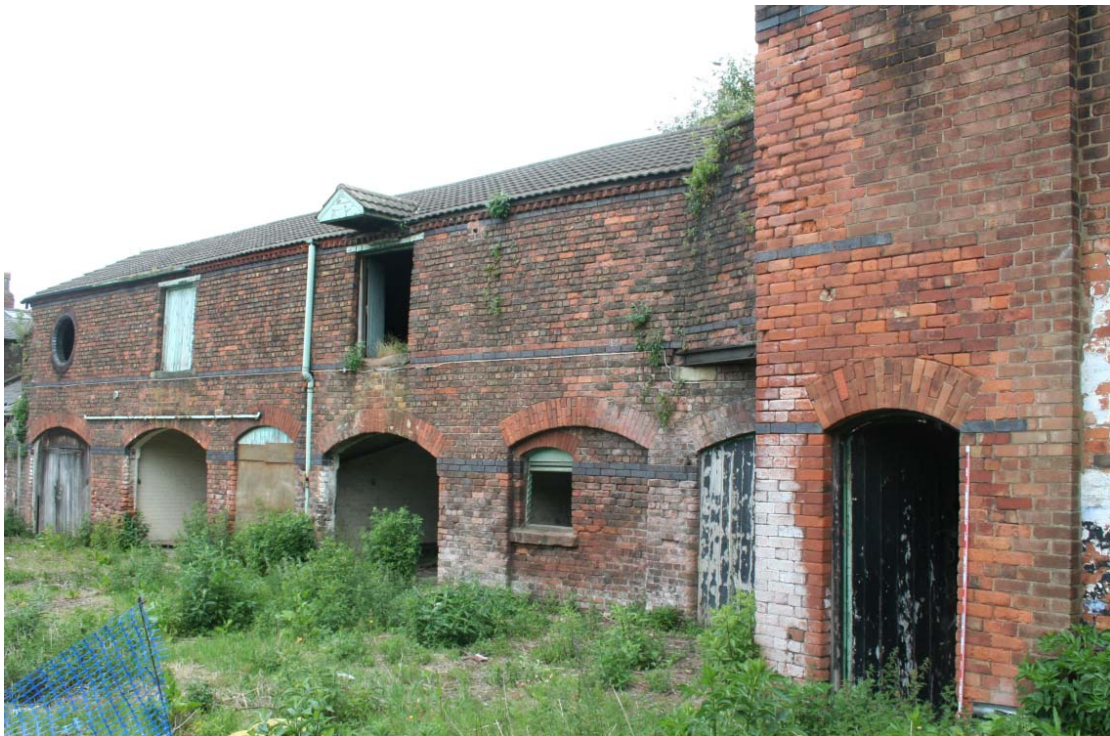
Plate 11: South-facing elevation, 71 Smithdown Lane

- 3.5.3 **The principal (south-facing) elevation:** the south-facing elevation is orientated east/west on its long axis and is constructed of red brick (Plate 11; Figs 12 and 13). The facade is broken up by seven doors and one small window at ground floor level which allow access into the individual rooms (rooms **5, 6, 7, 8, 10, 12** and **13**). Five of the seven doors are large arched doorways designed to facilitate access for horses and/or carts into the various parts of the complex, while the smaller doors to rooms **8** and **5** lead to the hay loft and cookhouse. As previously described, despite the functionality of the stables they have retained and continued the elements of decoration present on the exterior of 69 Smithdown Lane. This is a blue Staffordshire brick string course which is present in three bands across the south-facing elevation (below the eaves, below the first floor windows and below the level of the springers for the ground floor arched doorways). The building has the

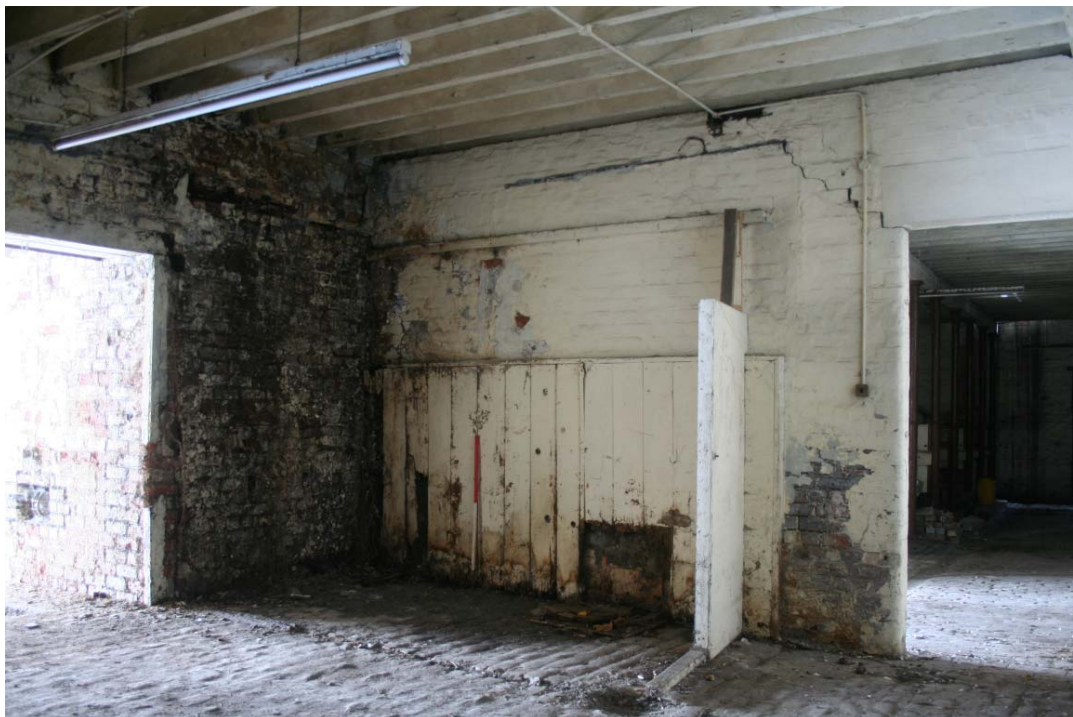
Plate 25: Ante-Room/Tack Room (**14**), 71 Smithdown Lane

- 3.6.21 This ante-room/ tack room contains many of the same features observed in rooms **11** and **15** and it is evident that all three rooms were contemporary in design and construction. This room contains only two timber plank stalls, both of which differ slightly in design from the those in the adjoining rooms suggesting that this space may have been used to segregate horses perhaps while they were groomed or fitted with the harness and tack before being taken into the courtyard to be hitched to the carts or carriages. Both stalls would have been supported at the northern end by vertical unembellished newel posts (probably half height); however, both have been removed. Voids in the granite sett floor indicate the presence of the vertical posts;

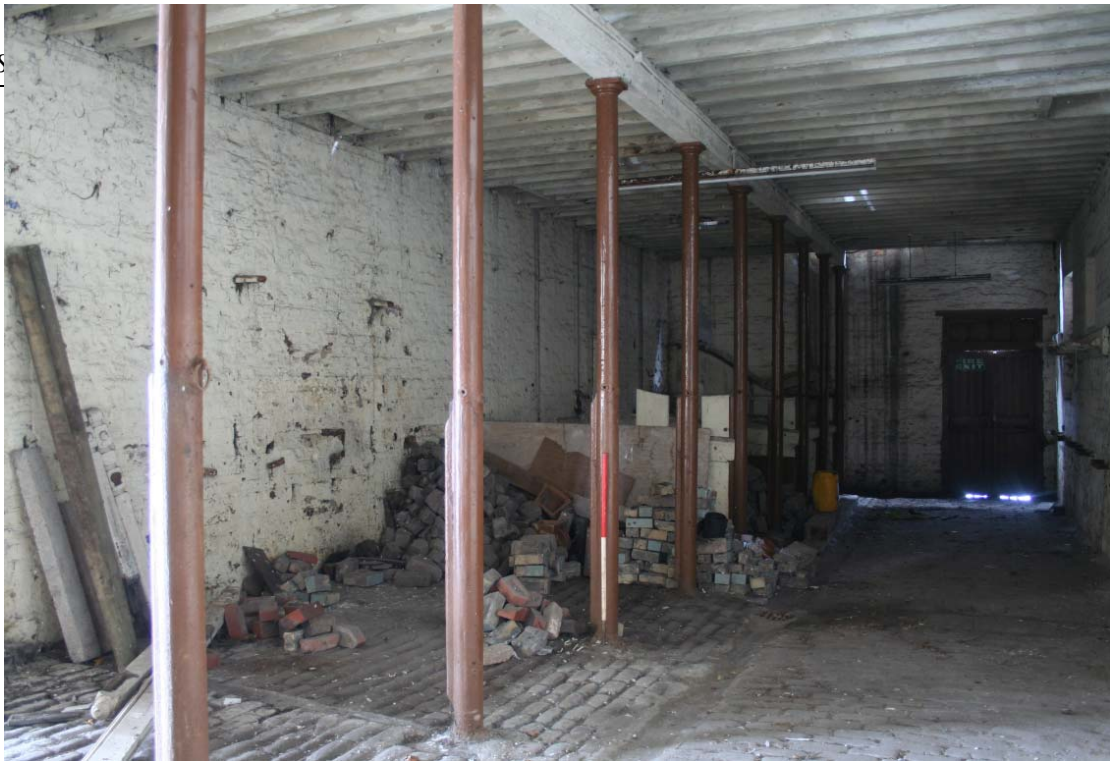
Plate 26: Main stables and stalls (15), 71 Smithdown Lane

- 3.6.18 A large doorway (later modification) has been inserted into the north wall of the former blacksmiths workshop to provide direct access into the largest area of stables and stalls (**15**). This doorway lacks the characteristic bull-nosed bricks observed at all the other original doors of the stable and is comparatively poorly finished. It is supported from above by a large RSJ lintel suggesting that this addition was made at the same time as the cook house was added at the south-east end of the complex.

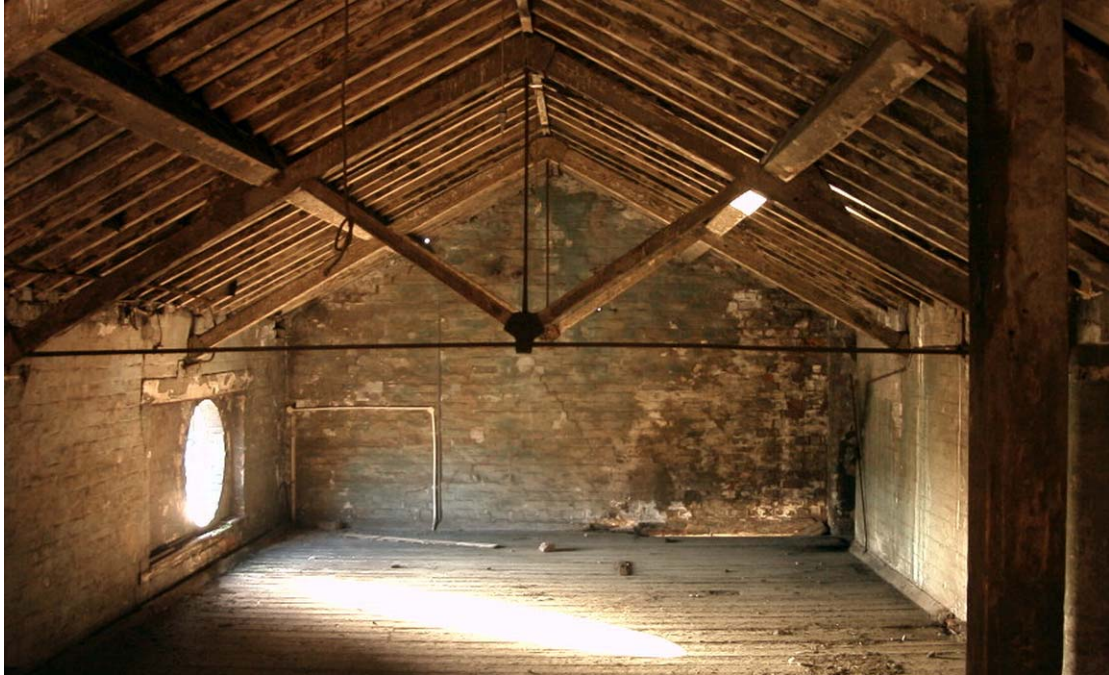
Plate 28: Roof detail within hayloft
(Image Courtesy of D Bridston)

- 3.7.1 A thorough survey of the first floor hay loft was not carried out due to the perceived instability and defective beams which form the first floor. A brief description is provided below as to the form and character of the roof structure on the basis of historic photographs.

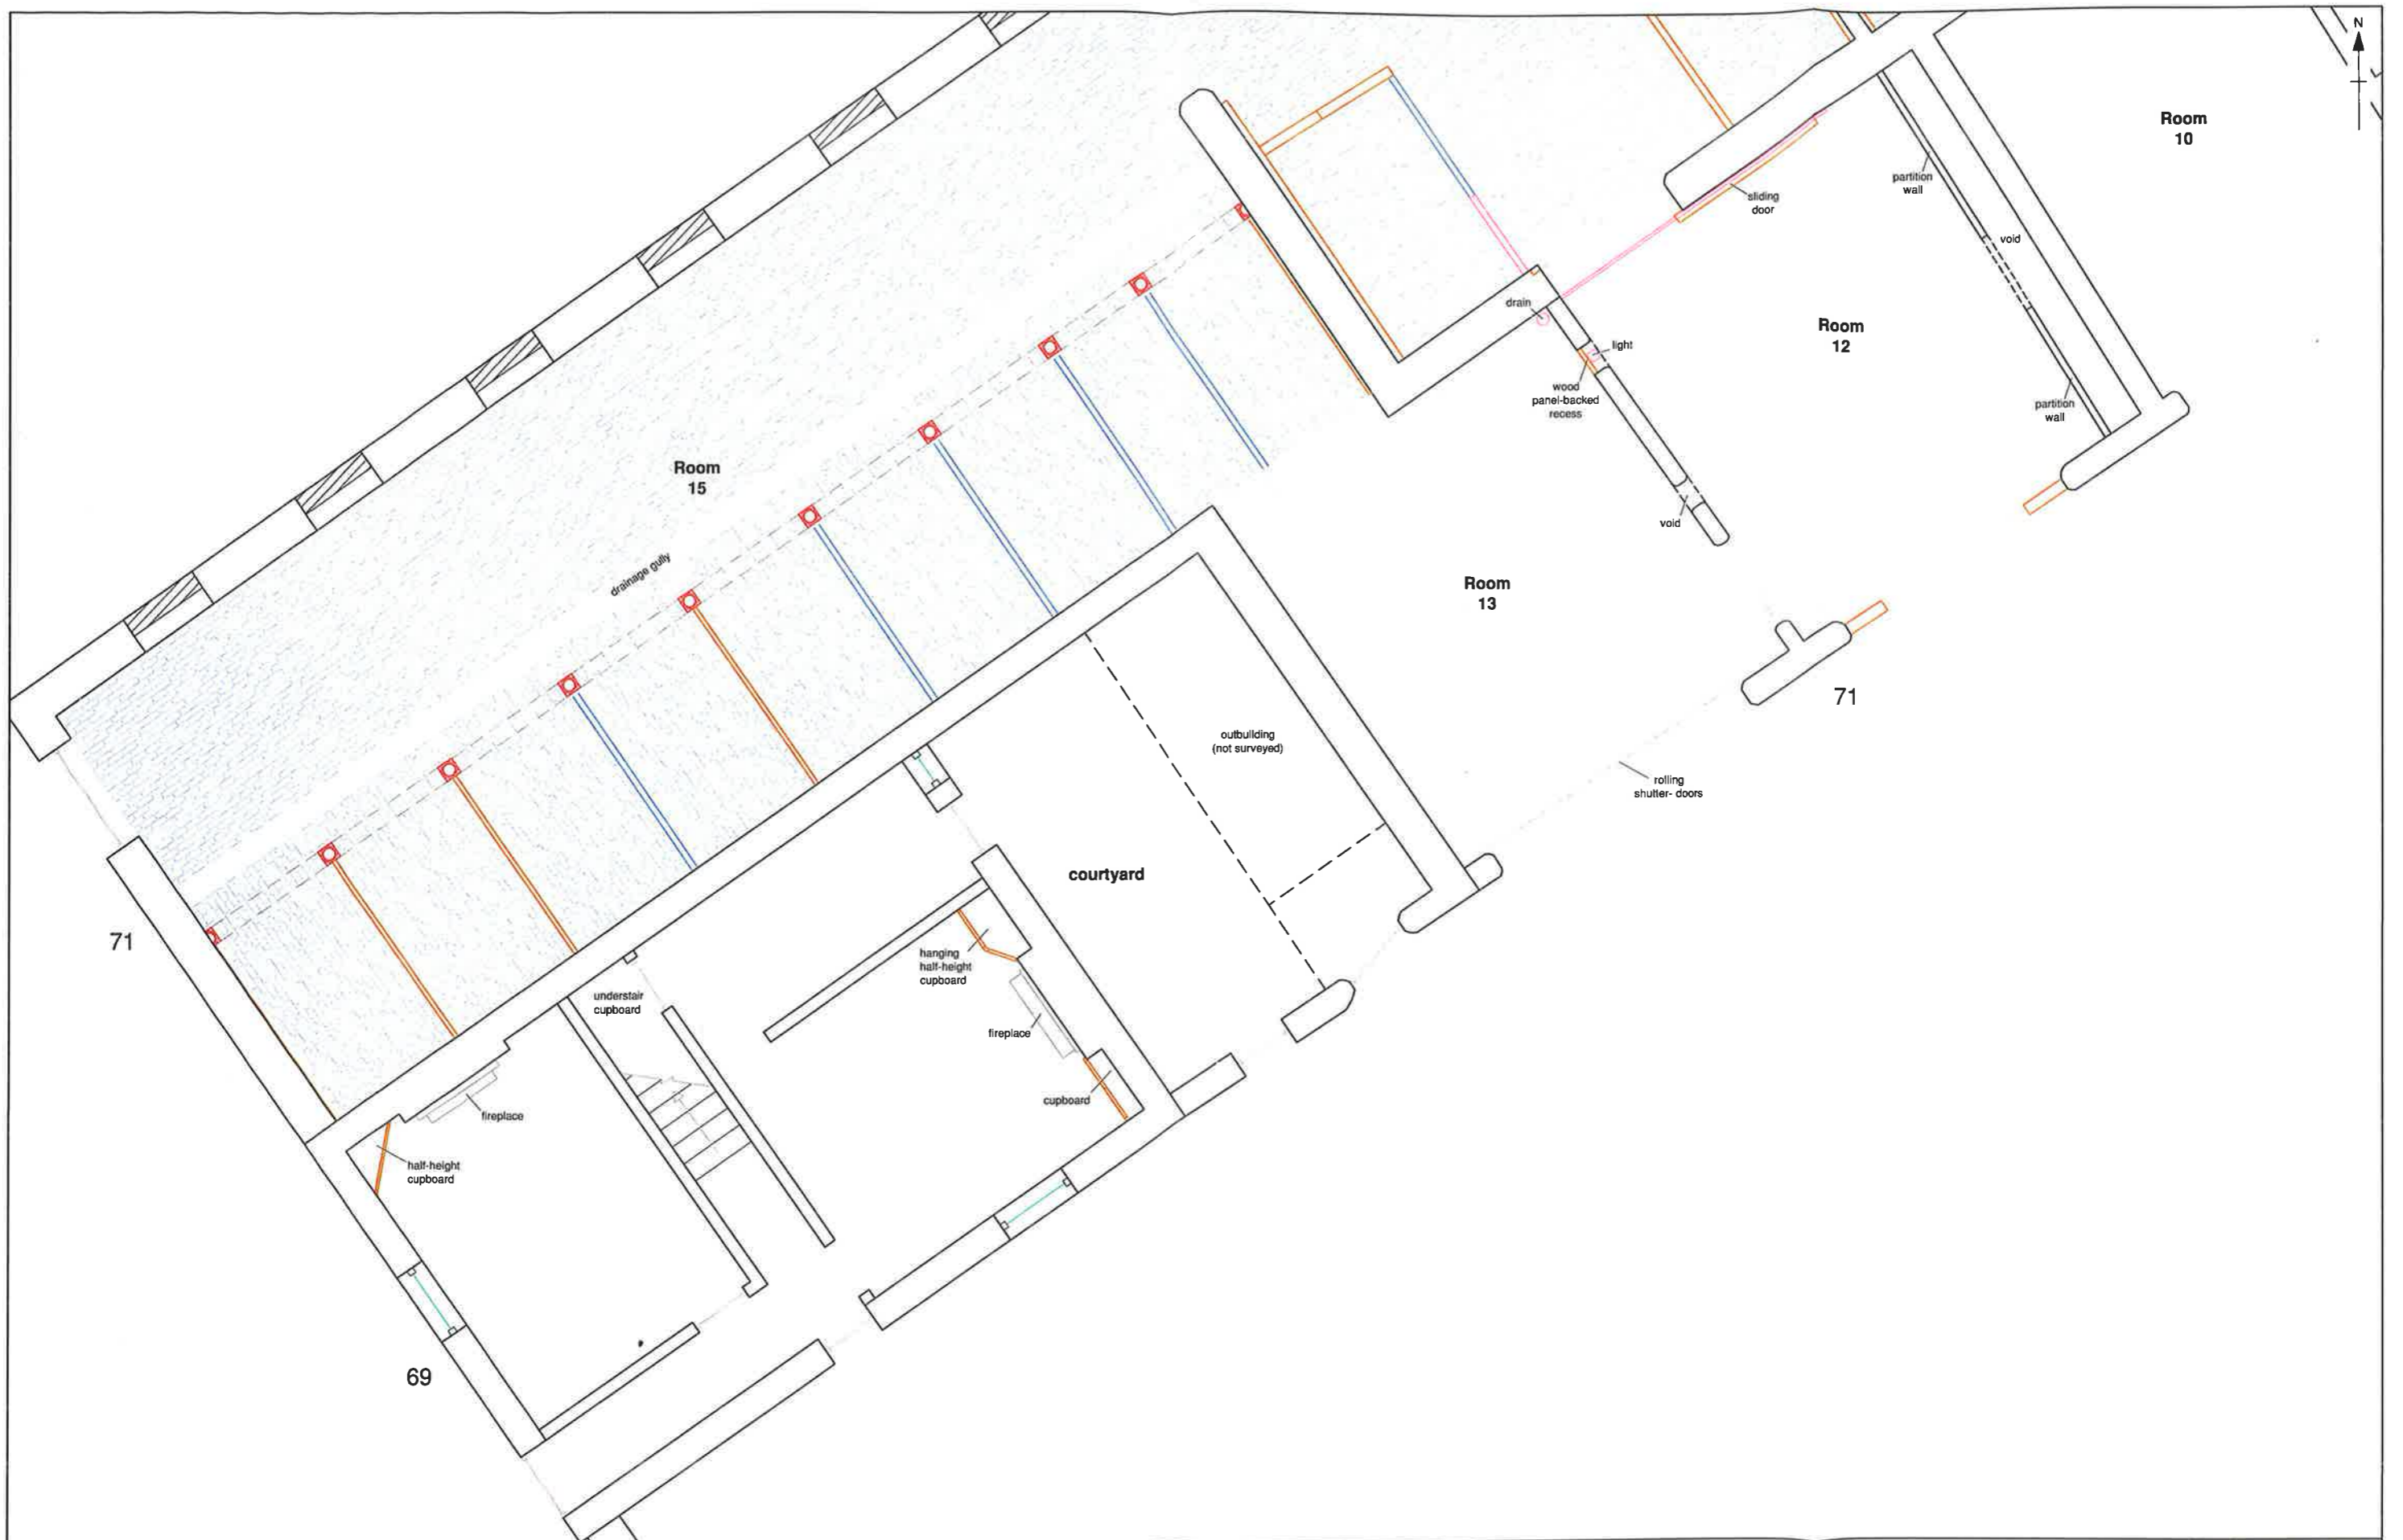
Figure 10: Ground floor plan, 69 Smithdown Lane, and south-western end of 71 Smithdown Lane

- 3.4.1 The building plan is orientated east/west on its long axis (Fig 10); it was designed for domestic use only and may have accommodated a single person, or a small family. The ground floor is divided into four rooms (Rooms **1-4**); a living room (**1**), hallway (**2**) providing access to the exterior and to the first floor, a dining room or parlour (**3**) and a small kitchen (**4**). All rooms on the ground floor have poured concrete floors and the ceilings are of lathe and plaster construction between timber beams. The first floor was not fully investigated as water damage and partial removal of the floor meant that there was no safe access. A brief visual inspection undertaken from the stairwell showed that there were four doors leading from a small square central hallway. Three doors led to bedrooms, while the fourth, a
