Bembridge Fort, Isle of Wight Archaeological Investigations

June 2019

Document Type: Report on Archaeological Investigations

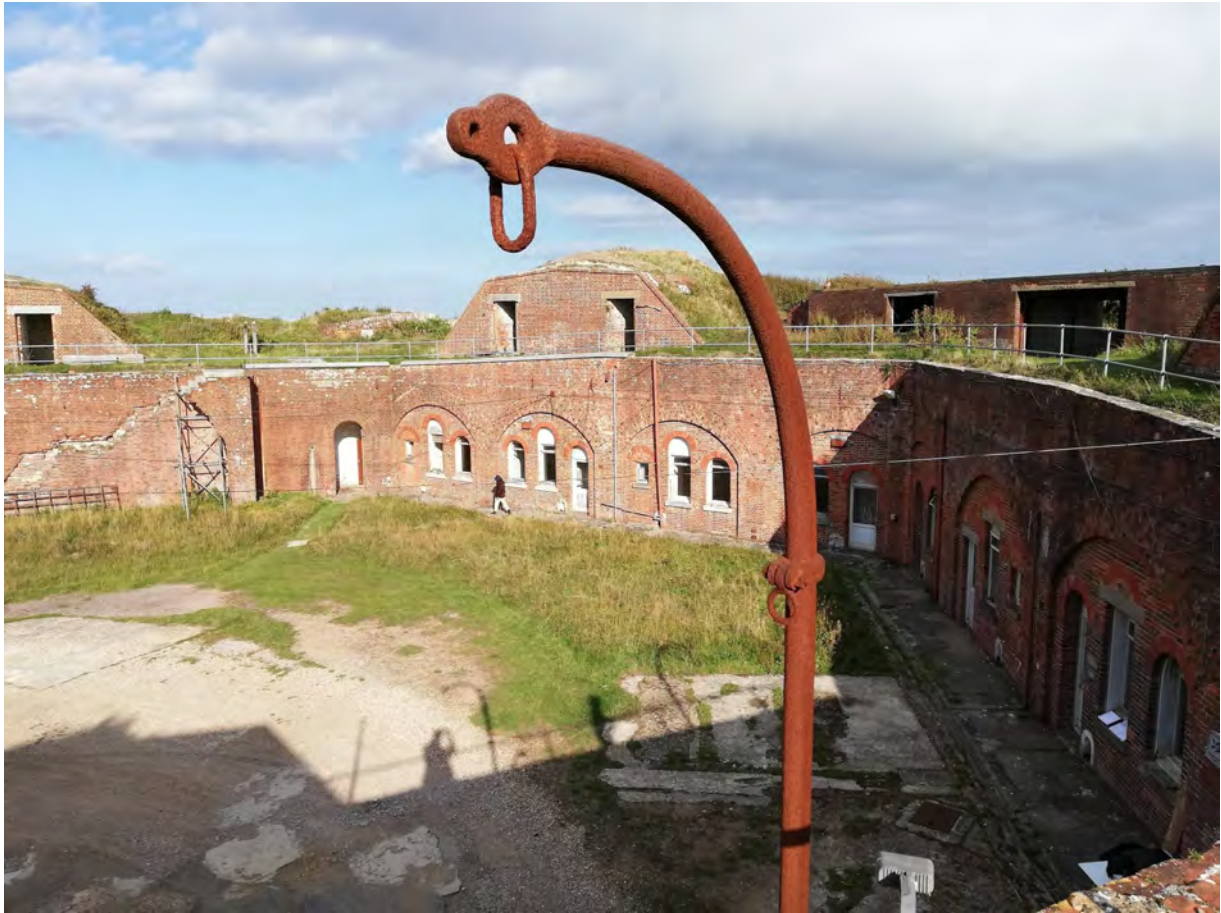
General view of the Officers' Quarters from the ramparts. Note how the appearance of the windows has been seriously compromised by the 1960's modifications.

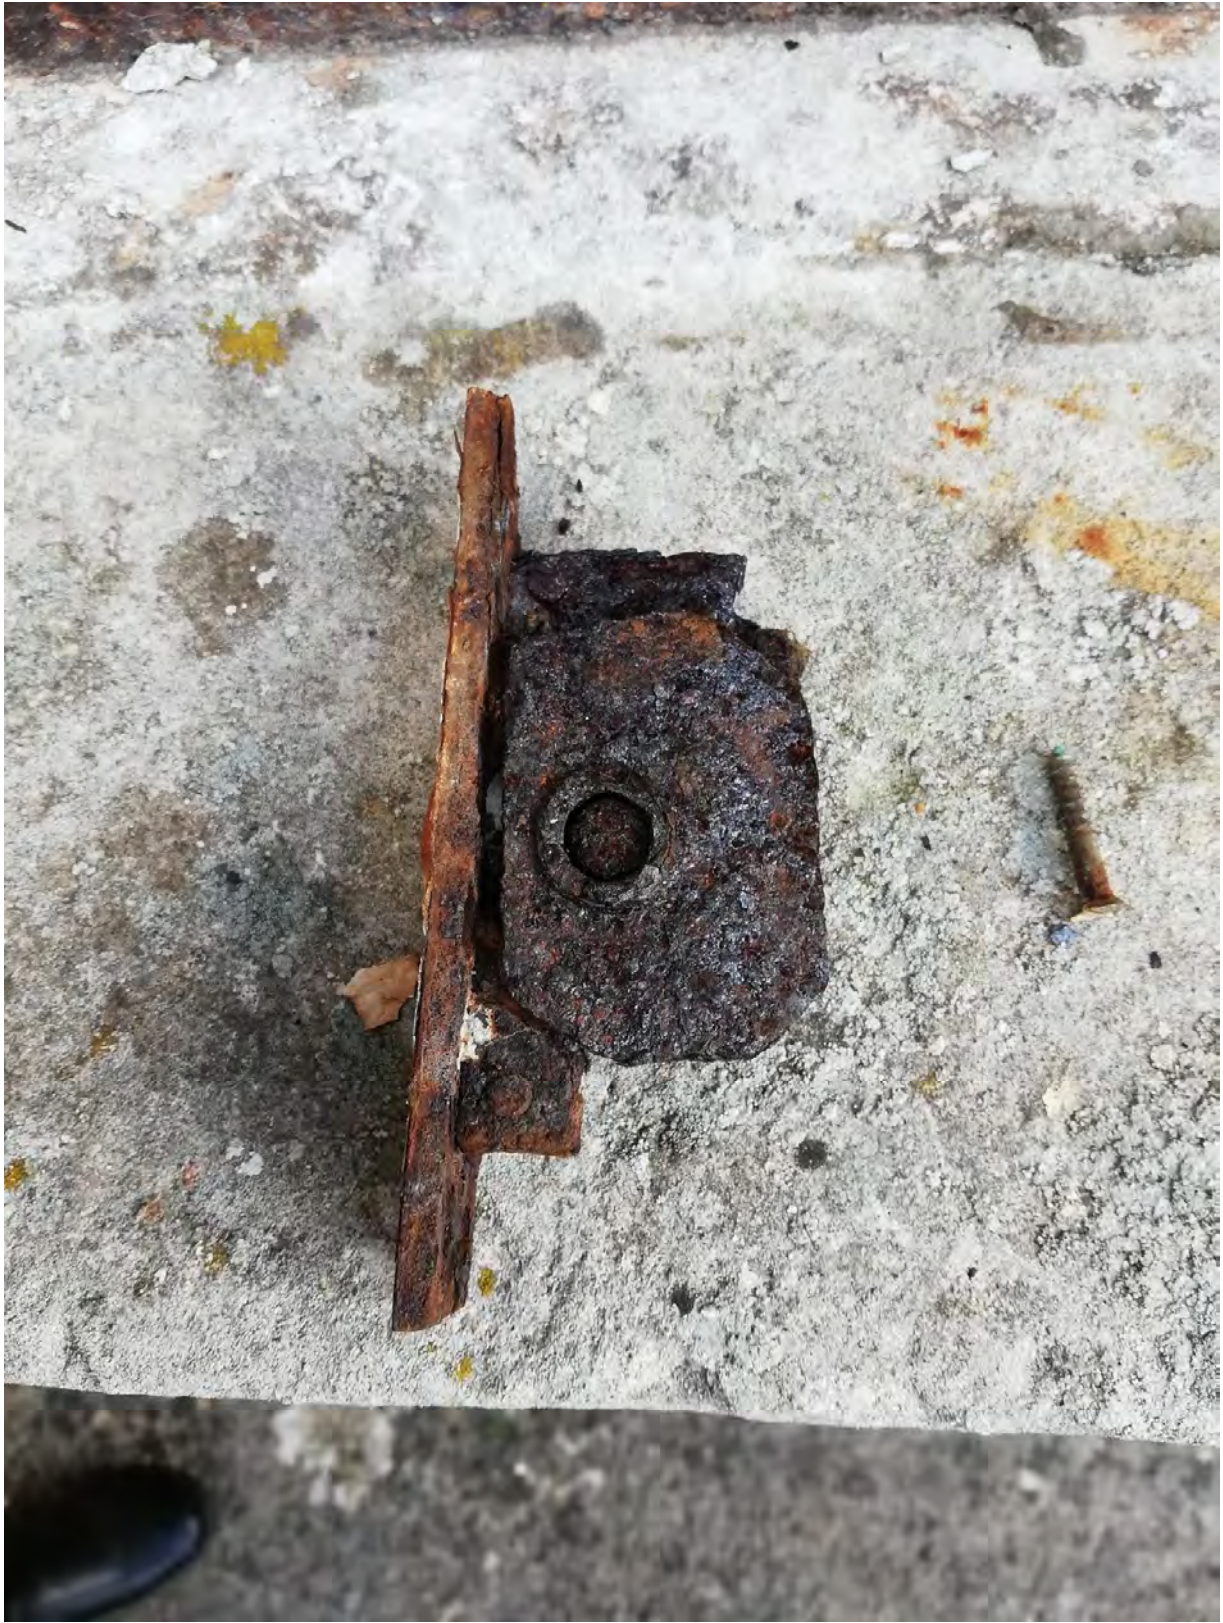
Cast-iron axle-pulley removed from window (A2) dating from the 1862-67 period. This pattern of cast-iron axle-pulley was widely used in the early-to-mid-Victorian period. It is of a relatively cheap design, manufacturer unknown. It is similar to designs produced by Woods and W. Bullock of Birmingham, who clearly marked their products.

Note the effects of the marine environment, the cast-iron case being seriously corroded.

- 3.4.5 In opening A2, the frame of the original sash window survives and two pulleys are visible, one to each side of the window positioned at the bottom of the arch opening. These are two original cast-iron axle-pulleys, produced by to an unidentified manufacturer. One axle-pulley was examined and this was found to date from 1862-67, this pattern of cast iron axle-pulley was widely used in the early to mid-Victorian period. It is of relatively cheap design, manufacturer unknown. It is similar to designs produced by Wood and W. Bullock of Birmingham, who clearly marked their products.

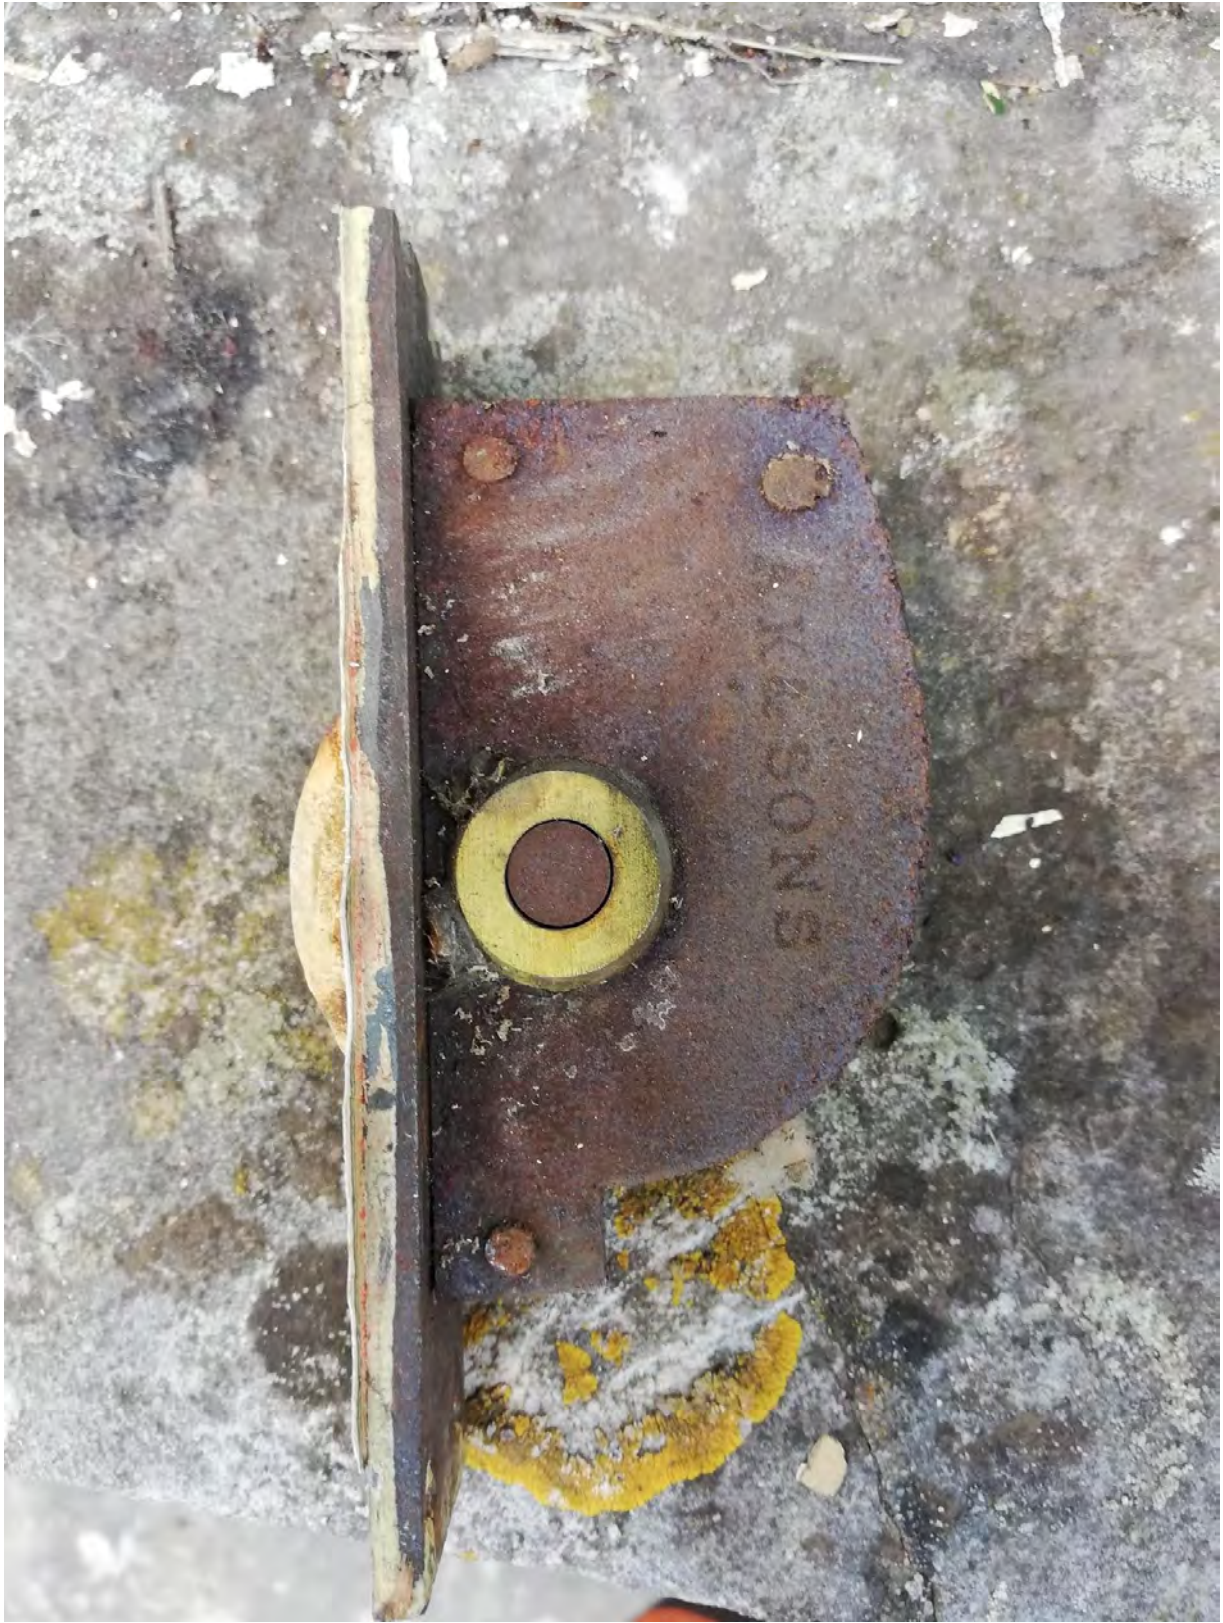
Detail of good-quality cast-iron axle-pulley with brass bushes and painted face-plate - from original window of 1862-67.

Several of the original sash windows were fitted with this pattern of Kenrick pulley - a design in use from the circa 1840's until it was superseded with an improved design in circa 1866.

Kenricks constantly improved their sash-pulley ranges throughout the 19th century. Details, such as the shape of the case, axle sizes, and the typeface used for the Kenrick legend all clearly indicate the date of the pulley. Both 'serif' and 'sans-serif' fonts were used in the 1860's, 'sans-serif' appearing on the improved version introduced in circa 1866.

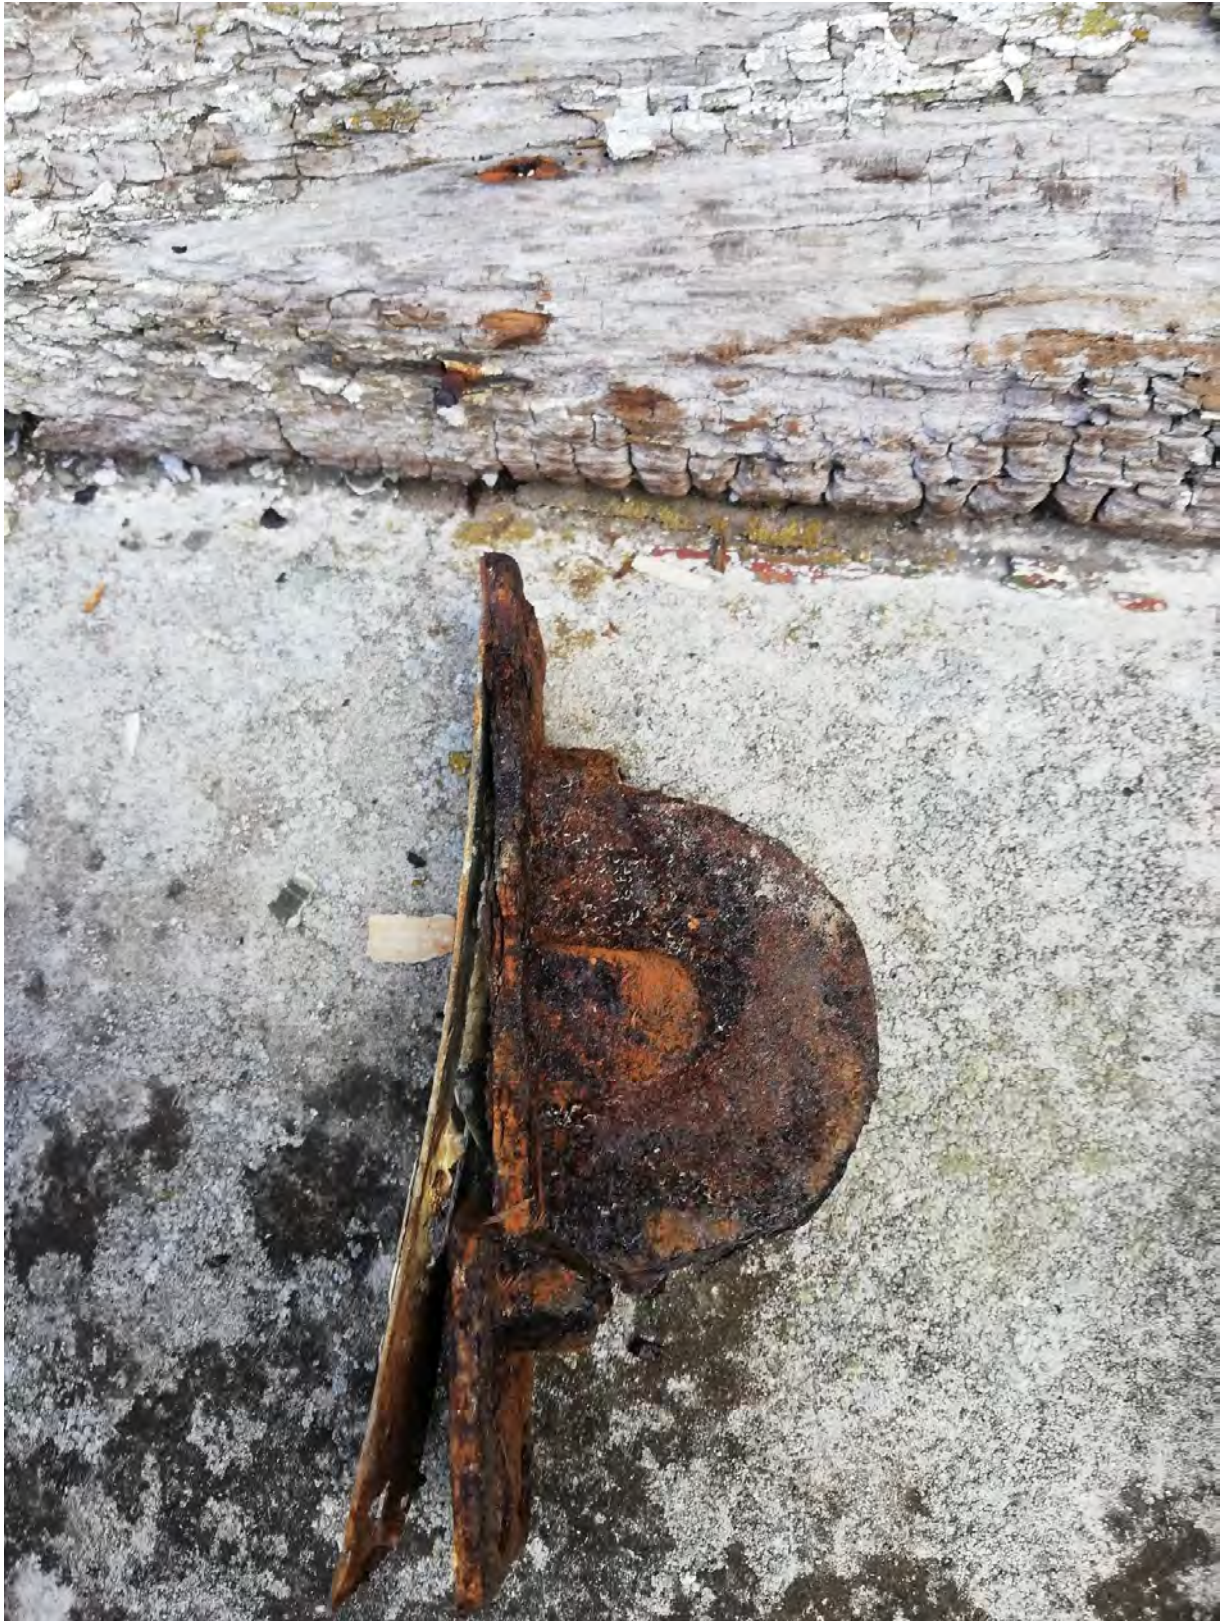
Detail of secret axle-pulley from window (C8). This pulley of a secret axle design dates from the circa 1925-39 period and is almost certainly a replacement.

Note the stamped-brass face-plate. The make of this pulley is unknown.

3.4.21 A pulley survives to the side of each window frame, a pulley from window C8 was further investigated and this showed that it dates from c. 1925-39 period, and probably replaced the original cast-iron axle-pulleys. This secret axle pulley¹ has a stamped-brass face-plate, although the make of the pulley is unknown. Internally, the frames survive for the two openings which are boarded up in the bottom half although it is likely that the original sash window joinery survives beneath this (Plate 26). Removal of one of the boards revealed the sash window weight (see Fig.9)

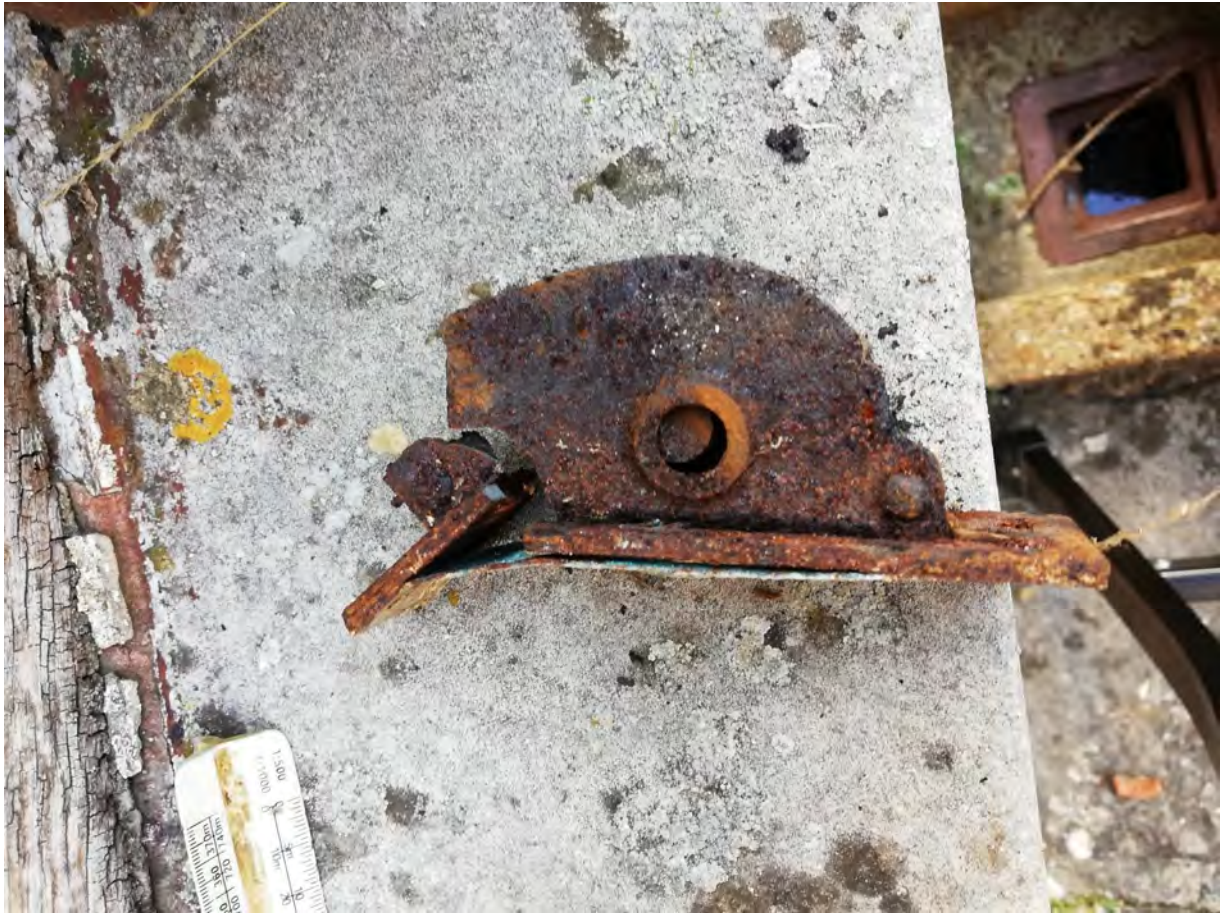
Detail of the cast-iron axle-pulley with stamped-brass face-plate and brass rim to wheel. This pattern of axle-pulley dates from the circa 1925-35 period.

It was fitted by brass screws into window (A3). There was no evidence of earlier pulleys, indicating this sash-pulley is contemporary with this window, which has the cheaper form of arched head.

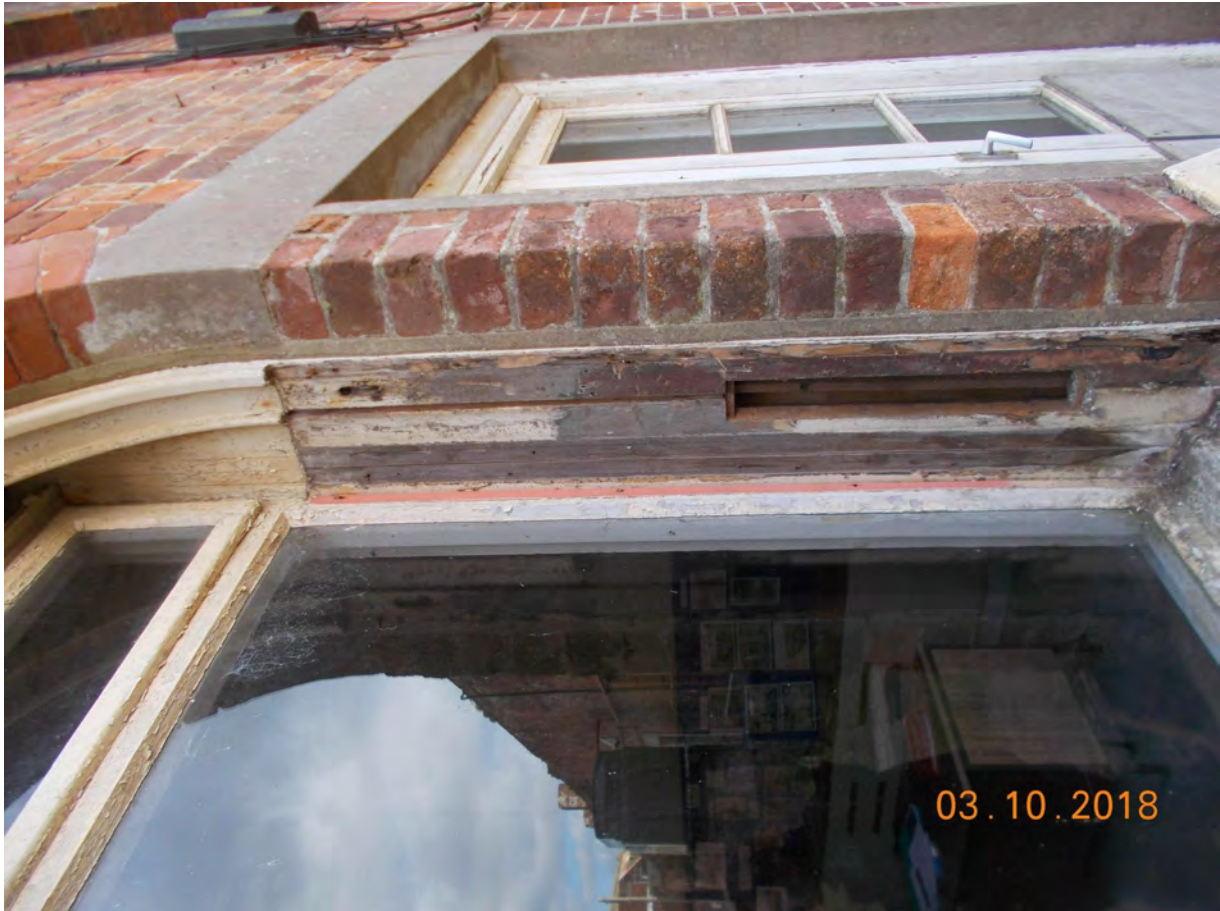
View of window (H20(?)) in Bay H showing pulley-stile revealed following removal of circa 1968 cover-board. Note centrally-placed pocket-piece, superior arched head design and cast-iron Kenrick axle-pulley, shown in position. The pocket piece was provided each side of the box-frame to access the weights for sash-cord replacement. There were two schools of thought as to where these were positioned - one school believing in a centrally-placed pocket-piece to access both weights - the more common arrangement being a pocket-piece set behind the lower sash.

There is an important area of original paint archaeology preserved in this situation. Note the unpainted areas previously covered with the internal staff-bead and stop-bead of the internal sliding shutters. Also note the fact that the beaded outside lining has been cut back to allow the fitting of the cover-board. The original primer of the circa 1968 top-hung window is clearly visible.

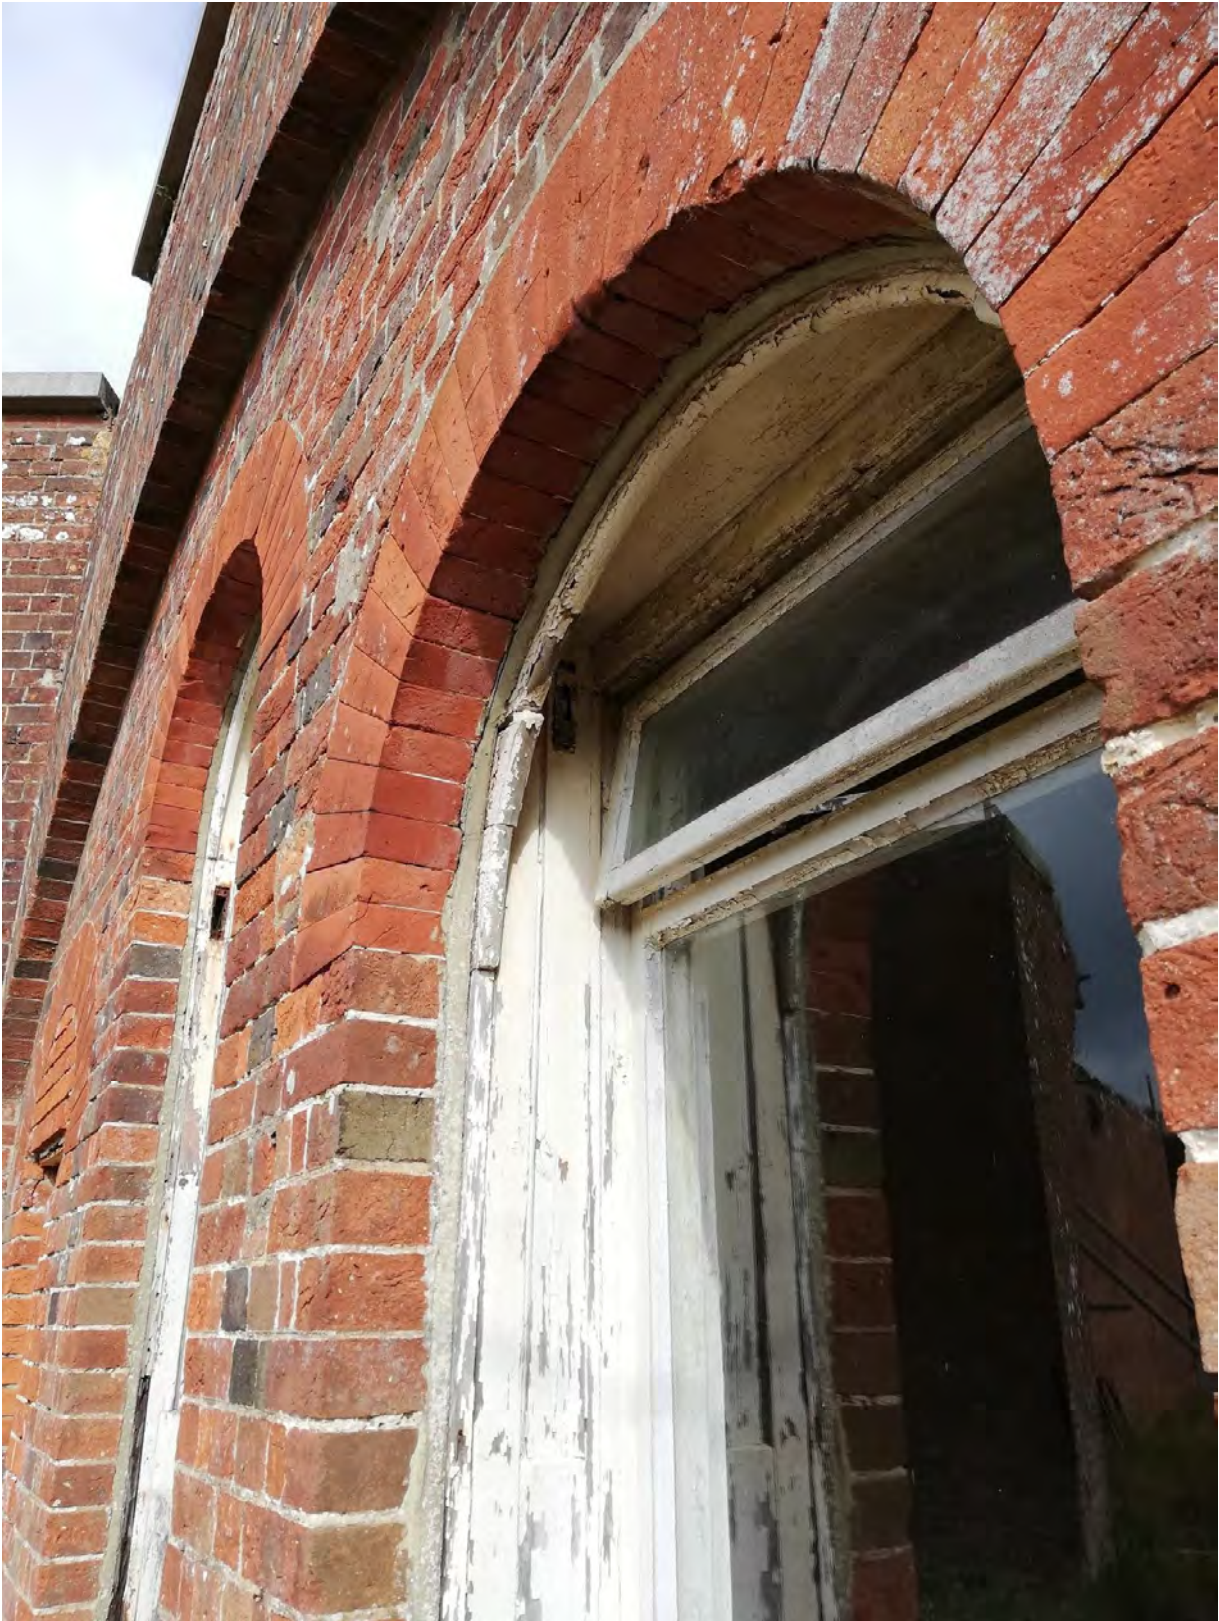
View of window (A3) with cheaper (more common) arched head construction.

This window was fitted with the brass-faced axle-pulleys shown in the previous image and requires further investigation in terms of paint analysis and construction - for instance, evidence of re-sited joinery, such as the internal shutter-box, would bear lever-marks, previous nail-holes, etc.

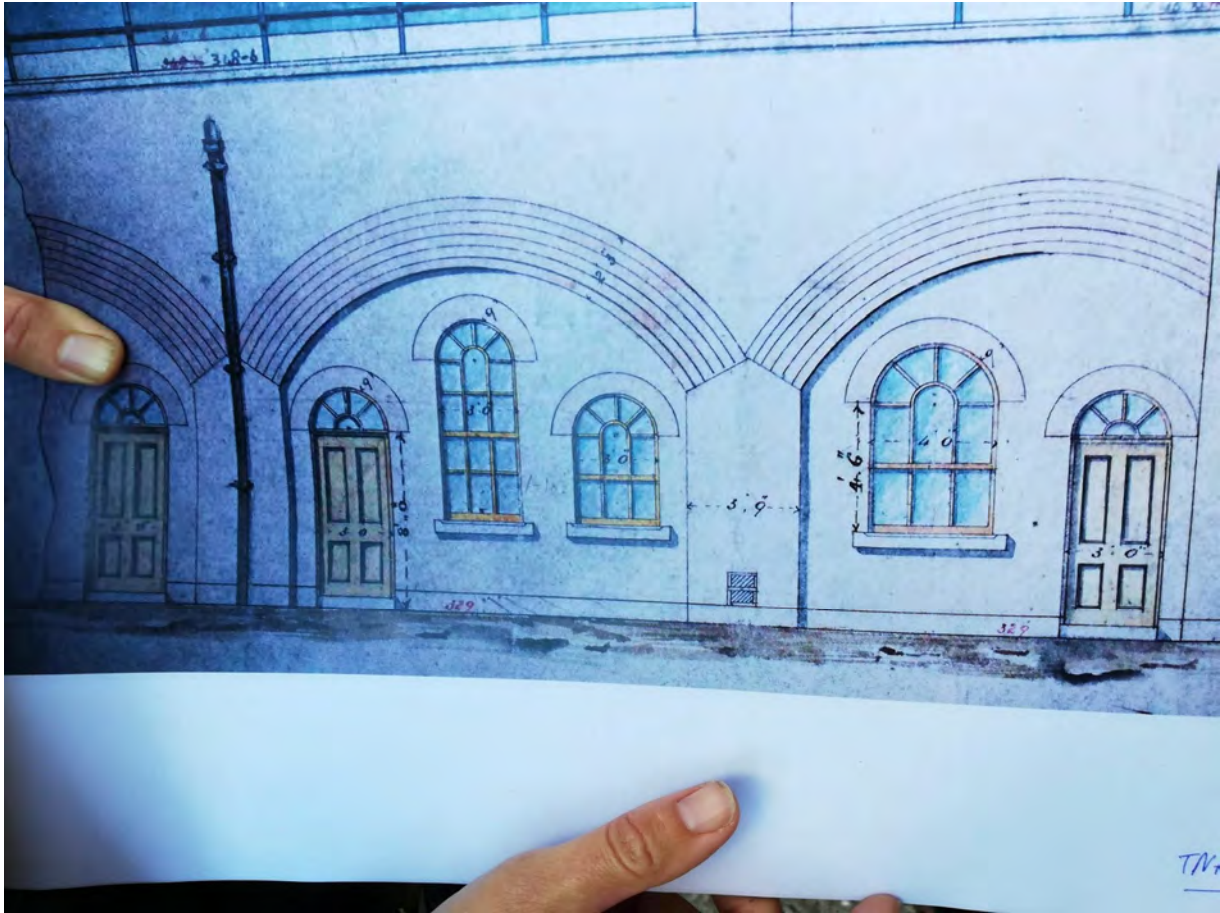
Detail from the original drawings showing the original glazing arrangements and vertical glazing-bar directly above the central arched pane.

Interestingly, these drawings indicate fully-operational sash windows, however the smaller windows would have had a small one-pane high lower sash and the joinery detailing may have been designed to mimic a meeting-rail profile on a fixed light.

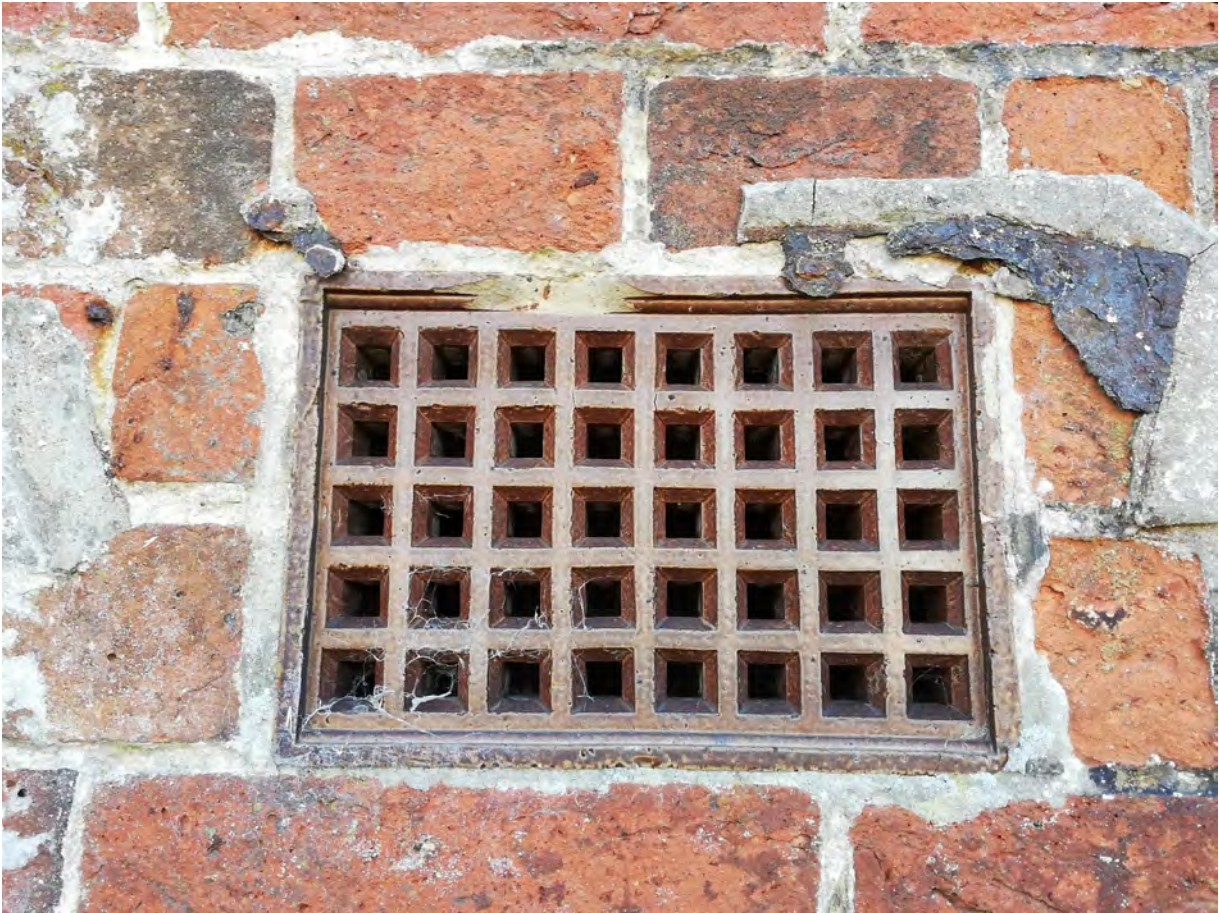
Detail of salt-glazed pottery air-brick, of a design produced in the circa 1925-35 period.

This pattern was also produced in terracotta with a matt red slip-finish and was widely used in the housing stock of the 1920's-30's.

The ovolo-moulded horizontal border top and bottom is a hangover from the earlier late-Victorian and Edwardian decorative air-bricks which were largely phased out by the manufacturers during the mid-1920's.

It is probable that this air-brick was fitted at the time of the 1930's improvements to the Officers' Quarters.

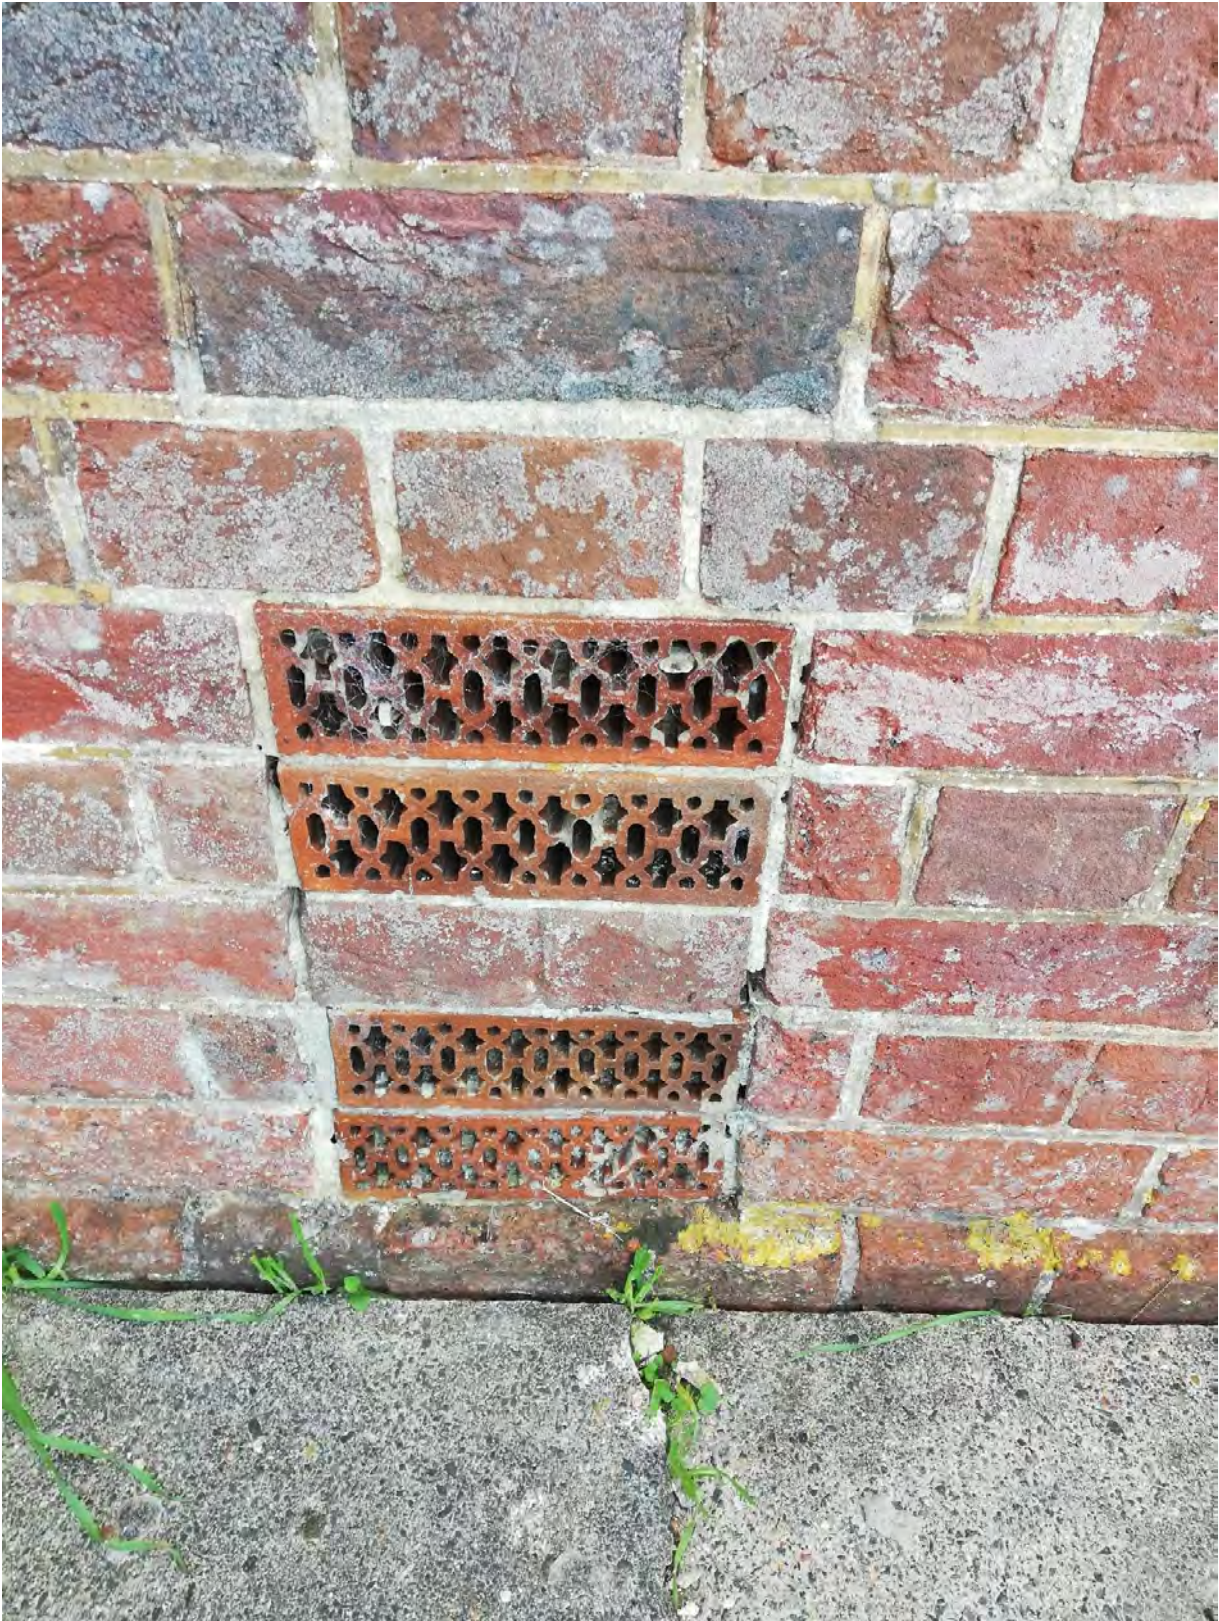
Detail of original air-bricks, typical of ornamental mid-Victorian designs.

Air-bricks of this pattern have been seen as early as 1838 in a rectory in Guildford, Surrey.

Possible manufacturers include Carters of Poole, Dorset, George Jennings, and Doultons of Lambeth, London.

This design is used extensively throughout Bembridge Fort.

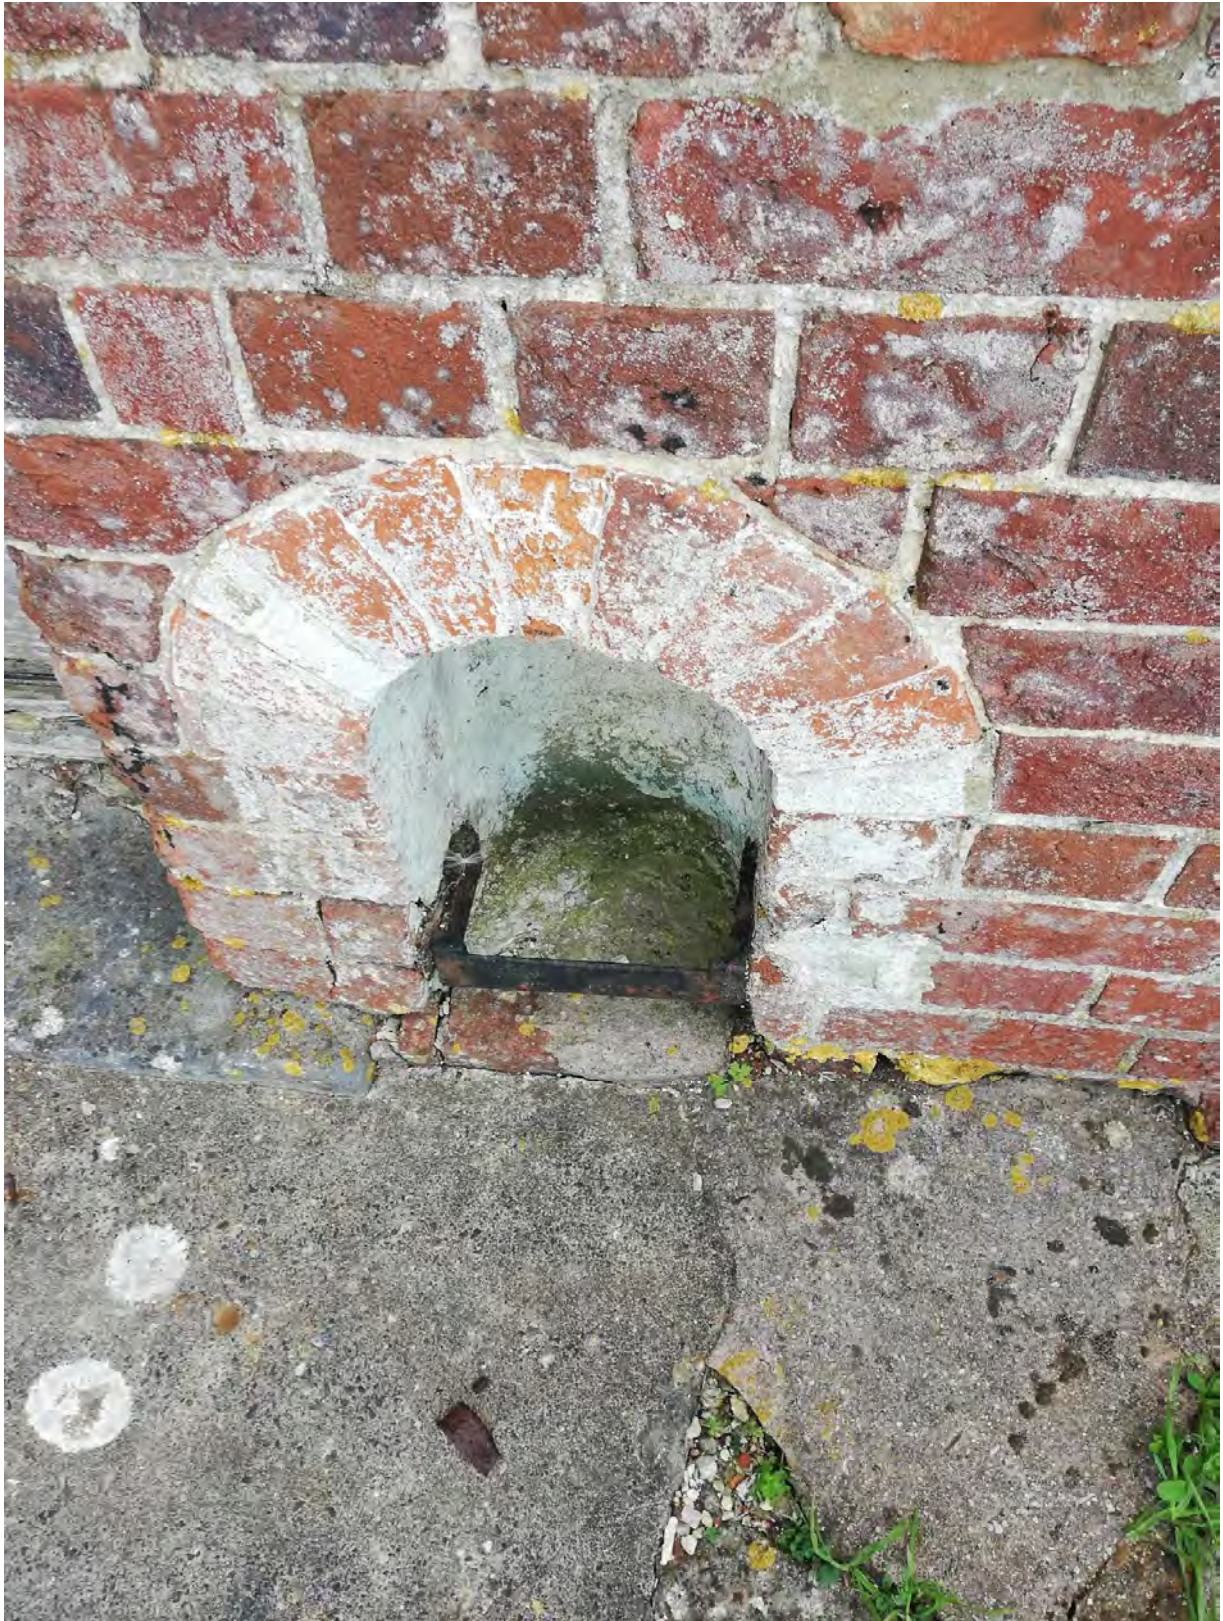
Detail of typical basic restrained military-type boot-scraper of the wall-mounted design, almost certainly contemporary with the original build.

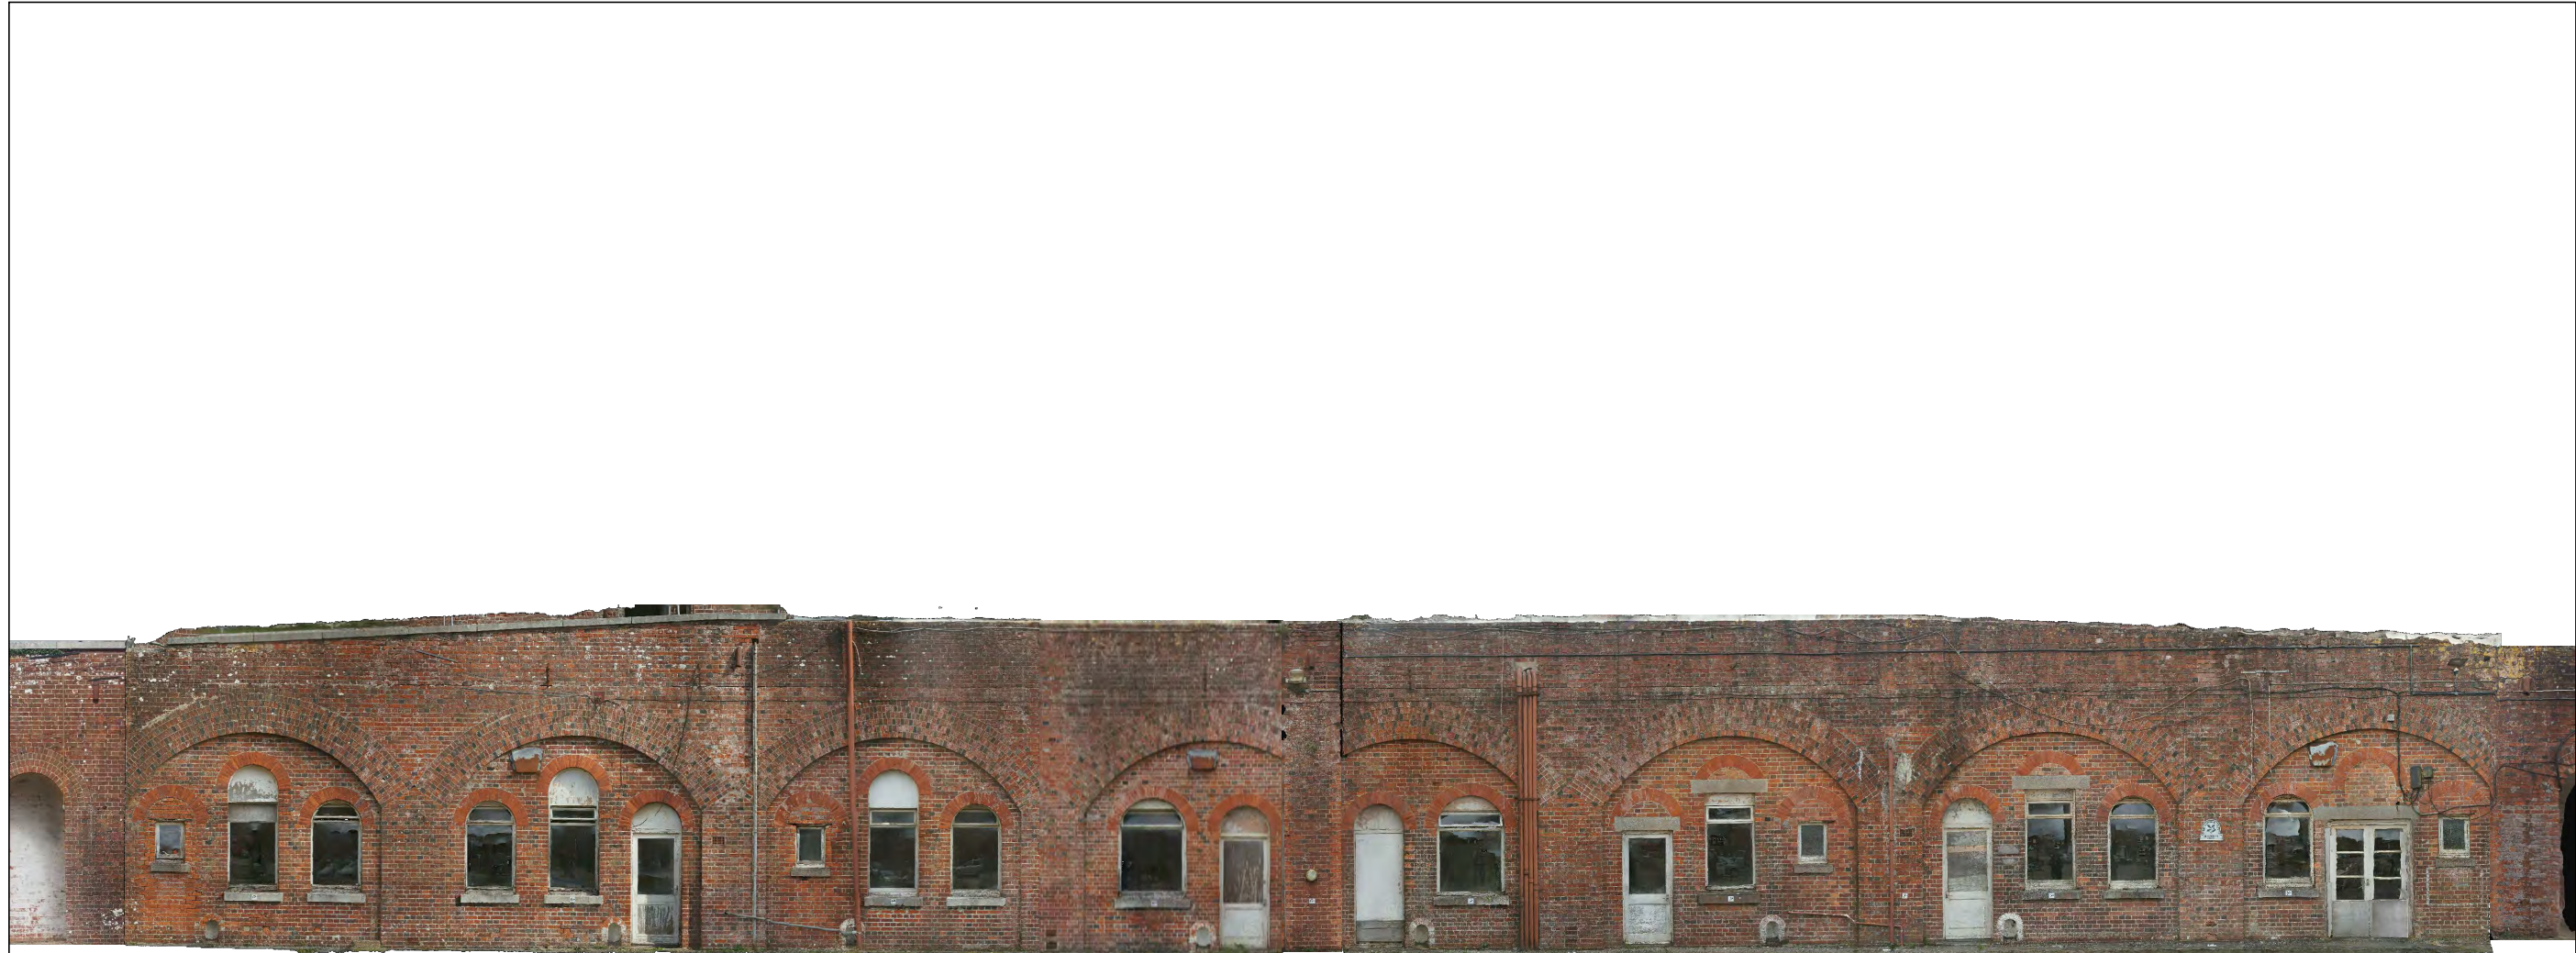
Figure 4: Bembridge Fort, Officers' Quarters Elevation

Bay A Bay B Bay C Bay D Bay E Bay F Bay G Bay H

A1 A2 A3 B4 B5 B6 C7 C8 C9 D10 D11 E12 E13 F14 F15 F16 G17 G18 G19 H20 H21 H22

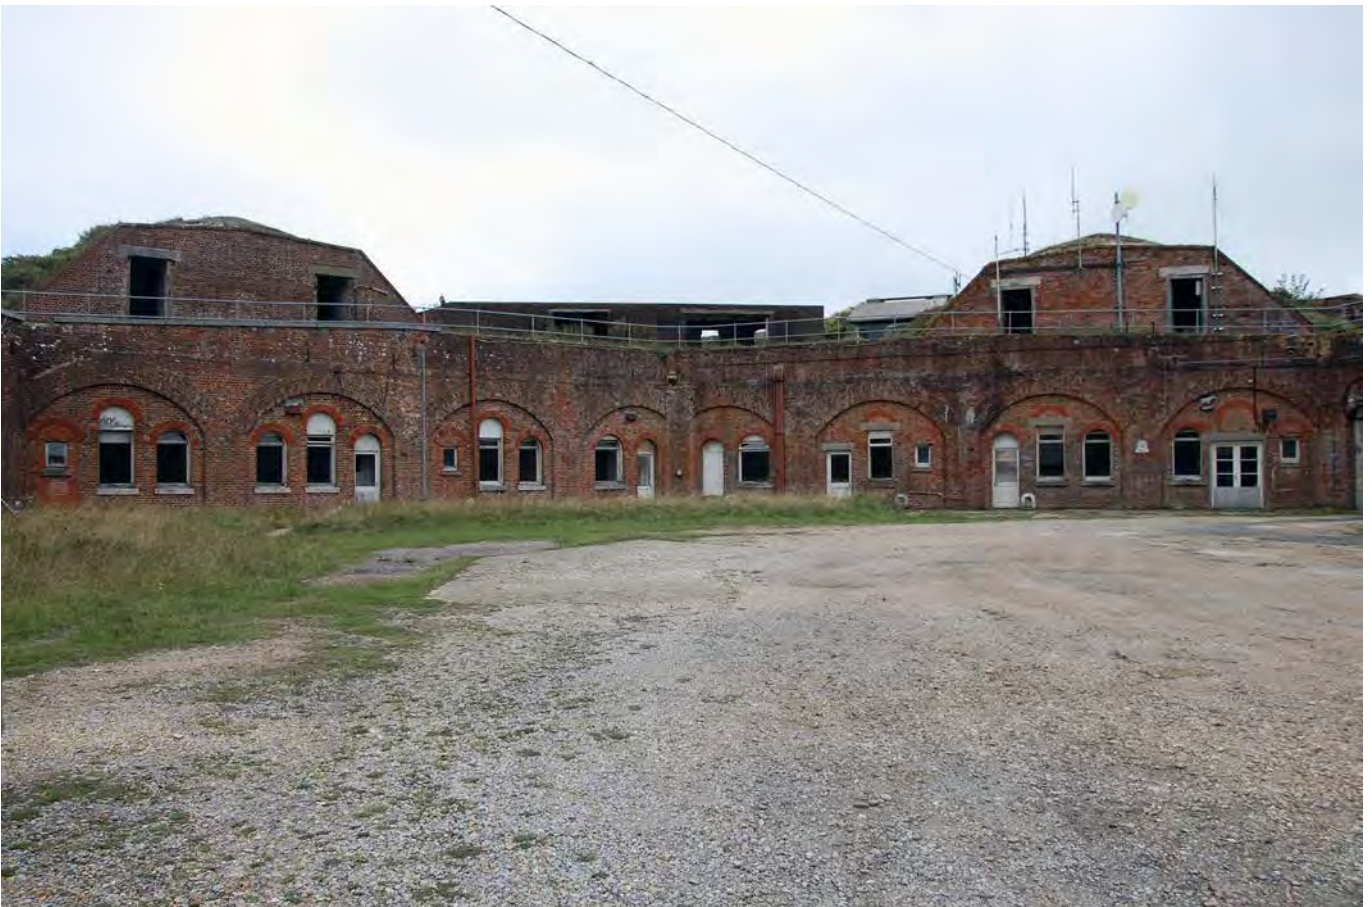
Plate 4: East facing view of Officer's Quarters

3.2.1 The east facing elevation of the former Officers' Quarters consists of eight casemated bays constructed in red bricks which includes vitrified bricks (Plate 4) (Fig.4). As designed, these casemates were intended to house four officers and their servants, as well as the Officers' Mess, but by 1889 the two southernmost casemates had been redesignated as the Master Gunner's Quarters. At this time it is thought that very few soldiers were living at the fort (Cantwell, pg.27), as it was too remote to make a good barracks and the centre of military activity was at Sandown.
