Bembridge Fort, Isle of Wight Archaeological Investigations

June 2019

Document Type: Report on Archaeological Investigations

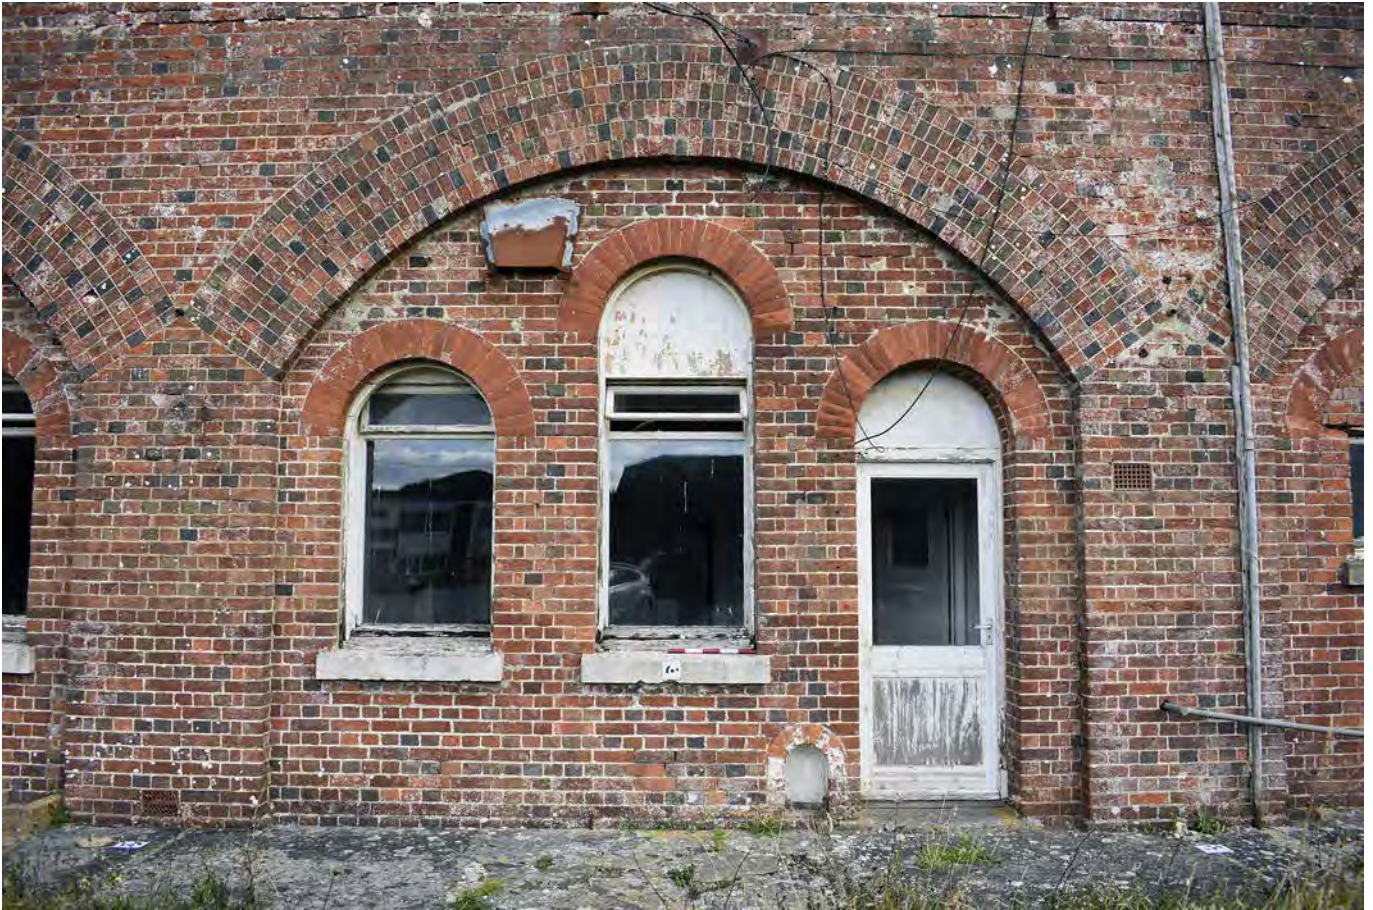
Plate 5: Bay B, showing original construction

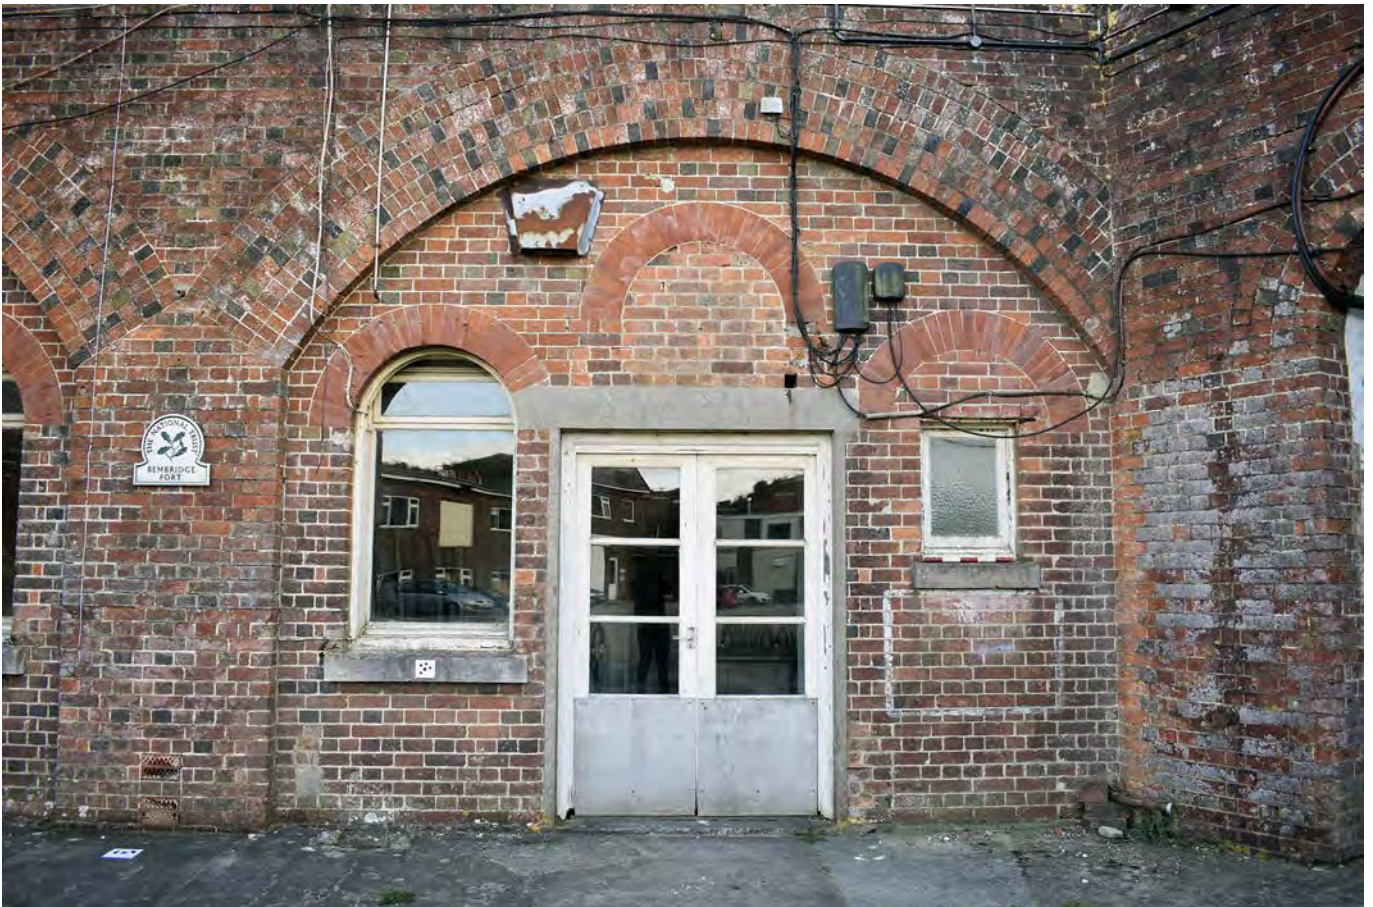
Plate 6: Bay H, showing later infill and insertion of door

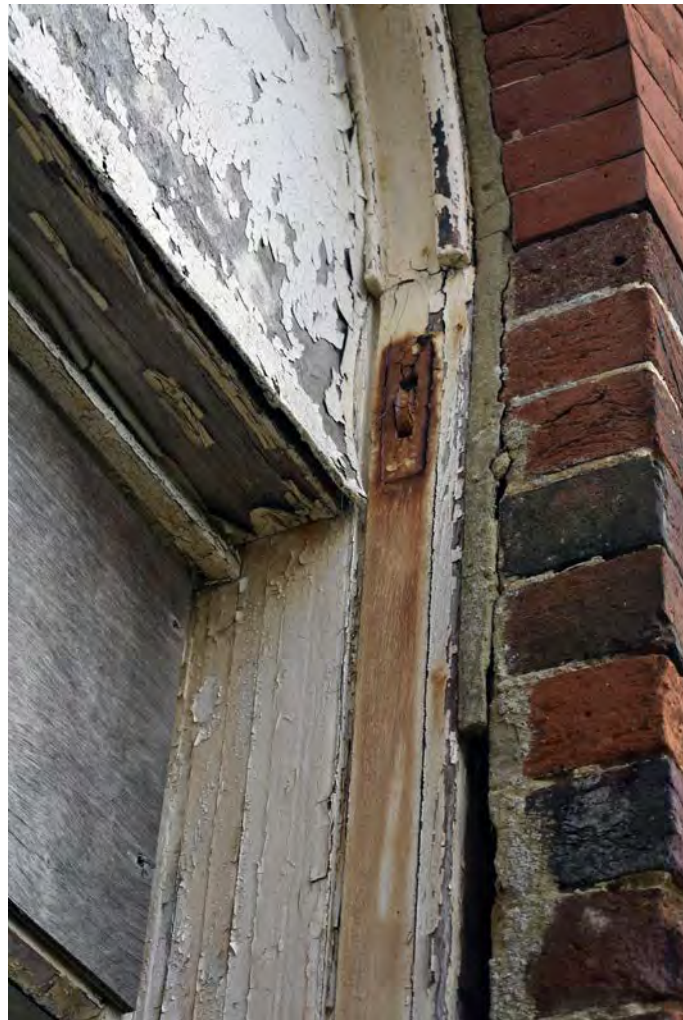
Plate 10: Bay A, opening A2 showing superior type of primary sash window

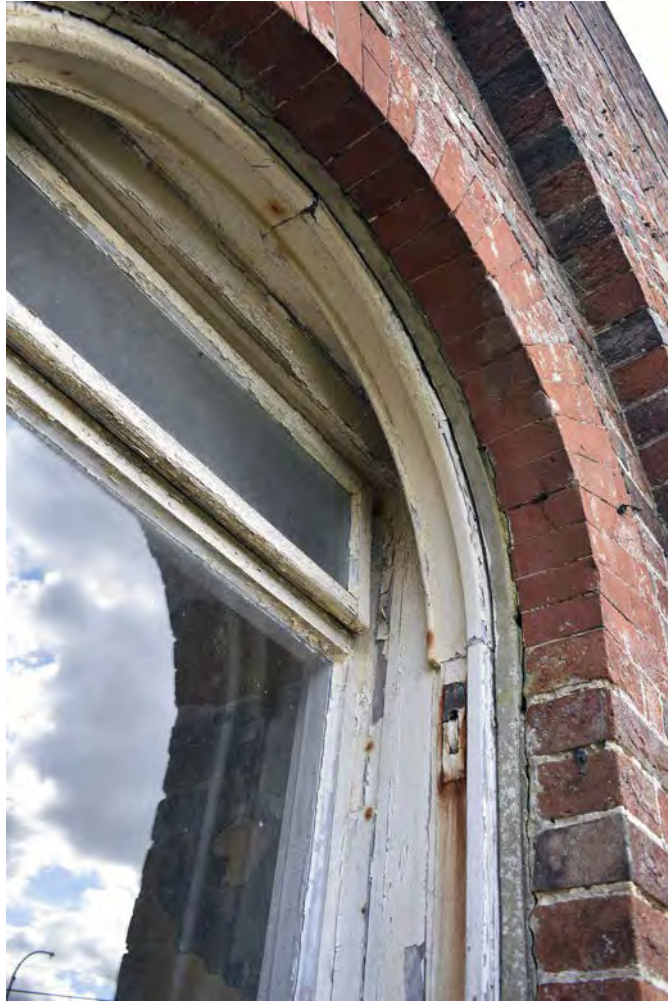
Plate 11: Bay C, opening C9, showing inferior type of sash window

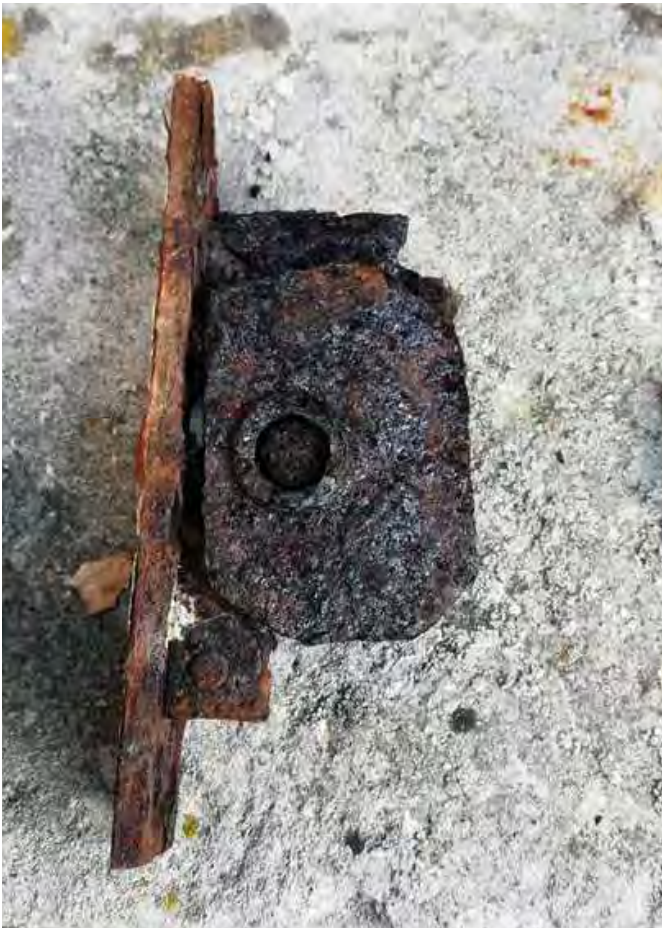
Plate 12: Cast-iron axle-pulley removed from window (A2), dating from the 1862-67

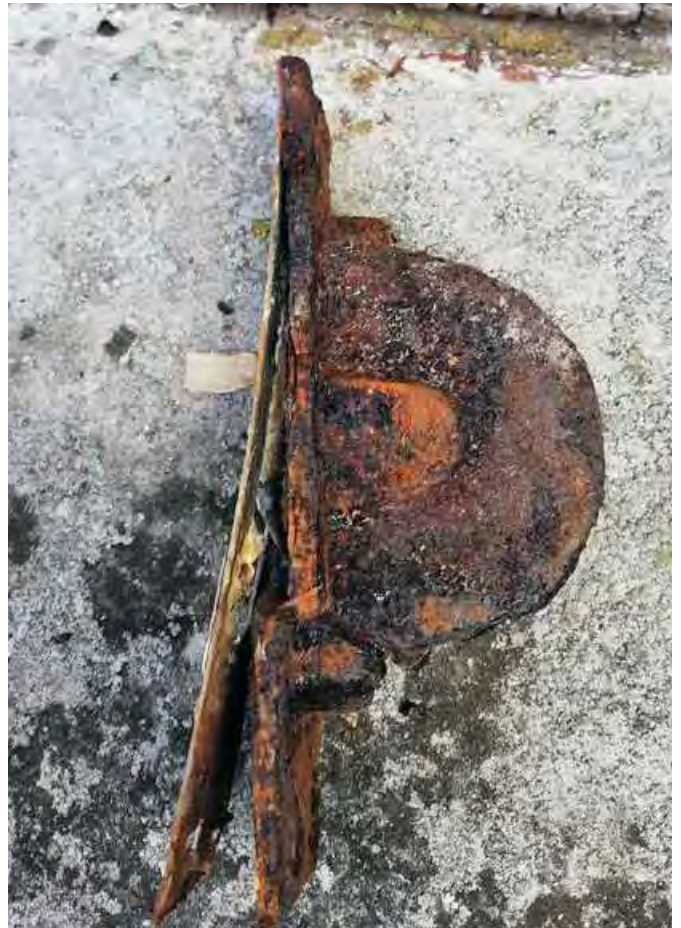
Plate 13: Secret axle dating from 1925-39, probable replacement

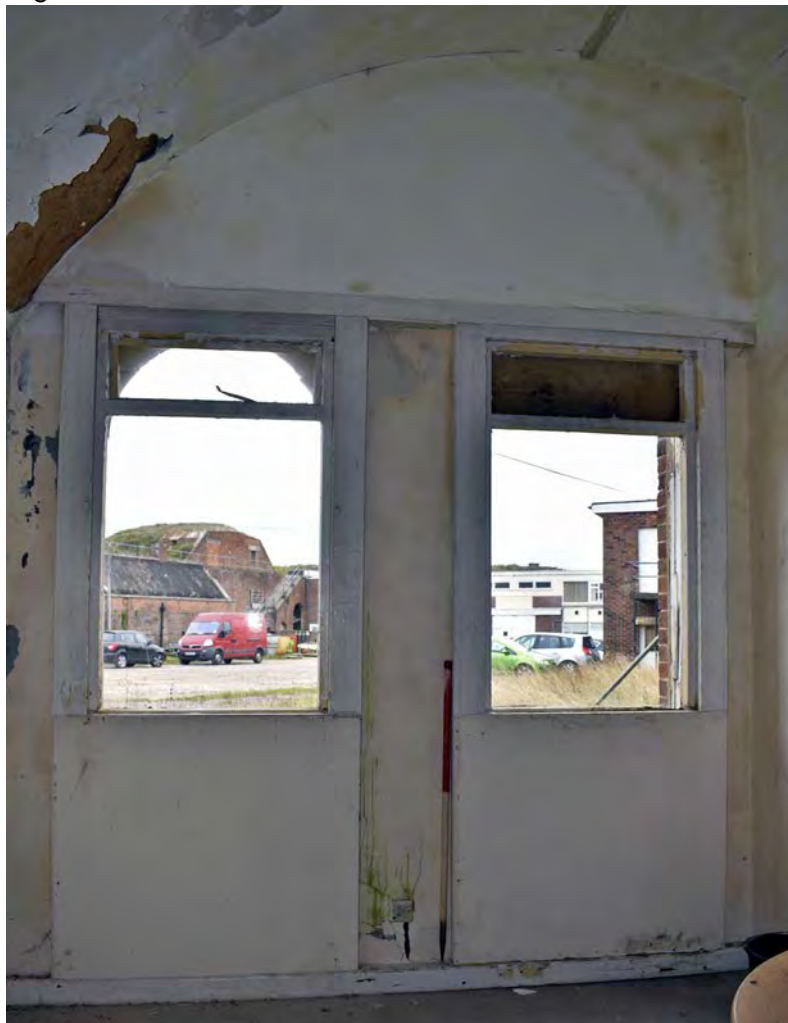
Plate 19: Bay A, internal view of openings A2 and A3

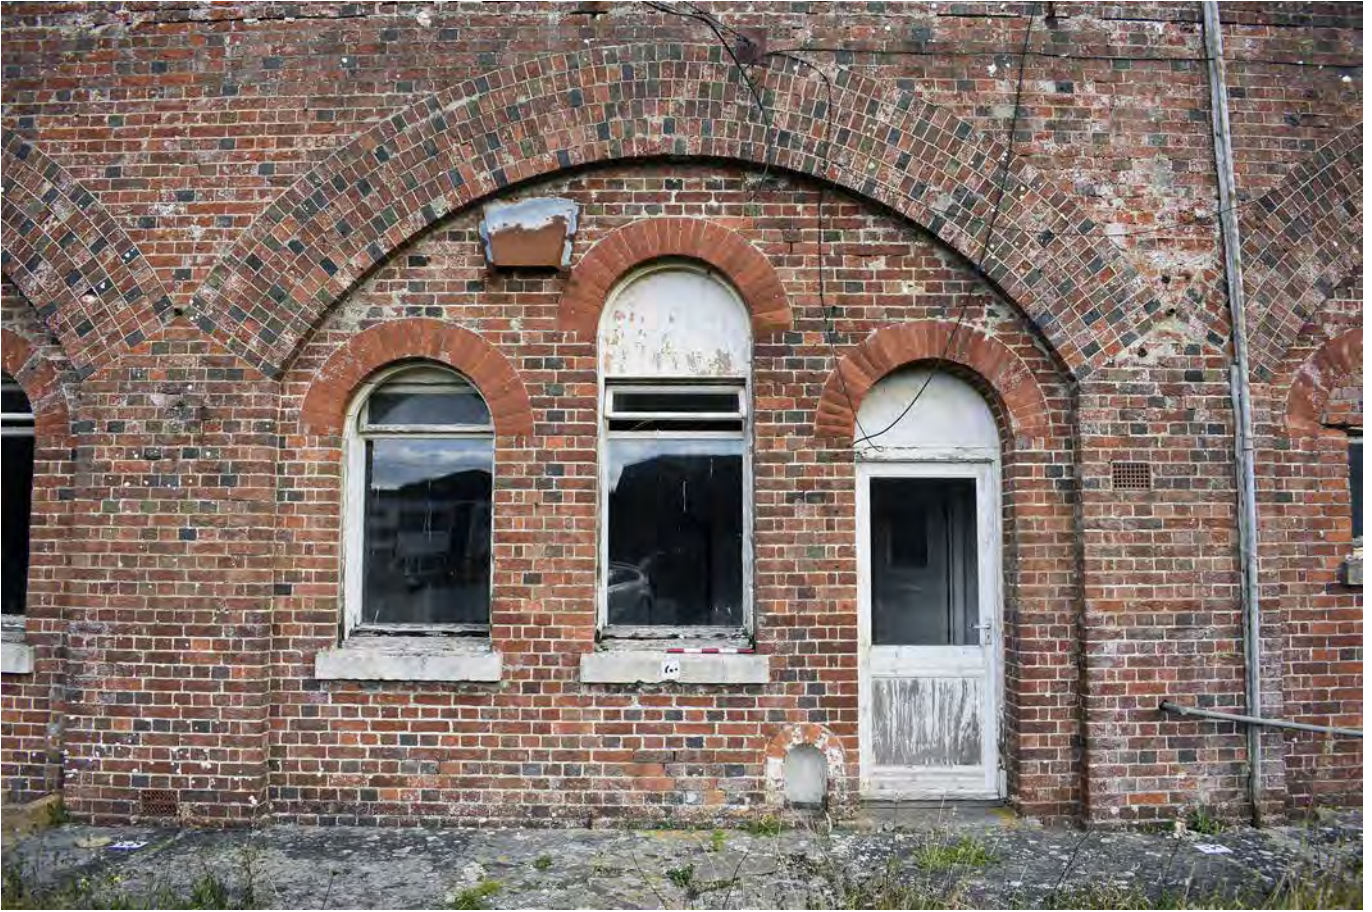
Plate 20: Bay B, external view

- 3.4.10 Bay B is significant as it retains the original arrangement of the bay with two windows and a door to the south (Plate 20). Both windows retain their original 1862-67 box-frames, although the sill area suffers from decay, the frames are quite repairable (Plate 21). Internally, the vertical sliding shutter-boxes are visible. Both windows B4 and B5 are of the superior construction previously described for opening A2 in Bay A. This bay was formerly used as a Mess Room (see Fig. 7).

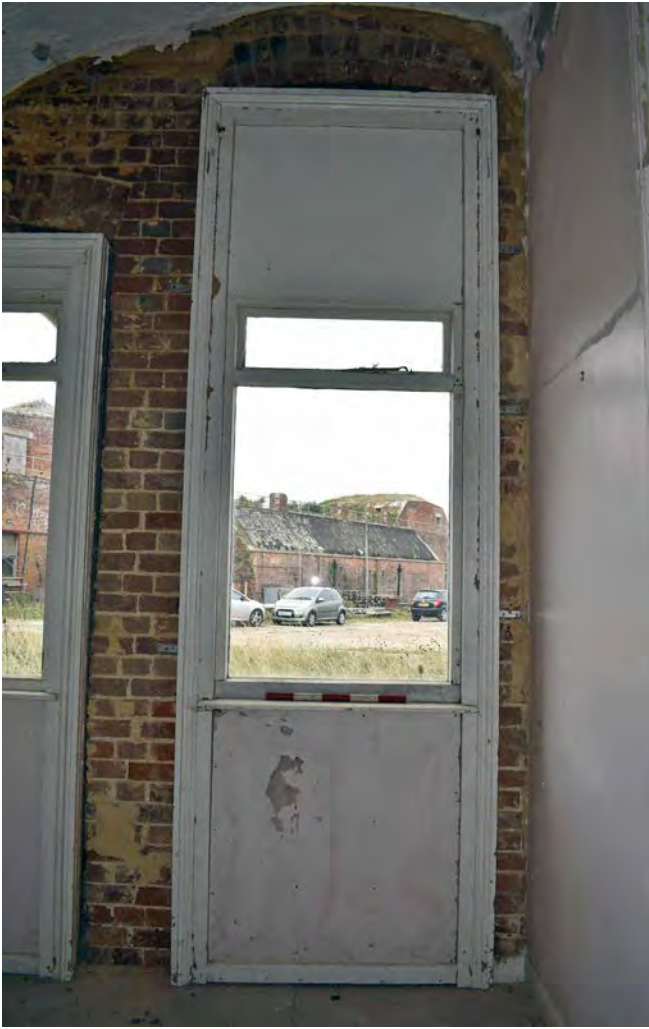
Plate 26: Bay C, internal view of sash frames

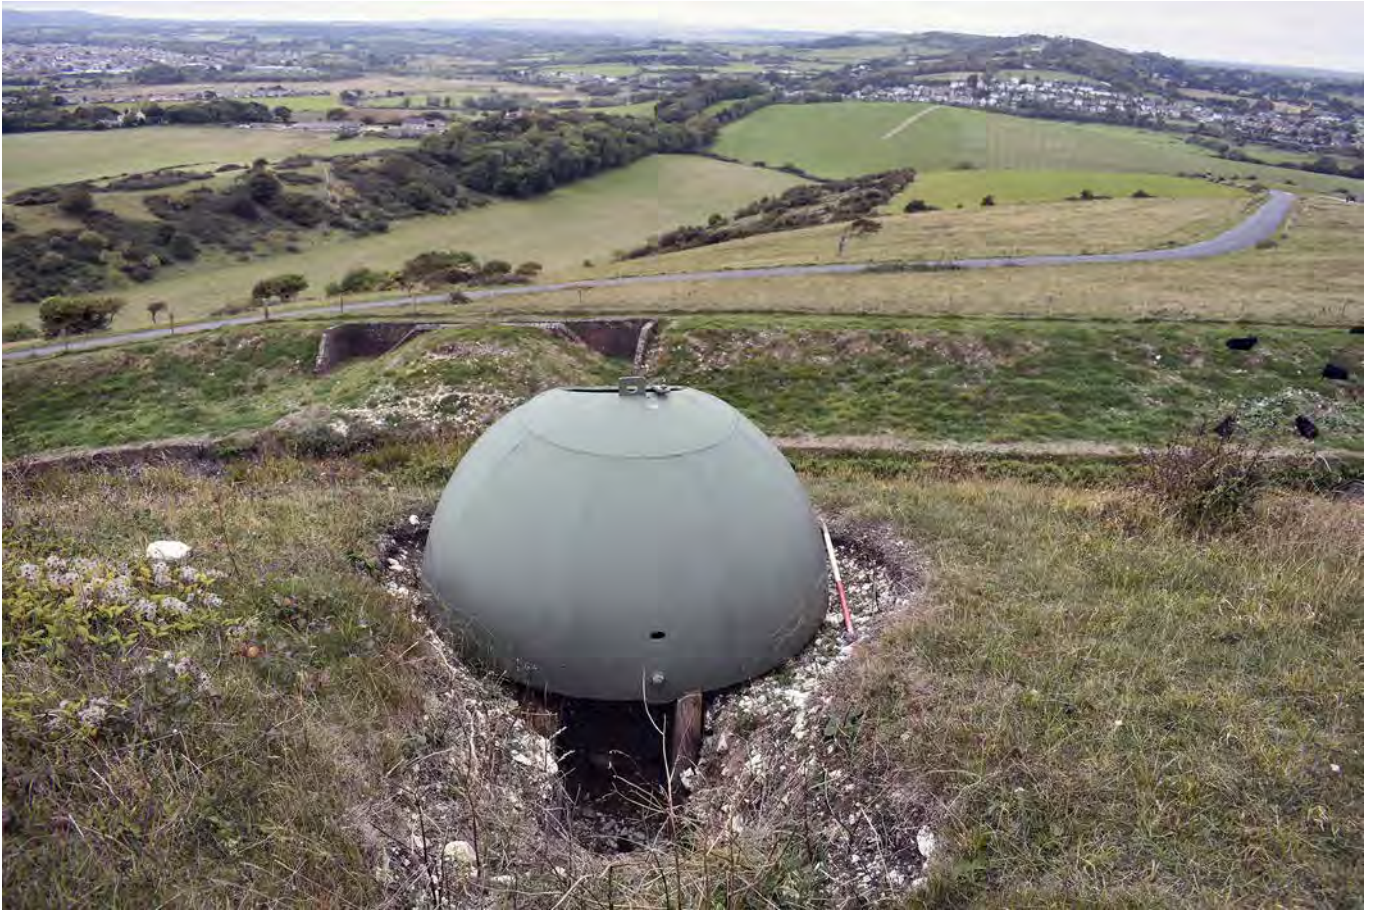
Plate 57: Allan-Williams Turret (west)

- 4.4.1 There are two surviving examples of Allan-Williams Turrets at Bembridge Fort, one is situated at the north edge of the terreplein, and the other at the west end. The better example is to the west as the rotating dome remains in situ and the metal work is less corroded and affected by the weather conditions (Plate 57).

lined, although the actual pit of the turret is metal lined (depth 0.77m), however this is now badly corroded. The dome is painted green internally (the base is 1.80m in diameter), and the various elements survive well, including the roller bearings and the revolving bracket for supporting the gun. It was designed for a machine gun to be fired either through the front loophole which was further protected by shutters, or through the circular opening in the roof in a light anti-aircraft role. Both the circular opening in the top and the front loophole survive.

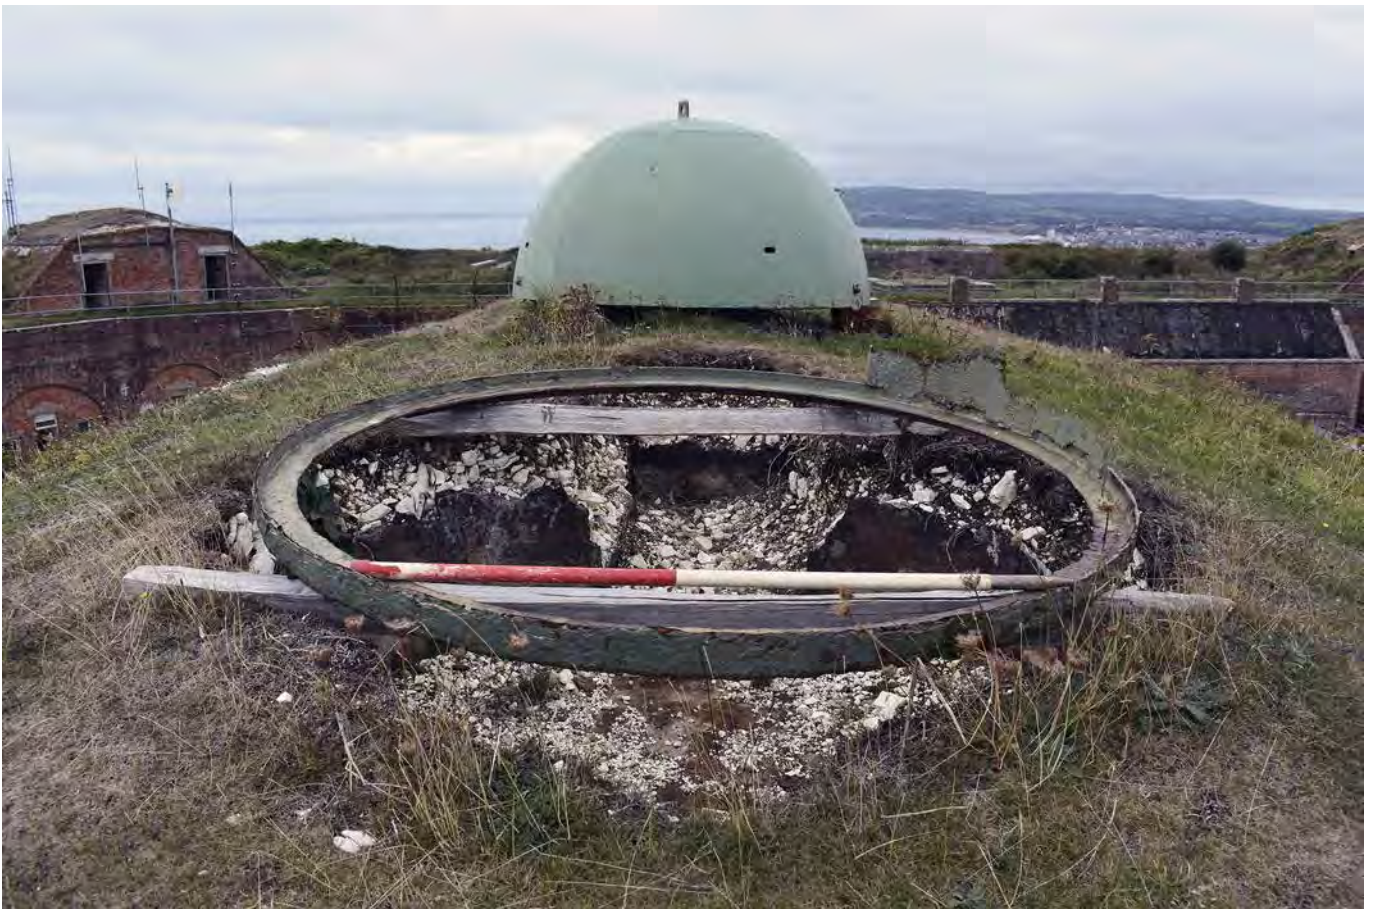
Plate 58: Allan-Williams Turret (east)

- 4.4.5 The example to the east survives less well as the dome has been removed and placed next to the pit (Plate 58). The circular metal base on which the dome sits remains *in situ*. The metal is badly corroding in places although the key elements of the turret survive including the roller bearings and revolving bracket for supporting the gun.

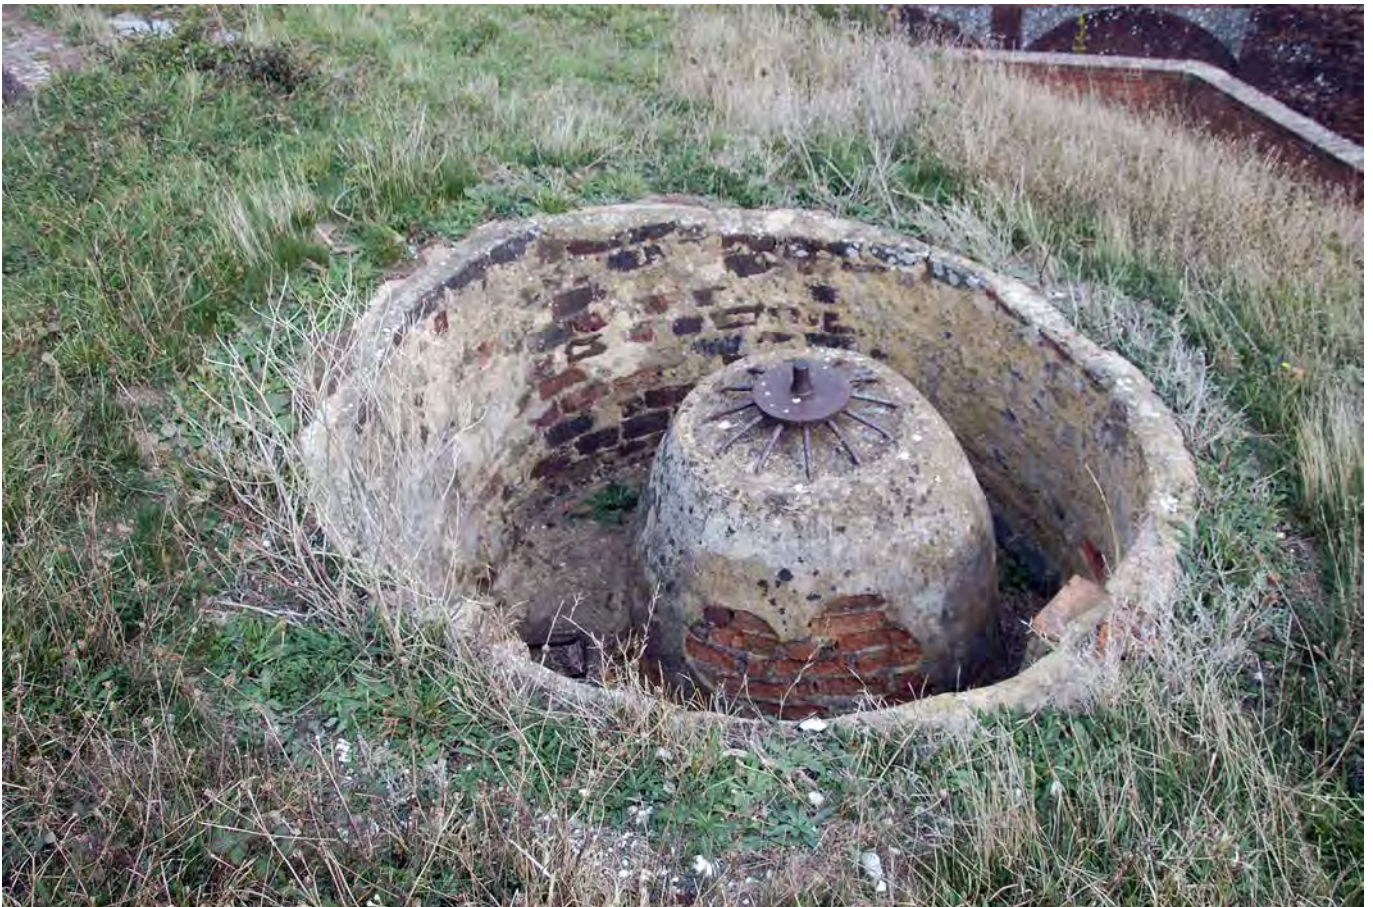
Plate 59: Spigot Mortar emplacement (west)

- 4.4.6 There are two Spigot Mortar gun emplacements on the terreplein at Bembridge Fort, one is situated at the north-west end of the site and is accessed via a cut in the 19th-century gun emplacement (Plate 59). The second is situated at the east end of the fort to the rear of the radar building. Both conform to the description of a typical spigot mortar pit. This type of gun allowed for short range local defence only, and would have been used to protect the fort, particularly the radar installation. A third possible emplacement was also identified to the south-west of the Position Finding Cell, this emplacement has largely been destroyed but surviving evidence suggests it conforms to the same typology.

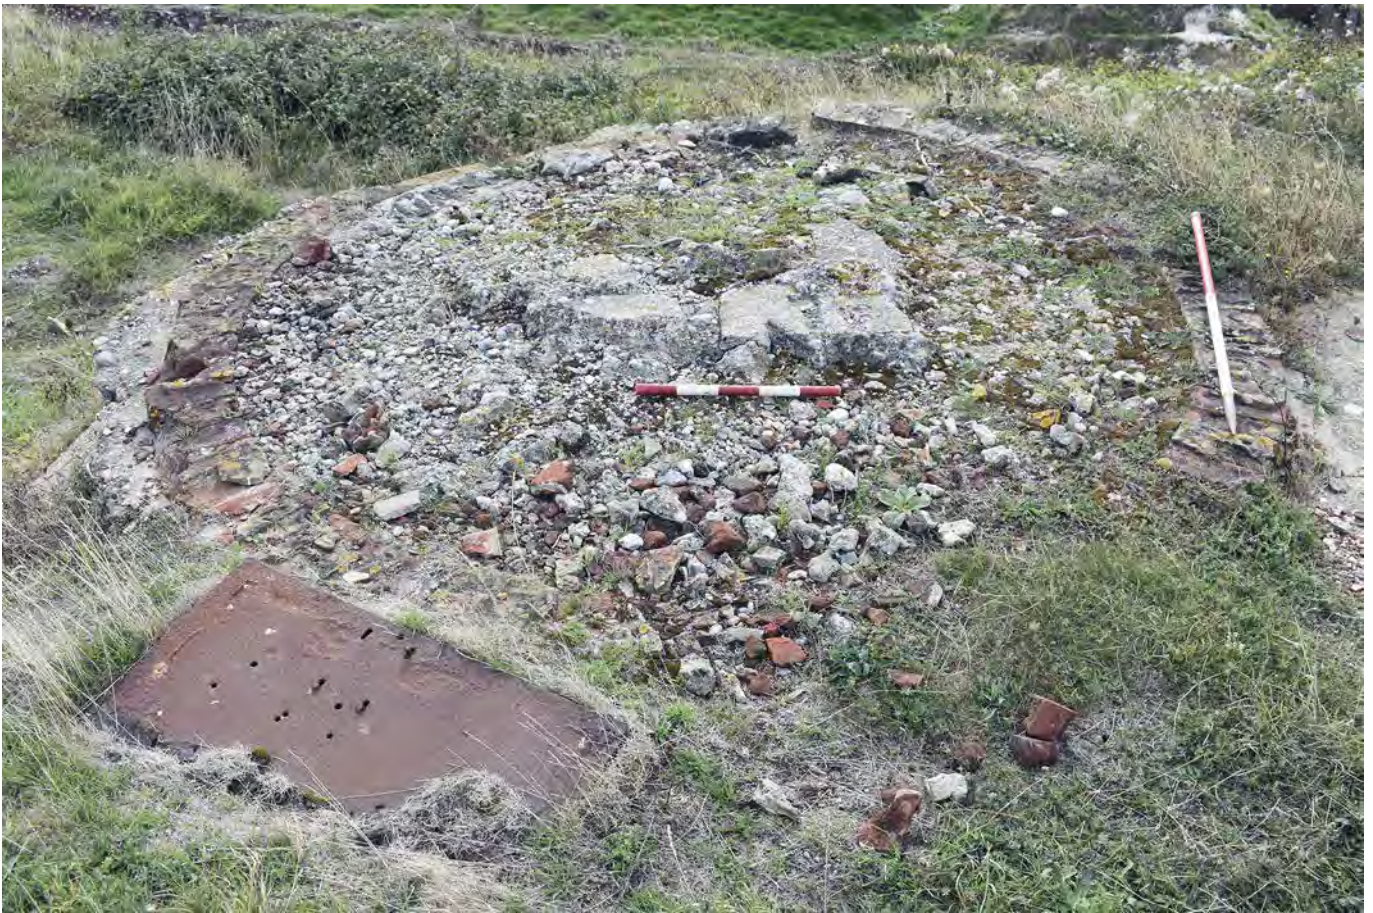
Plate 60: Spigot Mortar emplacement (east)

- 4.4.8 The east emplacement is brick built and has been covered with a cementitious render, the height of the emplacement walls slope down in the direction of the outer fort (Plate 60). The walls are supported by two tall buttresses to the west and shorter ones to the east. The depth of the emplacement is between 1 - 1.23 m and the diameter is 2.65m, and the concrete cylinder extends to a height of 0.95m.

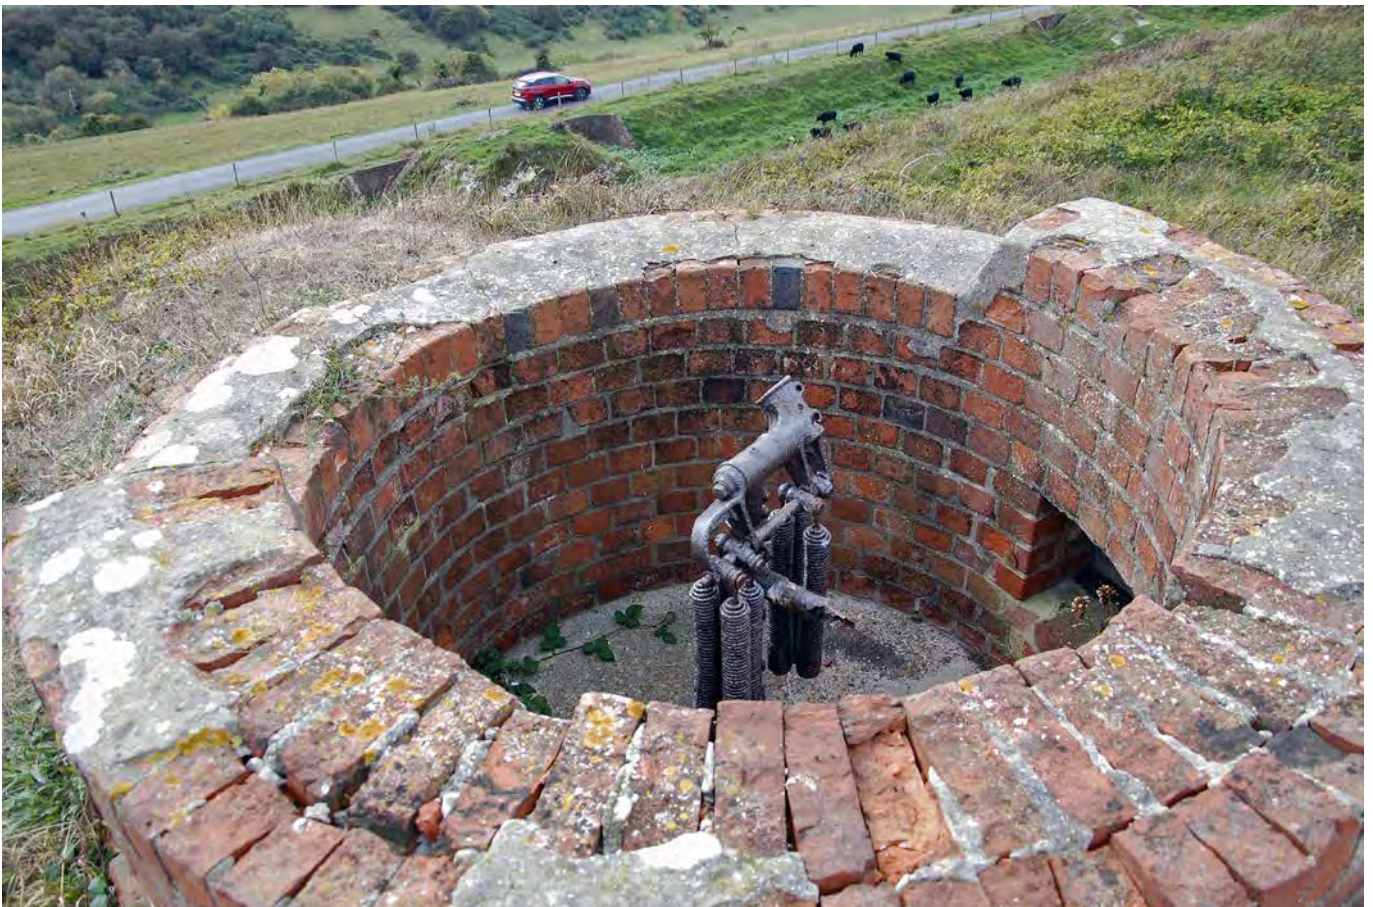
Plate 61: Remains of Spigot Mortar emplacement

- 4.4.10 The remains of a possible third spigot mortar emplacement was identified immediately to the west of the roof level of the Position Finding Cell (Plate 61). There are little standing remains of this former emplacement, but the feature is brick lined with truncated concrete and rubble in the centre. There is a concentration of concrete in the centre, which may be the remains of a concrete cylinder from a spigot mortar emplacement as described above.

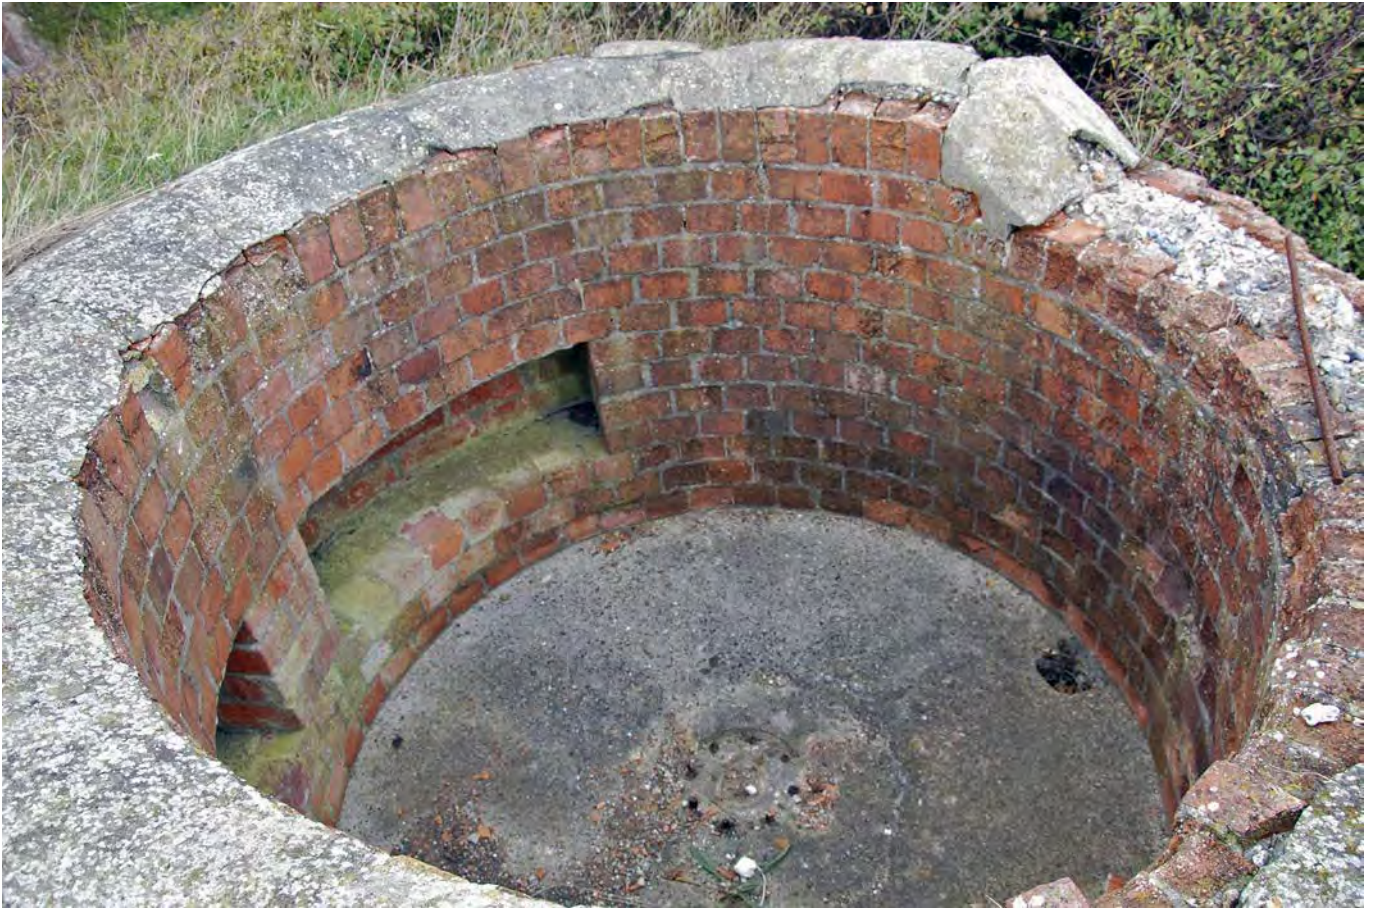
Plate 62: Motley Stalk (west of access)

containing the mount is the better surviving example and is on the terreplein to the west of the access point (Plate 62). The other is situated immediately to the north of the radar building. Further investigation is required to confirm the accuracy of the typology of the emplacement and the rarity of its survival. Initial research suggests the survival of the mount in such complete condition is rare.

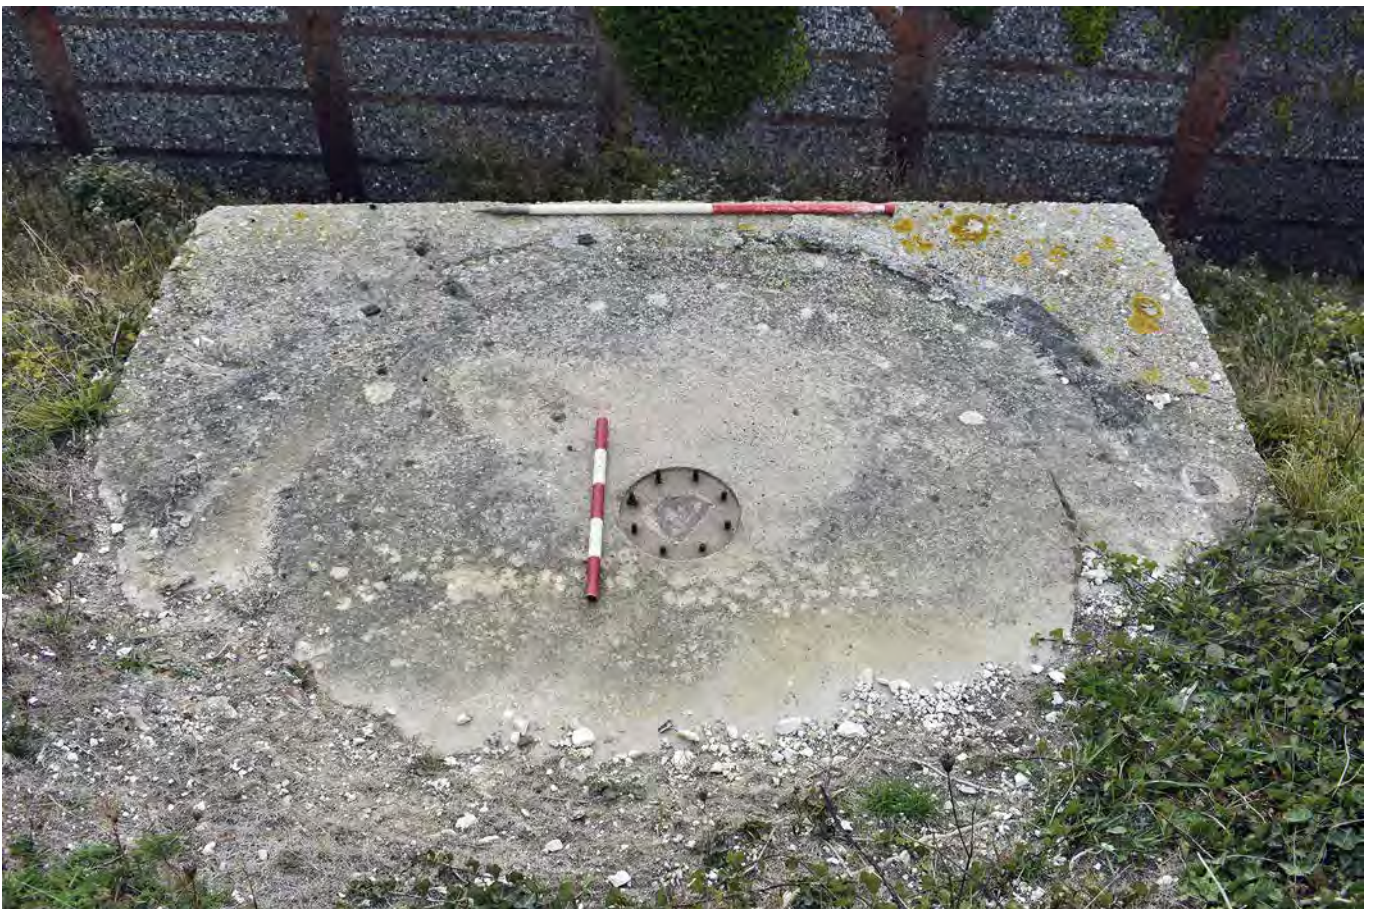
Plate 63: Motley Stalk (east)

- 4.4.12 The emplacement containing the Motley Stalk mount on the southern edge of the terreplein is brick lined and rendered at the top, it has an external diameter of 2.20m and is built to a depth of 1.10m (Plate 63). It also has two protective recesses built into the brick wall which would have allowed for the storage of ammunition. There are seven springs attached to the gun hold, which acted as a counter balance for the guns which would have clamped on to the fitting. The latter extends to a height of 1.20m. Handles to the side of the emplacement facilitated access into the pit by those operating the gun.

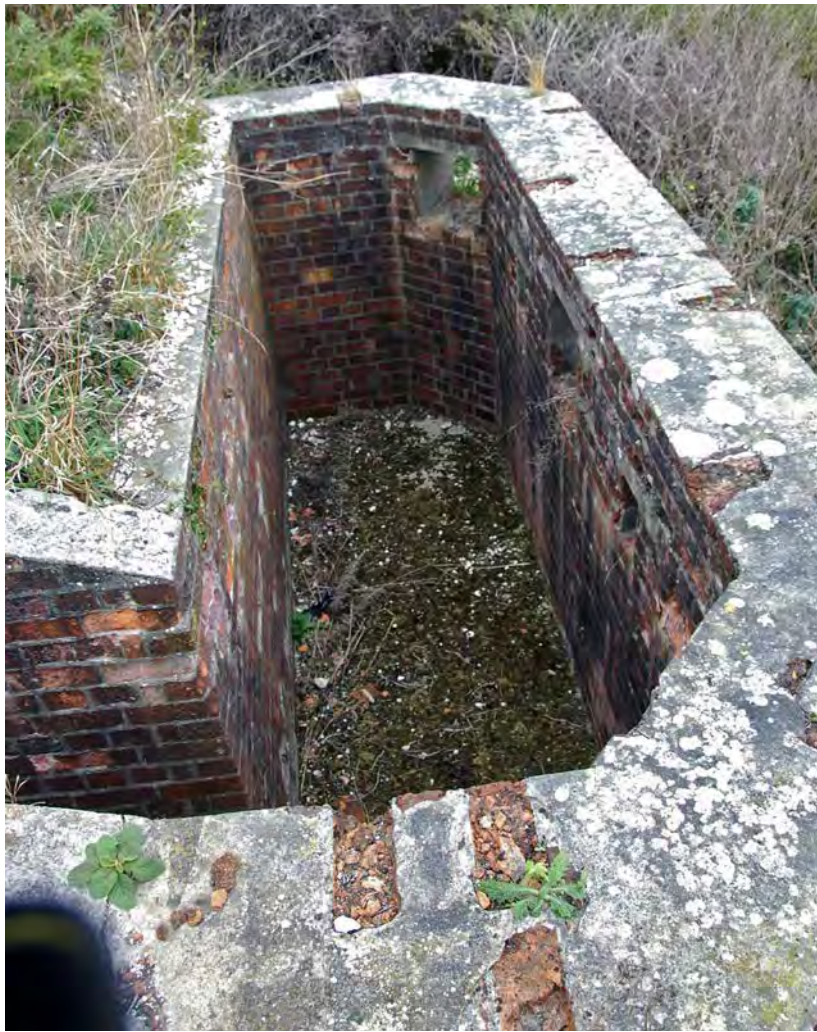
Plate 64: Possible surviving Motley Stalk (south)

- 4.4.14 A further concrete platform is situated at the south-east, to the west of the radar area (Plate 64) at the very edge of the earthworks. It is a concrete platform with a circular recess (1.64 in diameter) in the middle and eight meta bolts extending from the concrete 0.04m. In the centre of this is a further circular area which is 0.25 in diameter. It is thought that this is the remains of a Motley Stalk emplacement as it follows the same typology as those described above. The surrounding brick protection has been demolished, but the footprint of this is evident in the concrete.
