**HENLLYS HALL**  
**BEAUMARIS**  
**ANGLESEY**

Henllys Hall, Beaumaris  
Anglesey

Archaeological Assessment Report

Report no 2000-2001/065/AUA8109

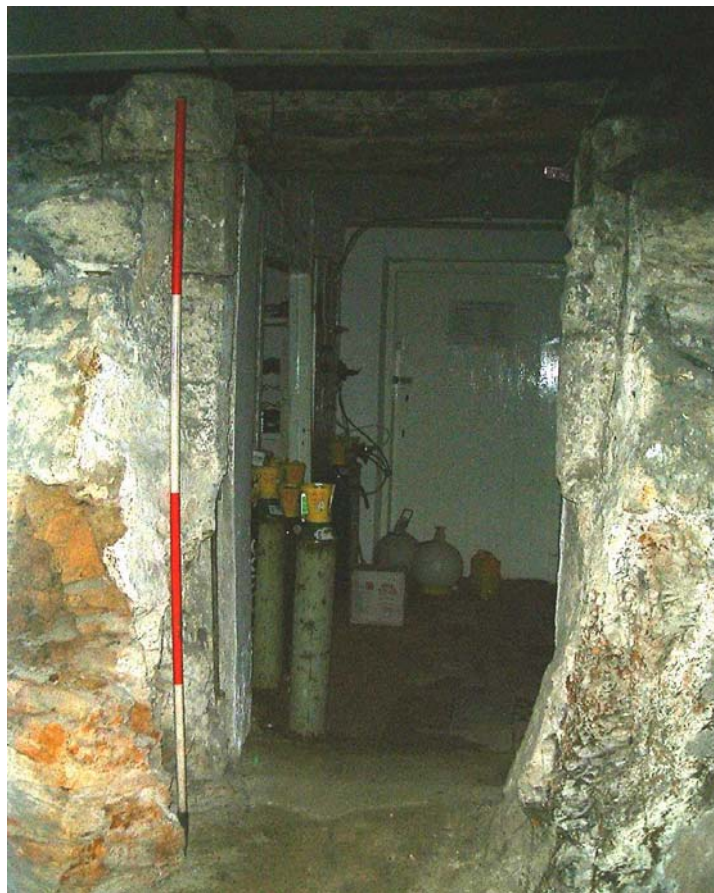
Plate 2: Early doorway in the basement of the present Henllys Hall

- 2.2.2 The basement of the Henllys Hall Hotel was also inspected, and a pair of stone door jambs was recorded; the jambs were associated with short lengths of stone wall, and neither the jambs nor these wall fragments appear to relate to the present build of the hall.

- 4.1.5 **Field Survey:** the only evidence recorded during the field survey of the proposed development site that potentially pertains to the medieval period lies within the present Henllys Hall. In the hall's cellar, a pair of stone door jambs were identified, each of which is keyed into a block of masonry, that appears to be the remains of a doorway predating the present building (Site 27); both blocks of masonry appeared to have been cut through when the present building was erected. The jambs are not closely datable, but are broadly consistent with a medieval or earlier post-medieval date range. The base of the jambs lies c1.5m below the ground floor of the present building and one possible interpretation is that they relate to an earlier structure which had a floor level 1.5m lower than the present hall's floor, but this should be treated with caution, as it is not known whether the relict doorway was originally at ground floor or basement level. The doorway stood some 8m west of the eastern corner of the hotel. Its orientation was such that it could, but need not have, been part of the earlier hall which stood on the site prior to the rebuilding of 1852-3 (Section 4.2.3).

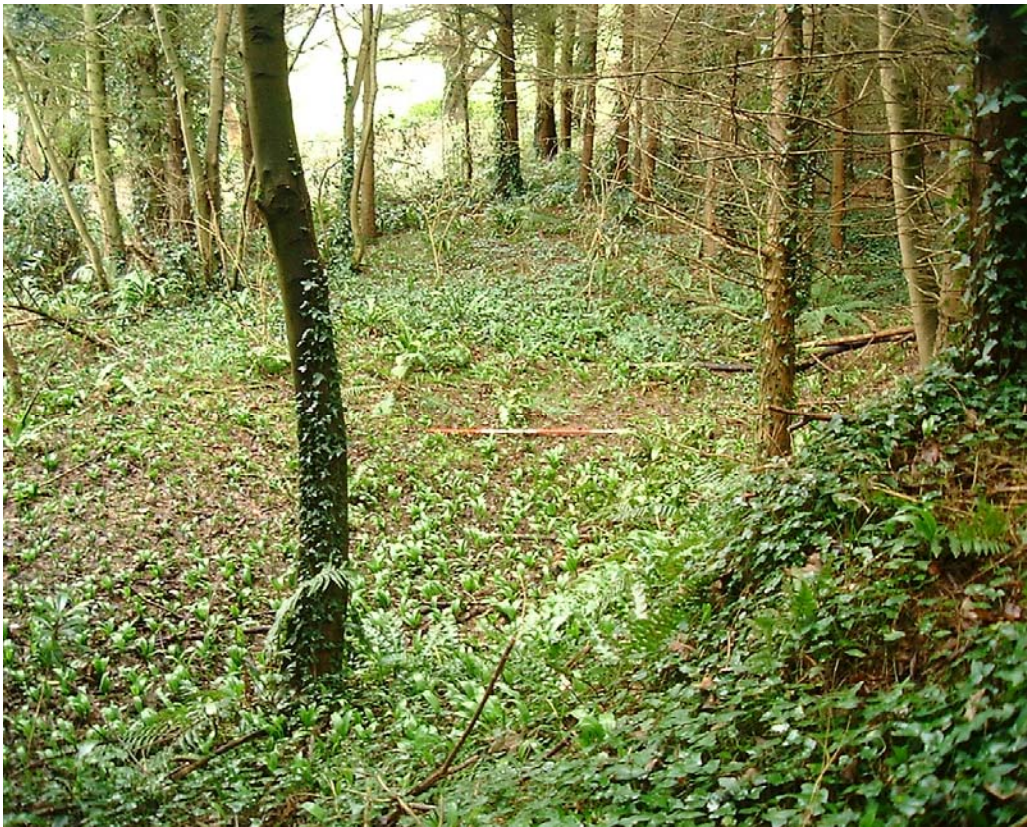
Plate 3: Site 28, Levelled platform within Henllys Hall grounds, looking south

**Notes** A levelled rectangular area measuring 114m x 16m was observed. Although it had recently been surfaced with roadstone for use as an overflow carpark, it was first mapped on the Ordnance Survey 1:2500 map of 1889. The established nature of the eastern boundary confirmed that the levelling was not a recent event. This appears to be a parkland feature, though perhaps one intended for a specific sporting activity.

- 6.2.1 **Detailed Survey:** it is recommended that a detailed survey should be conducted of the earthwork remains identified towards the south of the eastern part of the site (Site 28), in order that this feature might be better understood and related to historic maps. As this relates to relatively late landscaping it must be regarded as having a low priority in terms of the overall recording and evaluation programme.

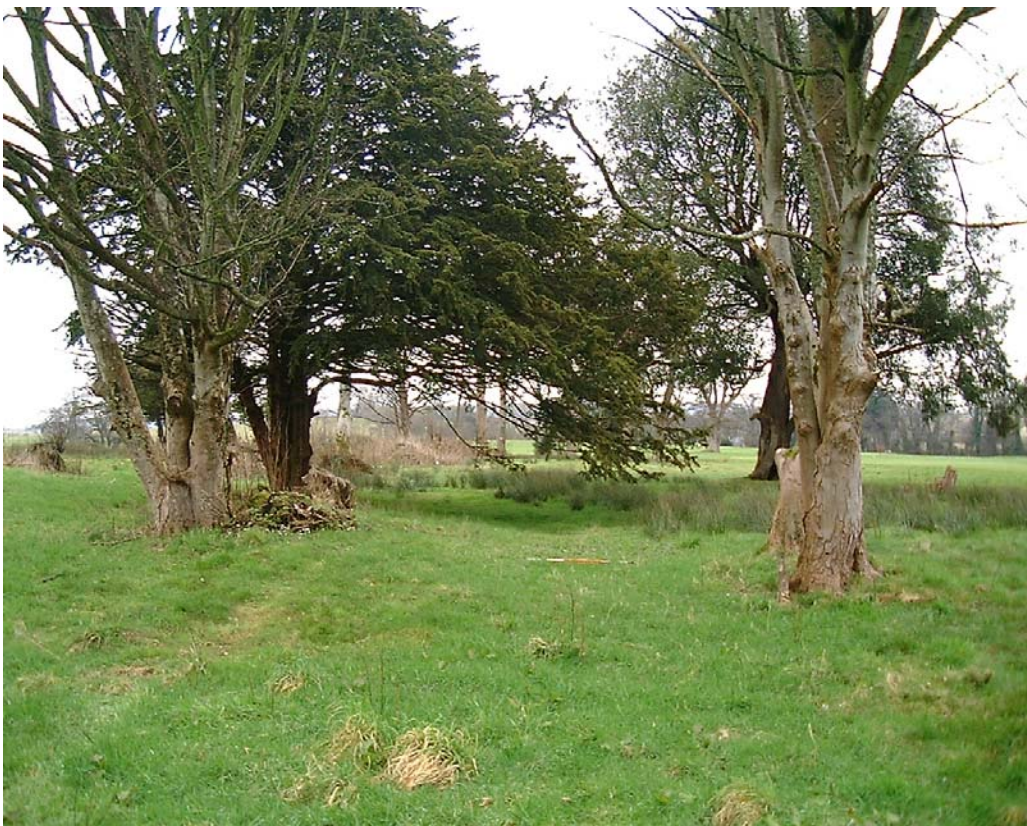
Plate 4: Site 31, tree lined avenue looking south-west

**Site number** 31  
**PRN** -  
**NGR** SH 60147757  
**Site name** Avenue 1, Henllys Hall grounds  
**Site type** Avenue?  
**Form** Alignment of trees  
**Period** Post-Medieval?, Modern?  
**Notes** Two parallel alignments of ash and yew trees were tentatively identified, suggesting the former presence of an avenue c8m wide. This feature was found to be close to the position of the former eastern boundary of the orchard shown on the estate map of 1830 (UWB Henllys ms 1191).  
**Sources consulted** LUAU field survey  
**Visit date** 22/02/01
