# Theale Airfield Hanger Sheffield Bottom West Berkshire

## Historic Building Investigation and Recording

**Oxford Archaeology**

June 2004

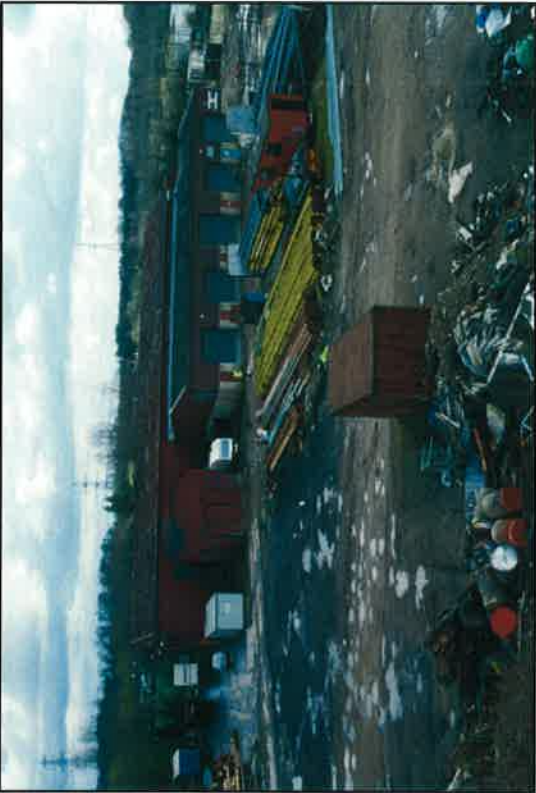
Plate 1: West view of site

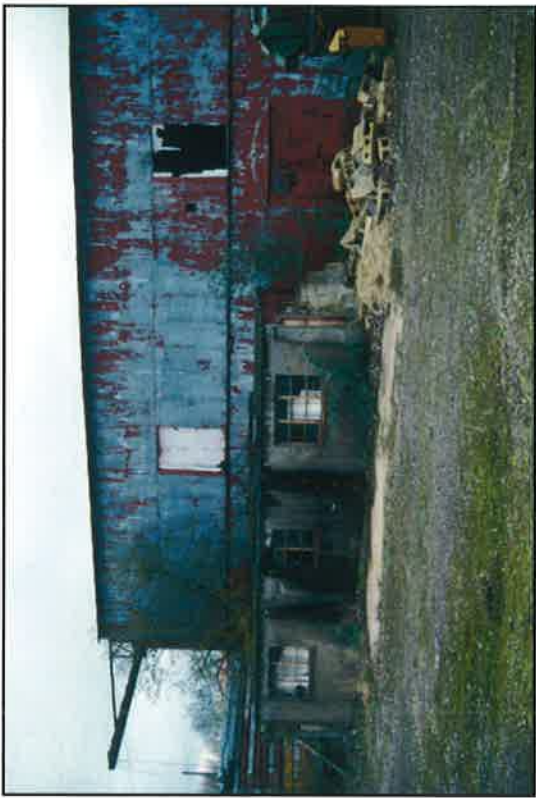
- 4.2.4 A drainage channel runs along the perimeter of the concrete base which is visible along the south east elevation. This presumably once ran along the north west elevation although due to the modern development this is not possible to confirm (Plate 7). The earth drainage channel rises to a height of c.0.80 m to meet a levelled area to the south east of the hanger. Both metal and iron drainage pipes are visible along the section of the drainage channel. The levelled area has a concrete base and is thought to have been used as an area in which vehicles were parked prior to entering / departing the hanger (see Plate 2).

Plate 2: South-east elevation showing Block F

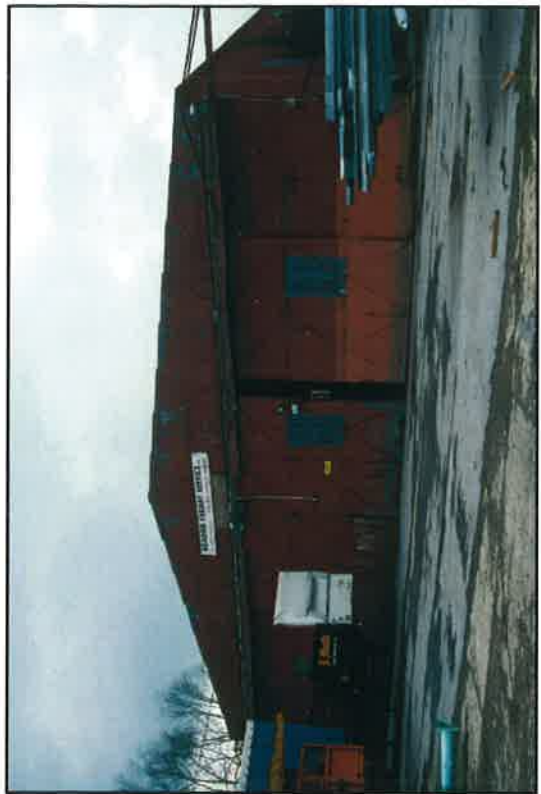
operated on small wheels, that would have permitted vehicle access (Plate 3). Two smaller access doors are located on the south east elevation. Internally the hanger is a large empty space with few distinctive features.

Plate 3: North-east elevation of hanger

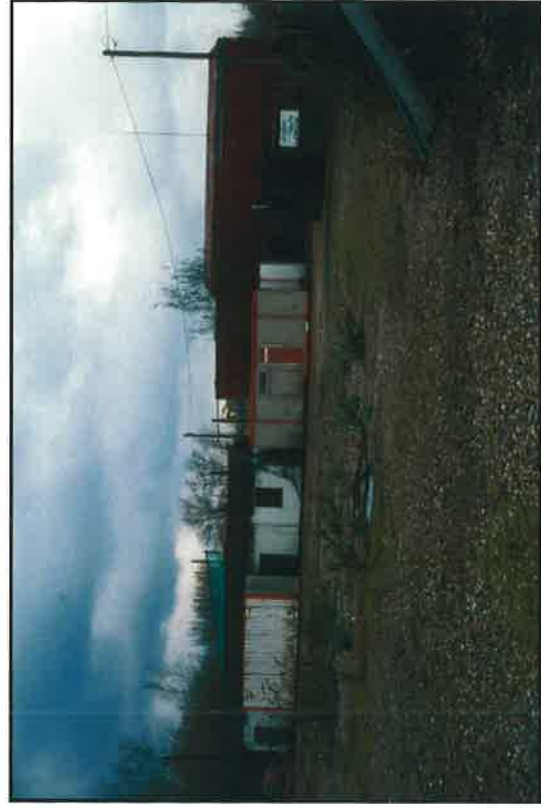
- 4.1.2 Five blocks stand independently of the hanger to the south west which are all single storey brick built structures (Plate 4). These are all thought to be associated with the airfield; it is possible that these were used as store rooms or class rooms during operation. A rapid survey was conducted of the immediate area surrounding the hanger and no further archaeological features relating to the airfield were found. Works undertaken by Fishers Surfacing has meant that any evidence relating to the airfield has been largely demolished. The wider landscape surrounding the hanger has been subject to gravel extraction and therefore any further archaeological elements are no longer extant.

- 4.4.1 Blocks A - E are located to the south west of the hanger and are all brick built (see Plate 4). With the exception of blocks C and D these are all Second World War airfield structures which are likely to have been used as training, administration or storage rooms during this period. They are all of a simple and functional nature that was common for airfield structures built during the war. It was decided at the outset

Plate 4: General east view of external blocks

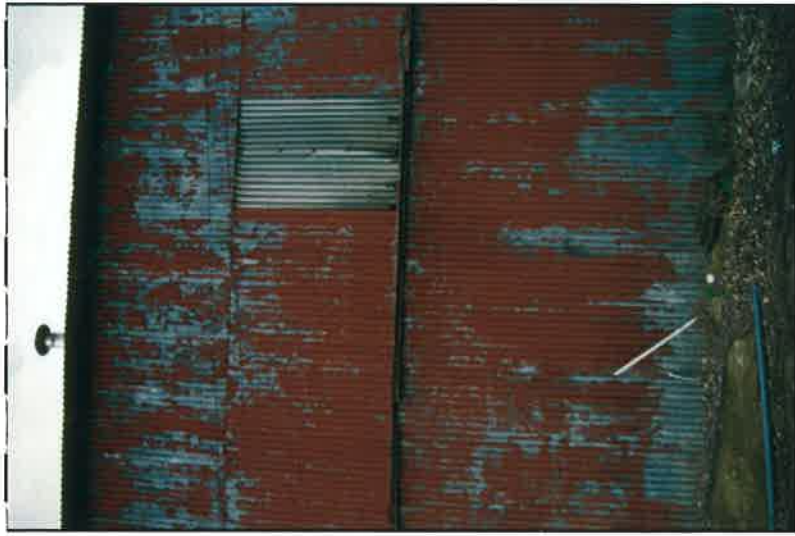
- 4.2.1 The hanger at Theale is clad in galvanised corrugated iron, painted red to resist corrosion. The hanger is constructed from large sheets of corrugated iron that are held together with iron bolts. The exact dimensions of the individual sheets vary and in some areas have been replaced with modern plastic clear sheeting (Plate 5).

Plate 5: North-east elevation showing construction detail

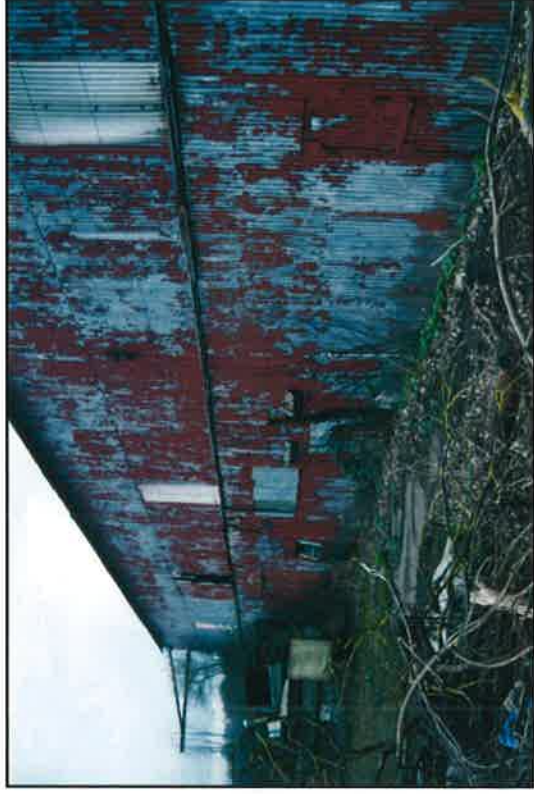
- 4.2.2 The corrugated iron exterior walls meet a concrete base (depth 0.12 m) (Plate 6). Along the south east elevation this projects c. 0.20m from the base of the walls (it was not possible to confirm this measurement throughout the entire building due to restrictions with access).

Plate 6: North-east view of north-east elevation

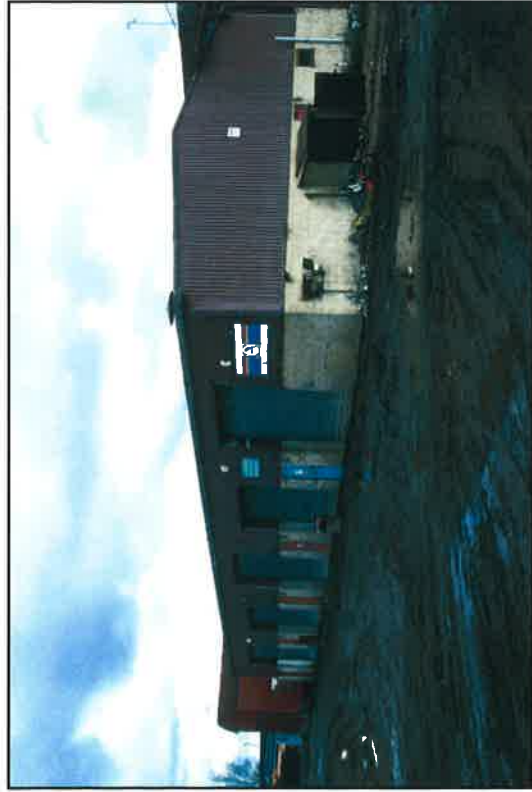
- 4.2.5 The north west elevation of the hanger is obscured by a recent extension that appears to be a series of garages or storage units (see Plate 7). It is constructed from breeze blocks with five rolling garage doors and five wooden doors. It is probable that this elevation is of the same form as the south east elevation as such military buildings are commonly of a standard form. Internally there are no features to suggest that the north west elevation reflects an unusual form.

Plate 7: General north-west view of north-west elevation

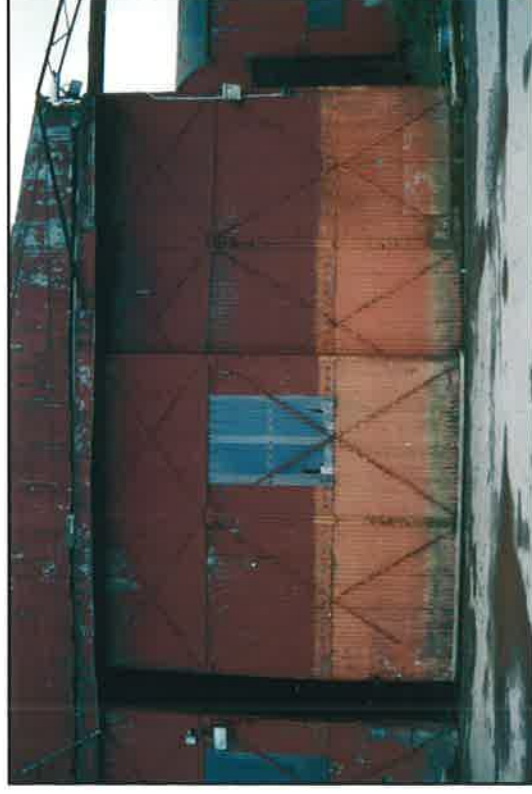
- 4.2.6 The main access areas for the hanger are at the north east and south west elevations. The sliding doors are constructed from corrugated iron and the height to the top of the doors is 6.4 m. The north east and south west elevations consist of 6 doors that slide to the east and west so that the full length of the faces is open. This would have permitted the access of large vehicles for maintenance. Each door consists of 2 equal divisions (5.6 m by 2.51 m) with iron bracing running horizontally and diagonally providing the support for the construction of the doors (Plate 8). The corrugated iron panels are attached to the iron bracing by iron bolts (Plate 9). The doors are shut with a large iron clasp and bolt and an iron handle is used to open the

Plate 8: Sliding doors, north-east elevation

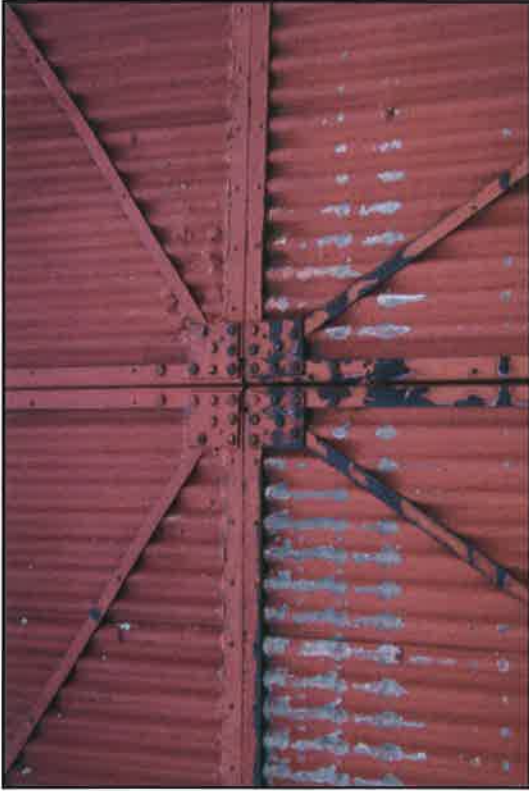
Plate 9: Construction detail of sliding doors, north-east elevation

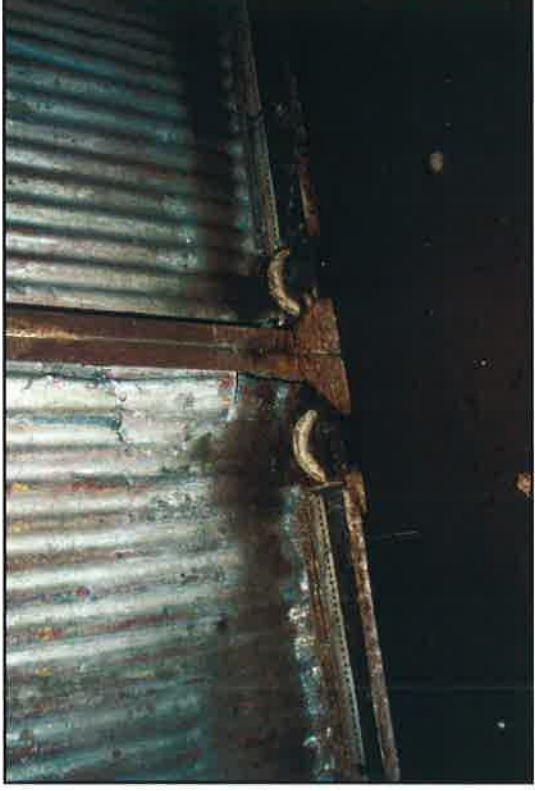
- 4.2.7 The doors operate on a sliding mechanism through the use of small iron wheels that are visible internally (Plate 10). Iron bars hold these on either side of the wheel at the base of the door and run along an indent in the concrete floor. Externally, above the doors there is a horizontal iron casing that houses the overhang mechanism for the sliding doors. These extend 3.8 m beyond the width of the hanger to the east and west (Plate 11). The overhang mechanism consists of iron rails on which the doors are able to slide back. This construction is supported by iron bars arranged in a triangular formation which are used to hold this mechanism in place (Plate 12).

Plate 10: Rolling mechanism of sliding doors, north-east elevation

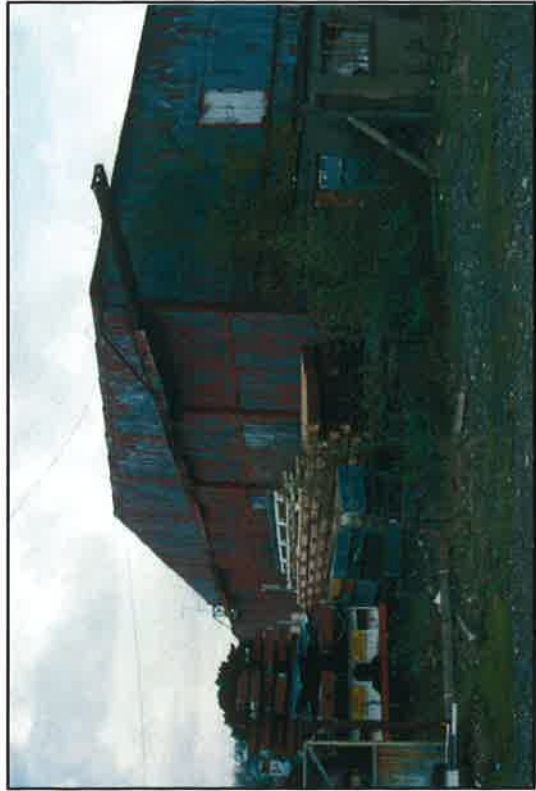
Plate 11: Sliding doors, south-west elevation

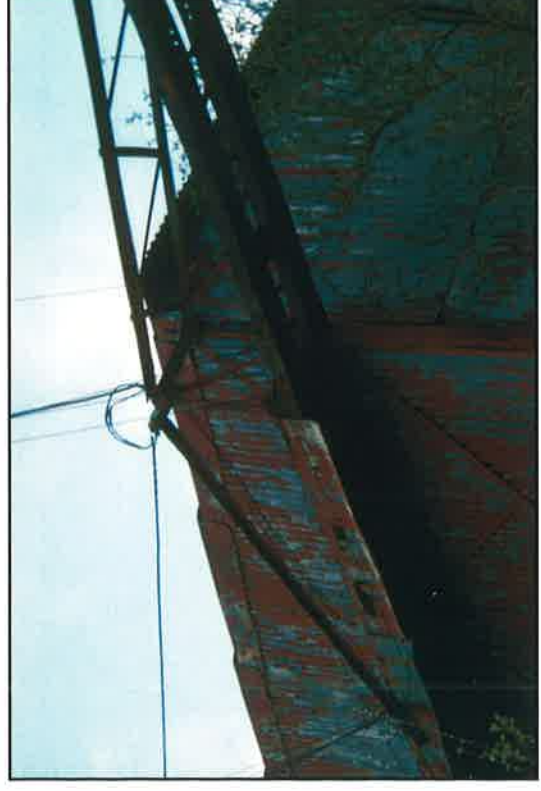
Plate 12: Overhang structure of sliding doors, south-west elevation

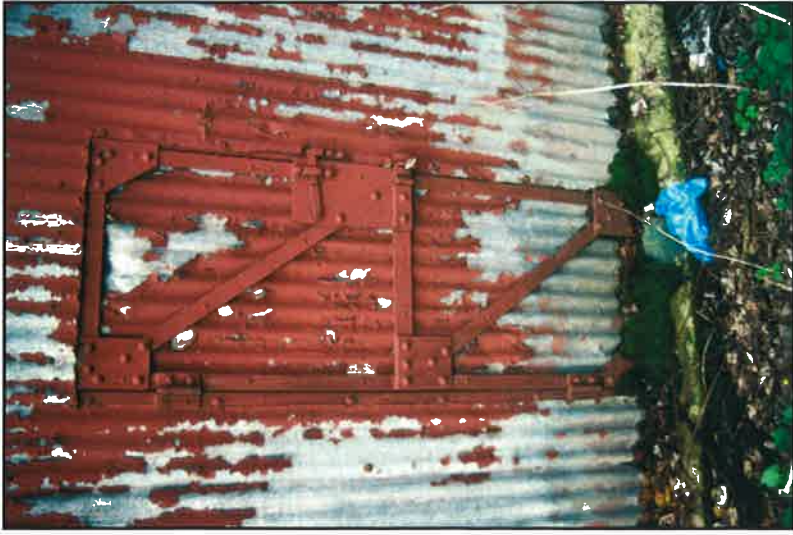
- 4.2.8 There are a further two doors providing access along the south east elevation. The first door is located towards the north end of the elevation (Plate 13). This is constructed from corrugated iron and incorporated into the construction of the hanger. The door has an iron frame and measures 2.07 m by 0.77 m, thus allowing individual not goods access. It is hinged, opens externally and is secured with a locked latch. The second door is a larger plain iron door (2.41 m by 2.22 m) that is secured in the centre by an iron bolt (Plate 14). This doors is raised from the ground on a concrete base to a height of 0.27 m. It is likely that this door allowed access for equipment associated with the maintainance of the vehicles.

Plate 13: Doorway 1, south-east elevation

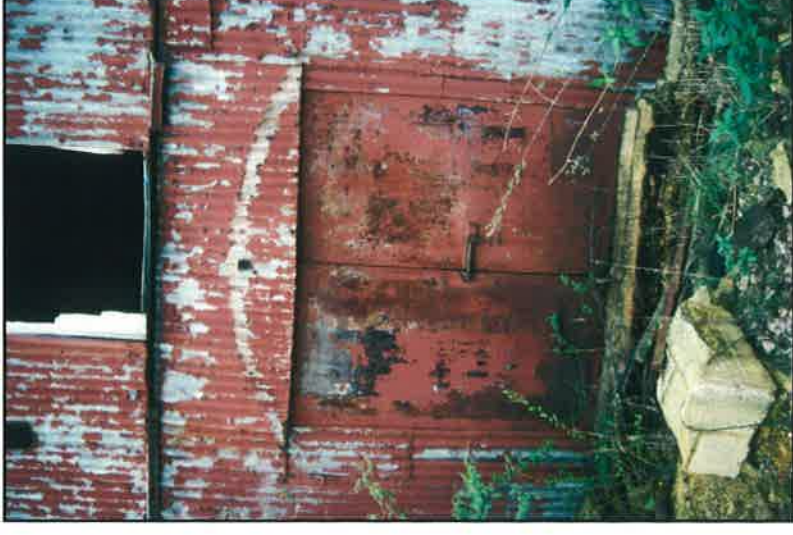
Plate 14: Doorway 2, south-east elevation

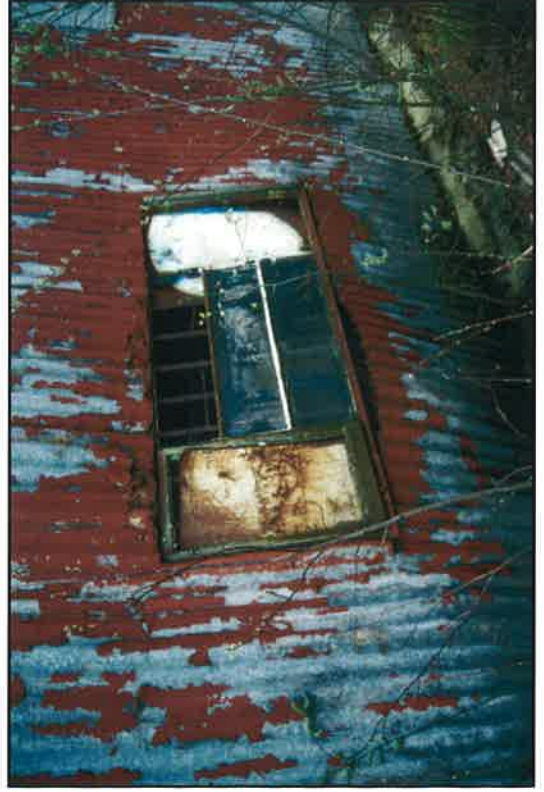
- 4.2.9 There are a total of three crittal windows within the hanger. One window is located along the south east elevation measuring 1.83 m by 0.75m (Plate 15). This has an iron frame with two end lights (now boarded) encasing three internal panels of lights. Two further windows are evident along the north west elevation. These are located between block G and the modern addition running along the remaining north west elevation. The more northern of the two windows measures 3 m by 1.10 m and has three lights contained within three sections. The second window measures 2 m by 1.10 m and has three sections containing three lights. Both windows are at a height of 1.70 m from the base of the hanger and have iron frames, wood sills and glass panes. It is possible that additional windows once existed on the north west elevation that are no longer extant. Such windows are common in second world war buildings of this type although the number of windows is usually limited due the risks these would have entailed. Glass windows are also likely to shatter as a result of vibrations created by the movement of aircraft.

Plate 15: Window, south-east elevation

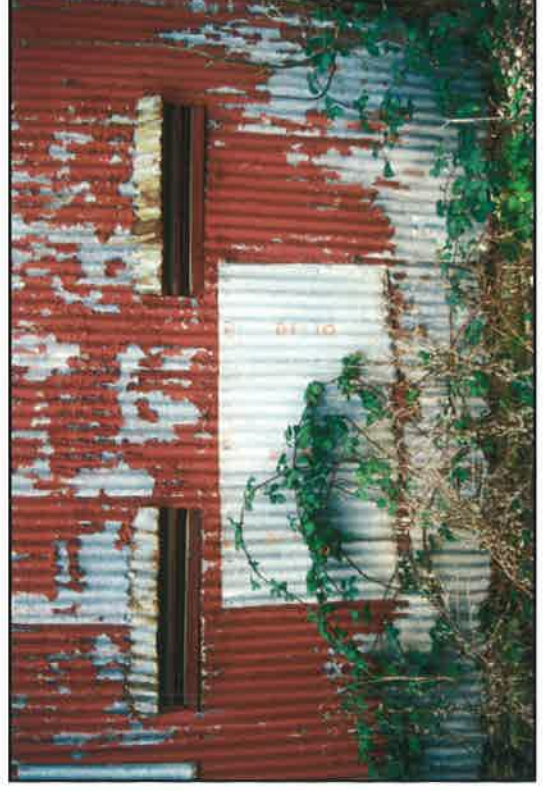
- 4.2.10 Two ventilation slots (1.09 m by 0.34 m) are built within the construction of the hanger, along the south east elevation, at a height of 1.70 m from the base (Plate 16). The corrugated iron has been moulded so that it overhangs the slots preventing water from entering the hanger internally. These ventilation slots also serve in illustrating the benefits of corrugated iron as it is possible to manipulate the material to incorporate such additional features. It is probable that two further ventilation slots were once evident on the north west elevation although these are now obscured by the modern structure.

Plate 16: Vents, south-east elevation

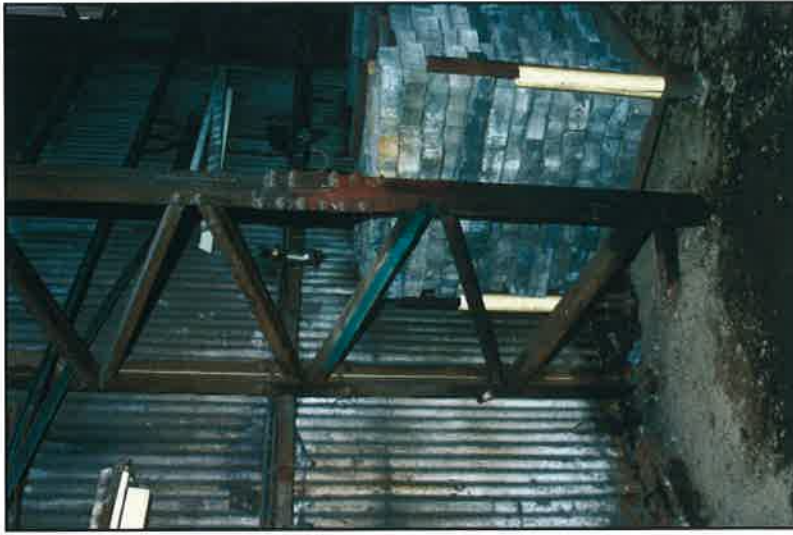
- 4.3.1 Internally, few extant features survive providing information as to the working mechanics of the hanger. It is a large open space with a flat concrete floor that is lipped at the north east entrance to facilitate vehicle access. The corrugated iron elevations directly meet the concrete floor (Plate 17). The hanger houses 15 steel portal frames spaced at 3.4 m increments. Five iron bars extend horizontally along the length of the corrugated iron elevations (Plate 18). These are evenly spaced from the base of the elevation to the roof at 1.7 m intervals and are 0.6 m in thickness. Each vertical girder is bolted to the iron bar and these in turn are attached to the corrugated iron by small iron hoops that pass through the corrugated iron at 0.38 m

Plate 17: Roof truss, detailing base of post, south-east elevation

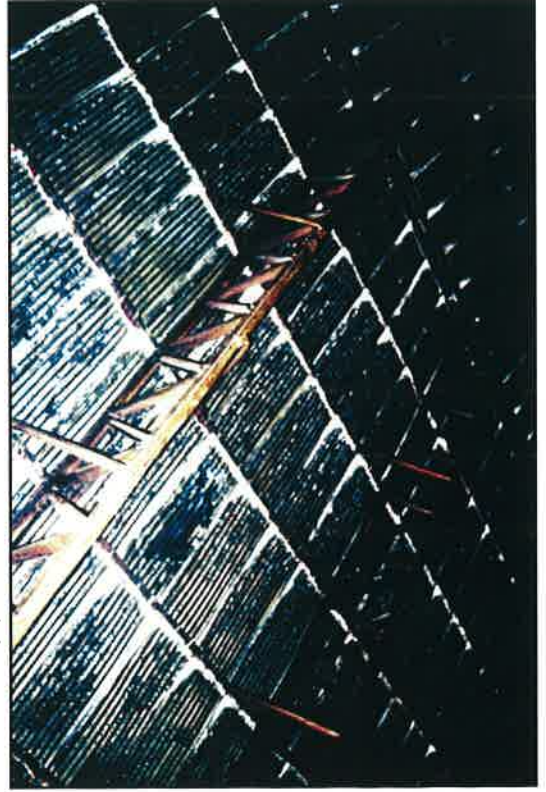
intervals. The corrugated iron roof sits on the portal frame trusses and is secured by iron supports extending in a V shape from either side of the frames (Plate 19).

Plate 19: Internal west view of roof

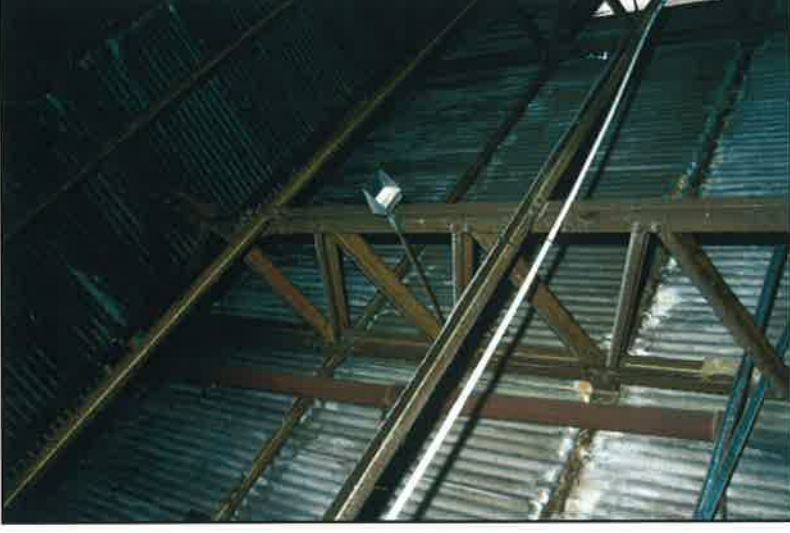
Plate 18: Roof truss, south-east elevation

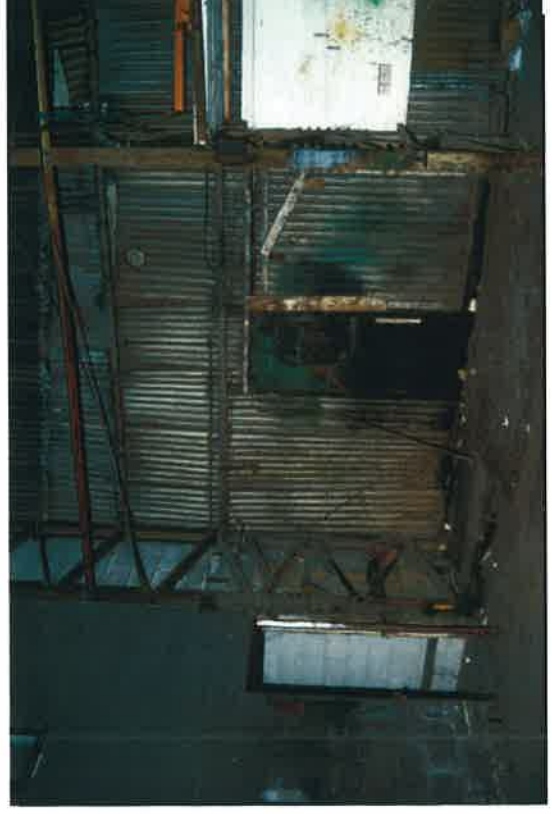
- 4.3.3 Two doors are extant along the southern end of the west elevation. The more southerly of the two is a wooden door with a frame measuring 2 m by 2.18 m (Plate 20). A concrete ramp extends up to meet the area of the door which would have facilitated the transportation of equipment. The second door is a sliding wooden door with a brick surround and located between trusses 8 and 9. It measures 3.26 m by 3 m and slides back within the construction of the hanger and therefore is at the same alignment as the corrugated iron elevation. The brick surround is built onto the corrugated iron which meets the trusses on both sides. These doors would not have permitted vehicular access but were large enough to allow for the transportation of equipment relating to the vehicles. There is no internal door linking block G to the hanger. An iron door remains extant providing access to block F.

Plate 20: Internal bay and door, north-west elevation

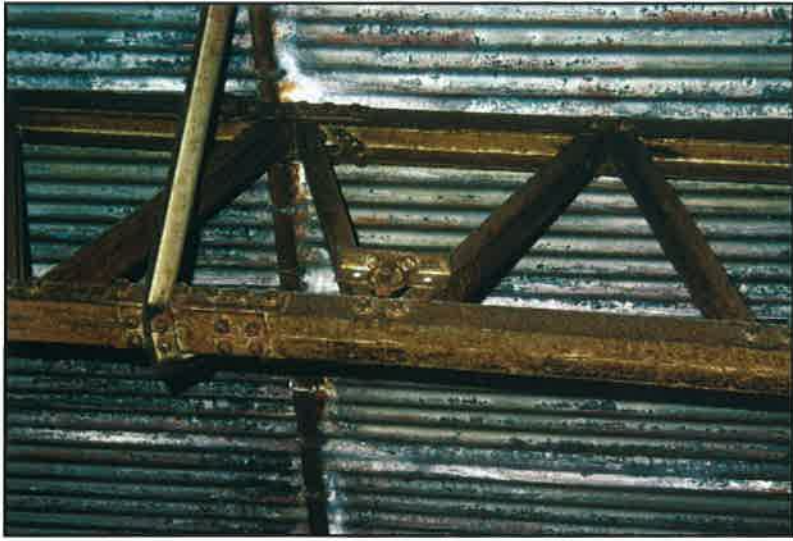
- 4.3.5 The second feature of note are eight pulley wheels which are attached to the portal frames. Four are located at the north east and south west of the hanger, two on the south east parameters of the roof and two on the north west. A further four are located below these on the vertical steel girders. Various iron mechanisms are evident on the frames which are thought to relate to this pulley mechanism (Plate 21). It is thought that these once held ropes or chains that were used to hoist heavy equipment. At the south western end of the hanger these are found on truss 13 and in the same alignment as the iron door. It is likely that these were therefore used to facilitate the transportation of equipment through these doors.

Plate 21: Detail of internal pulley mechanism, south-west corner

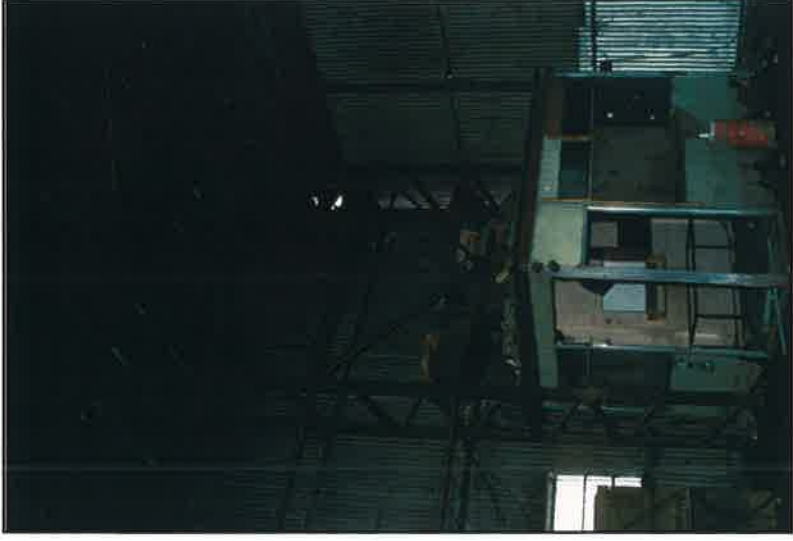
- 4.3.6 The hanger houses two internal breeze block buildings that relate to a different phase of construction. These presumably were inserted at a recent date by Fishers Surfacing. The first is located in the north - west corner of the hanger and measures 2.58 m by 3.59 m (Plate 22) and the second is located in the south west corner. It was not possible to gain the measurements of the latter structure as a large truck stationed in front of the structure meant that this was impossible (Plate 23).

Plate 22: Modern internal structure, north-west corner

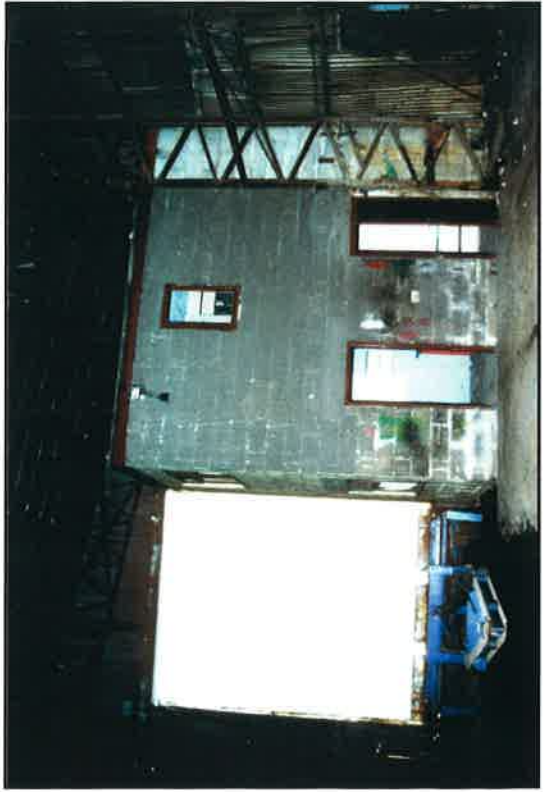
Plate 23: Modern internal structure, south-west corner

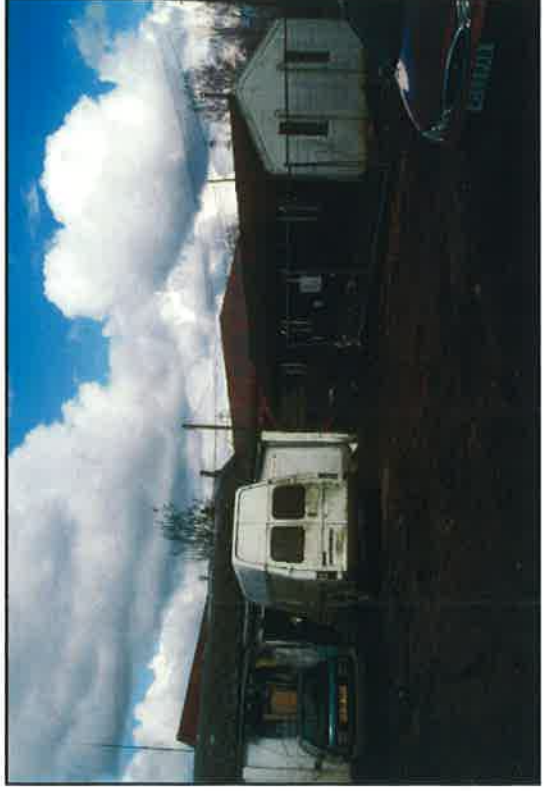
- 4.4.2 Block A is rectangular in plan, single storey with small buttresses to the external face of the walls (Plate 24). It has a gabled roof, concrete floor and three simple metal trusses (Plate 25). The windows are crittal type and sloped tiles extend to the window sills (Plate 26). Two sets of double doors and one singular door provide access (Plate 27). The building has two internal divisions and a sink and it therefore seems likely that its use was as a training room or some type of administration office.

Plate 24: South view of blocks A, B and C

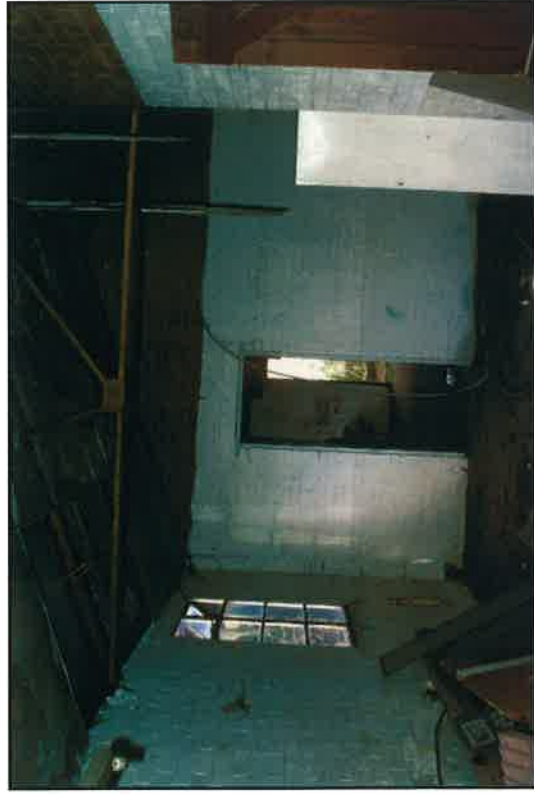
Plate 25: Internal south view of block A

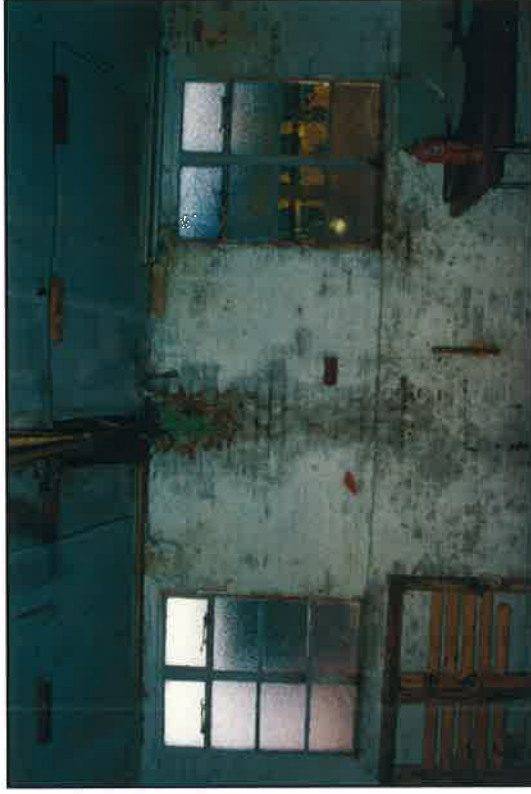
Plate 26: Internal windows, west elevation, block A

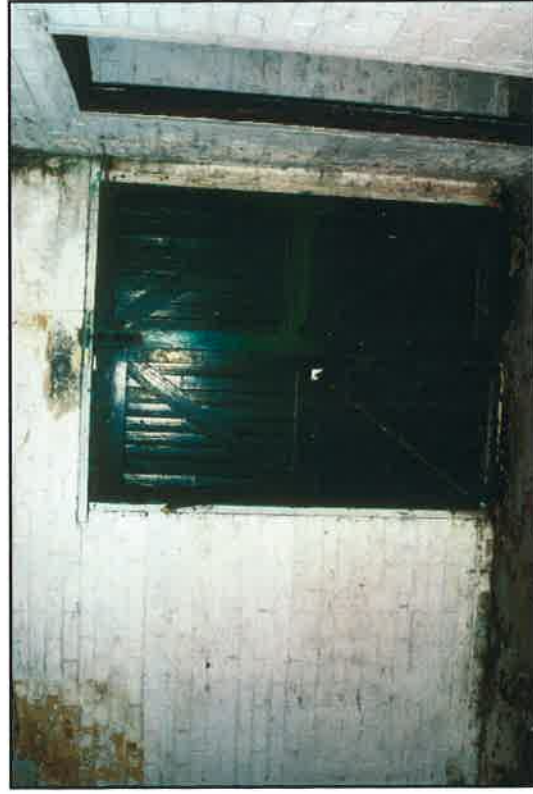
Plate 27: Internal door, east elevation, block A

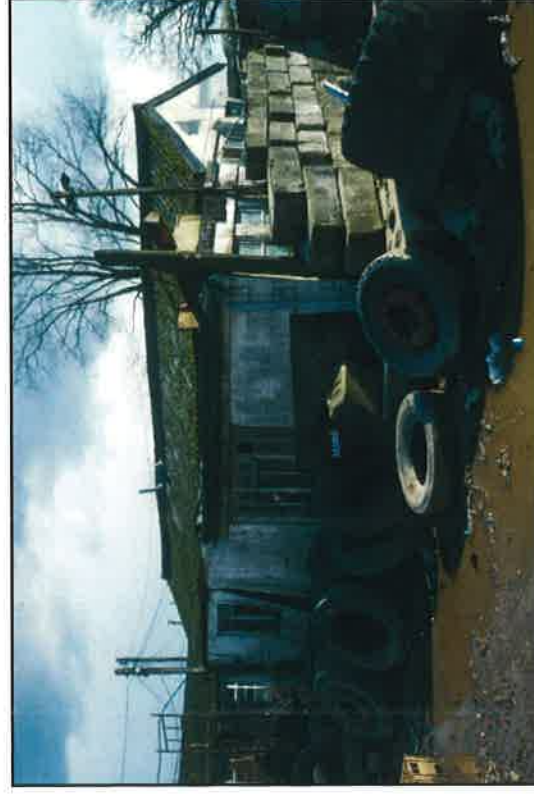
- 4.4.3 Block B is single storey with distinctive buttresses to the outer face (Plate 28). It has crittal type windows with sloped tiled sills (the same as block A), two doors and a wide opening which has been incorporated into the original wall. Block E is a later addition to the north of Block B although it is still thought to date to the Second World War. A secondary door has been added linking the two structures. It is of a similar construction, also with crittal windows and appears to be the used as a toilet block. Block C is a brick and concrete block extension to Block B and thought to be post World War two in date (Plate 29).

Plate 28: South elevation of blocks B and E

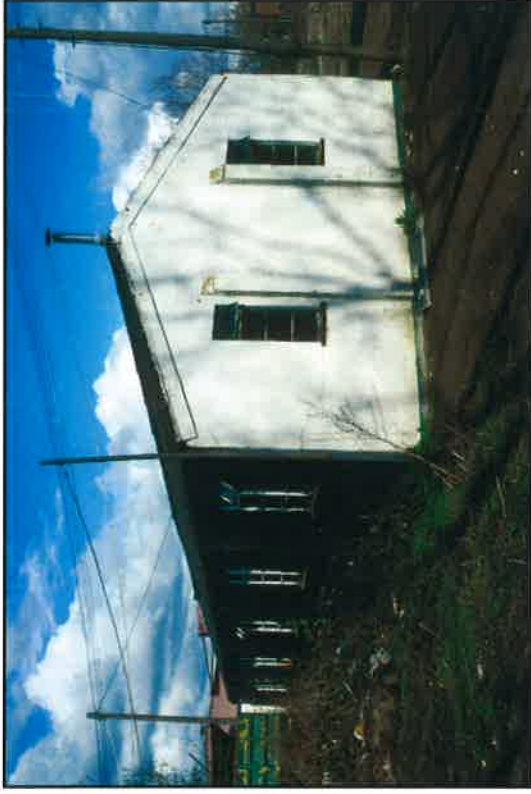
Plate 29: South view of block C

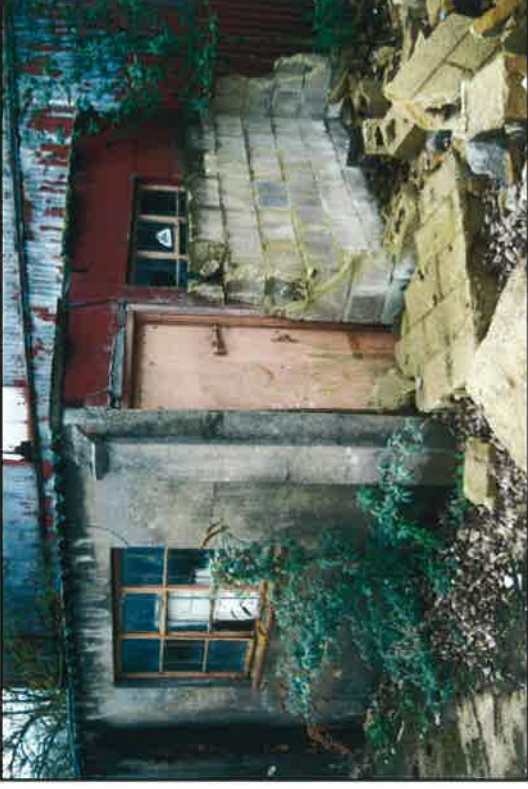
- 4.4.5 Block F is single storey with crittal windows, a pitched corrugated iron roof and buttresses to the exterior (Plate 30). It was not possible to gain access to the building although it was evident that it has softwood purlins. There are footings from other structures in front of it although these are not planned.

Plate 30: East view of block F

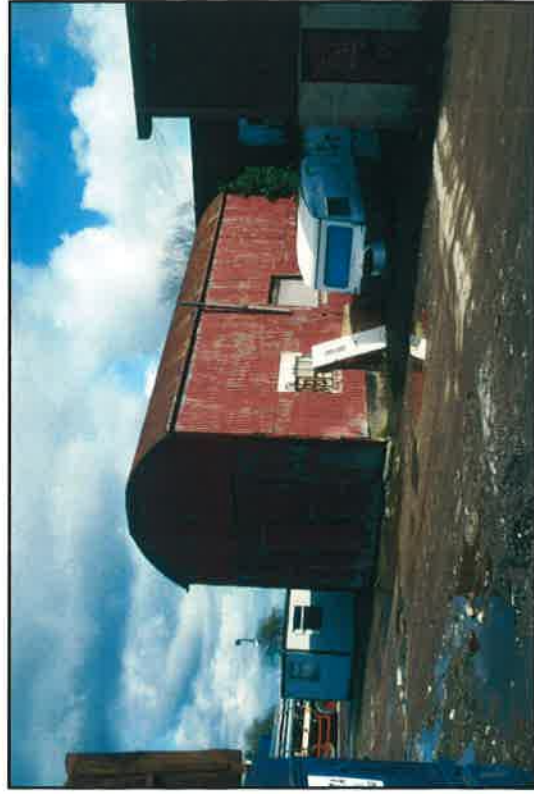
- 4.4.6 Block G is constructed from corrugated iron and the roof has been rounded into an arch formation (Plate 31). The elevations are bolted onto a breeze block base (0.50 m in height). The structure has one smaller corrugated iron north east facing door set in a wooden frame. A larger corrugated iron door faces to the north west that opens to the full extent of the elevation providing a large access area. The door is divided into four hinged sections each measuring 1.30 m in length and 3.56 m in height. Above the door is a diamond shaped plaque on which 'Main' is written. The structure has two crittal windows and a concrete floor. It is thought that it also relates to the world war two construction phase and is contemporary with the construction of the hanger. There is no entrance to this building from the hanger although the two buildings are connected by a breeze block structure (Plate 32). It was not possible to gain access to the block G at the time of inspection.

Plate 31: North-west elevation showing block G

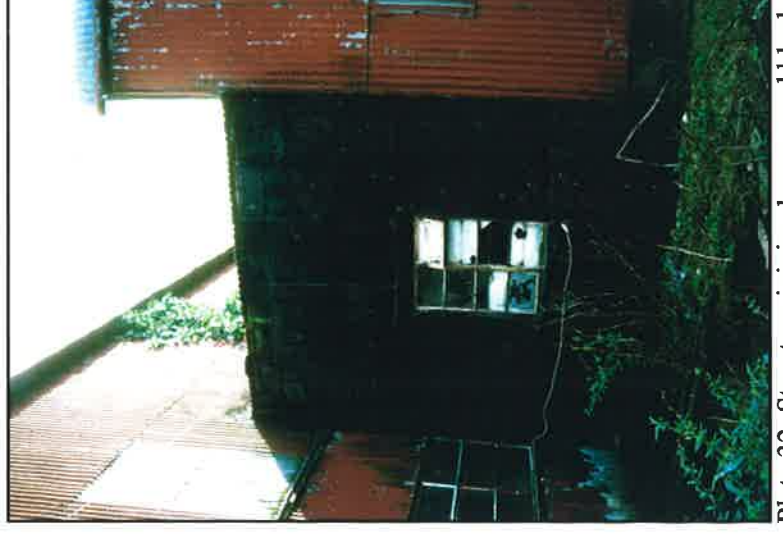
Plate 32: Structure joining hanger and block G
