# **CORPORATION STABLE YARD,**

**SMITHDOWN  
LANE,  
LIVERPOOL**

## **Archaeological Watching Brief and Excavation Report**

**September 2012**

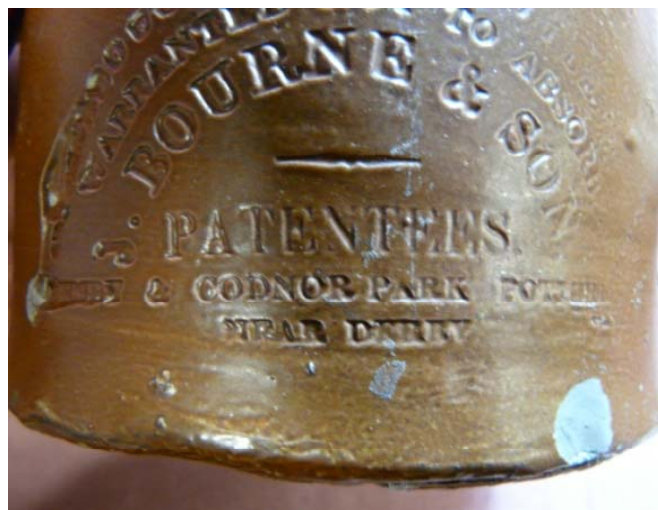
Finds Plate 1: Stamp of J Bourne and Son, 1852-1861

5.1.2 Although not in themselves of special interest, the concentration of stoneware bottles in context **144**, along with a small number in context **117**, can provide some evidence for dating. Many of the larger ink bottles are stamped with the name of their producer, J Bourne, a pottery in production from the early nineteenth century. Variation in the exact wording, reflecting changes in ownership and location of the kilns, allows the vessels to be dated with some precision. Finds Plate 1 shows potentially the earliest stamp, naming the producer as J Bourne and Sons, of Denby and Codnor Park Pottery, near Derby, and can be dated 1852-1861 (Askey 1998). Finds Plate 2 shows a bottle stamped J Bourne and Sons, of Denby Pottery which is dated later, 1861-1916.

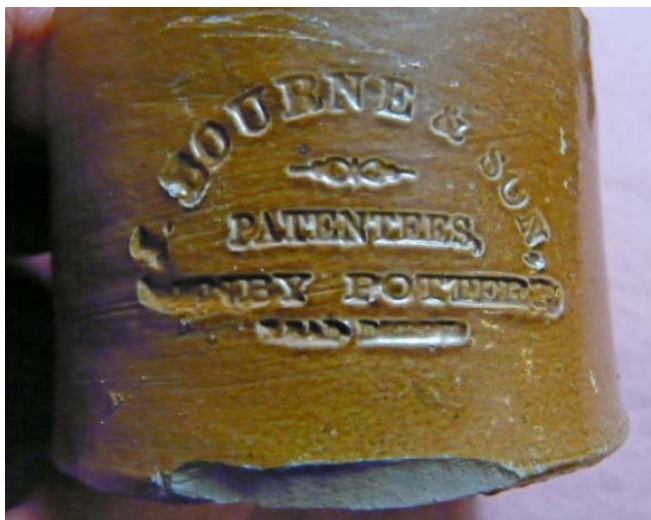
Finds Plate 2: Stamp of J Bourne and Sons, of Denby, dated 1861-1916

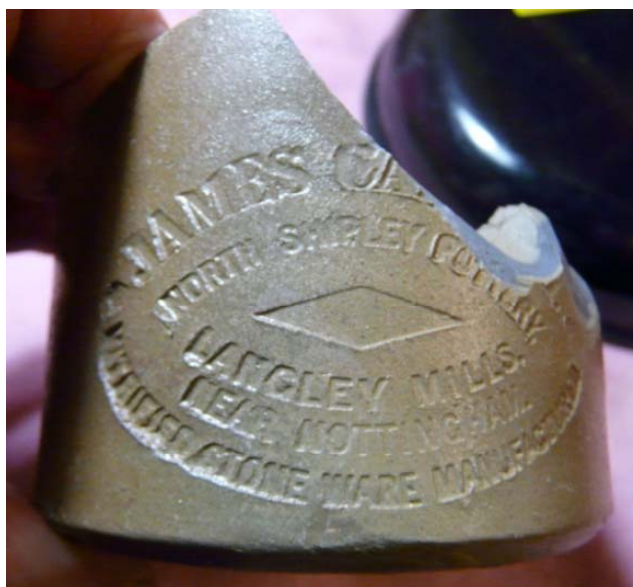
Finds Plate 3: Stamp of James Calvert dated 1865-1883

- 5.1.3 There is also a single bottle stamped [James] Calvert, of the North Shipley Pottery near Langley Mills, Nottingham, which can be dated between 1865 and 1883, the dates during which Calvert's pottery was in production (Finds Plate 3).

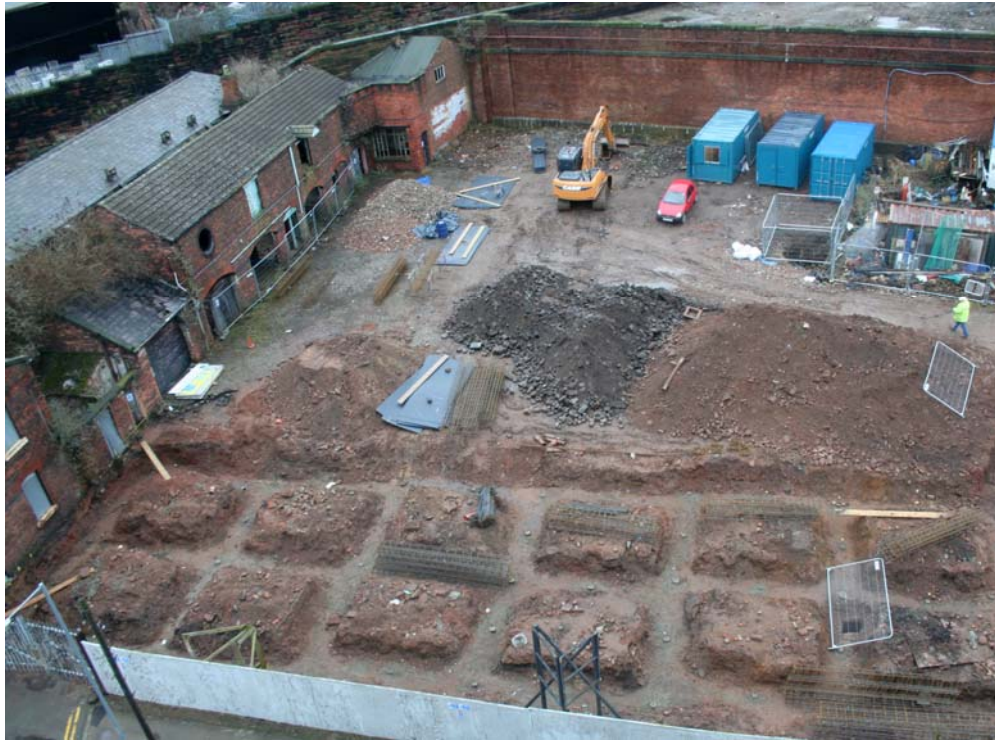
Plate 1: East-facing aerial view across the stable yard during the watching brief investigations

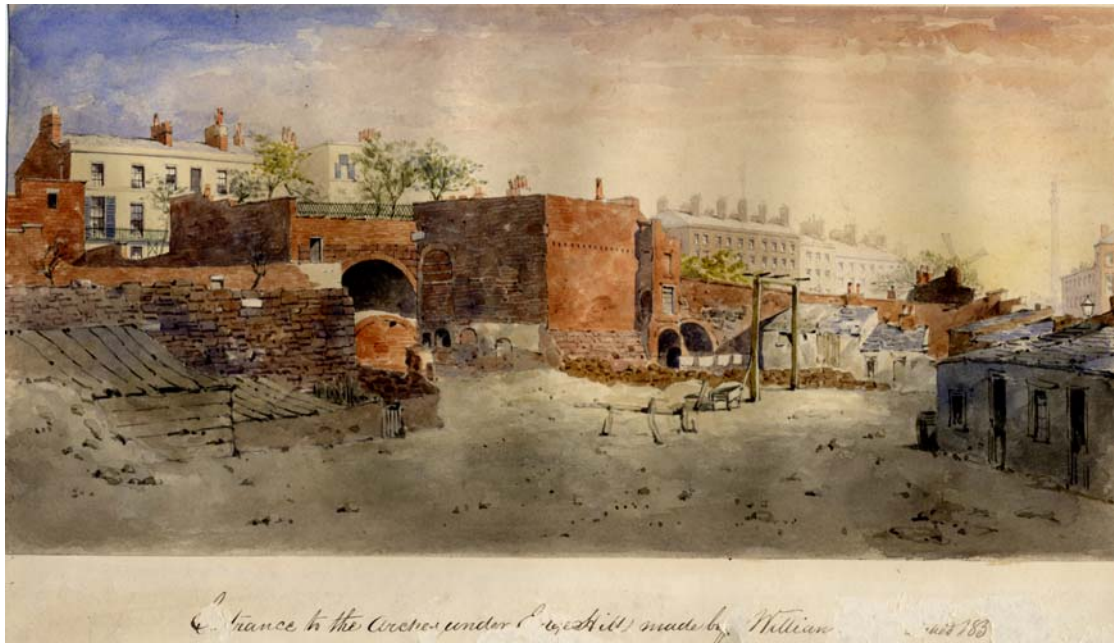
Plate 4: Painting by William Gawin Herdman titled *Entrance to the Arches under Edge Hill made by Williamson, 1837* (LRO)

below the present ground level at the northern limit of Area B (Plate 27). This corresponds with the images of quarry terracing shown in the watercolour prints of c 1837 produced by local artist, William Gawin Herdman (Plates 4 and 5), and also gives an indication of the nature of the levels for the upper terraces of bedrock. A vertical shaft, known to be Tunnel 4, **300**, was observed within the centre of the area although upon inspection there was no obvious sign of any brick vaulting.

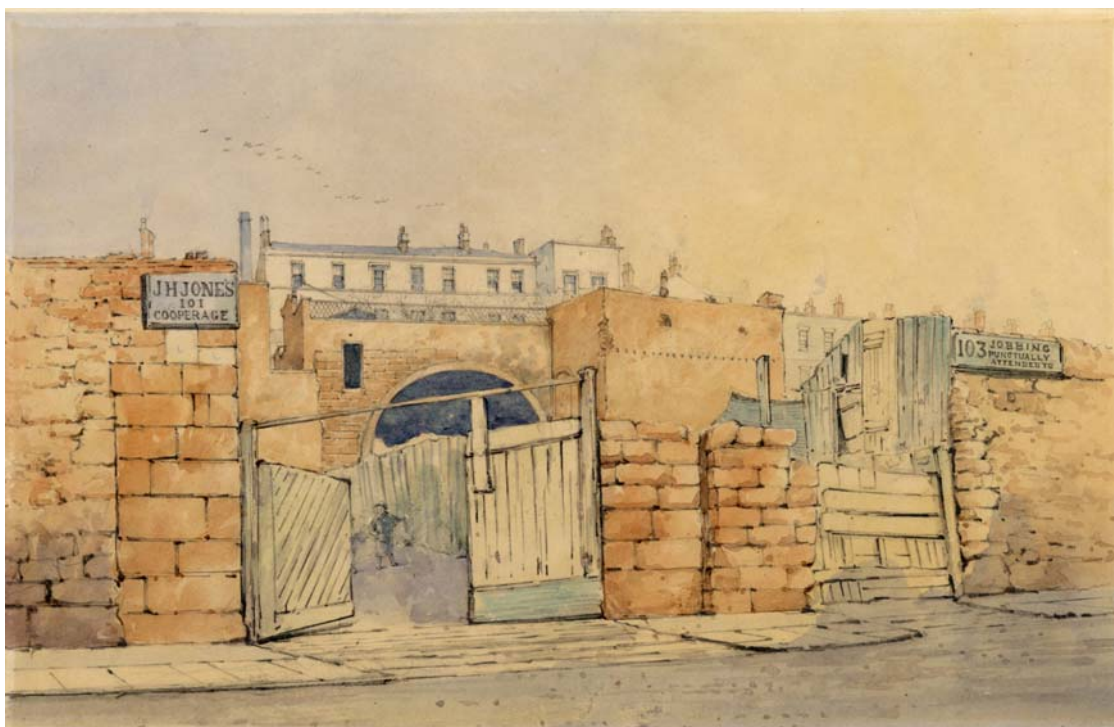
Plate 5: Painting by William Gawin Herdman showing the gates to the Cooperage with the triple decker tunnel and Mason Street in the background c 1837 (LRO)

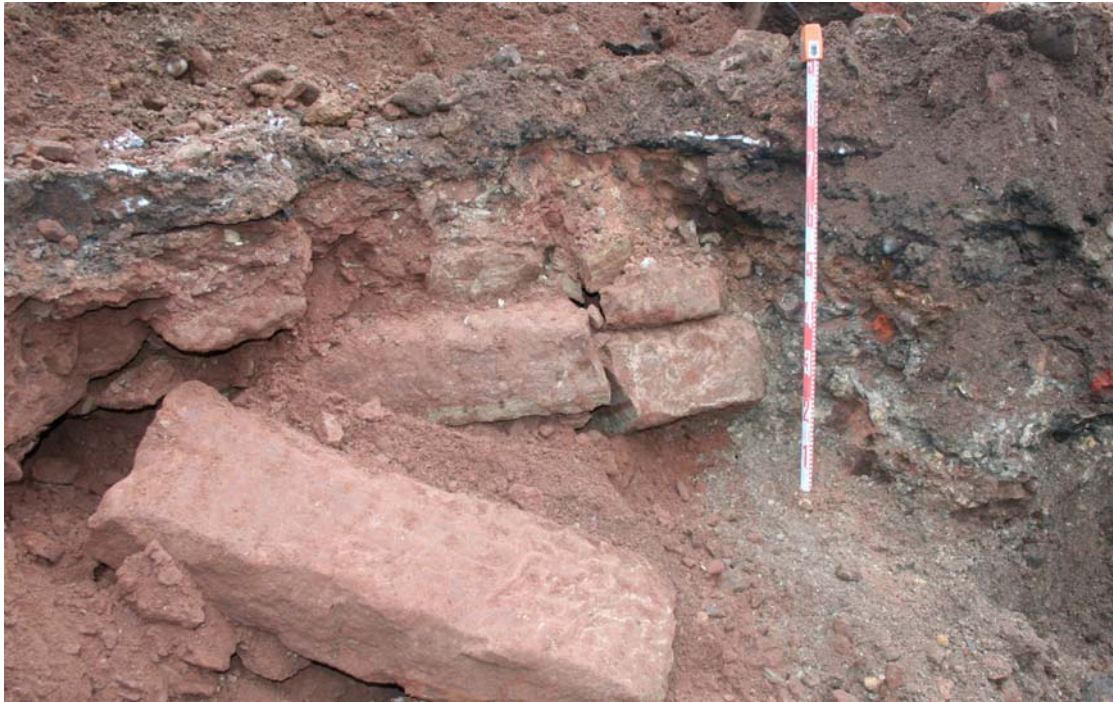
Plate 6: Sandstone retaining wall **011** at the north-eastern side of Area A

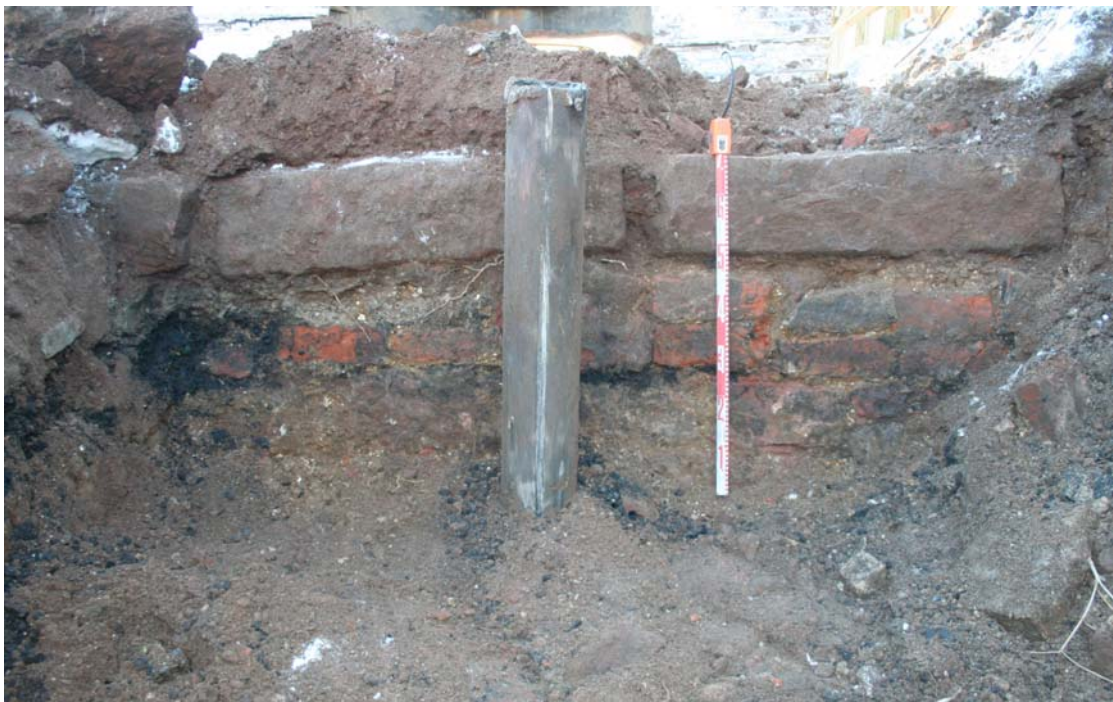
Plate 7: Red brick wall with pink sandstone coping stones **014**

- 4.2.2 **Results:** the watching brief was primarily concerned with the piling and excavation of foundation trenches for blocks one to nine within the footprint of the new building (with one being at the northern limit of the development and nine being at the southern limit of the site adjacent to the entrance to the Heritage Centre) and also the excavation of numerous drainage and man-hole trenches associated with the new build (Fig 2; Area A). The excavation of the building footings revealed several features of archaeological interest at the northern end of the site (Plate 6 and 7), and included several small sections of red brick wall. These all appeared to have post-dated the construction of the tunnels and correspond with demolished sections of the stable yard which fronted onto Smithdown Lane. At least two sections of stable yard wall on the north side of the tunnel comprised pink ashlar sandstone block footings with brick walls constructed on top of them. This pink sandstone probably represents material retrieved from the site and reused in the construction of the stable yard complex. The structures in this area are described as part of the watching brief (*Section 4.2.6; Plate 7*).

2.1m long by 0.26m wide and 0.5m tall. Wall **015** was located to the north of **014** and was orientated north/south measuring 1.6m long by 0.31m wide and 0.5m high. It included some large pink sandstone ashlar blocks, but their depth and the presence of mortar on the top of the blocks indicates that this was not a sill, but possibly some sort of foundation level string course. All brick walls were observed in section and were left *in-situ* to act as retaining walls during the course of the excavation for the footings.

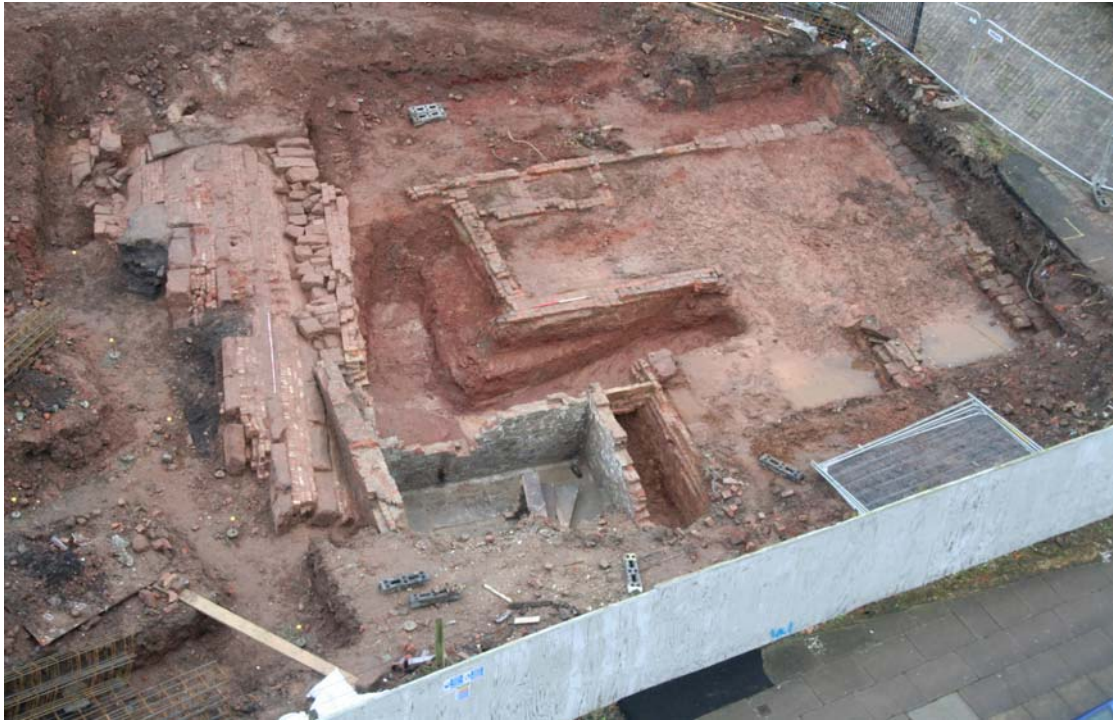
Plate 8: Aerial view of Trench 1A, within the southern half of Area A, showing Tunnel 1 (*I25*) and the stable block foundations

- 4.2.3 The mechanical excavation of the foundation trenches at the southern end of the site (within Trench 1A (Fig 2)) identified a brick arch (Plate 8 -12) which was constructed in the 'composite style' known to be used by Joseph Williamson when constructing his tunnels (also revealed was a series of buildings that related to the use of the site as a stable yard (Plate 8). The tunnel and adjacent stableyard buildings were subsequently recorded by excavation of Trenches 1A and 2A and are described in *Section 4.3*.

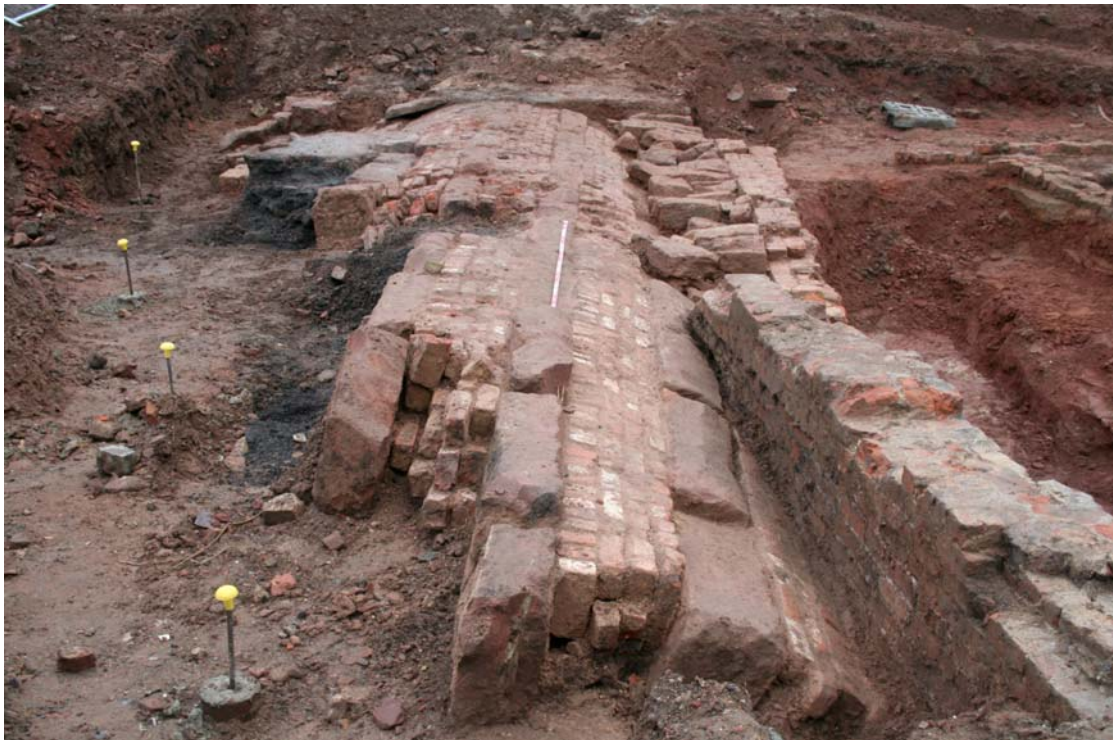
Plate 9: East-facing view across the collapsed arch of Tunnel 1 (*I25*) showing the 'composite style' of construction using brick and sandstone

shiners, headers and stretchers (Plates 8 -12). The quality of materials and of craftsmanship also varied and, in places, fragments of broken bricks had been used, although this might suggest later repair. There was also variability in the size, shape and finish of the sandstone blocks, although they had all been roughly squared and most were dressed. A buff coloured, sandy lime mortar, typical of the period, had been used as a bonding agent.

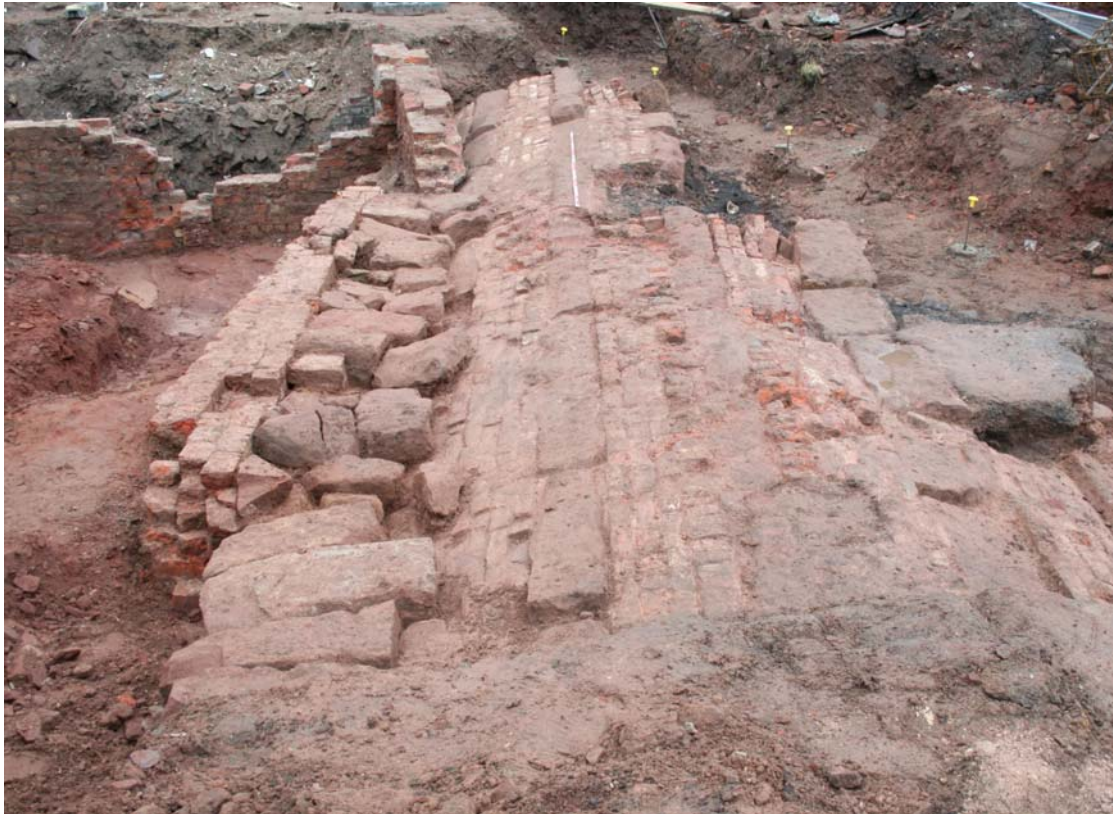
Plate 10: West-facing view across the collapsed arch of Tunnel 1 (*I25*) showing the 'composite style' of construction using brick and sandstone *I24*

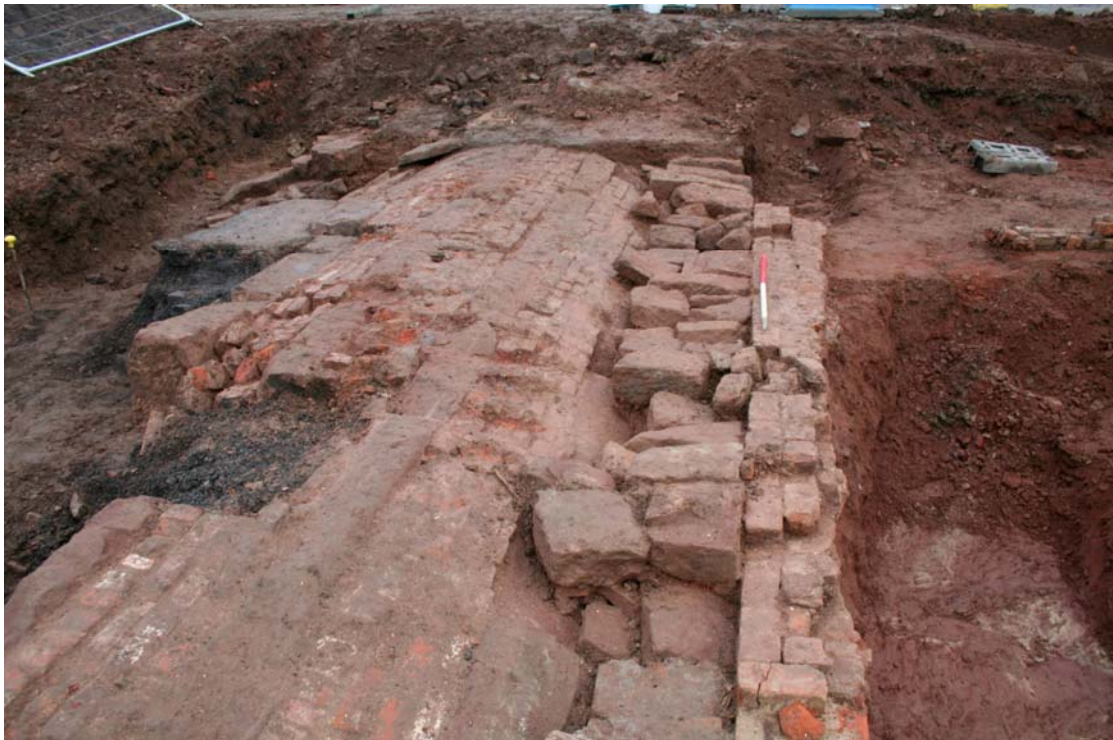
Plate 11: East-facing view showing the interface between Tunnel 1 (*I25*), sandstone blocks *I24*, red brick wall *I22* and the natural sandstone bedrock *100*

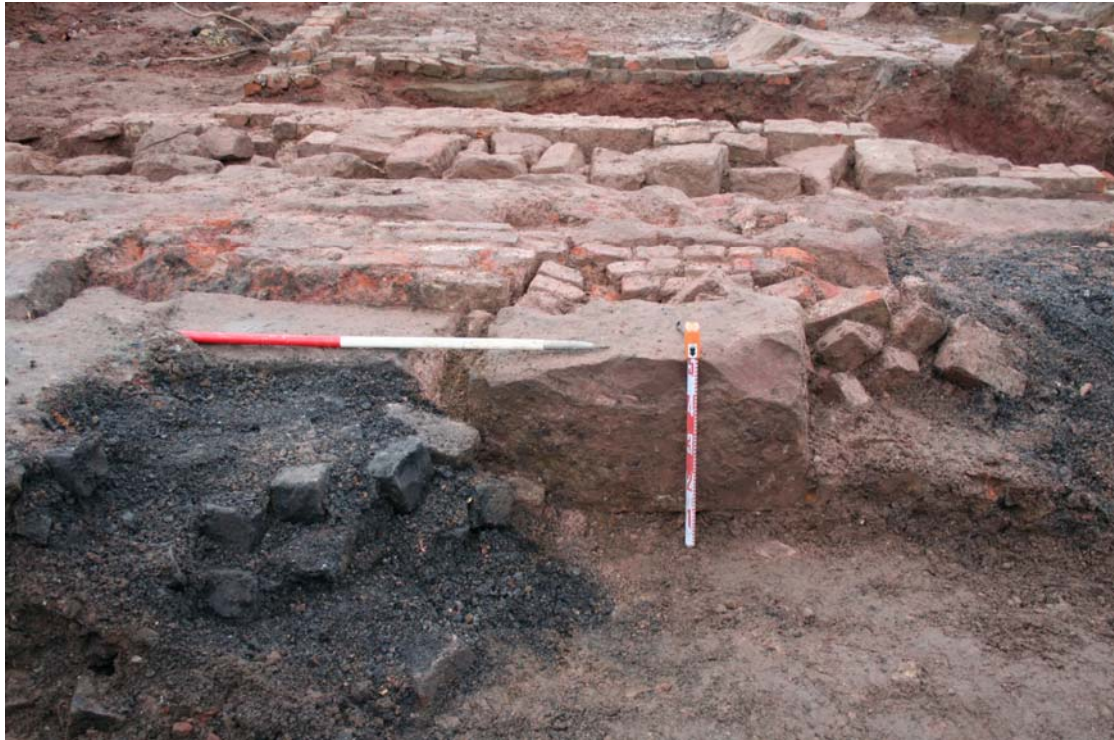
Plate 12: South-facing view showing historic truncation and make-up layers within the roof structure of collapsed Tunnel 1, **125**, and setts, **127**

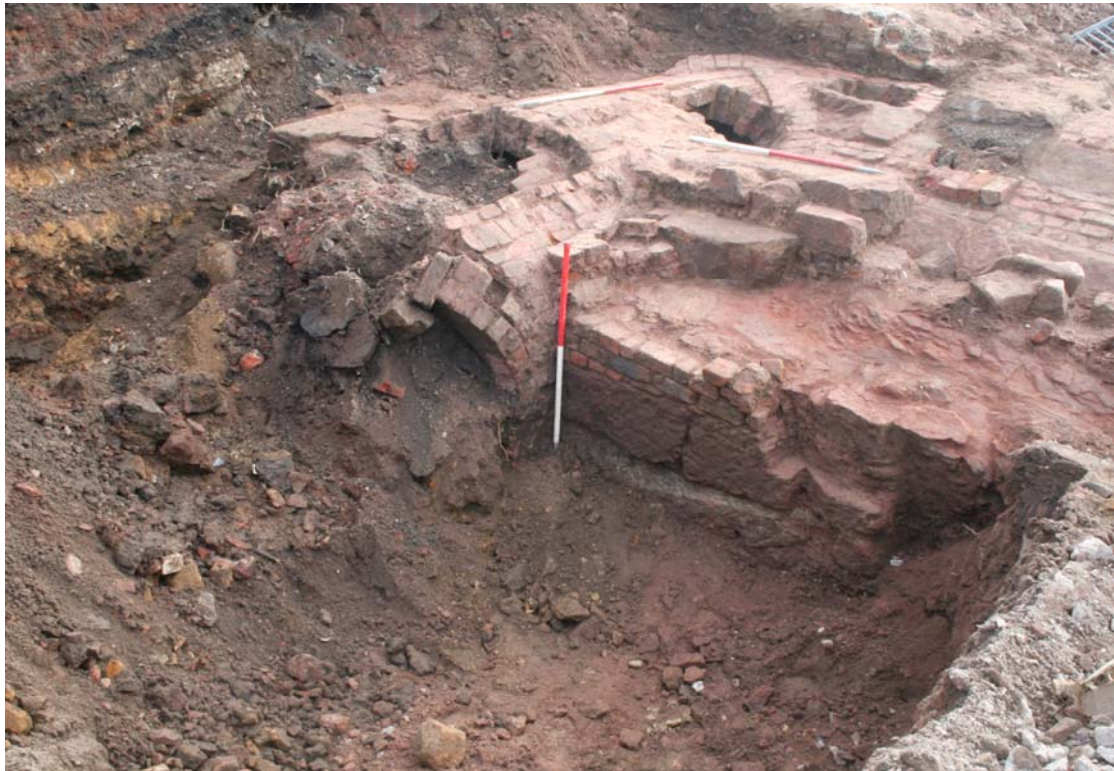
Plate 13: South-east facing view across the interface between Tunnel 1, **125**, and Tunnel 2, **176**

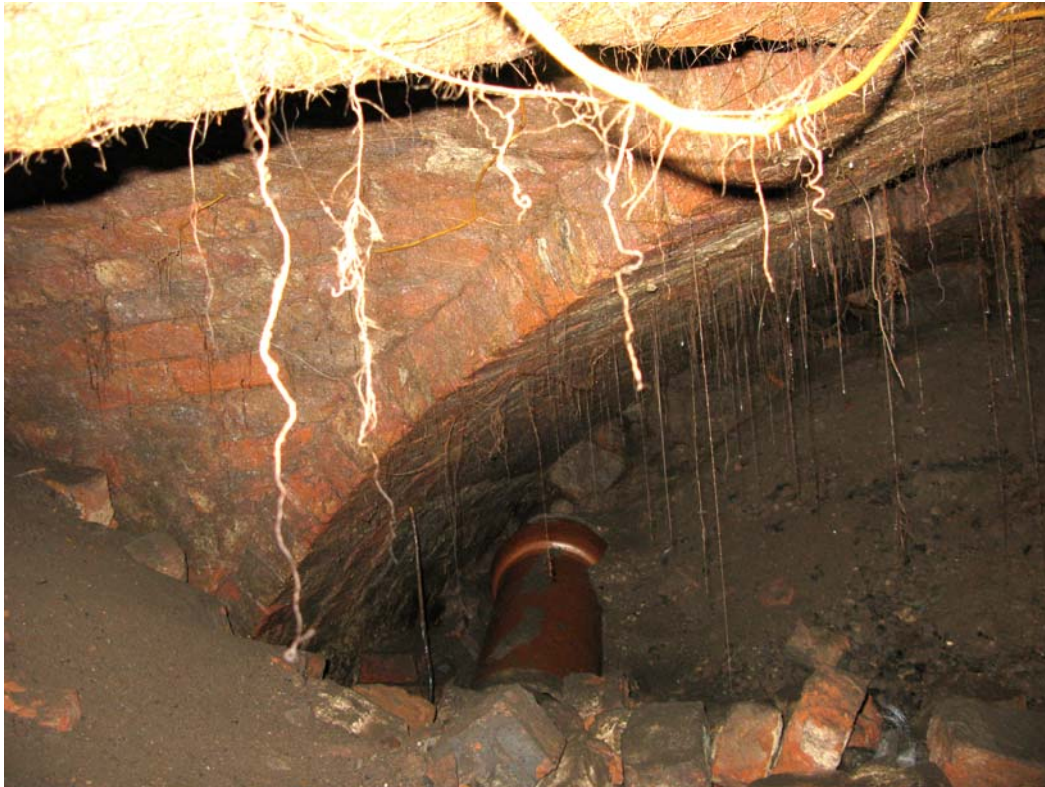
Plate 14: East-facing shot inside Tunnel 1, **125**, showing the interface with Tunnel 2, **176**, to the left of the picture

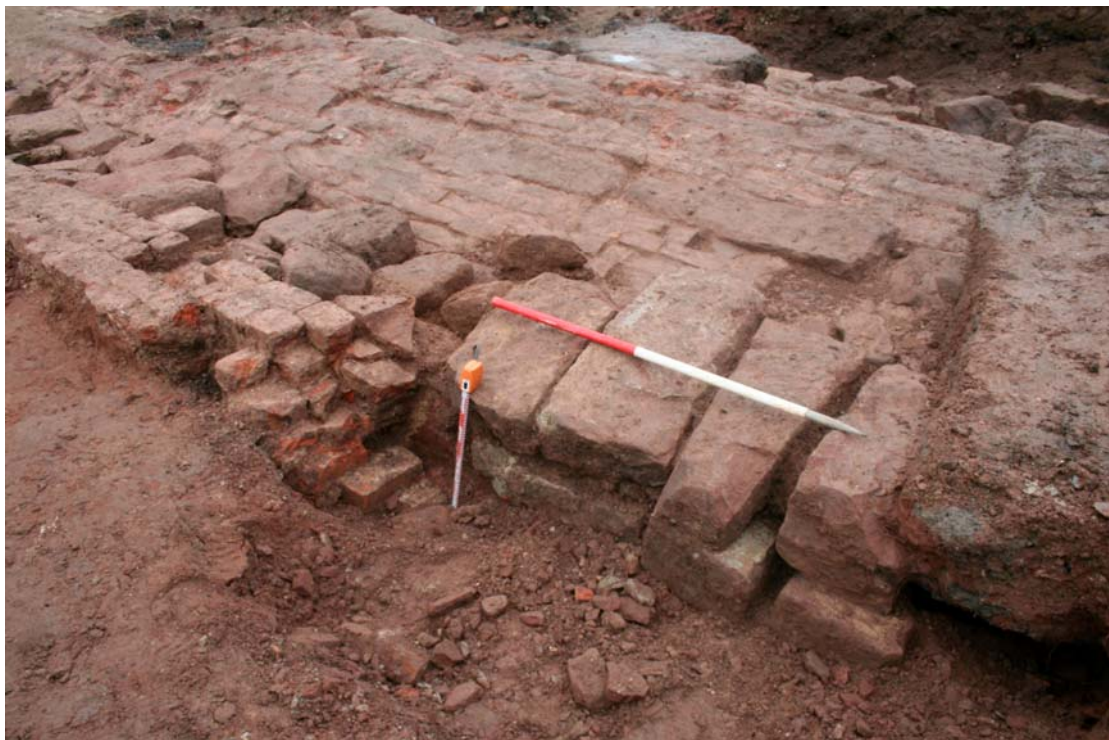
Plate 15: Sandstone levelling, **123**, placed along the extrados at the southern side of Tunnel 1, **125**

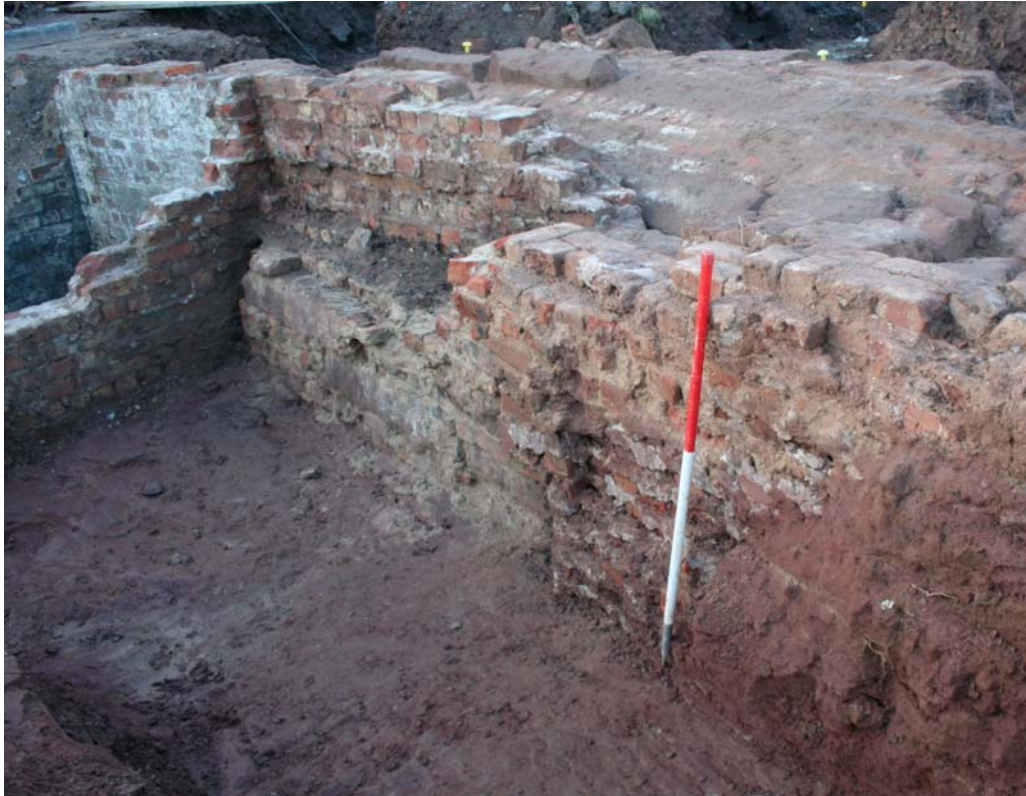
Plate 16: Interface of walls **122**, **133** and Tunnel 1 **125**

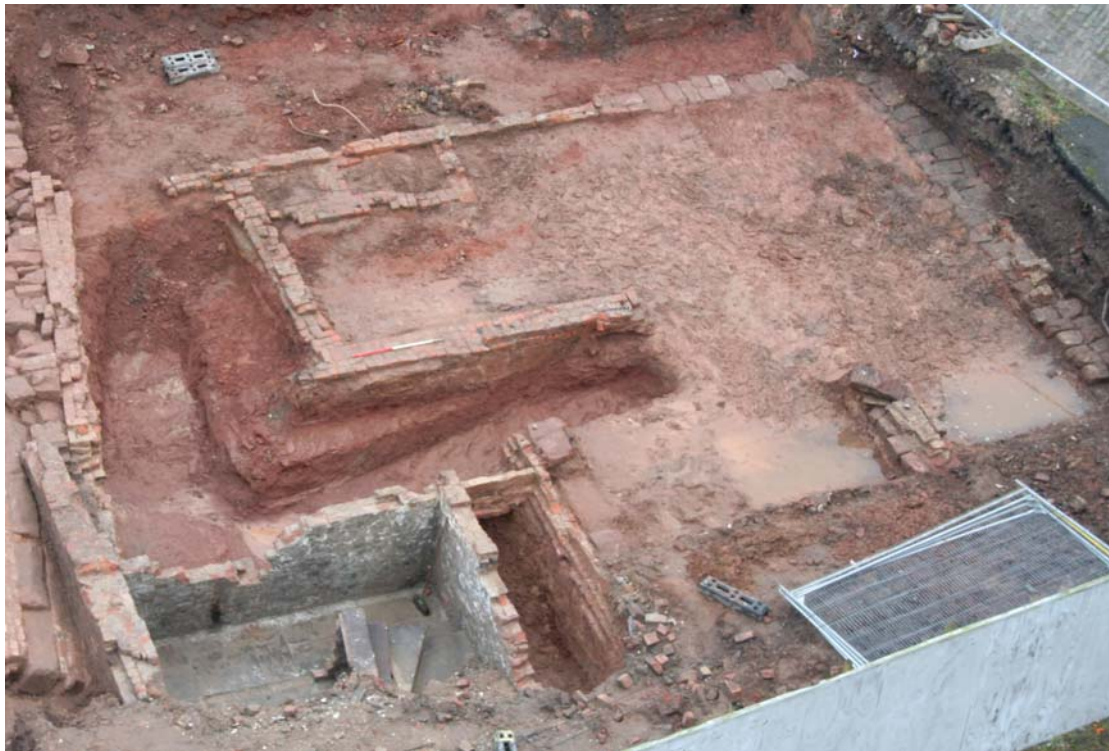
Plate 17: Aerial view showing the foundations of stableyard buildings to the south of Tunnel 1, **125**

- 4.3.21 The majority of the internal partition walls, or associated foundations, that related to the southern and rear parts of the house were no longer extant (Fig 12; Plate 17); it was therefore difficult to assign the limit and function of individual rooms in these areas because of the limited archaeological evidence.

- 4.3.22 A sandstone wall foundation, **112**, aligned east/west and constructed without a mortar bond, was overlain by the remains of a handmade red brick wall **113** to the south of the entranceway. This may represent part of the foundations of the southern pitched, gable-end of the house, which was visible on photographs of the building prior to demolition. A room or area was partly defined by walls **137** and **112**, although the eastern and western extents were not able to be defined. Another wall with sandstone foundations lacking mortar and brick-built upper courses running east/west, **102/103**, was located to the south of wall **112** and was the southernmost wall of the house (Plate 17).

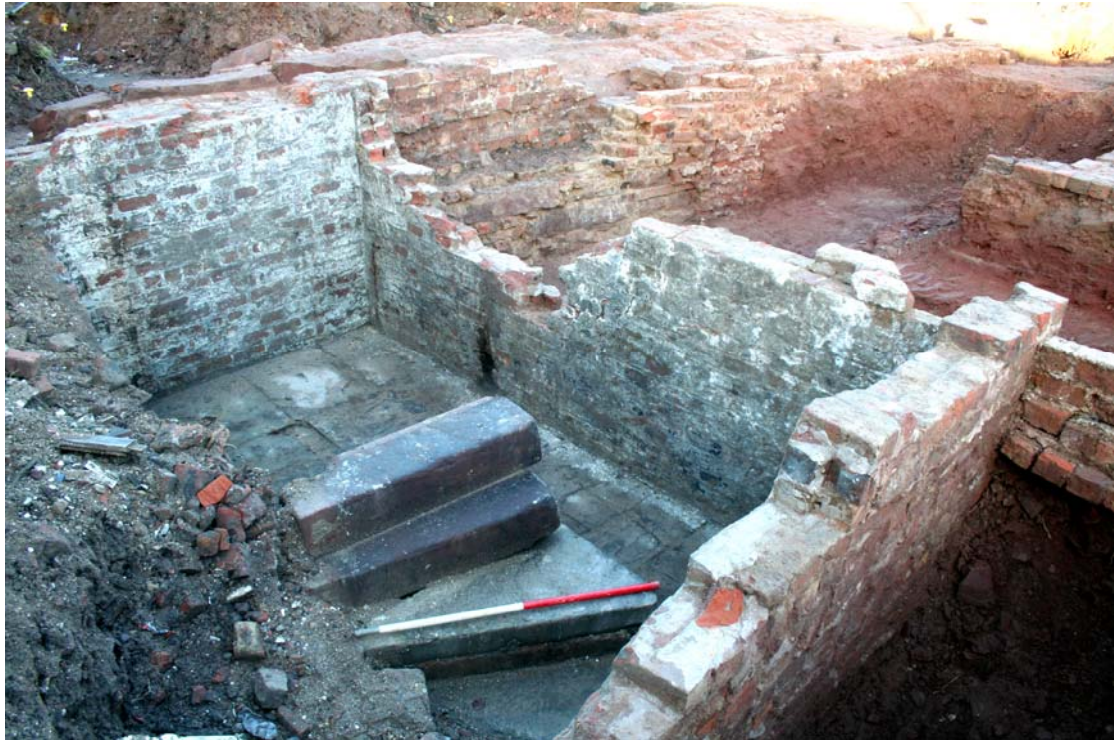
Plate 18: North-east facing view of cellar south of Tunnel 1, **125**

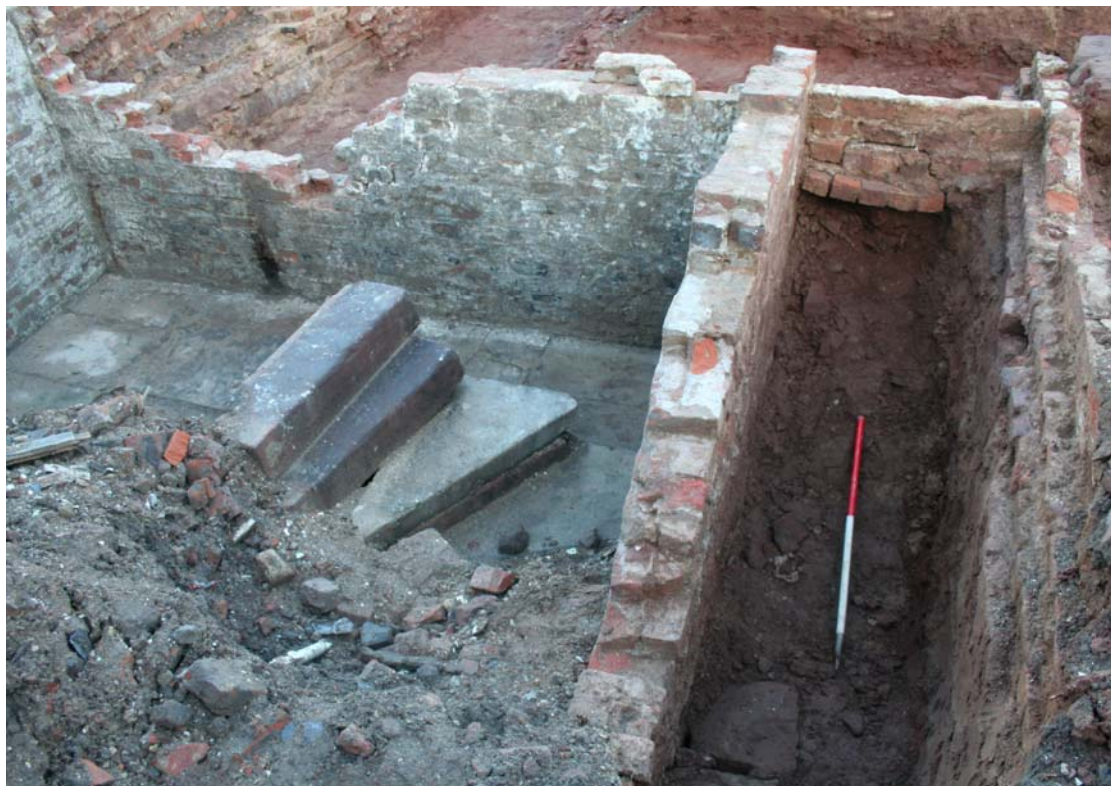
Plate 19: East-facing view across the cellar area showing walls **135**, **136** and **137**

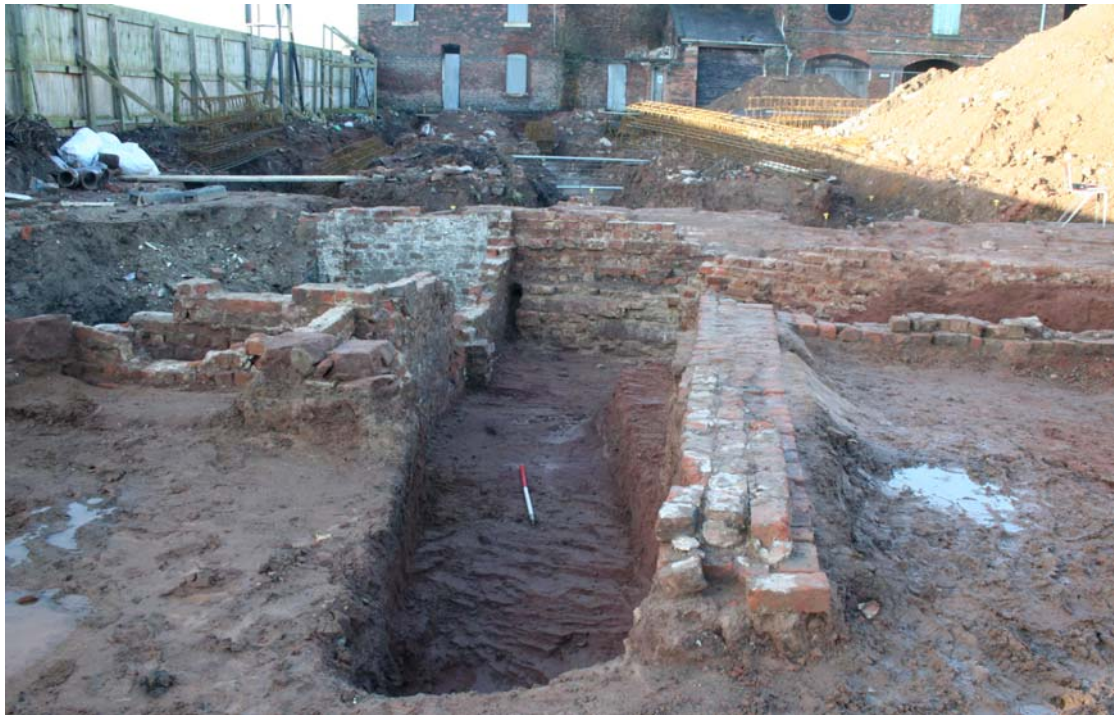
Plate 20: North-facing view showing walls **106**, **105** and bedrock **100**

- 4.3.24 Walls **105** and **106**, and the remains of walls **133** and **104**, defined the rear of the building (Plate 20), and were all of brick construction, with no indications of sandstone foundation courses; the walls were built over levelling deposits **118** and **114**. Cartographic evidence confirms that the building did not extend further east than the line of wall **104**. Extending south-east from wall **104** was a sandstone wall, **101**, which may be part of an earlier structure. It, and walls **104**, **102/103**, and **105** enclose an L-shaped rear yard, which was depicted on the nineteenth-century maps, and corresponds exactly with the area defined by, and the extrapolated continuation of wall **112** (Fig 13; Plate 17).

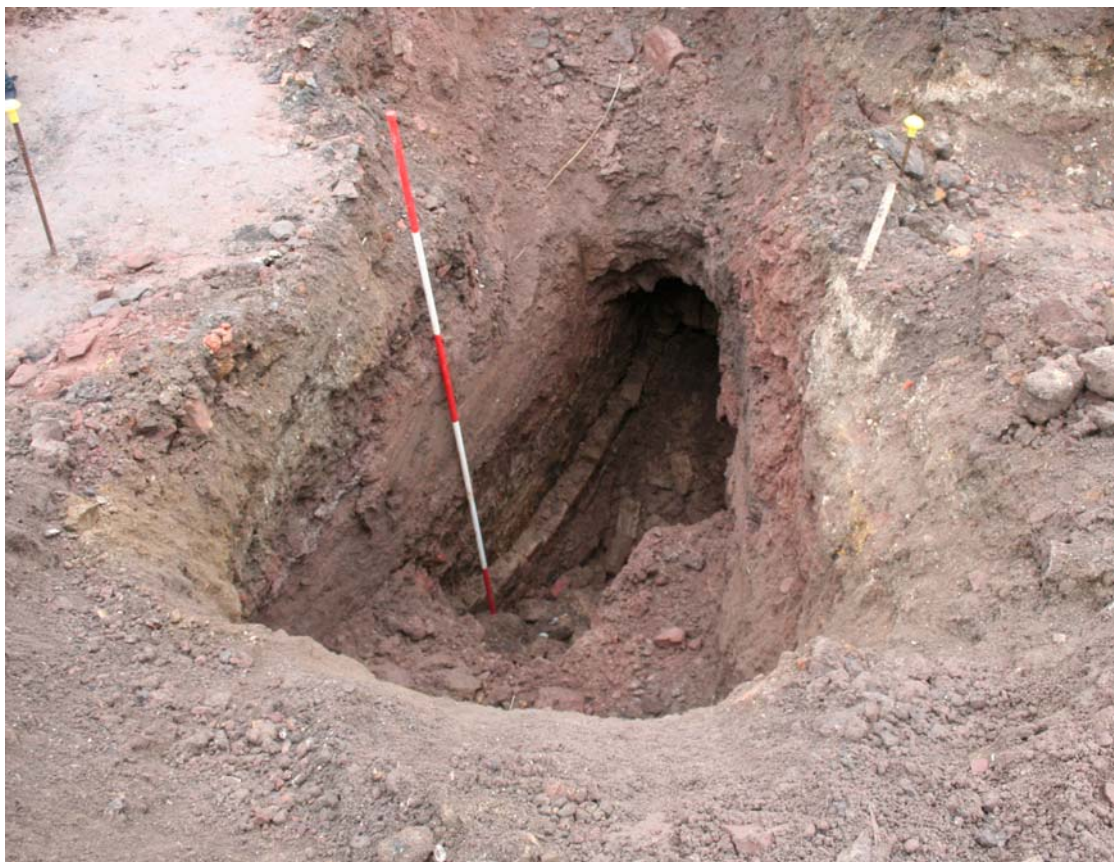
Plate 21: Tunnel 3, **173**, partially exposed within sink hole

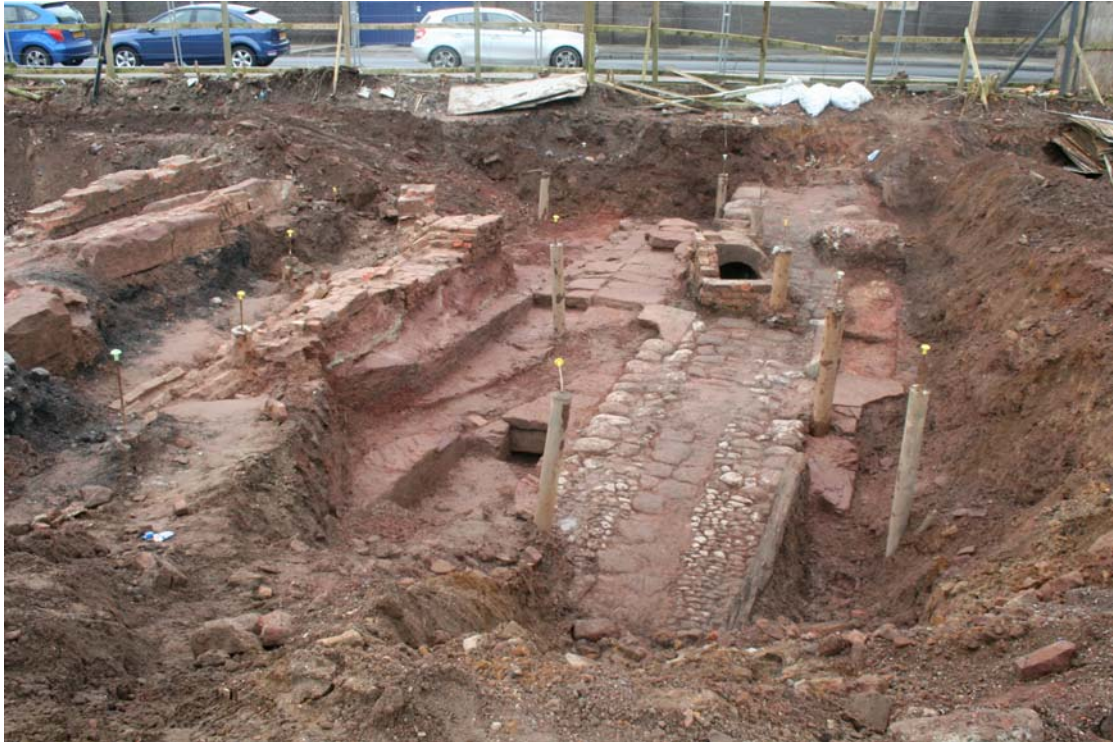
Plate 22: West-facing view across Trench 2A showing Tunnel 3, **173**, roadway **178** and paved area (over tunnel) **168**

- 4.4.2 Further to this discovery, and in consultation with the architect and site engineer, it was decided that a further phase of investigation was needed to ensure that no other piles 'failed' within this area as a result of direct or indirect impact upon Tunnel 3 or other associated subterranean structures. As a result a large area (Trench 2A), measuring 11.7m by 8.80m, was opened to the north of Trench 1A within Area A, exposing further sections of Tunnel 3 and a well-constructed sandstone and cobblestone roadway (Plate 22).

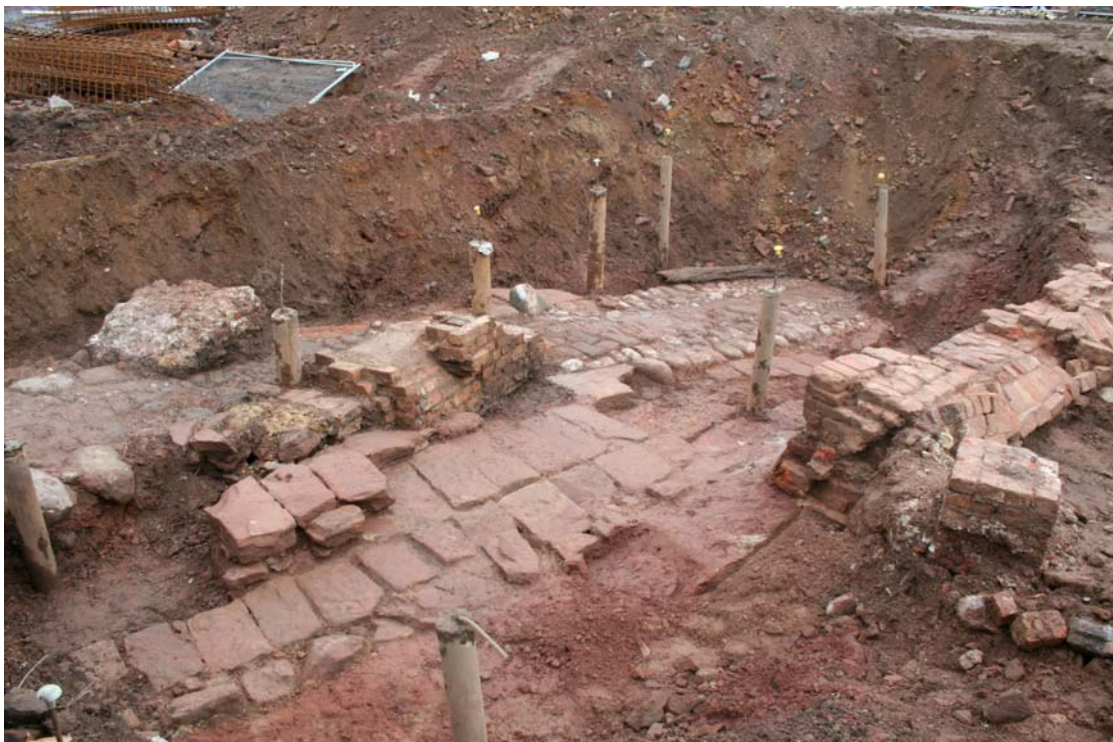
Plate 23: Pink sandstone paved surface **168**, over Tunnel 3, **173**, at the south-western limit of Trench 2A

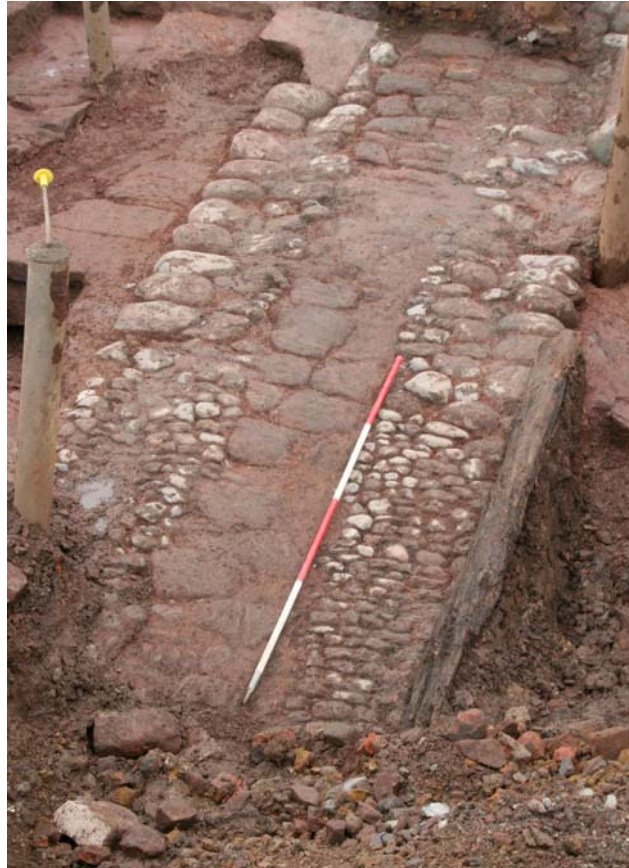
Plate 24: West-facing view across Trench 2A showing cobbled roadway, **178** and timber, **162** (to bottom right of road)

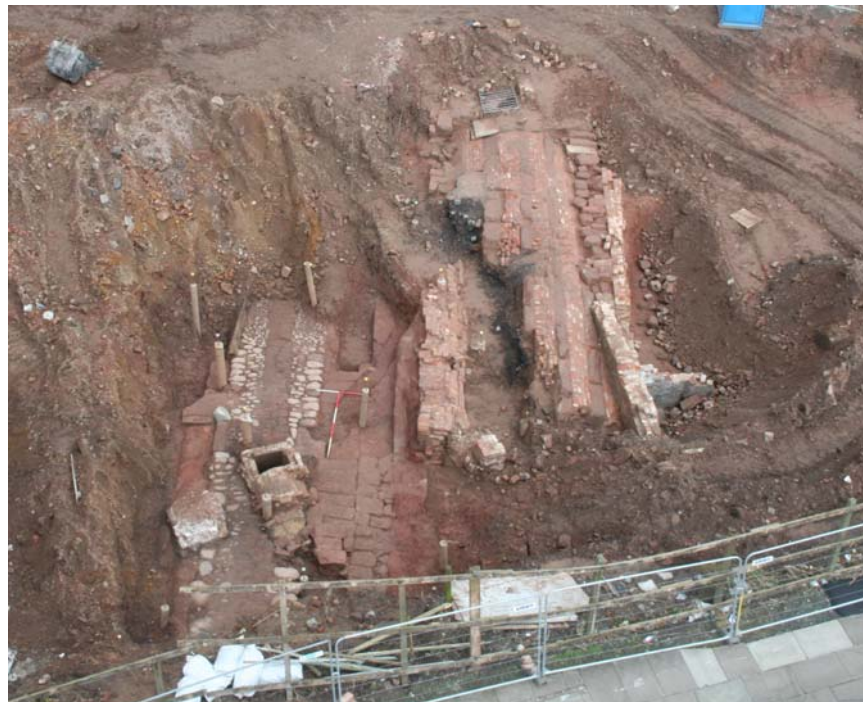
Plate 25: Aerial view showing Area A; Trenches 1A and 2A with Tunnel 1, **125**, and **145**, Tunnel 3, **173**, and the cobbled roadway, **178**

- 4.4.8 During the excavation of Tunnel 3, **173**, further brickwork and sandstone remains associated with the composite-style barrel-vaulted arch of Tunnel 1, **125**, were revealed. This section of Tunnel 1, **145** (centre of Plate 25), was in a far greater state of collapse than the sections previously identified (Plates 8-12). The brickwork was still partially bonded and orientated indicating its relation to Tunnel 1 **125**, however, the majority of the sandstone was missing or not *in situ*. This additional section suggests that the original span of Tunnel 1 would have been in excess of 4m.
