# **CORPORATION STABLE YARD,**

**SMITHDOWN  
LANE,  
LIVERPOOL**

## **Archaeological Watching Brief and Excavation Report**

**September 2012**

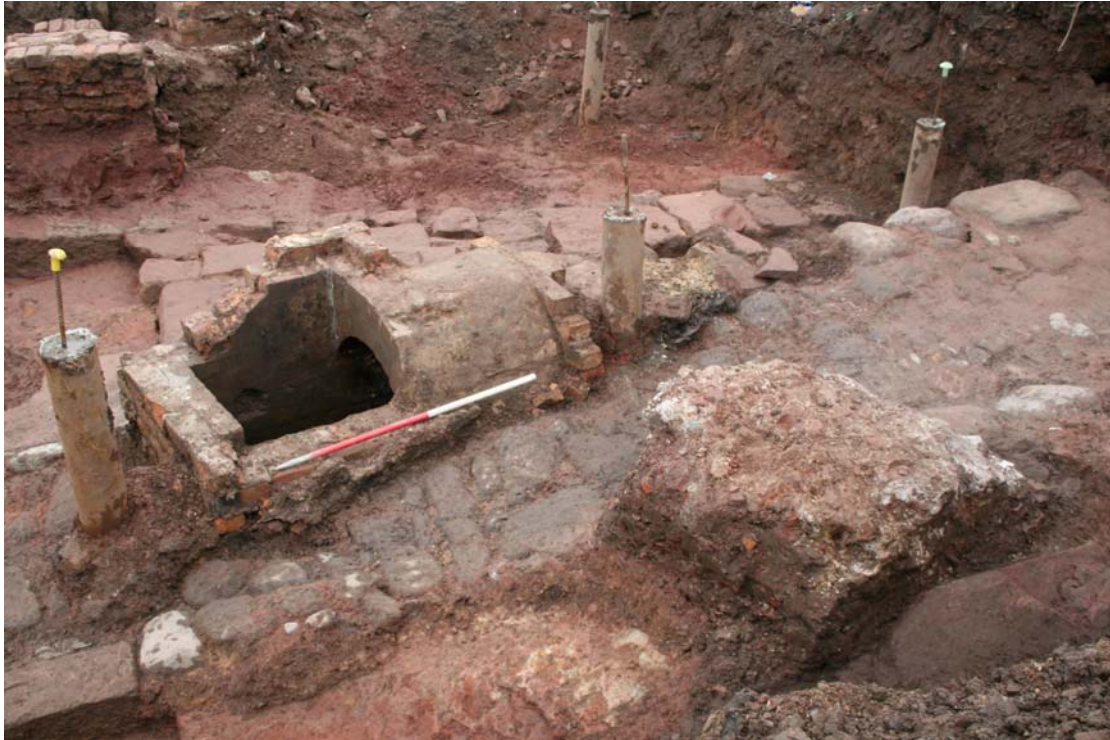
Plate 26: Red brick box culvert, **171**, cutting through roadway, **178**

- 4.4.9 The cobbled roadway **178** and Tunnel 3, **173**, had both been damaged by the later installation of a subterranean drainage channel **169** and associated brick box culvert **171** (Plate 26). The subterranean drain cuts across both the road and the tunnel on a north-west/south-east orientation, and it also cuts through the collapsed remains of Tunnel 1 **125** within Trench 1A. Areas of patched repair including clinker bedding, **127**, and concrete surface **126** are evident between sections of Tunnel 1, **145** and **125** (Fig 13). Drainage channel **169** meets the base of culvert **171**, which was probably connected to the stableyard buildings at the modern ground level by a vertical pipe which is no longer *in situ*.

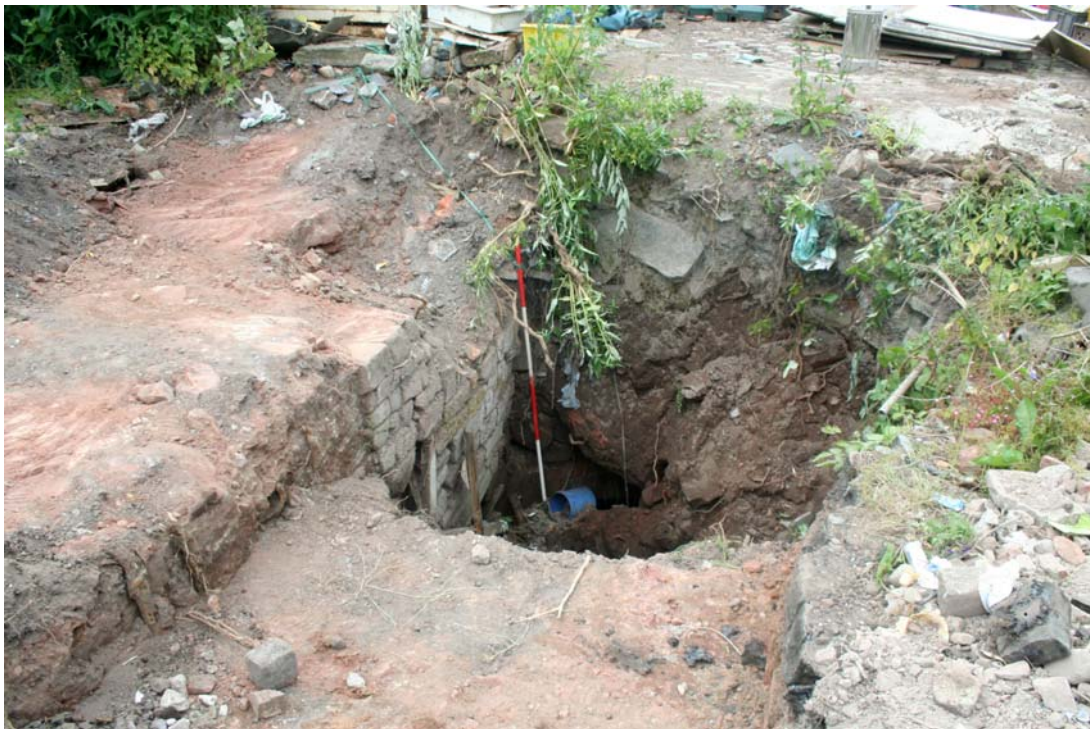
Plate 27: South-facing view across bedrock **302** and Tunnel 4, **300**

below the present ground level at the northern limit of Area B (Plate 27). This corresponds with the images of quarry terracing shown in the watercolour prints of c 1837 produced by local artist, William Gawin Herdman (Plates 4 and 5), and also gives an indication of the nature of the levels for the upper terraces of bedrock. A vertical shaft, known to be Tunnel 4, **300**, was observed within the centre of the area although upon inspection there was no obvious sign of any brick vaulting.

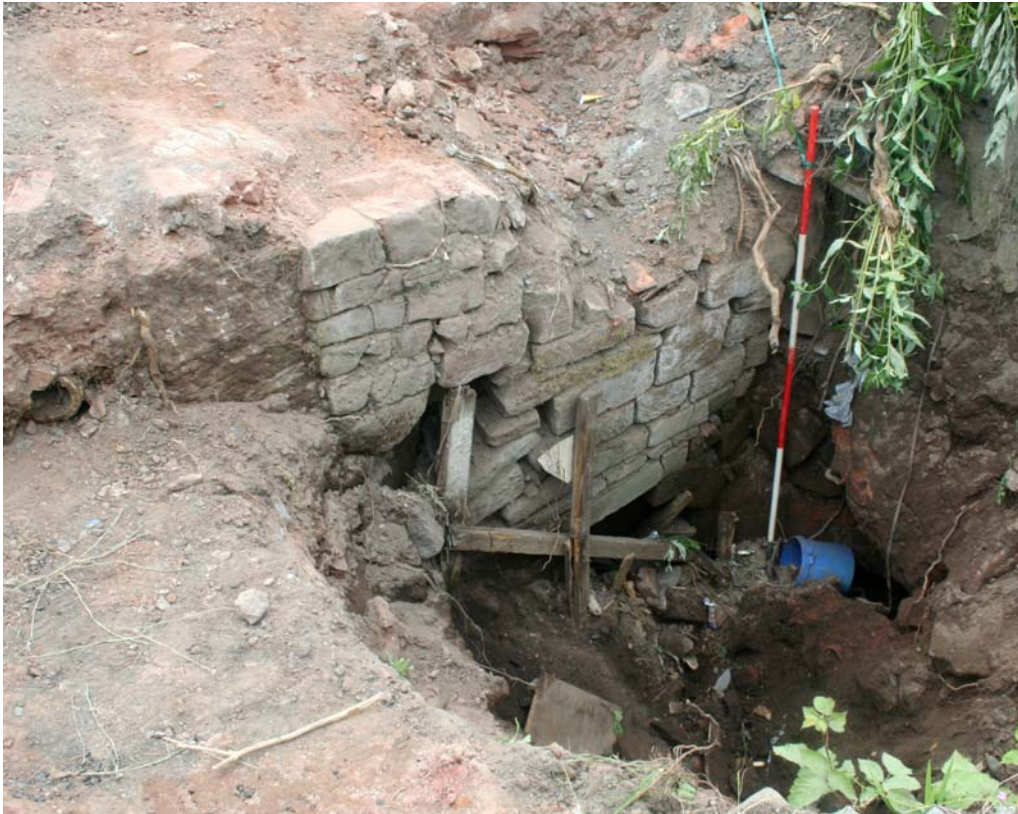
Plate 28: Interface between terraced bedrock **302** and sandstone retaining wall, **301**

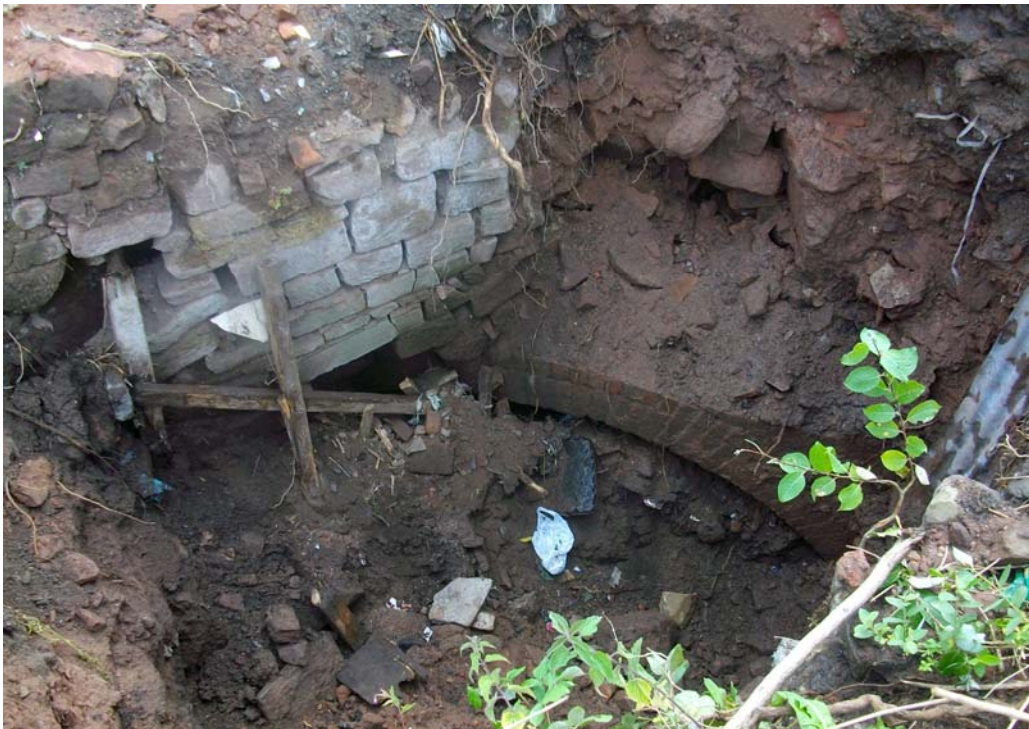
Plate 29: Area B showing interface between sandstone retaining wall **301** and brick vaulted Tunnel 4 **300**

- 4.5.5 Located beneath wall **301**, was a well-constructed and intact brick arch (Plate 29), **300**, which is apparently all that remains of the roof of Tunnel 4 within Area B. However, a small number of bricks were observed springing from the edge of the bedrock, which were displaced during the process of mechanical excavation to clear the area of debris. The vaulted arch of Tunnel 4 was constructed of handmade red brick with a sandy lime mortar bond. In cross-section, the tunnel roof was clearly visible as being only two courses thick with bricks arranged in a ratio of one course of headers to one course of sailors (with the sailor course forming the intrados of the arch). The impression of a flat arch was given by the construction of a level brick platform, extending across the roof of the tunnel and abutting the north-facing bedrock outcrop on the southern side of Area B. This levelling platform was constructed of seven courses of handmade bricks set in a stretcher bond formation. No measurements or further observations could be made due to a lack of access to the base of the trench.

- 4.5.6 The undamaged cross-section of Tunnel 4 (Plate 29) and the survival of the arch beneath the dry stone retaining wall **301**, supports the idea that Williamson constructed a number of his tunnels in sections, rather than as continuous brick structures. Sectional construction has been observed elsewhere within the tunnel network and it is likely that this method was also used here. There is no evidence of fracturing or broken brick work against the visible cross-section, which would indicate the presence of the now missing section of the tunnels' vaulted roof. This also suggests that it is likely that only one section has collapsed and further sections may also survive to the north-west, as well as the known section surviving to the south-east.

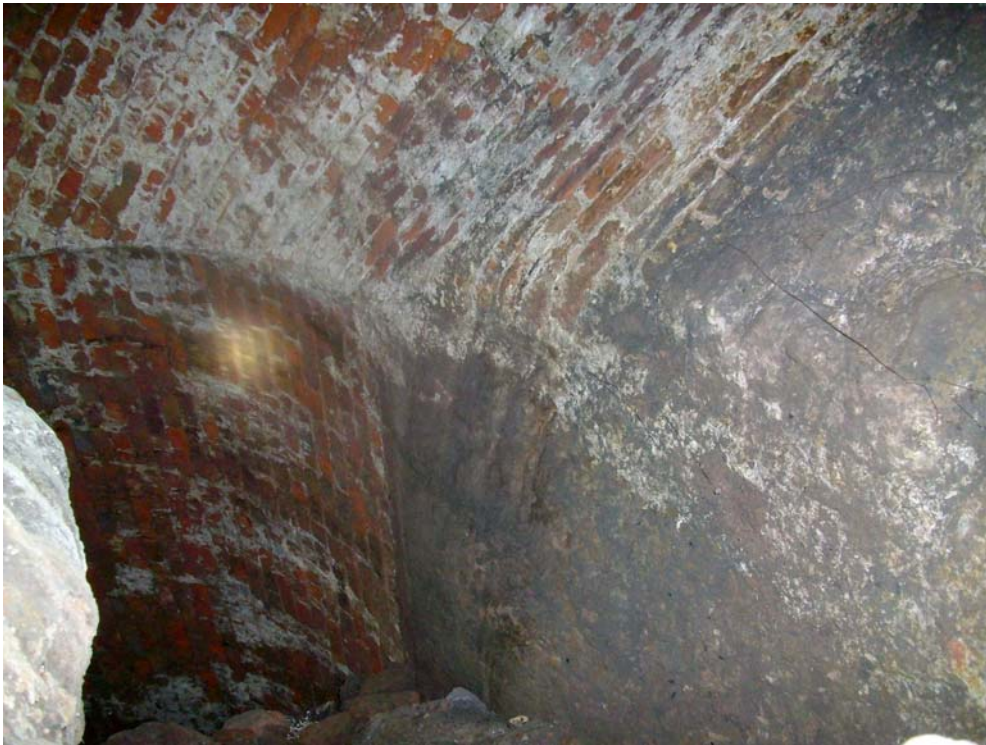
Plate 30: Interior view of vaulted Tunnel 4, **300**, accessed via the Triple Decker section of Tunnel network

- 4.5.8 The interior view of Tunnel 4 (Plate 30) indicates a more complex vaulted connection than had previously been observed during the course of the excavation, although it is arguably not dissimilar to elements of brickwork leading into the larger chamber known as 'the banqueting hall' which is located on the 'house site' on Mason Street. The limited available access and the lack of a clear vantage point, partially caused by fill **304**, meant that only a reduced view was visible; however the photographs would suggest a structure that was not dissimilar to an open-sided cloister vault, with the western side (?) being the open-sided component of the structure, leading off into a new tunnel.

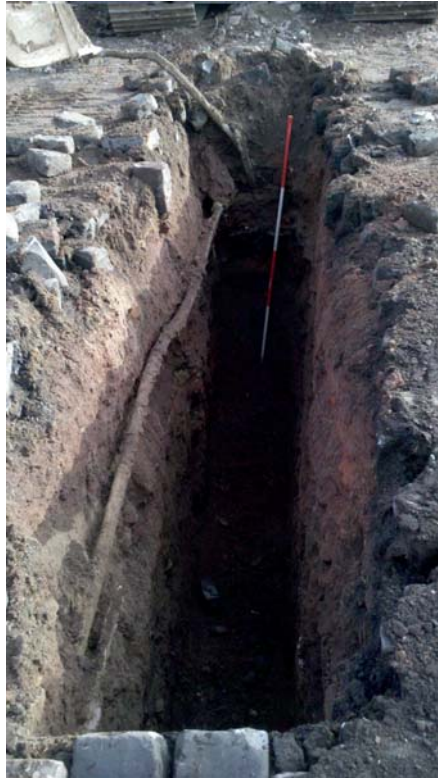
Plate 31: Area C Crane Trench 1C showing levelling deposits

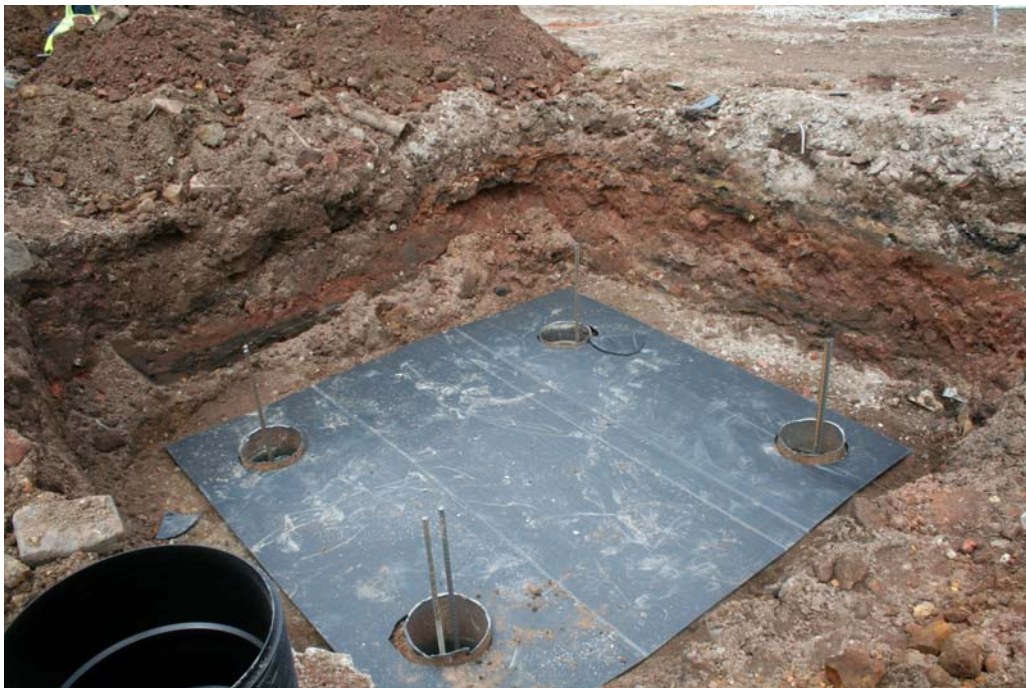
Plate 33: Area C, Crane Trench 3C showing levelling deposits in section

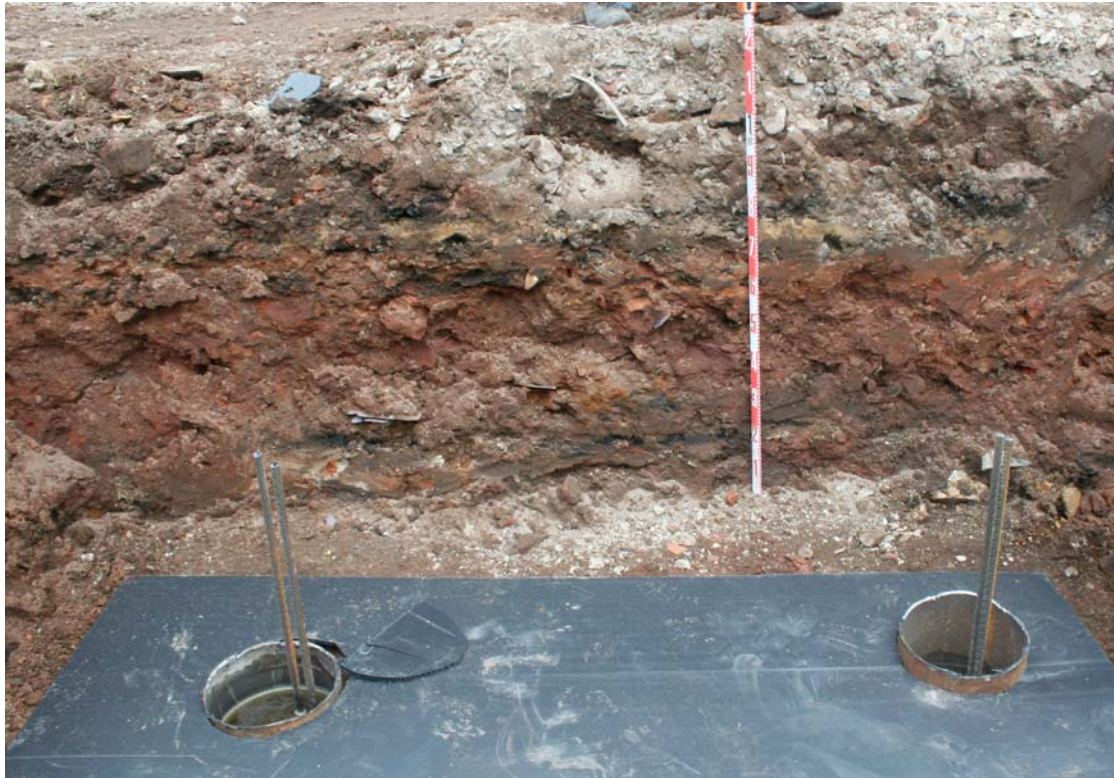
Plate 34: Area C Crane Trench 4C showing levelling deposits in section

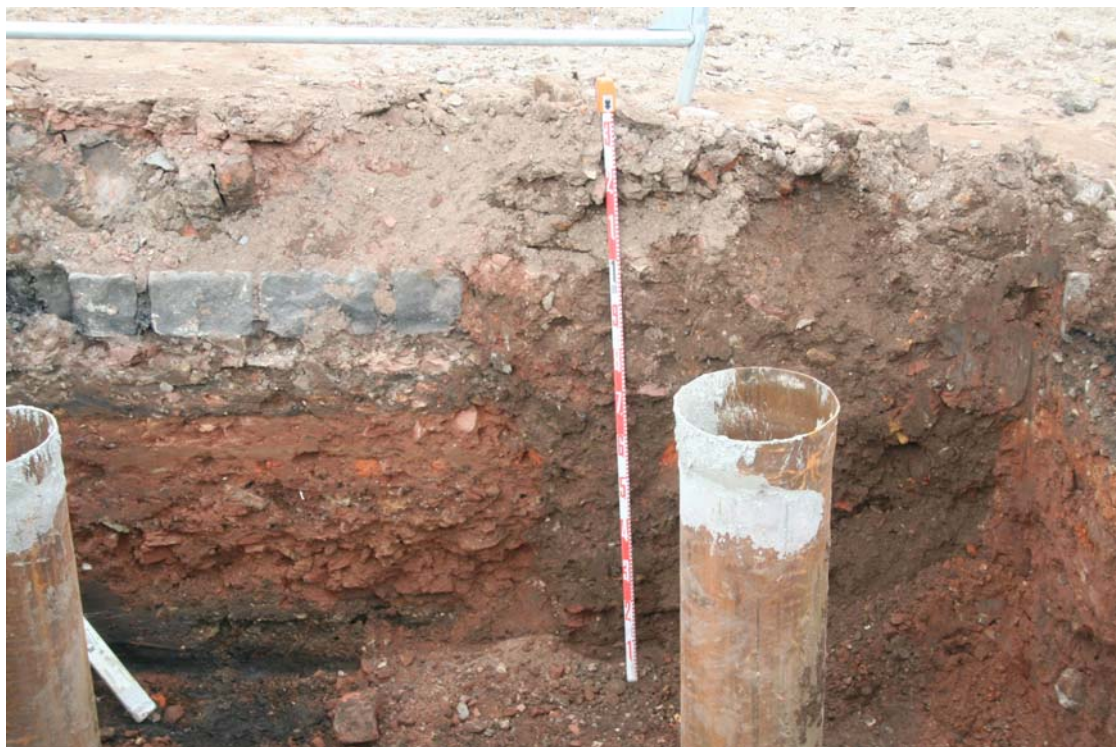
Plate 35: Area C Crane Trench 5C showing levelling deposits in section

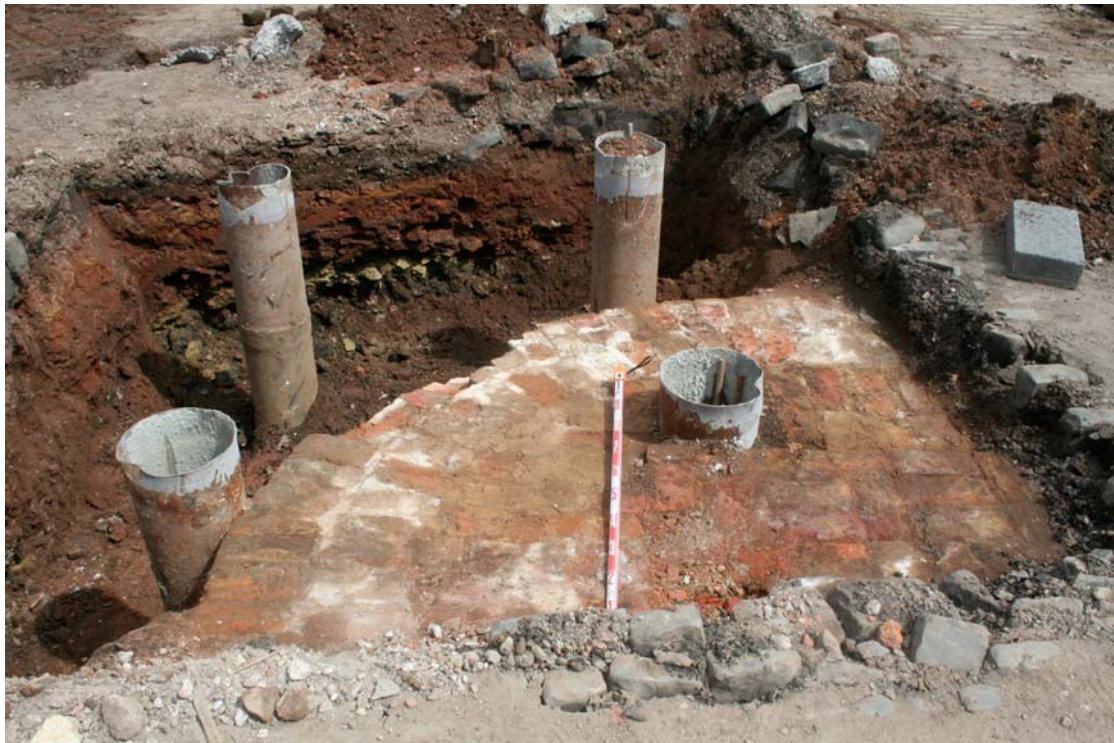
Plate 36: Area C Trench 6C showing circular brick platform **423**
