Cumbria College of Art and Design

Carlisle, Cumbria

Archaeological Watching Brief

Oxford Archaeology North

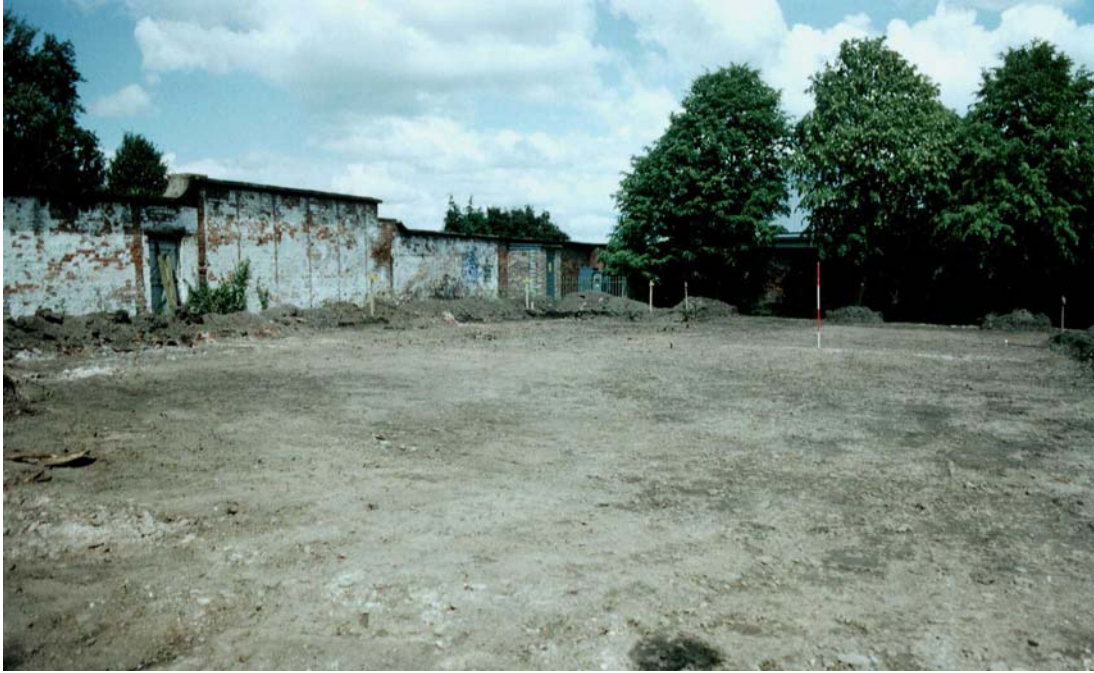
Plate 1: View of walled garden following topsoil stripping, looking north-west

- 3.1.1 The topsoil removed consisted of c0.30m of very dark grey, fine sandy silt, which had been heavily disturbed by root action; it was equivalent to overburden **16** identified in the evaluation (LUAU 2000b). The topsoil was found across the entire area of the walled garden, which is c40m x 43m in extent (see Fig 2). There was a slight increase in the thickness of the topsoil towards the south-west corner, which became more obvious in the course of the excavation of the drainage trenches. Several features became visible following excavation of the topsoil.

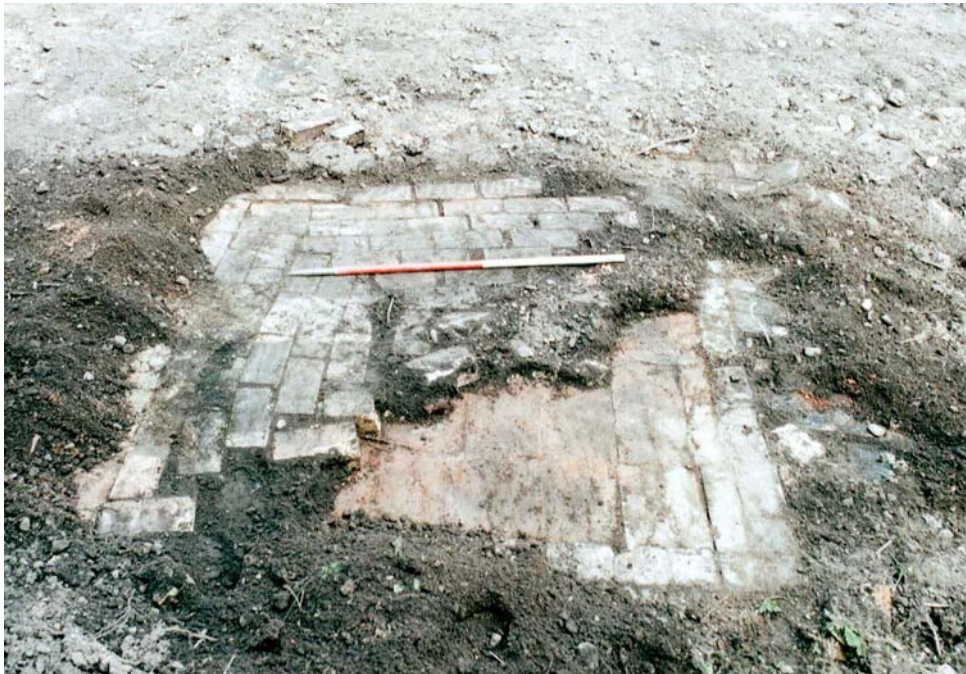
Plate 2: Feature B, sandstone and brick foundation, looking east

- 3.1.3 **Feature B:** to the south-west, c15m from the north-west wall, a brick and sandstone structure was uncovered (Fig 2); it consisted of one course of mid-yellowish bricks (each 0.23 x 0.11 x 0.08m) overlying a course of red sandstone blocks. The stone structure was not fully uncovered, since it was to be preserved *in situ*, but it extended over an area of at least 1.8m x 1.6m. The bricks were unfrogged and laid in rows aligned north-east/south-west, meeting rows aligned north-west/south-east. The regular sandstone blocks had been carefully dressed and varied in size (0.45 x 0.22m, 0.45 x 0.10m, or 0.30 x 0.22m); because of the limited depth of the excavation it was not established if there were further courses of sandstone beneath, or how deep the blocks were. There were two distinct foundation cuts, to the north-west and south-east of the structure, which were aligned north-east/south-west and abutted Feature C (Fig 2); the extent of the foundation cuts was 6.4m long by 2.8m wide. It is not certain what the function of the feature was, but it may have served as a garden feature such as the foundation for a small gazebo. Surrounding the structure was a mixture of brown, silty subsoil and pinkish mortary sand, which was clearly disturbed and had seemingly been infilled.
