AUGILL SMELT MILL

Cumbria

Archaeological Building Investigation

Document Type: Fabric Survey Report

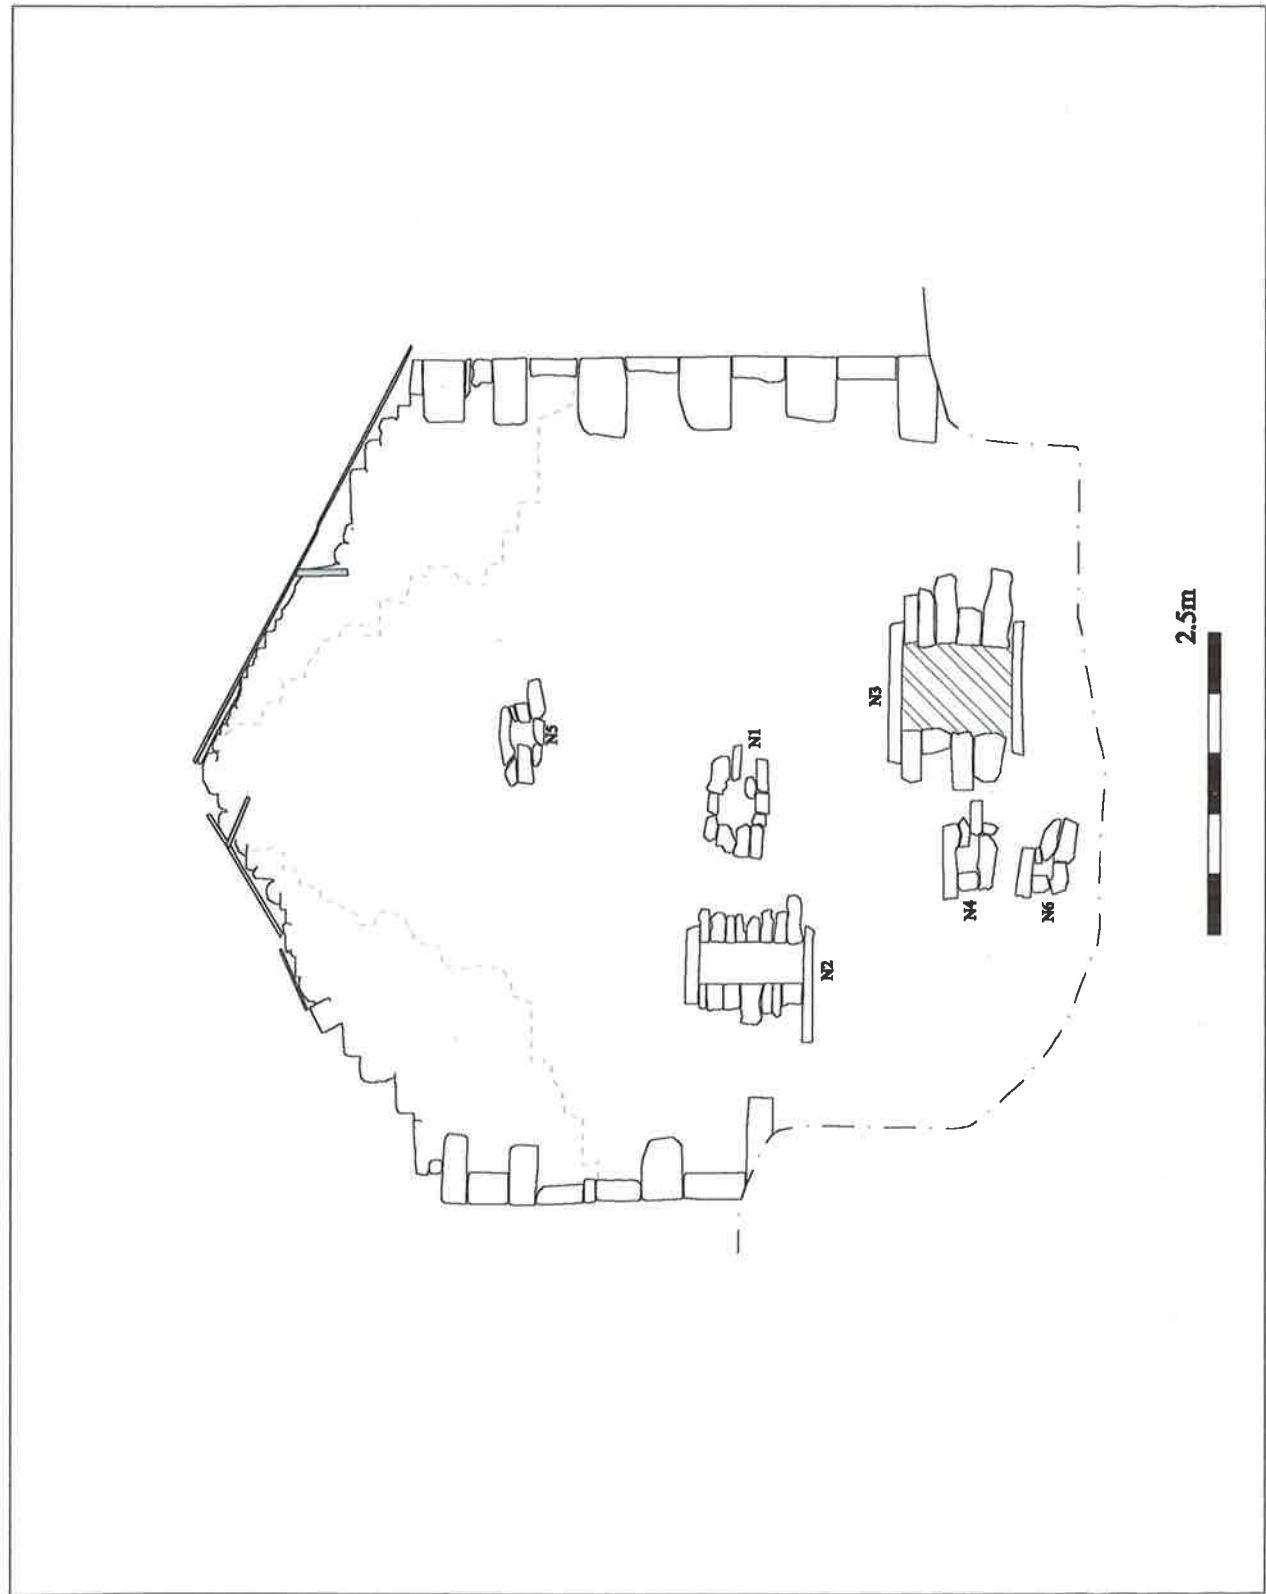
Figure 7: North External Elevation

4.2.1 *North external elevation of the mill (Fig 7):* the north external elevation forms the gable end of the building (Plate 3). The stonework is roughly rock faced, with large dressed quoins. The wall top is capped with large coping stones, which are selectively secured by two iron brackets. The base of the wall forms the southern face of the wheel pit and is c2m lower than the other elevations. Near the base of the elevation, and slightly west of the centre, is a square aperture (N3) with a stone lintel, blocked with loose sub-angular and rounded stone. Above this, and nearer to the centre, is a small hole broken into the wall (N1), which would appear to have been the support for the wheel's axle shaft; it is c0.3m high by c0.25m wide. There is a further small, narrow aperture (N2) to the east of this with a stone lintel and over-long sill. There is also a series of small putlog hole apertures set into the northern face of the wall. Near the base, and within the wheel pit, are two apertures, both to the west of aperture N3, and set vertically above; each has been deliberately constructed with an overset lintel, their internal sizes being 0.21m x 0.19m for recess N4, and 0.12m x 0.16m for recess N6. They appear to be set only into the northern face of the wall, but, as the southern face is buried above the upper level of aperture N4, it was not possible to confirm this. A further recess (N5) was set into the upper, central part of the elevation. This again had a deliberately set lintel and was 0.18m x 0.18m in size. This recess did not extend through to the southern face and had been blocked with a single unmortared stone. It would appear to be a further putlog hole.

- 4.2.2 There are also several minor subsidence cracks and some damage to the wall top. The upper courses of the elevation have a greater proportion of limestone, and the central core has a thicker, white mortar, not present around the tops of the gable; this suggests that the wall top is of a separate build.

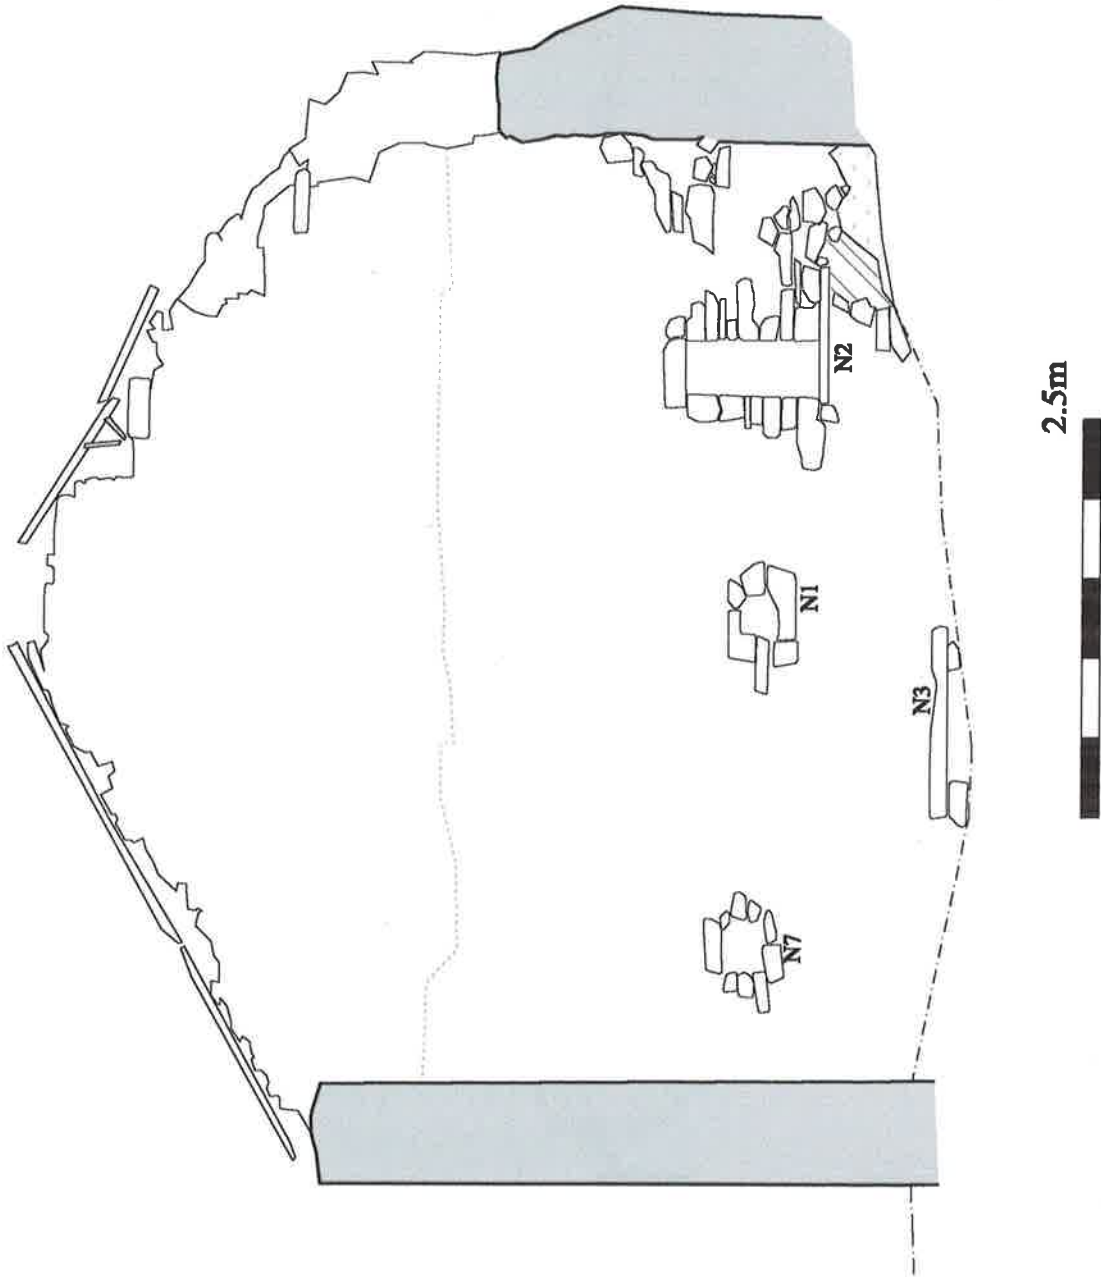
Figure 10: Room 1: North Internal Elevation

- 4.3.2 **Room 1, north internal elevation (Fig 10):** this forms the northern gable, and was constructed of sandstone in the lower part, but rebuilt in limestone toward the wall top, which was finished with large slate coping (Plate 8). There is a single narrow aperture on the east side (N2), with an over-long stone sill. Immediately east of this, and partially below it, is a rough, broken-out area, which has been almost entirely filled with loose stone. There is a small hole in the centre of the wall (N1) and another on the west side (N7), broken into the wall approximately 1.1m from the present ground surface. The central hole (N1) corresponds to that exposed on the external face of the wall, and was undoubtedly the axle support for the wheel. The top of a small aperture (N3) is visible in the centre at present ground level, but only the stone lintel and the top 0.2m of the opening are exposed. This corresponds to the blocked aperture on the northern face of the elevation, and its buried nature suggests that the internal ground level against the north wall was formerly substantially lower.
