A58 Blackbrook Diversion, St Helens Merseyside

Archaeological Excavation Interim Report

Oxford Archaeology North

April 2006

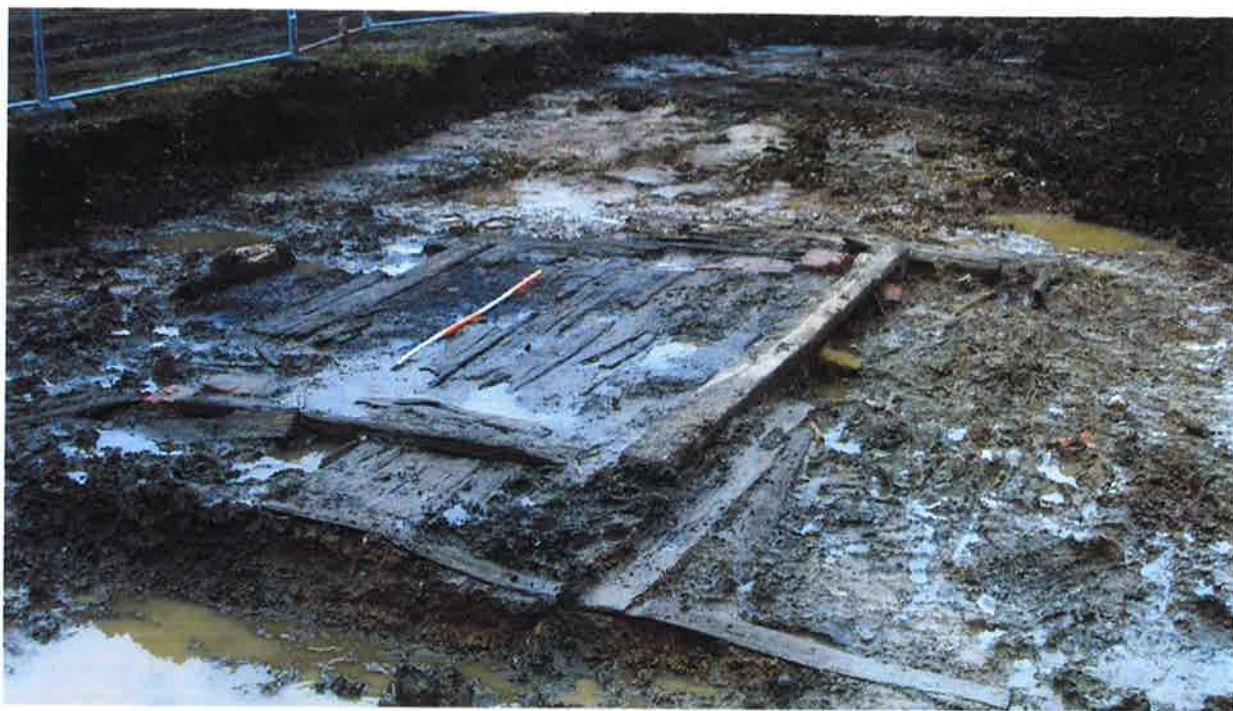
Plate 1: View of wooden platform in Trench A, looking north

- 4.2.3 The timber platform (Plate 1) was aligned north-east/south-west and was within the northern part of the trench, located within a natural hollow, and was directly above the natural clay. It measured almost 6m² and was formed by six rows of treated pine planks laid horizontally, each averaging 1.6m x 0.3m x 0.2m; these were edged by substantially thicker timbers (0.38m width) of varying lengths. The central area of the platform sealed a 0.30m thick deposit of clinker that formed an interface between the wood and the natural clay; it also functioned as a levelling layer supporting the platform. A similar deposit of clinker was observed along the structures north-western edge and measured 0.7m wide, separating the platform from a further line of timbers. Several timbers and poles around the outside of the platforms gave the impression of a collapsed building; in particular there was a 2.5m long pole attached to the northern edge, and thinner tapered planks were detached around the eastern side. Several areas of the platform contained patches of brick insets that appeared to have been laid within gaps in the wood to replace missing planks thus creating surfaces. The bricks were handmade and bonded with a grey ashy mortar. A small number of the bricks were seemingly replaced by

wooden blocks of identical brick dimension, although the reason that bricks were not used is uncertain. Two small, timber-lined, 'boxes', each measuring 0.35m by 0.20m, were observed behind the northern and southern timber border, sunk to a depth of 0.25m below the level of the platform. These 'boxes' possibly housed timber uprights, although a precise function was unclear. Several iron objects were observed protruding from the outside of the platform that were seemingly part of an integral construction element, although this could not be fully determined.

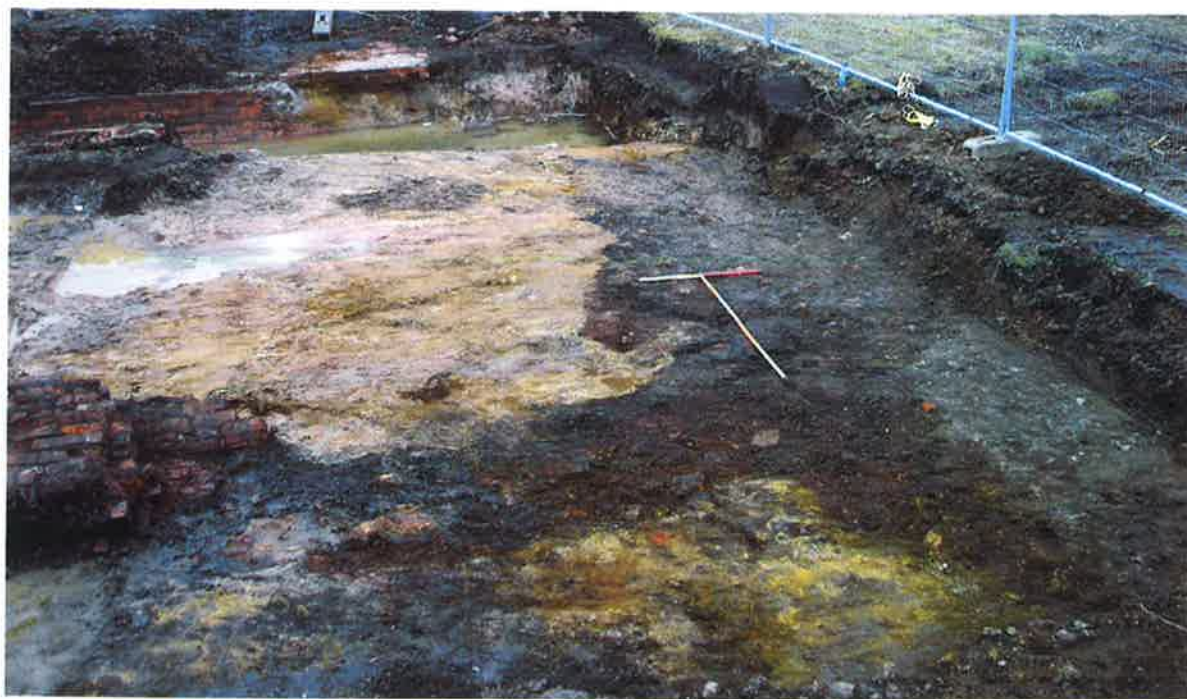
Plate 2: Remains of the Garwood-Pewsfall Incline extension in Trench B

- 4.3.2 Across the central part of the trench, at a depth of 0.45m below the turf, was a yellow-red silty-clay natural deposit which contained frequent sand patches. The clay was cut along the western edge of the trench by the remains of the incline, which comprised crushed brick, sandstone and clinker spread over a distance of 5m by 2m and was observed extending beyond the east-and south-facing section.

- 4.3.3 The incline in turn was truncated by the culvert which was installed at a similar time as the capping of the mine shaft, suggesting the culvert was operational after the mine was abandoned. A line of tumbled bricks, along the northern edge of the culvert, was possibly a disturbed, collapsed wall associated with a colliery outbuilding.

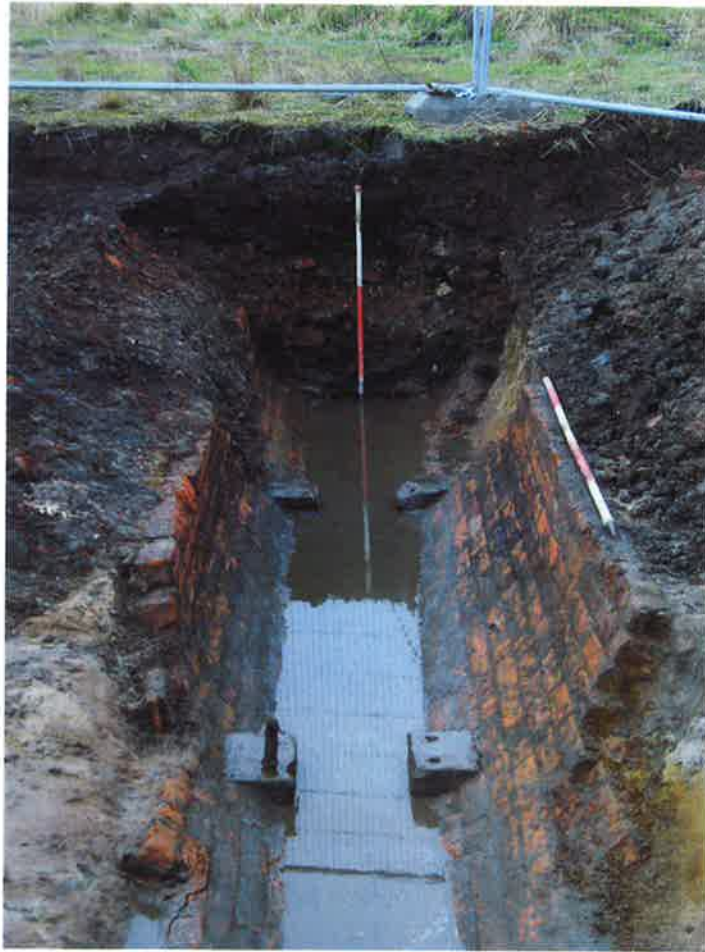
Plate 3: Culvert in Trench B

- 4.3.1 Trench B was located to the immediate north of a disused concrete capped mine shaft, and was aligned north/south. The trench was initially 5m x 10m in size, but was then expanded to 10m x 10m in accordance with the requirements of the Merseyside Archaeologist; it was excavated to a maximum depth of 0.45m. The trench was characterised by extant sub-surface remains associated with the late eighteenth century constructed Stanley Bank Incline, observed running north-east/south-west across the western edge of the trench (Plate 2). Other archaeological remains included a collapsed wall, a floor surface and a brick column that collectively represented part of a structure pertaining to a large, late nineteenth century building. Later archaeological intervention comprised an east/west aligned circular culvert (Plate 3) which crossed the southern edge of the trench bordering a disused mine shaft. The culvert was seemingly intended for drawing water away from the shaft during coal mining activity.

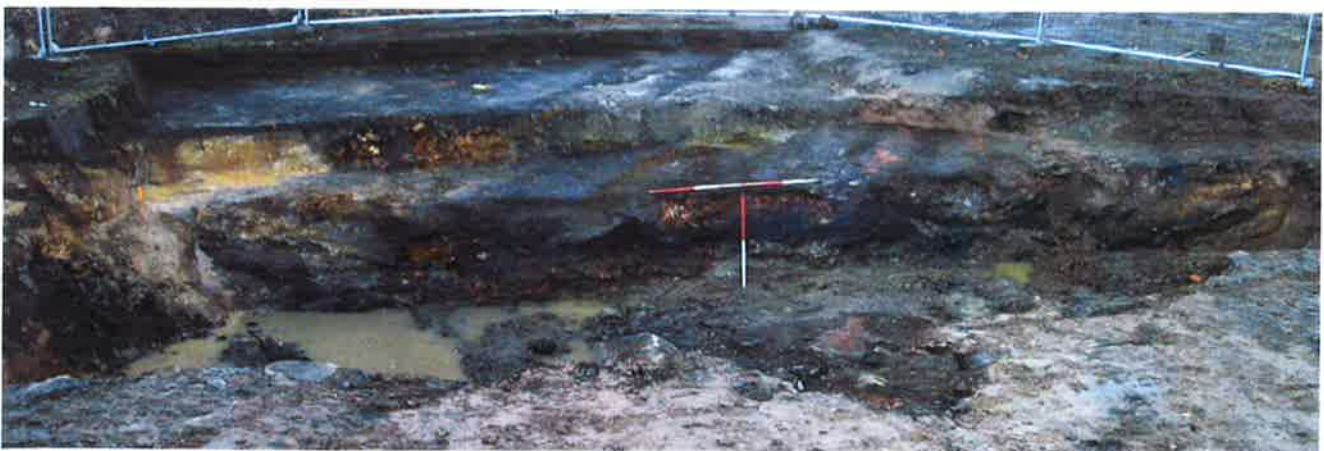
Plate 4: View of the cutting associated with the Garwood-Pewsfall Incline extension, looking south-west

- 4.5.2 It would appear that the ditch, and its subsequent back filling, represented two clearly defined phases of the incline. The initial phase comprised the excavation of a 10m wide ditch (Plate 4) cut into natural clay, that followed a north/south alignment resembling a cutting. The ditch had steep angled sides that bottomed onto a flat base, and was observed at an overall depth of 2.1m below the present turf line. The east edge of the ditch was flanked by a brick-

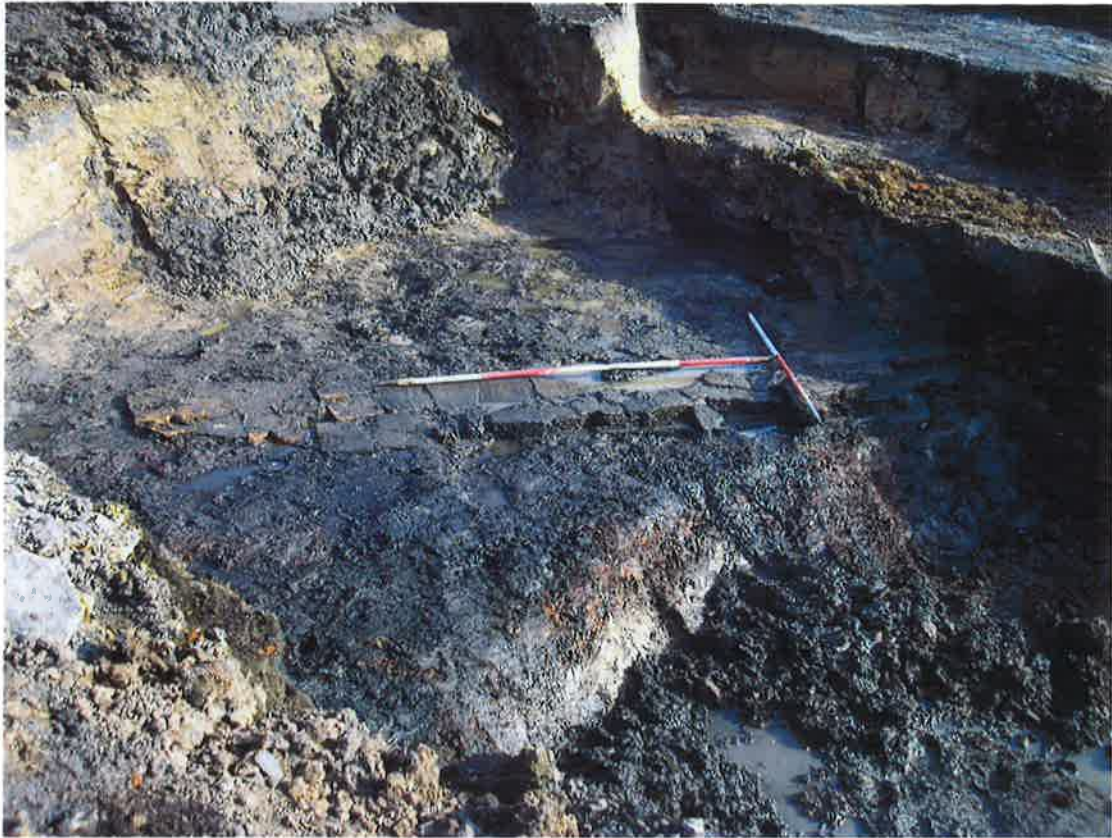
Plate 5: Brick drain within the cutting in Trench D

lined drain (Plate 5), that was probably intended to draw surface water away from the cutting. The drain was sealed by dark-grey silty clay that was possibly a redeposited residue of the original bank base. The width of the ditch, across this part of the incline, was substantially wider than the 6m wide cutting observed within Trench 38 across the Garswood-Pewsfall Incline during the 2004 evaluation. The wider ditch on the Stanley Bank Incline may be the result of a re-cut along the western edge of the ditch allowing for the insertion of a twentieth century land drain, and the engineering demands that were required across a higher area of the landscape.
