A58 BLACKBROOK DIVERSION

St Helens,
Merseyside

**Topographic Survey
and Evaluation.**

Oxford Archaeology North

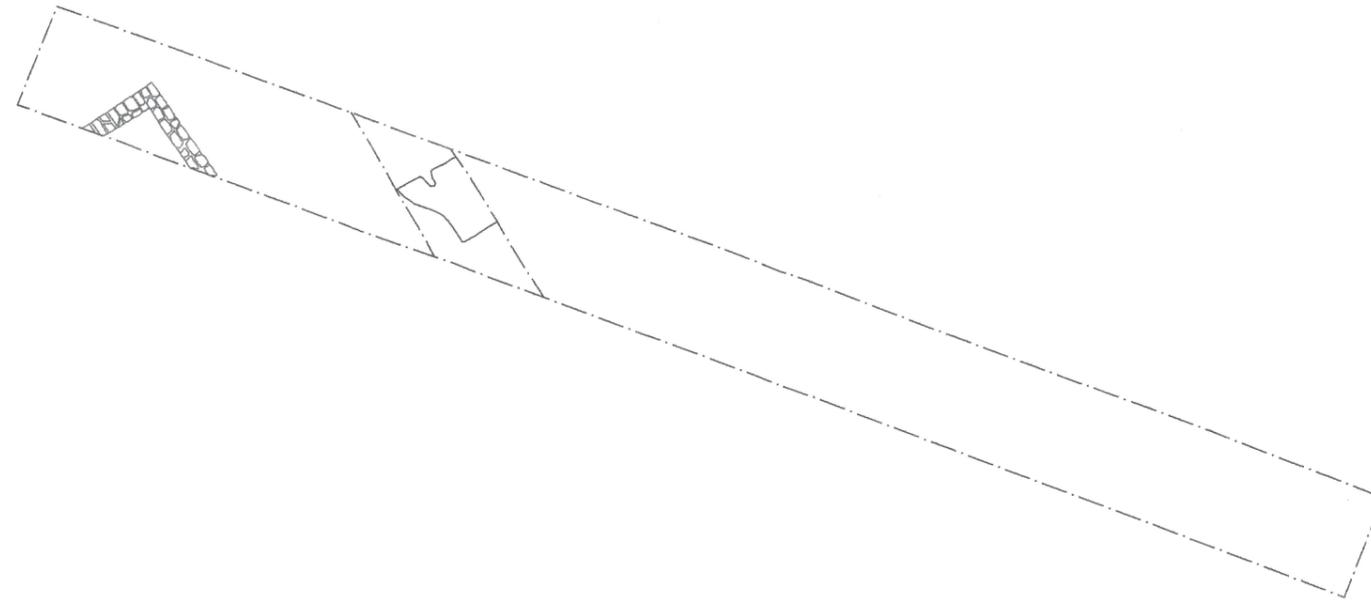
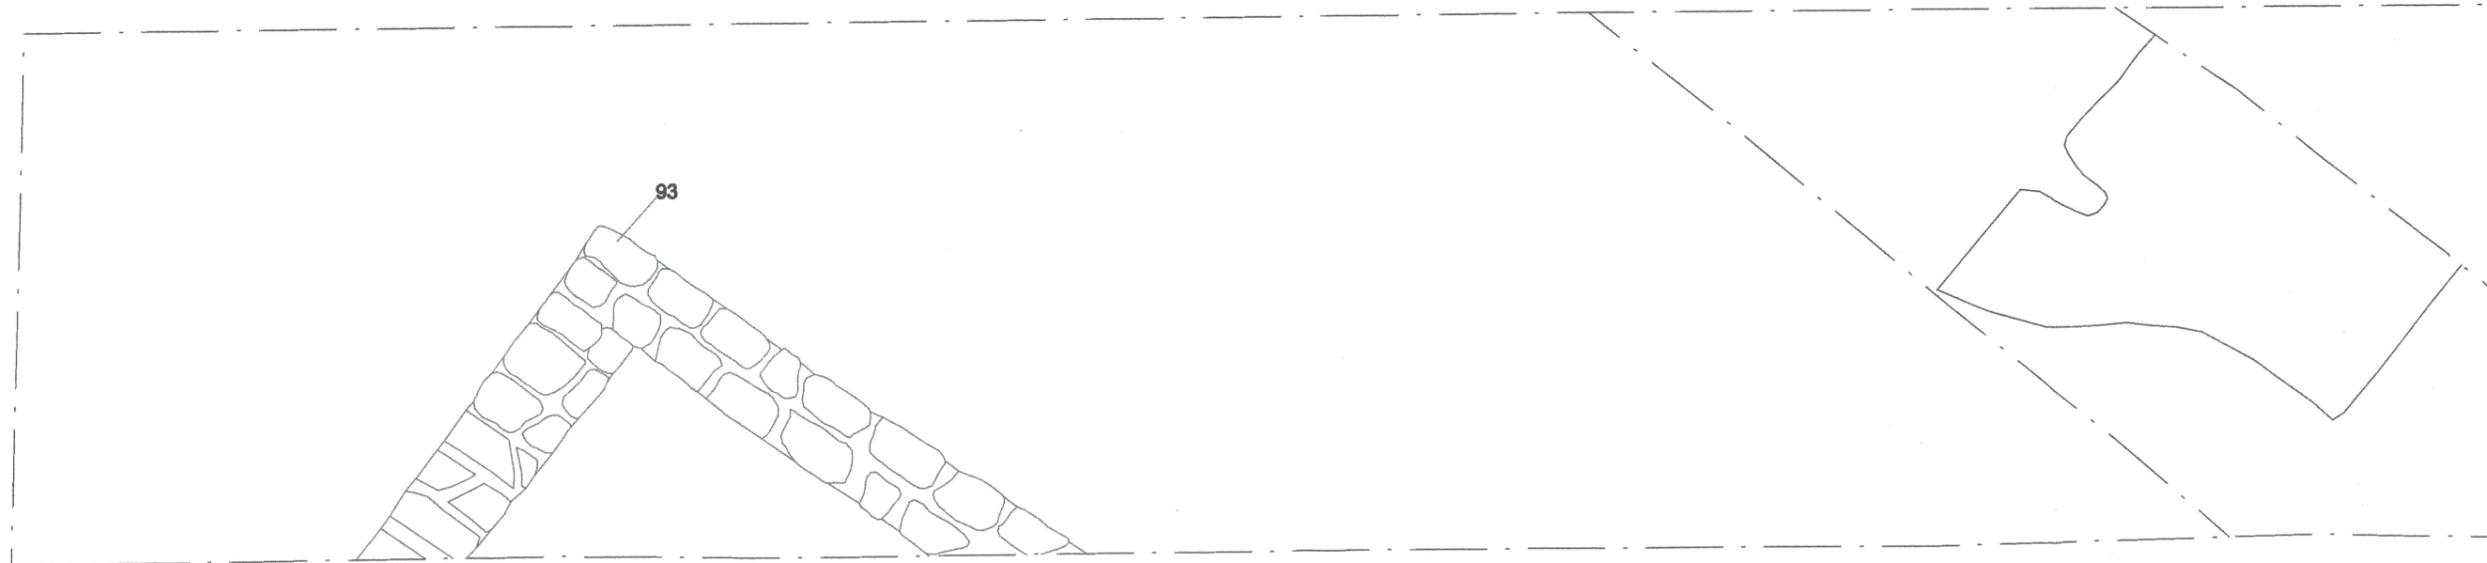
Figure 11: Plan of Trench 33 showing building foundation 93

Detail of features at north-west end of Trench 33

- 5.2.12 **Trench 33 (Figs 6 and 11):** within this trench a brick foundation, **93**, was revealed (Plate 10). The foundation formed a right angle, aligned north-east/south-west and north-west/south-east. It was exposed for a length of 1.65m north-west/south-east and a length of 1.15m north-east/south-west. The foundation was 0.3m wide, only a single course deep and was built out of complete and half bricks of two distinct types (Fig 11). Given that only a corner of this structure was revealed it is somewhat difficult to infer a purpose for it, although the lack of depth of foundations would suggest it was probably not a very substantial structure and may have been for a shed.

| 33 | 20 x 1.8 | west-north-west/east-south-east | Two land drains and a brick foundation, 93 , were the only features revealed within this trench. The foundation formed a right angle, was two courses wide and was built out of both full and half bricks of two distinct types. |

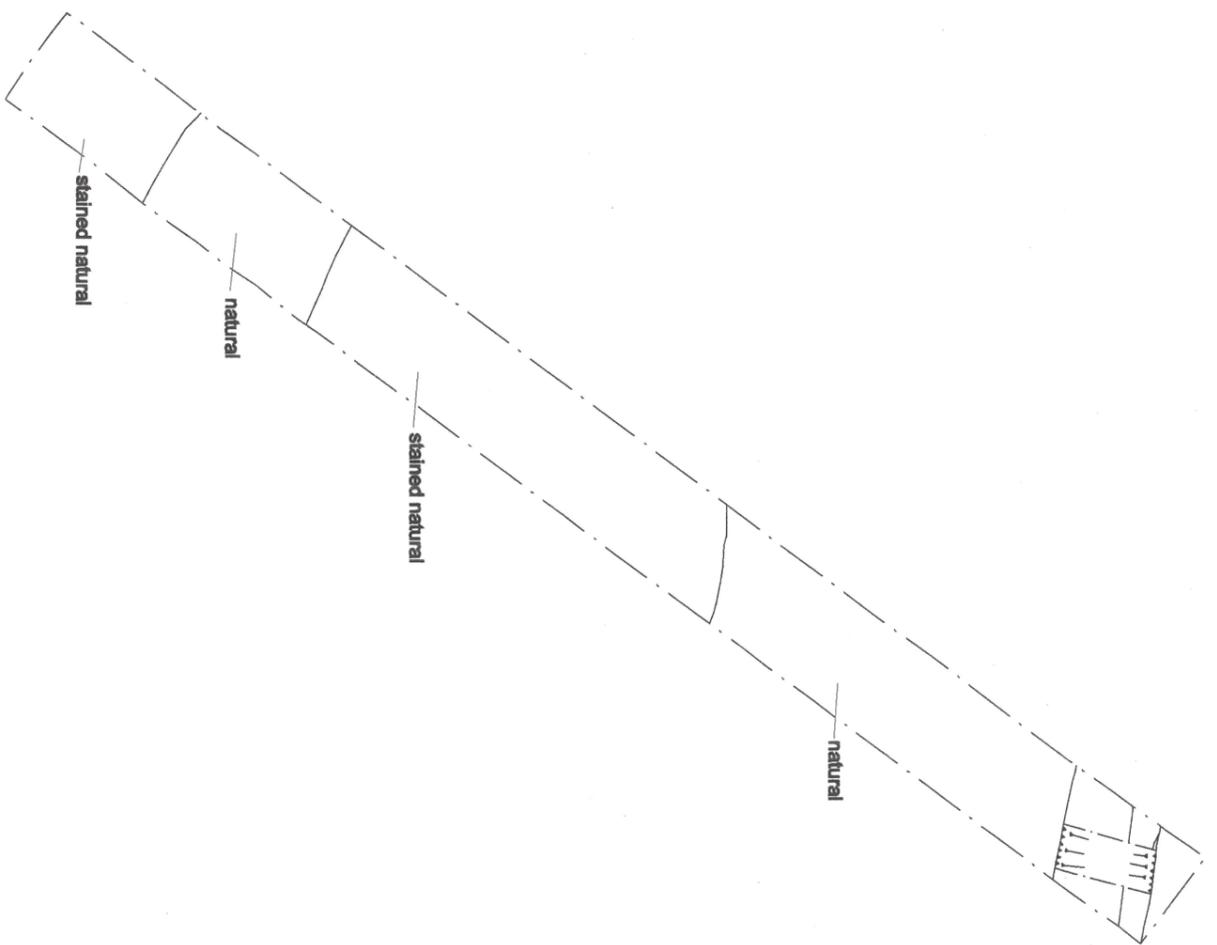
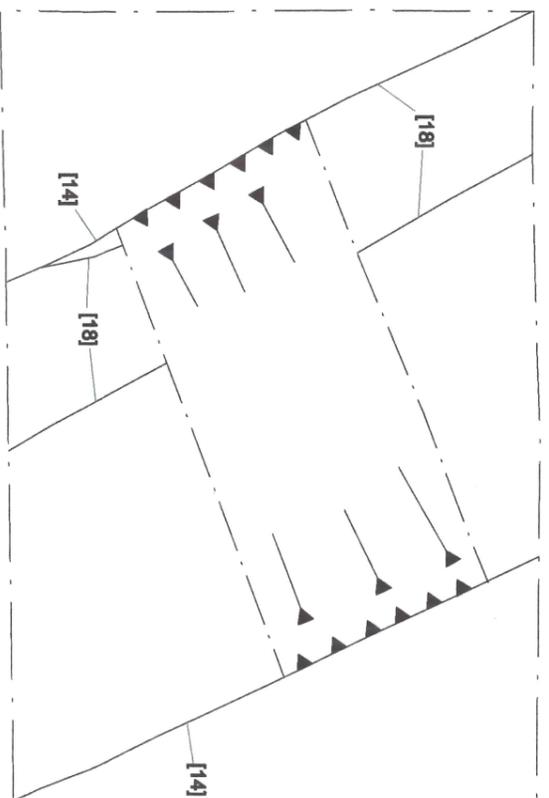
Figure 12: Plan of Trench 8

Detail of features at north-east end of Trench 8

| Trench Number | Size (m) | Alignment | Brief Description |
|---|---|---|---|
| 8 | 20 x 1.8 | north-east/south-west | This trench contained a north-west/south-east aligned ditch (14), itself truncated by a shallow recut (18). No finds were recovered from either of these features, leaving them undated. It seems most likely that ditch 14 represents a field boundary ditch. No further features were observed within this trench. |

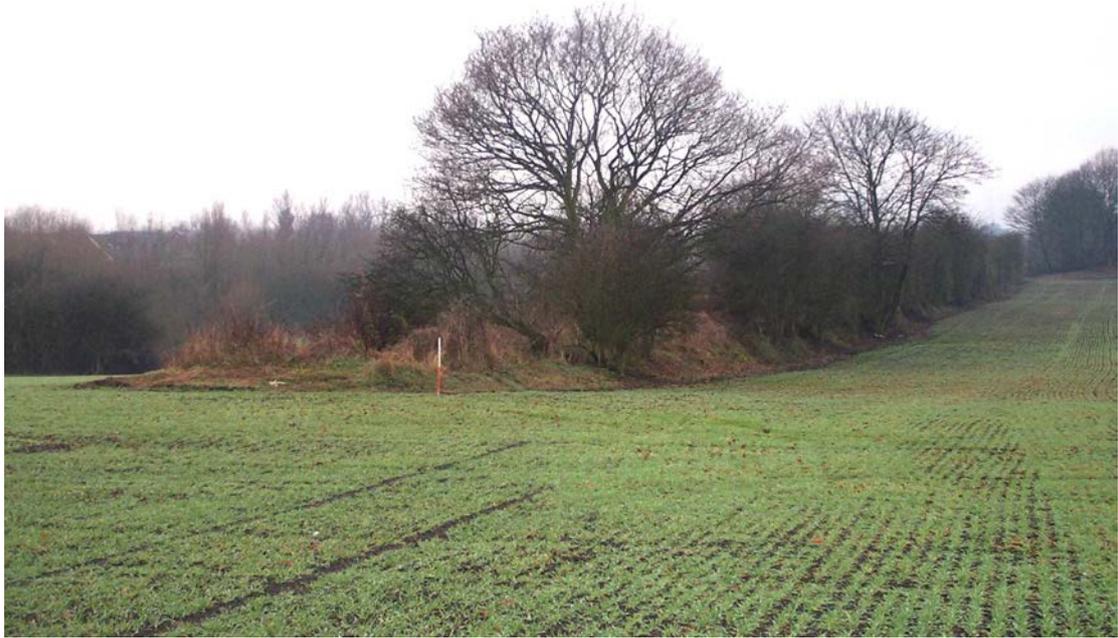
Plate 1: Site **08**, Garswood-Pewfall Incline, looking south-west

The Garswood-Pewfall Incline (Site **08**) has limited upstanding survival, but part of this will be cut by the proposed road. It is recommended that care be taken to minimise the disturbance to the extant earthwork during the construction of the road.

- 7.3.3 The Garswood-Pewfall Incline has limited upstanding survival, but part of this will be cut by the proposed road. It is recommended that care be taken to minimise the disturbance to the extant earthwork during the construction of the road.

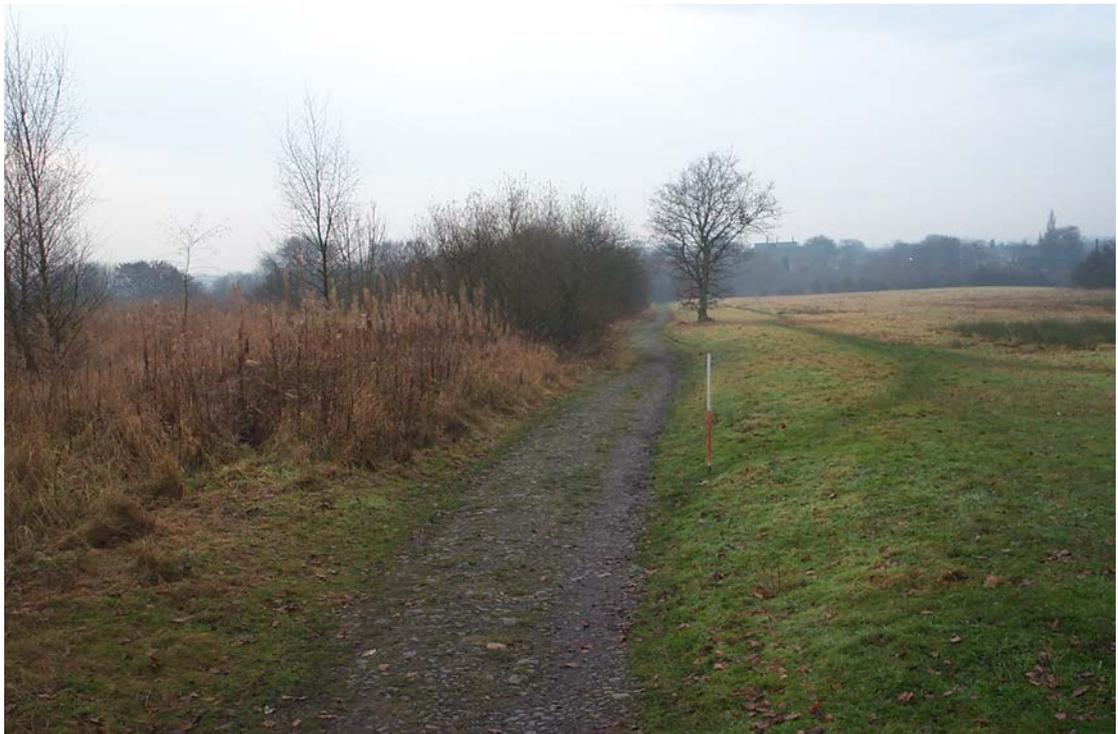
Plate 2: Site **07**, Stanley Bank Incline, looking south-west

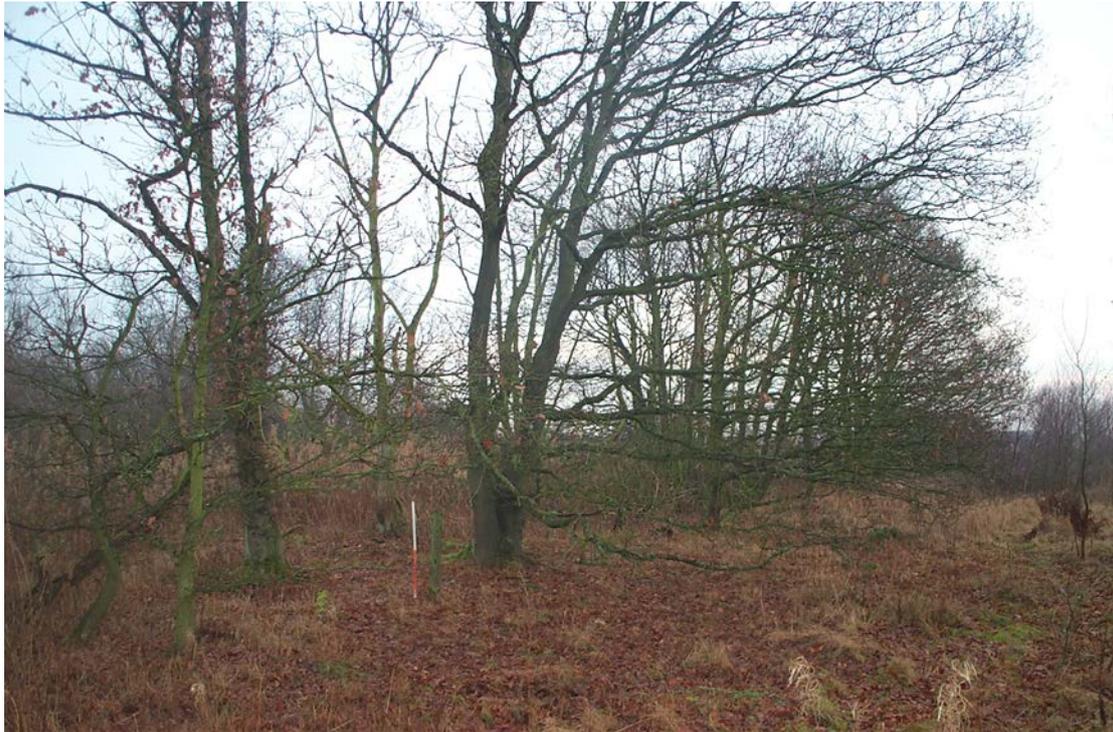
Plate 3: Site **14**, Embanked pond at Stanley Bank Farm, looking north

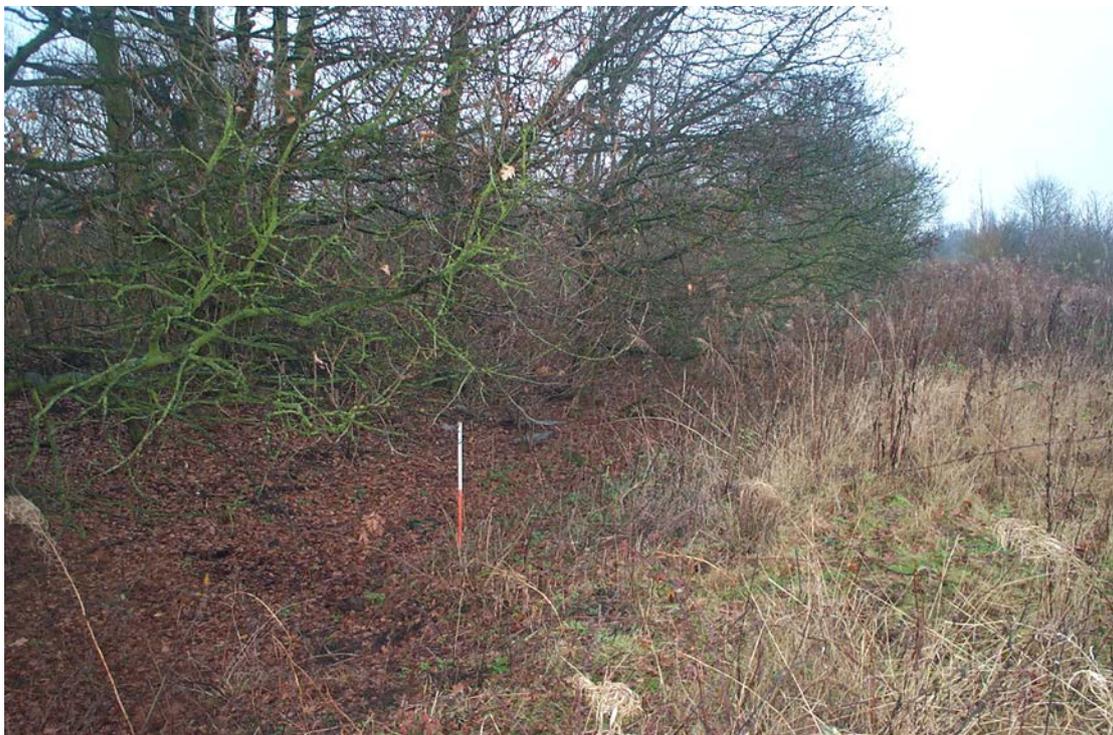
Plate 4: Sites **22** and **23**, part of embanked Garswood-Pewfall Incline, looking north

- 5.2.8 **Trench 38 (Figs 5 and 8):** this trench was located across the extrapolated line of the incline to attempt to locate any below ground remains of it and over Site 22 (Plate 4), comprising a bank and ditch. Excavation through the bank showed it to be made up of three distinct layers of redeposited natural boulder clay (Fig 8). The ditch (85) had a maximum depth of 1.2m and was found to be substantially wider than it appears today, with a width of over 6m. The ditch appeared to have been centrally recut, which was then backfilled within the last 30 years, although on either sides of the recut, the original, slowly silted deposits survived. As well as the expected bank and ditch, a further linear feature, with vertical edges was also revealed, that was probably a drainage ditch. A culvert, 83, constructed from brick, was also revealed, which appeared to be truncating the base of the bank. It is most likely that the bank was constructed to contain the area to the north-west of it, although unfortunately no dating evidence was recovered from either within or beneath the bank material. The ditch turned out to be far more substantial than expected; however, it is directly in line with the Garswood-Pewfall incline and to judge by the wide flat bottom was a continuation of the incline. Evidently, because of the slightly raised topography in this area, the continuation of the incline is here a cutting rather than an embankment. It is interesting to note that the gradient between the tops of the incline in Trenches 25 and 26 was 1:56, sloping down towards the south-west. The gradient down from Trench 26 to the bottom of the cutting in Trench 38 was remarkably also 1:56, confirming that this cutting was the base of the incline, and also demonstrating the precision of the design of the incline which provided for a precisely measured and engineered slope.

| 38 | 20 x 1.8 | north-west/south-east | This trench was located over Sites 22 and 23 , comprising a bank and ditch. Excavation through the bank showed it to be made predominantly from redeposited natural boulder clay. The ditch was found to be substantially wider than it appears today, with a width of c6m (cutting for the incline). Beyond the expected bank and ditch a further linear feature, with vertical edges was also revealed, that seems most likely to represent a drain. |

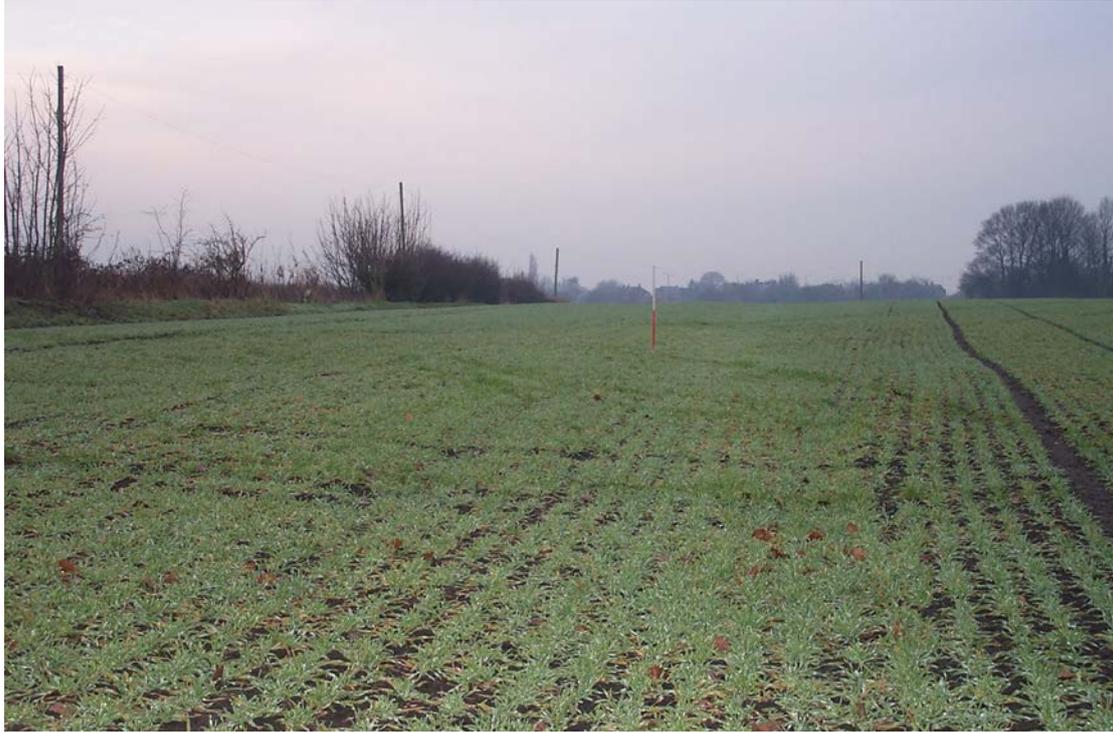
Plate 5: Site **21**, shallow linear earthwork, looking north-east

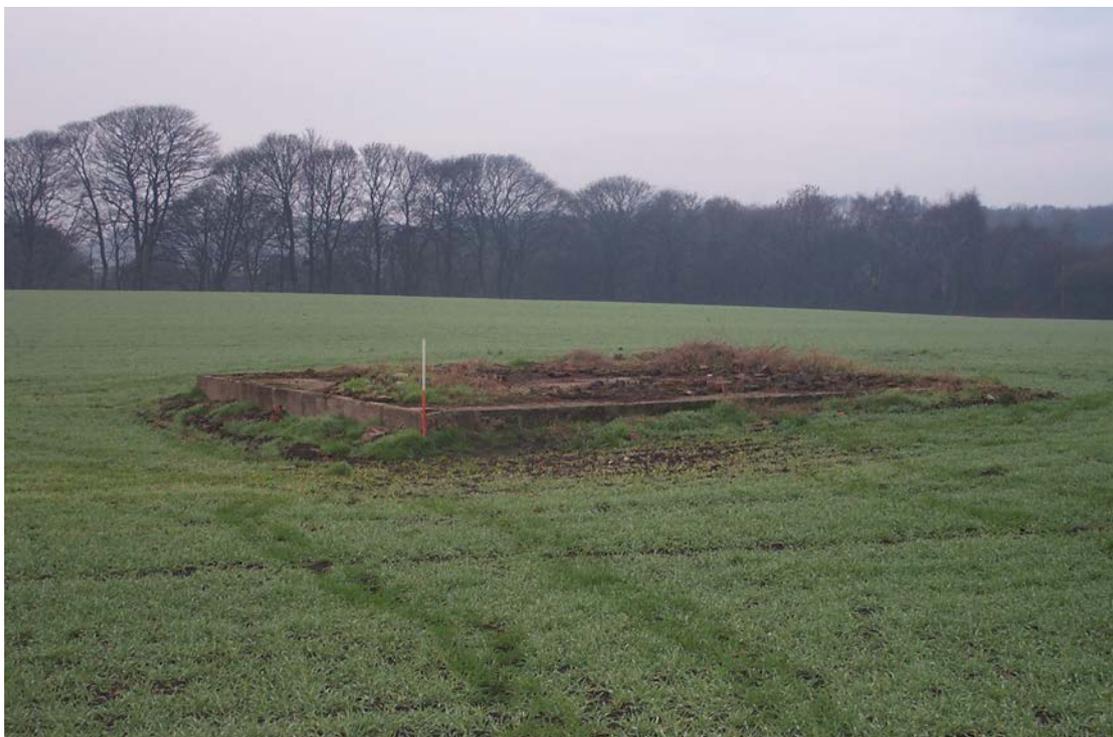
Plate 6: Site **15**, shaft at Garswood Colliery, looking west

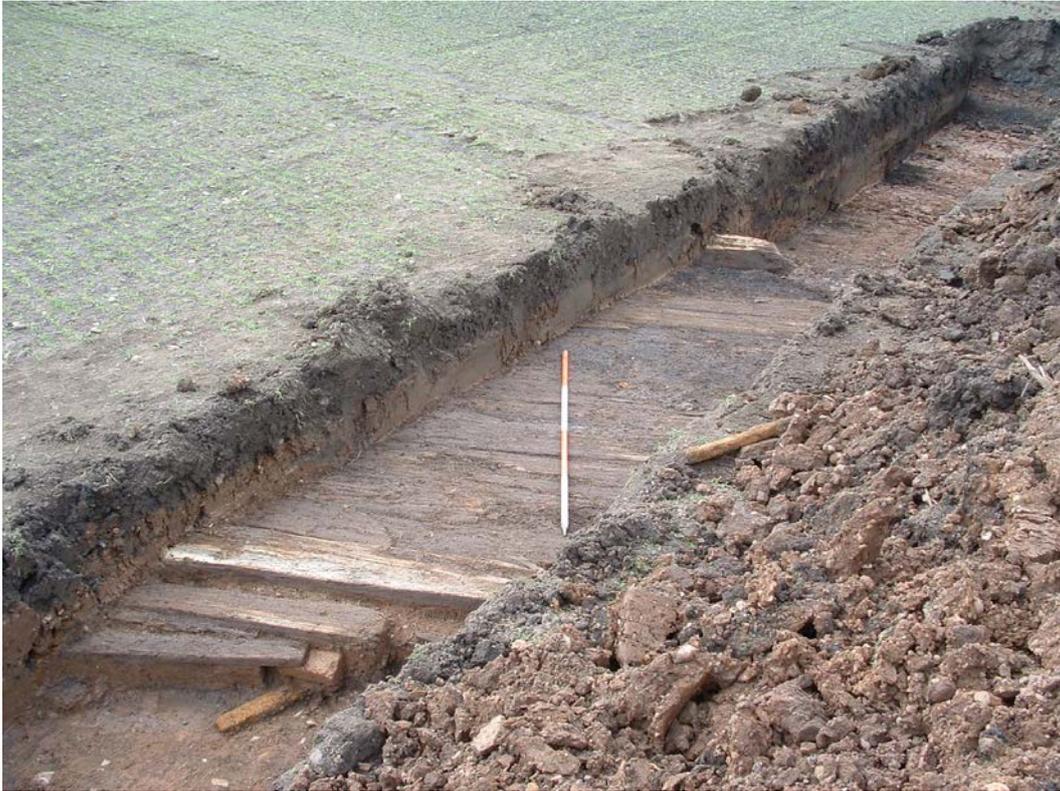
Plate 7: Wooden Platform 53, exposed in Trench 22

- 5.2.6 **Wooden Platform (Context 53) (Trenches 22, 39 and 44) (Plates 7 and 8) (Figs 5, 6 and 10):** a wooden platform, 53, was initially discovered within Trench 22 and two further trenches (39 and 44) were then placed in an attempt to discover its limits. Trench 39 unfortunately revealed only substantial modern truncation, but Trench 44 was successful in exposing the southern extent of the platform. Overall the wooden platform was exposed for a length of over 7m, although it should be noted its northern extent was not exposed. The platform was 4.5m wide, was aligned north-north-east/south-south-west and was constructed of timber planks of average dimensions 1.6m x 0.3m x 0.2m (Fig 10). On the outer edges of the platform, more substantial timbers had been laid, presumably to hold the structure in place. Towards the southern end of the platform a total of 15 bricks had been incorporated into the platform, possibly as a repair or due to a lack of timber. A small timber-lined 'box' had also been built into the platform. The timbers were placed on top of a 0.15m thick bank constructed from layers of redeposited boulder clay and burnt clinker deposits. This enigmatic structure remains difficult to interpret, although it is possible that it relates to the Garswood-Pewfall Incline which lies to the south of the wooden platform.

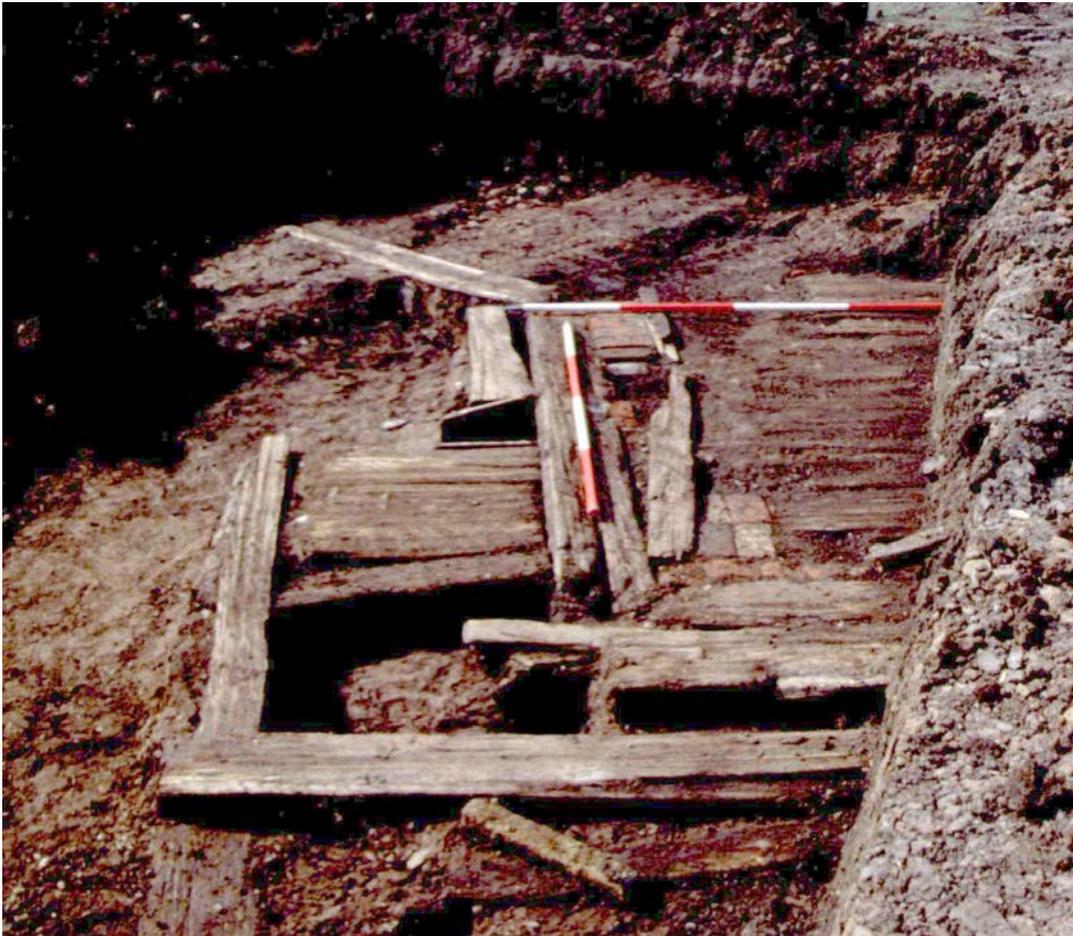
Plate 8: Wooden Platform 53, exposed in Trench 44

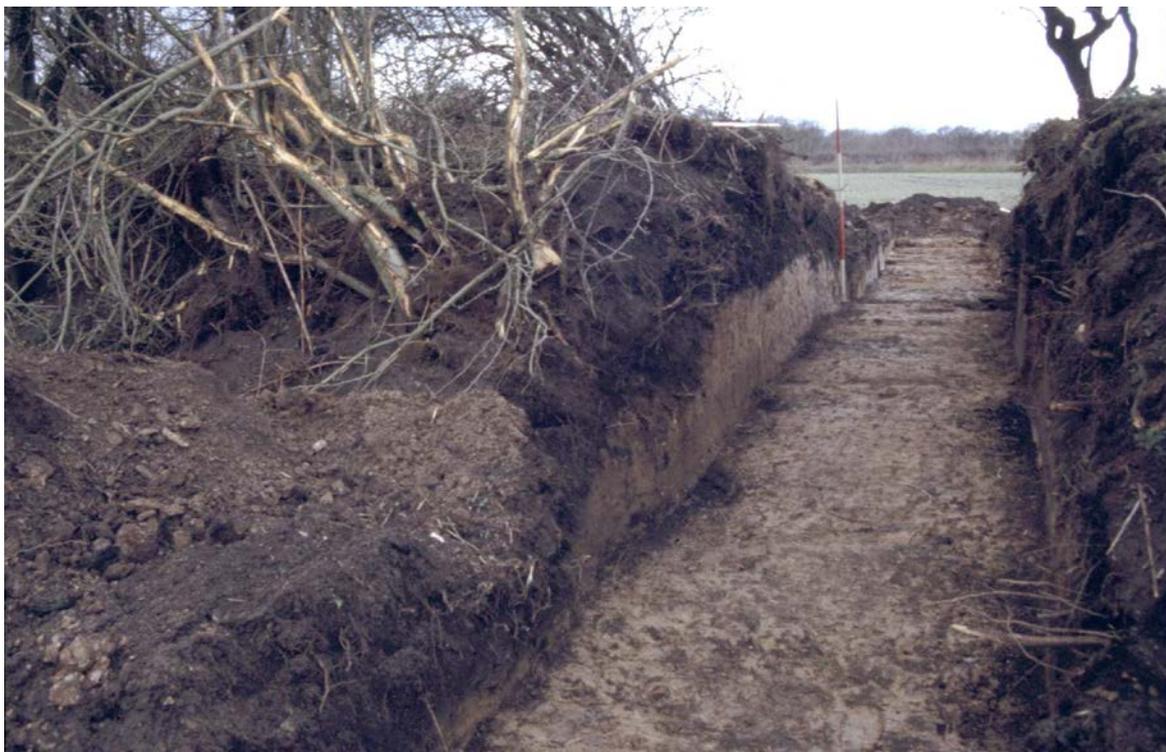
Plate 9: Section through Garswood-Pewfall Incline

- 5.2.7 **Garswood-Pewfall Incline (Site 08) (Trenches 25 and 26) (Figs 5, 6 and 7):** two trenches (25 and 26) were excavated across the extant incline embankment (Plate 9). The trenches showed that the incline had suffered a high degree of bioturbation, both as a result of rabbit action and also due to the trees and other vegetation now growing along it. The north-eastern trench (25) showed greater survival of the incline, to a depth of 0.87m, whilst in the other trench it remained to a height of 0.74m (Fig 7). Similar construction methods were observed in both trenches, with the lowest layer, a mid-brown silty clay, being placed directly upon the previous ground level. Immediately above this layer, a layer of light-yellowish-orange clay was deposited. These two layers were substantial in both trenches and both layers averaged a thickness of about 0.25m. Above these layers, a number of thinner bands of material were laid down, incorporating both layers of clinker/cinder and also layers of redeposited boulder clay; none of these higher layers were any thicker than 0.10m. It should be noted that the uppermost 0.25m was too heavily bioturbated to be able to infer its original material. These trenches have shown a very similar construction along the incline, and one that apparently did not require any kind of stone revetment.

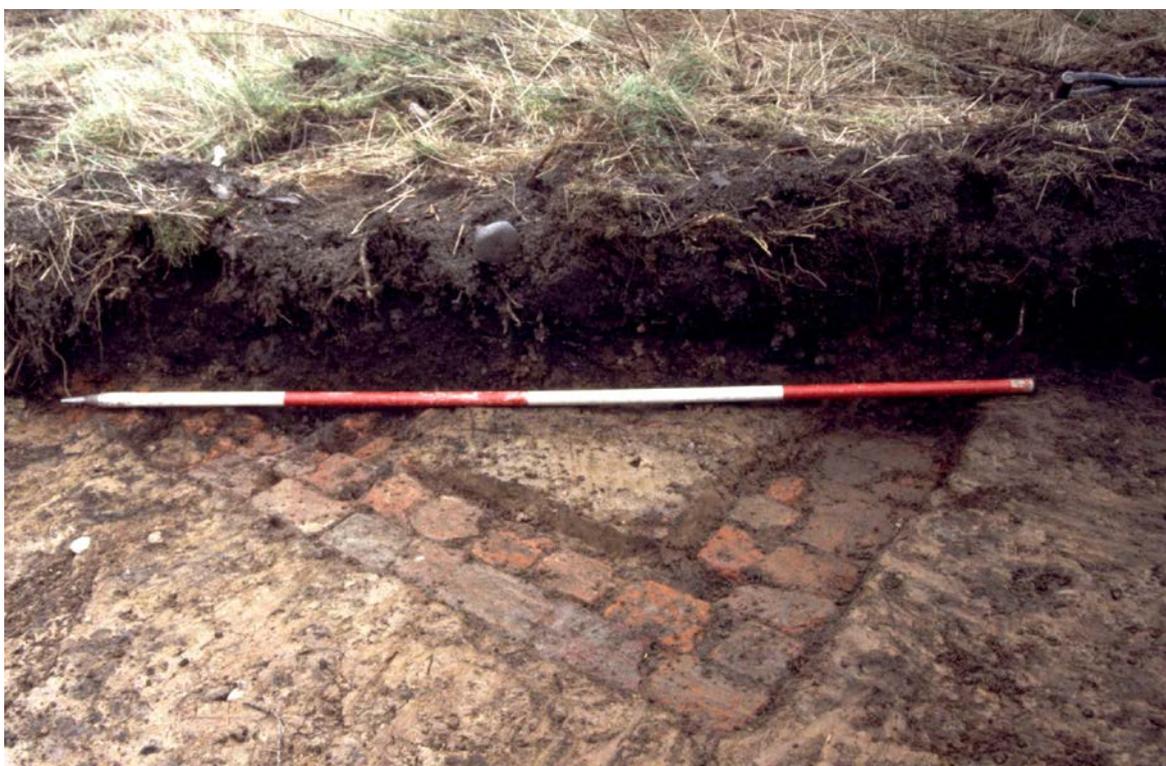
Plate 10: Brick Foundation 93, within Trench 33

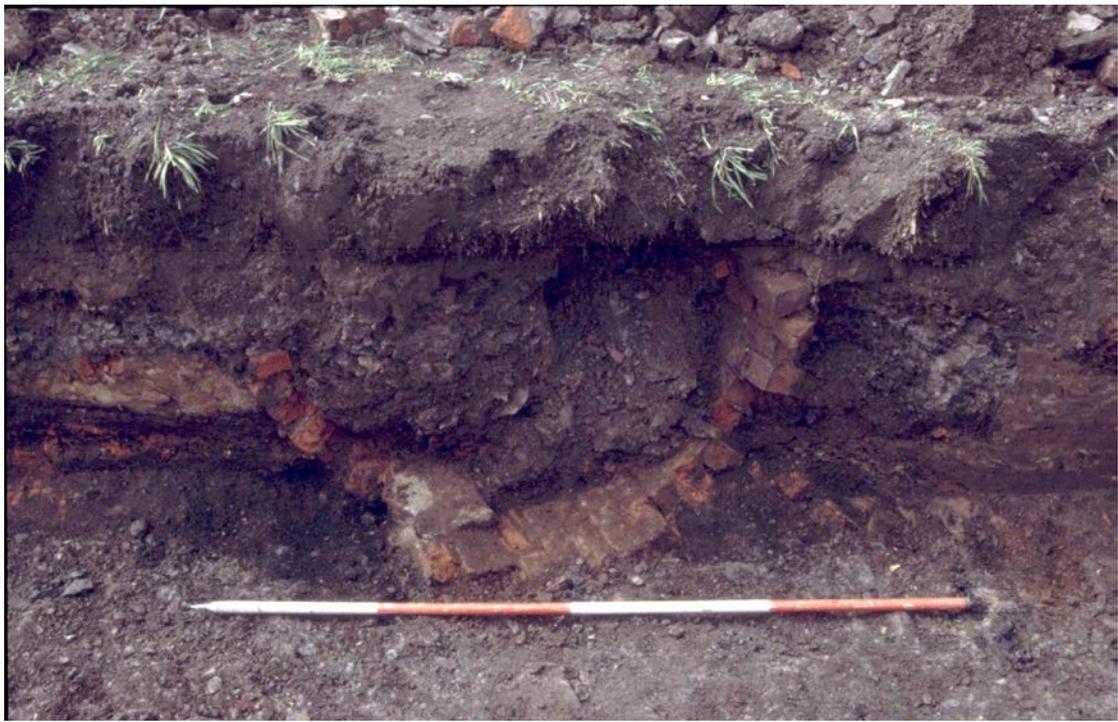
Plate 11: Brick Structure *100*, within Trench 42

- 5.2.14 **Trench 42 (Figs 6 and 9):** this trench revealed the most complete brick structure found during the course of this evaluation (Plate 12). The structure (**100**) was circular in section, with a diameter of 1.55m and it survived to a maximum height of 0.75m (Fig 9; Plate 11). It was constructed from reddish-orange unfrosted bricks of average dimensions 234 x 110 x 78mm and had been filled with crushed shale colliery waste, suggesting that it had been deliberately in-filled. The construction cut for this feature was less than 0.1m wider than the structure on the southern side, whilst to the north it was approximately 0.5m wider. There was a suggestion of another similar structure, **97**, at the southern end of the trench, which was constructed of identically-sized bricks and bonded with a similar (dark-brown) mortar. This structure appeared to be curving up into the section, but an insufficient amount of it was exposed to know whether it was of similar form to **100** (Plate 11). The function of structure **100** remains somewhat difficult, as there was no evidence of silting or burning, although it would certainly appear to relate to the industrial past of the site.

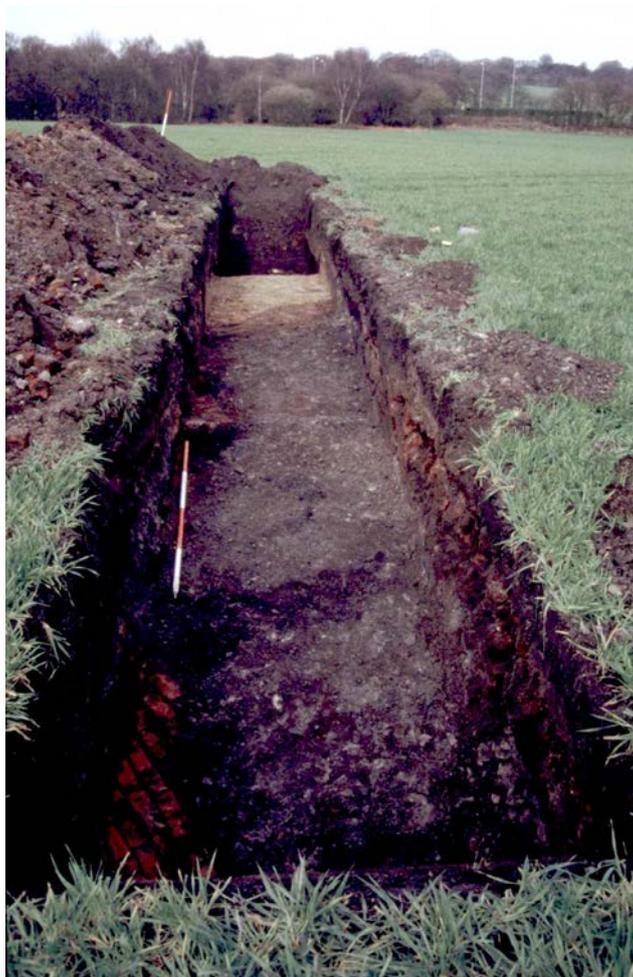
Plate 12: Trench 42 looking north
