**44 AND 52 CHURCH STREET,
LANCASTER
LANCASHIRE**

Watching Brief Report

Archaeological Watching Brief Report

Report no 1998-99/044/AUA7872

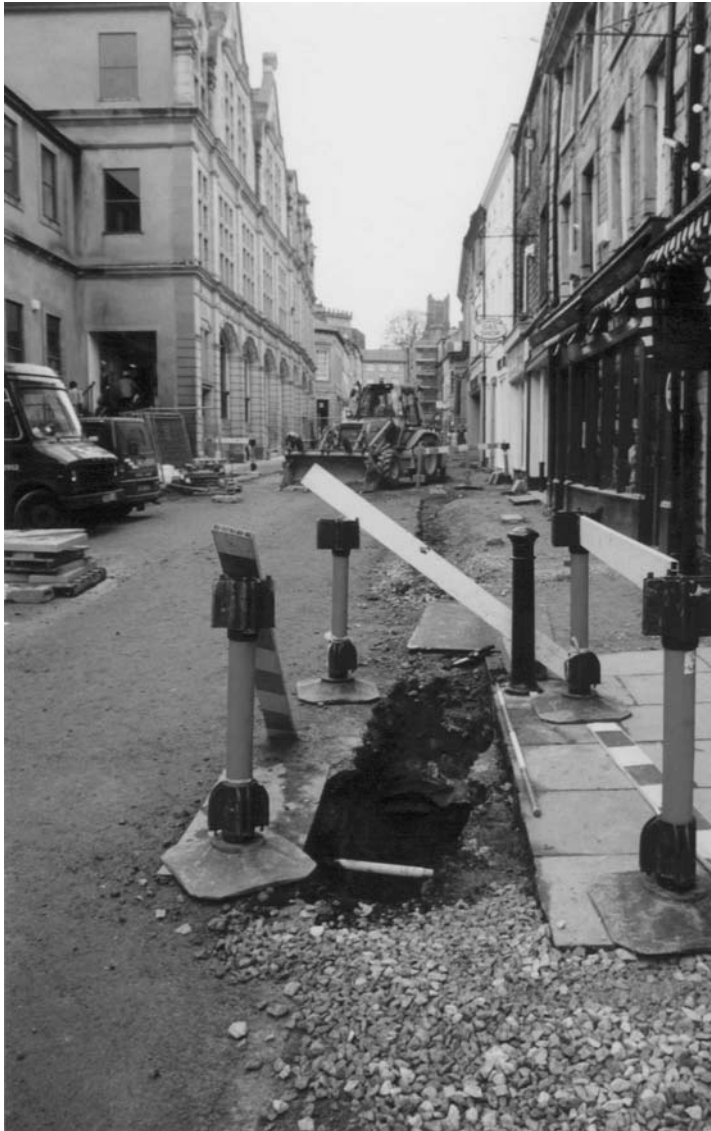
Plate 1 Surface view of No 44 Cellar exposure - > NW

- 3.1.1 **Development Impact:** the pedestrianisation of the south-east end of Church Street has resulted in the street level being increased by 0.11m, and the pavement was re-paved to a similar level. A mechanical excavator was used to remove c0.15m of tarmac to allow for the foundation of the new surfaces and this caused the roof of a vaulted cellar belonging to 44 Church Street to collapse (Plate 1) as the top of the vault was only 0.15m below the pavement (Plate 2). Remedial work was carried out the following day and a breeze block wall was constructed to 'shore up' the vaulted roof, and to limit the extent of the void that needed to be filled with concrete. The watching brief was undertaken following the construction of the breeze block wall and prior to the in-filling of the south-western void with concrete.

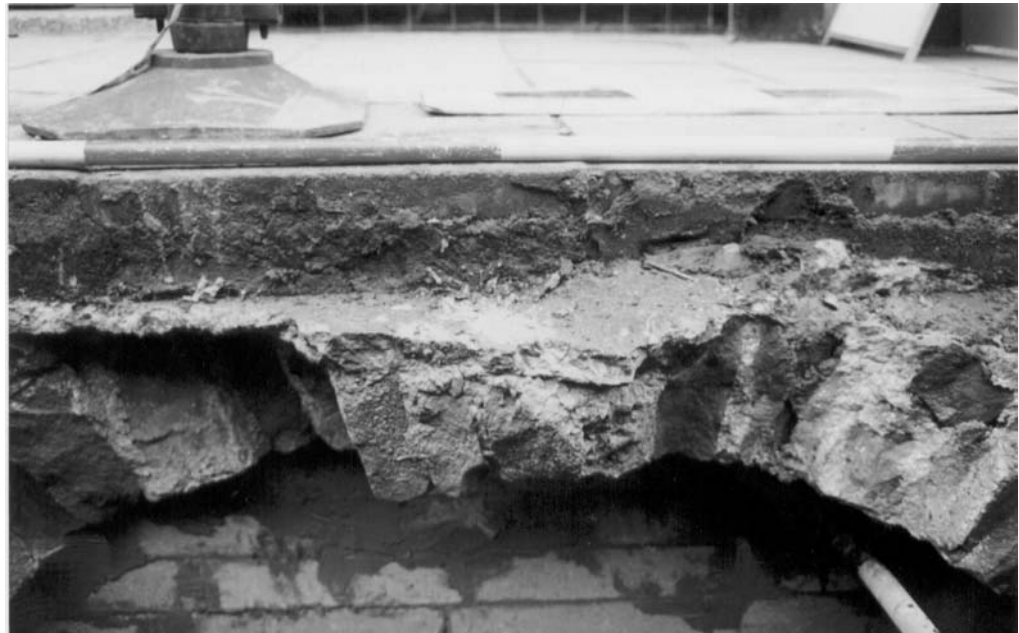
Plate 2 Crown of No 44 barrel vault in relation to pavement surface > NE

- 3.1.2 **Cellar Description:** the cellar extended south-west beyond the facade of the main building; it was 3.18m x 3.10m in size and had a maximum height of 1.88m. The walls/vault comprised approximately twelve courses of sub-rectangular stone blocks and flatter stones were incorporated towards the crown of the vault. The walls of the vaulted cellar abut the main walls of the building, except where a recess has been created and stones from the roof vault have been keyed in, so as to provide additional strength. The cellar was floored with small to medium-sized cobbles, and was accessed by a doorway from a corridor offset from a series of storerooms within the basement of 44 Church Street. The doorway (Plate 3 and 4) has at least two phases of construction, and the base of the present door is 0.53m below that of an earlier phase of doorway. The westernmost jamb combined moulded ashlar stones with two stepped chamfers (0.91m and 1.35m high), which relate to the original phase of the doorway. The top of this original doorway is set above the crown of the cellar vault, and clearly pre-dates the construction of the cellar. The lower section of the present doorway is roughly cut through the wall foundation, and it is evident that this phase of the doorway was more pragmatic than ornate in function. The later doorway has been narrowed by a 0.25m wide, rough masonry extension which has been butted to the original eastern ashlar jamb. The later door jamb is butted by the vault of the cellar, which clearly post-dates the narrowing of the doorway. A carved recess, c0.03m in depth, is set into the stone work, and provides evidence of a wooden door frame.

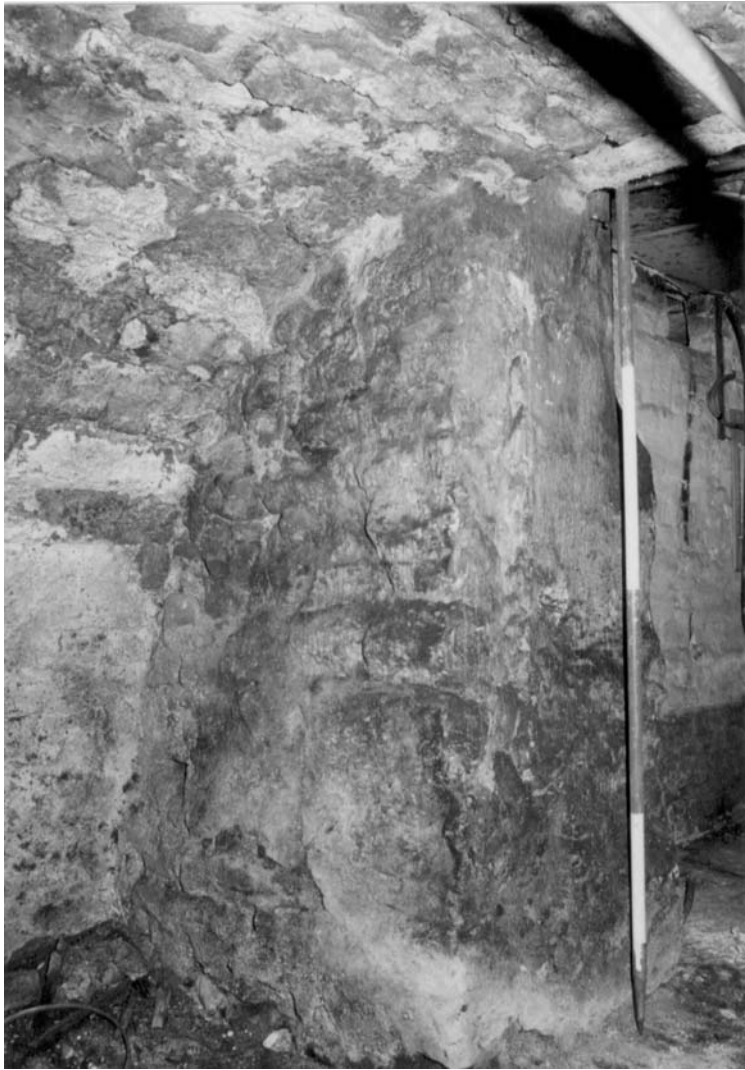
Plate 3 No 44 cellar entrance through principal façade viewed
From within Cellar > north-east

- 3.1.3 The base of the earlier doorway to the cellar is only 1m below the present street level and it is probable that this was the door to an undercroft, which was subsequently deepened with the construction of the vaulted cellar and basement. The front storeroom, in the west corner of the basement, also has an external doorway extending through the principal facade. This has been reduced in width and beyond it is a small vertical shaft which served as a coal shoot. Although there is still coal debris evident, the shaft is presently topped by pavement slabs and has not been used in the recent past. Originally the door possibly also provided access to the undercroft.

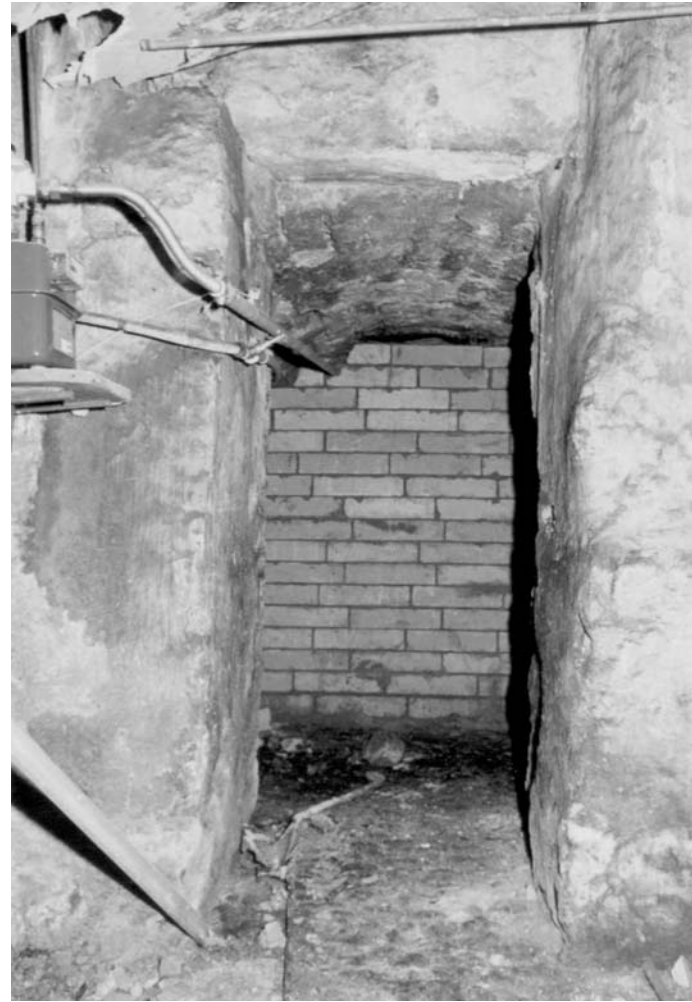
Plate 4 No 44 cellar entrance through principal façade
looking south-west

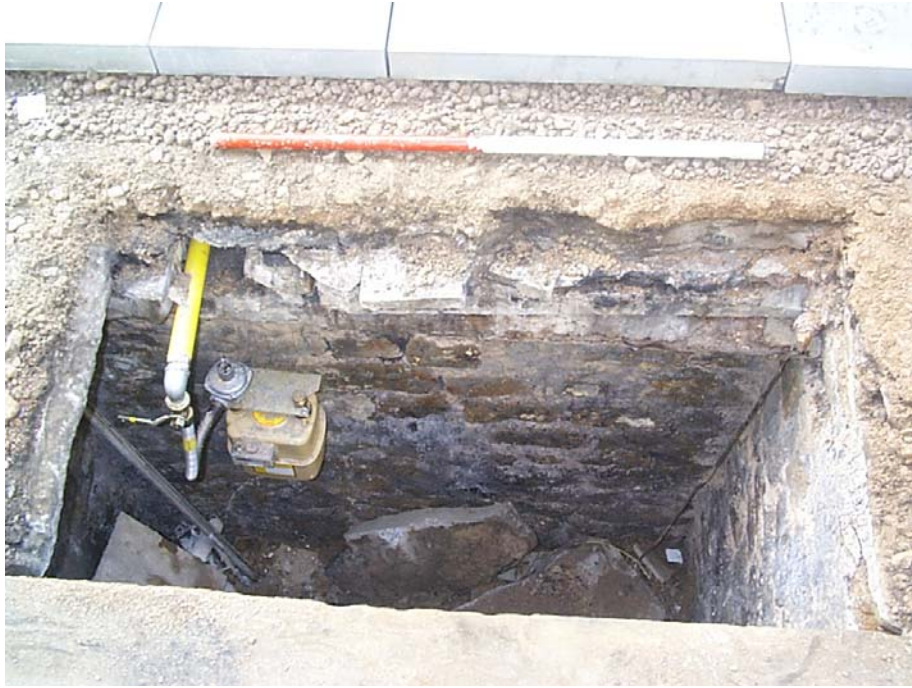
- 3.2.1 **Development Impact:** in the course of the stripping of the tarmac surface, a mechanical excavator collapsed the cellar roof of 52 Church Street (Plate 5). With respect to the front elevation, the cellar door is offset below and to the right of the present shop entrance and is therefore located at the eastern corner of the basement room. As there was a gas meter installed at the south-eastern end of the cellar, it was decided that it would be easier to reroof the cellar, rather than move the meter and then fill the cellar with the concrete. As a consequence the development had only a relatively minor impact upon the cellar fabric.

Plate 5 No 52 Church Street cellar viewed from street > north-east

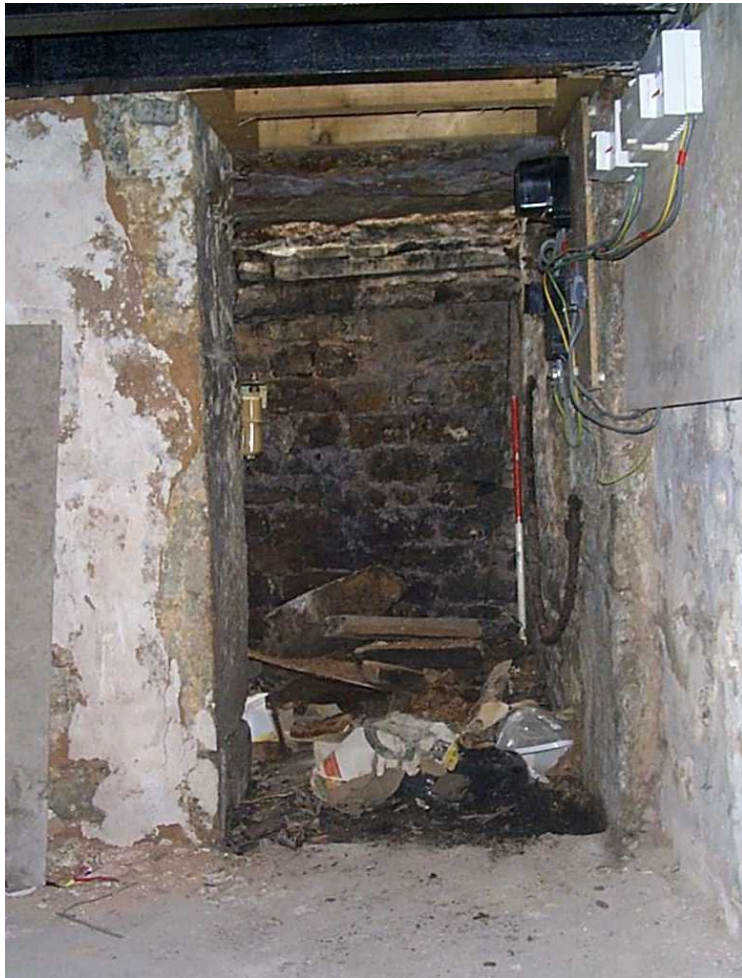
Plate 6 52 Church St. entrance into cellar through principal façade > south-west

- 3.2.3 **Cellar Description:** the cellar was rectangular in shape and projects 1.55m into the street out from the principal facade of the building; it is 1.68m wide. The walls consist of 13 courses of regular stone blocks, which are typically 0.1m x 0.2m with larger coursing towards the wall base (0.32m x 0.17m). The foundation wall of the building's front elevation comprises a significant number of large rounded river cobbles (0.17m x 0.17m). The cellar doorway incorporates long and short quoining, made up of some large tabular stone blocks which were placed vertically and horizontally; there was no evidence of a recess for a door casing (Plate 6). The roof of the cellar comprised three large flagstones, which had been fitted closely together and were each about 2m in length, 0.55m wide and 0.18m thick. The original cellar floor was found to be 0.07m below a cement floor and consisted of small to medium-sized cobbles. The original height of the cellar would have been 1.90m. The cellar walls are keyed into the principal facade of the building, but the overall construction of the cellar would suggest that the cellar post-dates the building of the basement wall.
