# **GISBURNE PARK**

## **Walled Garden Assessment**

**Oxford Archaeology North**

Issue No:	2007-08/662
OAN Job No:	L9831
NGR:	SD 825 498

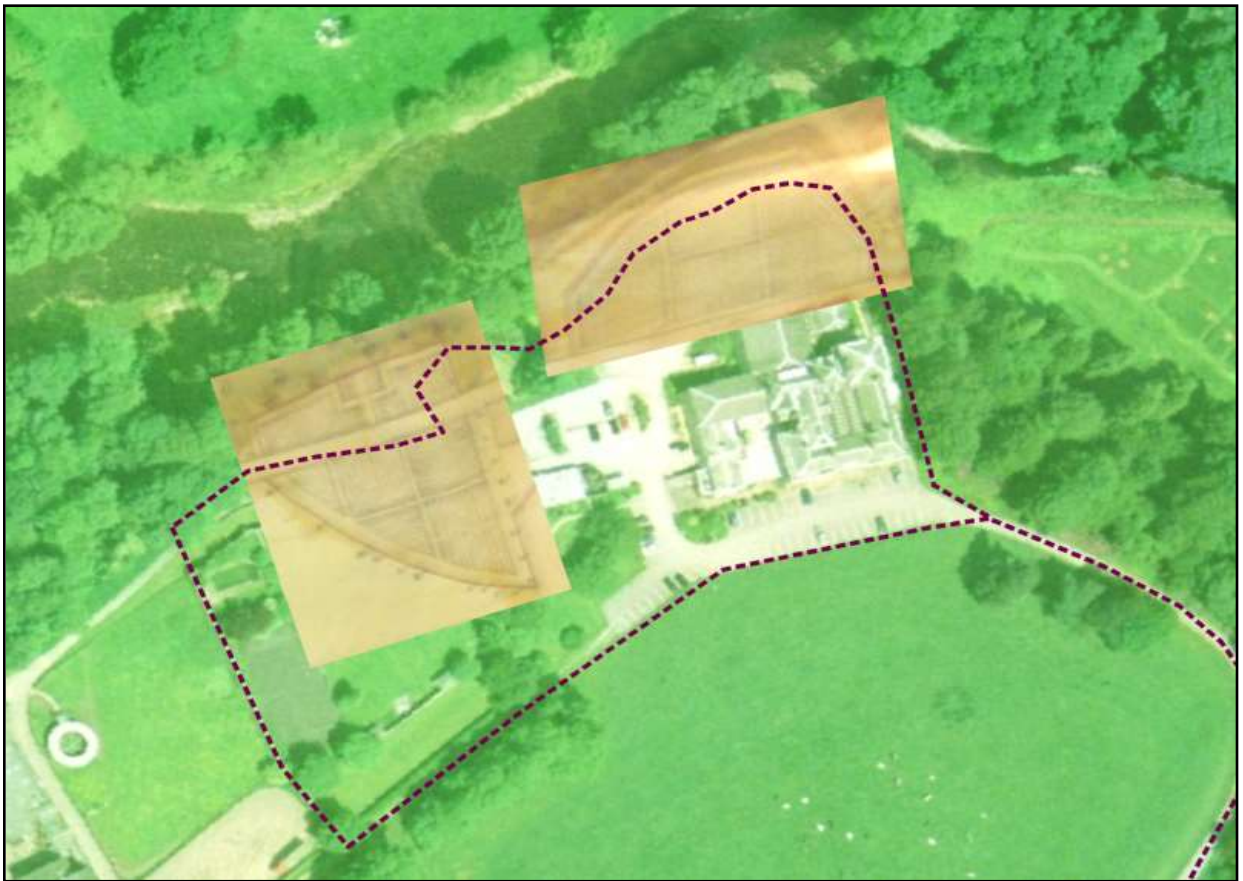
Figure 4: Original garden layouts projected onto their approximate location on the current vertical aerial photograph

- 3.2.4 Today the eastern former garden has been built upon by a later extension to the hospital, and the western garden is still split by a roadway (Fig 4). The northern section is now wooded waste, on the edge of the river valley, and the southern section has been substantially altered by subsequent garden design and coincides with the area of the proposed development. The plan also depicts a very substantial driveway running from the lawn area at the south of the hall towards the village of Gisburn to the south, where a gate lodge is shown. This connects with the embanked road still shown on the modern map, and which was the original route to the hall; however, this feature is not depicted on any subsequent mapping, and had presumably fallen out of use.

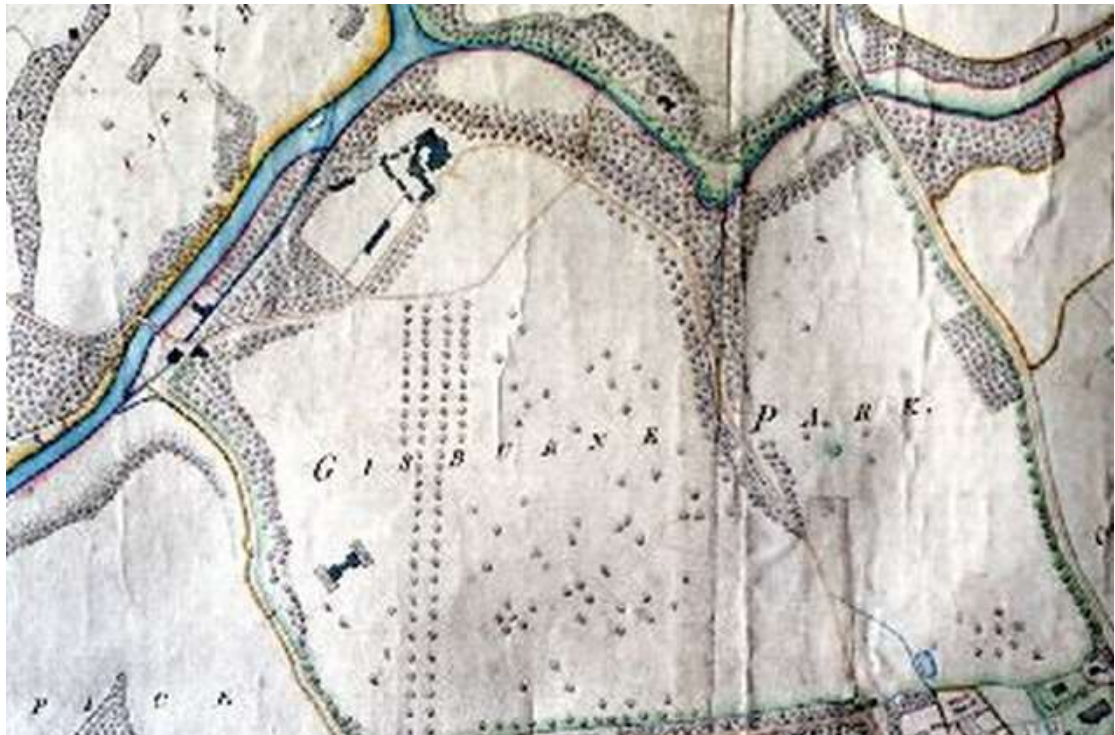
Figure 6: Plan of Gisborne Park By White, 1812

- 3.2.6 **White's estate plan of Gisburne Park, 1812 (MD335/1) and unnamed estate plan of 1817 (MD335/1/1/12/1/192)** (Figs 6 and 7): these maps show a reasonable level of detail of the area of Gisburne Park, and as there is little difference between them, they are discussed here as one map. On both the eastern of the two avenues, shown on Jeffery's map, has not been mapped suggesting that it had fallen out of use, but the western avenue is still depicted. Both maps fail to depict the earliest gardens shown in 1735.

- 4.1.17 **The Park:** from as early as White's map of 1812 (Fig 6), there has been a tree-lined avenue depicted running from north-east to south-west across Gisburne Park, and this survives to the present day. A raised sub-square platform (Site 28), to the south-east of the original country house, is shown as an earthwork on the 1909 OS map (Figs 10 and 11) and was also visible as an earthwork during the site visit (Fig 12 and 13). This appears to represent a landscaping feature and, as it was not shown on the 1850 mapping, is unlikely to have been the site of a building. Examination of LiDAR aerial survey data picks out this sub-square feature and also shows the course of an extant sunken trackway (Site 29) (Fig 12) that was also depicted on the 1909 OS mapping. This was a wall-retained terrace that was constructed to create a stock-proof sunken barrier between the gardens and the park to the south that would not interrupt the southward view from the house. In particular, it served to obscure traffic from the main house that passed on a roadway around the garden to Gisburne Mill. A further sunken lane (Site 30) is shown on the LiDAR survey that runs southwards from the Ha-Ha and then curves to the south-east. Two earthworks of uncertain function were observed between the sub-square platform and the Ha-Ha (Fig 12); these consisted of a sub-circular rise (Site 26), that was *c* 20m in diameter and a curvilinear curved earthwork (Site 27) that partially enclosed this grassed mound.

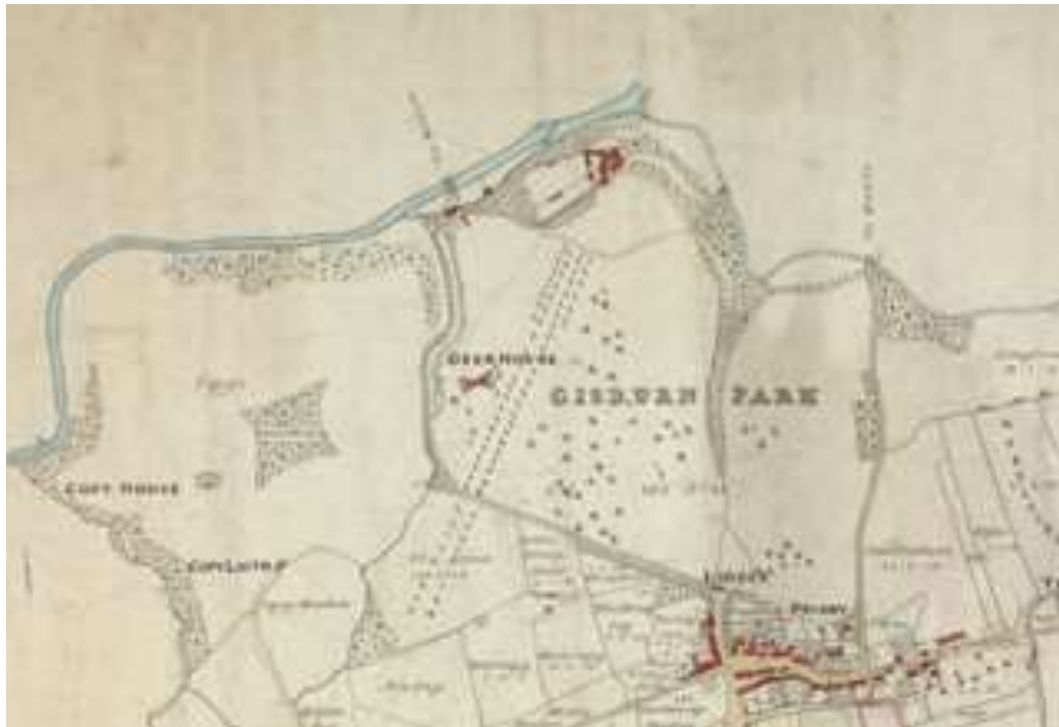
Figure 8: Extract from the Tithe map of the Township of Gisburne, 1844

- 3.2.8 **Tithe map of the Township of Gisburne, 1844 (MD335/1/5/4)** (Fig 8): this plan shows the area of the township of Gisburne, including the village, the surrounding fields, and the park and hall. However, due to the scale of the map, there is not sufficient detail to determine individual elements of the garden area. The hothouses mapped on the 1812 and 1817 maps appear to have been depicted somewhat stylistically as they are both shown as single blocks.

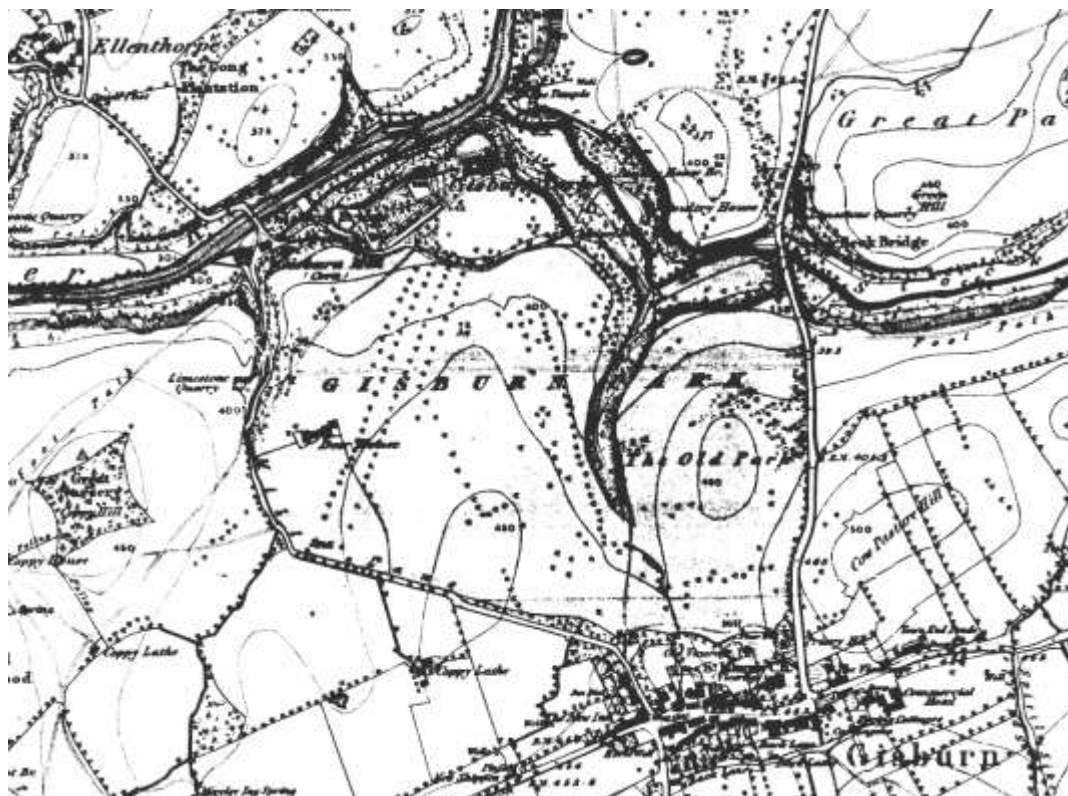
Figure 9: Extract from Ordnance Survey map six inch map of 1850

- 3.2.9 **Ordnance Survey, 6" to 1 mile map (1850)** (Fig 9): the first edition six inch map of 1850 does not show detail of the garden layout, but does show a clear plot of the eastern garden, which was then still in use as a lawn. The western avenue to the south of the hall was again shown in the park, although the eastern one was

- 3.2.10 The six inch Ordnance Survey mapping shows that by 1850 the gardens have been enclosed with walls and that this formal layout includes a series of footpaths around the walled edge and diagonally across the garden. There are also two ranges of hothouses, as well as additional buildings at the north-east and south-west corners. Smaller features are indicated by the map in the eastern half of the garden but are not well enough defined at this scale to determine their nature.

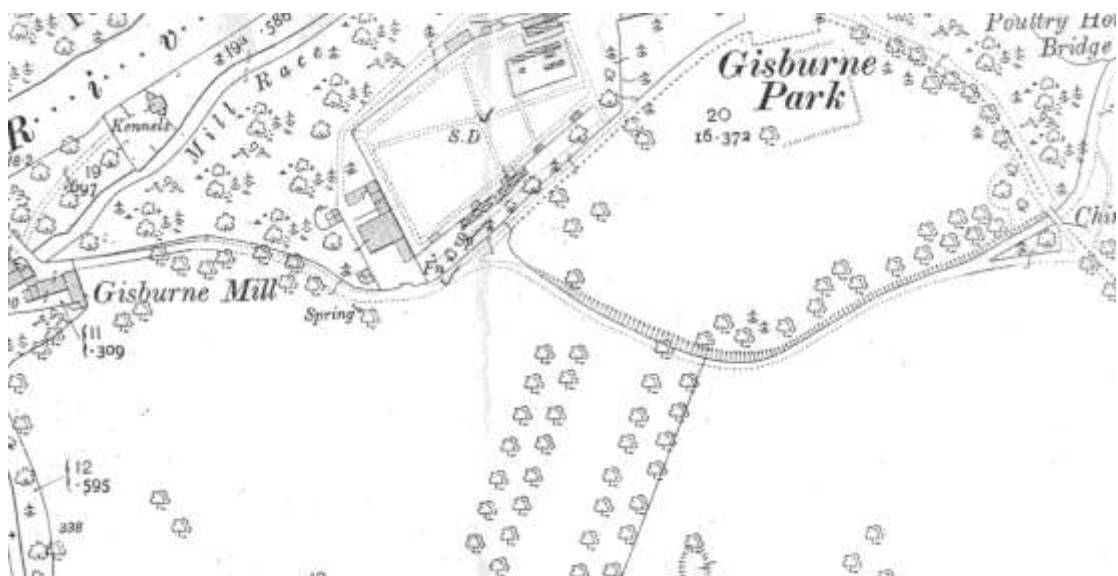
Figure 11: Detail of Ordnance Survey 25" map (1909)

- 4.1.16 **Ornamental Features and Pathways:** although the 1850 and 1909 OS maps (Figs 9 and 11) depicted pathways, some of which were tree-lined, that ran around the inside circuit of the walled garden and subdivided the area into five irregular polygonal areas, no trace of these survived. The sundial that was shown as a centrepiece on the 1909 OS mapping was also absent. The western half of the garden has been re-landscaped since the 1909 OS maps were produced, including the addition of tennis courts and a swimming pool; the central north/south path coincides with the line of the later wall, which divided the garden from the stable yard area, and is likely to have removed any trace of the path. It is therefore unsurprising that the internal features in the western part of the have not survived.

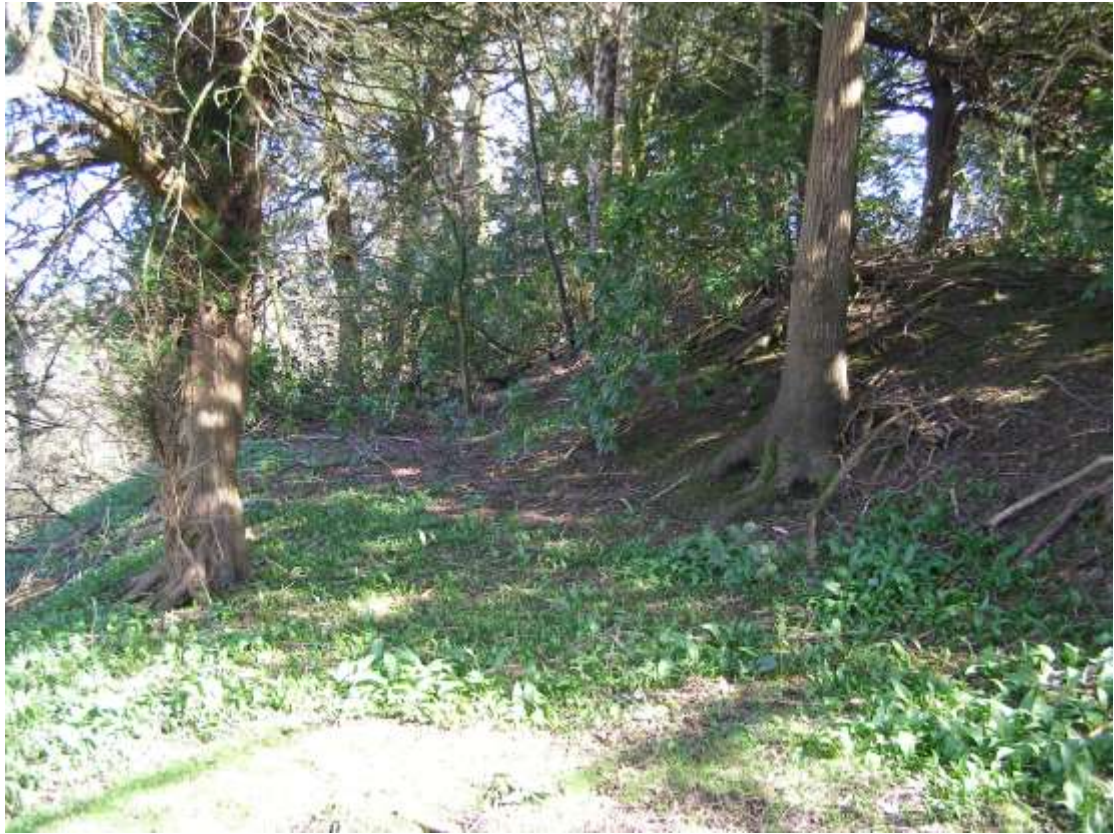
- 4.1.2 ***The Gardens as Depicted in 1735:*** the earliest surviving element of landscaping design at Gisburne Park was a terrace (Site **13**), located to the north of the present day walled garden (Fig 13; Plate 1). This consisted of a narrow strip of land that was c 1.5m lower than the ground level of the ground to the south upon which the later walled garden was established. This terrace was lightly wooded at the time of the site visit and, beyond the northern edge, dropped away to the River Ribble. A large earthen bank defines the southern edge of the terrace, which was probably the spoil mound from the excavation of the adjacent sunken track. The northern edge of the terrace appears to correspond to one of the garden boundaries depicted on the 1735 map by Bourguignon (Fig 4) and, as this area was not subsequently developed by later landscaping, it is the only feature from the earlier garden design that is still visible.

Plate 1: The northern terrace edge (Site **13**) of the original garden (as depicted on the 1753 map), which overlooks the River Ribble

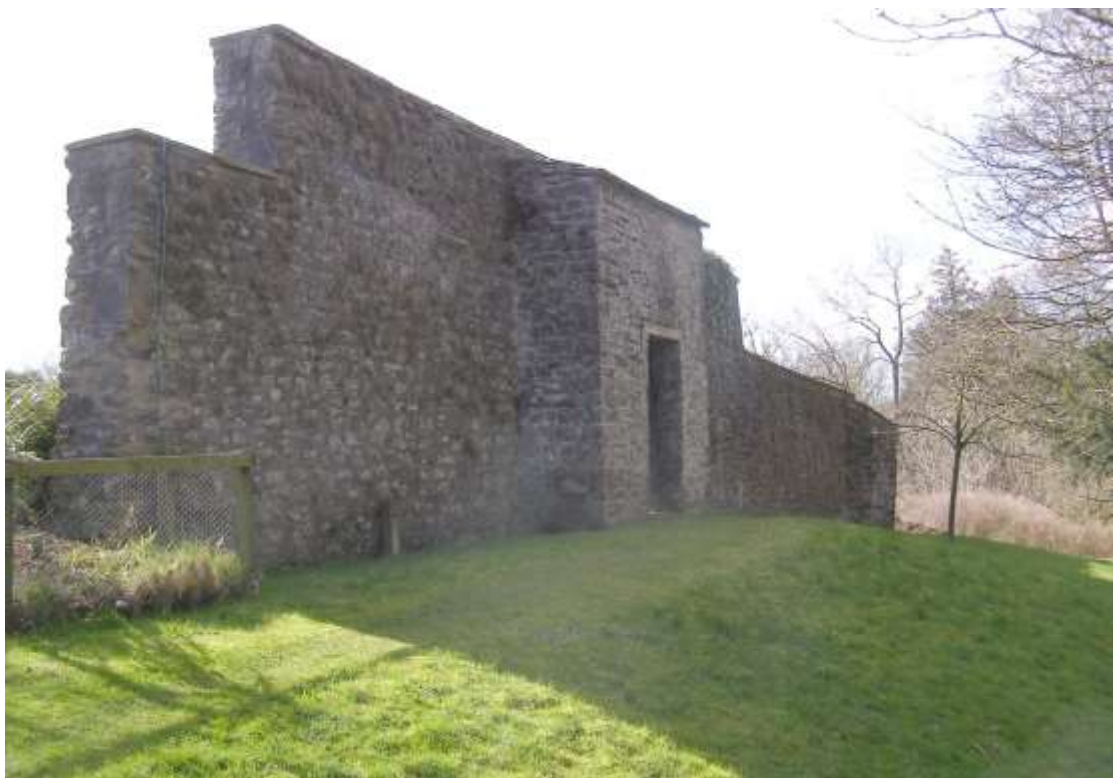
- 4.1.10 In most places the outer face of the wall was constructed from grey stone and features one surviving squared access 'turret' (Plate 2) (Site **23**). Its externally severe aspect is accentuated by the increase in wall height over the northern access gate which is suggestive of fortification crenalations. In dramatic contrast, the inner face of the wall is constructed from bricks and decorative features that would have

Plate 2: The northern wall (Site **14**) viewed from outside the garden showing the external turret of the recessed arched entrance (Site **23**).

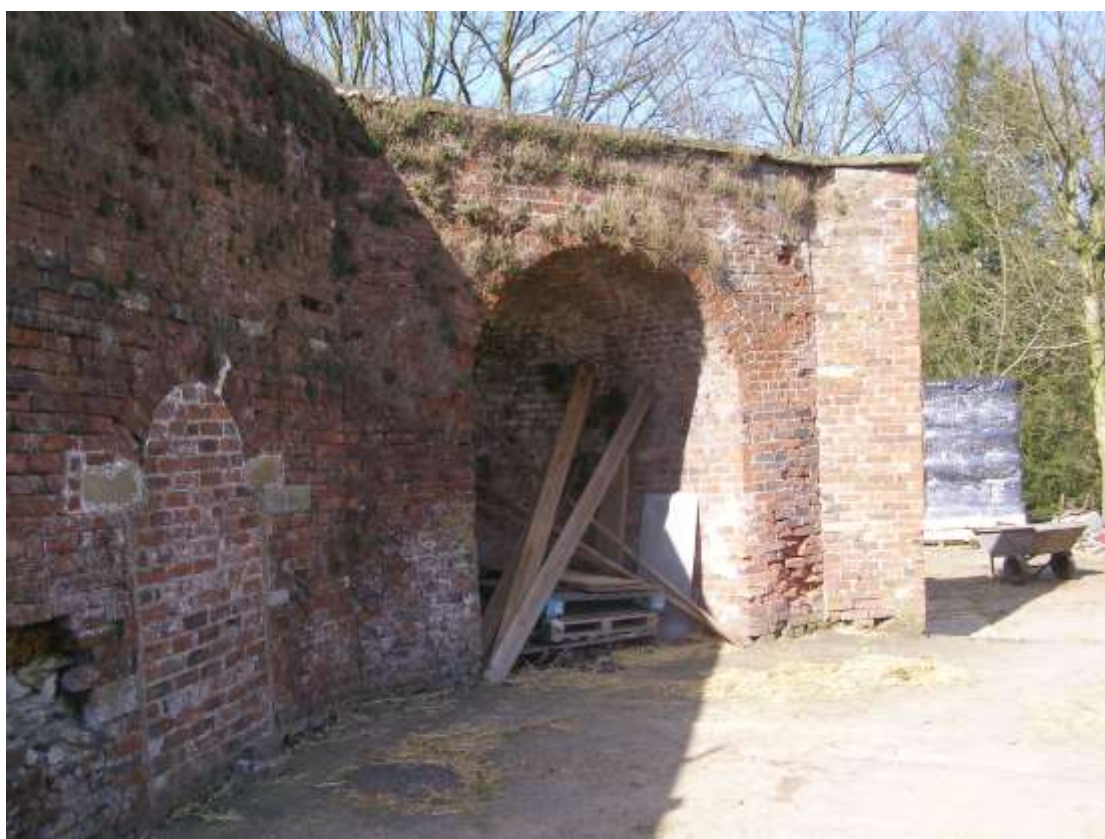
Plate 3: Vaulted recess (Site **16**) set in the north-western corner of the walled garden

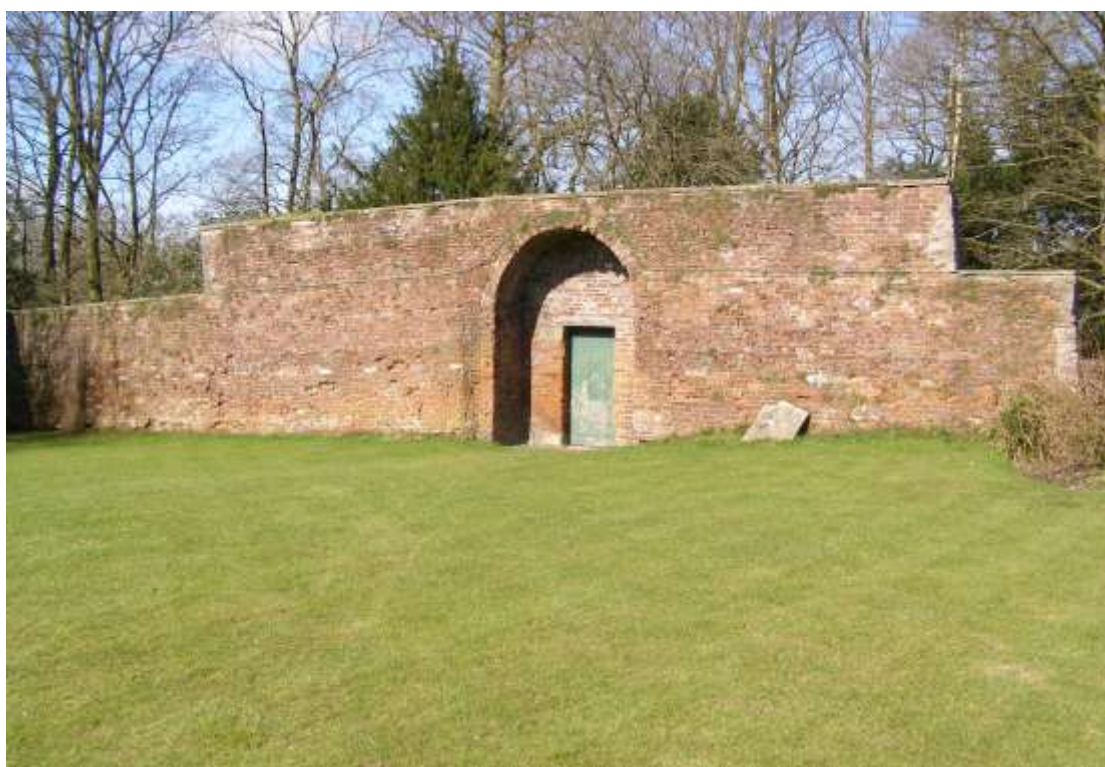
- 4.1.4 The northern wall (Site **14**) survived as a 35m stretch to the west of the head gardener's cottage, and ran for around 18m to the east of this building (Fig 13; Plate 4). The gap between this wall section and the cottage accommodated an earlier extension to the cottage (shown on the 1909 map), but this had gone by the time of the modern mapping. This northern wall portion featured a large and elaborate gateway (Site **23**) to the garden and several buttresses that were triangular in plan. The gateway was original, but the buttresses were later additions, intended to strengthen the wall, and were not shown on the 1909 plan.

- 4.1.9 **Walled Garden Design:** the fabric and design of the walls attests to a structure with a purpose that far exceeded any practical requirements for a garden wall. Notably, the decorative and ornate elements of the garden are on the internal side of the wall, rather than the external side as would be appropriate for a walled nursery garden. This garden boundary marker became instead an expression of style and, perhaps, a demonstration of private wealth. The high wall may have been important, in order to afford privacy to the garden from the access road that ran to the south of the house. The scale of the wall and the execution of features within it, such as the access archways, demonstrates the deliberate construction of a piece of ornate architecture (Plate 4).

Plate 4: The northern wall (Site **14**) showing the recessed arched entrance (Site 23) from inside the garden

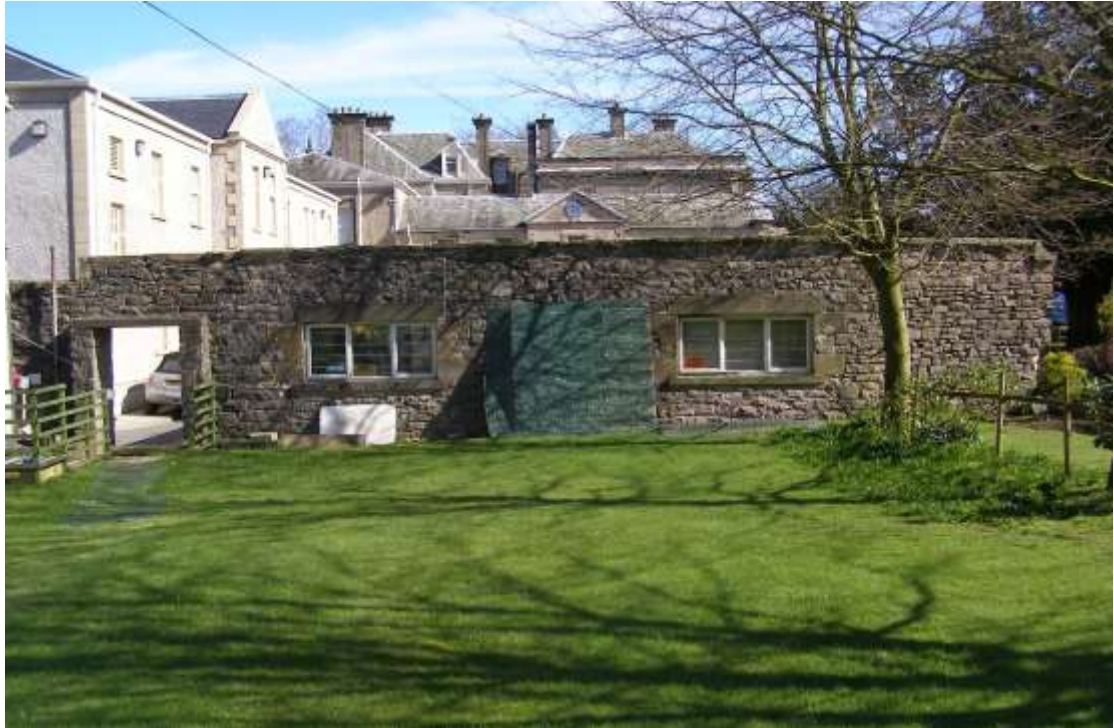
Plate 5: The eastern wall section (Site **19**) which has a stone-built internal face and has been adapted as part of a garage.

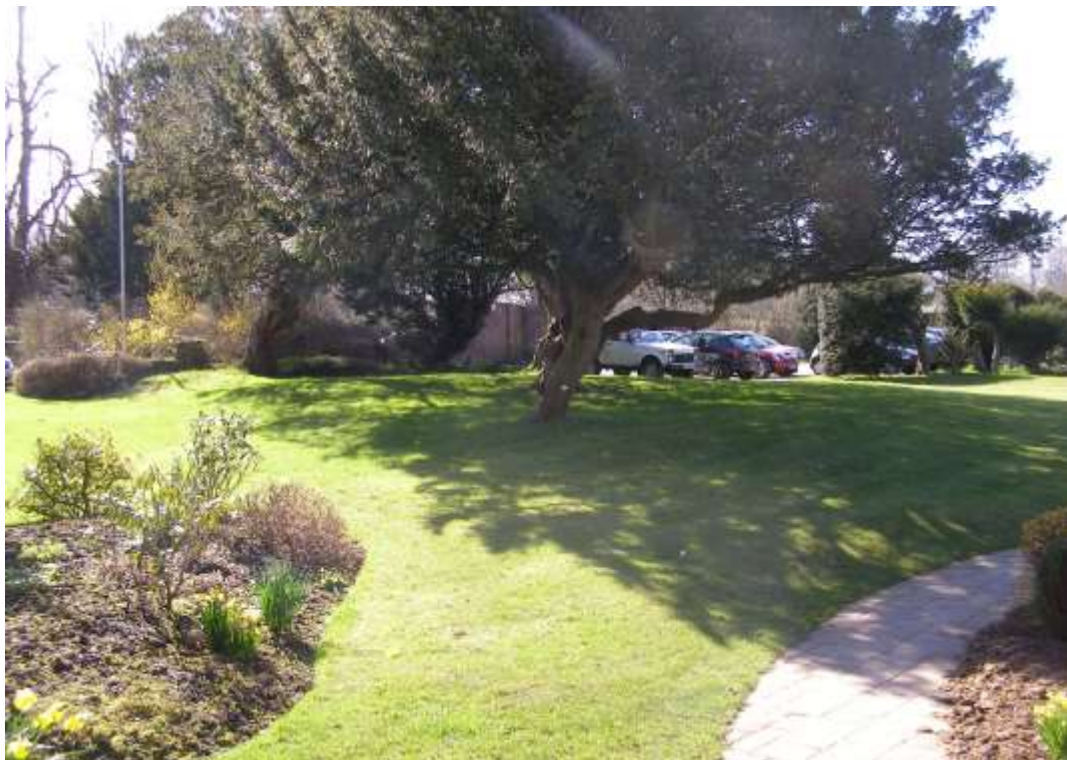
- 4.1.7 A truncated butt of wall at the southern end of this section of walling was aligned with an earthwork bank (Site **24**) that extended towards the south-eastern corner of the walled garden (Fig 13; Plate 6), and corresponds with the line of a wall shown on the 1909 plan; the earthwork is probably the remains of this line wall. However, given the location of the house to the east of the garden, and the apparent importance of the visual impact of the garden when it was first designed, it is possible that the original eastern wall may have been a low wall demarcating the garden extent. As such, it would have defined the space of the garden but allowed a vista of it from the house.

Plate 6: A distinct terrace edge (Site **24**) that marks the line of the eastern section of garden wall

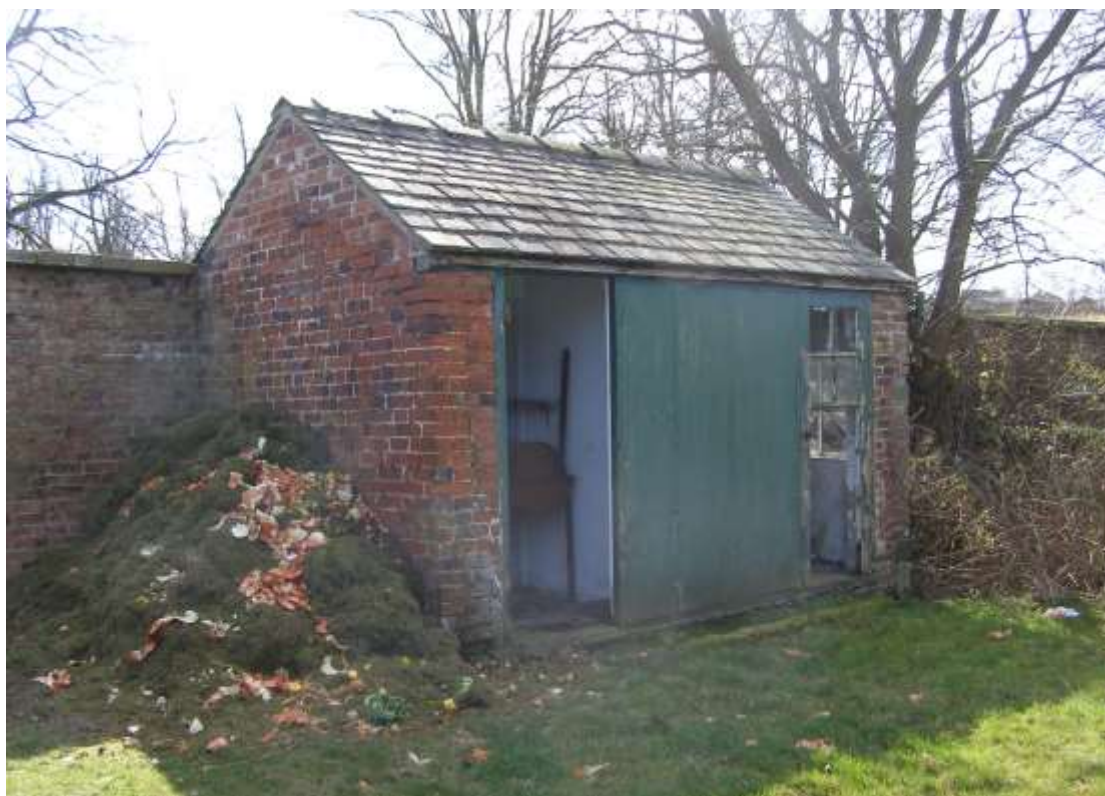
- 4.1.8 The southern garden wall (Site **17**) survived as a 50m stretch of walling with two gable-roofed outbuildings (Site **22**), that projected into the garden area to the north of the wall (Fig 13; Plate 7). This section of wall was built entirely in brick and may reflect that this was an internal wall; the OS 1909 plan shows a further wall running parallel to, and to the south of, Site **17**. This latter wall was shown as tree-lined and would have been the external boundary to the garden. Although there is now a low wall following this southern line, it is modern and there is no evidence of an earlier structure. A line of greenhouses was shown on the 1909 plan occupying the space between these two walls, and set against the extant wall (Site **17**). However, there are no longer any structures here, and no scars on the southern side of the wall to record their former existence.

Plate 7: One of two surviving small outbuildings (Site **22**) that were constructed against the internal face of the garden wall (Site **17**)

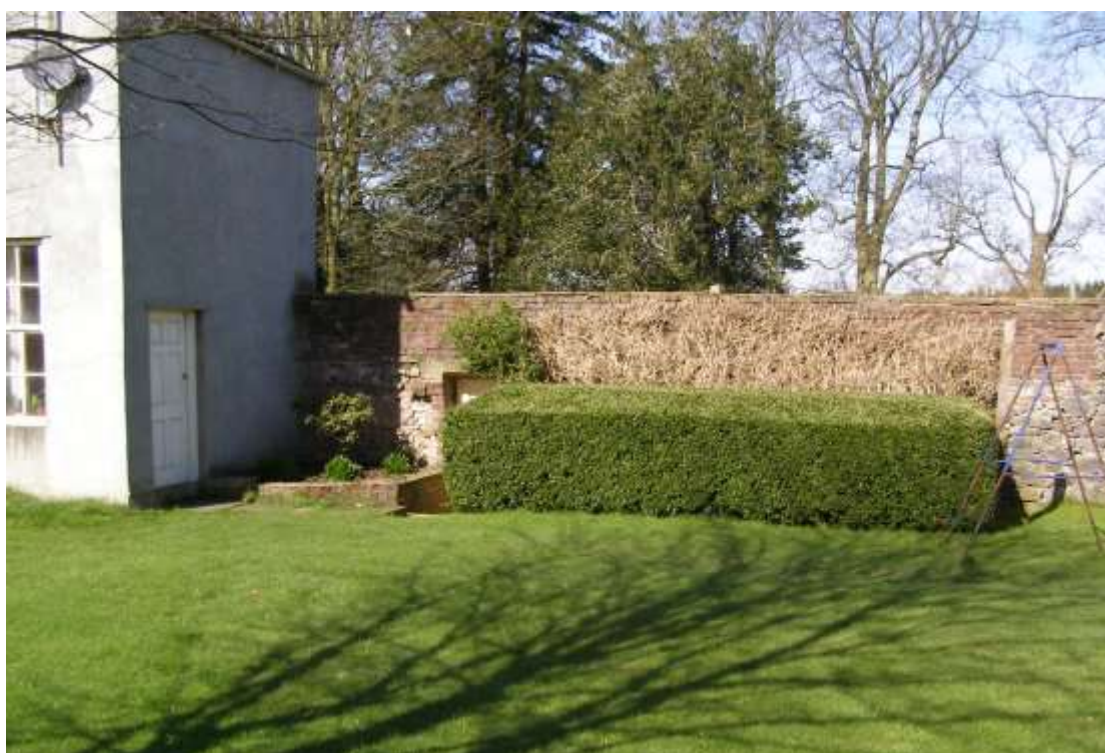
- 4.1.6 Extending east from the cottage is a short section of wall, orientated east/west, which again has a stone outer face and a brick inner face (Site **18**) (Plate 8). The north/south return of this wall is distinct in that it has a roughly coursed and roughly-dressed stone face on the inside, as well as the outside face. The differential treatment of this wall section might suggest that it was a later addition; however, the line of it is shown on the 1909 map. The wall now serves as the western face of a modern garage, and has had two windows inserted through it.

- 5.1.4 The section of garden wall that will be removed has two elements: an east/west section (Site 18) that retains its original character and has a brick inner face and stone outer face. It would appear that this was, from the outset, in a part of the garden that was intended to have a nursery function, as it includes a single plain, unornamented door, and contrasts with the elaborate entrance-way (Site 23) through the northern wall. The second element of garden wall is the north/south section (Site 19) (Plate 5) which has a stone-built internal face and has been incorporated into a later garage. The presence of the stone inner face would suggest that it has been rebuilt, at some stage, and possibly when the garage was constructed. As such, this wall has less archaeological significance than the east/west section of wall (Site 18).

Plate 8: The north-eastern section of garden wall (Site **18**) to the east of the Gardener's Cottage (Site **20**)

eighteenth/early nineteenth garden design. As such, the building would warrant being recorded by building survey prior to its demolition. At present any recording will be severely limited by the extensive external render and the internal plaster, and it will not be possible to remove any of the wall coverings until it ceases to be occupied. It is therefore recommended that a building survey be undertaken immediately before the development is initiated, when it will be possible to selectively remove the wall coverings to enable the recording and analysis of the underlying fabric. The building should be subject to an English Heritage (2006) Level 3 survey. At the same time a photographic survey should be made of the east/west section of garden wall (Site 18) once the ivy, covering its internal face, has been removed.

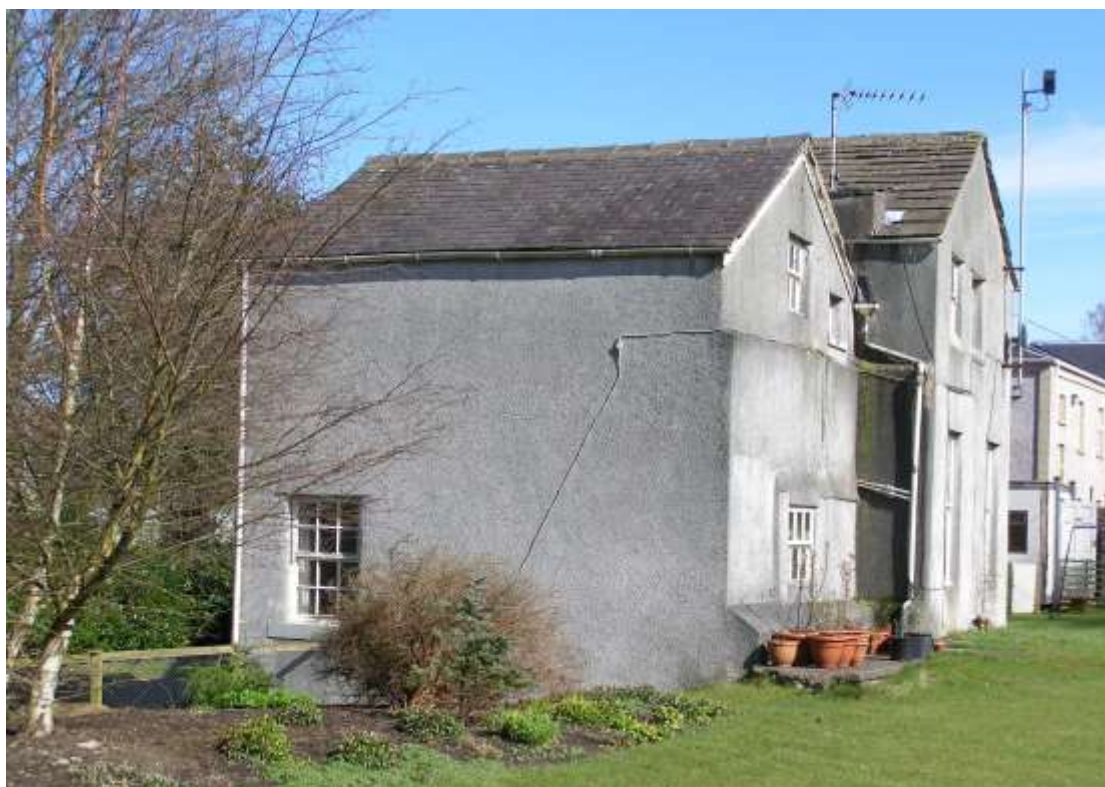
- 4.1.13 **Northern Buildings:** three buildings that projected northwards from the northern wall of the garden, as shown on the 1909 mapping (Figs 10 and 11), were no longer visible on the ground, although one of them was the 'turret' that contained the northern doorway (Fig 13; Plate 2). One further building that was depicted on the 1909 map, and which was no longer visible above ground, was an annex on the western side of the head gardener's cottage, in the north-eastern corner of the garden. This space was occupied by a flower bed at the time of the site visit (Plate 9).

Plate 9: The western face of the Gardener's Cottage (Site **20**) showing the gap where there had been a former annexe to the cottage

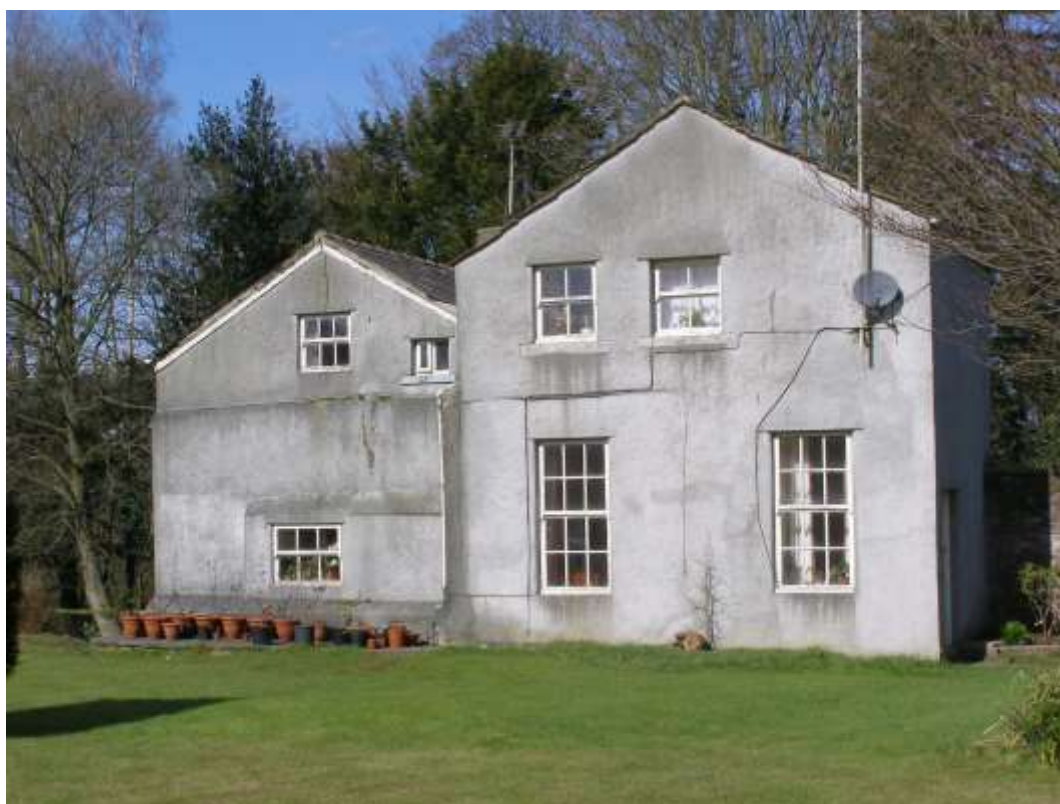
- 4.1.14 **Head Gardener's Cottage:** the cottage survived as a two-storey gabled building with slate roof tiles and a rendered exterior (Fig 13; Plate 10). The building consisted of two, slightly staggered, contiguous abutting structures with wooden-framed windows and stone window sills. Access to the interior of the buildings was not available at the time of the survey; however, it was evident that all internal walls were plastered and an inspection would not, in any case, have revealed very much. Although the walls have been externally rendered, it is possible to provide some comment on their construction. The two elements of the structure have a very different make-up of floor plan, shape, and windows. In particular, the westernmost cell has only two small six-light windows, and a very small two-light window, facing into the garden, whereas the side facing out of the garden had two large 12-light windows, a large 16-light window, and a small two light window. The principle façade of the building was evidently facing away from the garden, and may have perhaps reflected concern that the family, when enjoying the garden, were not overtly watched by the gardener. The eastern cell, interestingly, has a reverse situation. The principal windows are two very large 12-light windows (with two four-light windows on the first floor) facing out onto the garden, and on the opposite side, facing away from the garden, there are only two, small two-light windows. When this cell was constructed the principle façade was clearly facing towards the garden and reflects a very different change of emphasis from that of the western cell; it is evident that they were not contemporary. The easternmost cell has a thicker ground floor wall, and was possibly butted onto the westernmost cell; at a later stage this building was raised to add a first floor.

Plate 10: The southern face of the Gardener.s Cottage (Site **20**) showing the two distinct eastern and western cells

- 5.2.1 The development will have a limited impact upon an already severely disturbed garden and, as such, there are insufficient grounds for impeding the development; however, there is a case for the preservation by record of those elements of the landscape that will be most severely affected. The greatest impact of the development will be upon the Gardener's Cottage, which is a component of the late
