LIVERPOOL CANAL LINK, Liverpool, Merseyside

Archaeological Evaluation Report

Oxford Archaeology North

November 2006

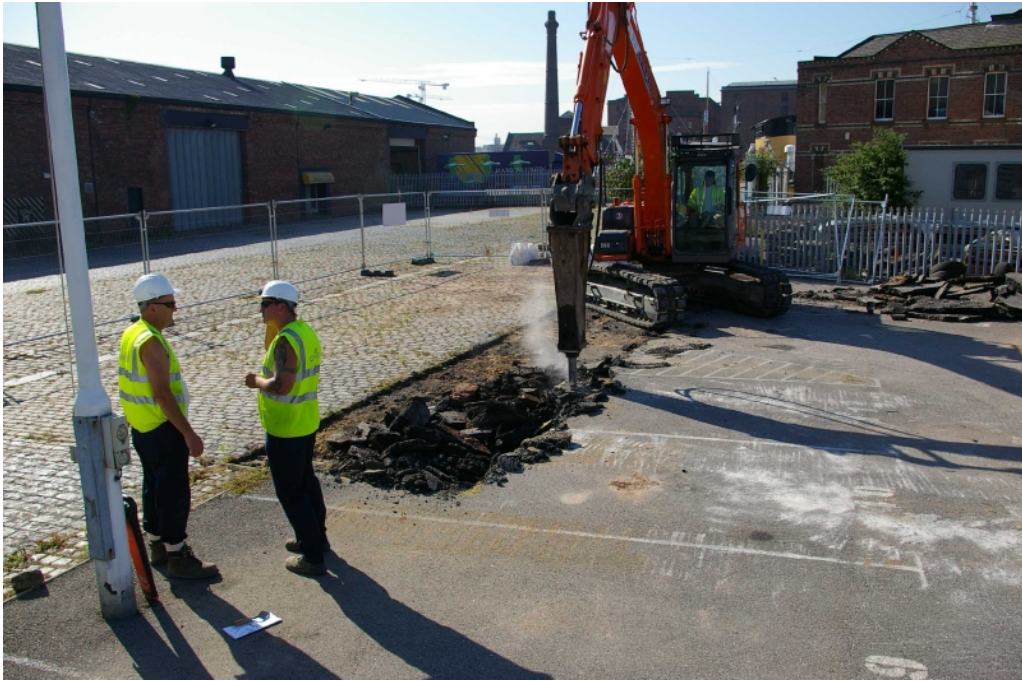
Plate 1: General working view of Trench 401, looking south-east

4.2.1 Trench 401 (Figs 3, 12, 13 and 14) was located to the west of the extant Mercedes Garage, and south of the Porsche Garage (Plate 1). The trench was on the edge of the proposed Mann Island development area, which is proposed to be immediately north-east of the Canal Link development area. As such it served to inform both developments and the results of this trench have been incorporated into the Mann Island evaluation report (OA North 2006). The trench was intended to investigate the eastern edge of Manchester Dock and the associated quay side. The trench was excavated using a 12 ton 360° excavator, alternating between a 1.8m ditching bucket and a smaller toothed bucket where required. The trench was aligned north/south, and measured 9.70m by 4.70m; it was excavated to a maximum depth of 2.00m with stepped and battered sides from a depth of 1.00m on the north-, south- and east-facing sections to allow safe entry and egress from the trench.

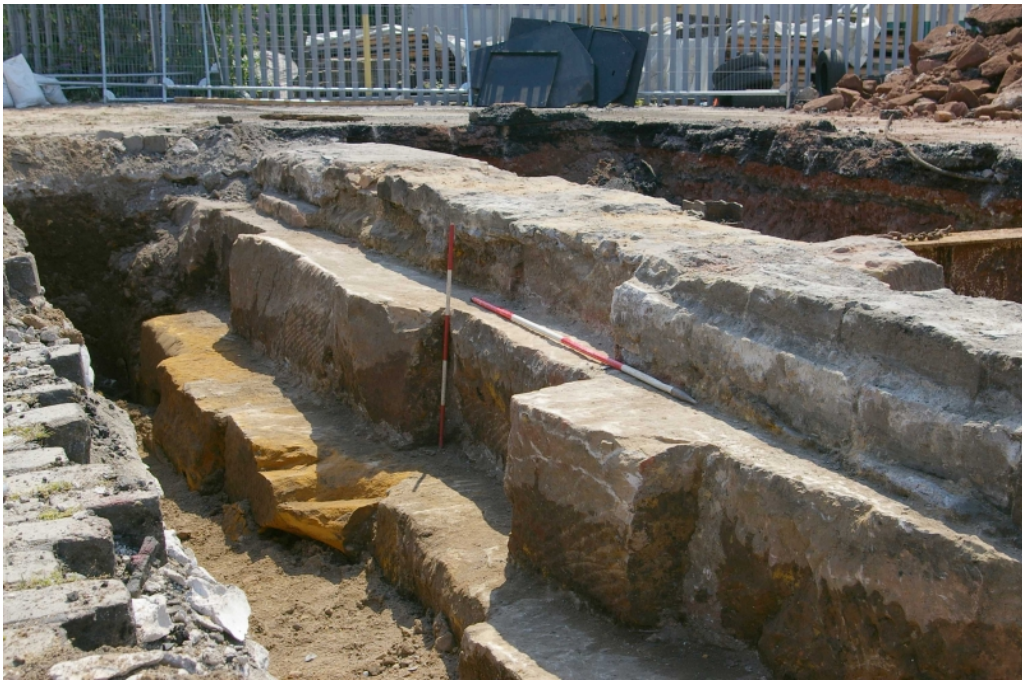
Plate 2: View of Trench 401 showing the rear eastern face of Manchester Dock wall, **3109**, looking south-west

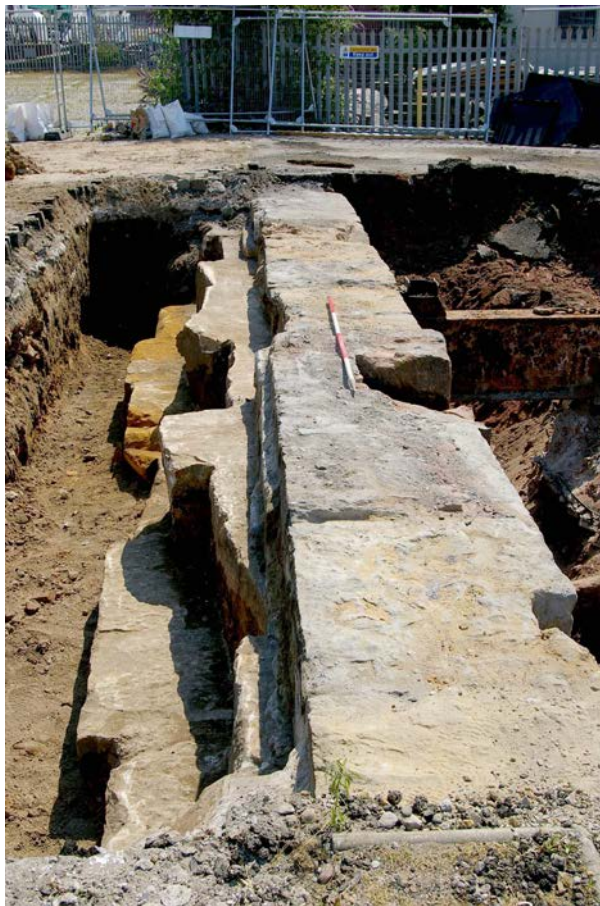
Plate 3: View of Trench 401 Manchester Dock wall, *3109* and girders *3121*, looking south

- 4.2.14 Overlying the dock infill **3111**, and the road surface **3119**, was a light grey reinforced concrete base, **3120**, which was laid to support structure **3121**, a series of very substantial iron beams orientated east/west (Plate 3). The beams formed a kind of prefabricated metal frame for a later GWR warehouse on the site of the infilled dock. Overlying this was **3122**, a heterogeneous backfill deposit consisting of loose brick demolition material mixed with mortar dust and a light brown sandy soil, which probably represents the demolition phase of the warehouses after they fell out of use.
- 4.2.15 Above this at the top of the sequence was the current car park surface **3123**, which was made of black tarmac and aggregates.

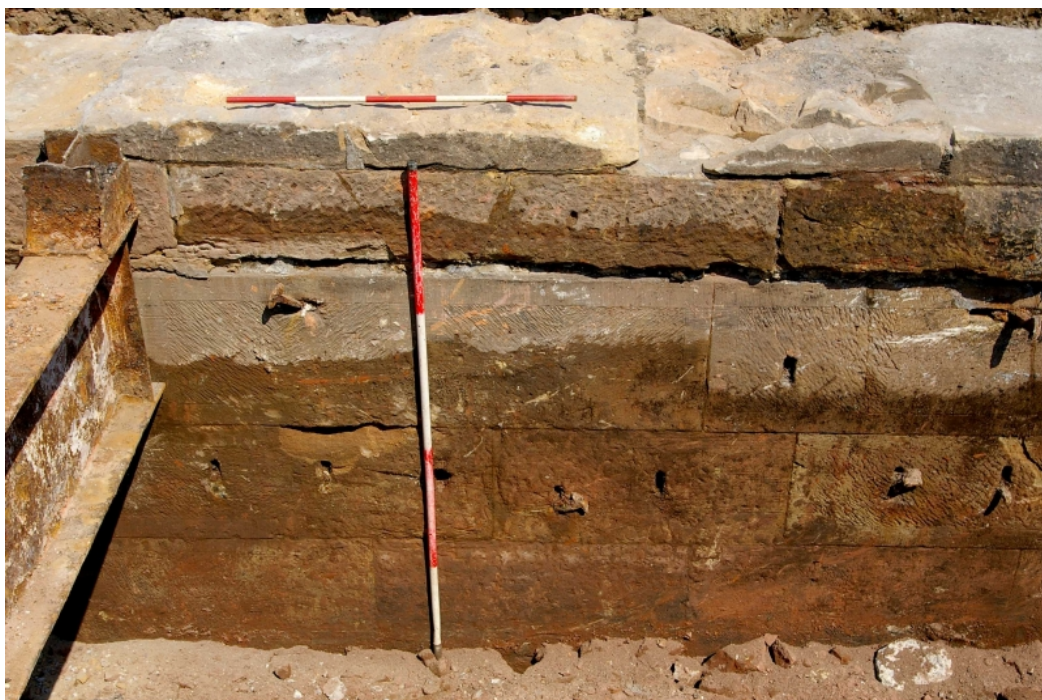
Plate 4: View of Trench 401 showing the front western face of Manchester Dock wall, *3109*, with part of the girder structure *3121*, looking east

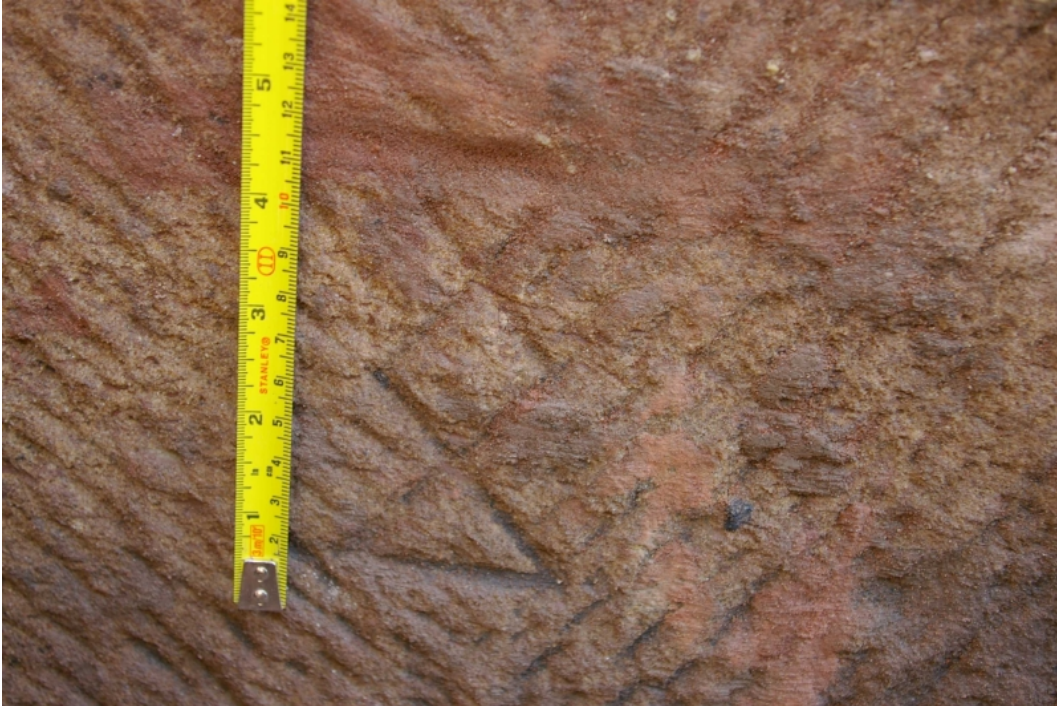
- 4.2.6 The west-facing elevation of the Manchester dock wall also exhibits numerous mason marks (Fig 13; Plate 5), of which four were observed during the course of recording. All were simple geometric shapes which would have been specific to each mason; the fact that there were four individual marks indicate that at least four masons worked the stone blocks that made up the Manchester Dock wall at this point.

Plate 5: View of Trench 401 showing a close up of a mason's mark on the western face of Manchester Dock wall, **3109**, looking east

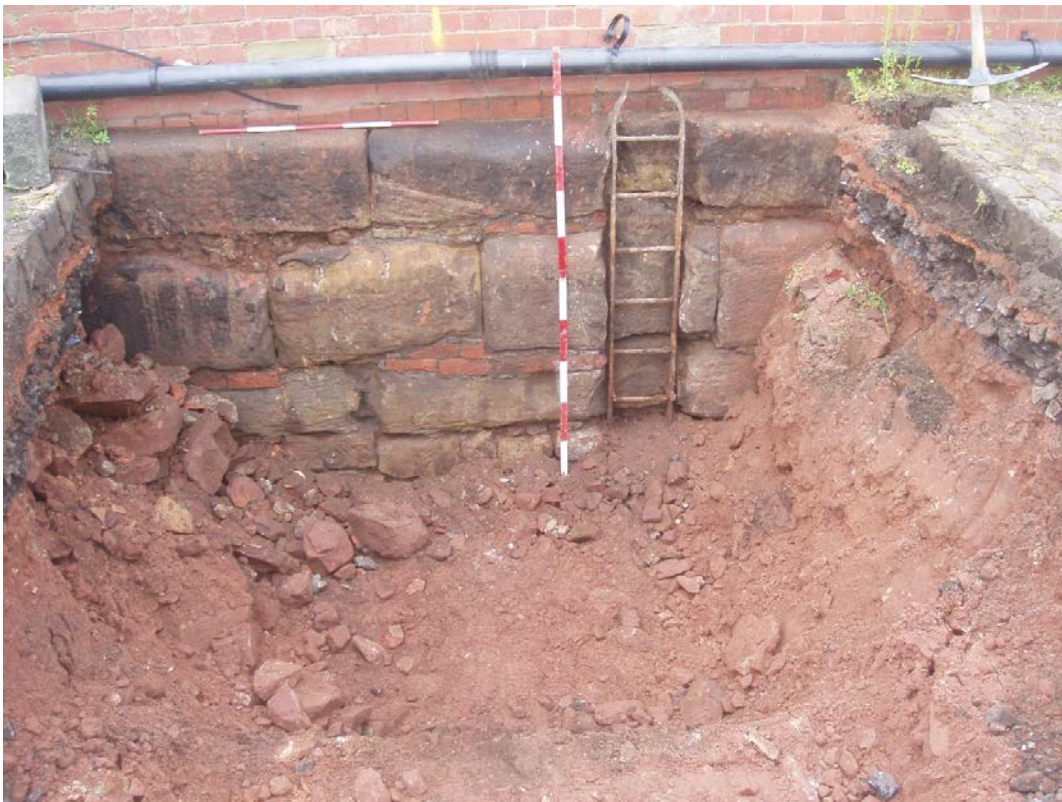
- 4.3.2 The earliest feature seen within this trench was a substantial wall, **3053** (Plate 6), constructed of large blocks of pink sandstone. The blocks were on average 1.1m long by 0.45m thick but the width of the wall was obscured by the GWR brick building which was constructed on top of the sandstone wall. The blocks were constructed in a cross bonded pattern and built courses, which varied somewhat in thickness. The finish of the visible face of the wall was smooth and the corners of each block had either been finished as rounded or have been worn to that form. The wall **3053** is consistent in form and location with the southern wall of Manchester Dock.

Plate 6: Trench 402, showing south wall of Manchester Dock, **3053**, below the GWR building, looking south

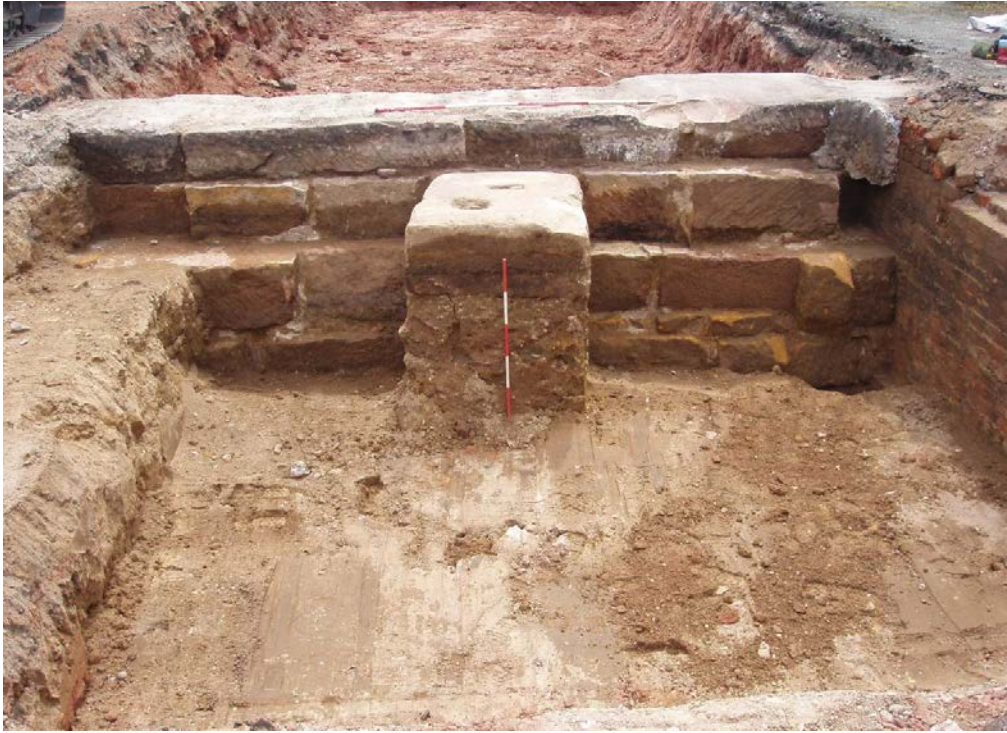
Plate 7: Trench 403, showing the rear face of the north wall of Manchester Dock, **3000**, the crane / jib base **3001**, and brick wall **3003**, looking south

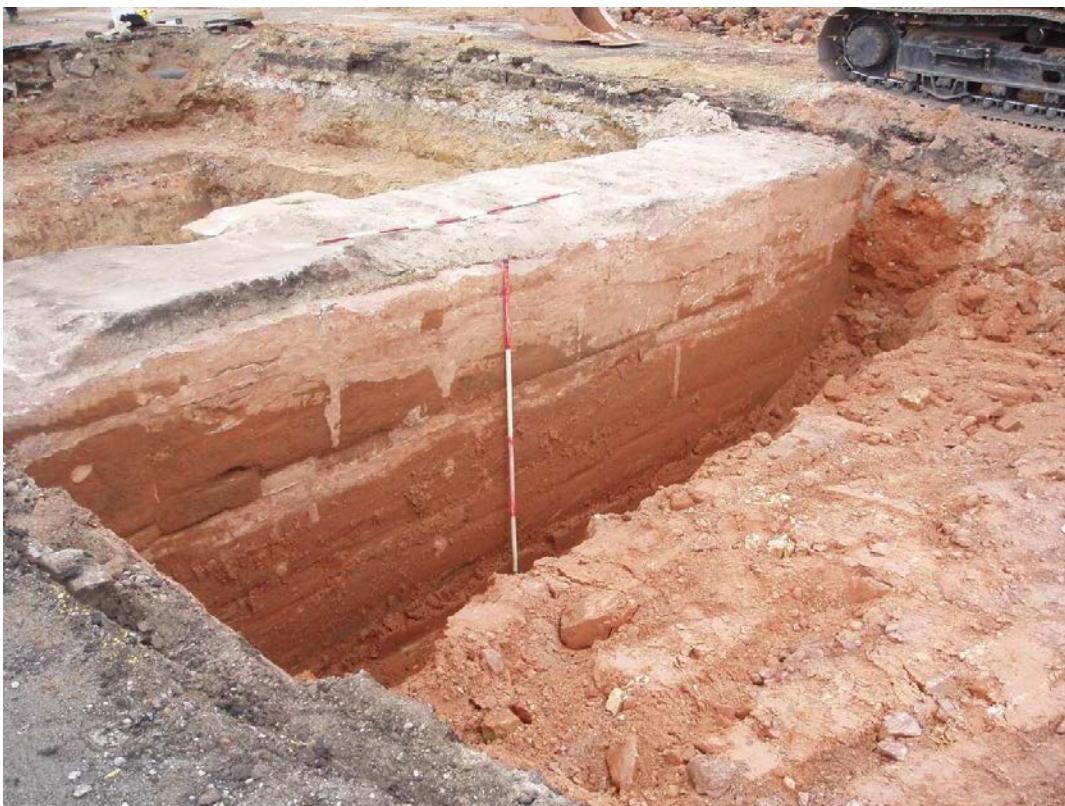
Plate 8: Trench 403, showing the front face of the north wall of Manchester Dock, **3000**, looking north-east

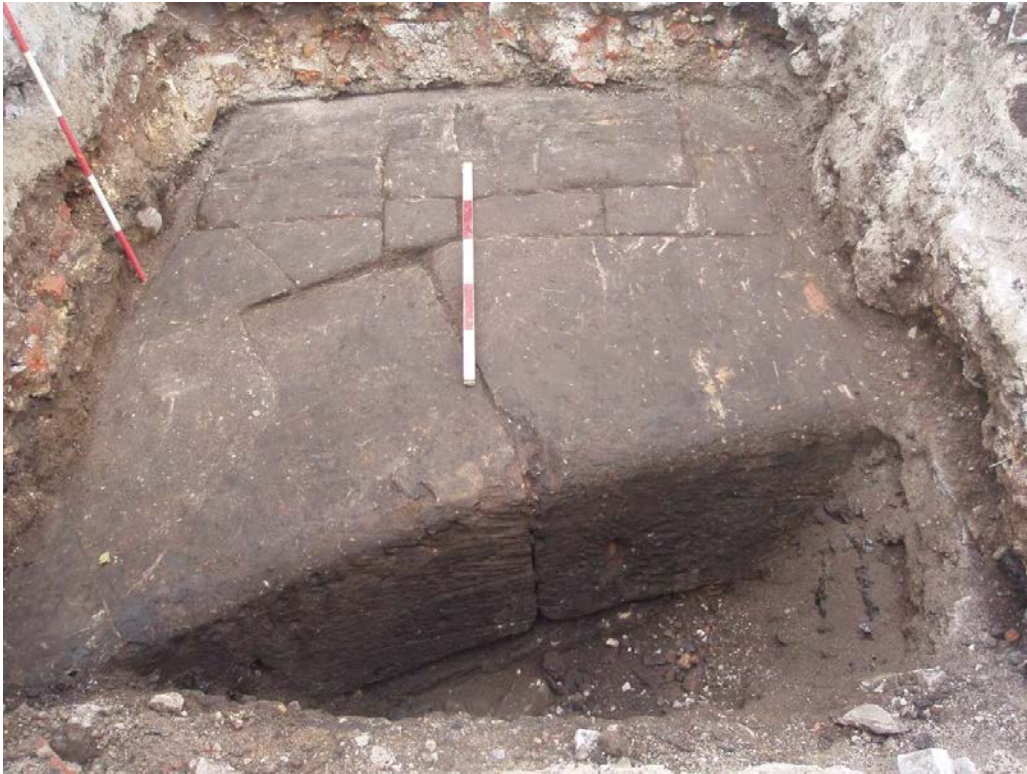
- 6.2.3 **Chester Basin:** Chester Basin was revealed in Trench 404 and was found to be in excellent condition. It survived to full height and the associated quayside was also present. The wall was constructed of large blocks of pink sandstone and at this point was seen to curve corresponding with the north-eastern corner of the dock.

Plate 9: Trench 404, showing the front face of the curved wall of Chester Basin, *3080* and the quayside, *3081*, behind, looking east

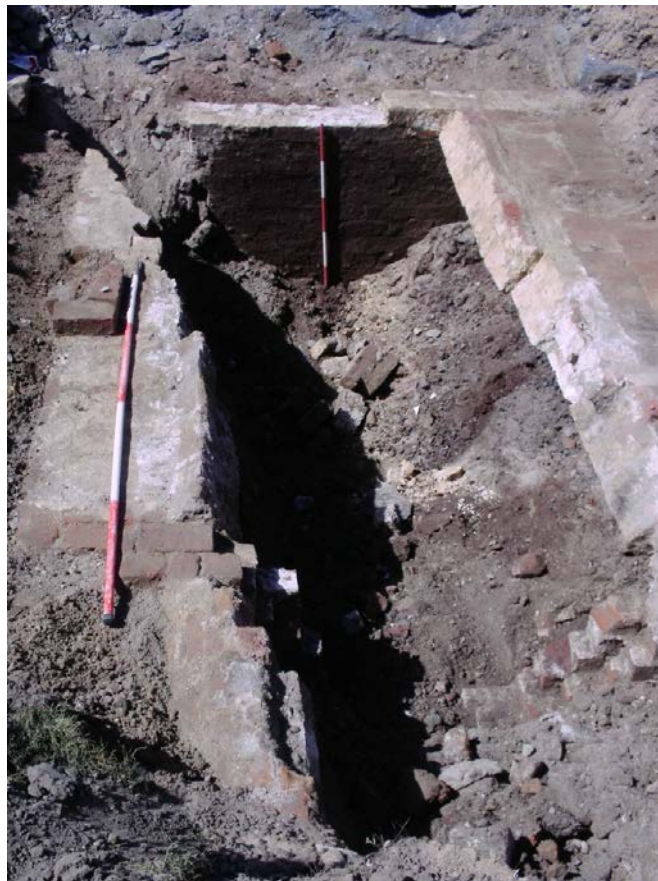
Plate 10: Trench 405 showing the culvert *3101*, looking north

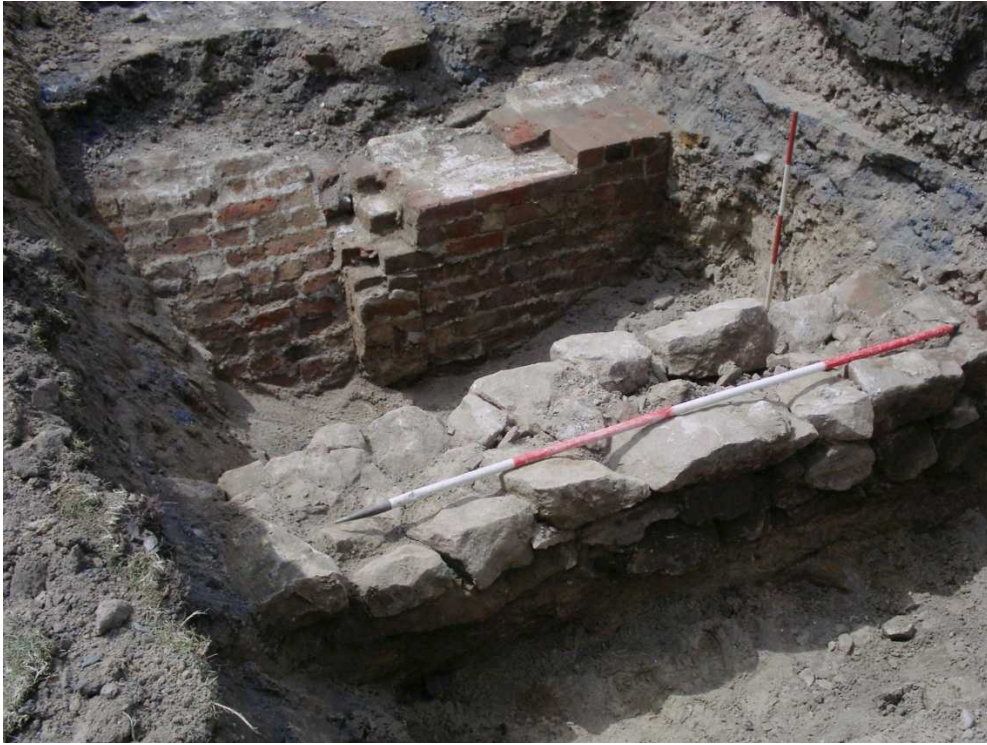
Plate 11: Trench 405 showing the brick culvert **3101**, and sandstone wall **3097**, looking north-west

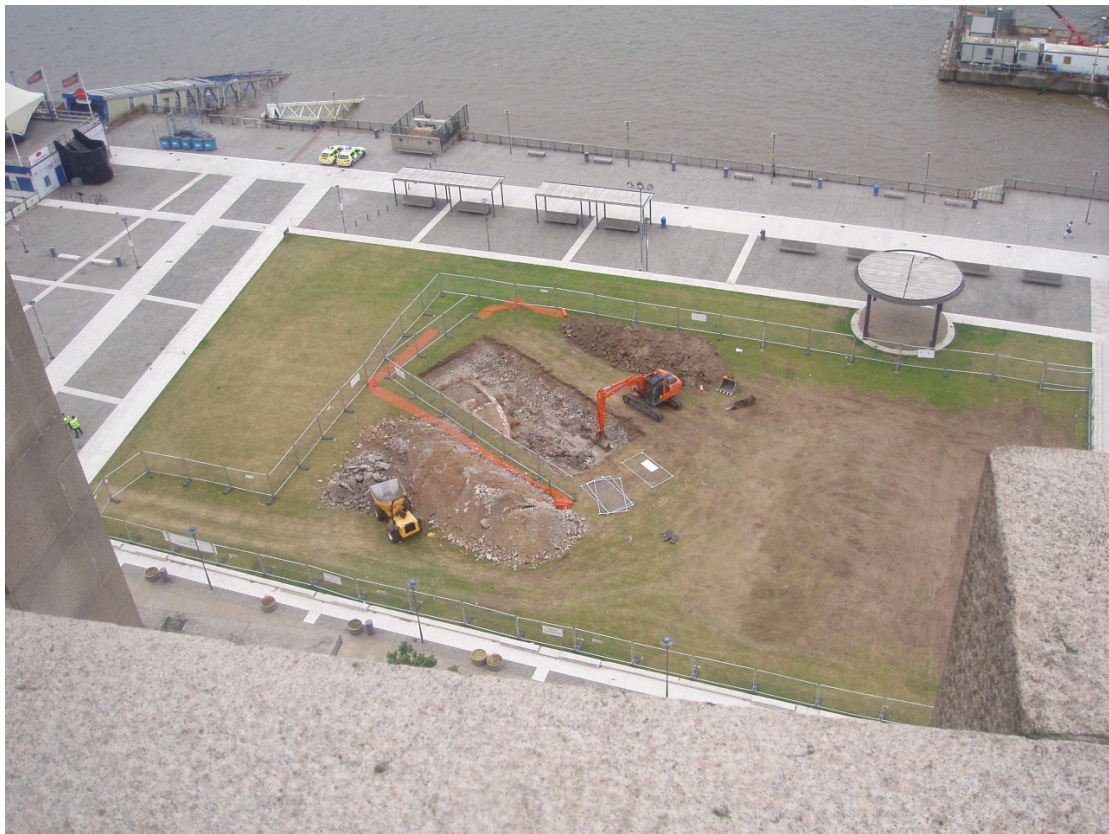
Plate 12: Trench 406, general view, looking west

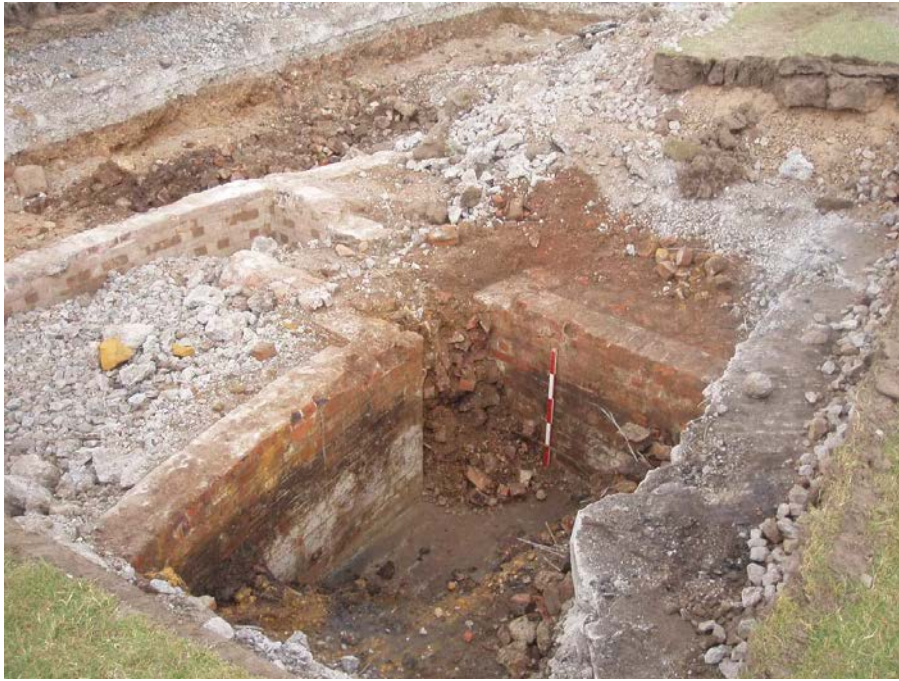
Plate 13: Trench 406, showing the various curved brick walls **3036-3039** and **3069-3071**, and concrete floor, **3050-3072**, looking north-west

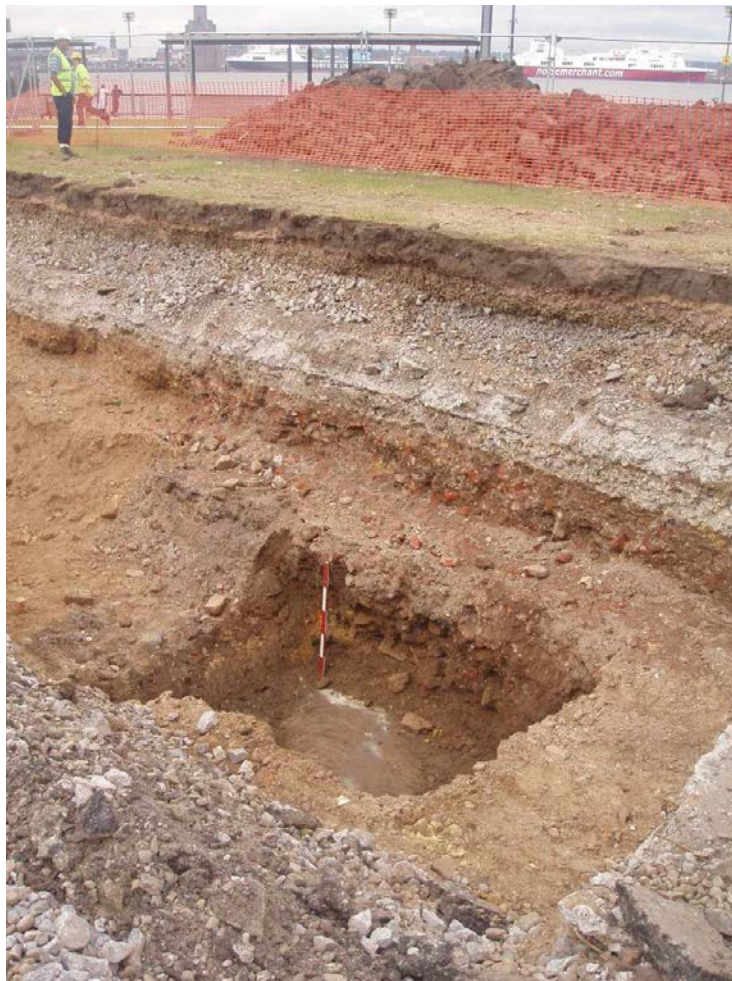
Plate 14: Trench 406, showing the large cut feature **3040**, with the concrete **3068** visible at the base, looking south-west

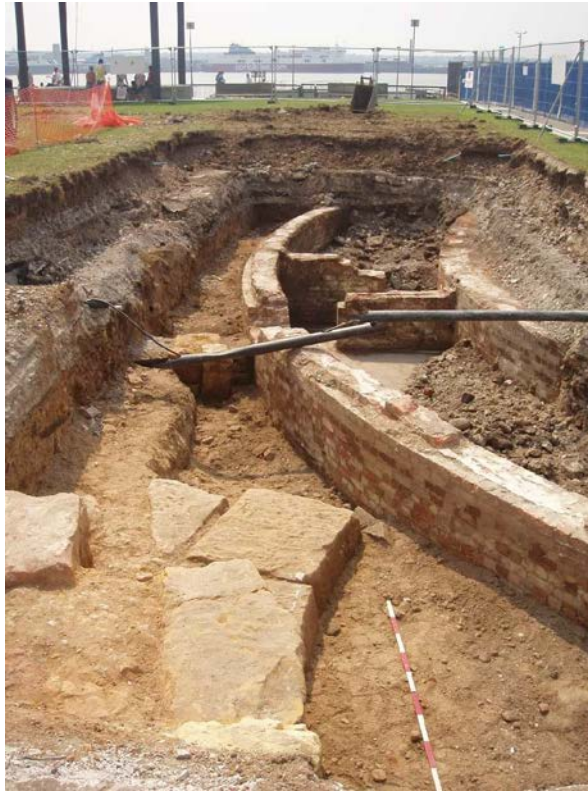
Plate 15: Trench 407, showing the curving sandstone wall **3015** of George's Basin and the later curved brick walls **3024** and **3030**, looking west

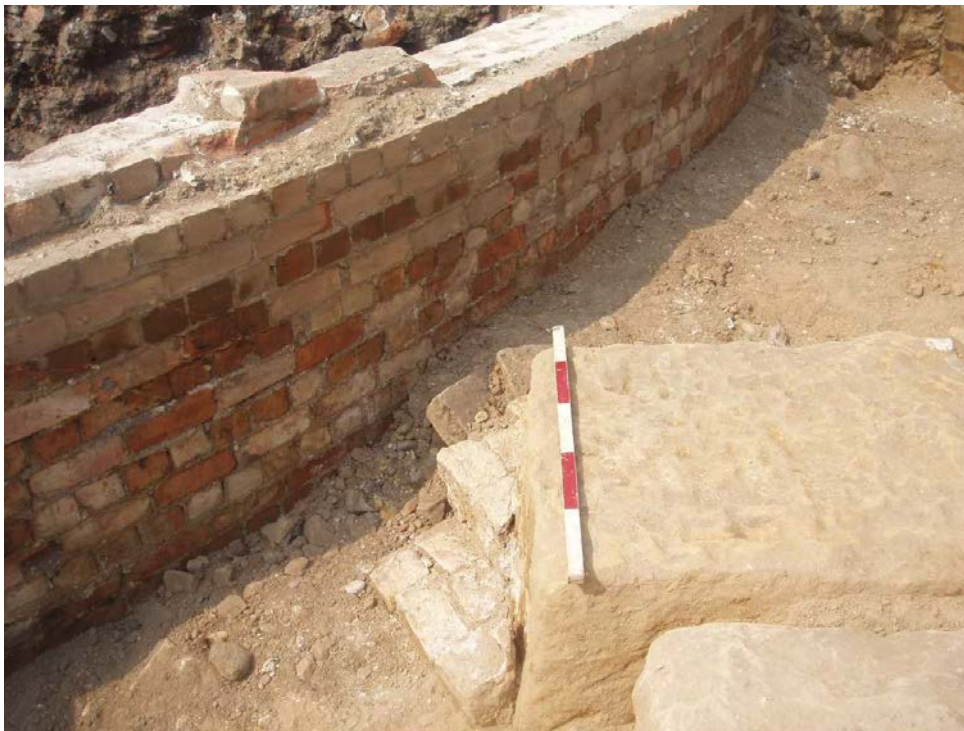
- 4.6.6 Possibly associated with this wall was a small section of brick wall, **3052**, abutting the visible western end of the wall **3015** (Plate 16). Brick wall **3052** was of similar brick and mortar construction as wall **3020** and may have run east / west. There is a trace of mortar on the upper surface of **3015** between walls **3052** and **3020** and it is suggested that these two brick walls were associated, being parts of the same structure, and constructed using the yellow sandstone wall **3015** as foundations. Wall **3052** was truncated by the brick circular structure, **3024**.

Plate 16: Trench 407, showing the curving sandstone wall **3015** of George's Basin, abutted by brick wall **3052** and truncated by the later curved brick walls **3024** and **3030**, looking north

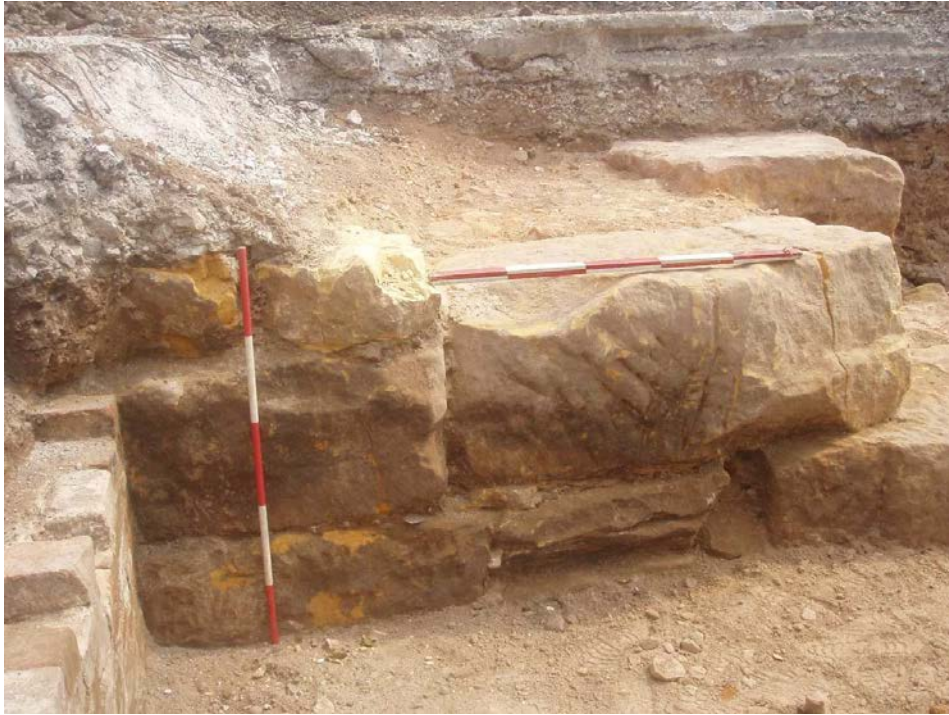
Plate 17: Trench 407, showing the curving sandstone wall **3015** of George's Basin, looking south

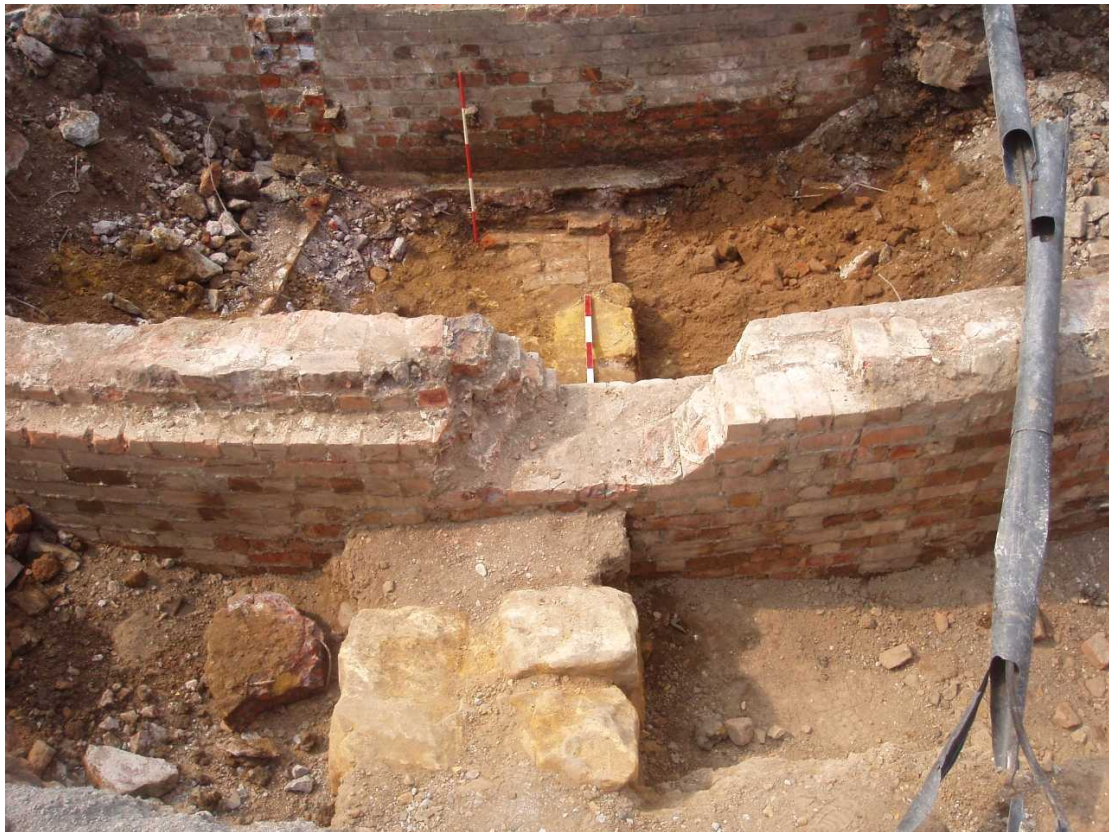
Plate 18: Trench 407, showing the yellow sandstone wall **3018** running north / south, truncated by the later curved brick walls **3024** and **3030**, looking north

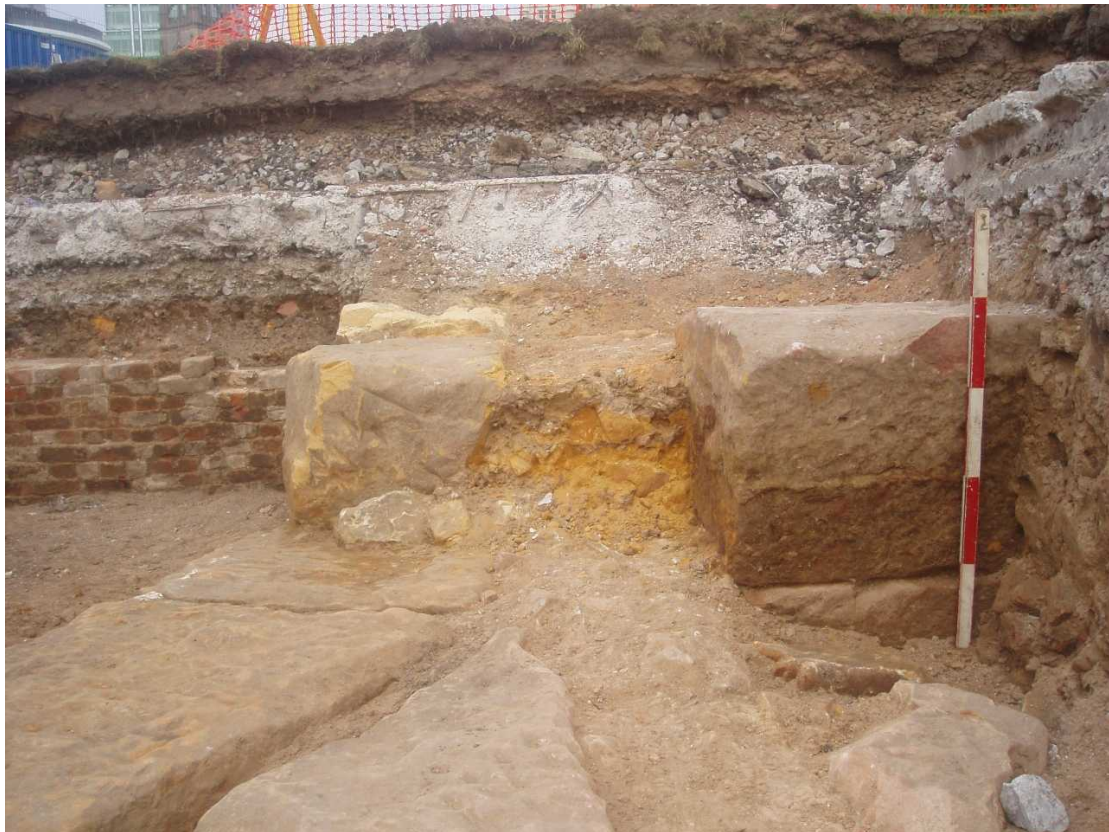
- 4.6.5 Abutting the yellow sandstone dock wall **3015**, at the east end of the trench was a brick wall, **3020** (Plate 19), that ran for over 2.45m north / south; this wall clearly post-dates the dock wall. Wall **3020** was constructed of hand-made, unfrogged mid-red bricks, built in an English Garden wall bond with buff coloured sandy lime mortar; it was 0.6m wide (three headers wide) and over 0.68m deep (nine courses). The western face of the wall was in good condition and the masonry was well dressed indicating that it was an exposed face. The wall is consistent with a building or standing structure but none is shown on any of the historic maps in this position.

Plate 19: Trench 407, showing from left to right the brick wall **3020**, the curving sandstone wall **3015** of George's Basin, and the pink sandstone pillar **3016**, looking east

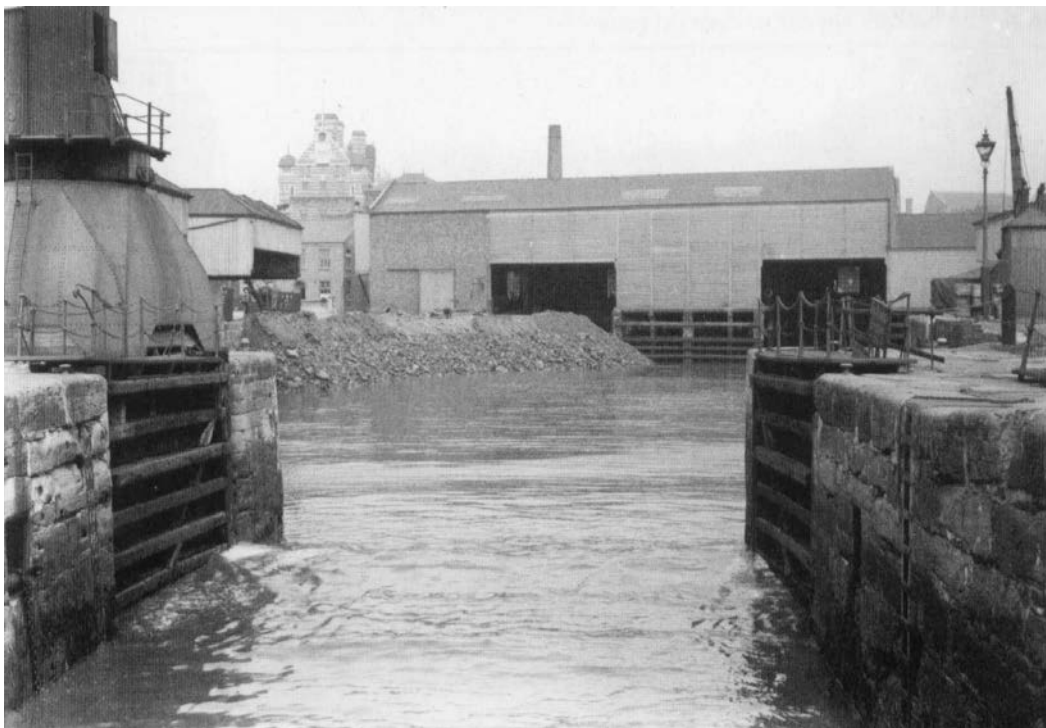
Plate 20: View of Manchester Dock, with overhanging warehouse in 1929, looking east from the dock entrance
