NINE STANDARDS, KIRKBY STEPHEN, CUMBRIA

Archaeological Desk- Based Assessment Report

Oxford Archaeology North

February 2005

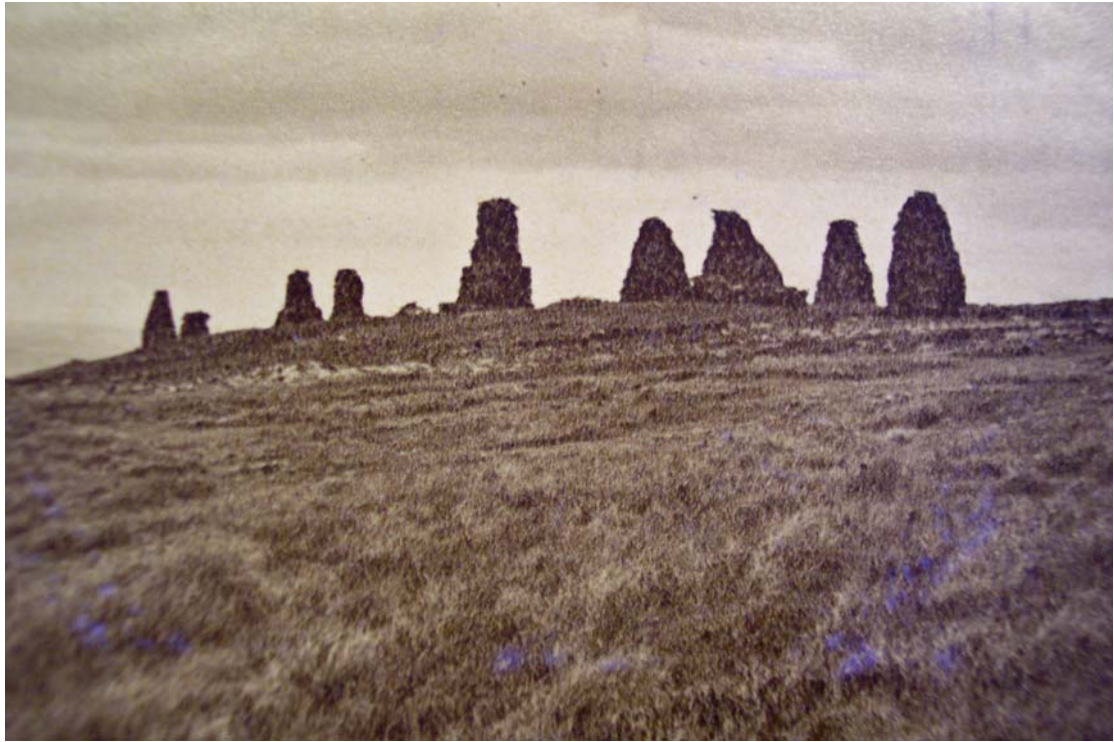
Plate 1: Postcard of Nine Standards, 1918, looking north-east

- 3.3.11 By the early twentieth century, the first known photograph of Nine Standards eliminates the need for a reliance on textual description. A postcard from 1918 (Plate 1; CRO(K) WDX/882/A/2/53) shows the nine cairns, and they can be numbered with ease from right to left. The third is notable for the platform that surrounds its base, and the fifth also has a low, wide platform at its base with a sharp decrease in girth around halfway up the cairn. Between the fifth and sixth is a small pile of stones, possibly a collapsed or recently started cairn. An undated photograph of early twentieth century date (Plate 2; CRO(K) WDX/882/A/1/66) is taken from a similar position to the 1918 postcard, but probably post-dates it. The platform around the third cairn has been built up, and other minor changes are visible in the profiles of the cairns.

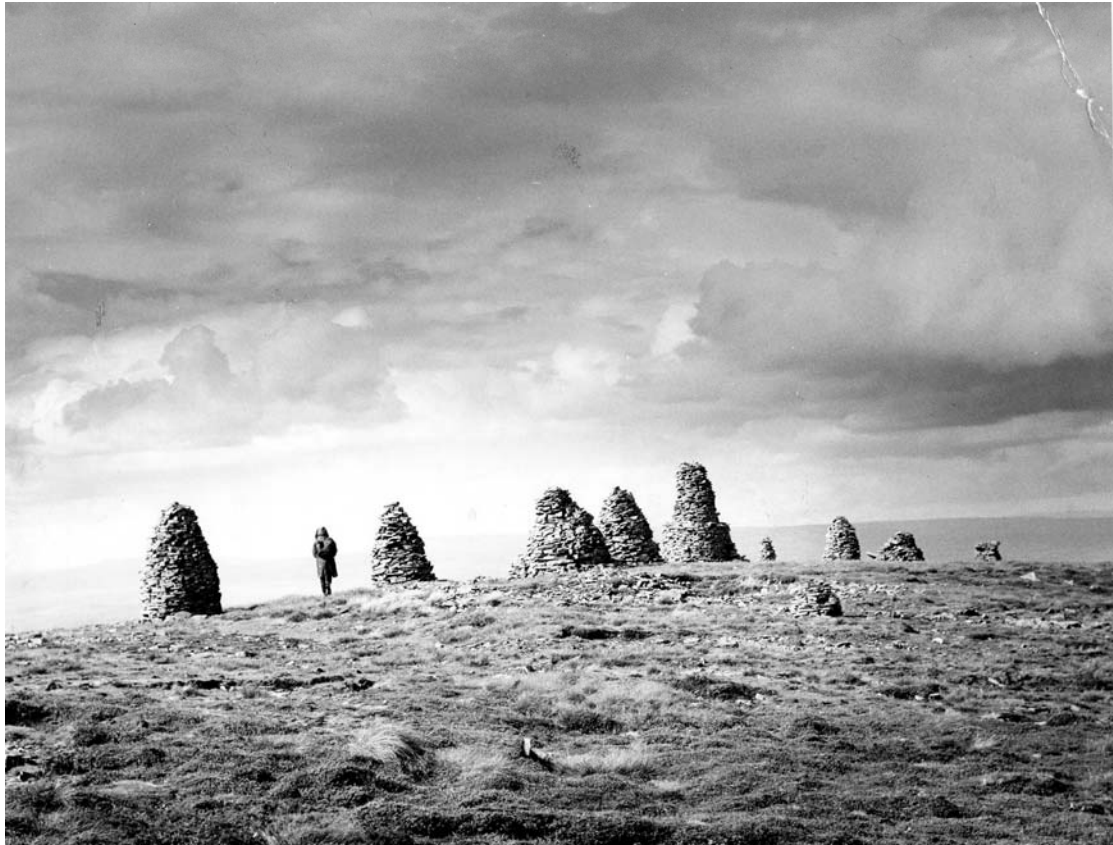
Plate 3: Photograph of The Nine Standards, 1974, by Geoffrey Berry, looking north-west

- 3.3.12 By 1974 the pile of rocks between the fifth and sixth cairn appears to have been built up, and the seventh cairn to have collapsed (Plate 3; Berry 1974). The view does not show the ninth cairn, and a sketch from 1980 also omits it (Plate 4; Wainwright 1980). Other postcards of this general period show a similar configuration but are undated and so do not reliably contribute to an understanding of the cairns development (eg Boardman nd). A walkers’ guide from around this time states that some of the cairns were large and one had a good stone shelf to sit on around its base (Sowerby and Sowerby 1979, 27). A few years later, another guide describes the cairns as follows: ‘*The cairns are of differing sizes, one considerably taller than the rest. The shape of each is similar, round with a base some two to three feet high, but continuing up to eight or nine feet. Some ingenious fell-walkers have attempted to raise a tenth cairn, but it has reached a height of only about four feet, so far*’ (Finch 1982, 61). Small changes to the profiles can also be noted in later photographs (Plate 5 (Anon 1994, 1), Plates 6 and 7).

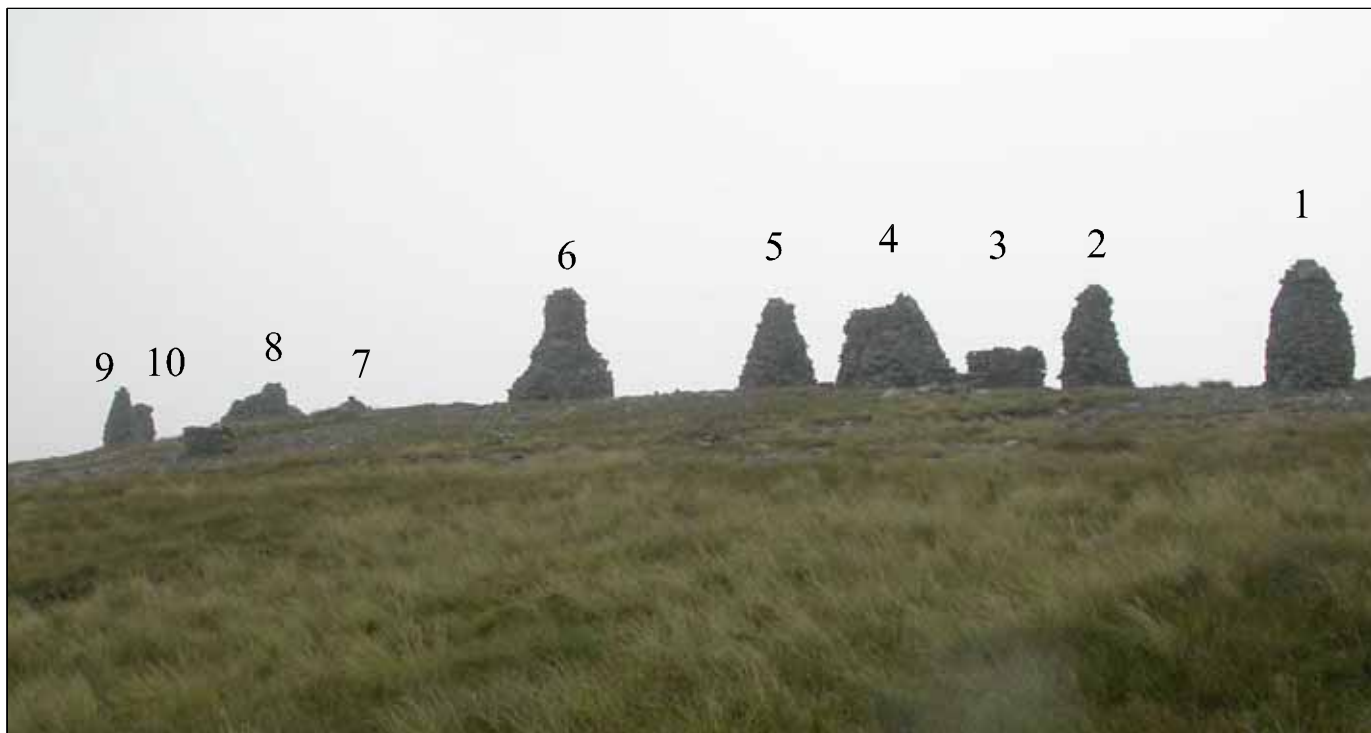
Plate 9: General view of Nine Standards cairns looking east

- 4.2.1 The cairns are numbered from north to south, as shown in Plate 9. They are briefly described below primarily as an assessment of condition. No detailed measurements were made.

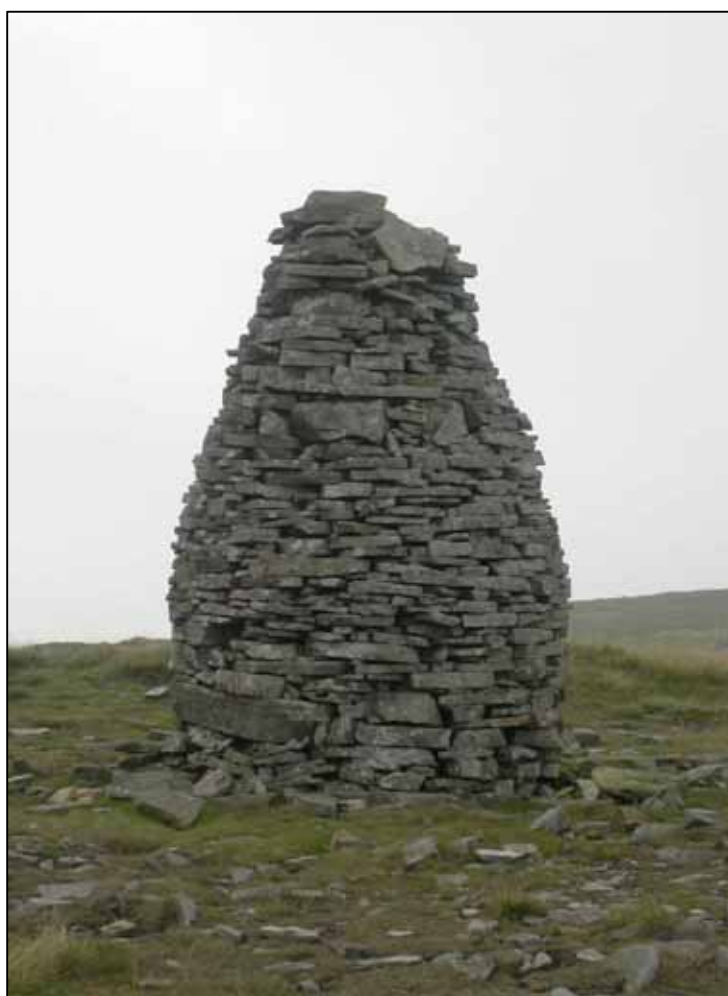
Plate 10: View of Cairn 1, looking south

Cairn 1: a large bee-hive shaped dry-stone cairn (Plate 10) has been very carefully manufactured and is in a superb condition. There is little or no collapse on the ground and only occasional gaps in the dry-stone surface. The shape of the cairn has not changed significantly since the 1918 photograph (Plate 1), and it would appear that it has not been subject to any rebuilding. However, the 1994 photograph (Plate 5) shows it as being ragged around the top, whereas it is now relatively tidy, indicating that it has been subject to limited repair.

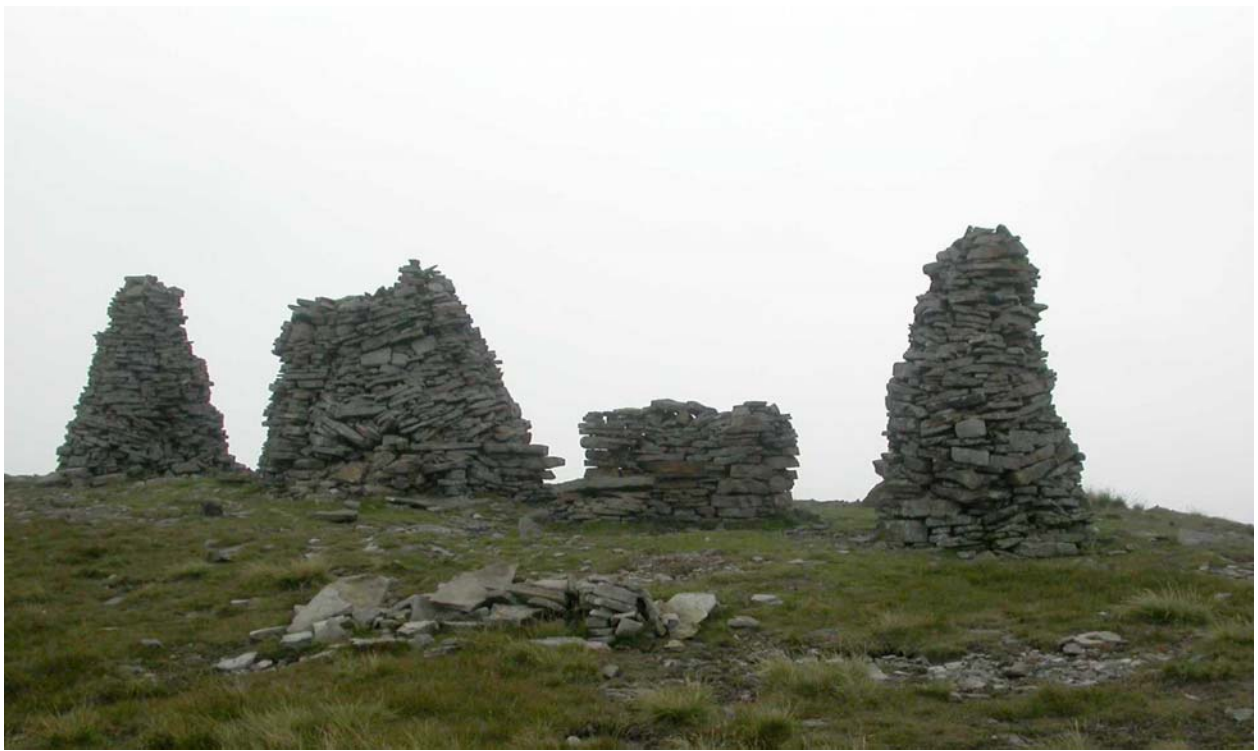
Plate 11: View of Cairns 2, 3, 4 and 5 looking north-east

Cairn 2: this is a large irregular cone-shaped, dry-stone cairn (Plate 11). The 1918 photograph (Plate 1) shows it to have a relatively uniform profile, in contrast to the very irregular profile at present, and it is evident that it has been the product of a number of repairs. At present there is no collapse at its base and it is intact; however, by virtue of the clearly repeated repairs, it is in a weakened state by comparison with other cairns which are more original and therefore have a more integral structure, such as Cairn 1.

Cairn 5: a large conical cairn (Plate 11) has a uniform profile, which is very similar to the profile that it had on the 1918 (Plate 1) and 1974 (Plate 3) photographs. The lack of irregularities in the profile would suggest that it has not been subject to casual repair, and there is a lack of collapse at its base which would suggest that there has been no recent deterioration.

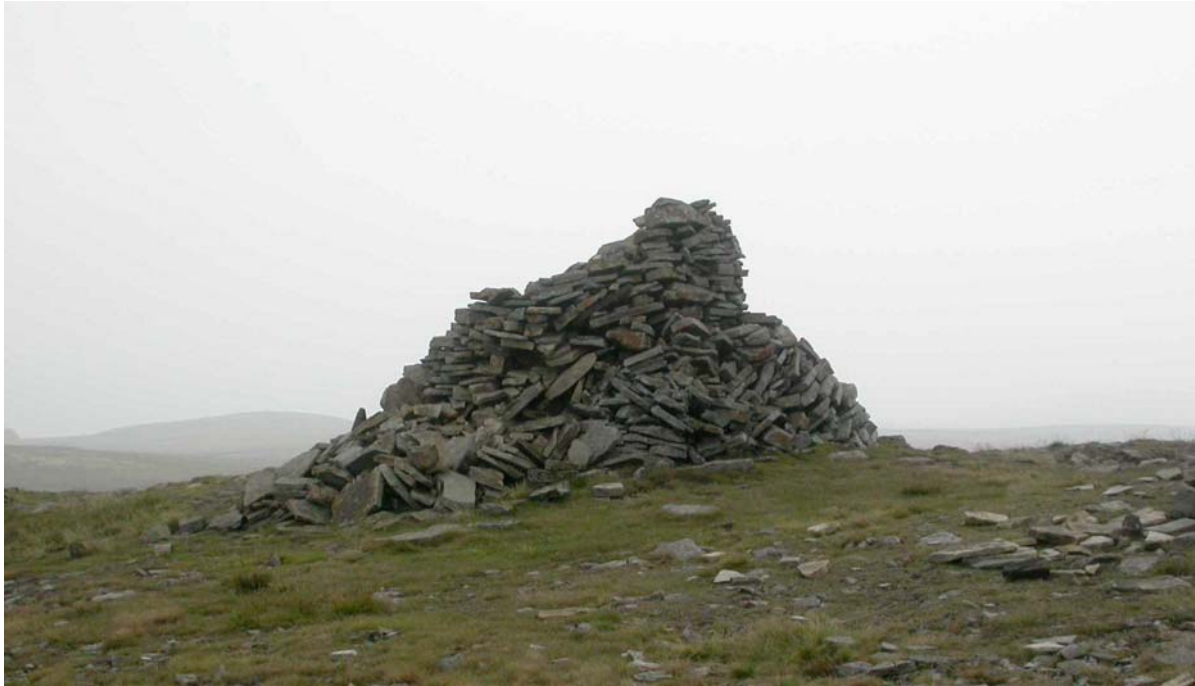
Plate 13: Cairn 8 looking north-east

Cairn 8: a very collapsed mound of stones has a residual and reduced column of intact dry-stone masonry in the centre (Plate 13). The 1918 photograph (Plate 1) shows the cairn as intact, and at this date it had a stepped profile, with a wide circular base, and a tall pinnacle on top; as such it was similar in profile to Cairn 6. By 1974 the cairn had been rebuilt into a beehive-shaped dry-stone cairn (Plate 3) and at that date was intact. An undated but relatively modern postcard also shows the cairn as intact, which may be an indication that the collapse occurred relatively recently. There is little indication of the beehive shape in the surviving remnants of the present cairn, which is probably the remains of the cairn's core.

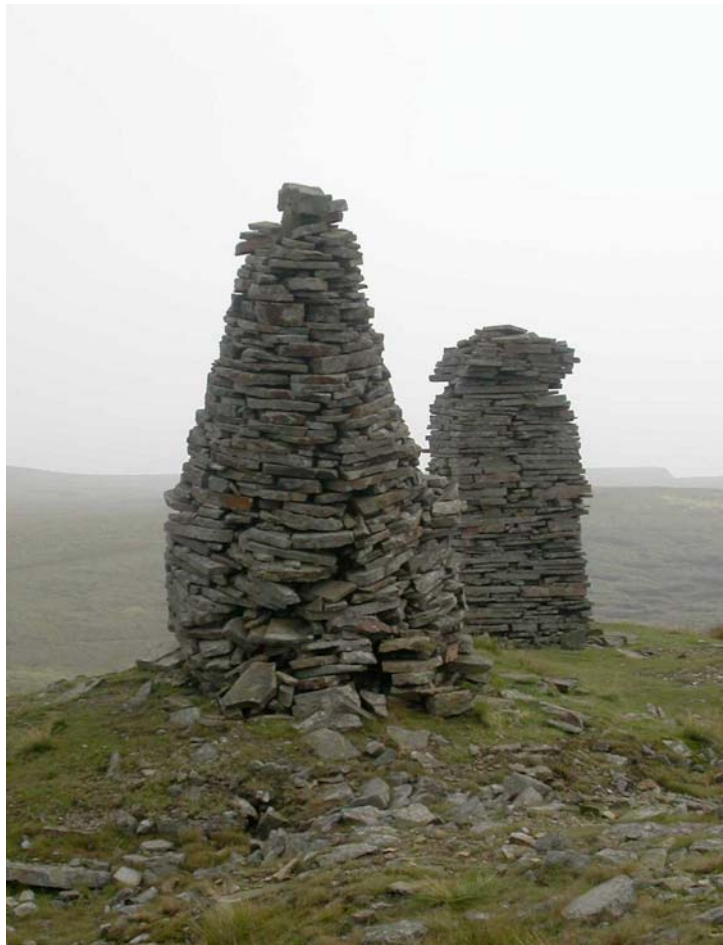
Plate 14: Cairn 9 with Cairn 10 in the background, looking north

Cairn 9: Cairn 9 has a drum base with a conical top (Plate 14). It is in very good condition, and there is little or no collapse at its base. It bears a great resemblance to the cairn depicted here on the 1918 photograph (Plate 1), yet in subsequent photographs it seems very different (eg Plate 3). The 1974 photograph (Plate 3) shows a wide drum, then a step in with a partly collapsed stub of a pinnacle cairn on top, and in the later postcard, whilst showing the cairn in better condition, it has a sloping shoulder leading to a narrower drum-shaped section on top. Given the very considerable changes in form over the twentieth century it must be concluded that the cairn has been rebuilt on many occasions. The fact that the last rebuild bears such a striking resemblance to the cairn in 1918 may be an indication that this or a similar photograph was available to the cairn builders during cairn restoration and that they deliberately tried to model it on its earliest recorded form.

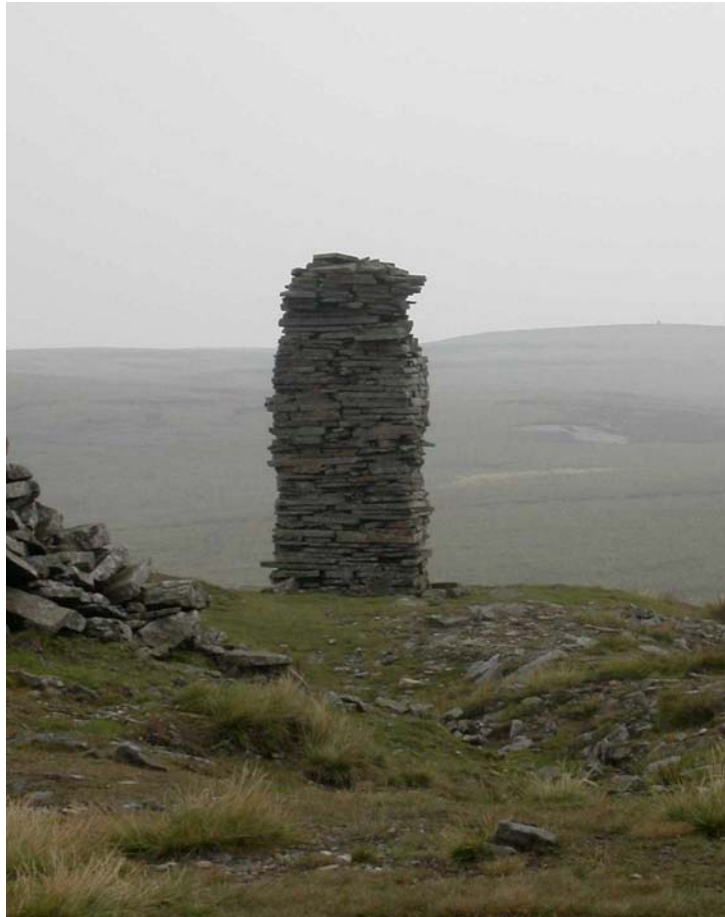
Plate 15: Cairn 10, looking north

Cairn 10: a square-sectioned, vertical profiled dry-stone cairn (Plate 15) is in extremely good condition and there is no sign of collapse at its base. There is a slight narrowing just below its top, which gives it a characteristic shape. It is not quite as high as the adjacent Cairn 9. Although only the top of the cairn is visible on both the 1918 and 1974 photographs (Plates 1 and 3), the shape of the cairn top is very similar to that surviving at present, and it would therefore appear that the cairn did not significantly degrade nor has it been repaired, during this period.
