BARROW PORTS REGENERATION PROJECT, CUMBRIA

Archaeological Evaluation Report

Oxford Archaeology North

May 2005

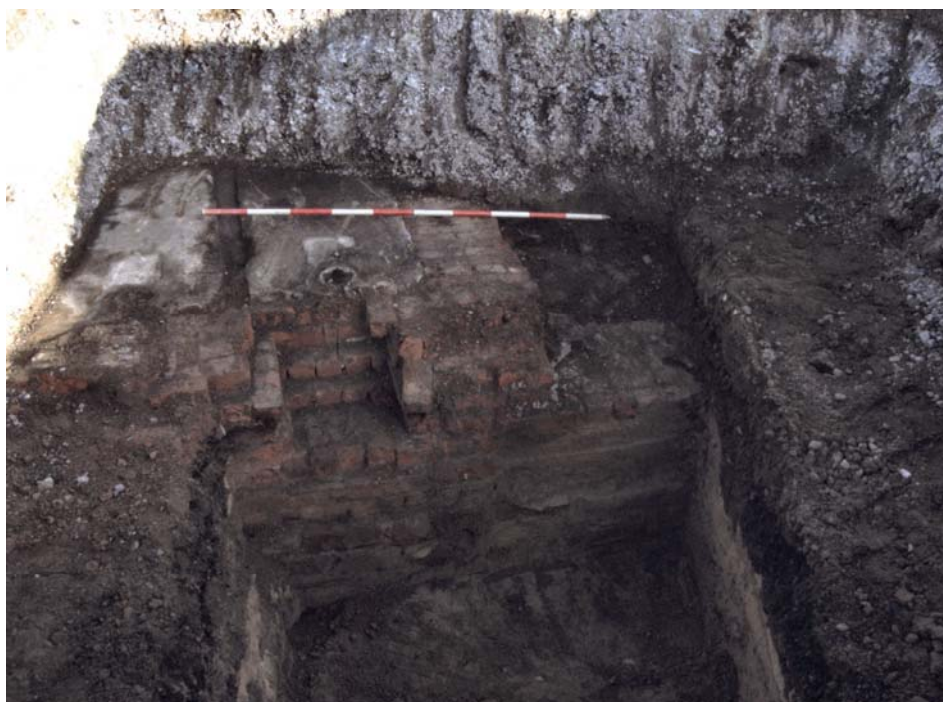
Plate 3: View of probable toilet block in Trench 6

- 5.1.3 Trench 6 can be seen to be located across the east wall of the large warehouse-like building, with the expanded sondage area straddling the wall. It is possible that wall **605**, encountered within the sondage, represents the foundations of this feature while the observed drainage features could represent a toilet block added to the outside of the structure. If these are the remains of toilets, the position of the drainage pipes would indicate that they were accessed from outside. While identification as a toilet facility is most likely, the possibility that the structure has some function relating to the adjoining entrance, which was serviced by a length of railway track, cannot be discounted.

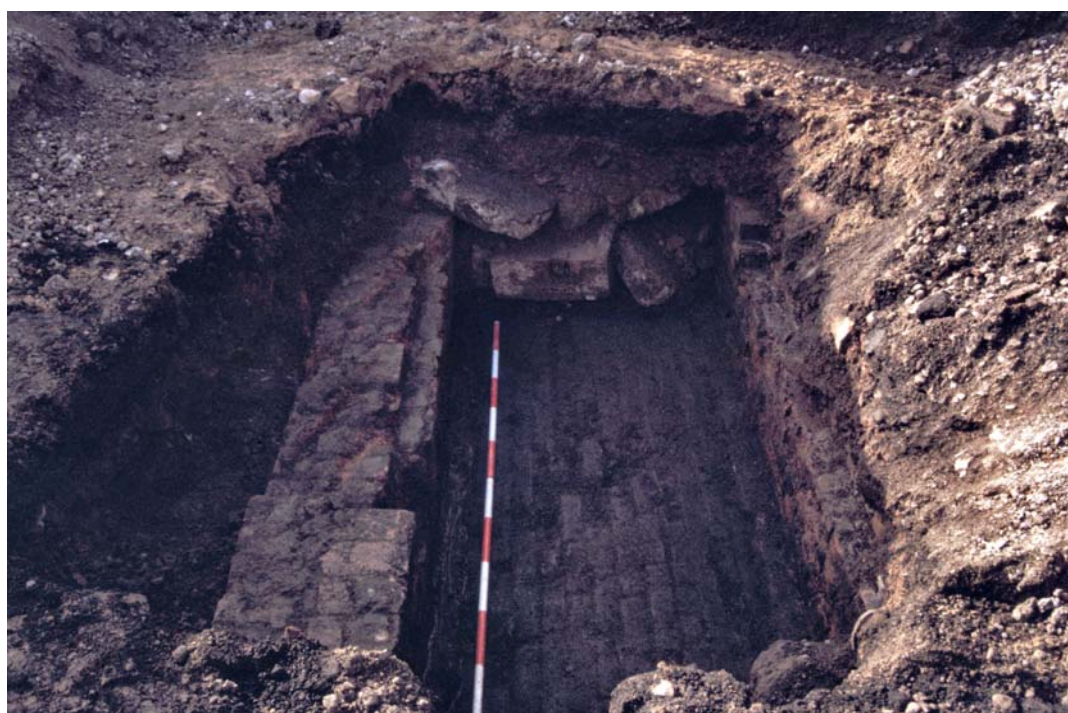
Plate 4: View of probable culvert in Trench 22

- 3.2.8 **Trench 22:** the trench was aligned north/south, with a 4m by 3m sondage machine-excavated at the northern end. Beneath a 0.3m thick deposit of soft, light brown silty-sand topsoil, **2201**, a 1.05m thick layer of slag, **2202**, was recorded. Beneath this was a black sandy-silt layer containing large amounts of demolition debris, **2203**, which in turn lay on top of **2204**, a 0.19m thick layer of loose light-brown sandy-silt containing frequent small angular stones. Beneath this was a layer of bricks and large lumps of concrete within a matrix of clinker, **2205**, which was up to 0.5m thick. Removal of layers **2204** and

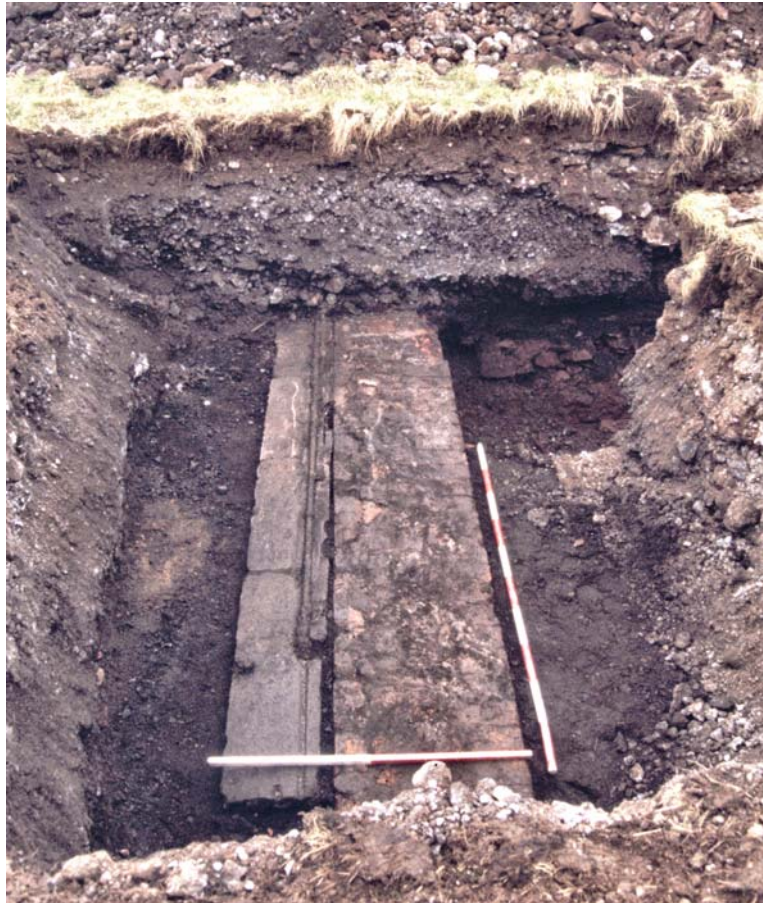
Plate 5: View of wall and iron pipe in Trench 23

- 3.2.9 **Trench 23:** the trench was aligned north/south and measured 8m by 1.6m and had a sondage (4.5m by 2.5m) excavated at the southern end. The mid-brown sandy-silt topsoil, **2301**, was 0.2m thick and lay above a 1.1m thick deposit of slag, **2302**. Beneath the slag was a narrow, 0.1m thick, band of soft black sandy-silt with brick flecks. Removal of this layer revealed, for a length of 4m, a 0.6m wide brick wall, **2307**, which had a height of eight courses, and a slightly stepped out sandstone foundation (Plate 5). Abutting, and running adjacent to, wall **2307**, was a linear structure, **2308**, which comprised limestone blocks, measuring on average 0.80m x 0.40m x 0.23m, with a groove carved in them to carry a narrow iron pipe. A 0.2m thick layer of light yellow and brown silty-sand with angular stones, **2304**, was deposited against, and level with, the surviving top of wall **2307**. Sandstone rubble layer **2305** was up to 0.5m thick and had been deposited against wall **2307**, presumably as a backfill within the construction cut, while beneath this, the bottom of light-yellow sand layer **2306** extended below the vertical limit of the excavation. The lack of inclusions in this deposit may indicate that this could be the natural subsoil into which the foundations had been cut, or alternatively, redeposited dredged material within which the foundations were bedded. The deposit was similar to yellow sand layer **2309** and mid-brown sand layer **2310**, which had been deposited against structure **2308**; these again lacked inclusions and could represent either redeposited natural subsoil or dredged material.

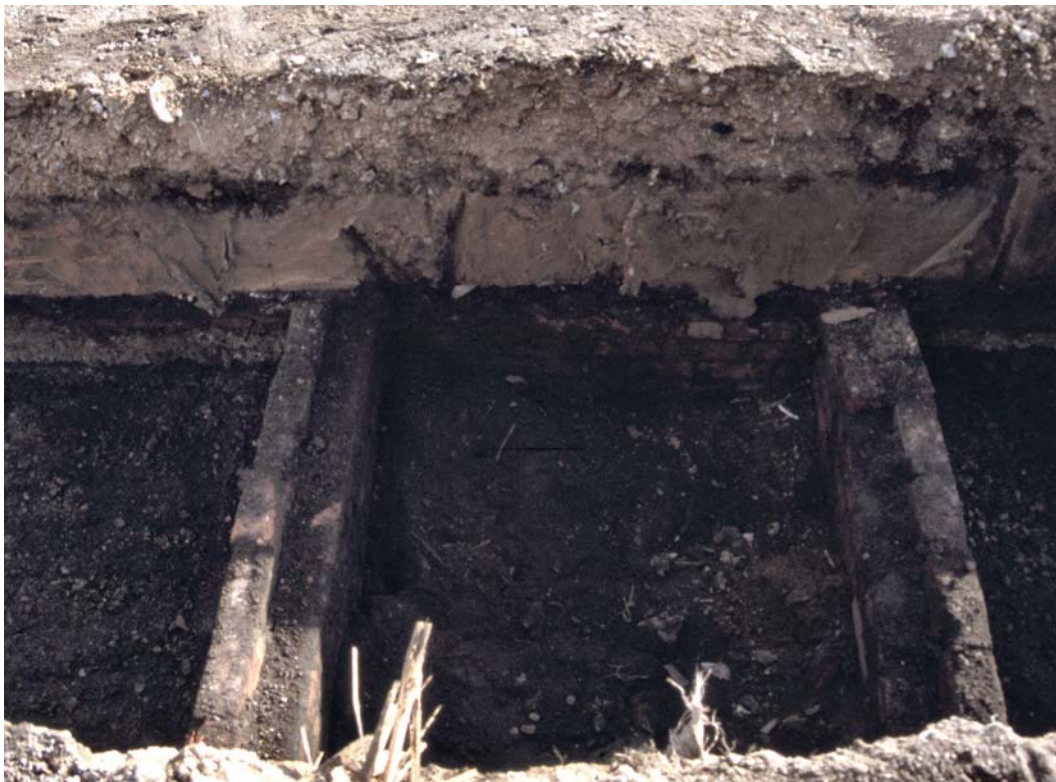
Plate 6: View of brick structure *3504*, within Trench 35

- 3.3.5 **Trench 35:** beneath a 0.2m–0.3m deep hard-packed gravel surface, **3501**, was a 0.3m deep dump layer, **3502**, consisting of a loose, very mixed, silty-sandy-clay with inclusions of demolition debris (brick, rubber floor matting and other refuse). Below layer **3502** was a layer of mixed slag, clinker and coal dust, **3503**, which was at least 1m deep, and extended down to the base of the trench. Layer **3503** appeared to have been deposited over **3504**, a small rectangular structure, measuring 2.7m, in a north-west/south-east orientation by 1.7m in a north-east/south-west orientation (Plate 6). It was constructed of brick, two courses wide, and survived to a maximum observable depth of 1.3m.

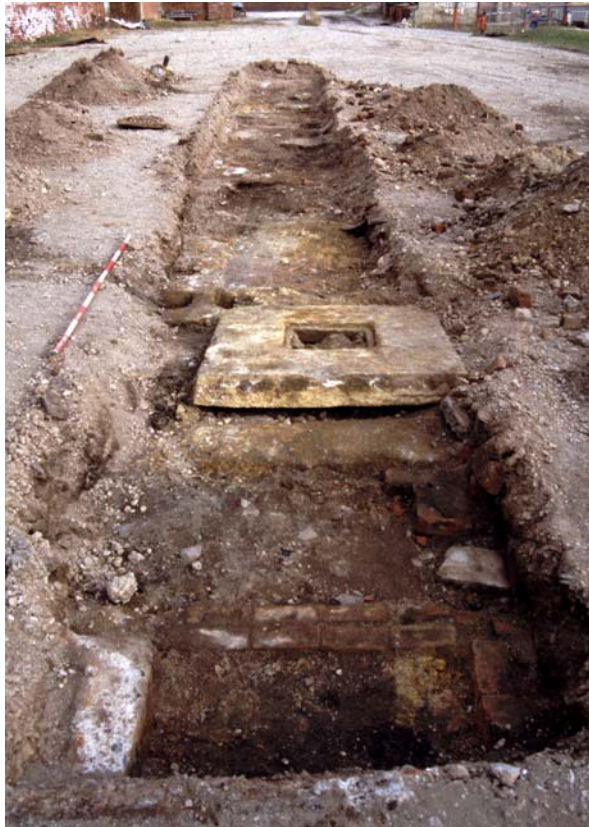
Plate 7: View of concrete and brick structures within Trench 37

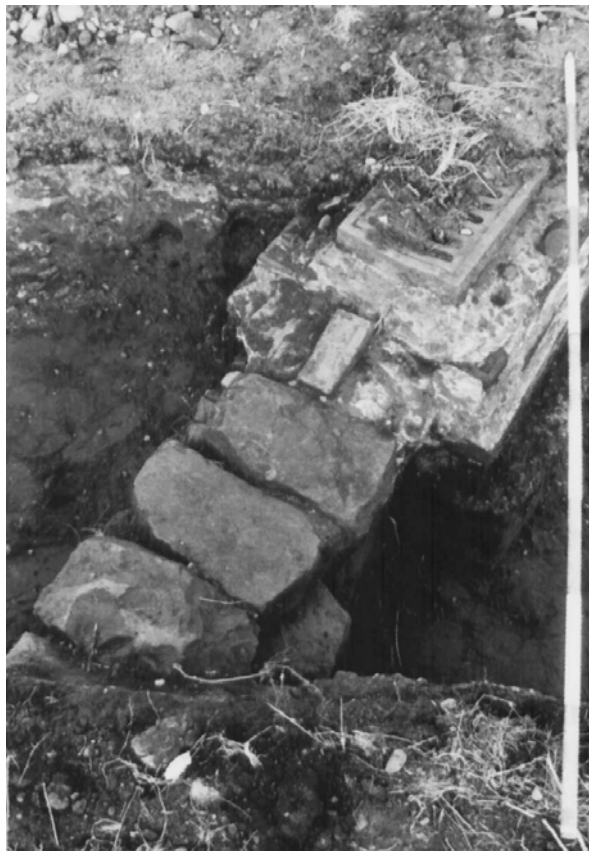
Plate 8: Close-up of drain **5304**, within Trench 53

Trench Number	53
Location	Ramsden Dock Access Road
Alignment	North-west/south-east
Dimensions	20m x 1.7m
Maximum Depth	1.2m
Description	The removal of the topsoil, 5301 , within this trench revealed two brick structures, 5303 and 5304 . These structures were cut into a deposit of sand, 5302 .
Trench Number	54
Location	Ramsden Dock Access Road
Alignment	East/west
Dimensions	20m x 1.7m
Maximum Depth	1.9m
Description	This trench revealed topsoil, 5401 , overlying bands of sands, 5402 , all slumping downwards towards the south. No archaeological features were observed within this trench.
Trench Number	55
Location	Ramsden Dock Access Road
Alignment	North-west/south-east
Dimensions	20m x 1.7m
Maximum Depth	2.0m
Description	The topsoil, 5501 , in this trench overlay a deposit of hardcore, 5504 , which itself overlay a concrete beam, 5503 . This beam overlay a deposit of sand (5502).

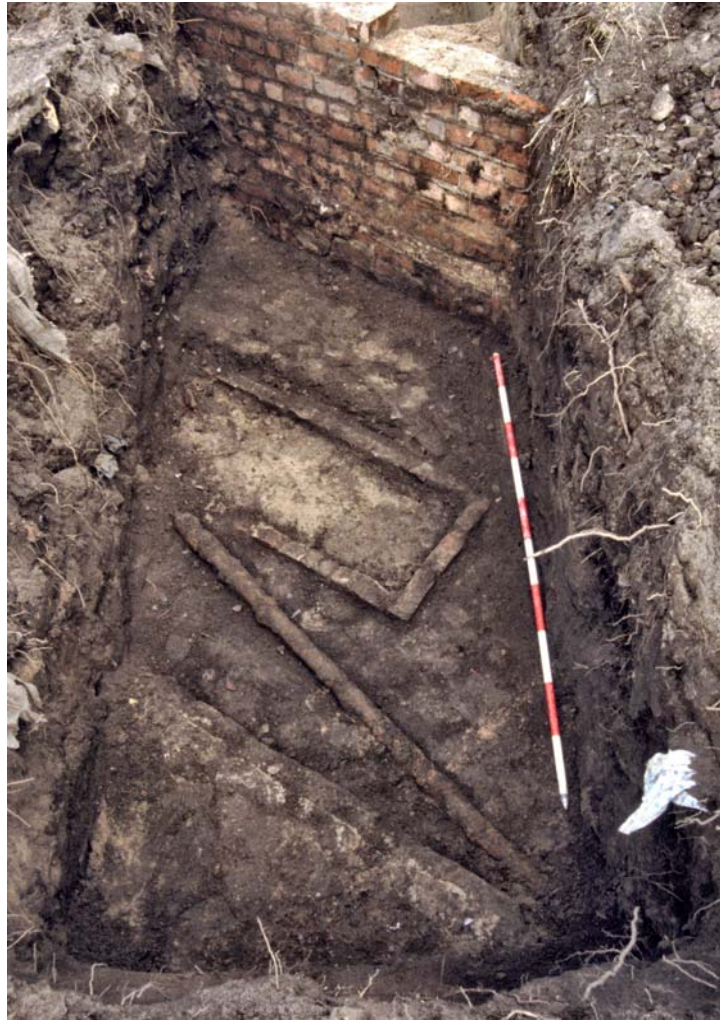
Plate 9: View of brick structures within Trench 66

- 3.5.2 **Trench 66:** beneath blackish-brown friable silty-clay topsoil, **6601**, the remains of three brick structures were revealed (Fig 8, Plate 9). Wall **6605** ran north-west/south-east at the southern end of the trench, was a single brick wide and survived to a height (*c*1.25m) of ten courses of machine-made brick laid on a brick and limestone foundation plinth. Deposit **6606**, a 1m deep blackish-brown silty-clay mixed with brick and concrete rubble, glass and pipes had been deposited against the southern side of wall **6605**. Beneath deposit **6606**, to the south of wall **6605** and on the same alignment, were two rectangular brick structures, **6607** and **6608**; these were of similar construction, being a single row of bricks, one course high and set on a concrete base. A cast iron pipe ran between these two structures. The deposits in the centre and at the northern end of the trench appeared to be dumps of secondary material. Light brown fine silty-sand layer **6603** lay just beneath topsoil **6601** and sloped sharply to the north where it contained a 2.2m long by 0.13m thick concrete slab, **6604**, which sloped at about 30° and was possibly laid as a revetment. Overlying slab **6604** at the northern end of the trench was deposit **6602**, a large dump of demolition debris comprising bricks, concrete and drain pipes.

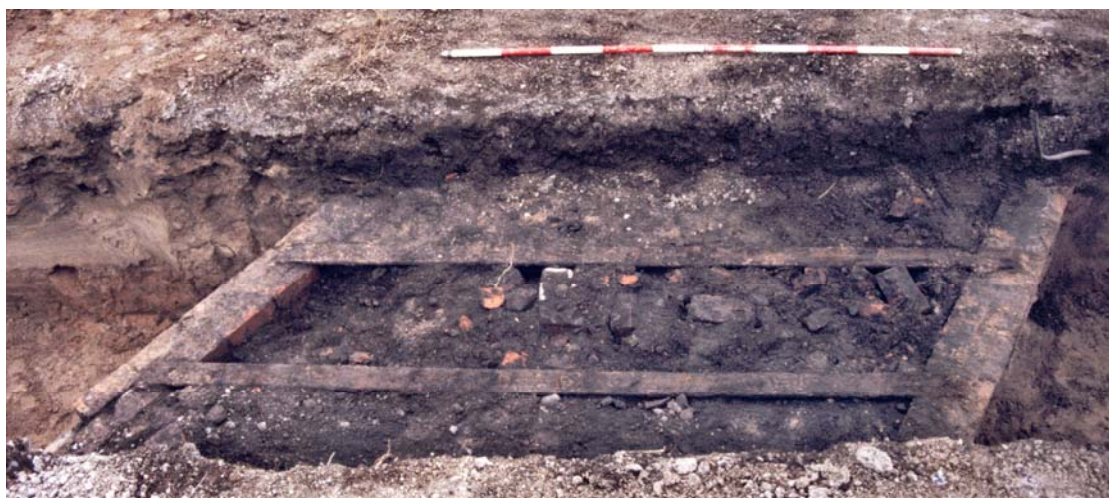
Plate 10: View of walls **8605**, within Trench 86

- 3.5.4 **Trench 86:** the removal of a 0.15m-0.2m thick compacted gravel layer, **8601**, revealed a 0.2m deep preparation layer, **8602**, which comprised compacted demolition debris. Below this was layer **8603**, a pale grey loose sand with no notable inclusions, 0.5m thick, possibly originating as a deposit of dredged estuary sand. Removal of **8603** revealed **8604**, a 0.3m thick layer of fairly loose mid-orange sand with a high content of small- to medium-sized stones. Layers **8603** and **8604** were cut by two broadly parallel walls, **8605**, both aligned north-east/south-west. The walls were 0.2m wide and survived to a depth of eight courses, extending beyond the limit of excavation. The lack of pointing would suggest that these were foundations, while two iron girders, roughly 0.8m apart and bonded to the top of the walls at an oblique (east/west) angle, may have supported a floor (Plate 10). The entire space between the walls was backfilled with a loose, black dump of demolition material, **8606**, that could have derived from the destruction of the building represented by walls **8605**.
