TOWNHEAD FARM MELMERBY

Archaeological Building Investigation and Evaluation Report

Oxford Archaeology North

April 2003

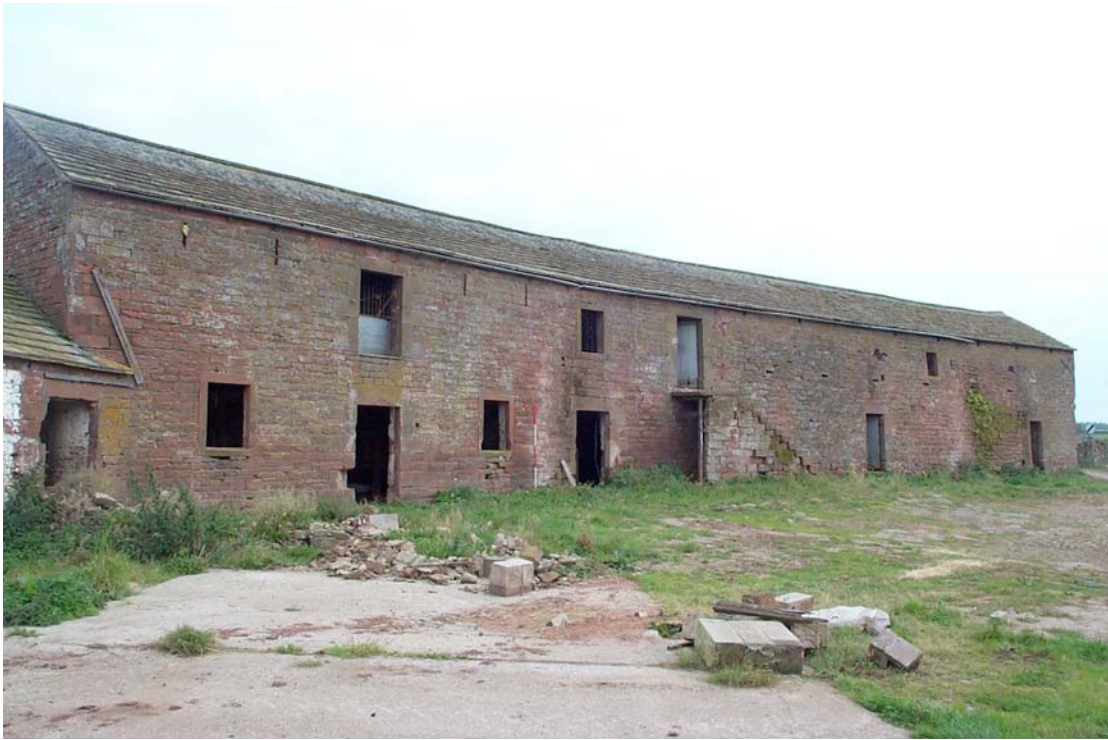
Plate 1: Western external face of the East range

- 3.2.2 **East Range:** this consists of a large threshing barn at the south end (Plate 2) and a smaller two-storey building at the north end. The lower part of the roof was finished with sandstone while the upper part is part slate and part corrugated concrete sheeting (Plate 1).

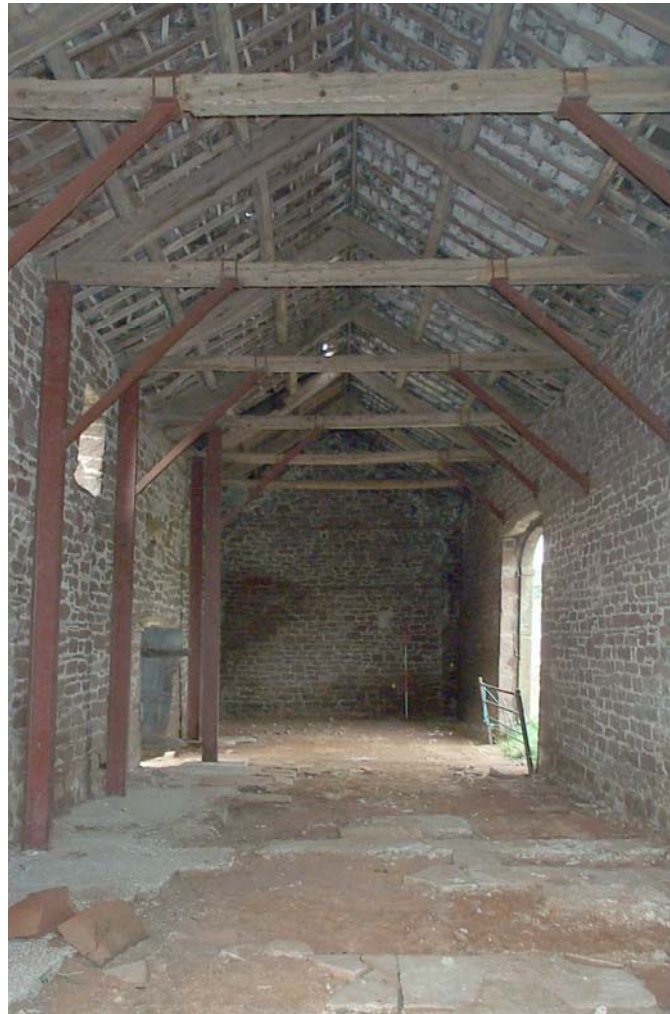
Plate 2: Threshing Barn (Room 1) looking north

- 3.3.2 **Room 1, fabric:** the floor is a mix of broken concrete and stone flags, although much of it has been removed revealing a sand bed. The ceiling is supported by seven trusses each consisting of a simple tie beam and overlapping principal rafters, all of which are roughly finished and chamfered, and some appear to be reused. On the west side these are supported by upright iron I-beams, and on the east side there are modern iron inclined struts between the tie beams and the wall (Plate 2).

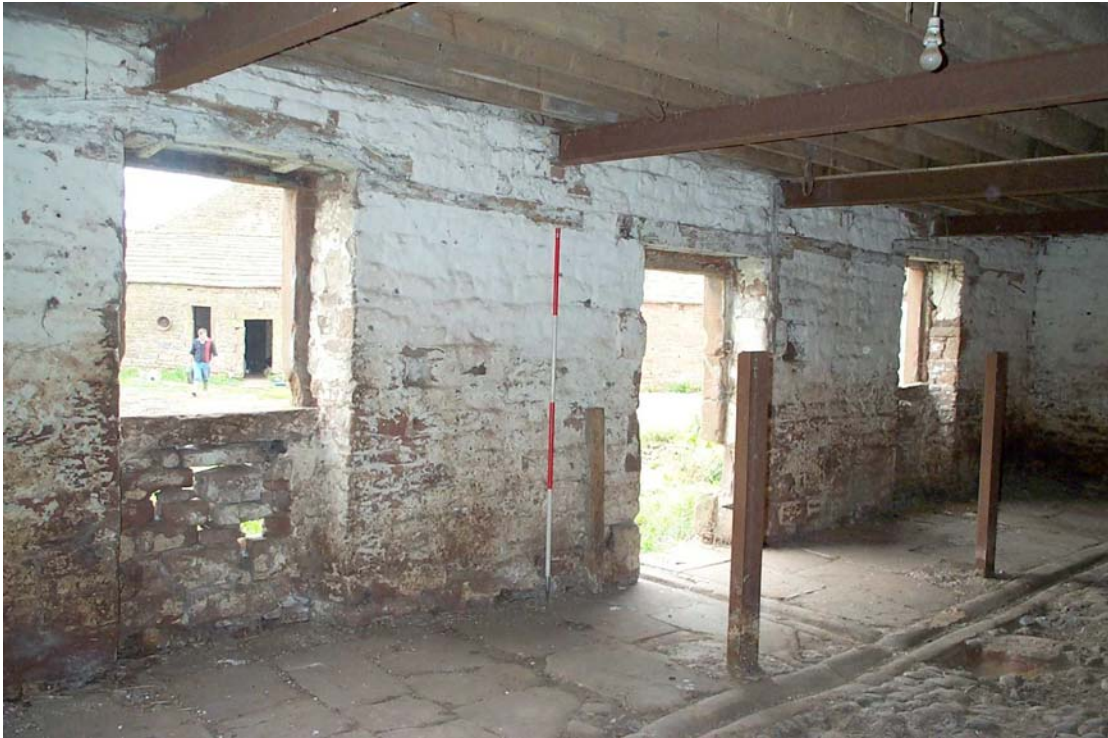
Plate 3: Internal view of Room 3 looking west

North of the threshing barn is a pair of ground floor windows, each with square stone surrounds, and slightly splayed sills, and between these windows is a doorway (Room 3; Plate 3). The build at this end is noticeably different, with much neater courses of dressed blocks, augmented by short string courses levelling the stonework, which extends across the top of the south end. There is another large aperture above the north door forming a first floor loading door, in the same style as the one below but shorter. There are also four narrow slit vents across the wall top.

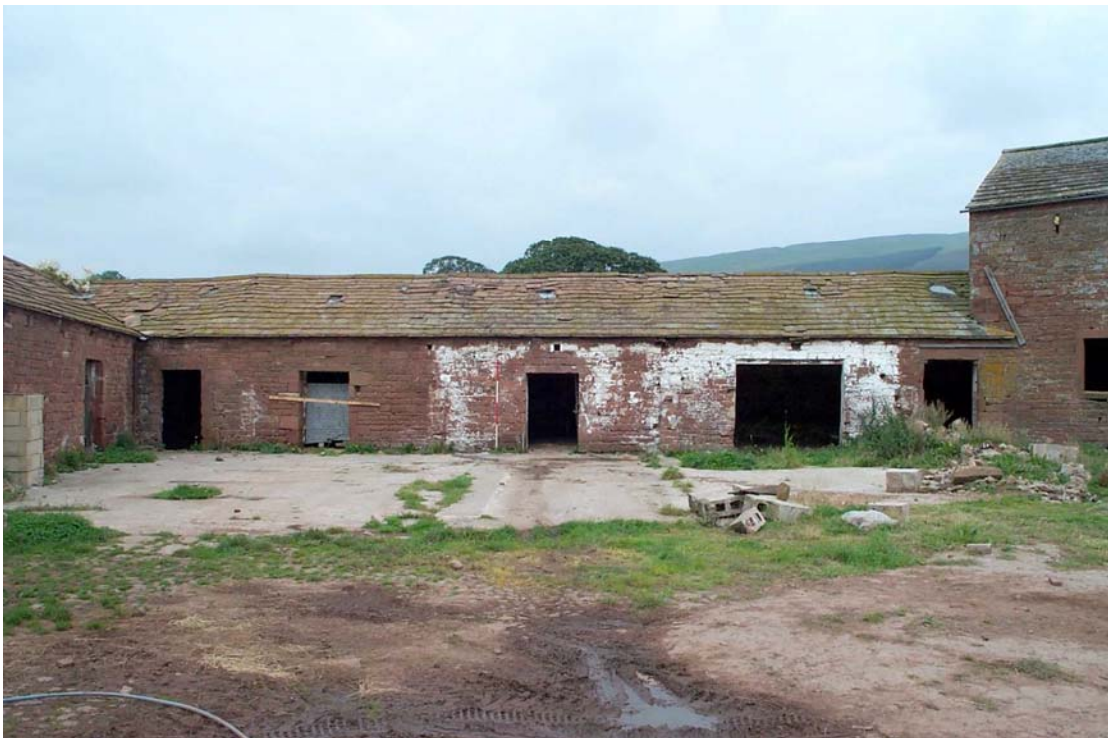
Plate 4: South-west external face of the North-east range

- 3.2.9 **South-west elevation:** there are four pedestrian doorways; one at the south-east end, one to the north-west of the centre, one in the centre and one at the north-west end. All of the doors are finished with quoined jambs and heavy stone lintels, although the central two have noticeably narrower lintels (Plate 4). The doorway to the south-east of the centre, is markedly larger, and has been enlarged if not inserted, utilising an iron I-beam lintel and has rebuilt jambs. There is an area of possible rebuild to the south-east side of the south-east doorway and the ruined remains of a wall running into the courtyard, butting the wall at this point. There are small holes above the two central, pedestrian doorways which are of unknown function.

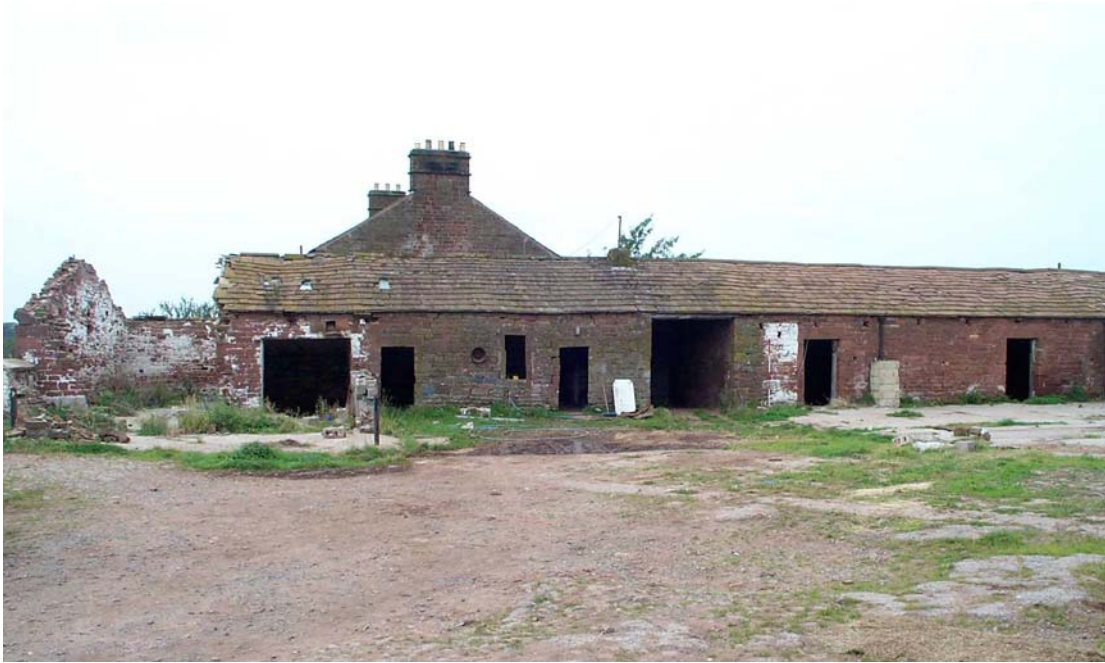
Plate 5: Eastern external face of the North-west range

- 3.2.11 **North-West Range:** a row of five single storey rooms, forming part of the north-east range at the corner. These consist of a large byre at the north-east end and probable workshops to the south-west. The roof consists of sandstone slabs with a small stone chimney near the centre.

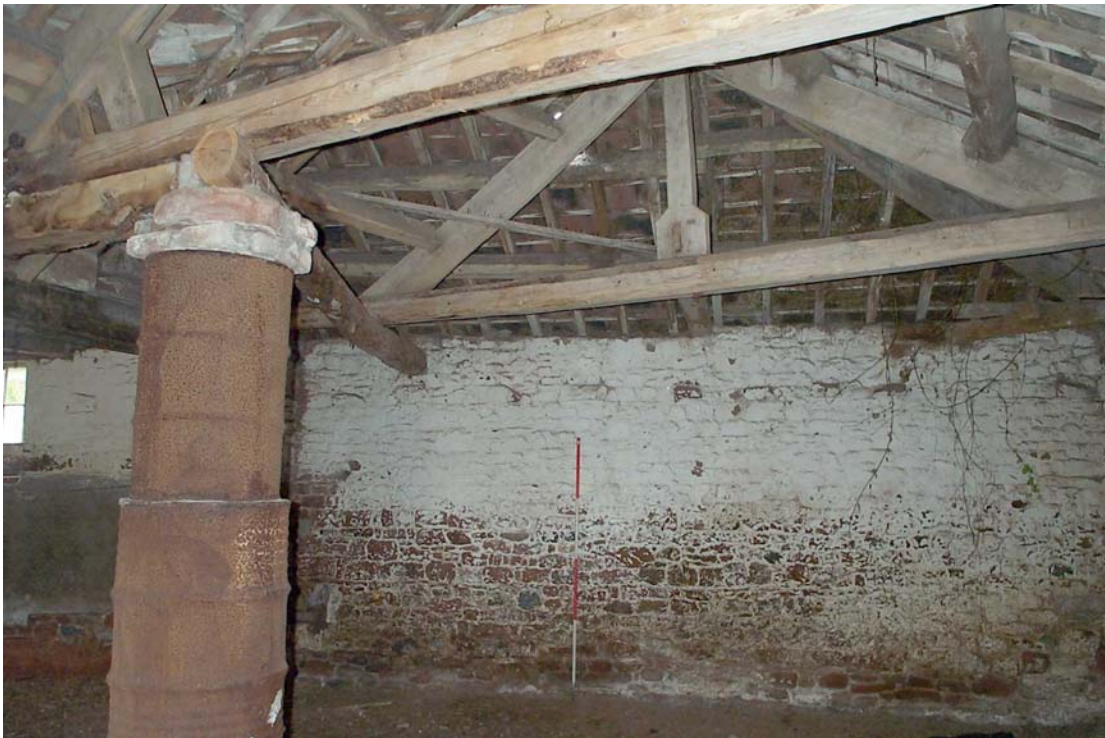
Plate 6: Internal view of Room 10 showing the makeshift use of concrete filled drums to support the roof

- 5.1.5 A number of minor alterations and repairs were also carried out. Wider, wagon-style, doorways were inserted into Rooms 1, 7 and 15. A truss was replaced in Room 10 and supported by concrete filled steel drums. Steel I beams were added to Room 1 to support the trusses, with inclined steel struts fastening them to the east wall. All of these alterations seem somewhat *ad hoc*, carried out either as necessary repairs or due to alterations in the use of certain parts of the complex. The addition of steel I beam supports to Room 1 demonstrates that the alterations that had already been made resulting in the raising of the roof could not be supported by the original fabric of the structure.
