# Witches' Tower Second Floor and Roof Works

Lancaster Castle

## Archaeological Watching Brief Report

Report no 1998-99/028/AUA7838

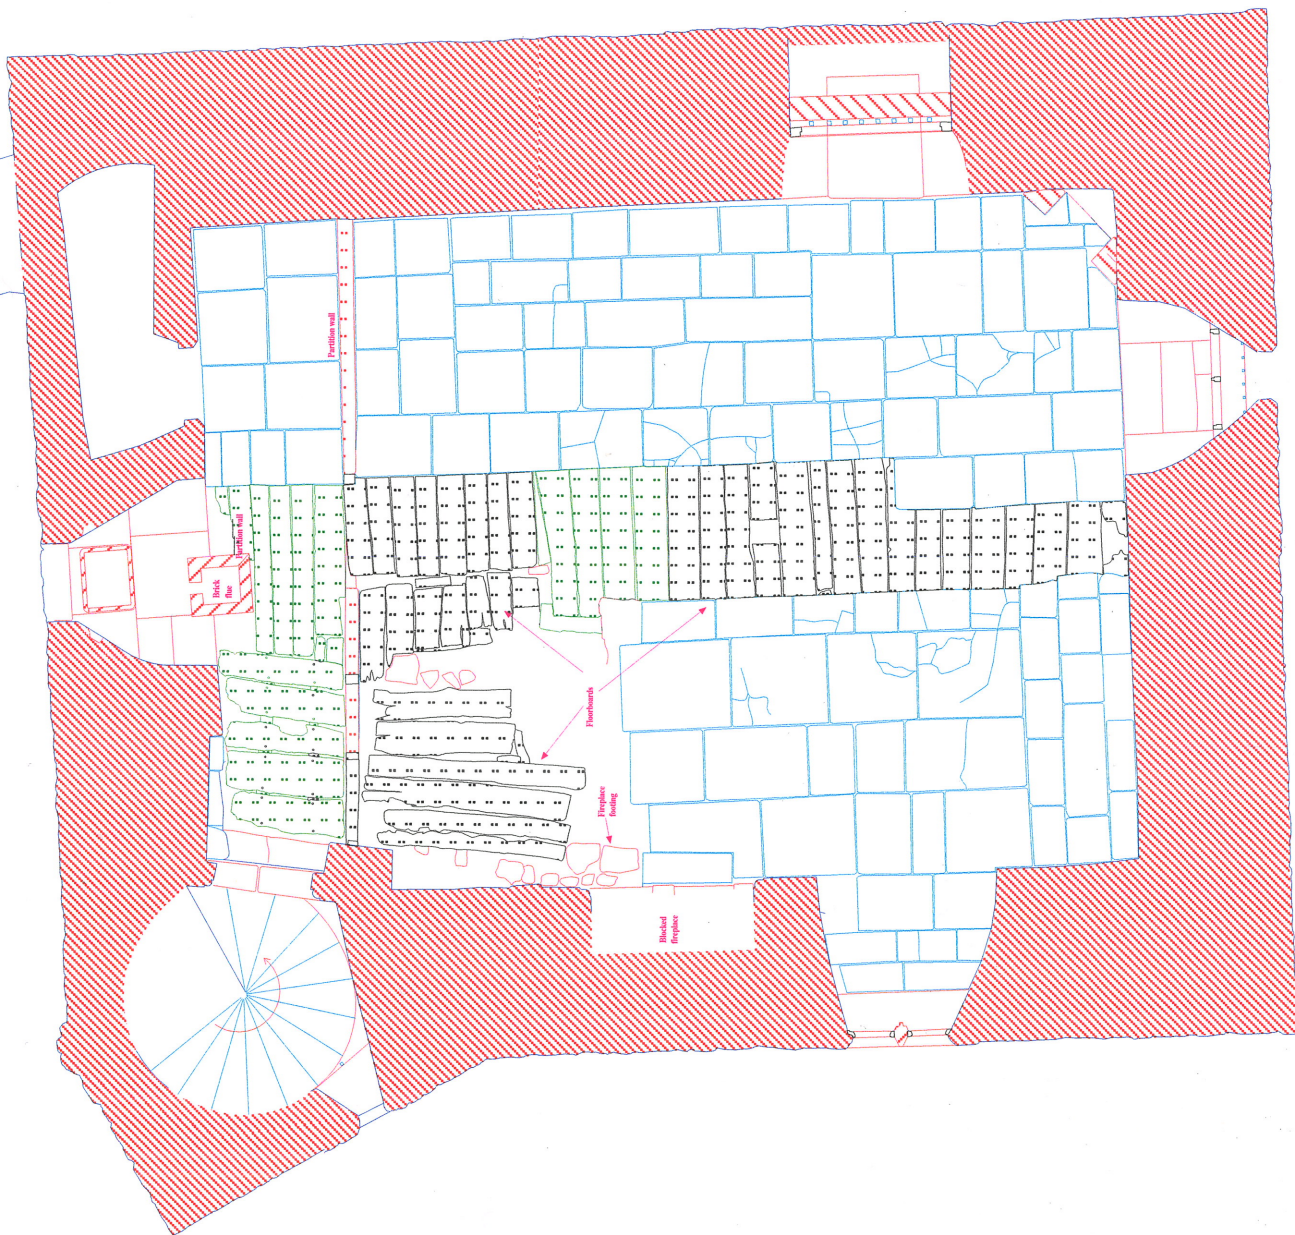
Fig 2 Second Floor Plan

### 3.2 SECOND FLOOR WORKS (FIG 2)

- 3.2.1 **Lifting of Flagstones:** five stone flags (LUAU 1996, nos 63-67) were lifted in the western part of the access passage at the northern end of the upper room of the tower. The flags were 12mm thick, and were bedded on an 8mm deep layer of lime plaster. Below the plaster was a continuation of the daub material previously uncovered during the lifting of the flagstones adjacent to the door from the stairwell (LUAU 1996).

- 3.2.2 The daub was thickest (64mm) where it butted the stud partition wall on the south side of the passage, tapering to a depth of only 7-8mm on the northern side of the passage. Below the daub were five thin north/south aligned floorboards. The boards sloped down towards the partition wall and were secured by pairs of square-profiled nails on to two east/west aligned timbers below.

- 3.2.3 The east/west aligned floorboards (already partially uncovered) were butted to the north/south aligned boards with the exception of the southernmost board which finished short; the gap was made up with two small pieces of board which extended a short distance below the eastern north/south aligned board.

- 3.2.4 **Central floor area:** removal of daub from the central floor area revealed further floorboards similar to those previously uncovered to the east, and showed that the southern ends of the boards were nailed to one of the main joists which had been partially uncovered during the earlier phase of works.

- 4.1.1 The newly uncovered floor areas (Fig 2 and Plate 1) corresponded to what had been seen during the 1996 recording programme (LUAU 1996); the daub and other make up placed over the boards probably related to the levelling up of the floor in the mid-late eighteenth/early nineteenth century when the timber partition was inserted.

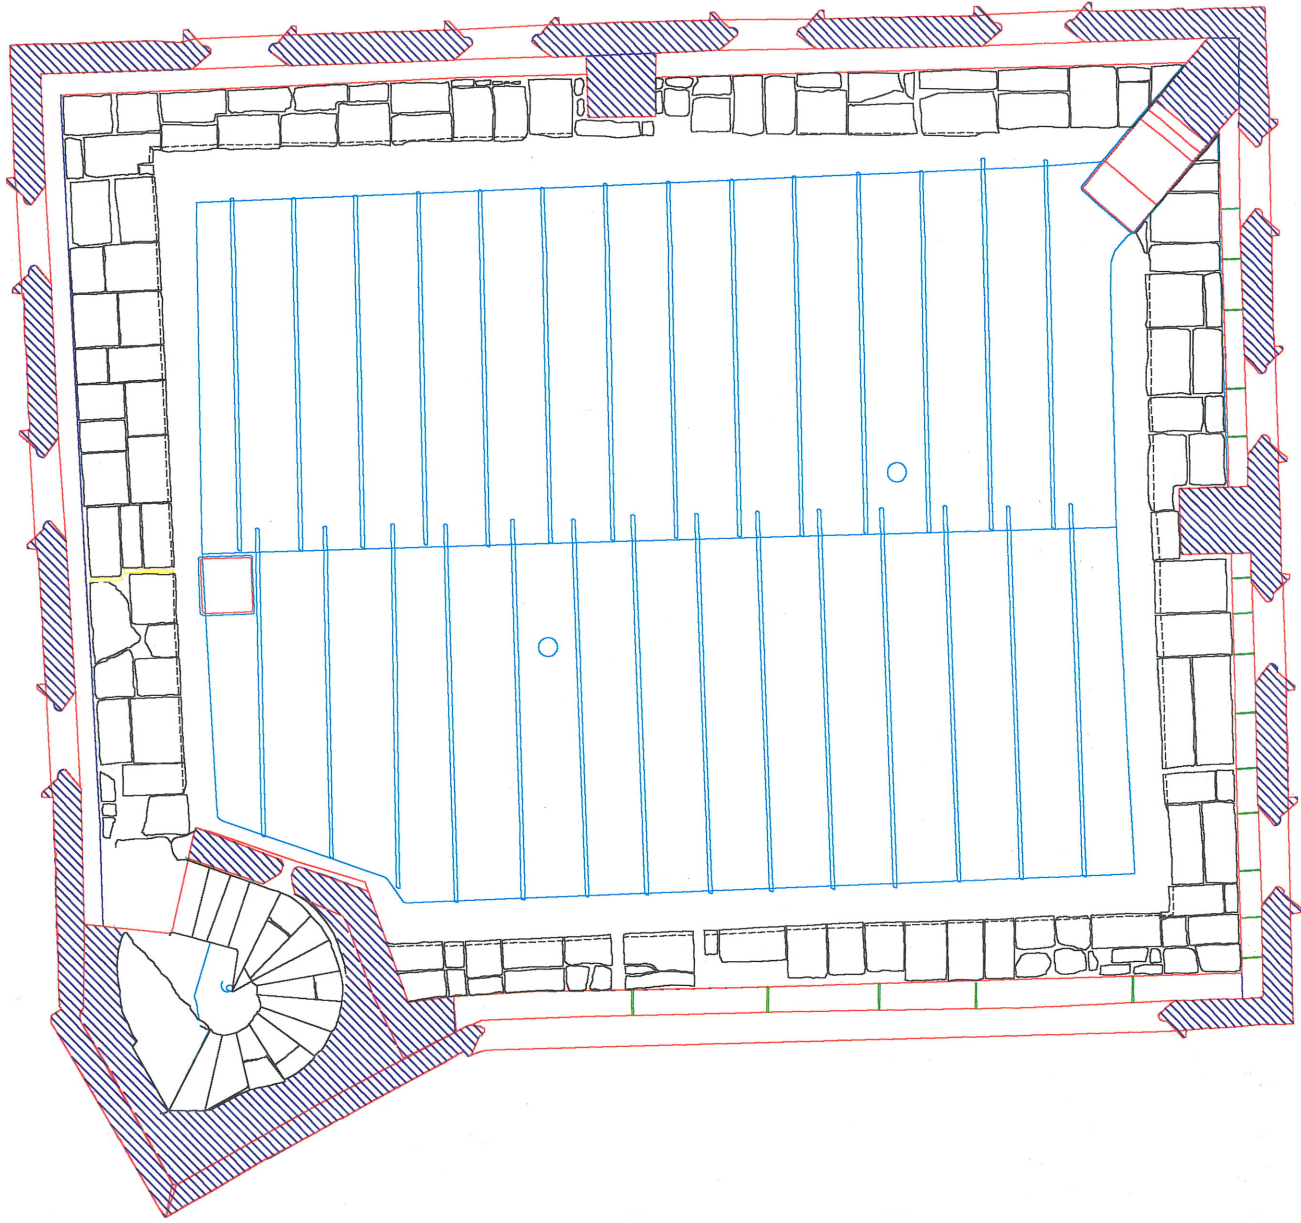
Fig 4 Parapet Plan

- 3.4.1 A decision was made to strip the entire roof, rather than attempt to repair the existing lead. The removal of the lead created an opportunity to complete the recording of the tops of the tower walls, to record the outer elevations of the gutters, and the plan of the flagstone surface between the base of the parapets and the gutter (Figs 4-7).

- 3.4.2 The stripping revealed that the stonework between the gutters and base of the parapet walls was butted against the medieval fabric of the tower. Some of the stones appeared to have been re-used from a string course, and had a chamfer on one edge with a hollow moulding below.

- 2.1.3 The second floor timbers were recorded in plan (Fig 2), the stair turret was recorded in plan (Fig 4), and the wall tops were recorded in plan and elevation (Figs 4-7).

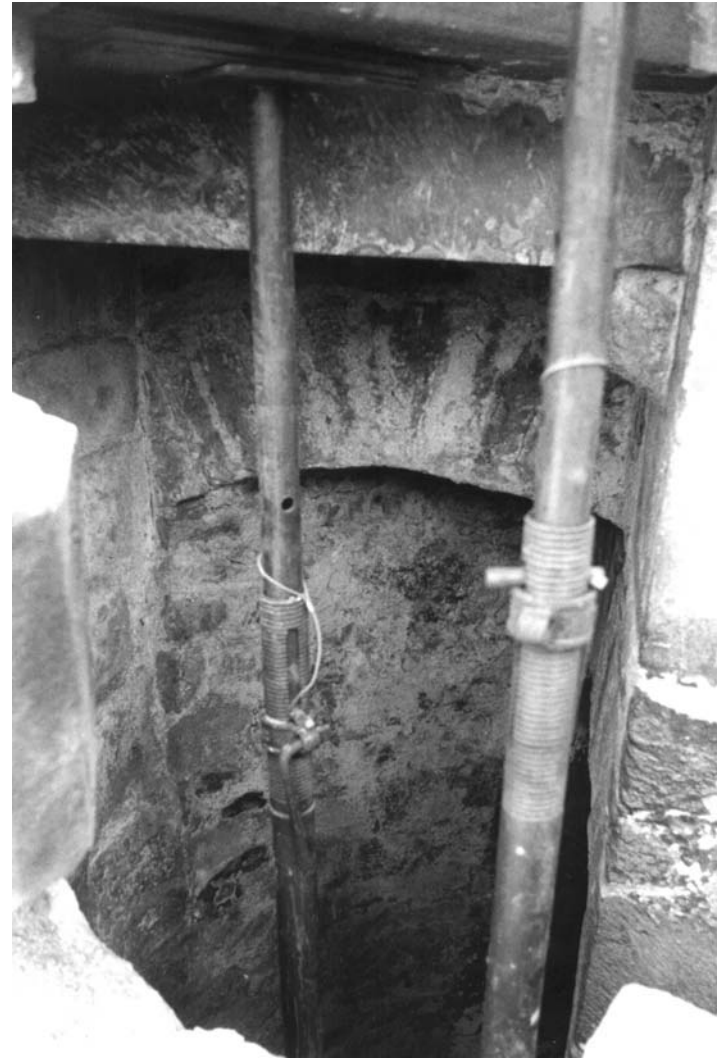
Plate 2 Interior of the stair turret viewed from the east

- 3.3.3 The outer wall of the stairwell protruded into the north-western corner of the roof area, and was butt-jointed to the inner face of the main wall. The wall continued above the stairwell in the form of a relieving arch (Plate 2), before continuing to join the parapet.
- 3.3.4 The stairs were constructed with both single and two piece treads, jointed into the outer wall. A very substantial blocking has been inserted, at the second floor level of the turret, around the newel and this partially obscured some of the treads. The blocking extended across the full width of the stair and was constructed with relatively small flat pieces of sandstone, bonded with a hard pinkish brown cement. There is also what appears to be a blocked doorway in the north-western side of the stairwell, consisting of a recessed area with a relieving arch of small sandstone blocks above.

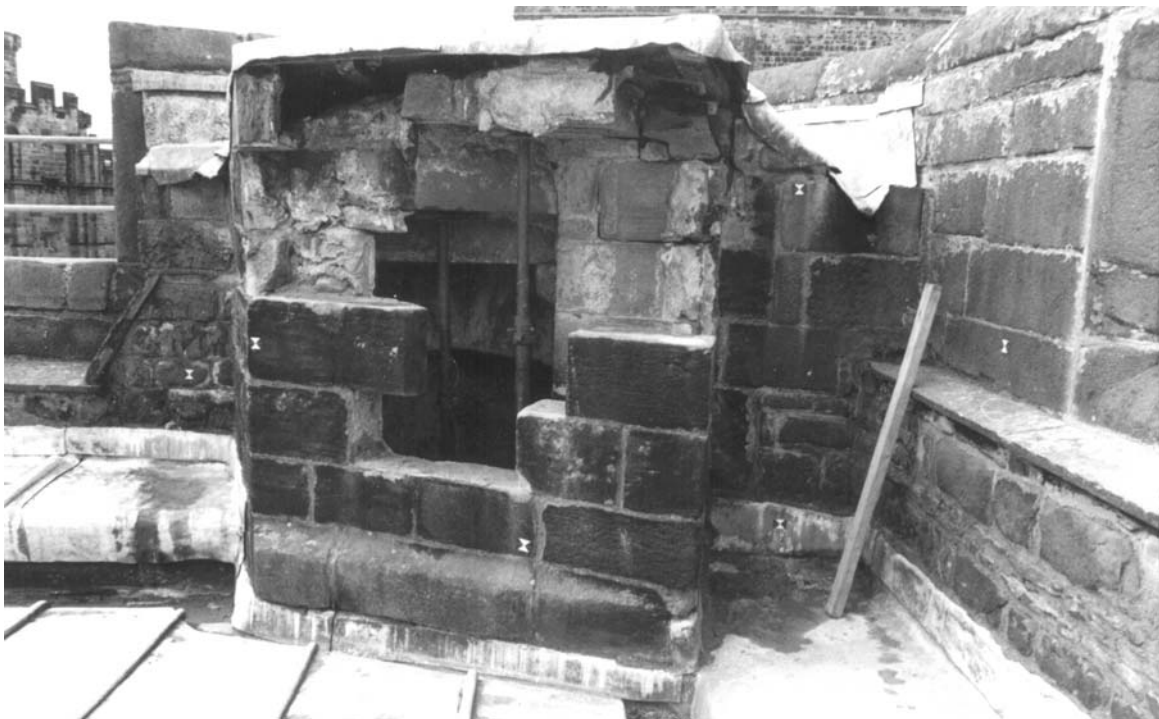
Plate 4 Stair Turret from the east

- 3.4.5 Three inscriptions (*JD 1779*; *G Hansbrow Dec 21 1836*; *A Hansbrow 1837*) were identified carved into the lead sheet overlying the stair turret. They were recorded *in-situ* and then cut out of the sheet; they have been deposited with Lancaster City Museum.

- 4.3.2 There are also graffiti inscriptions on the lead sheet over the stair turret dating from between 1779 and 1837, and these pre-date the inscription dating the last re-roofing (1860). However, it is likely that the lead sheet covering the top of the stairwell has been re-used. The sheet appears to be of sandcast lead, rather than the milled lead with which the main roof area was covered. Part of the edge of the sheet had two parallel lines on the border, which crossed on the corner; these probably marked the edge of the original sheet, but have been lost from the other edges where the sheet has been cut down. The 1779 inscription, however, does provide a *terminus ante quem* for the use of the lead.
