PLUMLEY LIMEBEDS

Interim Survey Report

Report no 2000-2001/044/AUA8059

**CHESHIRE STRATEGIC PROGRAMME OF RECLAMATION
PLUMLEY LIMEBEDS, NORTHWICH**

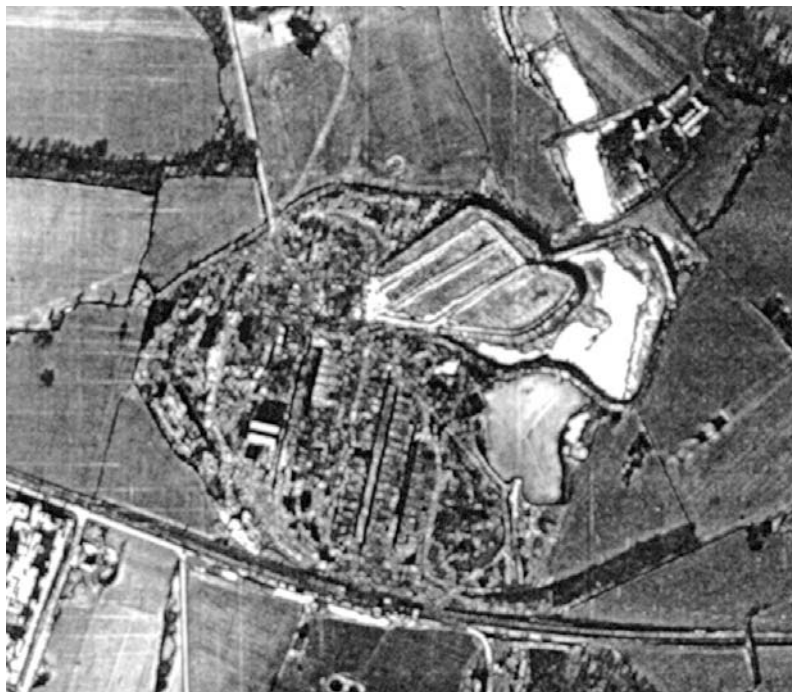
- 1.3.5 **Post-War Operations:** after the end of World War I, the munitions plant was demolished (Plate 2). The original Ammonia Soda plant reverted to the production of Soda Ash but, in 1919, the Ammonia Soda Company Ltd went into voluntary liquidation on the grounds of poor market conditions (UMAU 1999). Brunner Mond then bought the site outright and production continued, but in 1926 the site was finally closed. From the 1940s to the 1980s the large warehouse was used to store sodium salts by Associated Ocel (Moore's forthcoming).

Plate 2: Vertical air photograph of the Plumley site, taken in 1946

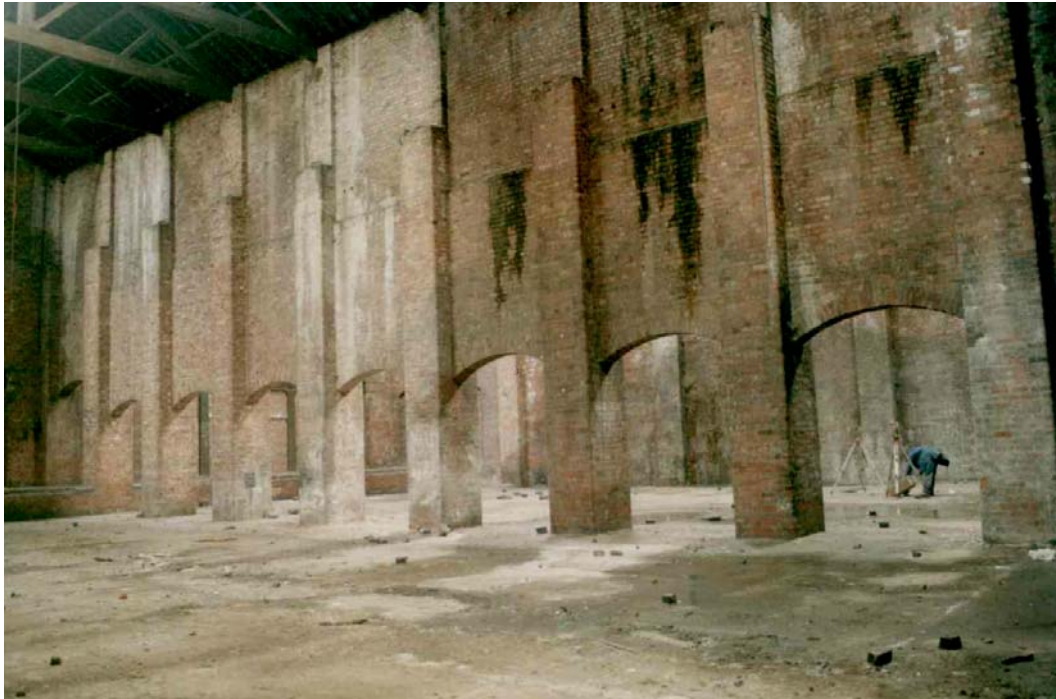
- 3.2.3 Internally there are two cells with a concrete floor and an internal loading platform at the eastern end, which is c0.8m high (Plate 4). Set into this eastern wall are two metal stanchions, on either side of the central east/west aligned wall, with an I-beam above. These were formerly large apertures for loading and unloading materials into the warehouse platform and onto the external loading platform; these apertures, however, have subsequently been filled. The central wall dividing the two cells has nine arched openings with a three-course-high brick arch (Plate 3). The openings are 3m high and 2.44m wide; the walls are 0.34111 thick, as are the walls of the warehouse. The piers of the arches measure approximately 1.08m square (Plate 3).

Plate 3: Central arched wall in the interior of the warehouse, looking south-east

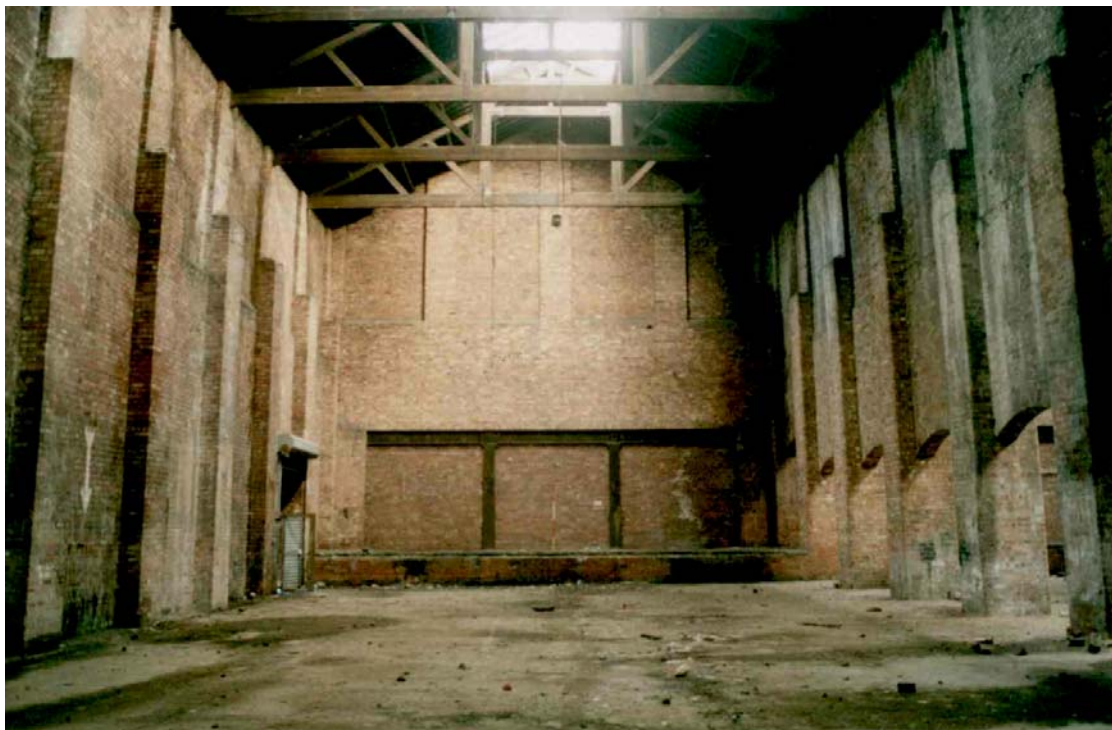
- 3.2.1 A full survey to RCHM(E) Level 2 standards was conducted on the warehouse according to the requirements of the methodology (*Section 2.2*). This involved a photographic survey of the upstanding structure, both to the interior and the exterior, and a detailed ground-plan produced with a reflectorless Total Station output into a CAD system.
- 3.2.2 The warehouse is a rectangular structure measuring 31m by 28m (Fig 3). It is buttressed on three sides (the north, west and south sides) and the east side faces towards the railway lines (Site 10), where there was an external loading bay (Alan Moores pers comm) (Plates 4 and 6). The buttresses measure 0.96m in width and

Plate 4: North-cell of the warehouse, showing bricked-up loading bays, looking east

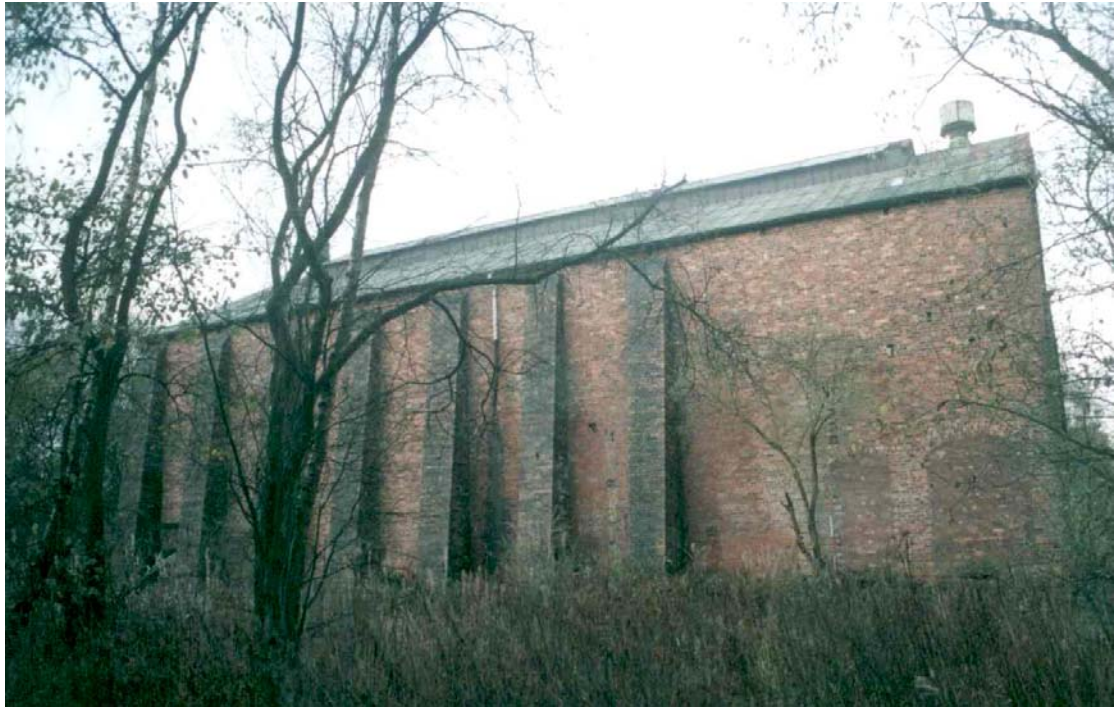
- 3.2.4 Two blocked doorways are visible in the south elevation, leading into the building from the south-east corner (Plate 5), and in the south-west corner is a recently blocked door. A blocked window is visible in the east elevation, north of the centre of the southern cell at mid-wall height. A blocked door is visible in the north-west corner, which had been narrowed, prior to blocking, by the insertion of 0.18m of brickwork. Drains are visible along the north and south internal walls, c0.05m deep. The main door is in the north-east corner, and is now protected with a roller shutter (Plate 6).

earlier doors to the loading bay. The two door-ways and wall scar appear original. There is evidence of a below ground east/west aligned tunnel to the east of the ponds and under the two easternmost buttresses (Plate 5).

Plate 5: South external elevation of warehouse, showing blocked doorways and roof scars in the south-east corner

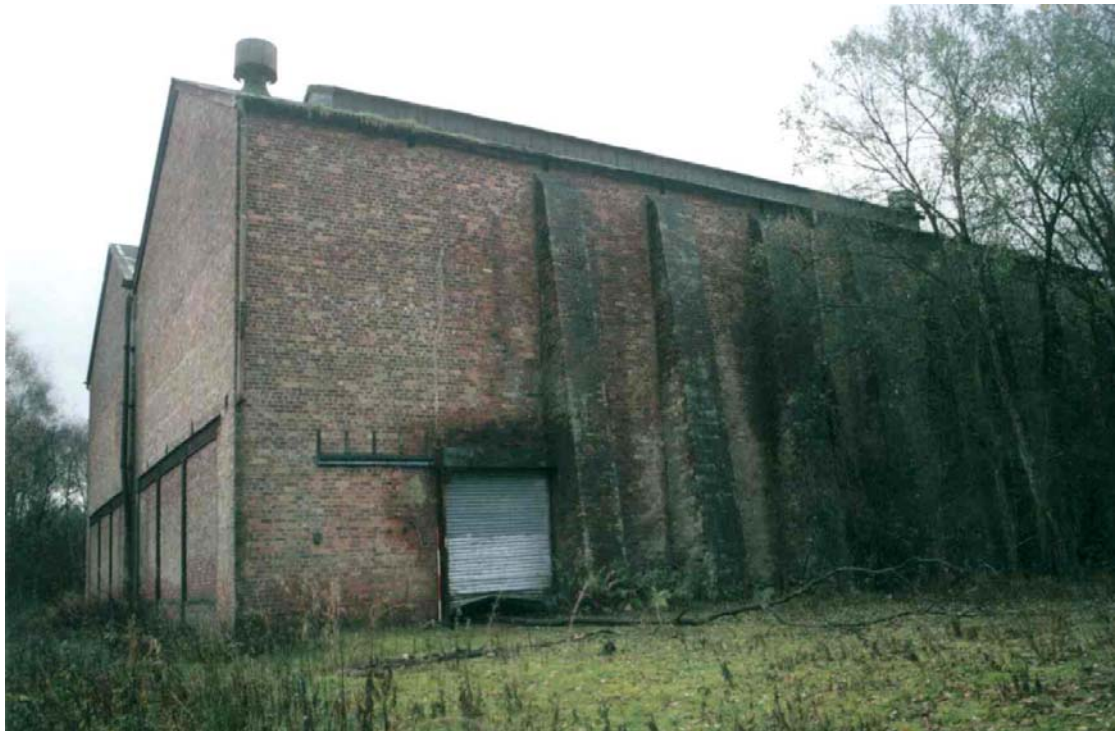
- 3.2.6 Externally, there is evidence of an earlier sliding door on the north-east side of the building, which has now been replaced by the shuttered door (Plate 6). The buttresses stop short of this door suggesting that they post-date the sliding door. The blocked door in the north-west corner has a hanging bolt loop on the lower west side at floor level; a concrete floor is visible below the door and is c0.18m thick. A drain runs down the centre of the north side of the building.

Plate 6: North and east elevations of the warehouse, showing shuttered door and bricked-up loading bays
