**NORTH WEST WATER HAWESWATER
ESTATE
Cumbria**

Detail Survey Report

Report no 1998-99/ AUA7789/012

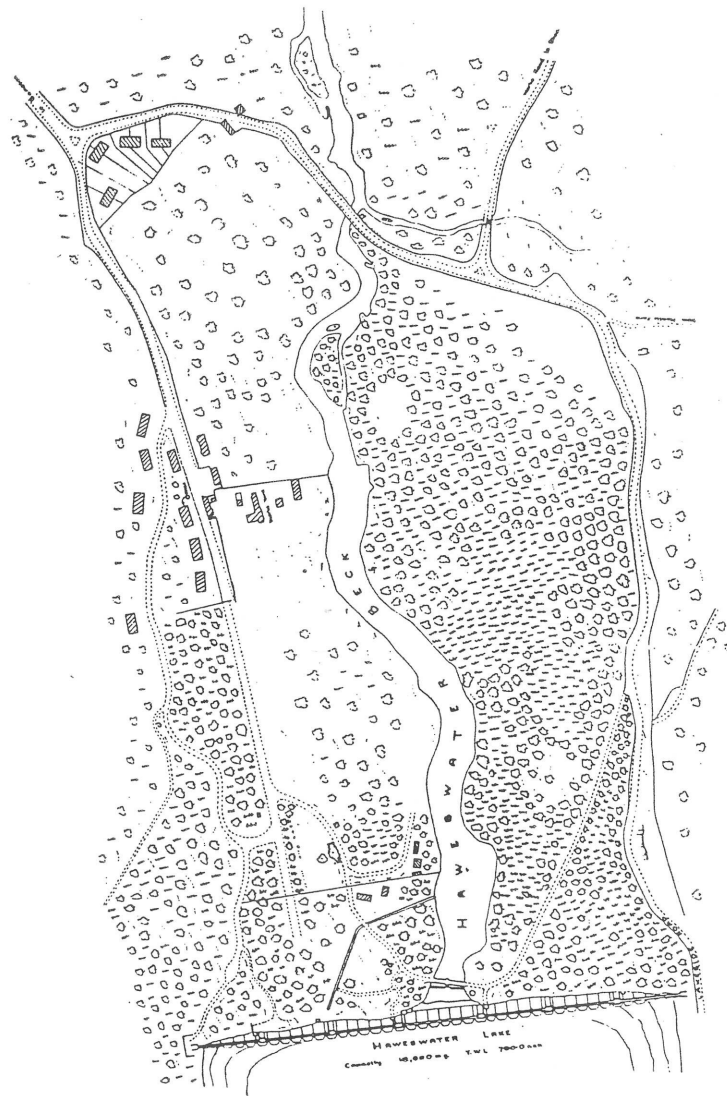
Figure 12 Burnbanks Village following dismantling, 1:2500 (c1980) (NWW 4152/1)

4152/1 Burnbanks [reduced] village, location plan, nd [as shown by the OS 1977], scale 1:2500

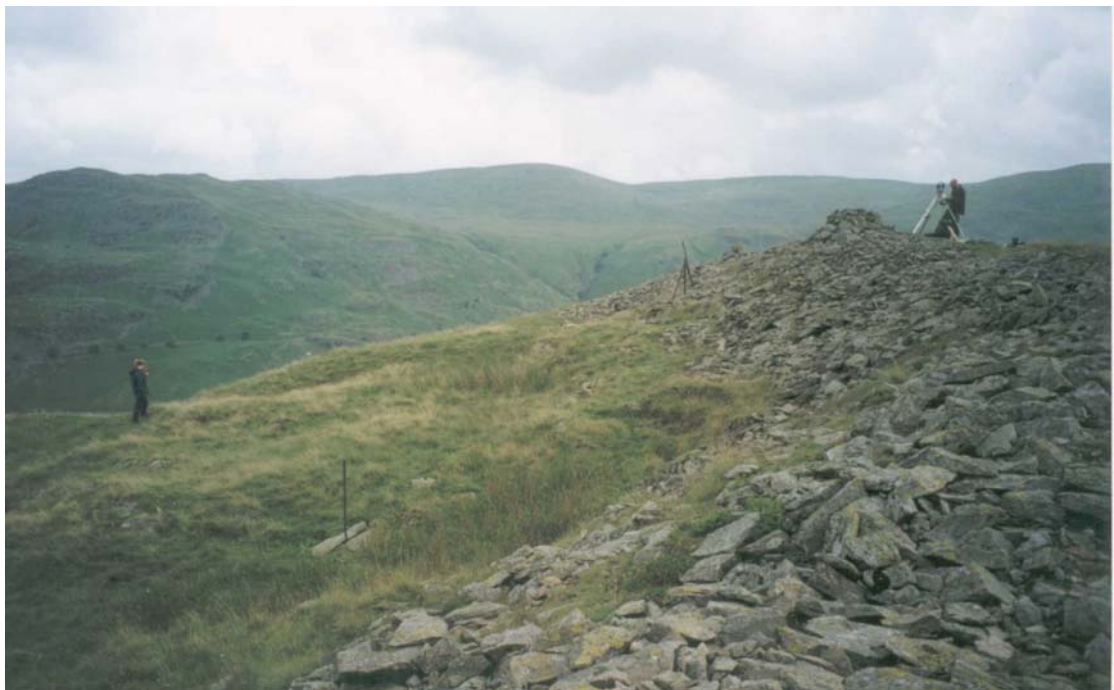
Plate 4 Photograph of Castle Crag Inner Rampart (H158) – looking east

- 5.3.2 **Function:** There is a relative paucity of hill forts within Cumbria, particularly by comparison with those found in some parts of southern England or southern Scotland (Feachem 1966, 64). The Lake District examples tend to be characterised by their small internal area, and are often promontory forts whereby the emphasis of the defence is on the natural topography. Castle Crag certainly has very effective natural defences which provide considerable defensive protection from three sides, but it also has prominent multivallate man-made defences to protect the south-western neck of the promontory. These defences comprise two rock cut ditches and a very substantial and prominent rampart.
