# All Saints Church High Wycombe

Archaeological Watching Brief Report

March 2011

**Client: All Saints Church PCC**

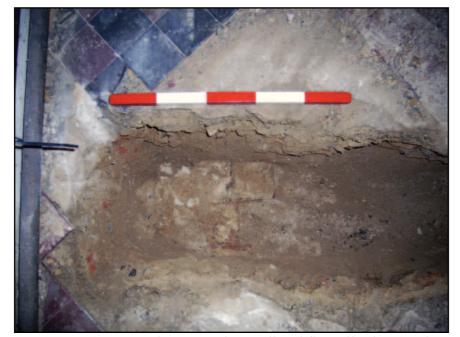
Plate 1: In situ medieval floor tiles in Trench 4

- 3.1.9 Four medieval floor tiles were observed at the western extremity of the internal part of trench four next to the western wall (Figure 2, Plates 1 and 2). These were photographed and retained.

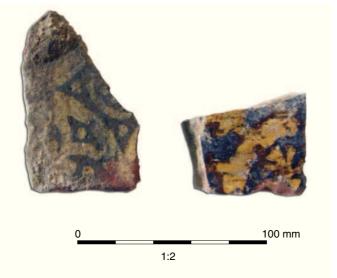
Plate 2: Detail of medieval floor tiles

In general the floor tiles are in poor condition. Most examples are fragmentary but at least seven are complete, or nearly so. Except for a couple of fresh tile fragments – possibly broken in antiquity - all the tiles are worn from use – in some cases the wear is extreme and all traces of the original upper surface have been worn off. Most tiles, including the decorated ones, are also covered to a varying extent in a white lime mortar. A few tiles are completely covered in thick mortar and none of their original surfaces are visible. The mortar covering from two or three tiles was scraped off during this assessment to better reveal their designs. The mortar covering suggests that the decorated tile floor became worn and defunct in antiquity and was covered over. Some mortared tile fragments were probably treated as rubble or hardcore. Some of the bags had labels inside recording details of find spot (at least one tile was found 'in situ'). These details are also in the comments fields.

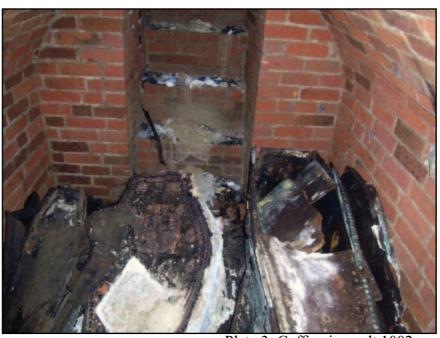
Plate 3: Coffins in vault 1002

- 3.1.6 A vault (context 1002) was revealed in trench three, below the central aisle immediately to the east of the baptismal font. The vault measured approximately 2.70 m in length, 1.40 m in width and 2 m in depth. It was constructed from a skin of red bricks with a barrel-vaulted top. This had previously been breached, presumably during Victorian restoration work. Steps led up from the vault directly beneath the font. Investigation of the breach showed this to be a burial chamber with at least six, and possibly up to nine, triple-shelled, fabric-covered 19th- century coffins (Plate 3). At least five of the coffins were adult sized and one was probably that of a child.
