VALE ROYAL PUTTING GREEN CHESHIRE

Watching Brief Report

Archaeological Watching Brief Report

Report no 1998-99/042/AUA7870

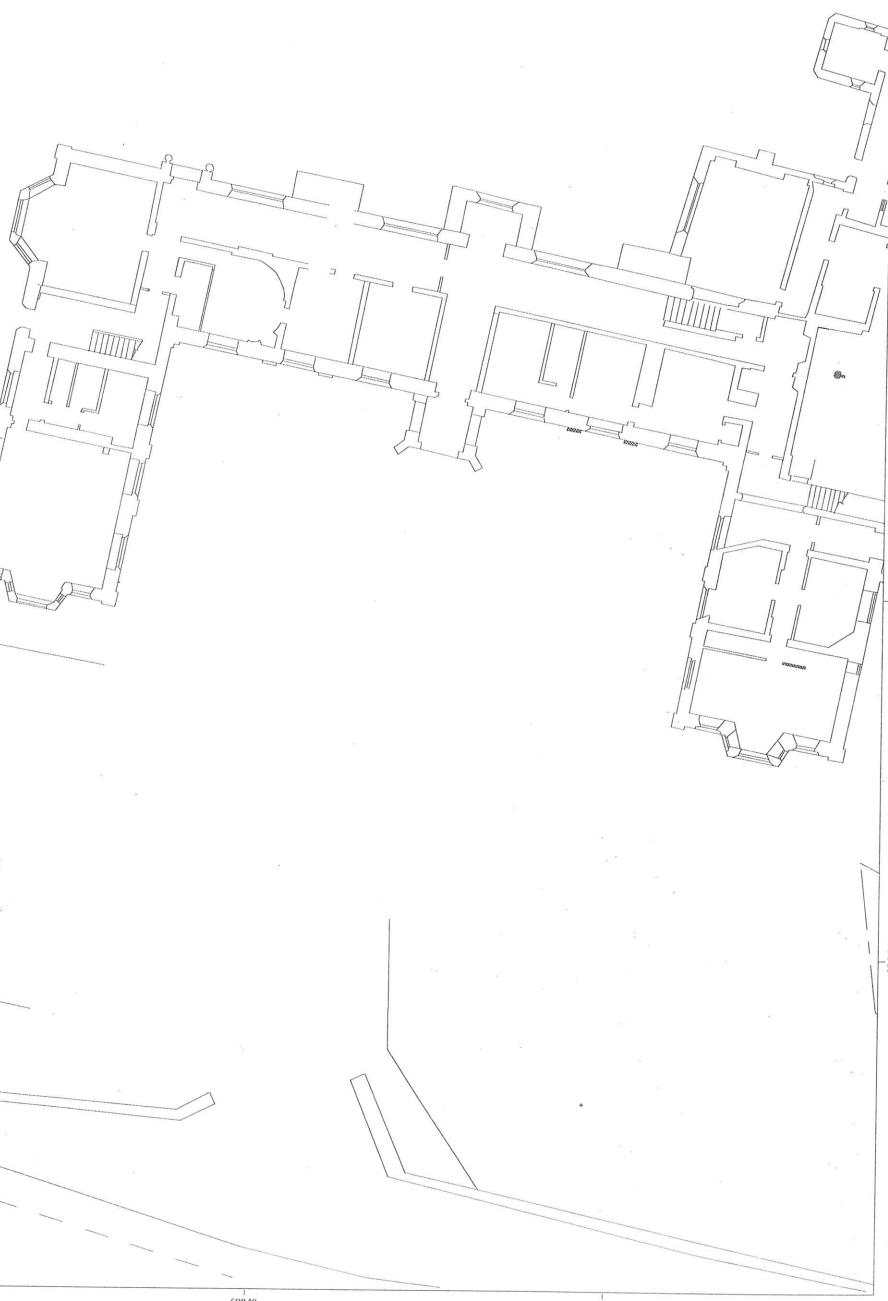
Fig 2 Putting Green Location

- 2.1.1 The planned position of the putting green was 20m to the north-west of the north-west corner of the Clubhouse (Fig 2). The layout of the green was sub-triangular in shape, with sinuous sides and the western edge close against a sandstone wall, defining the edge of a car parking area. The proposed putting green was approximately 200m² in area, and required a shallow soil strip to allow a stone carpet drainage layer to be inserted in the ground, prior to the area being covered with imported soil and seed.

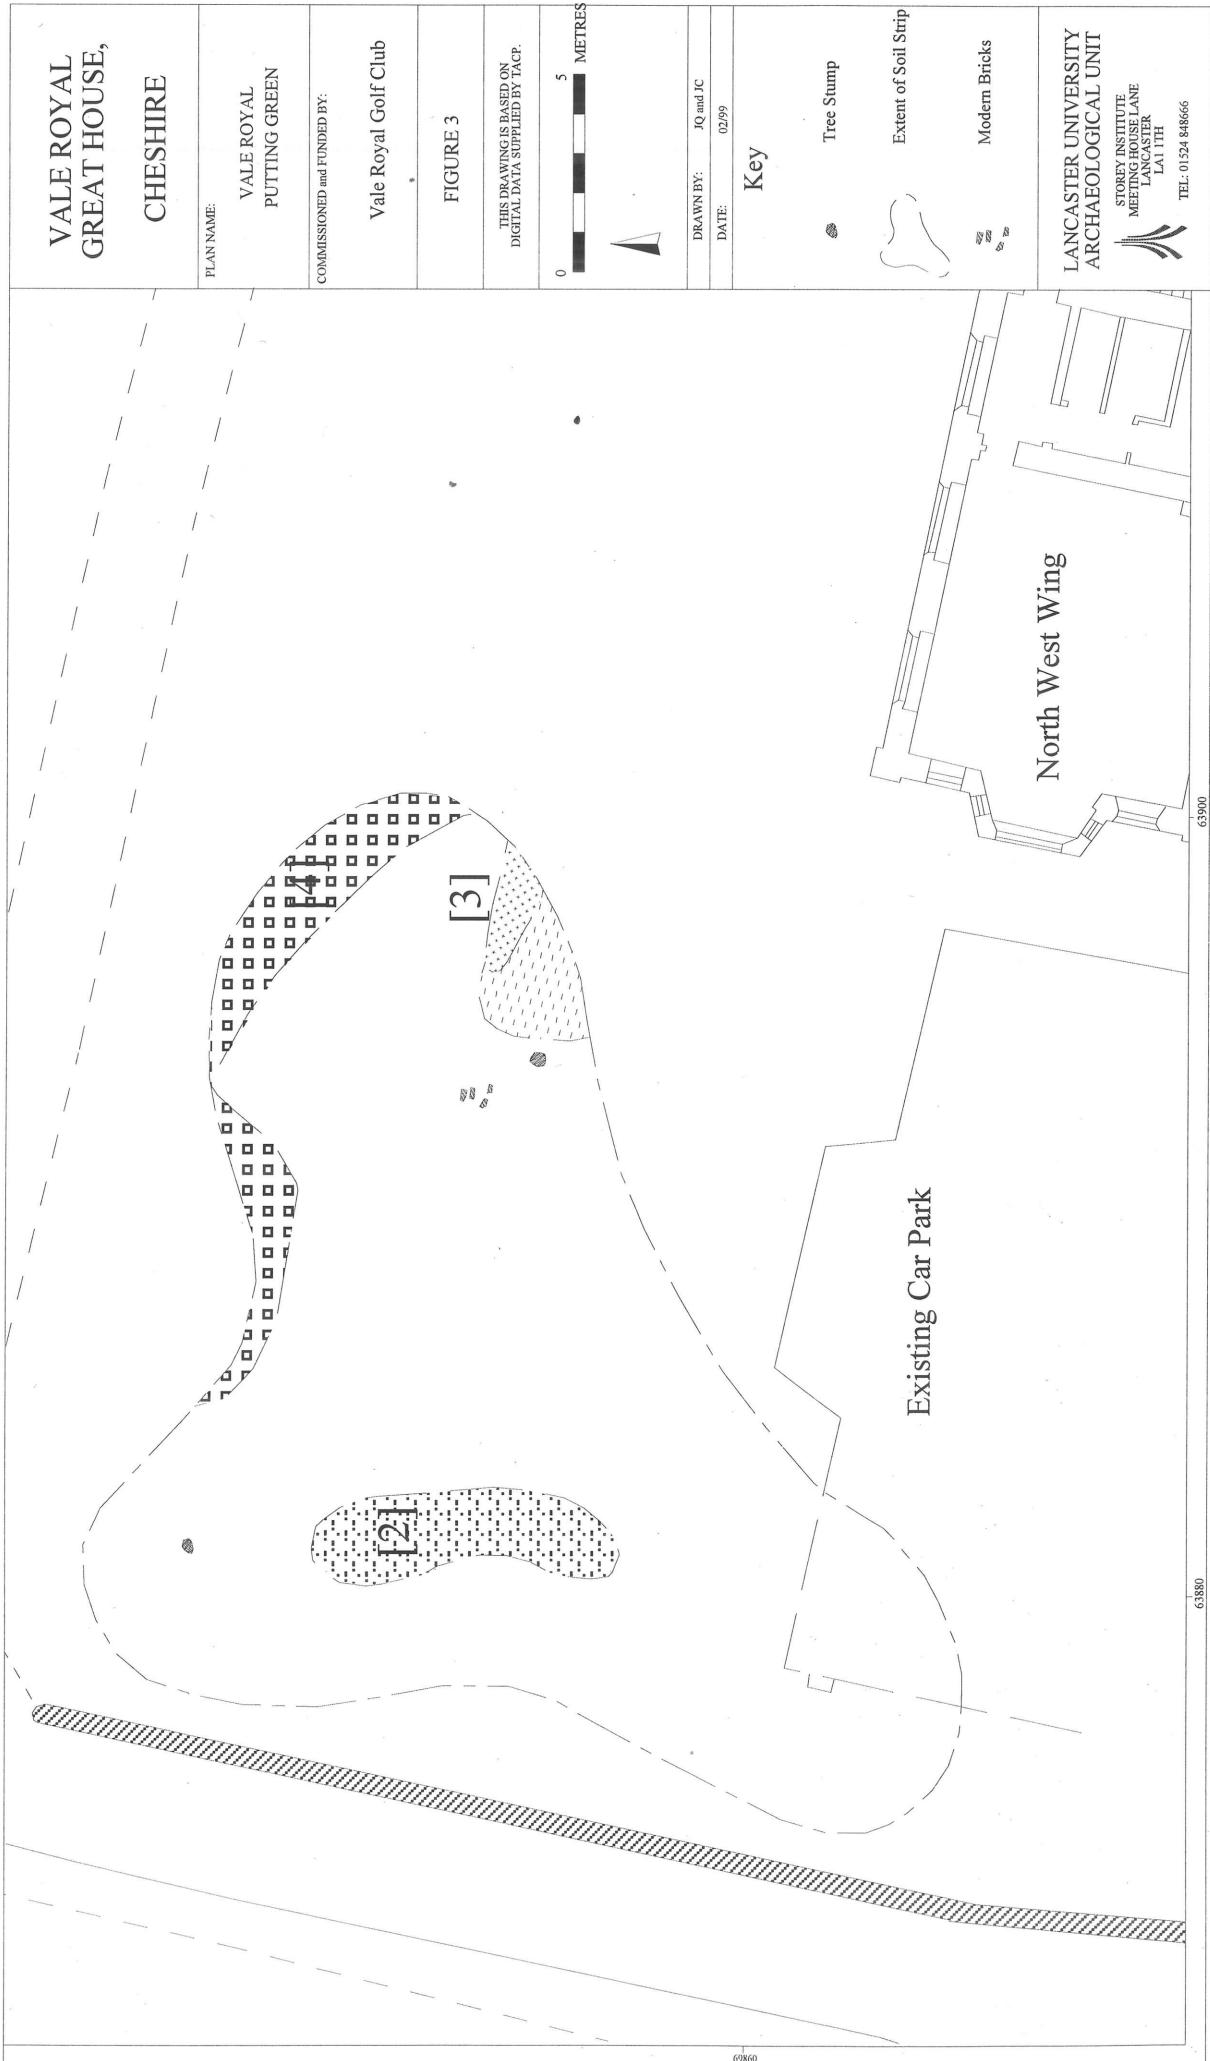
Fig 3 Putting Green Soil Strip

- 3.1.2 A certain degree of variation was observable in respect of the surface exposed by the soil strip (Fig 3). In the mid western part of the stripped area, a small patch of medium limestone gravel [2] was observed, which was aligned north/south and measured 8m by 1.5m in extent. On investigation, it was established that the limestone gravel formed a surface extending beneath deposit [1]. Following discussions with the green staff it was evident that this surface was the remains of a former car parking area, and that much of deposit [1] was infill of very recent date.

- 3.1.3 Towards the eastern corner of the stripped area a deposit of greyish-white cement mortar and gravelly clay was encountered [3]. This deposit appeared to form a deliberately flat and compacted level, and, although not fully understood, clearly represented another recent hard-standing. In places strands of polythene sheeting could be seen protruding from the deposit, which measured 5m by 2m in area.

- 3.1.4 Along the north-eastern perimeter of the stripped area, a zone of slightly lighter-coloured sandier-textured soil [4] was observed. Deposit [4], although difficult to differentiate from [1], appeared to have fewer inclusions and gave the impression of being a comparatively undisturbed soil horizon. It is possible, however, that deposit [4] was merely a lens within the general top-soil deposit.

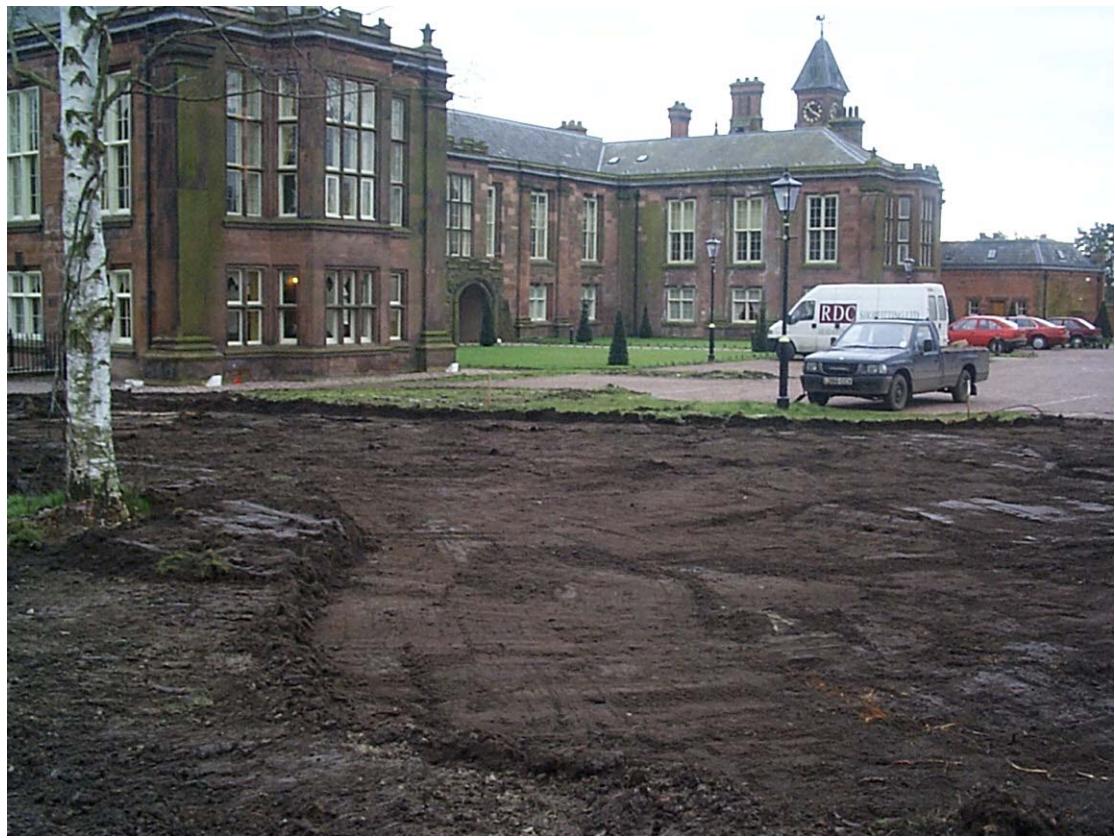
Plate 1 General view of Putting Green following soil strip > south-east

The construction of the putting green involved a superficial topsoil strip over an area of some 200m², adjacent to the north-west corner of the Great House. Topsoil was removed by a tracked mechanical excavator under archaeological supervision, and the resultant spoil was used for landscaping nearby to the east of the house. The movement of the spoil was also subject to archaeological supervision.

The topsoil strip extended to a maximum depth of 0.08m and was made through modern deposits; this overlay a hard-standing deposit which was the surface for an earlier car park. No excavation through the hard-standing was undertaken. No archaeological features or finds were encountered and the development has not had any impact upon any significant archaeological resource.
