November 1997

THE FIRST WHITE CLOTH HALL
KIRKGATE
LEEDS
WEST YORKSHIRE

Archaeological Building Survey Report

Report no 1997-98/(026)/7680

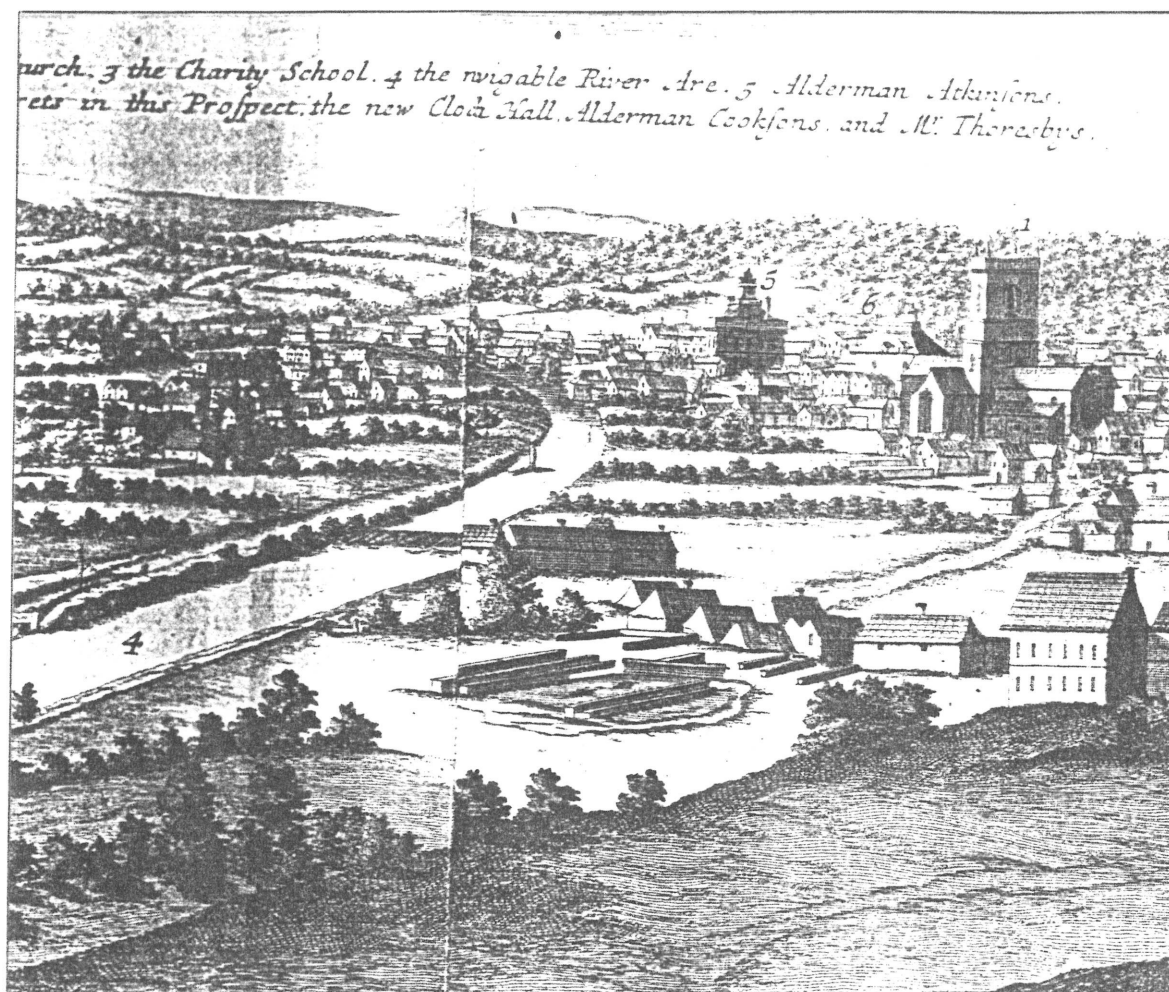
Figure 3: 'The Prospect of Leeds from Knostrop Road', Place, F. 1715 (reproduced from Thoresby, R. 1715 *Ducatus Leodiensis*:1)

3.1.5 The only other early eighteenth century evidence of the building is on Place's map of 1715 (Fig 3). This map indicates that the new cloth hall was located between Alderman Atkinson's and Alderman Cookson's houses, but it is not clear which, if any, of the buildings depicted is the cloth hall.

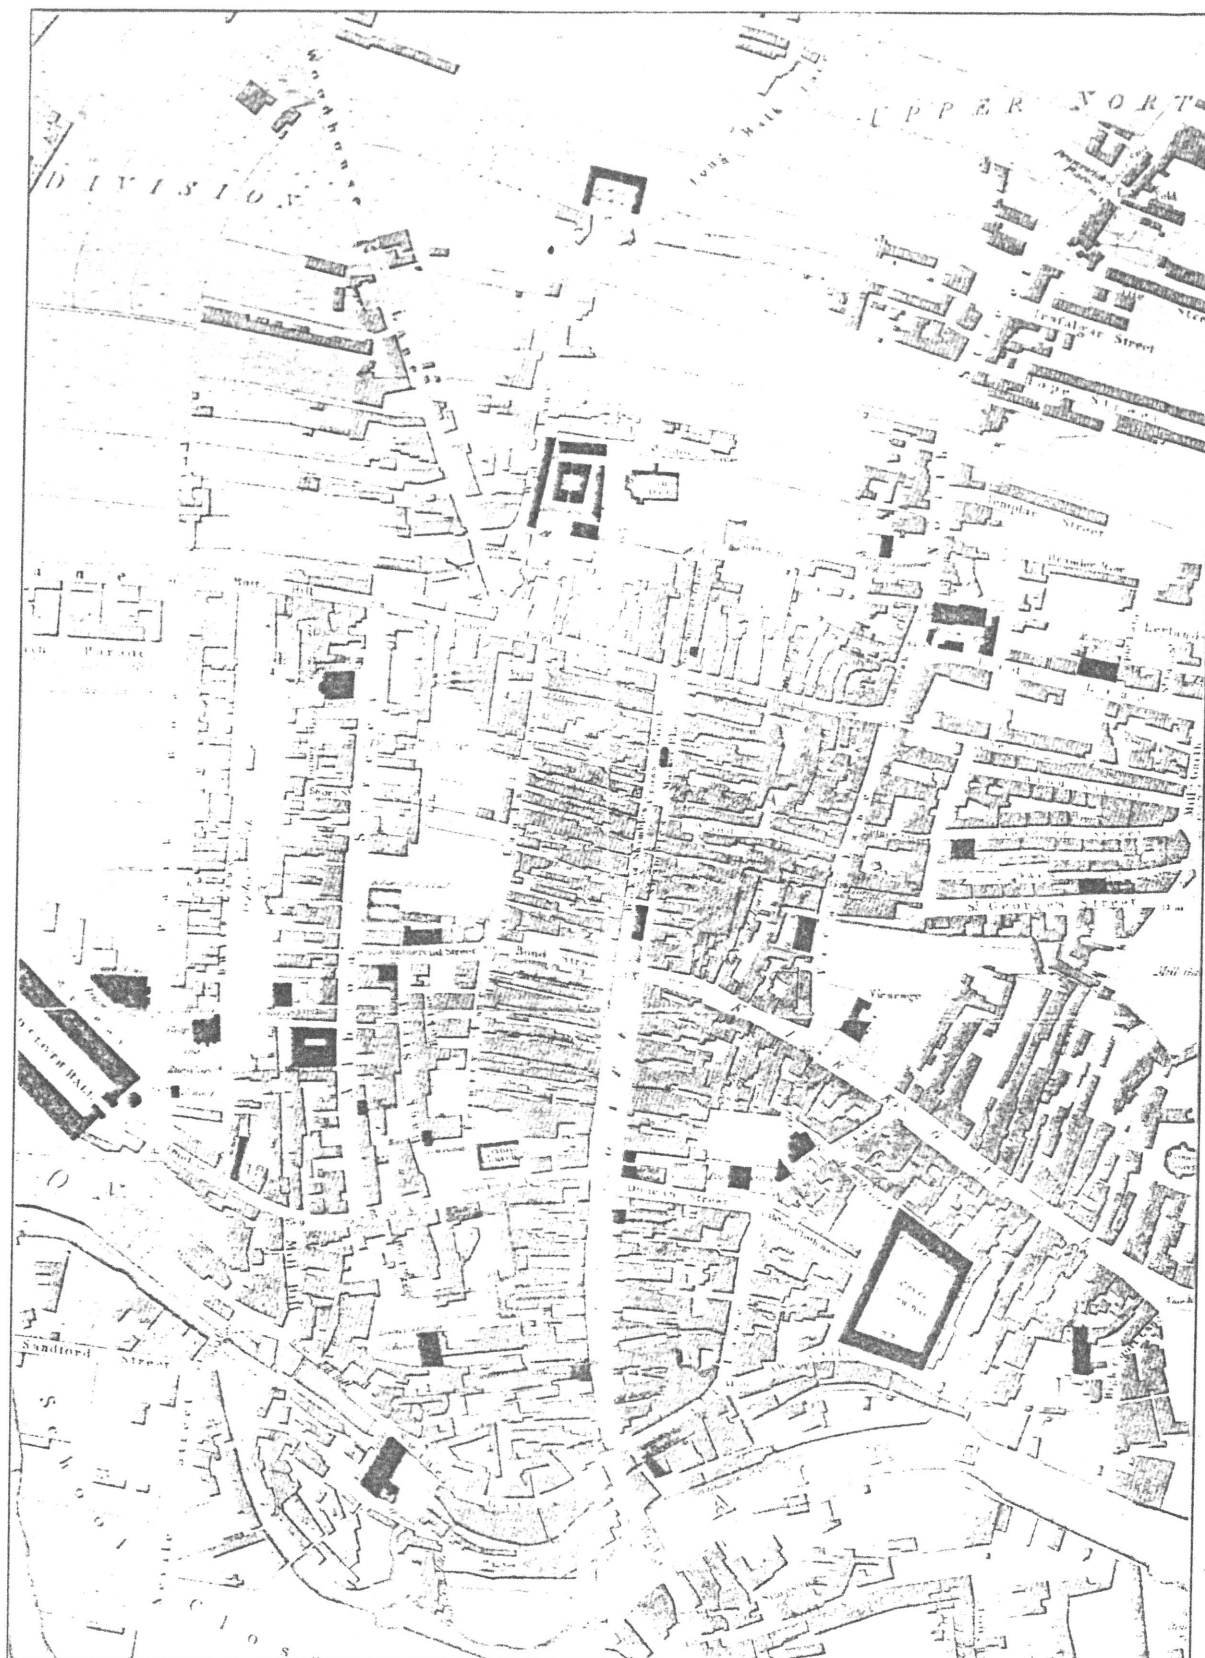
Figure 6: 'Plan of the Town of Leeds and Environs', Giles, N. & F. 1815, 1" - 90 yards

- 3.3.2 It is clear that by the early nineteenth century the building had been converted to domestic/retail residences. Giles's map of 1815 is the first to illustrate these changes (Fig 6). It depicts houses built across the street frontage, thus reducing the courtyard to a light well and the east and west ranges were extended to the rear; the western extension was later to be known as Crown Court. The depiction of the third White Cloth Hall, located immediately to the south, graphically illustrates the transferral of the original function of the building to a more commodious site.

- 3.4.4 **1775-1815:** the main changes to the building occurred at a date between 1775 and 1815 with the construction of houses blocking the courtyard and the rear extension of the east and west ranges. The first maps to indicate these changes is Giles' map of 1815 (Fig 6) and the OS map of 1850 (Fig 7) which illustrates the property divisions. The east range comprised one property, with an adjacent house blocking the courtyard; the west range was a single property with additional street frontage achieved by an extension across the courtyard; the south range was divided into four with a possible access point in the south-east corner of the courtyard. The west wall of the south range is set back from the alignment of the west range which could be an original feature, or possibly represents a re-alignment to accommodate the adjacent terrace.

- 4.4.7 **First floor:** the only substantial remains of the original west arcade of the White Cloth Hall are the first floor wall and windows as exposed externally, in what has now become the courtyard. The windows [169, 170, and 171], dressed with semi-circular brick voussoir heads, are located at the first floor level of the west arcade. The brick voussoirs spring from sandstone blocks, and also have keystones of the same material. Two of the windows, those at the north and south ends [169 and 171], have sandstone sills which have suffered some erosion from the effects of weathering and physical damage. The remains of a fourth window can be seen within the junction of the arcade and the later northern wall which effectively truncated the arcade and enclosed the courtyard; this is illustrated for the first time on the 1815 town plan of Leeds (Fig 6).

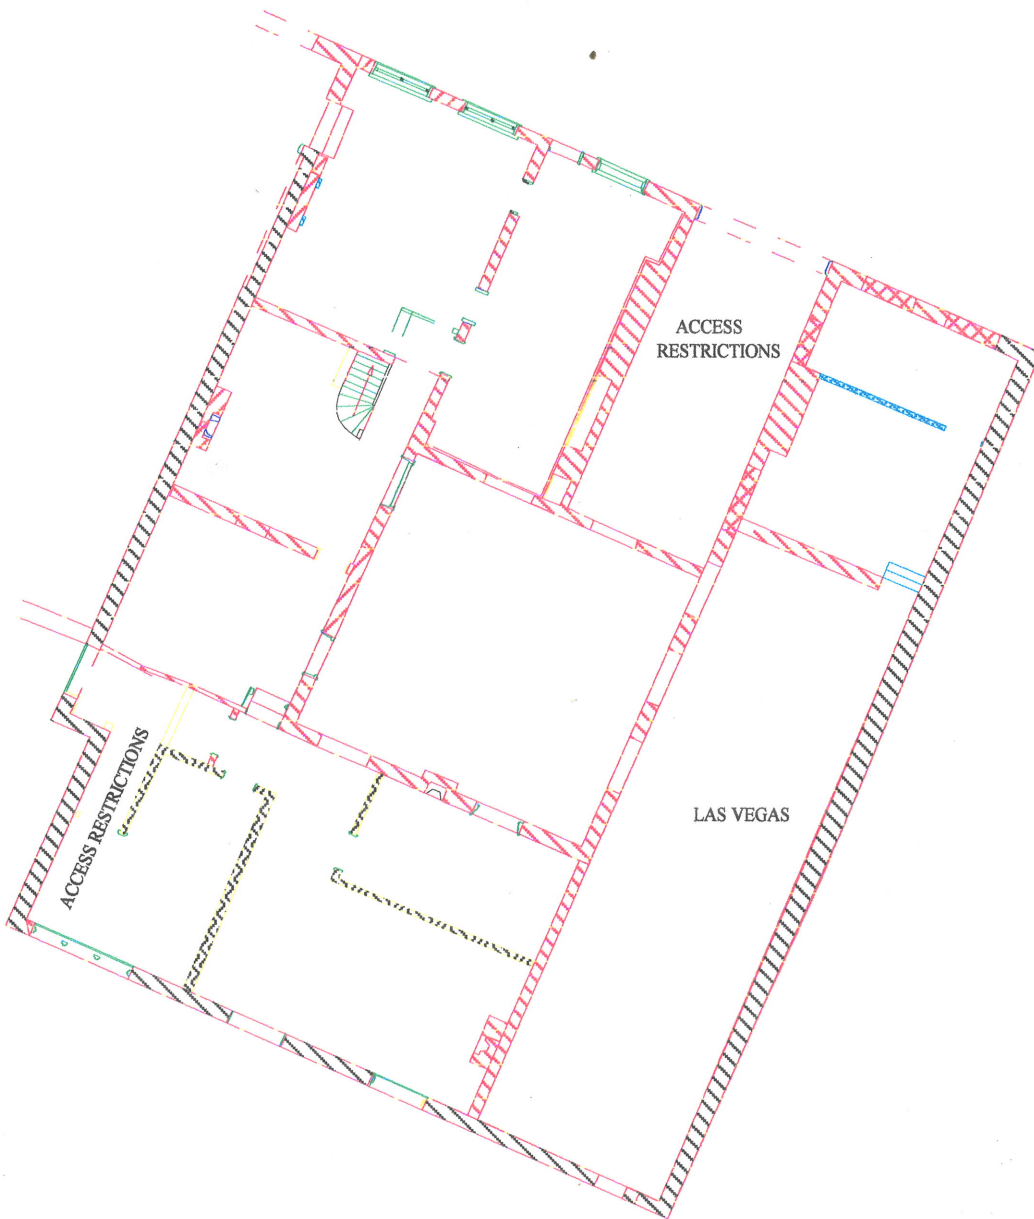
Fig 11 First Floor Plan

- 4.5.14 An interesting feature, associated with the dividing wall, can be seen in the roof space of the room it creates (Fig 11). This is a square shaped structure with gable ends facing north and south, and is constructed from lathe and plaster. It rises vertically from the upper edges of plaster coving [152] and is suspended from the roof purlins by a braced timber frame; the gable ends extend upwards to the ridge plate. It is contained within the space of the roof and in this form gives extra depth to the ceiling and corresponding height to the room below. Interpretation suggests that this was a lantern-type arrangement, which has subsequently been enclosed by the renewal of the roof above. The timbers of the lantern are machine cut and considerably more recent than those of the plaster coving ceiling which it is set into. It is clearly a later insertion but it is not possible to establish a precise date for it.

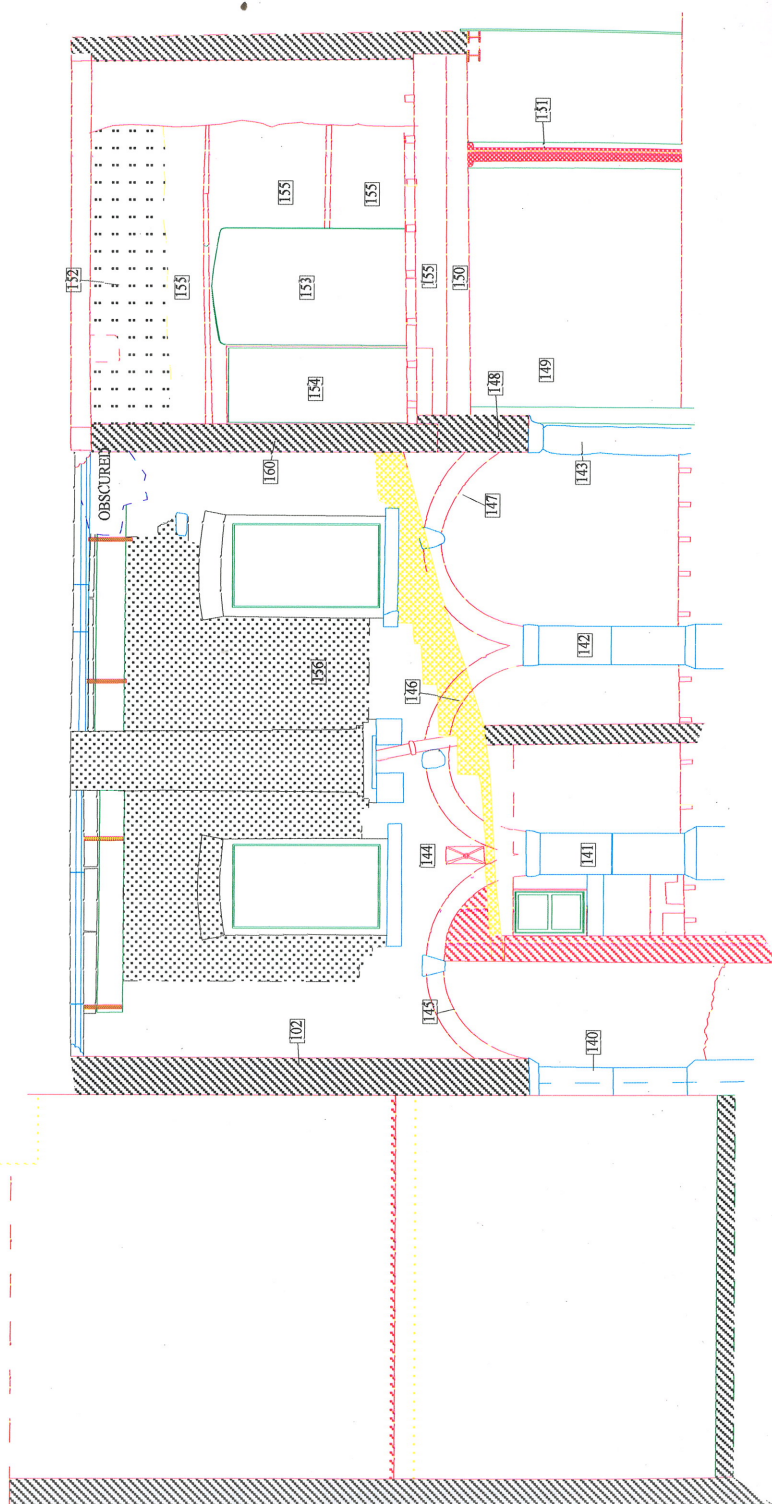
Fig 18 South Arcade Elevation

- 4.5.1 What was originally the south arcade wall of the White Cloth Hall (Fig 18) has undergone substantial change since its construction in 1711. Its north face is no longer exposed to its full height as an external elevation; it has effectively been truncated by the insertion of a late sloping roof leaving only the upper level exposed in what is now an enclosed rather than open courtyard. Externally, the most obvious change is the replacement of the original windows; however, what is not clear is the sequence of events from the period of use of these windows to the rebuilding of the wall and the change in position and shape of the windows.

- 4.5.2 **Ground floor:** the ground floor (Fig 18 and 10) of the south arcade, located internally beneath the confines of the sloping roof, retains four sandstone pillars [140, 141, 142, and 143] from the 1711 arcade. The east/west alignment of the pillars, each with moulded capital and base, exist in varying states of repair. All the pillars have suffered some damage to their faces and decoration; one in particular [143] has been extensively cut back. The bases of the pillars are hidden beneath the present timber floor level.

- 4.5.11 In place of the upper three to four courses of brick is a very large timber beam that, at both ends, has been cut into the remaining first phase brickwork [144]. Bolted to this beam are metal brackets supporting the guttering above. This style of bracket has also been noted within the east arcade. The wall is finished with a moulded sandstone string course [138] into which the brackets are cut.
