Lancaster University Archaeological Unit undertook a programme of archaeological work at Samlesbury Hall, Lancashire (SD 6236 3050), commissioned by RSCE Consulting Engineers on behalf of the Samlesbury Hall Trust. The archaeological investigation was undertaken as part of the Restoration and Development Project 2000 programme.

**SAMLESBURY HALL
ARCHAEOLOGICAL
ASSESSMENT**

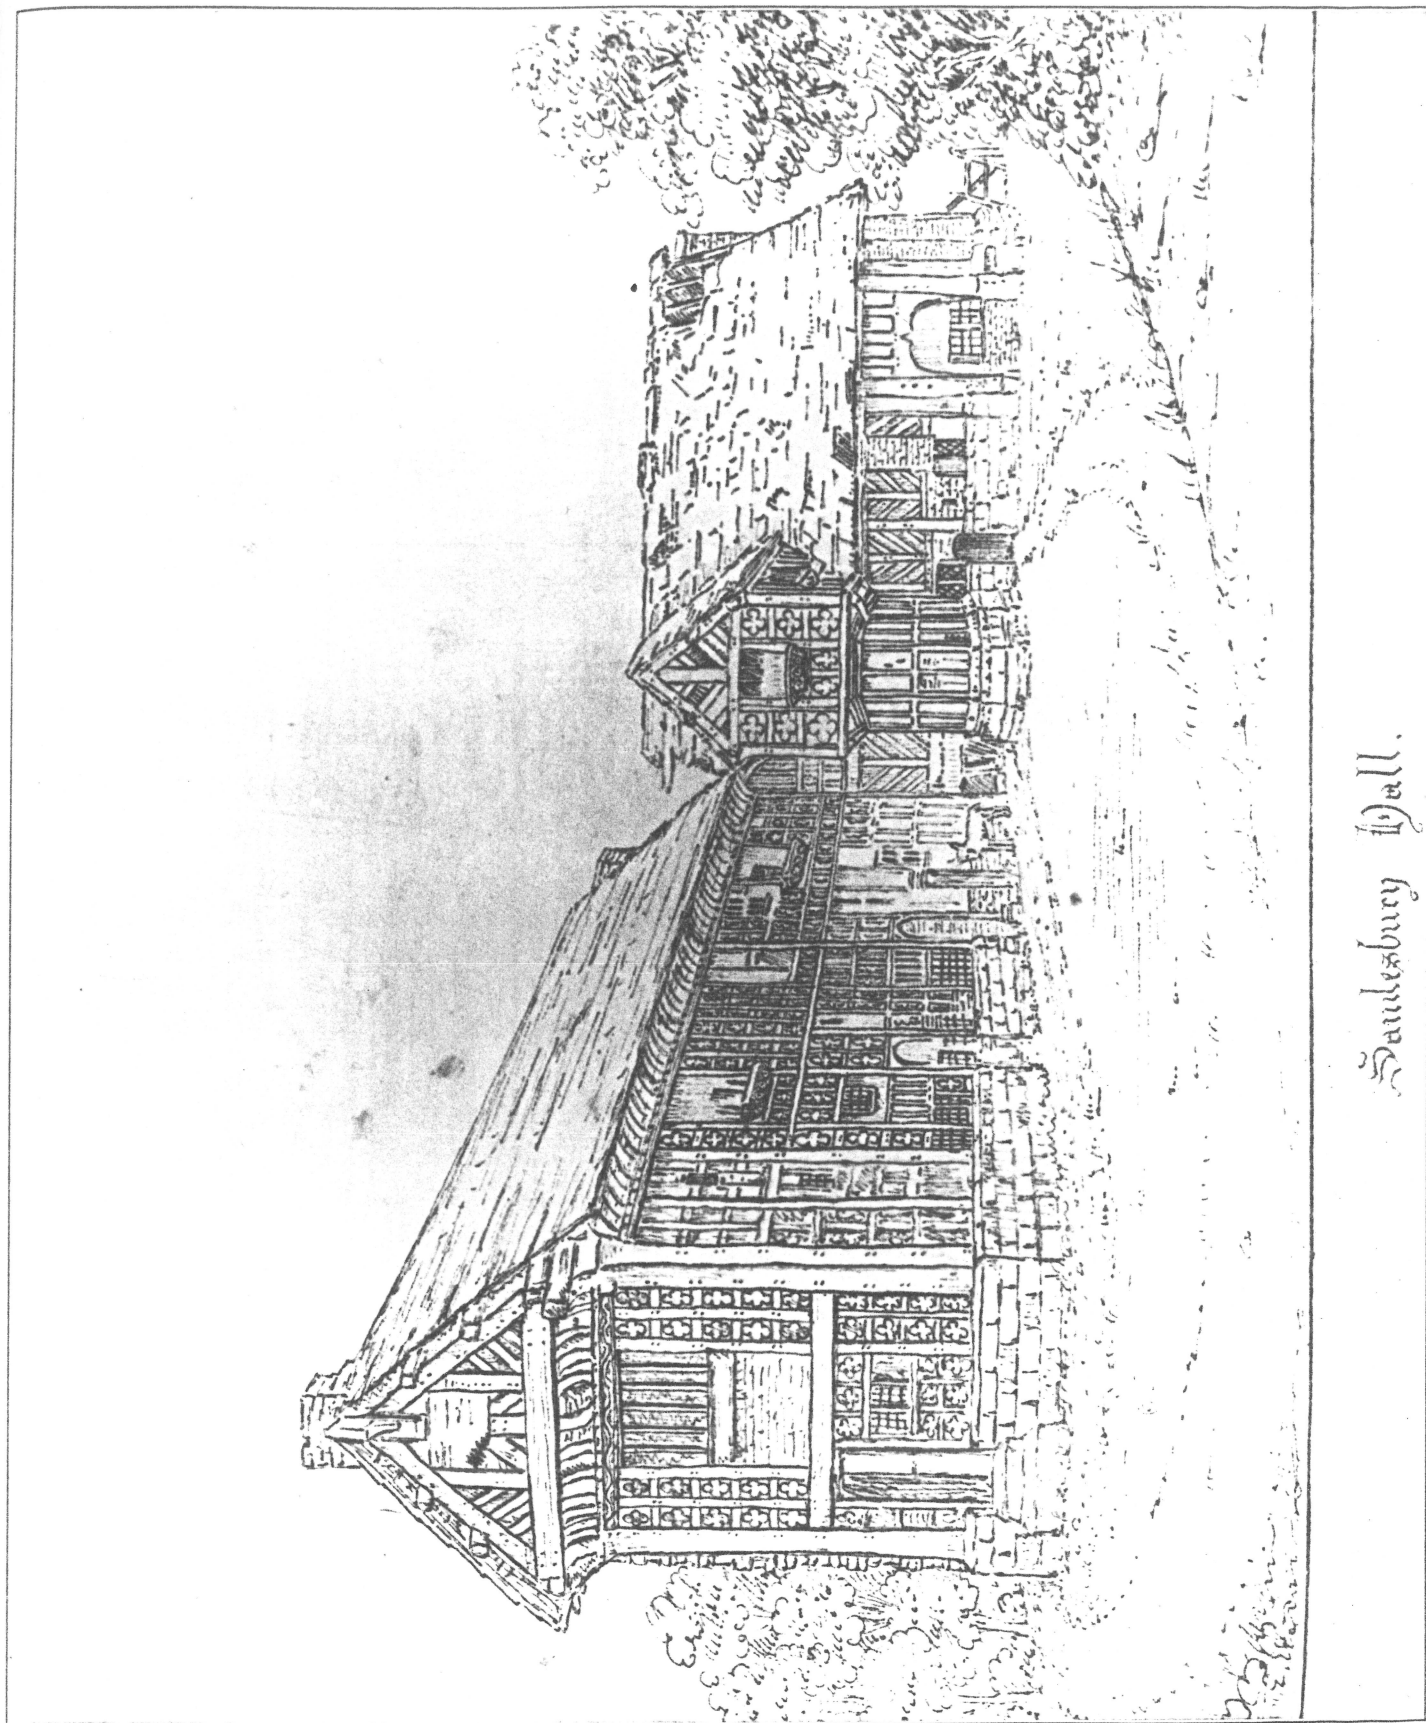
Figure 2: illustration showing moat, Addison, undated c. 1800 - 25

- 3.7.3 Despite the extensive search for plans or other drawings, Agnes Addison (LRO DDX 1235/4/19) was found to be the only illustrator to represent the moat as it actually was (Fig 2). We are otherwise reliant on the deduction and conjecture of earlier authors. Addison's small drawing (c1800-25) shows the Hall from the south-east, including the outshut to the east elevation, which seems to have been removed after c1833-35, being shown on only some of Rev SJ Allen's drawings at that date.

- 3.7.24 One of the outshuts is illustrated by Addison c1800-25 (Fig 2), two by Buckler in 1814 (Fig 5), and possibly three by Allen c1833-5. None of them are shown on Eaton's or Croston's plans, but at least one (at the east end) is identifiable on the 1822 Braddyll estate map (LRO DDHj Acc 4706, map 1), albeit at a very small scale. The east outshut, perched on the edge of the moat, was roughly 20 ft (6.1m) square, with a steeply pitched roof, possibly thatched, and had four windows, two in the gable, one above the other, and one in each side. Buckler (BM Add MSS 36368, f211) shows the gable windows as having ornate hood mouldings, almost certainly indicating re-use of late medieval windows, perhaps from Whalley Abbey, like the chapel window. None of the illustrators show an entrance. Access could have been from close to the quadrangle-side of the chapel wall, which was the only un-illustrated view. Buckler shows a doorway to the outside from the east elevation of the chapel, south of the outshut. This is still shown by Allen after removal of the outshut, there being no sign of a blocked doorway directly into the outshut from the chapel.

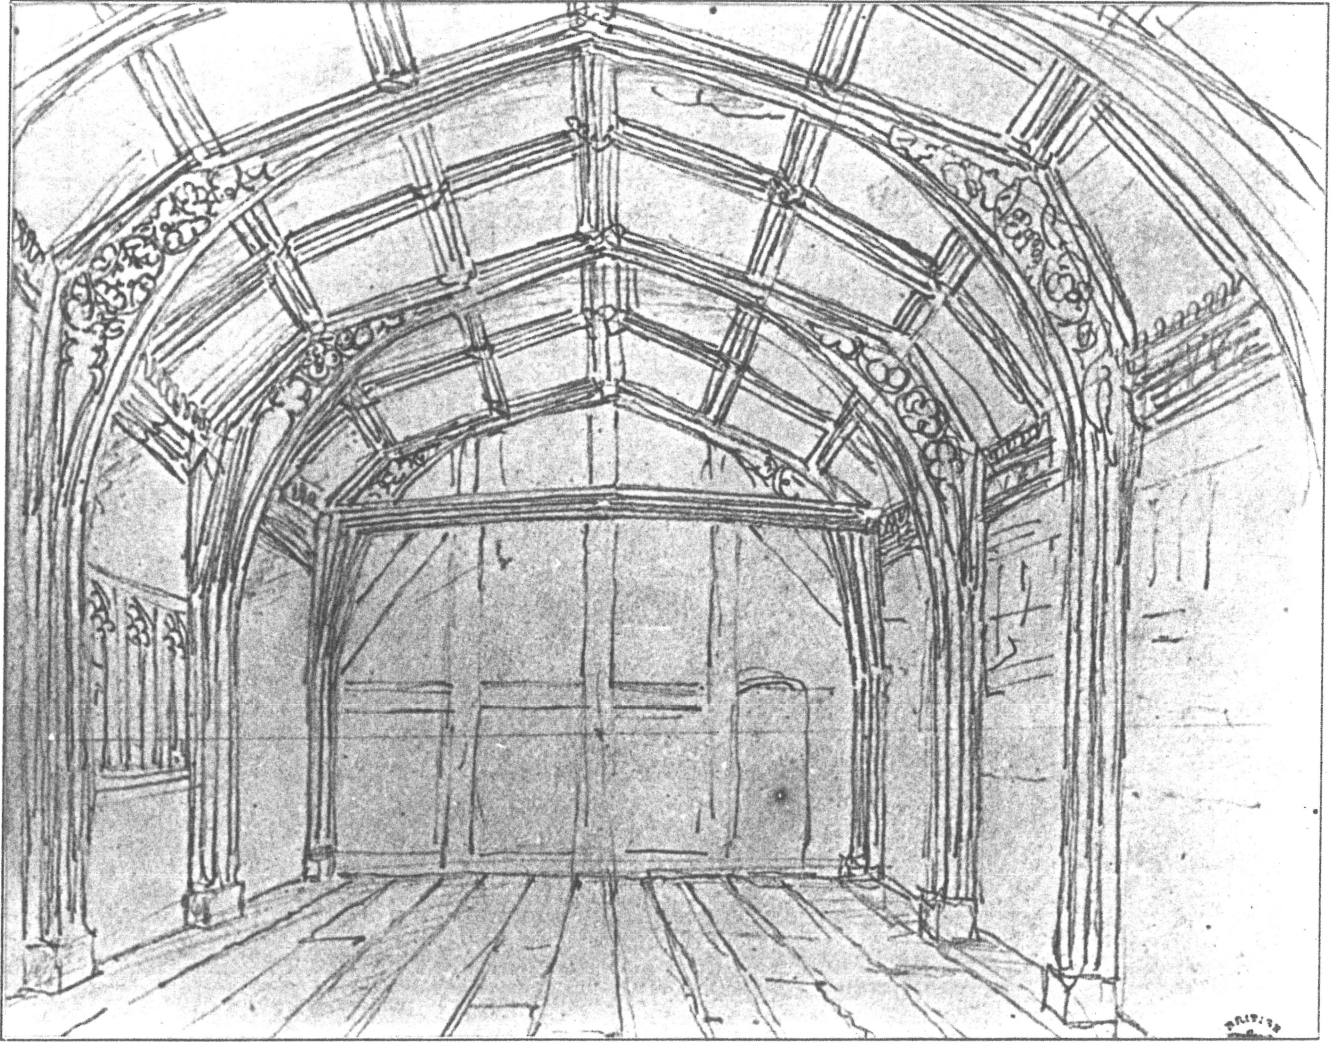
Figure 3: timber panelling at south-east end of chapel, Buckler, 1816

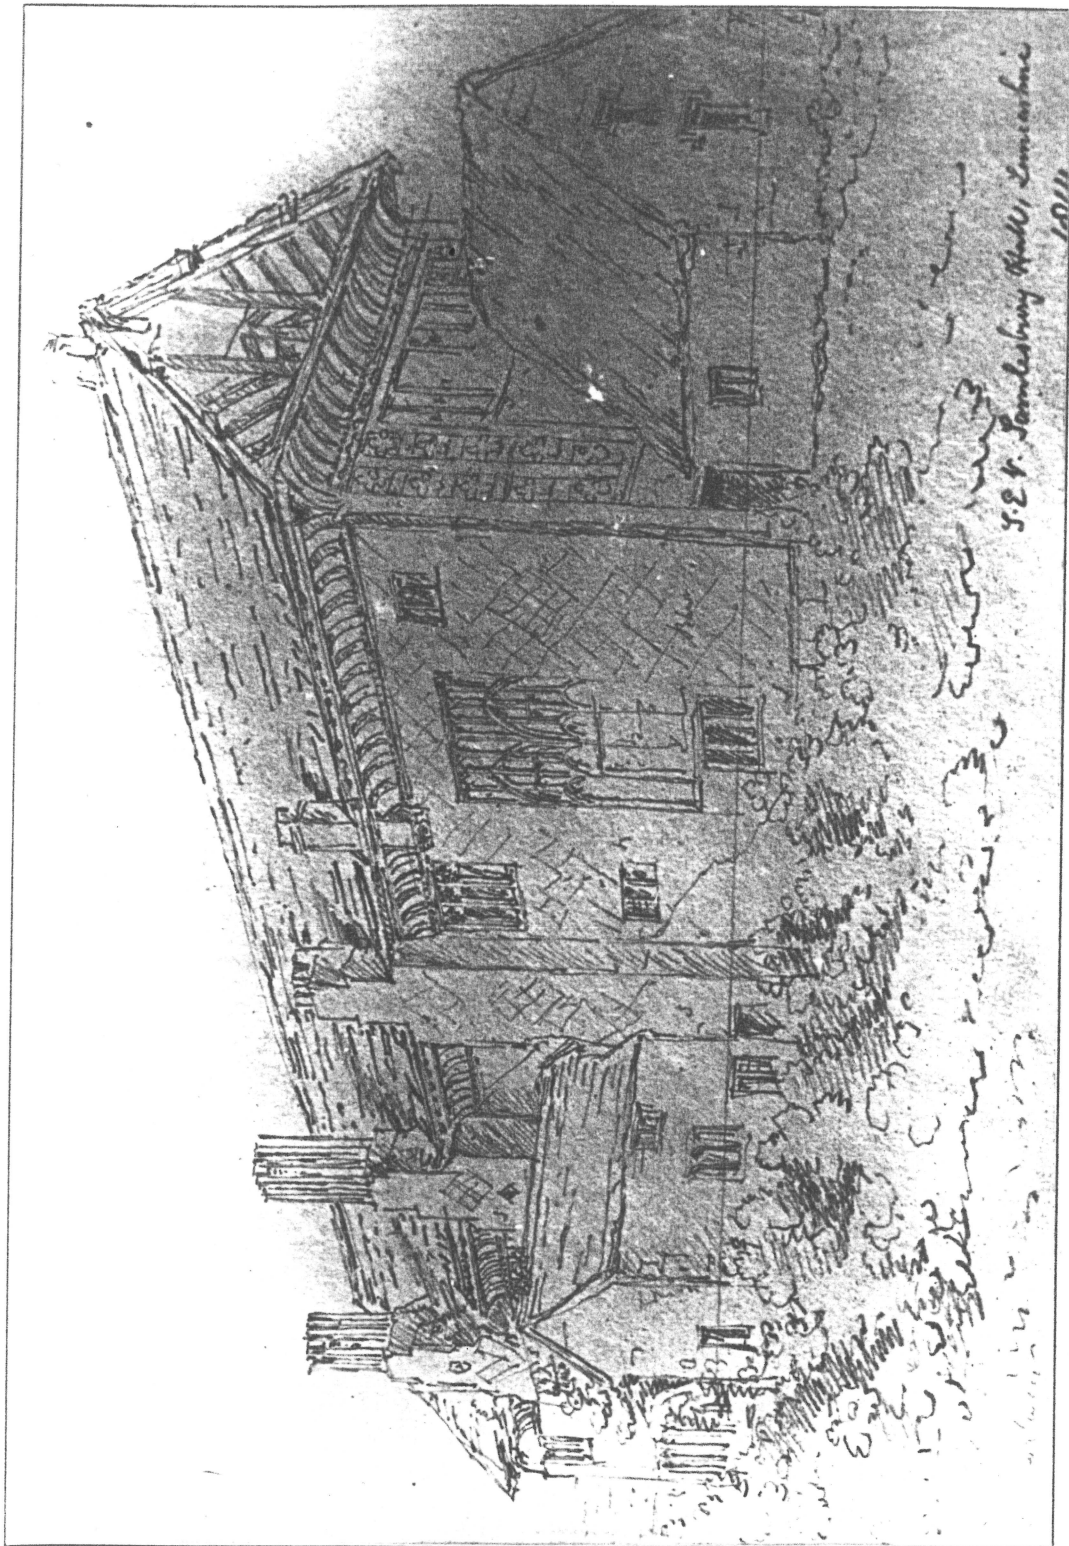
Figure 5: Samlesbury Hall, showing outshut attached to chapel, Buckler 1816

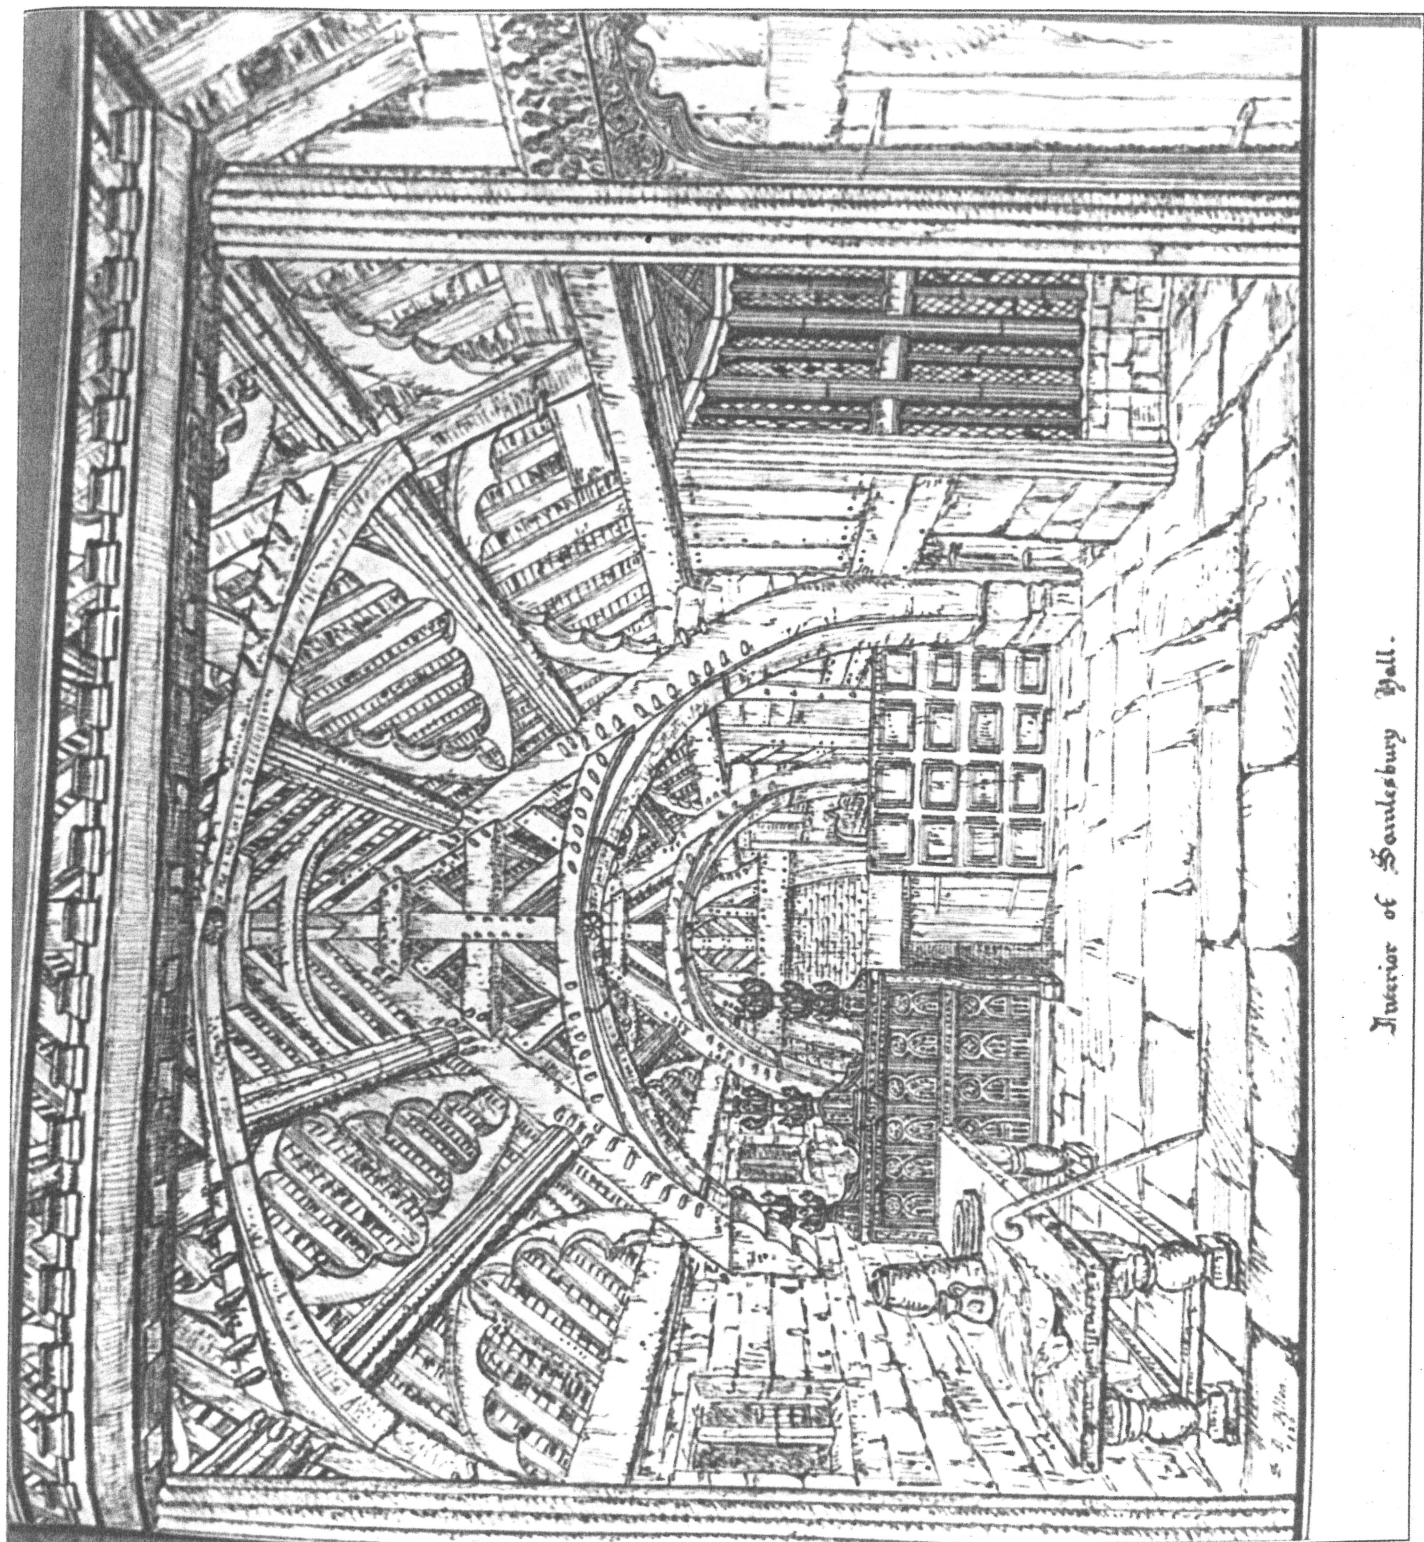
Figure 7: the great hall, Samlesbury, showing the re-use and adaptation of the portable screen, Allen, 1830

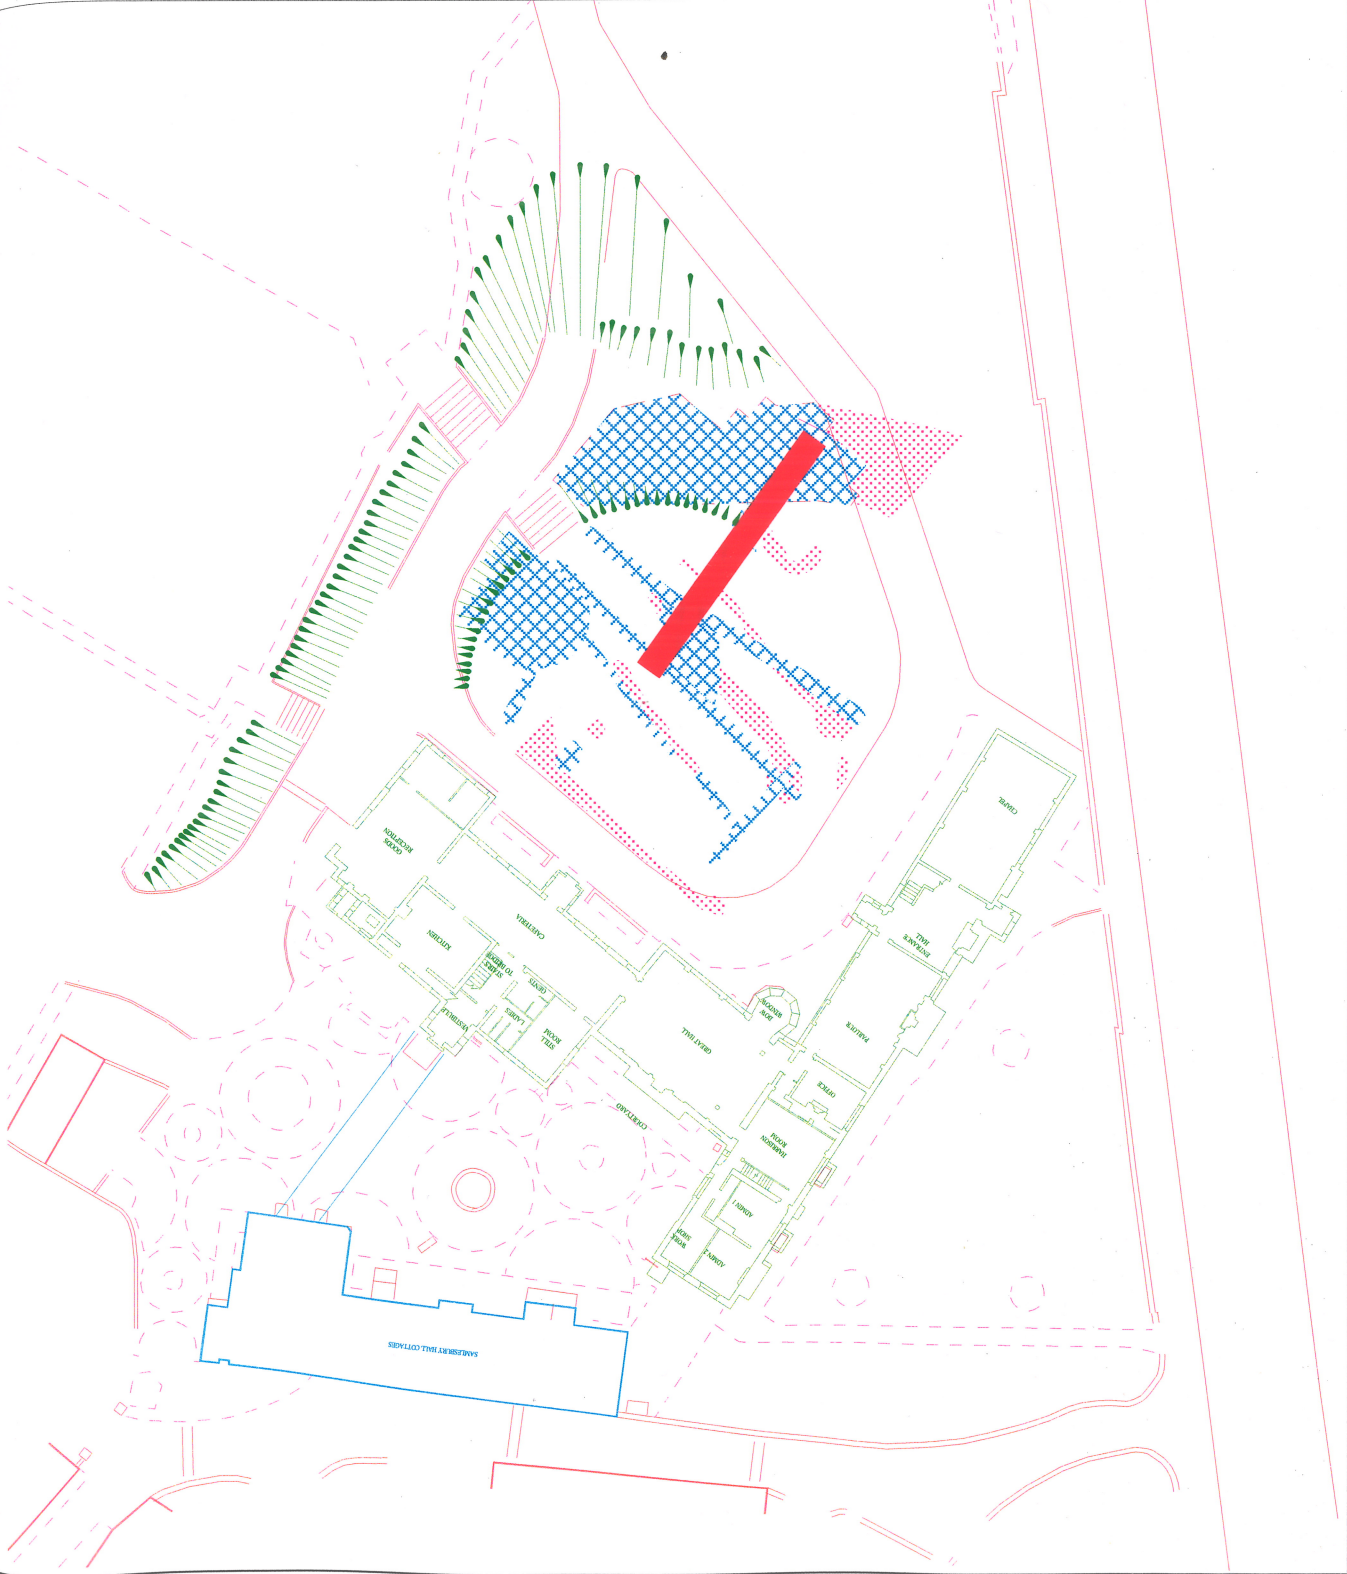
Figure 10: Samlesbury Hall and grounds showing topographic, geophysical and trial trench locations

- 4.3.1 The field inspection was limited by overgrown areas. Although no features were observed in these areas, it is possible that small scale, ephemeral features do exist here. The area to the south of the largest agricultural field has been levelled and concreted (Fig 10).

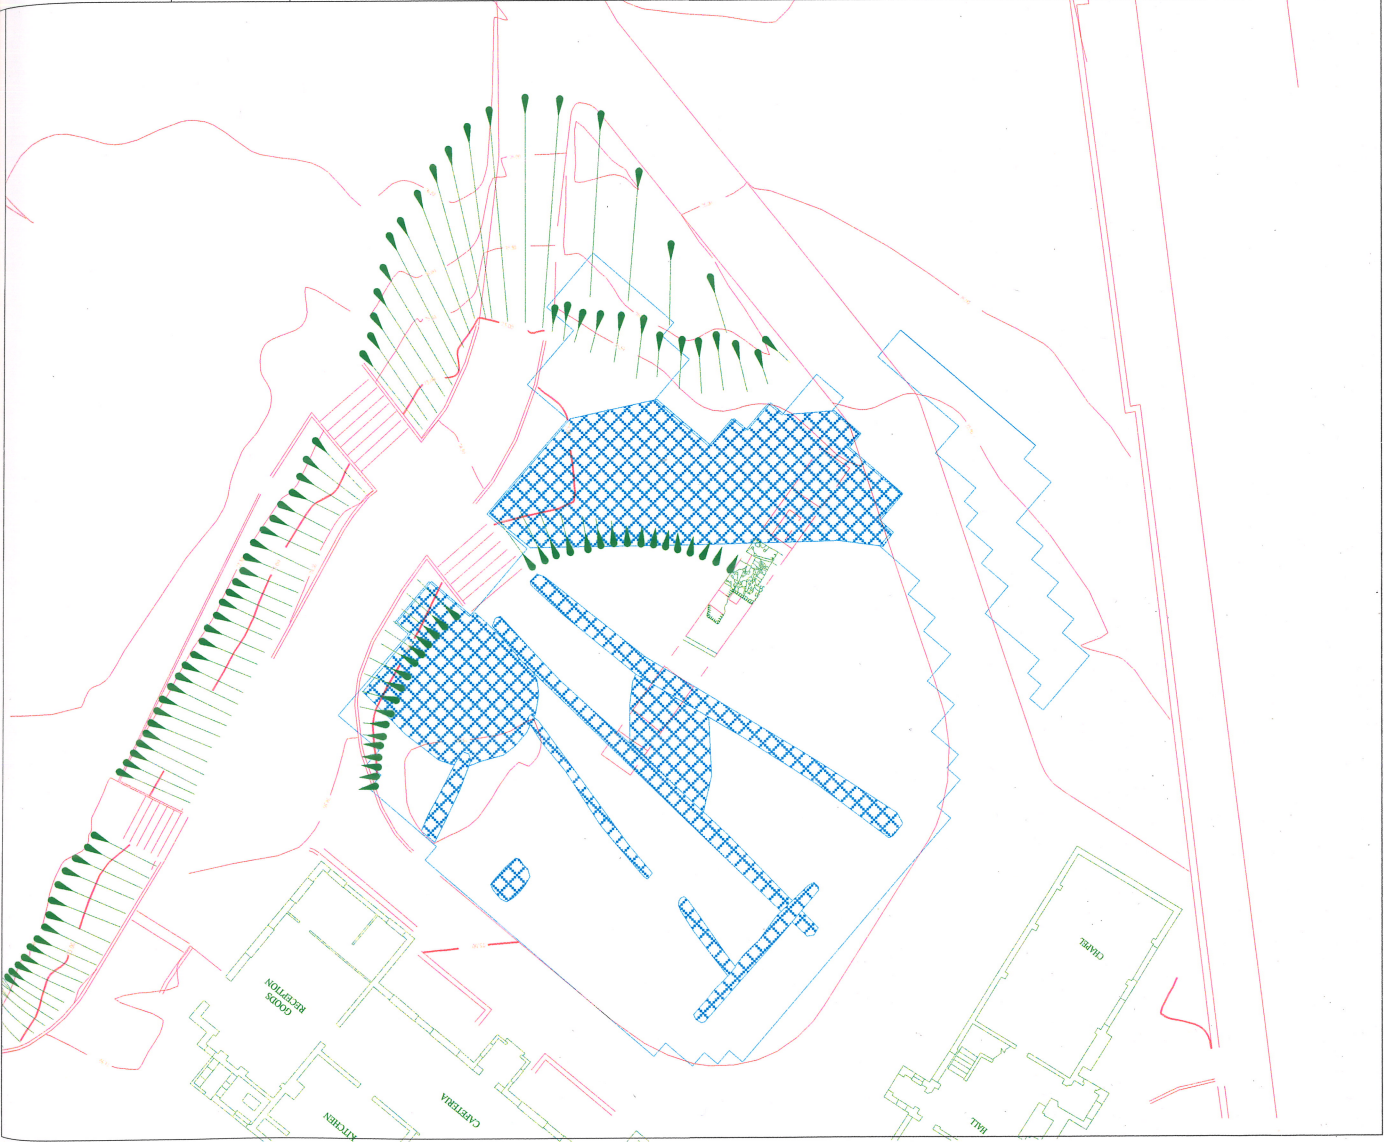
Figure 12: Interpreted Resistivity Survey Results

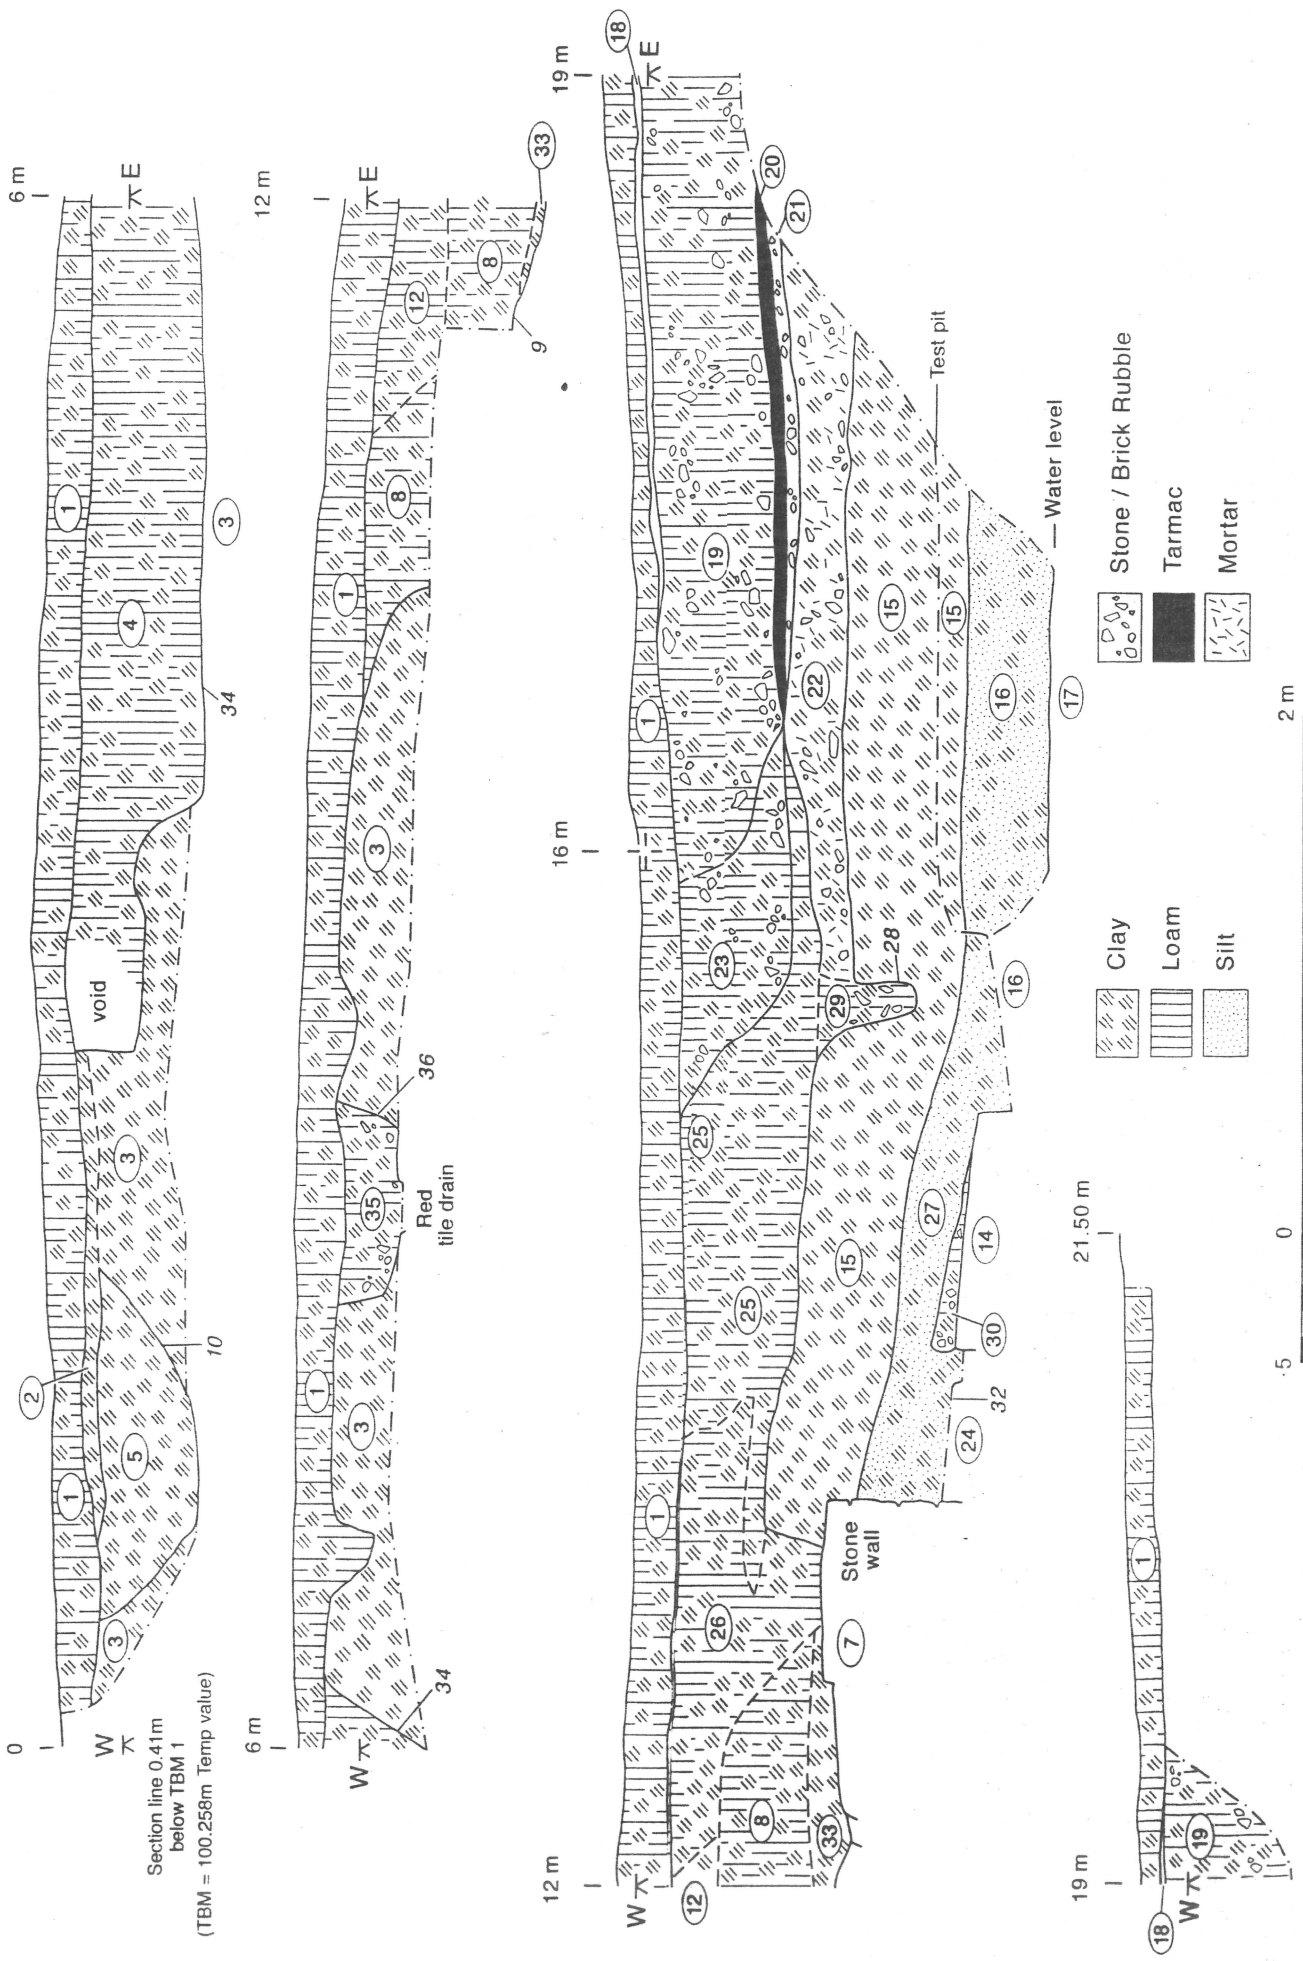
Figure 14: Trench section

Trench 1 Section 1 South Facing

- 4.2.3 Overlying the clay capping [15], there was a rubble make-up deposit [22] comprising brick mortar and sandstone fragments and a stony hard-core [21] which provided the bedding for a tarmac road [20] (its full width was not determined). It appeared that the roadway or drive was served at its western edge by a drain [28] filled by rubble and broken brick [29] set at or cut through the foot of a low bank of clay loam with clay patches [25, 26] which was part of the landscaping of the central area in front of the Hall. This suggests that the road, following the line of the moat, was slightly sunken, lying below the level of the landscaped lawns / gardens.

- 4.2.7 There were several linear features to the west of the moat, aligned approximately north/south, cutting into the natural clay subsoil and lying below the present topsoil. Two linear features were observed at the western end of the trench (Fig 13). A narrow feature with a curving base [10] may have represented a ditch, it was filled with a uniform deposit of mottled brownish grey clay [5]. This feature was partially overlain by a shallow stony deposit comprising subangular fragments of sandstone and brick in a stiff clay matrix [2] up to 1.80m wide and may have formed a rough surface or path. It lay approximately on an alignment between the main public entrance to the Hall and the steps, known as the 'Moat Steps', from the lawn down to the level of the drive. To the immediate east of the surface there was a pronounced 3.05m wide hollow, 0.48m deep [34], filled with topsoil-like clay loam containing some clay patches [4]. This may have been a feature of the former landscaping or cultivation. A tile land drain [35 / 36], cut into the clay subsoil, was also uncovered, but was left *in situ*. The whole feature was covered by a clay loam topsoil which contained post-medieval artefacts, including a 1925 halfpenny, which probably gives a good indication of the period when this material accrued.

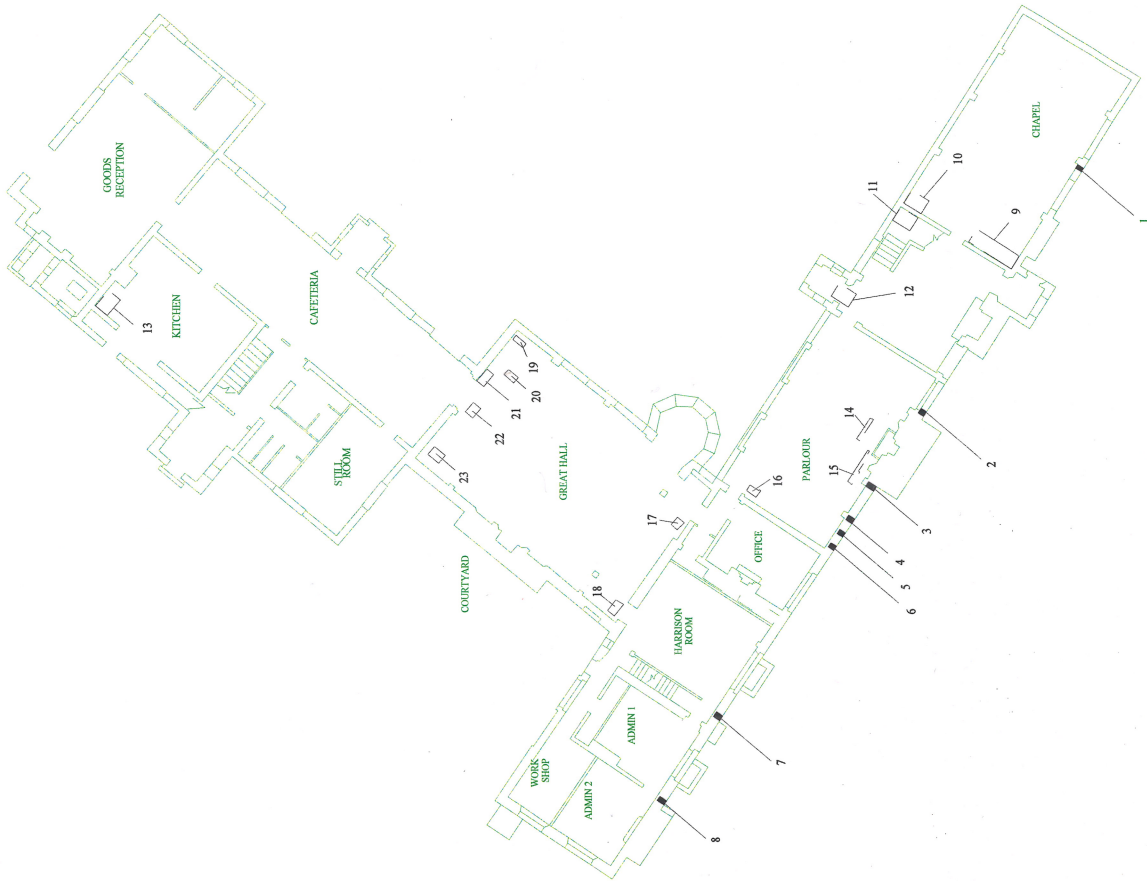
Fig 15 Samlesbury Hall, showing trial inspection areas
