June 1999

CARNFORTH LODGE
LANCASHIRE

Building Assessment and
Evaluation Report

Report no 1998-99/ 061/AUA 7886

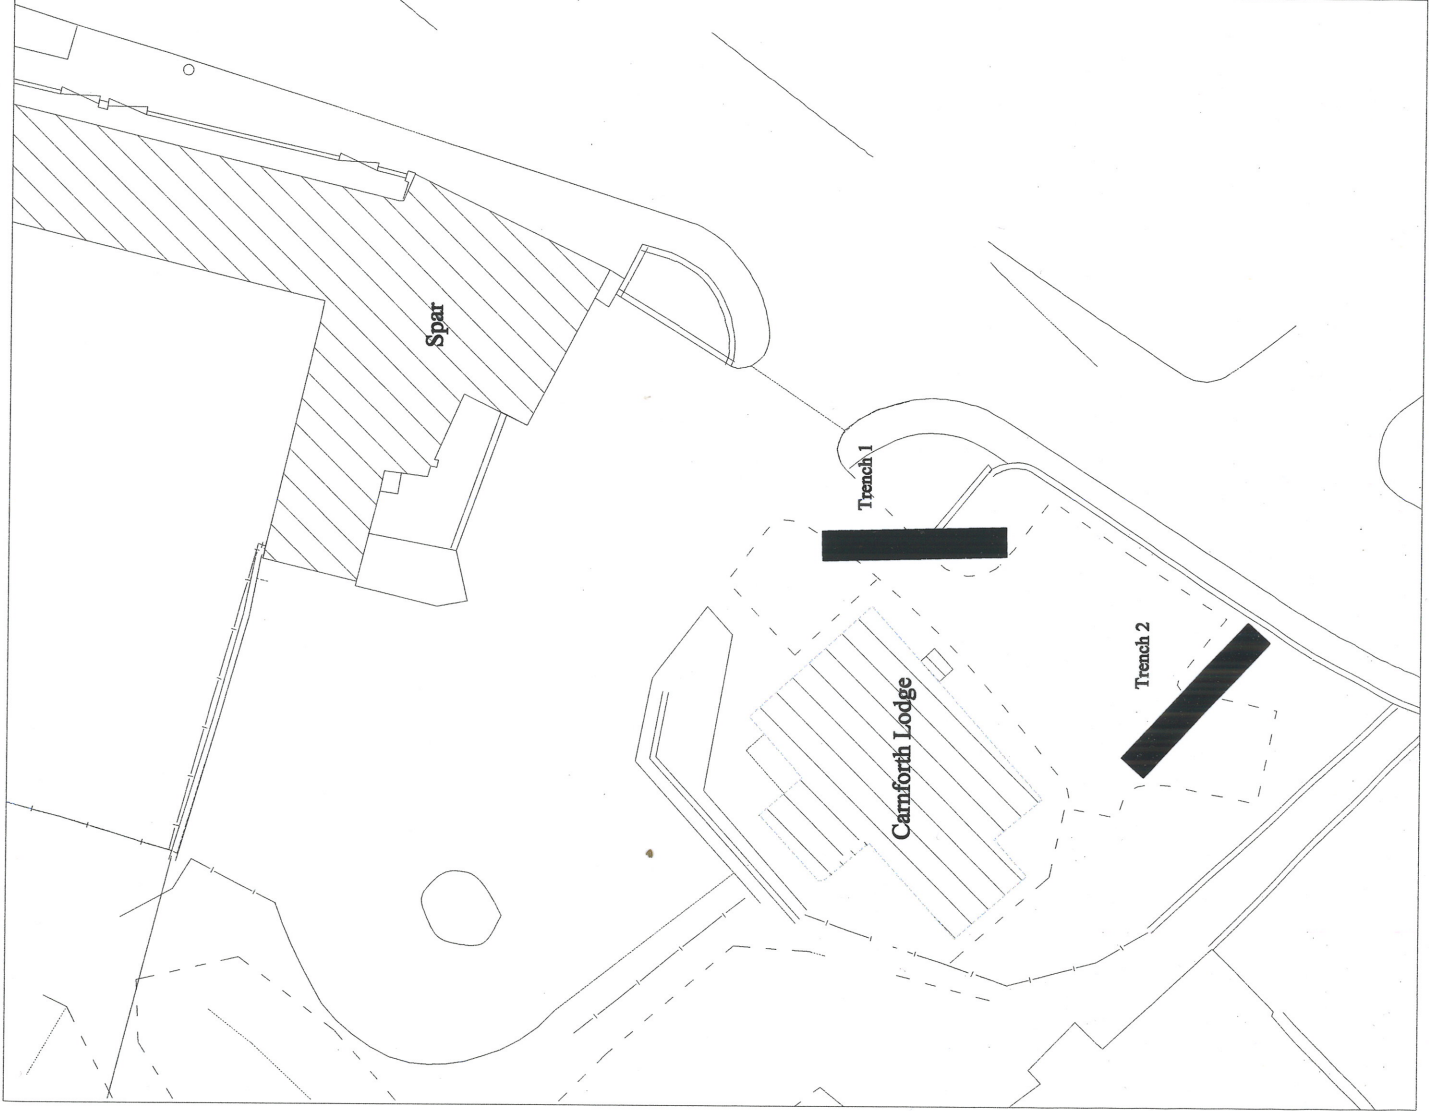
Fig 3: Trench location plan

- 4.2.1 **Base Stratigraphy:** Trench 2 (Plate 7) was 10m long and orientated south-east/north-west (Fig 3). The uppermost deposits comprised overburden associated with the driveway and garden, and correspond to those encountered in Trench 1; they were c0.30m deep to the south-east, and c0.60m towards the middle of the trench. Beneath the overburden to the

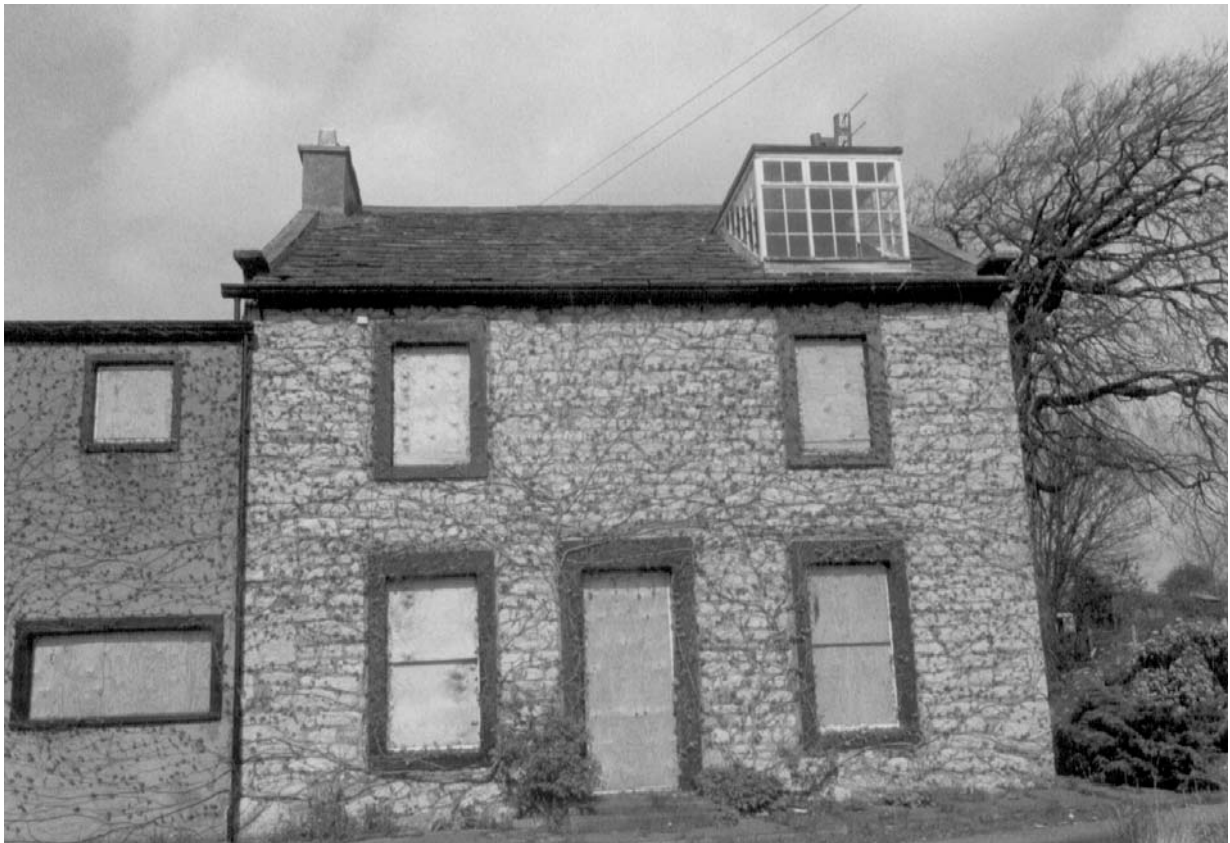
- 3.1.1 The lodge is a square double-pile building with a later addition butted onto the western side, and a relatively recent ground floor extension to the south. It is constructed in a vernacular style of unworked limestone irregular blocks, with alternate long and short regular dressed limestone blocks for the quoins. It was formerly a two-storey detached house, but a further floor had been created by the conversion of the roof space into an attic floor. All the doors and windows have uniform protruding, black painted sandstone architrave surrounds (Plate 1).

Plate 1: eastern elevation of Carnforth Lodge

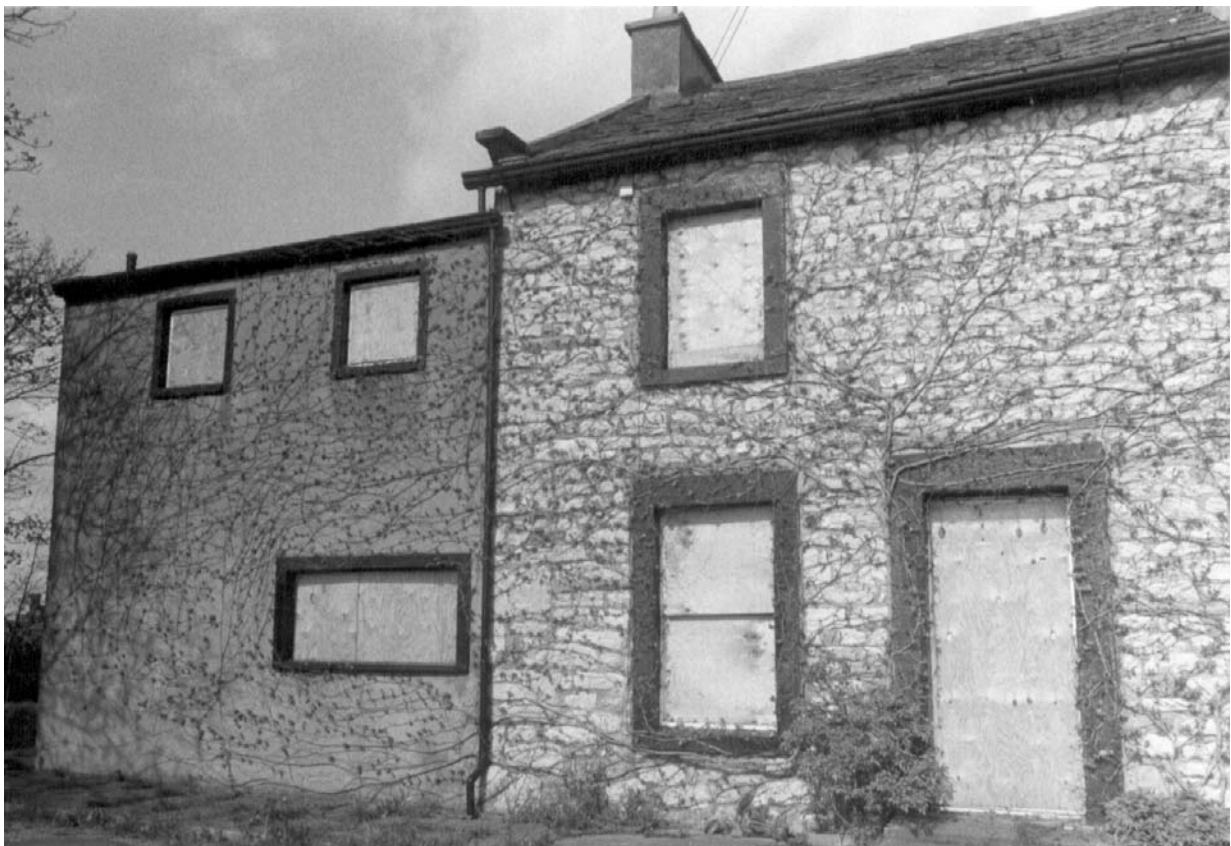
- 3.1.3 The extension/building to the south is butted against the main house and is externally rendered (Plate 2). There are two small first floor windows to the front with an elongated rectangular window at ground floor level. Internal inspection of the roof space showed that it was constructed of stone with simple Tie-beam roof trusses. It is possible that this building was originally a storage shed or small workshop constructed after the main house, which was then altered when the buildings were internally divided.

Plate 2: eastern elevation showing outbuilding extension

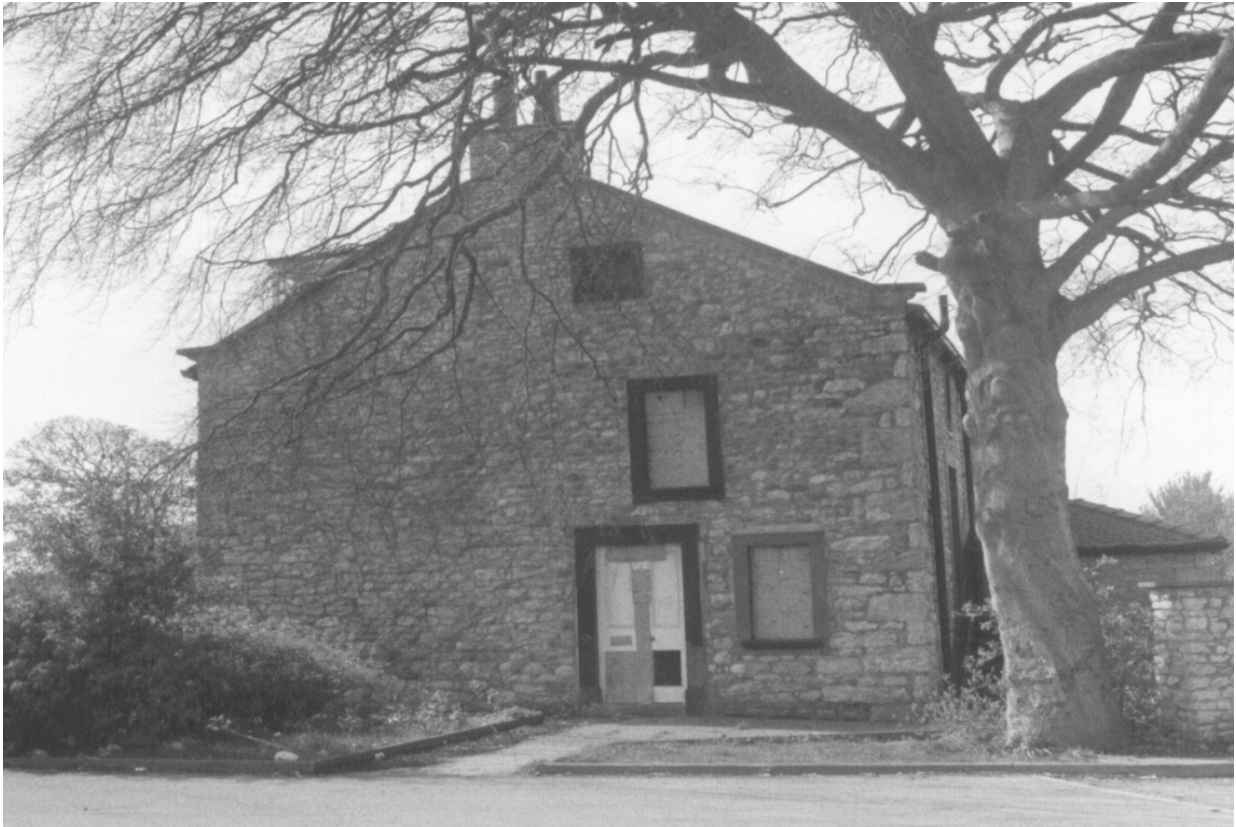
Plate 3: northern elevation of Carnforth Lodge

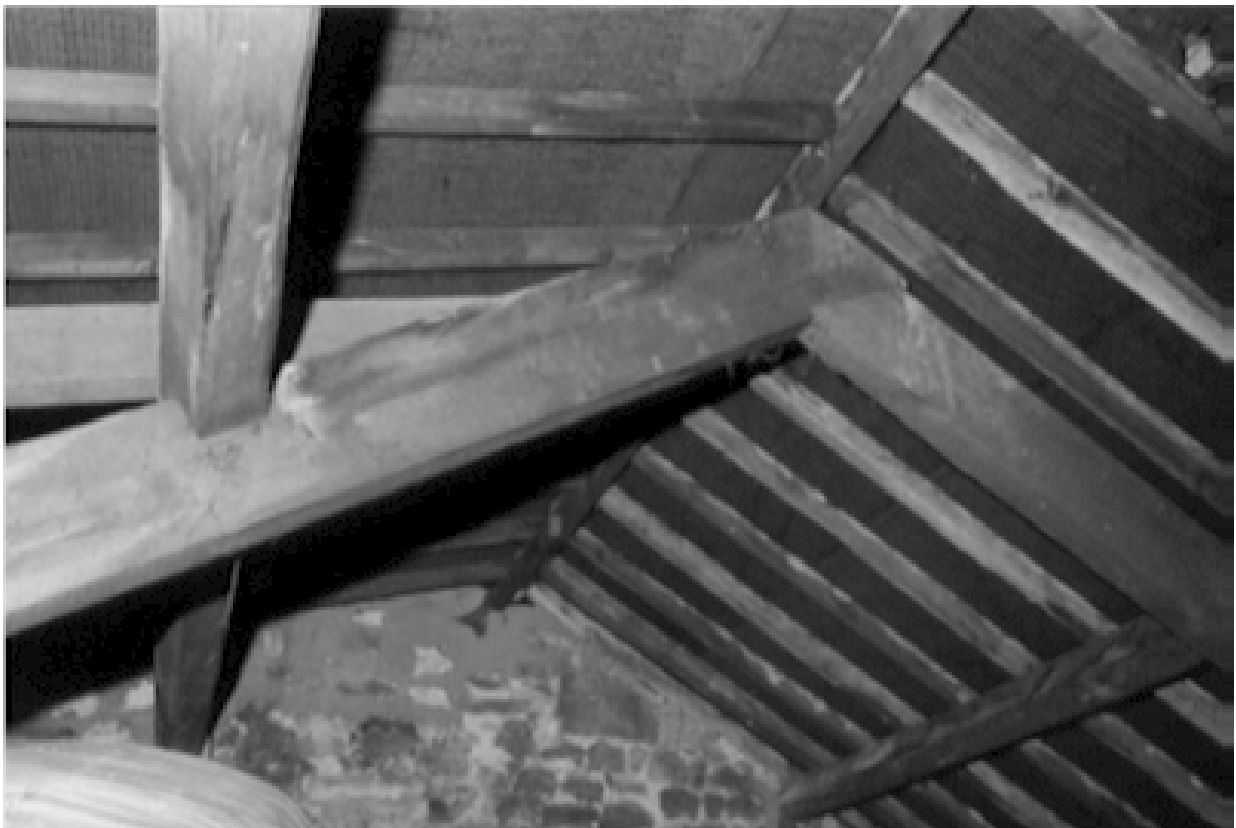
- 3.2.5 **Flat 4:** Flat 4 occupied most of the upper floor of the south extension, and the south-western part of the first floor of the main house. The flat consisted of four rooms, and no original features were visible. A trapdoor in the ceiling allowed access to the roof space of the south extension, which revealed that the extension was constructed of stone (all external walls were rendered). A roof-line scar was clearly visible on the exposed south gable of the main house, the roof above the south extension was supported on a simple central Tie-beam pine truss, and the south gable of the building. It appeared that the extension had been recently re-roofed, and extended eastwards by the addition of sloping timbers (Plate 4), which extended beyond the east blade of the truss, and supported the eastern side purlins of the roof.

Plate 4: tie-beam pine roof truss in the attic

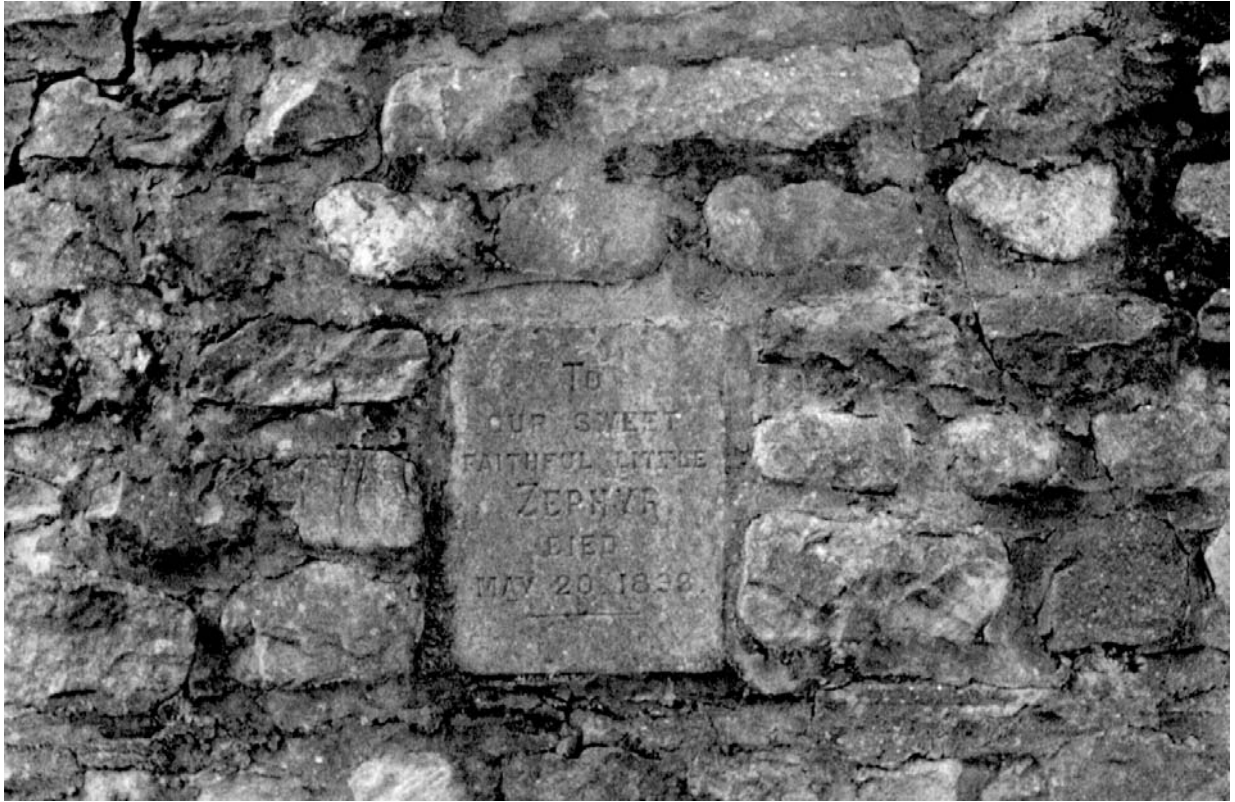
- 3.1.5 In the southern boundary wall is a pet's gravestone (Plate 5) inscribed:

TO OUR SWEET FAITHFUL LITTLE
ZEPHYR
DIED
MAY 20 1893

Plate 5: plaque set for pet's grave

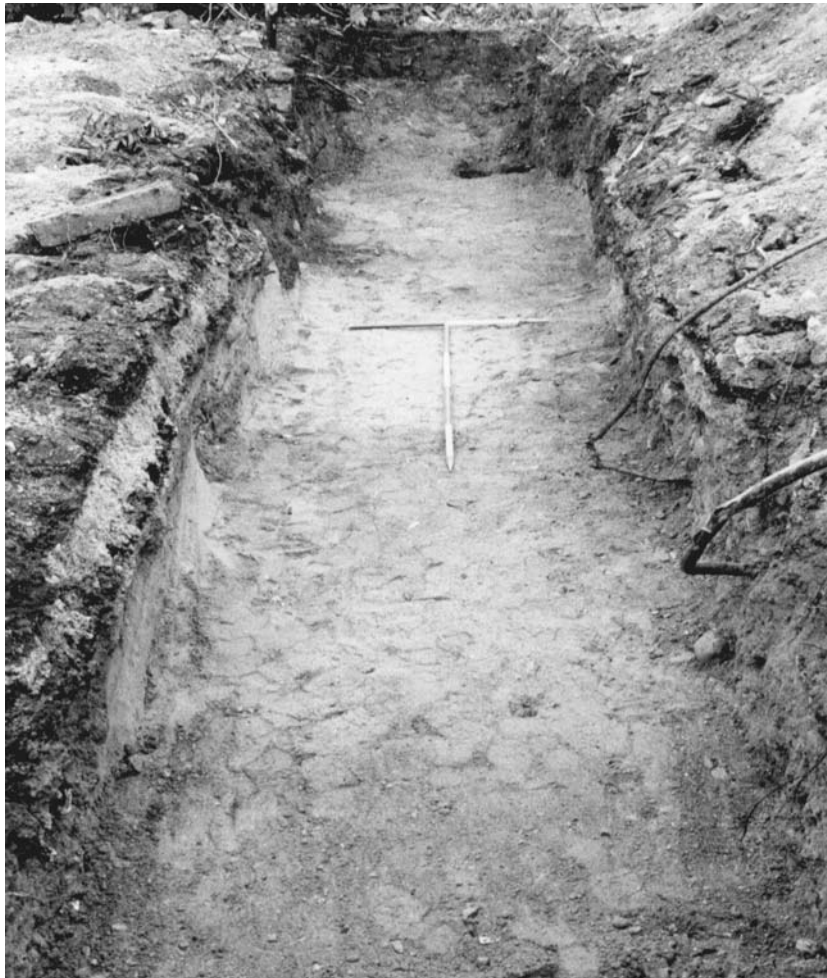
- 4.1.1 **Base Stratigraphy:** Trench 1 (Plate 6) was a 10m long trench in the north-easternmost corner of the study area, running north/south. The uppermost deposit was 0.54m thick and comprised tarmac and related hard-core for the original driveway and garden soils of the adjacent eastern garden. The remains of the north-east/south-west garden wall were also machined away (*Section 4.1.4*).

Plate 6: Trench 1, looking south

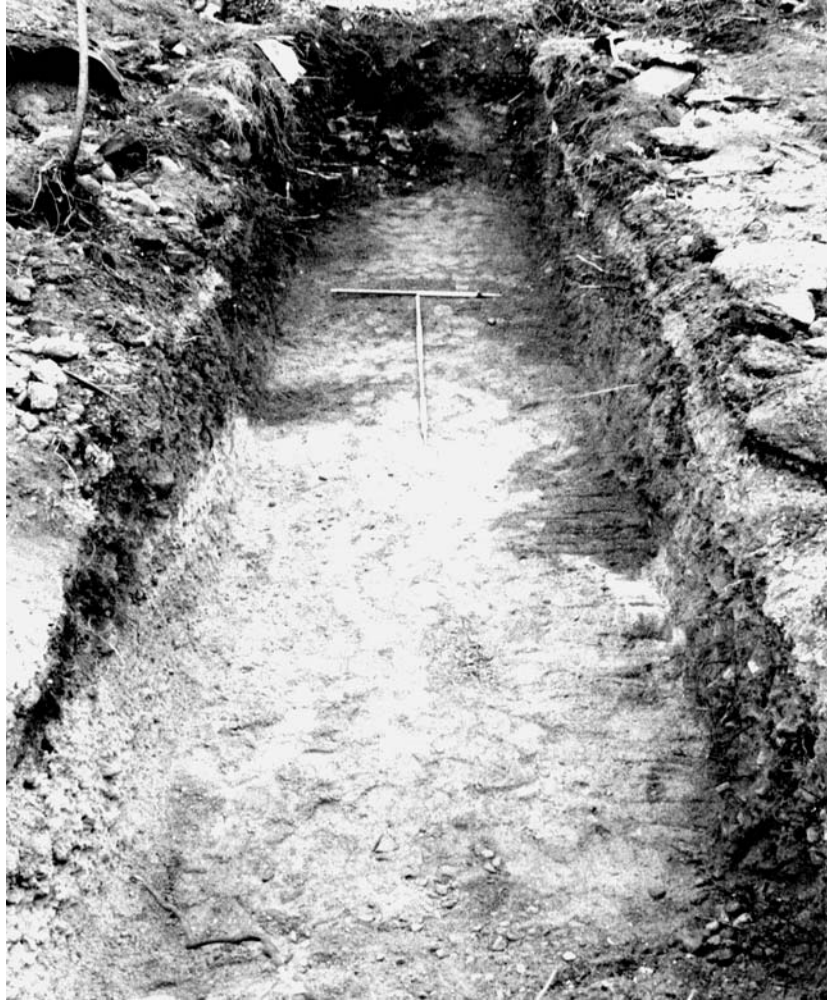
Plate 7: Trench 2, looking southeast

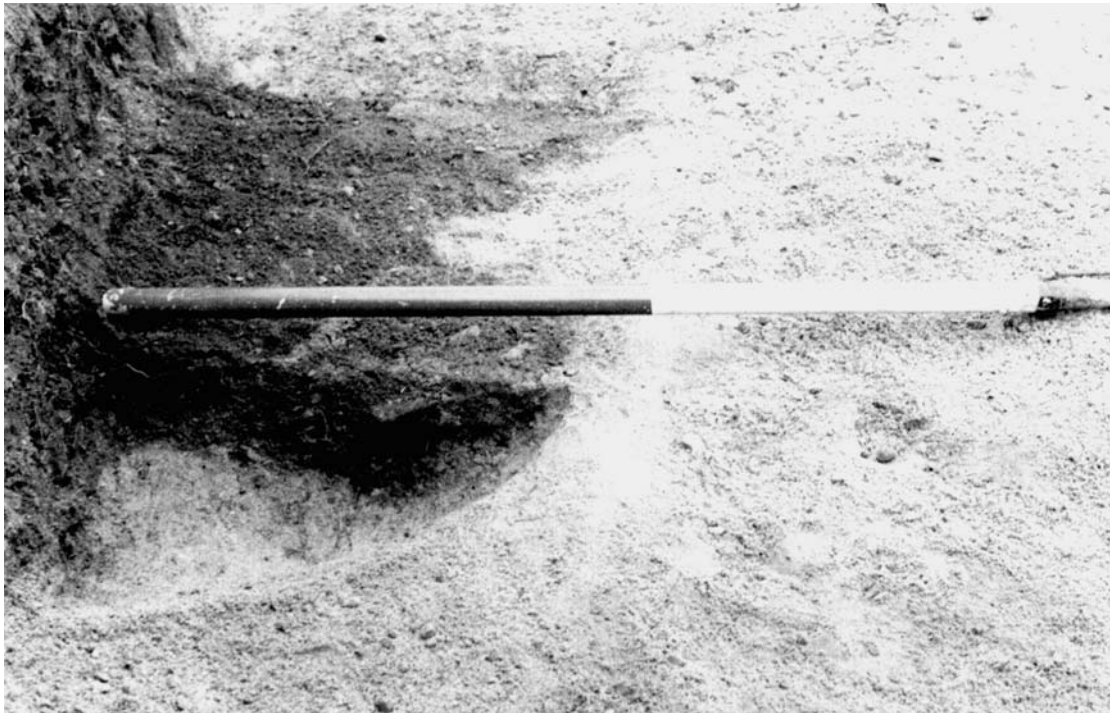
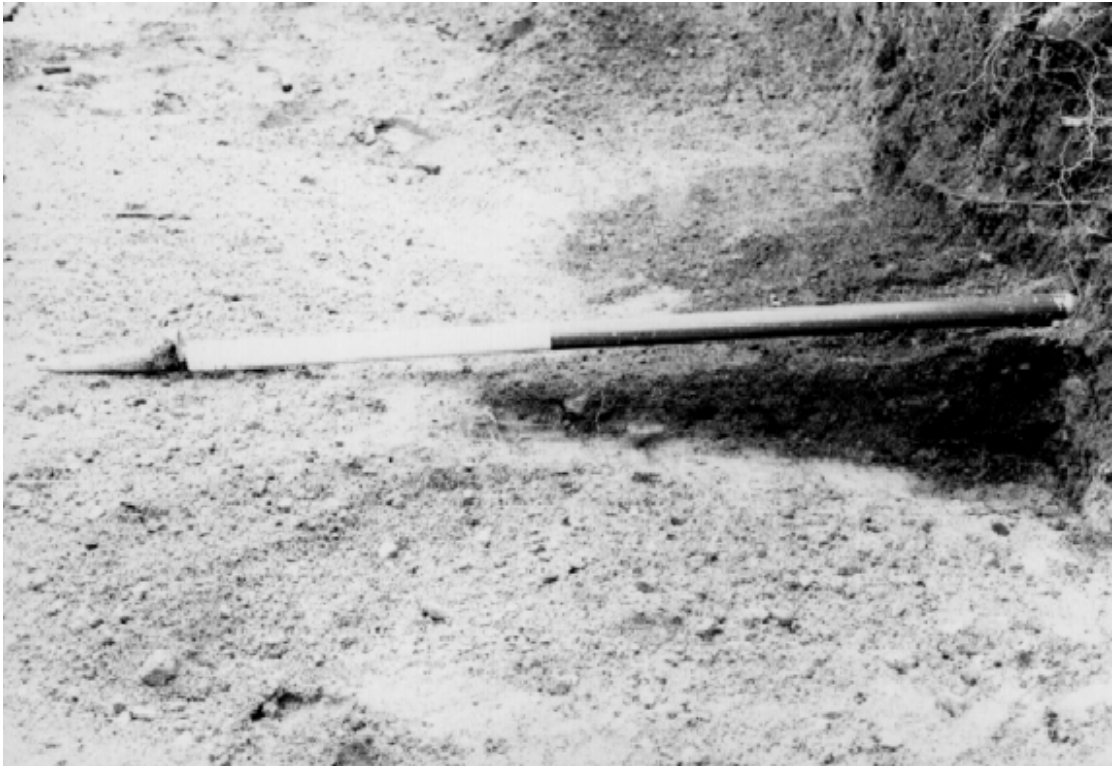
- 4.2.4 Removal of the subsoil [13] to the south-west, revealed a small feature [19], measuring approximately 1.2m by 0.6m, cutting the natural [1] (Plates 8 and 9). Its fill was identical to the subsoil, consisting of orangey-brown sand and gravel [20]. Upon excavation, the feature proved to be two small pits lying immediately adjacent to, and adjoining, each other. Both these features disappear into the section to the south-west. No archaeological finds were recovered within these pits.

Plate 8: east-facing section across pit [19/20]

Plate 9: north-facing section across pit [19/20]

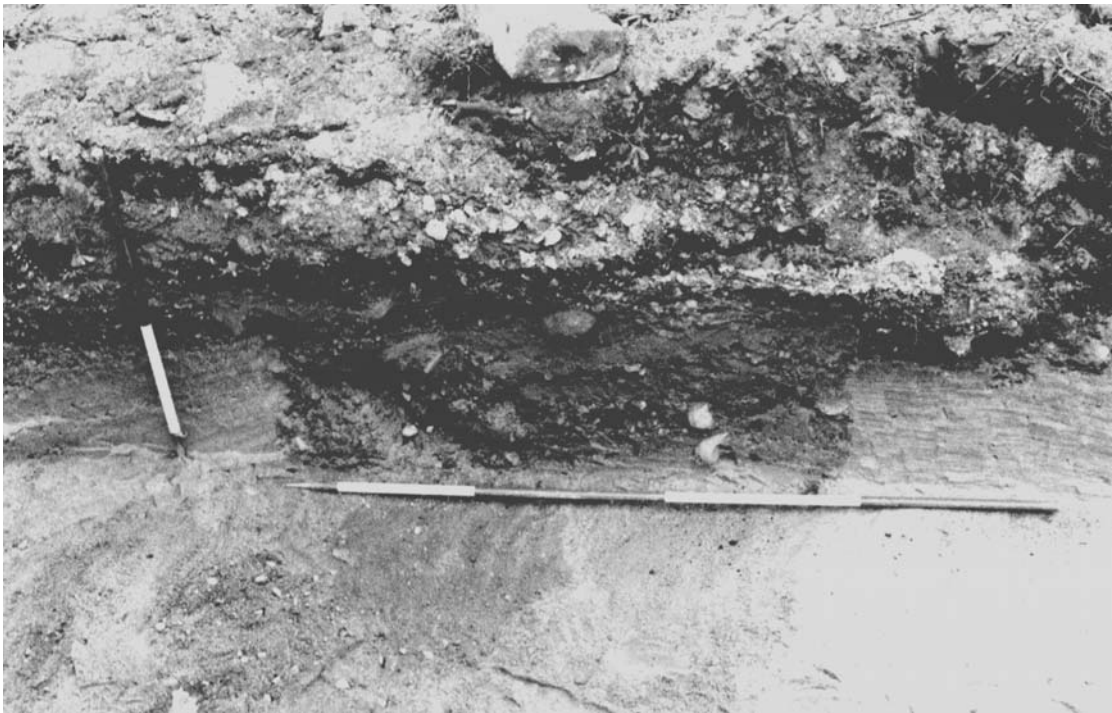
Plate 10. southwest-facing section of Trench 1
