# Base Court VI, Hampton Court Palace

**Historic Buildings  
Investigation and Recording**

**Client: Historic Royal Palaces**

*Historic Buildings Investigation and Recording*

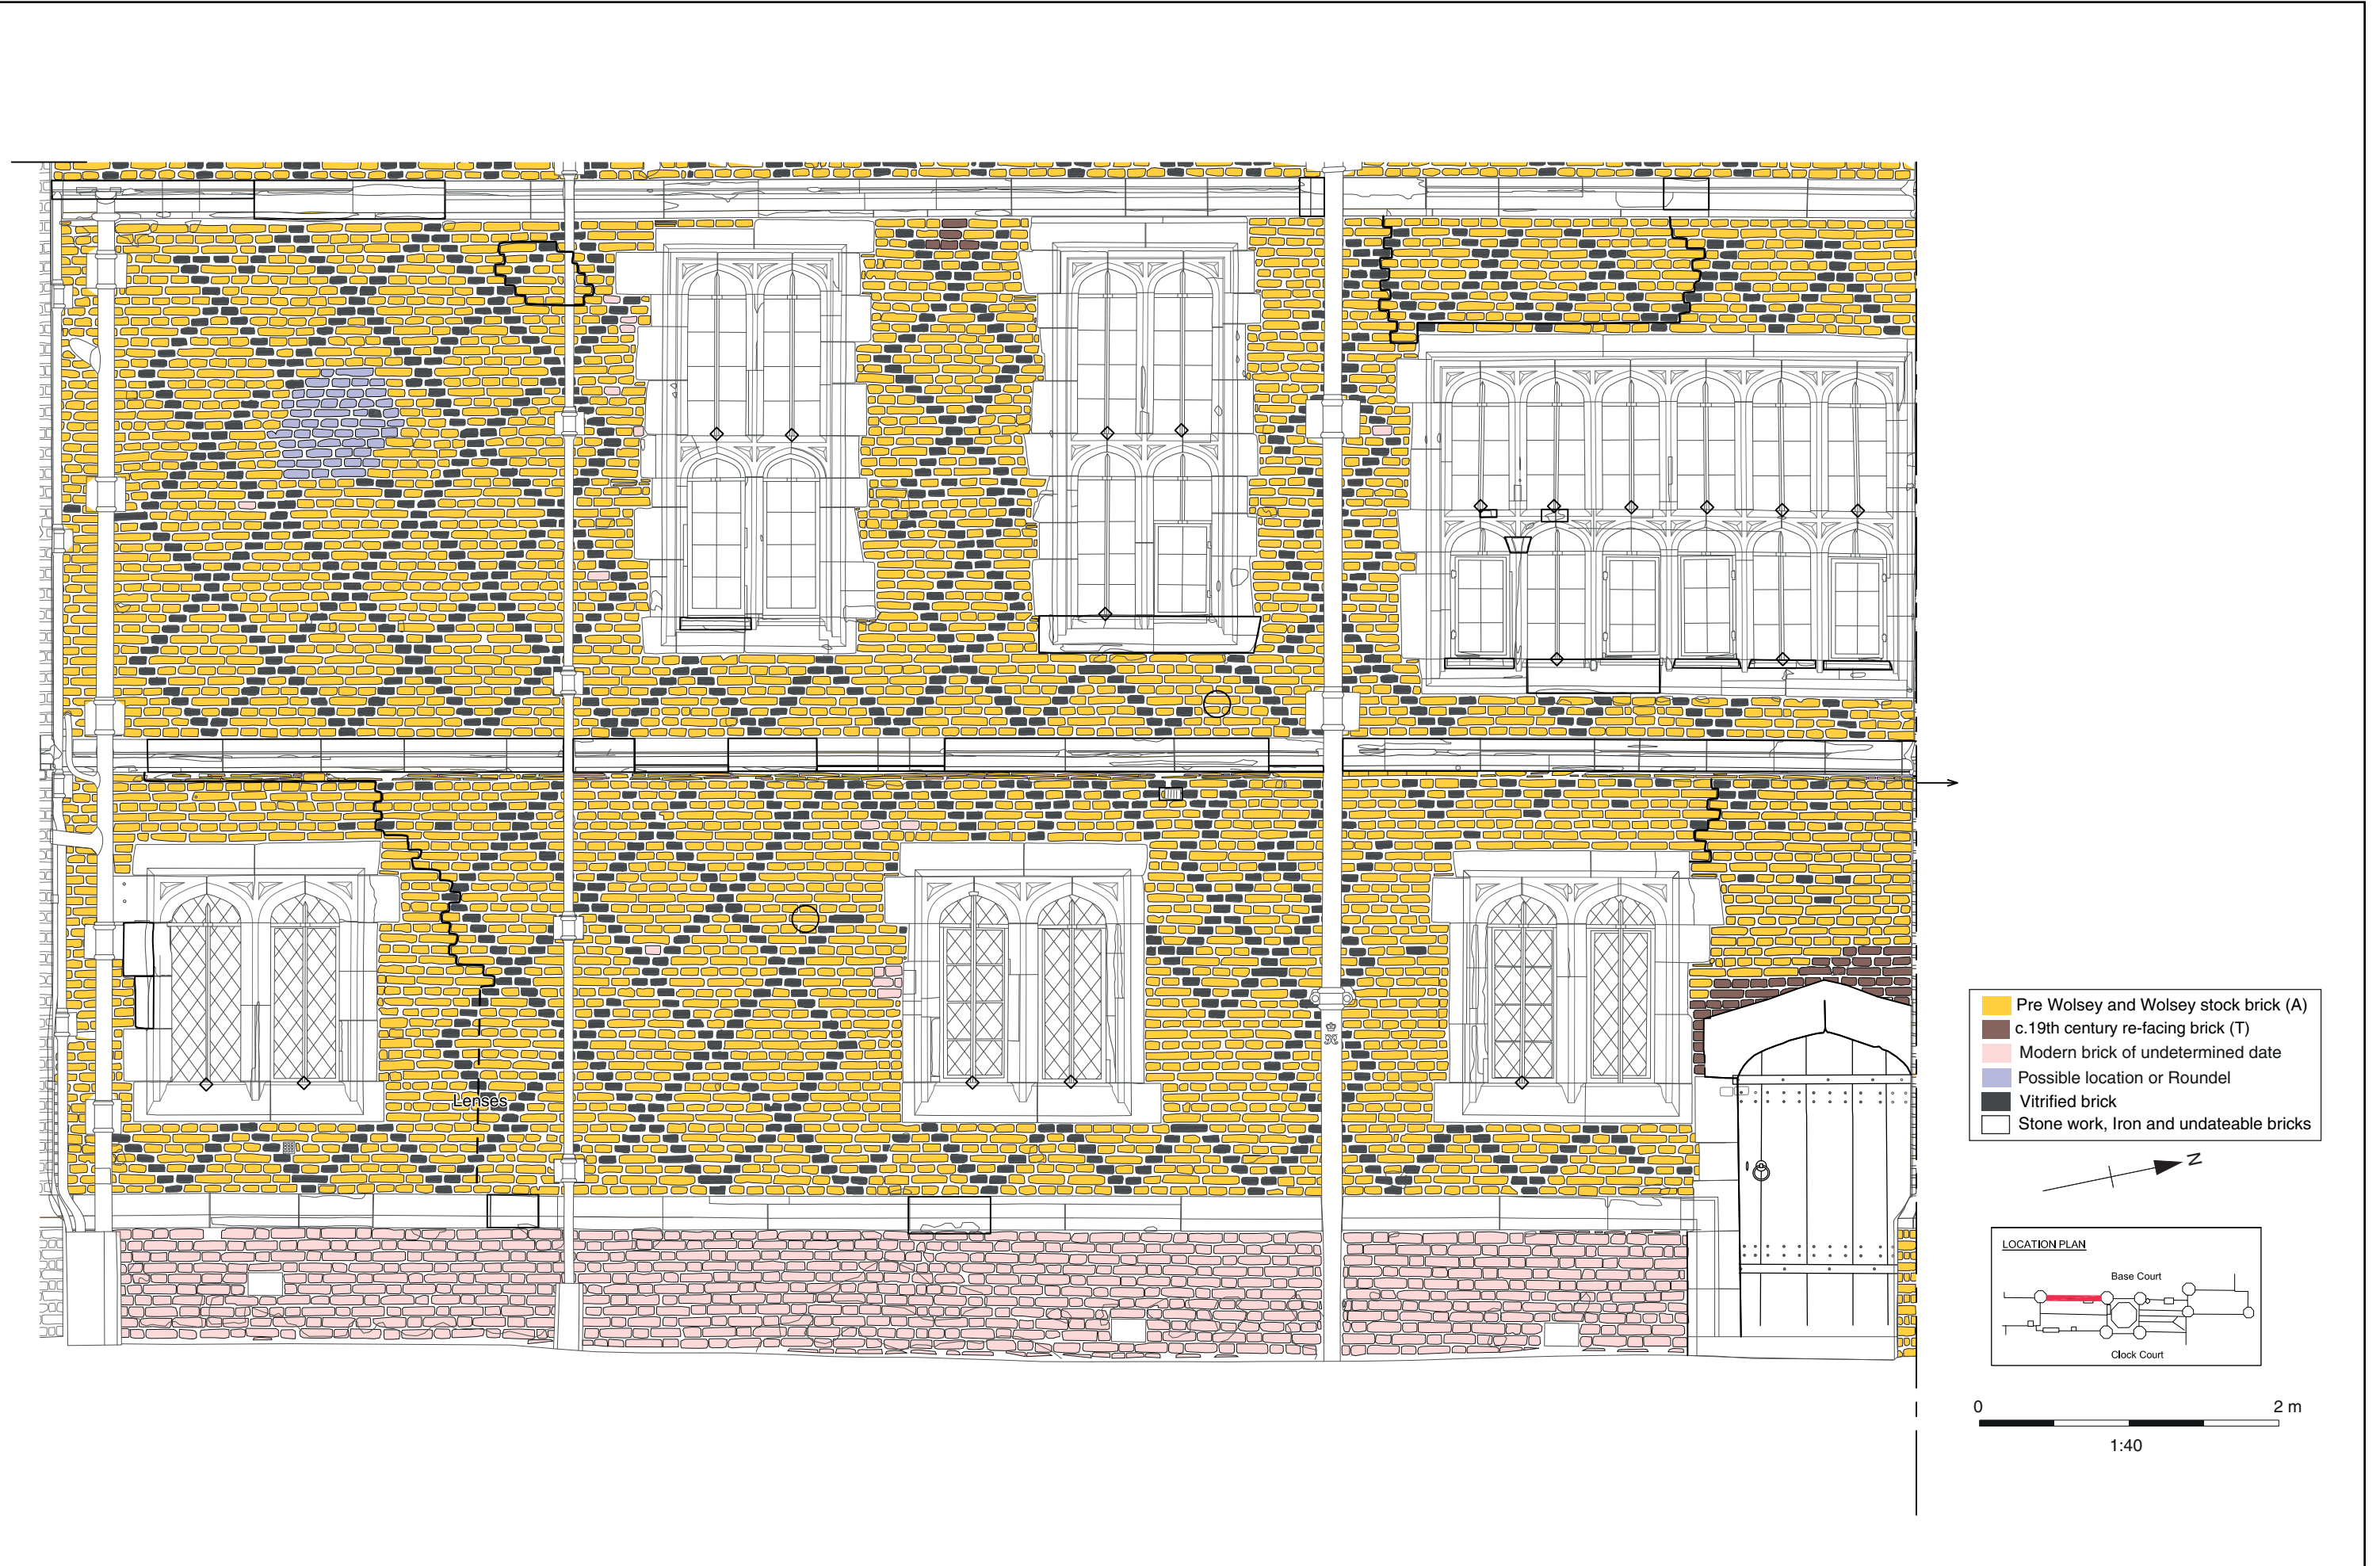
Figure 5: Lower West facing Elevation of Base Court, Part 1

3.2.2 The primary brickwork of this elevation is the Wolsey stock brick, Brick Type A, characterised by its almost unbroken diaper work and creamy lime mortar with large lime inclusions (Figure 5, Plate 3). This extends to window sill level of the second floor where the diaper work ends and there is a change in the mortar. On the left hand side of the first floor, where the diaper work is broken, there is a patch of rough pale grey lime mortar with speckle inclusions, which is a characteristically 19<sup>th</sup> century mortar. Although the bricks are very similar to those around them, they may be reused and it is possible that this is the location of a lost roundel (Area of purple brick in Figure 5). This feature is at roughly the same height as those on the Ann Boleyn Turrets. Another patch of this mortar is found around earlier bricks just under the string course and both areas may simply represent areas of minor repair.

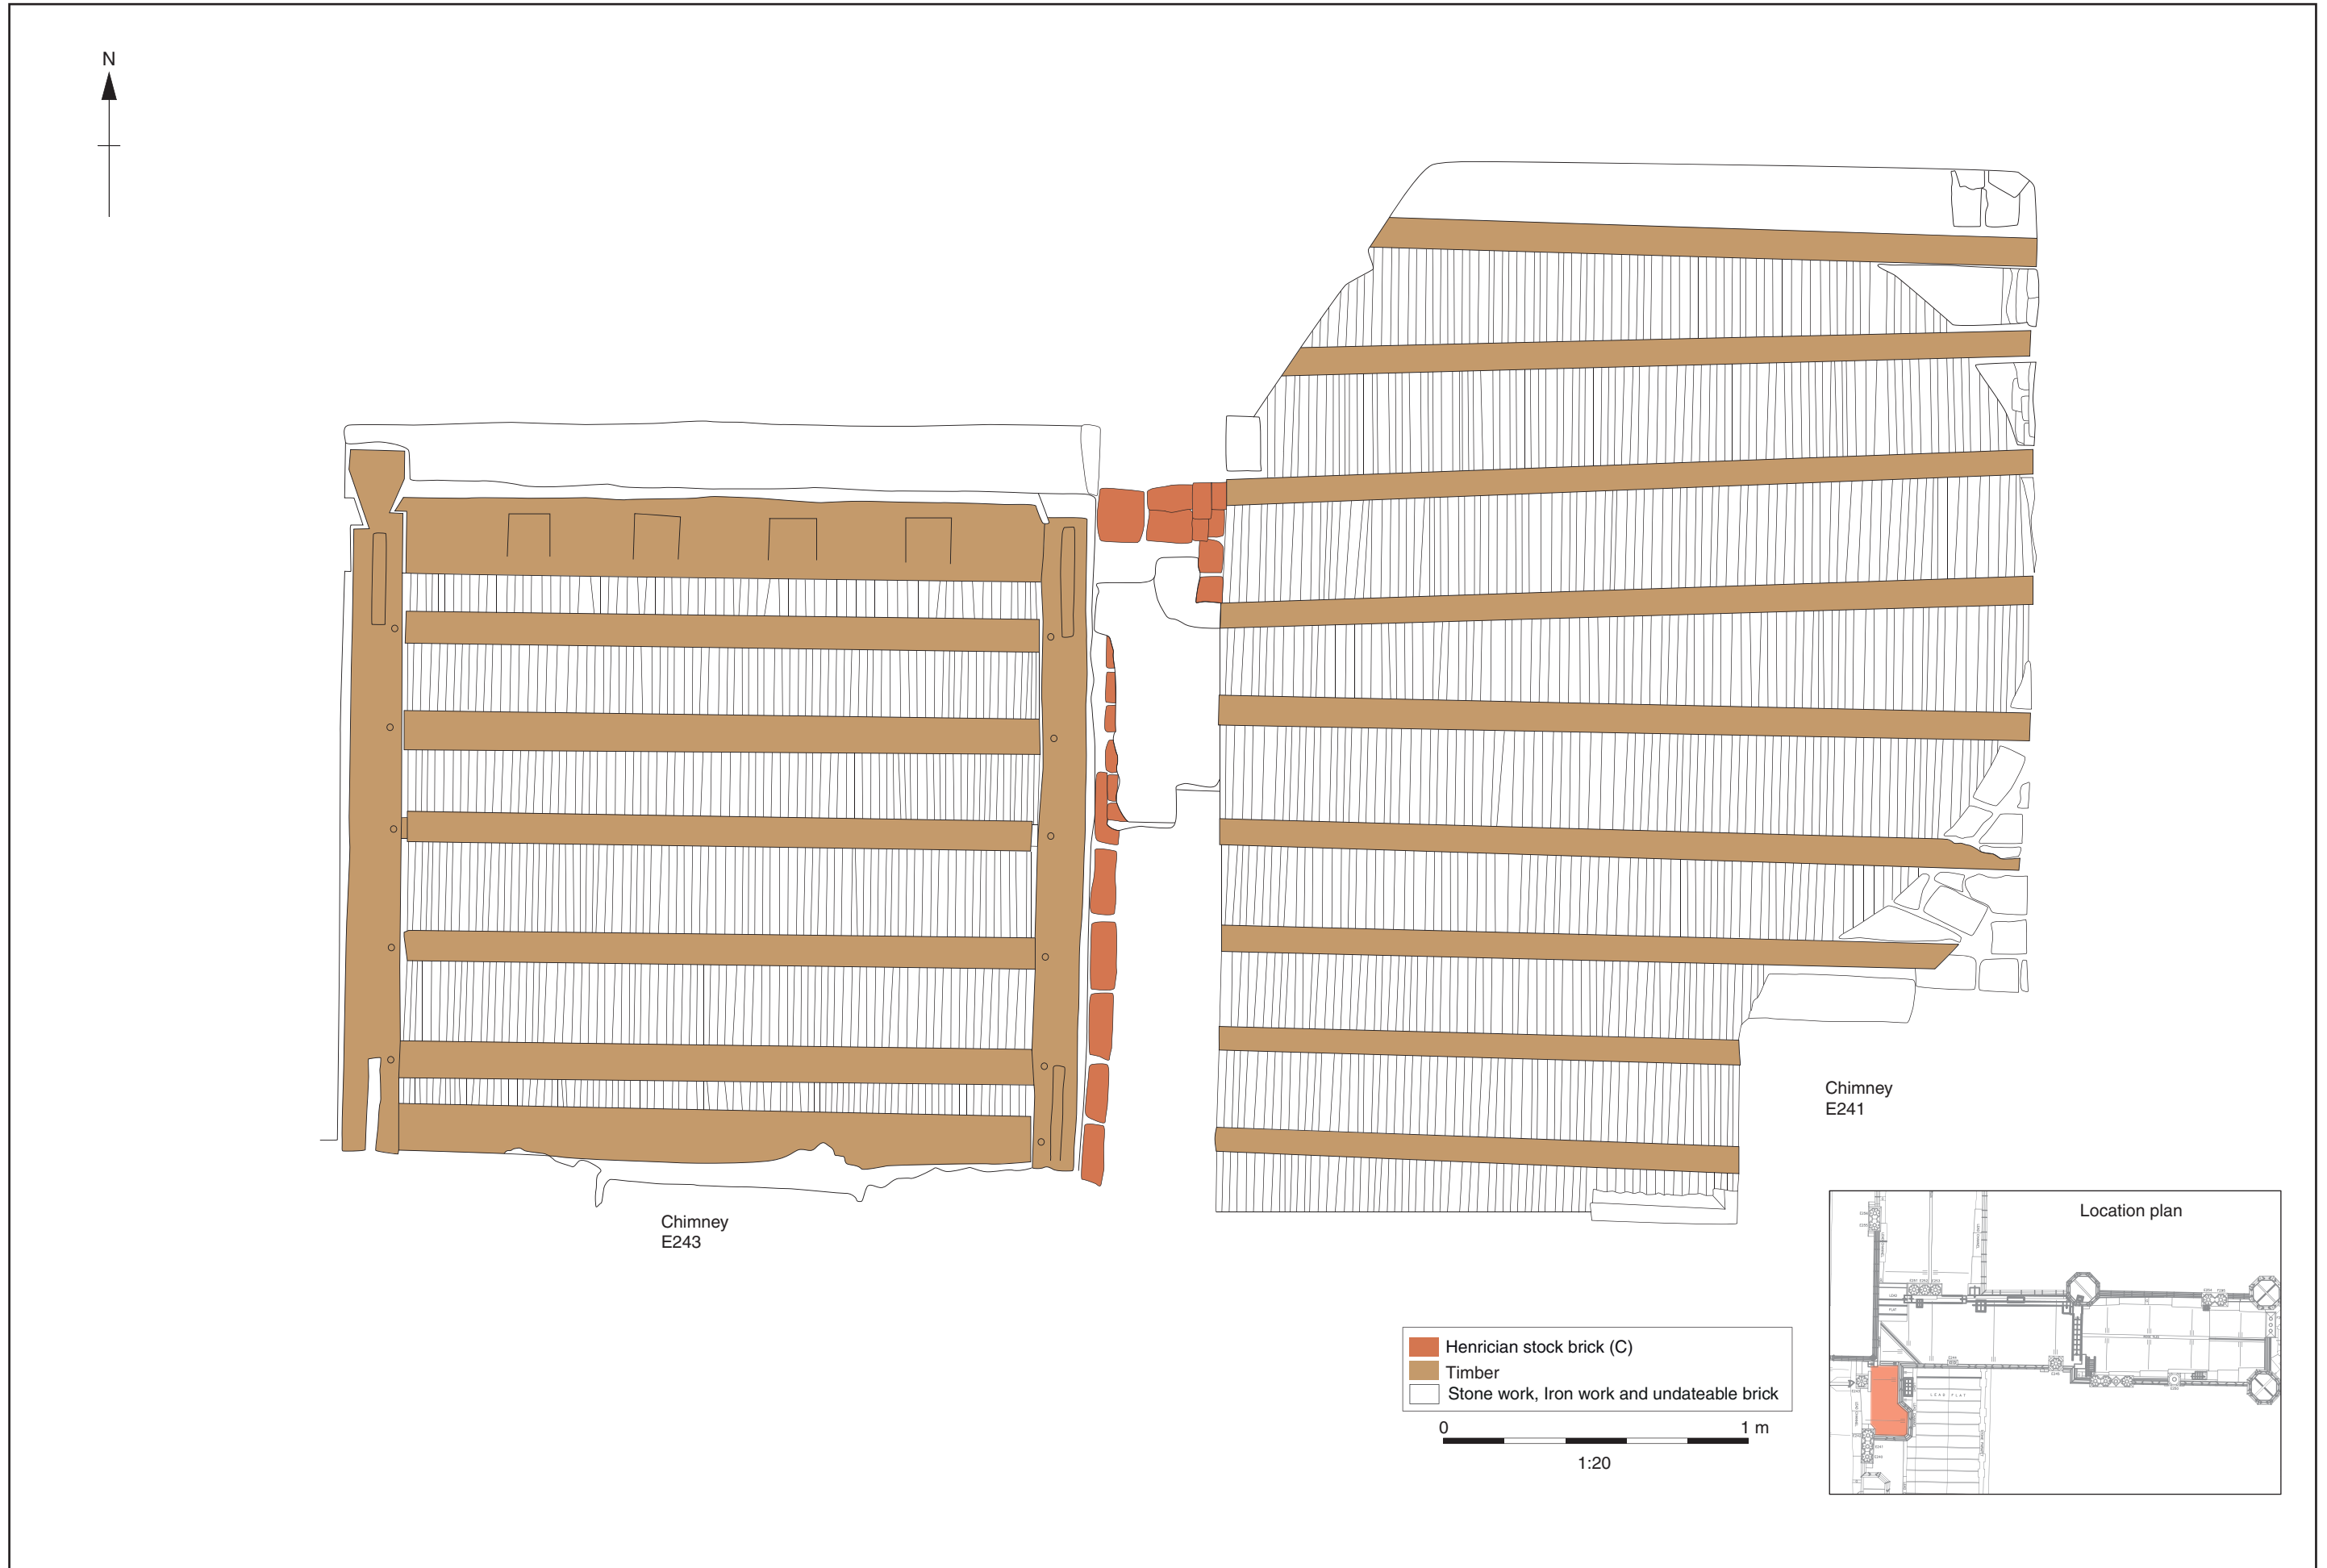
Figure 34: Plan of Roof 4

- 3.5.1 Roof 4 was added to the current investigation when a void in the south facing pitch was opened due to repair works. The space was previously inaccessible and relatively unknown. A sketch plan, appearing to date to the 1980s or 1990s was found in the Hampton Court Palace archives, suggesting that it was probably subject to a brief archaeological inspection during its last repair. It is located in the south west corner of Clock Court, behind the end of the east wall of Roof 3 (See Section 4) and the south wall overlooking the colonnade (Figure 3). It consists of an east roof space over a rounded stairwell (PF046) and a west roof space over a small square lobby leading to the Wolsey Suite (PF046A). A pitched lean-to roof covers both spaces, descending north to south and resting on the valley between it and the pitched roof the Wolsey Suite. The west and east spaces are divided by a north south orientated dwarf wall and each space has its own individual timber 'floor' structure, discussed further in Section 4. This area and its brick elevations represents clearly the addition to and heightening of the range by Henry VIII over and around a Wolsey structure.

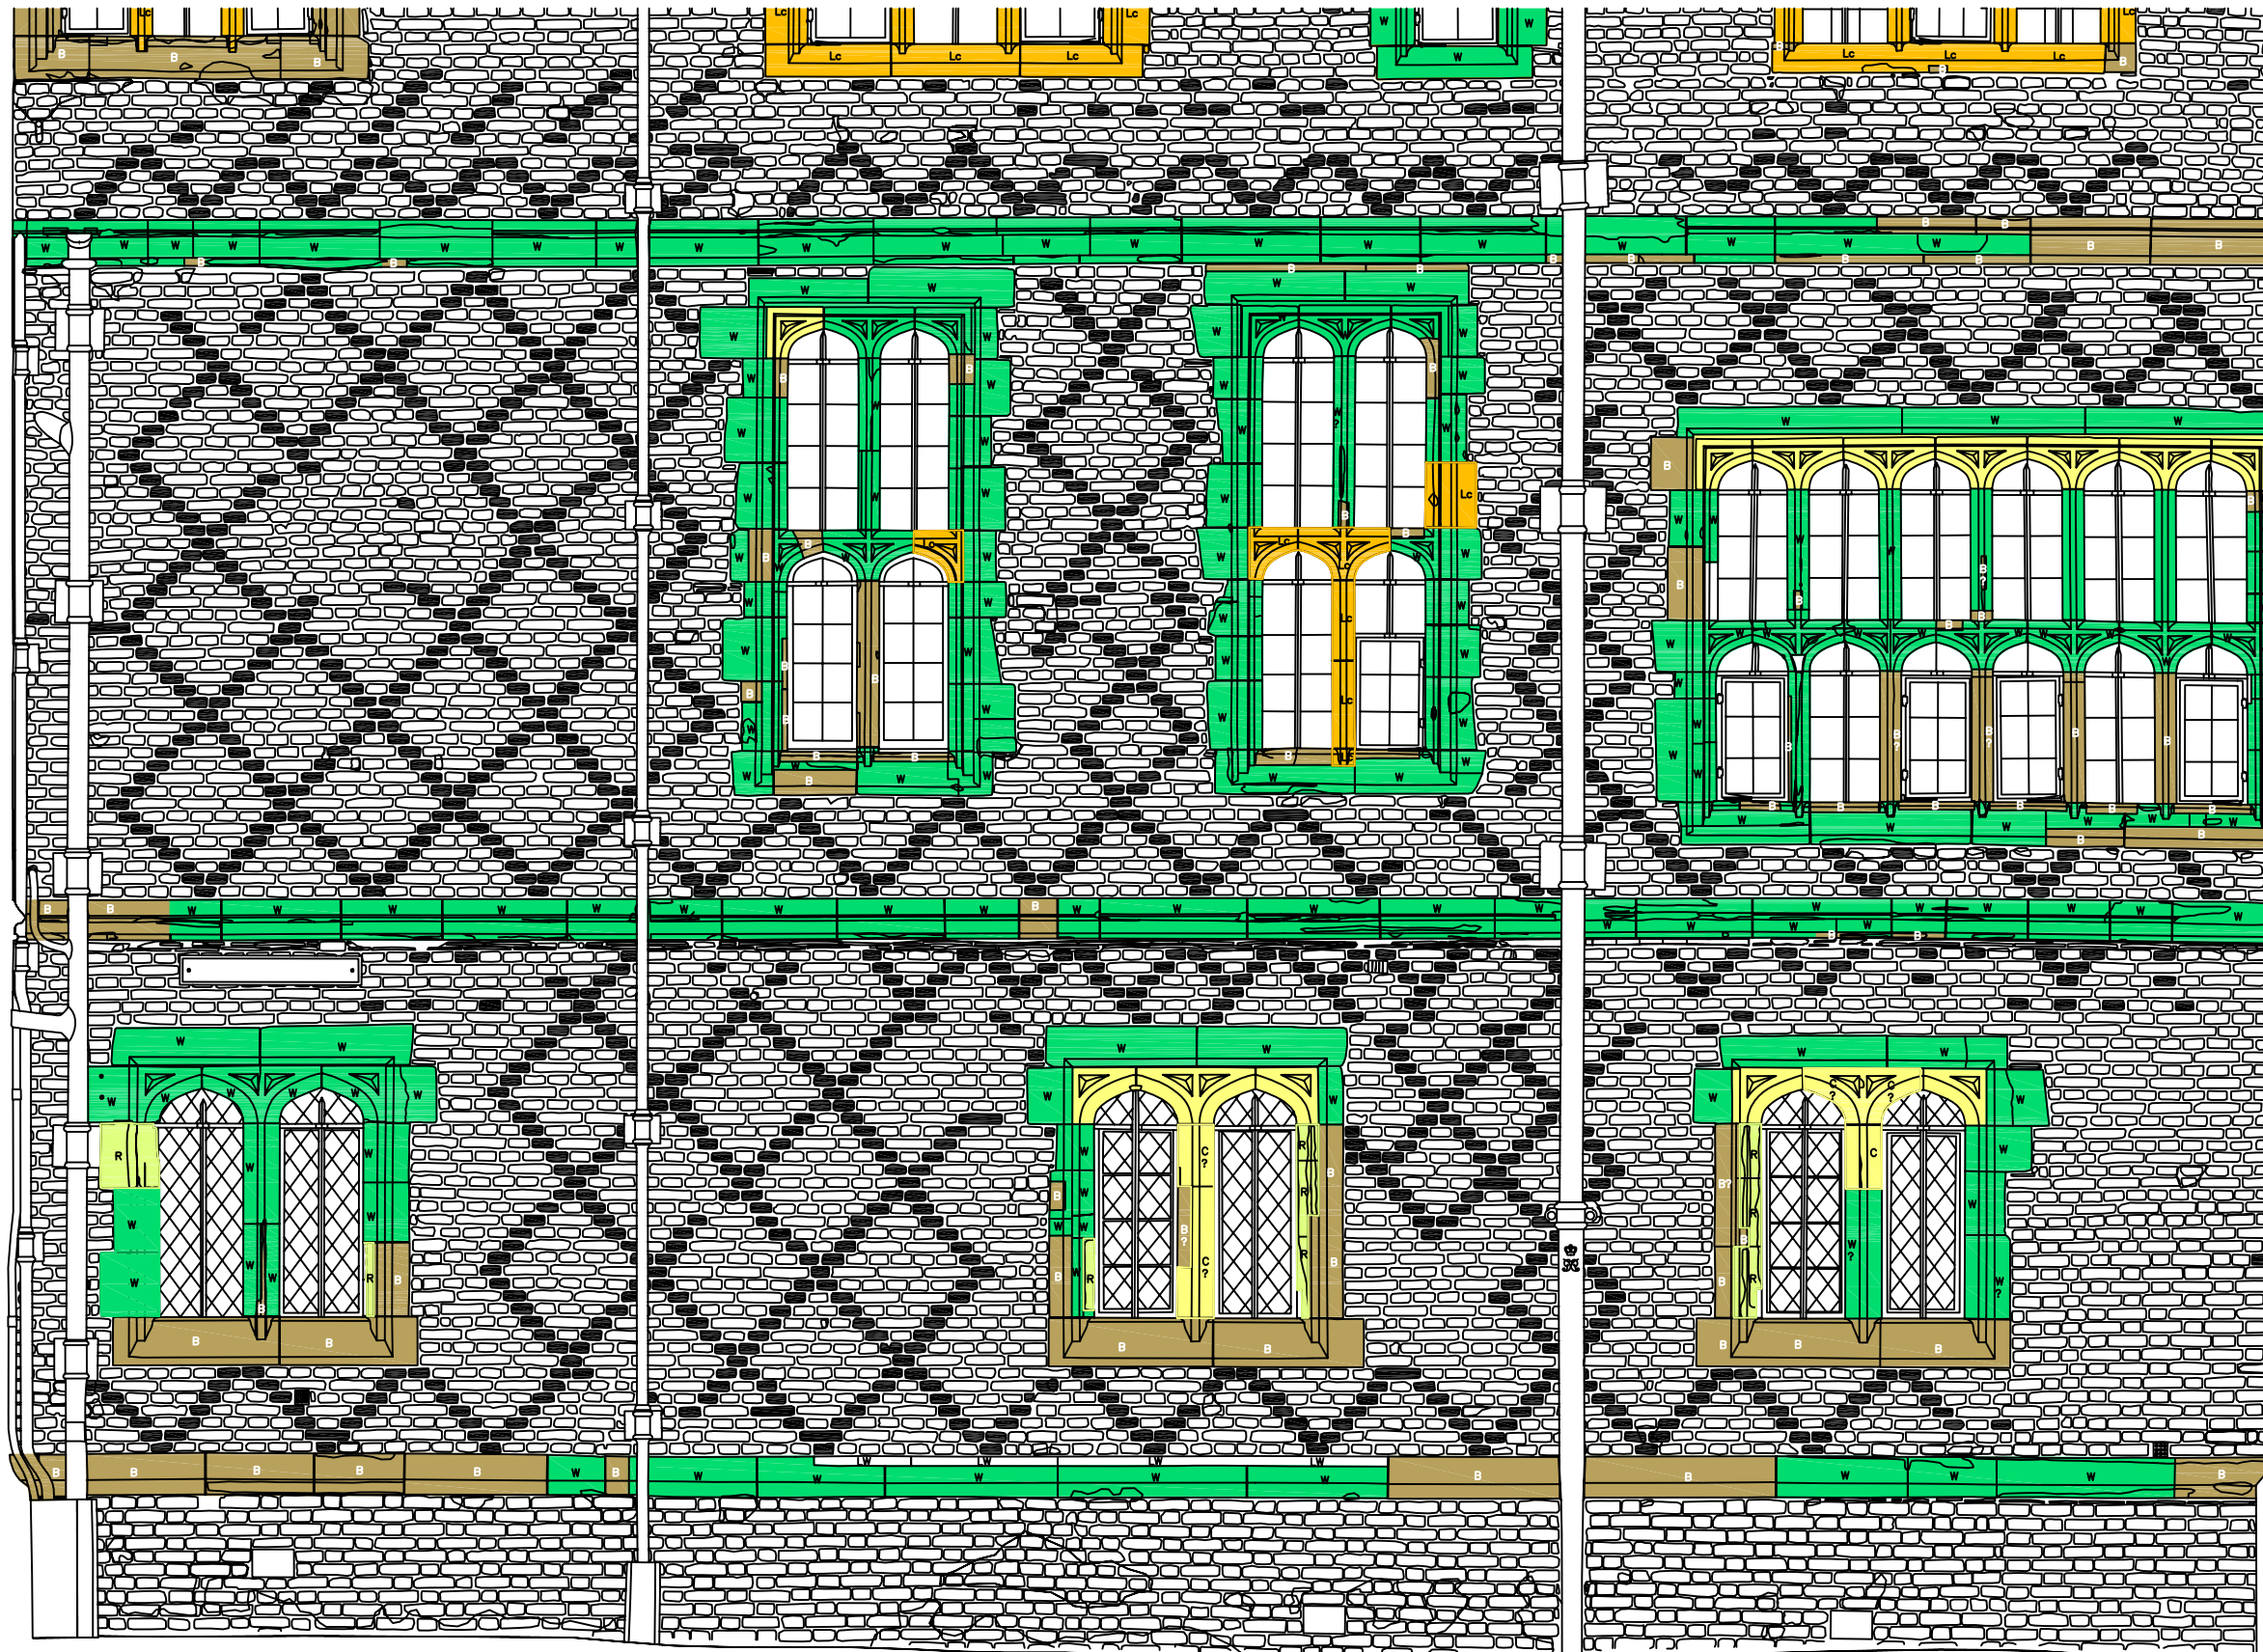
Figure 46: Lithography Survey of Base Court – West Facing Elevation Part 1

- 7.2.3 **Base Court – West Facing Elevation Part 1** (Figure 46) Block work around the window openings was recorded subsequent to some cleaning. These were found to include blocks of Caen stone, Bath stone (or possibly Taynton – the colour looks rather orange for Bath

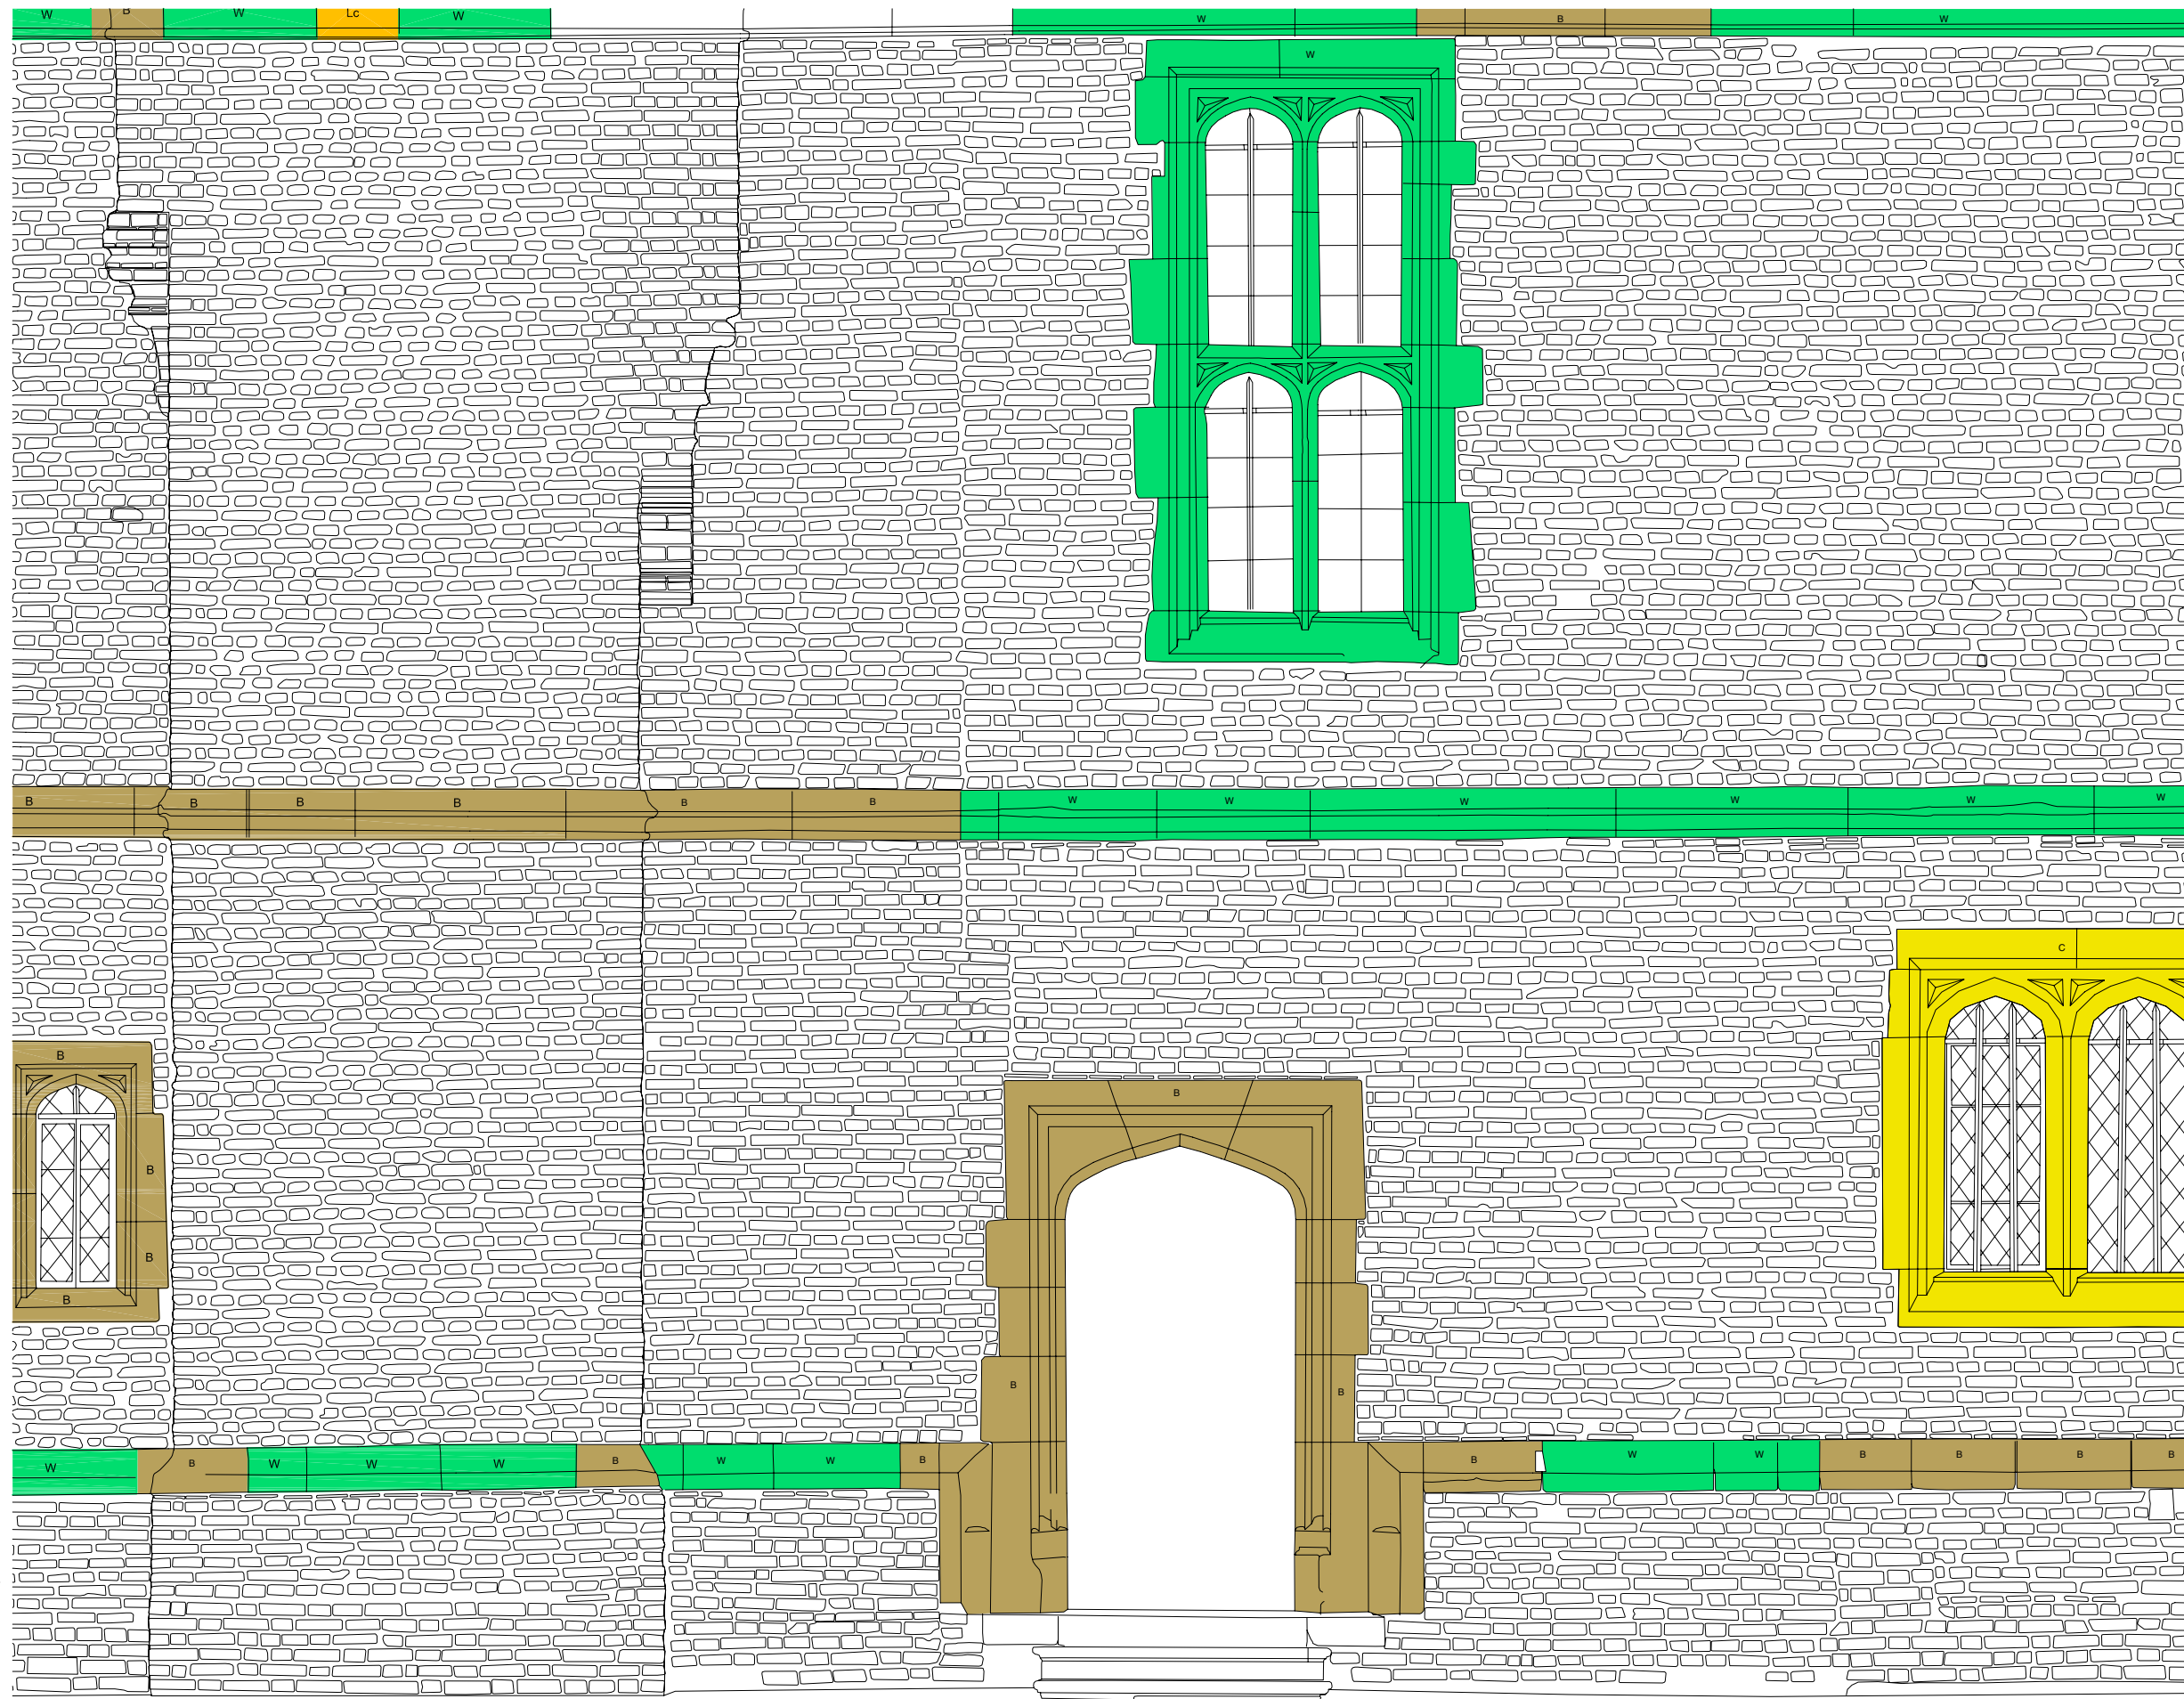
Figure 54: Lithography Survey of Lower Clock Court – East facing Elevation Part 2

7.3.5 **Lower Clock Court – East facing Elevation Part 2** (Figure 54) The string courses, windows and door surround had not been recorded on this elevation. The string courses were found to comprise a mixture of Bath stone and Wheatley limestone, which is in keeping with the previously recorded sections.

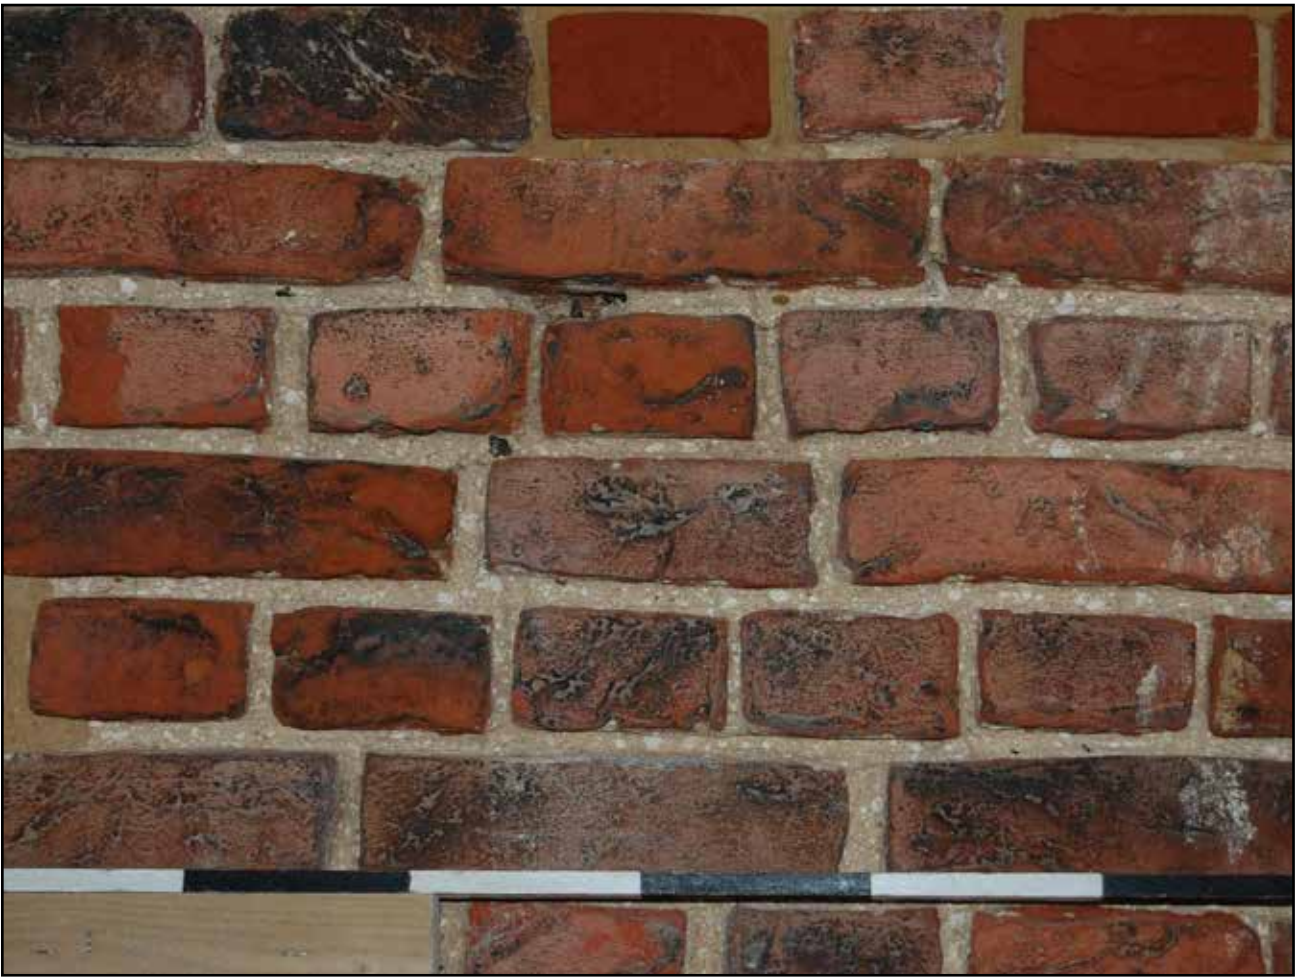
Plate 3: Base Court - West facing Elevation Part 1, detail of primary brickwork (A)

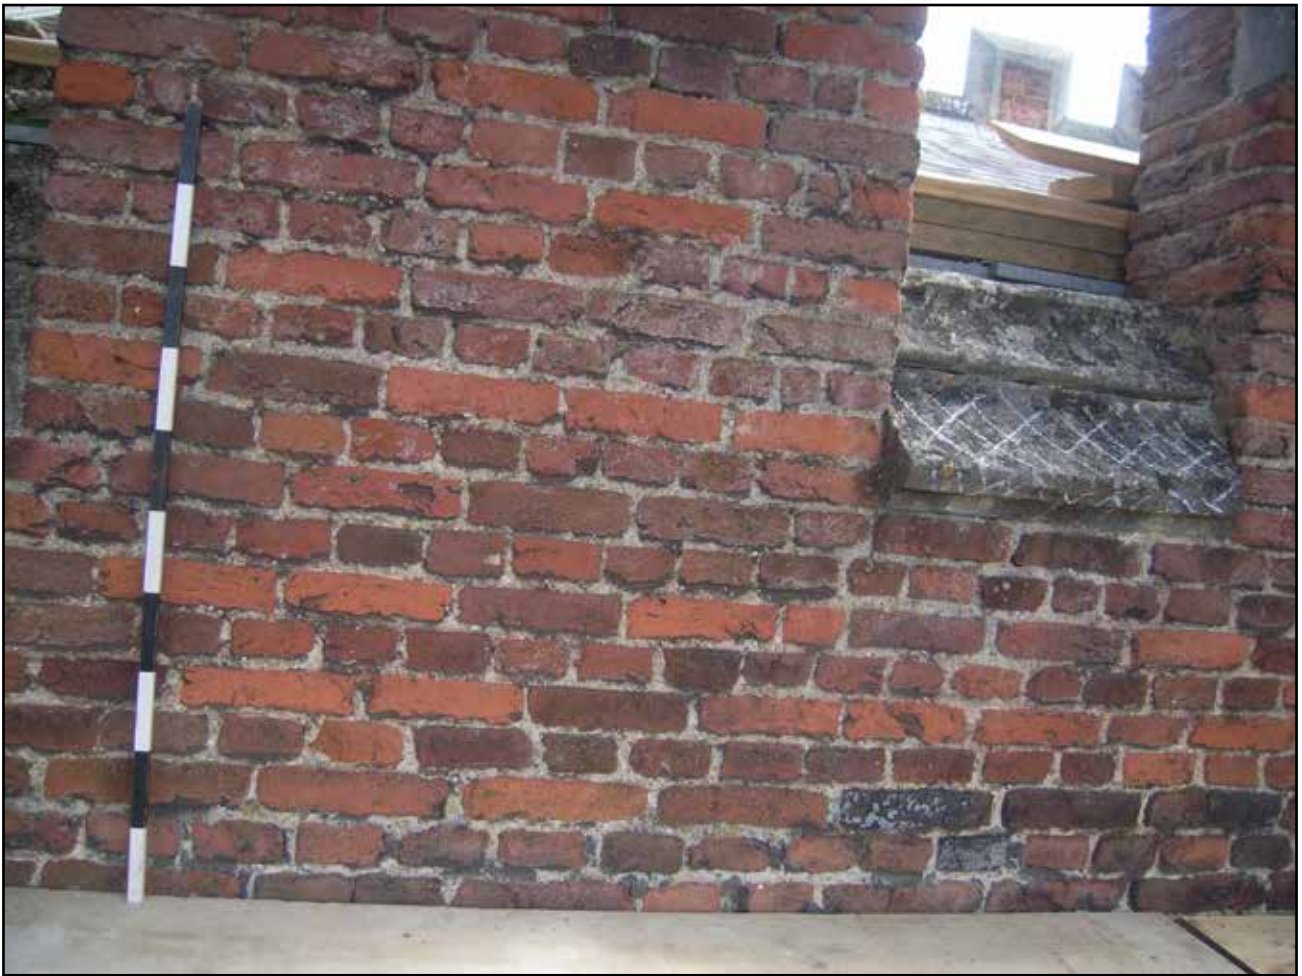
Plate 9: Mixture of Brick Type B and Brick Type V on Base Court parapet

- 3.2.8 The primary brickwork on this elevation is Brick Type A with its characteristic creamy lime mortar with large lime inclusions, but diaper work here is much more broken up than on the West Facing Elevation Part 1. Type V bricks appear again on the crenellations but unlike other west facing elevations, there is no clear change in brickwork from the earlier type (Figure 9). Instead we have what appears to be a mixture of reused A type bricks and V type bricks above the string course, with V type bricks becoming more numerous as they carry upwards (Plate 9). The crenellations are almost entirely faced with V type bricks.

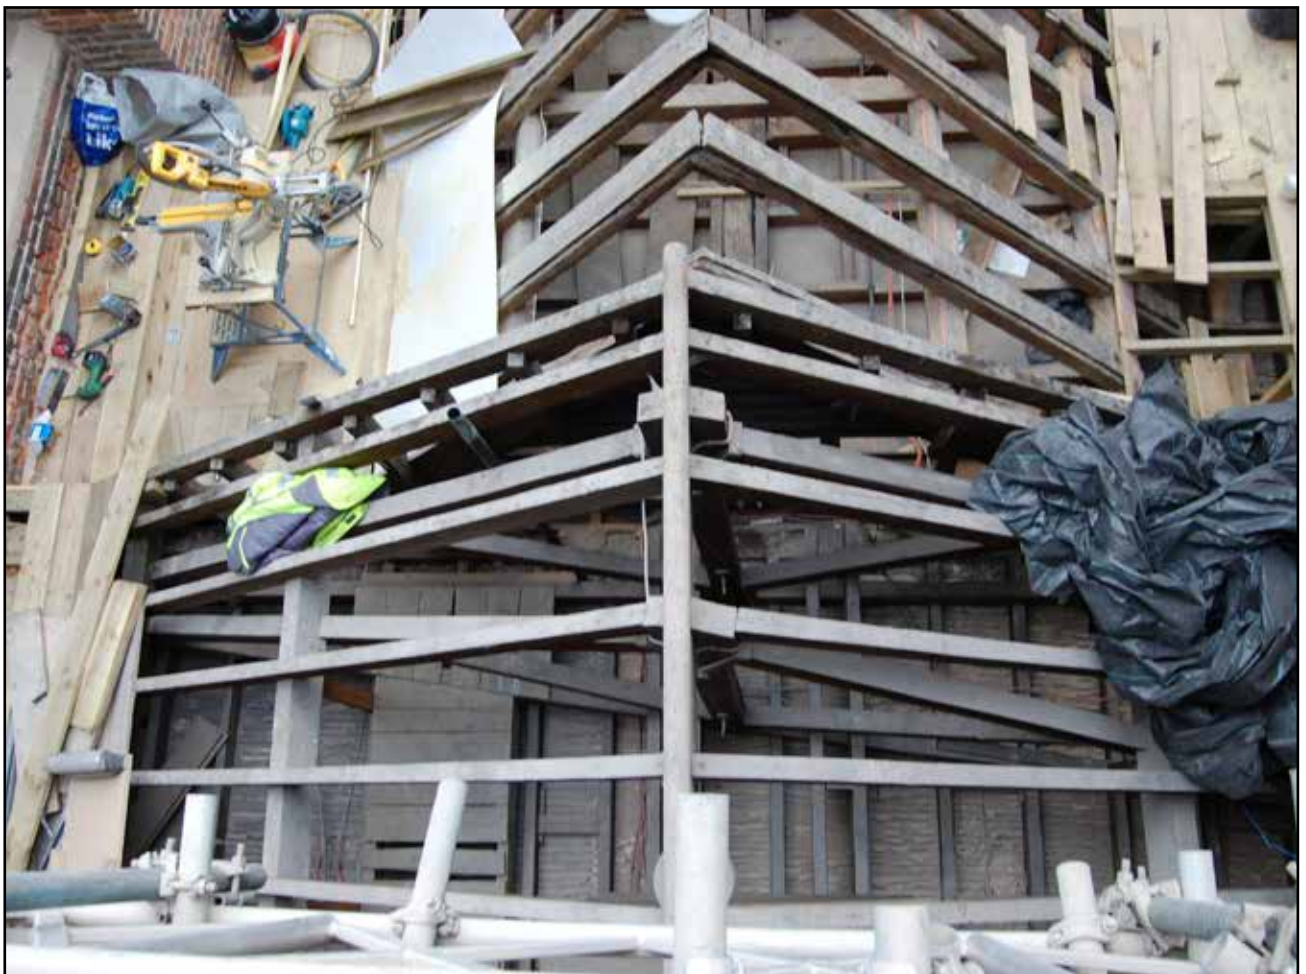
Plate 44: Roof 1 from above

- 4.2.1 Roof 1 was built in the 1930s over Apartment 30 and houses a large water tank (Plate 44). It is a gabled roof orientated north to south and abuts the Anne Boleyn Gatehouse on the north side. This structure replaces an east west orientated gabled roof, the remains of which can be seen on the interior of the Base Court parapet to the west (Figure 7). The roof is made up of two bays, Bay 1 and Bay 2, and three trusses, numbered Trusses 1 to 3 north to south.

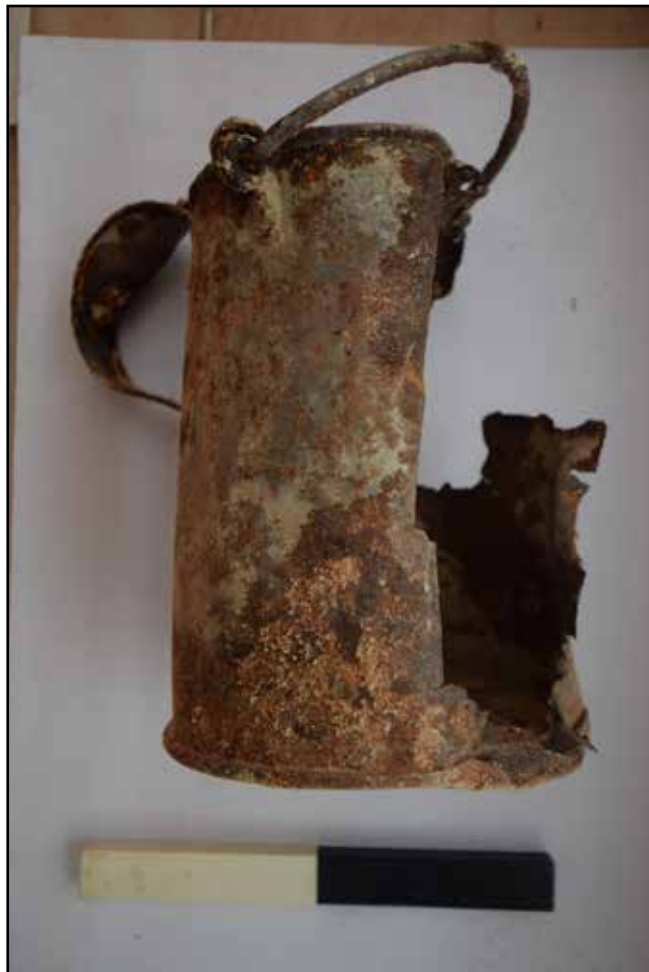
Plate 84: Tin coffee pot 'Time Capsule' found in the parapet of Clock Court – East Facing vation, Part

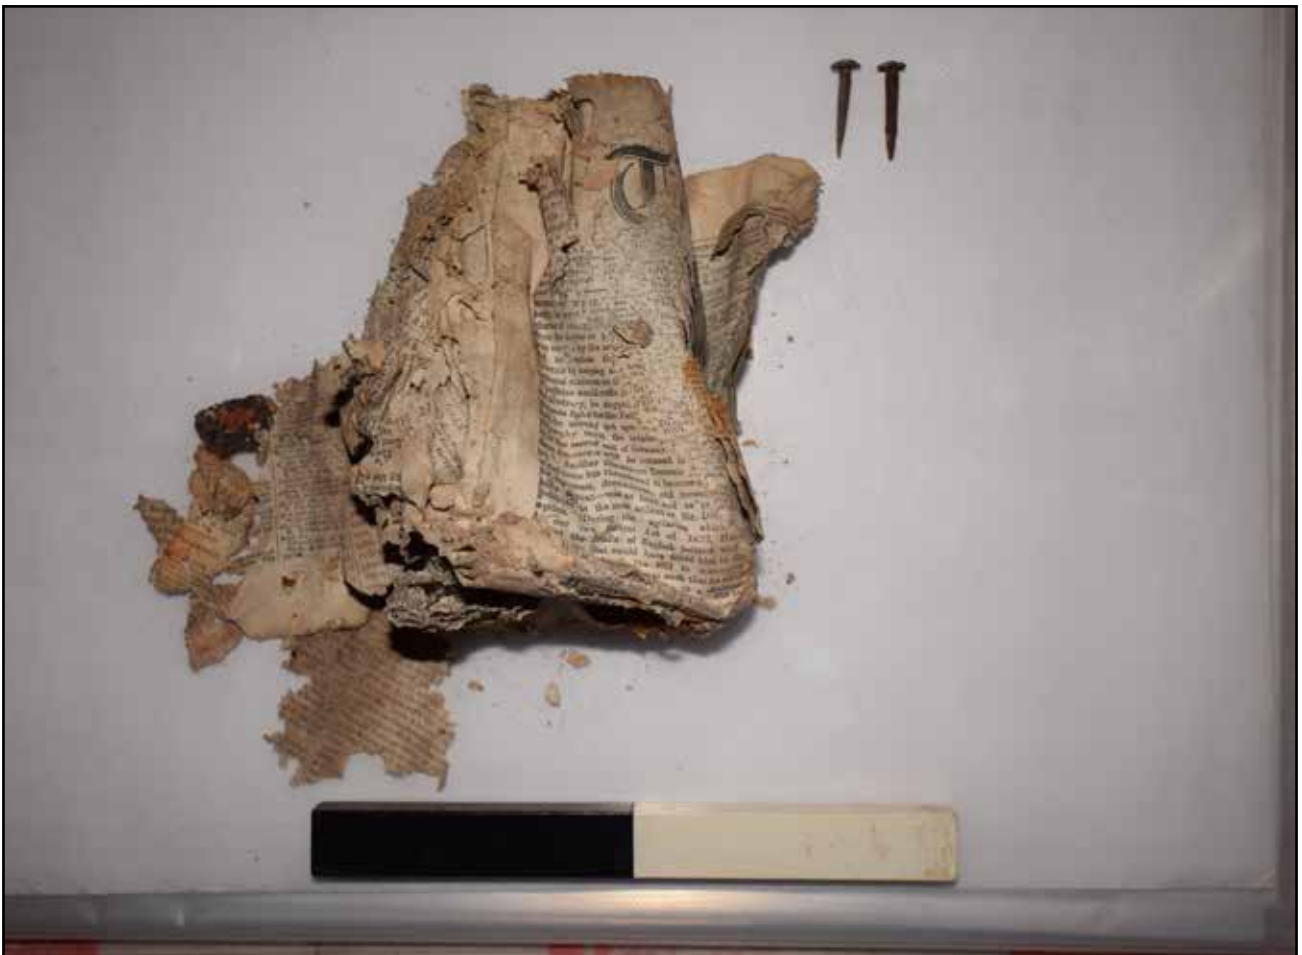
Plate 85: Newspaper and nails found inside tin coffee pot 'Time Capsule' from the parapet of Clock Court – East Facing Elevation, Part 1

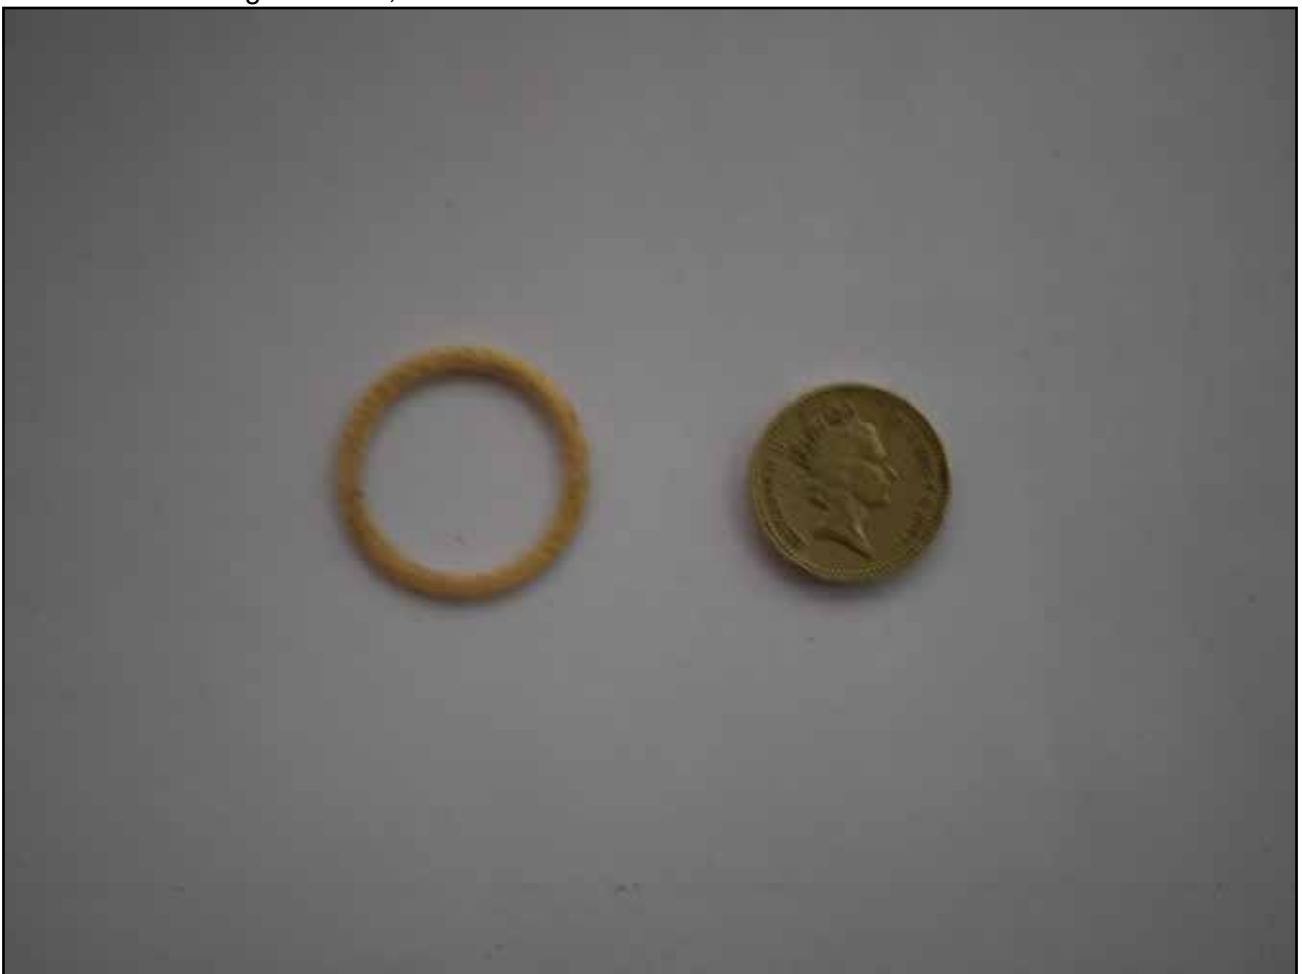
Plate 86: Bone ring found inside tin coffee pot 'Time Capsule' from the parapet of Clock Court – East Facing Elevation, Part 1
