STORRS HALL, ARKHOLME LANCASHIRE

Watching Brief Report

Archaeological Watching Brief

Report no 2000-2001/053/AUA8098

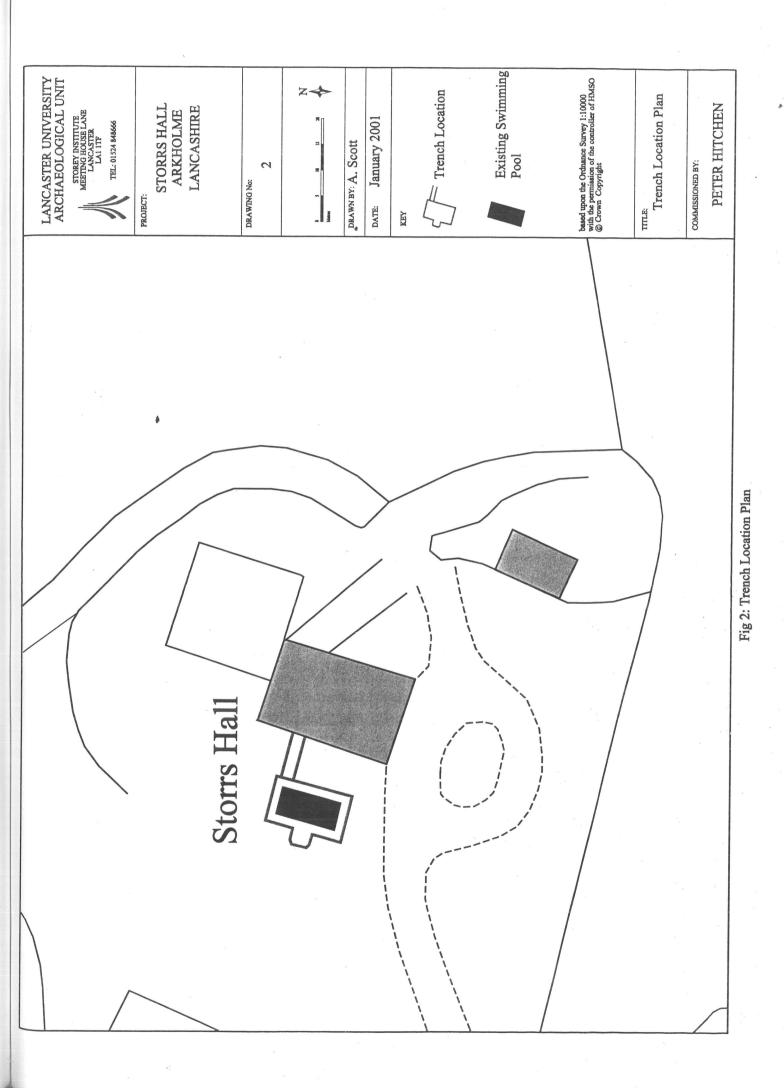
1.3.1 The site was situated within the grounds of Storrs Hall between Arkholme and Over Kellet. The development site consisted of narrow trench extending from the western side of the Hall around the footprint of the existing swimming pool (Fig 2).

- 3.1.1 Prior to excavation the site formed a secluded lawned area situated between the Hall and nearby tennis courts (Fig 2). The area excavated comprised a 2m wide trench extending approximately 16m by 12.5m around the existing swimming pool. A further off-shoot trench linked the swimming pool area with the hall. The western side of the area was taken down to a depth of 0.63m and the eastern side was excavated to a depth of 1.21m near the house in order to level the ground either side of a small garden wall (Plate 2).

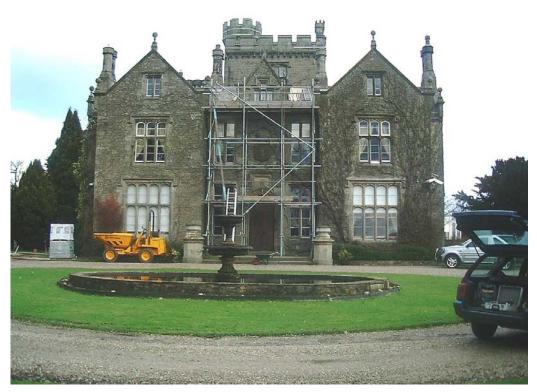
Plate 3: Storrs Hall (c 1848)

1.2.1 Storrs Hall is a grade II listed Tudor gothic mansion dating from 1848 (Plate 3), and was built on the site of an earlier hall, that was known to be in existence in 1698, but was itself rebuilt in 1702 (Robinson 1991, 243). The house has a symmetrical gabled front with an imitation pele tower and turret at the rear (Pevsner 1969).

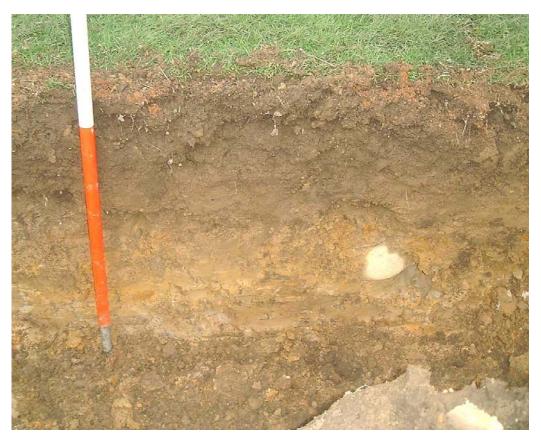
Plate 4: Section to the West of the Swimming Pool

- 3.1.2 The trench revealed considerable disturbance to the stratigraphy mainly at the eastern extent of the trench, which was attributable to the earlier groundworks for the construction of the swimming pool and associated drainage channels. Intact stratigraphic deposits were noted mainly at the western end of the trench and, where they survived, they were very uniform. The topsoil consisted of a 0.2-0.3m deep layer of garden soil and below this was a 0.15-0.25m thick layer of medium yellow brown clay sand subsoil (Plate 4). The underlying natural subsoil was made up of orange sandy clay, incorporating occasional sub-rounded stones and boulders; the upper level of the natural subsoil was c0.6m below the surface.

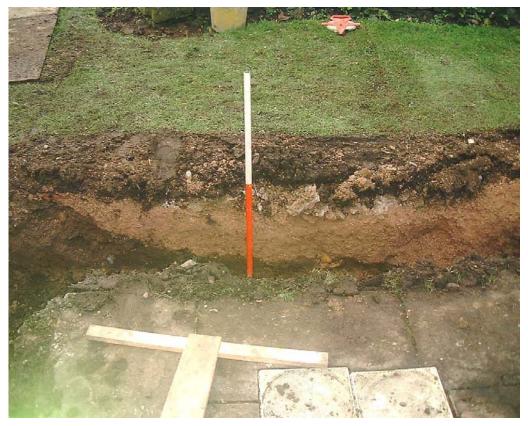
Plate 5: Section to the South of the Swimming Pool Showing Hardcore

- 3.1.3 The disturbed area, immediately adjacent to the pool itself, comprised deposits of pinkish hardcore and stone flags truncating the subsoil (Plate 5). The area immediately to the east of the small (now demolished) garden wall, and adjacent to the Hall itself, comprised 0.69m of grey shale hardcore above the original sub-soil in order to build up the ground in this area. Although the trench extended right up to the hall, there was no evidence of any earlier foundations or remains predating those of the present structure.
