ARTLEGARTH FARM
RAVENSTONEDALE
CUMBRIA

Fabric Survey Report

Report no 1998-99/069/AUA7895

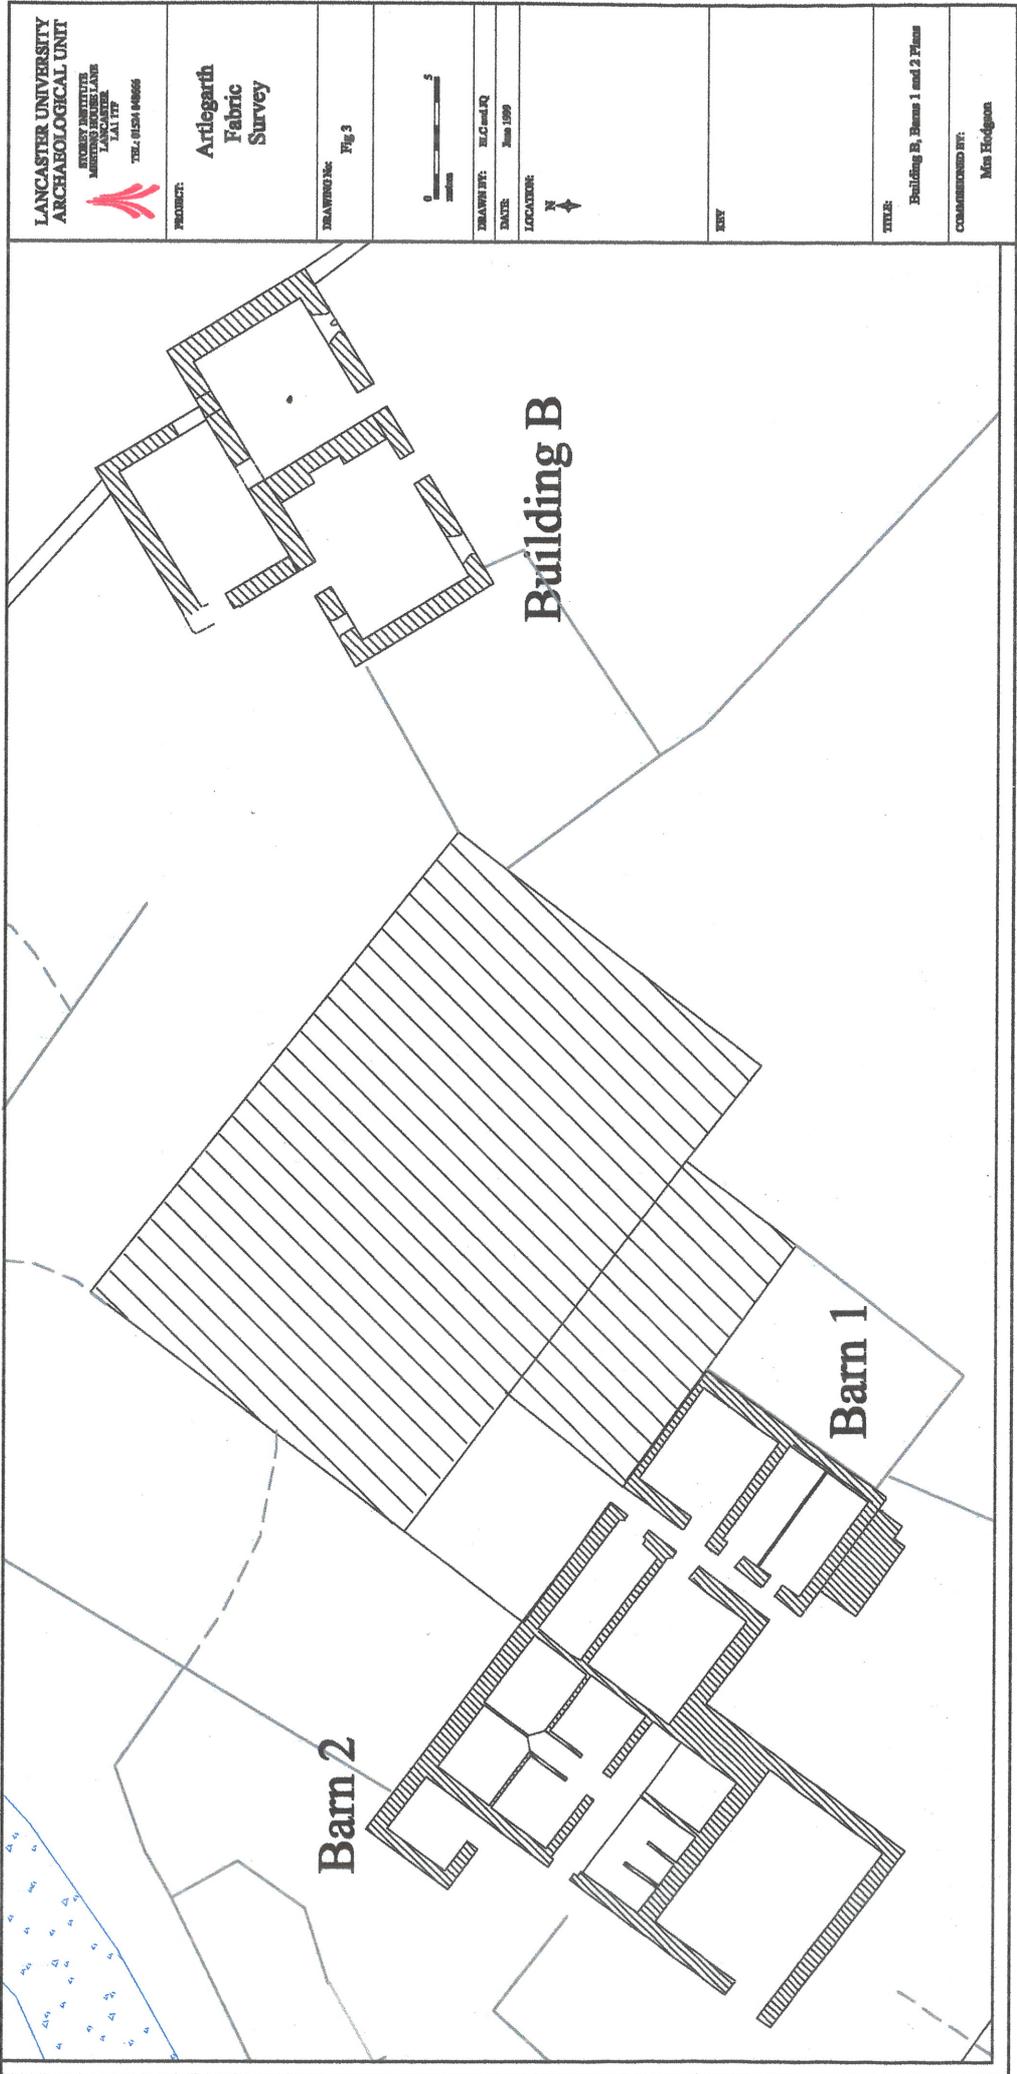
Fig 3 Building B, Barns 1 and 2 Plans

- 3.2.1 Building B (Fig 3) was situated to the south-east of Building A, and comprised what appears to be a pair of single-celled cottages, with a later outshut against the north elevation. The building incorporated local stone with large roughly shaped blocks forming the quoins, and several courses of thin stones which project from the outer walls. The south elevation (Fig 12) had two doorways in the centre, and a blocked two-light mullion window at either end. The western doorway had a substantial sandstone lintel, with a course of projecting slates above forming a drip course, as did the southern mullion window. The southern doorway had a simple slab-type lintel, and neither this door nor the window had a drip course above. Although the two doorways have differing lintel designs, they were of uniform size and in a similar location, and there is no reason to suggest that they were not of the original build. The two ground floor mullion windows have both uniformity of location and design and were almost certainly contemporary. A further mullion window was constructed over the westernmost doorway.

- 3.3.1 Barn 1 (Fig 3 and Plate 4) was a small, two storey barn at the north-western corner of the modern farmyard, with three rooms on the ground floor for housing livestock. The upper floor was accessed from a flight of stone steps butted to the south wall. The east elevation had a lean-to greenhouse built against it, and the northern end was obscured by a modern building.

- 3.4.1 Barn 2 (Fig 3 and 5) was a substantial bank barn at the north-western end of the modern farmyard. An outshut has been added to the north of the ramp to the upper floor, which was accessed through a wide double door, and consisted of a single large open space. The lower floor was divided into two large spaces with individual access doors. The one to the south was used as a storage area while that to north retained the original stall divisions.

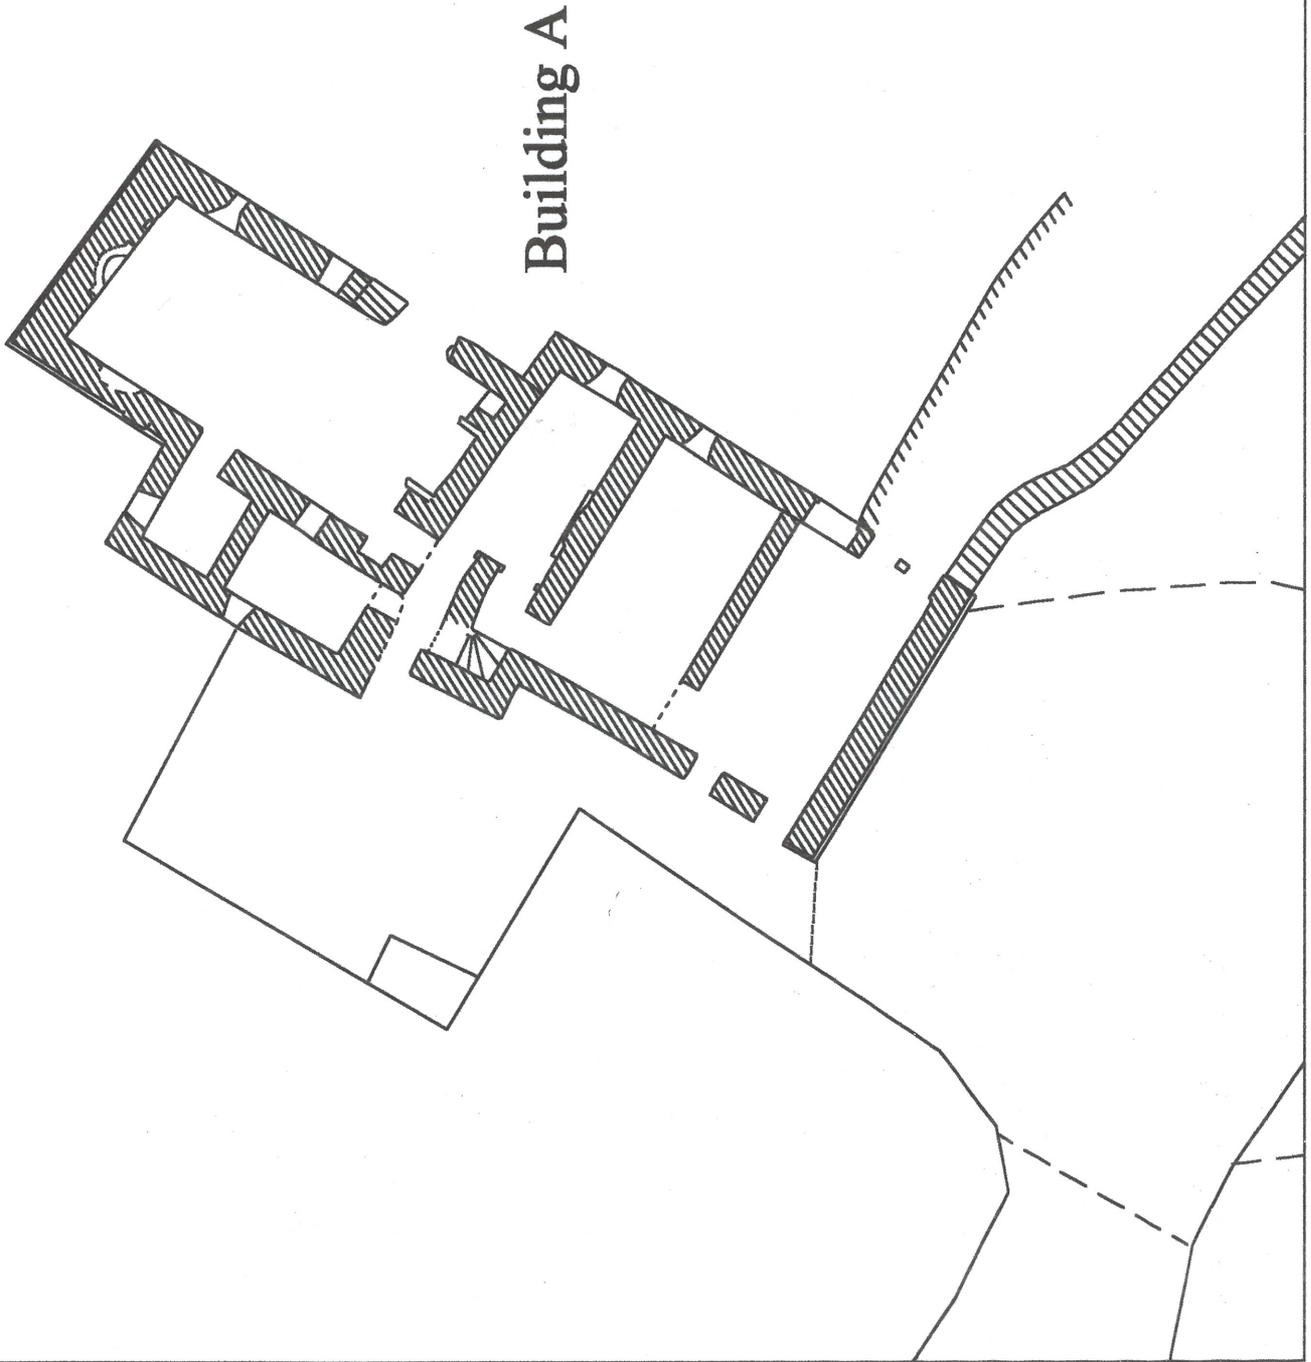
Fig 4 Building A Plan

- 3.1.1 Although the long axis of Building A is north-north-east/south-south-west, for ease of description the building was defined as being orientated north/south. Building A (Fig 4) comprised a bank barn at the southern end and the farmhouse at the northern end. A single key relationship indicated that the barn butted onto the house.

- 3.1.3 The farmhouse had a two-unit small house form (Brunskill 1978, 53), and the main facade was on the eastern side of the building. A central outshut extended from the western wall ((ii) Fig 4), and the observed evidence would suggest that this was bonded with the main western wall of the farmhouse. A second cell (iii) had been constructed to the south of the outshut, which was also bonded to the farmhouse wall and was, by implication, contemporary with the central outshut. These outshut cells were only single storey and had a lean-to roof, marked by an extant drip-course set into the western wall of the main farmhouse.

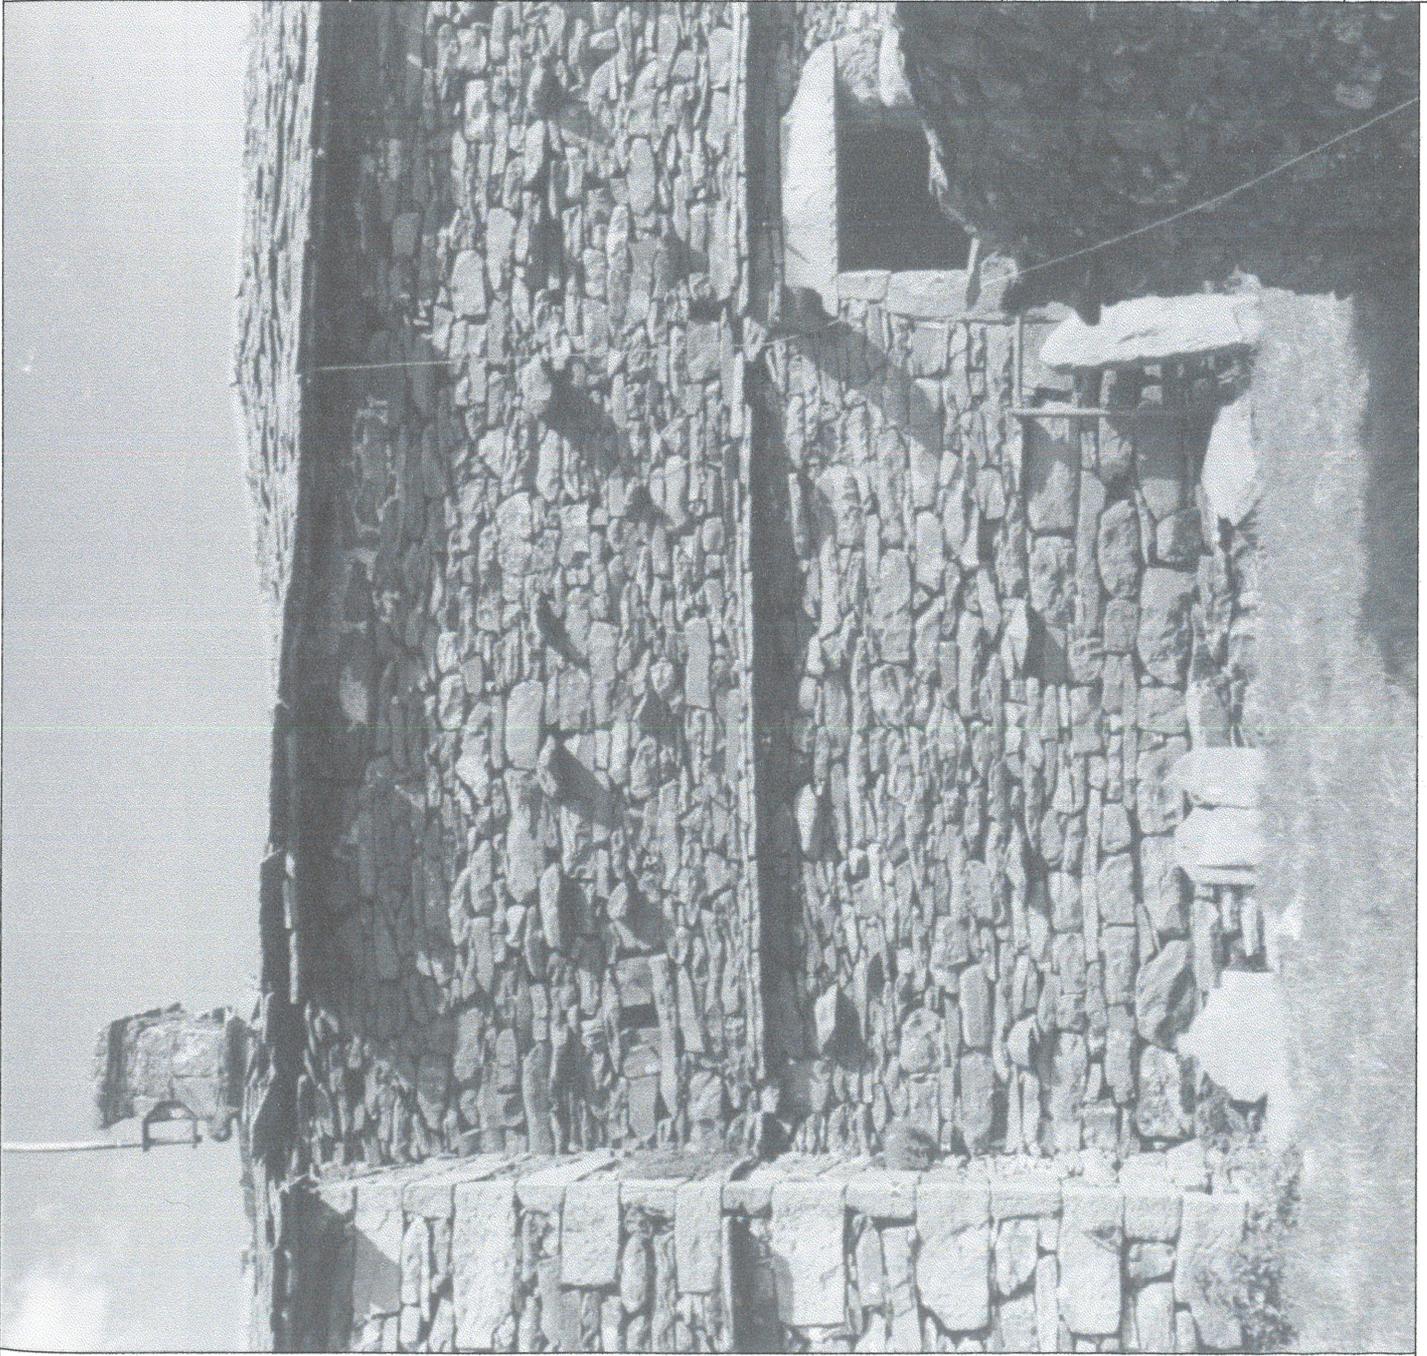
Fig 9 West elevation of Building A barn - central

- 3.1.9 **Barn layout:** the lower floor of the barn consisted of two large rooms (vi and vii) accessed from a pair of doorways at the southern end of the west elevation which appear to have been used for housing animals (Fig 4). The southernmost of these two doorways had a wooden lintel, irregular quoins to the south, and was irregularly defined on the northern side. Its design contrasts with the more systematic design of the adjacent doorway and it is possible that the northernmost doorway was a later insertion. The upper floor consisted of a large open wooden-floored space accessed from a ramp built up against the south-eastern corner of the building. The ramp led up to a wide tall doorway framed by coarse-grained sandstone quoins, with a shallow rebate and hinge settings for a double door.

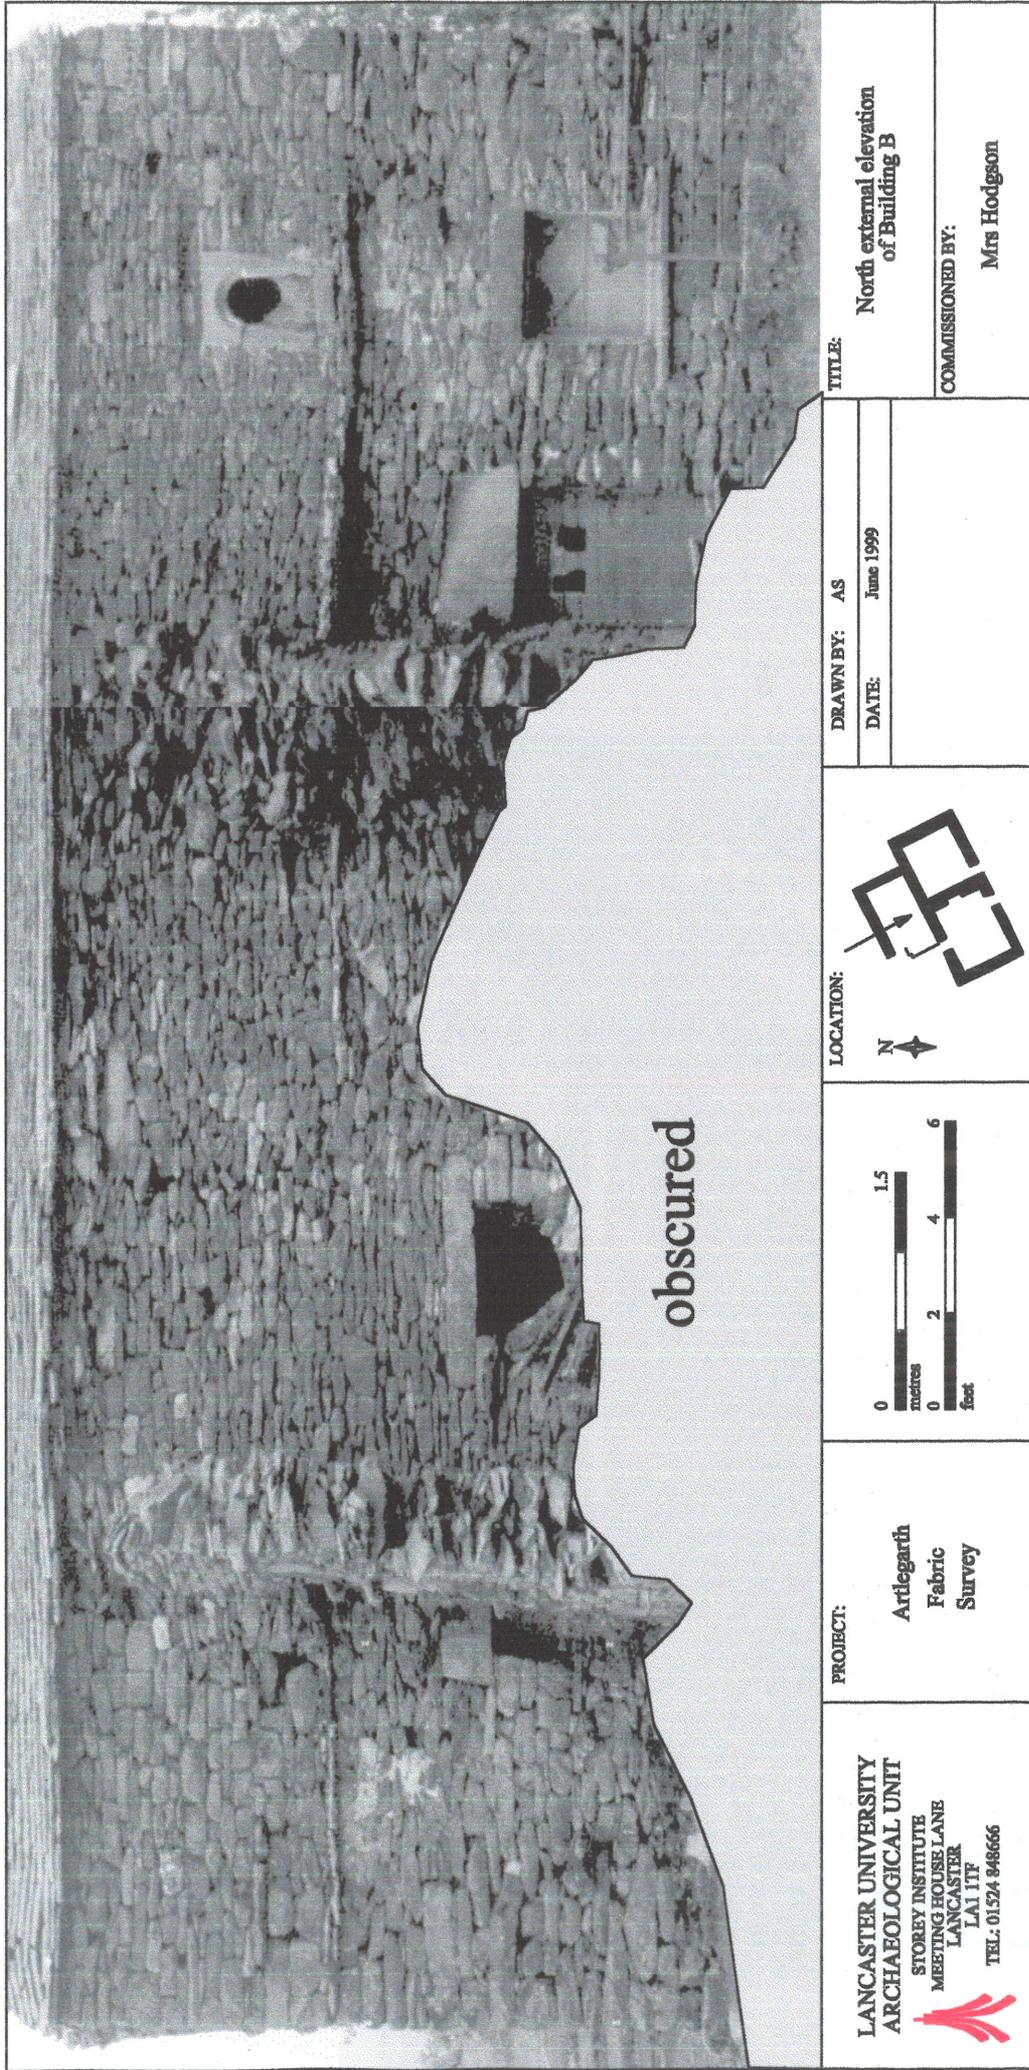
Fig 14 North external elevation of Building B

- 3.2.3 The north elevation of the western bay had a window which was clearly inserted at the east end of the ground floor with a doorway to the north and a substantial stone lintel above. At first floor level, is a small arched aperture with a slate drip course above. The only access to the first floor of the eastern cell was via a hatch. With the exception of the first floor gable in the southern wall of the western cell, there was no illumination for the first floors although there was a series of access hatches to each. There was no evidence of stair access to the first floor of both units which probably served as lofts, rather than as domestic accommodation.

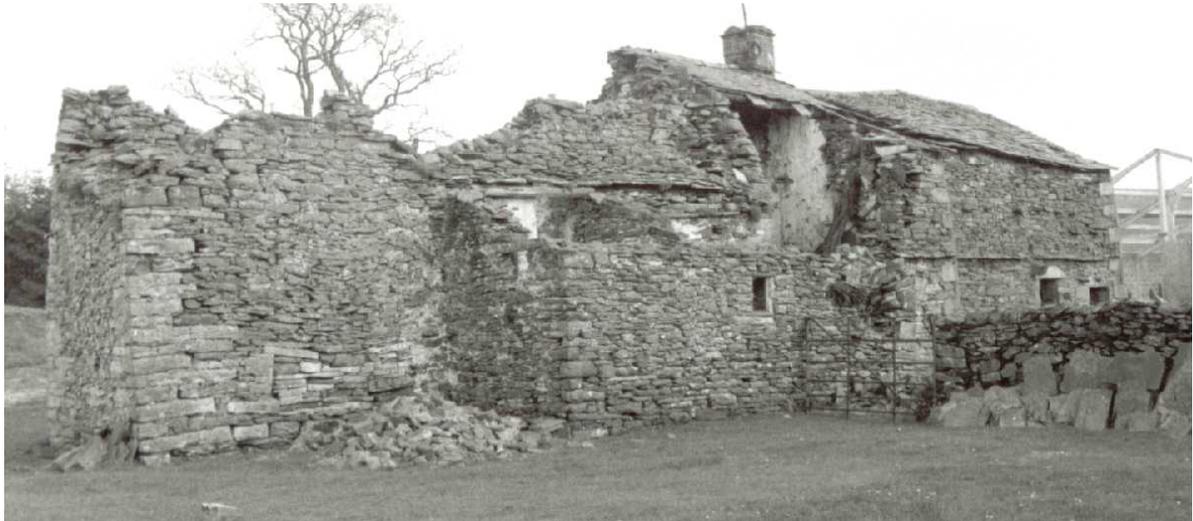
Plate 1 Oblique view of Building A from the north

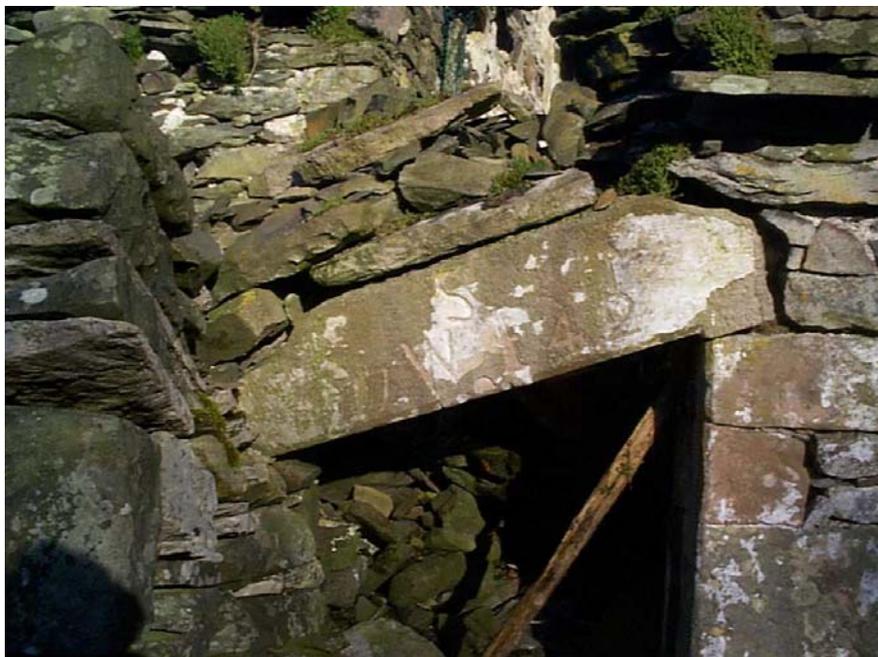
Building A comprised two elements a farmhouse, and a bank barn which was a later addition. The construction of the bank barn was dated by a lintel datestone of 1742. The original farmhouse was a two-unit small house, a type which can date back to the mid seventeenth century, and it is probable that this example was of late seventeenth or early eighteenth century date.

Plate 2 Dated lintel over the entrance to the Building A extension

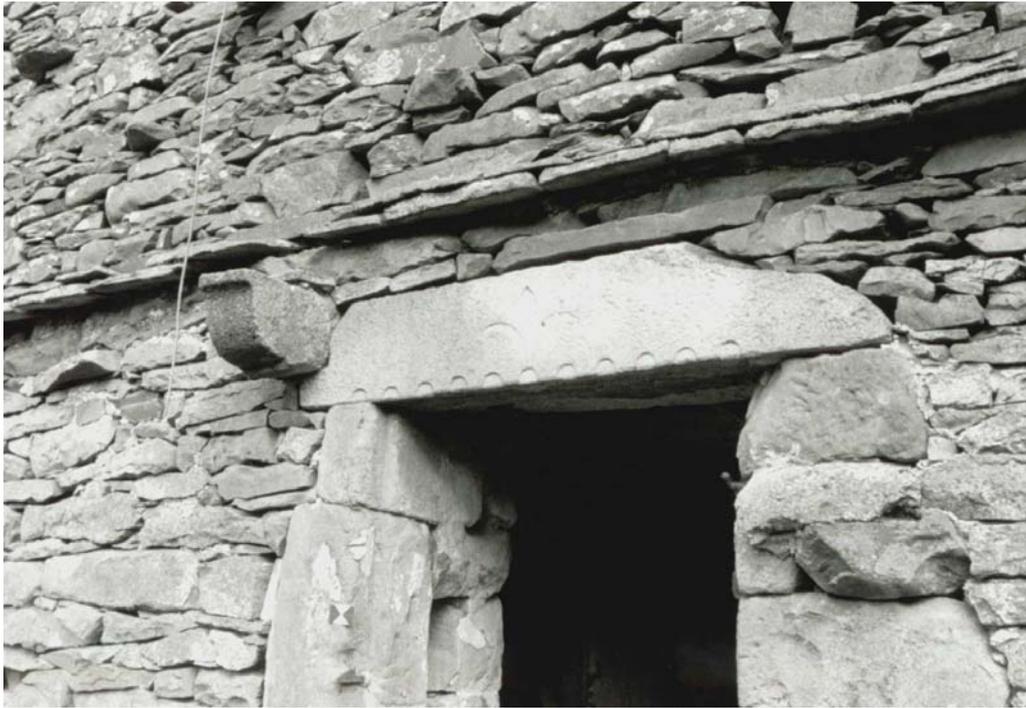
Plate 3 Fleur de Lys engraving on a stone re-used as a lintel over the south-western entrance to the Building A barn

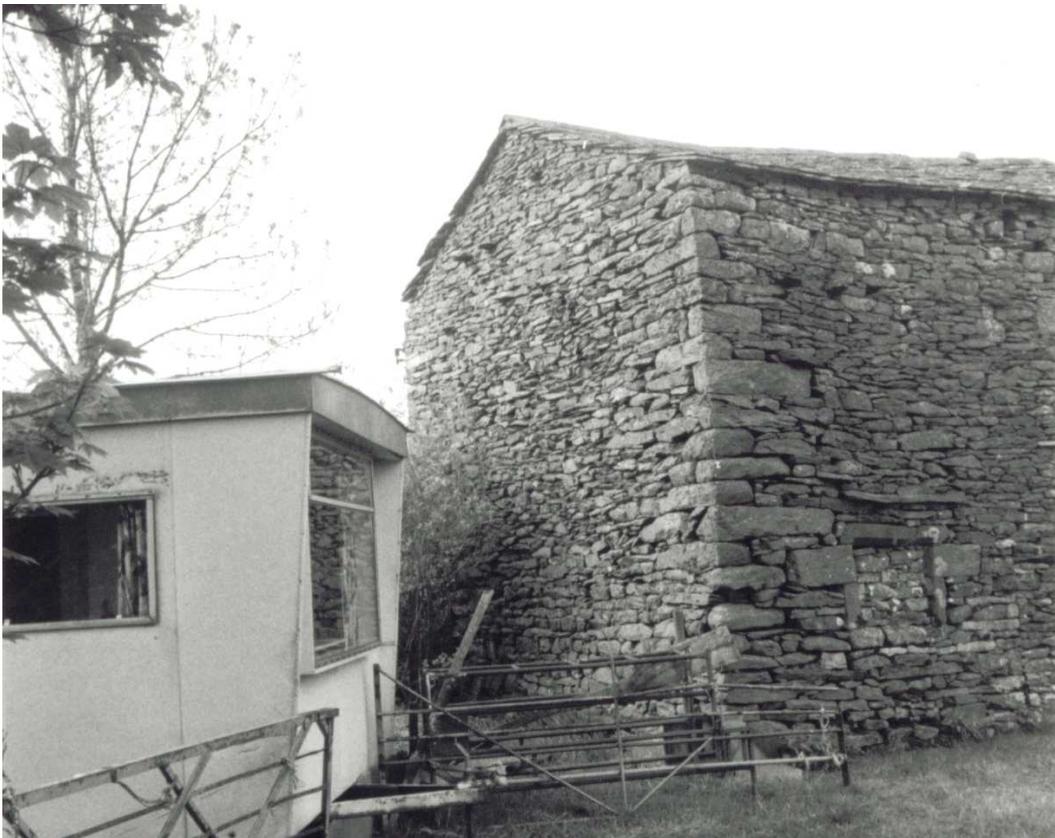
- 2.2.2 **Rectified Photography:** the external elevations of Buildings A and B and the internal elevations of Building B were recorded using rectified photography; photographs were taken using a Mamiya medium format camera, with an 80mm lens, and also a 35mm camera. It was not, however, possible to take rectified photographs of the western gable of Building B as the view was obscured by a large tree and static caravan. An oblique photographic record was created of this elevation instead (Plate 4).

Plate 4 Western gable of Building B

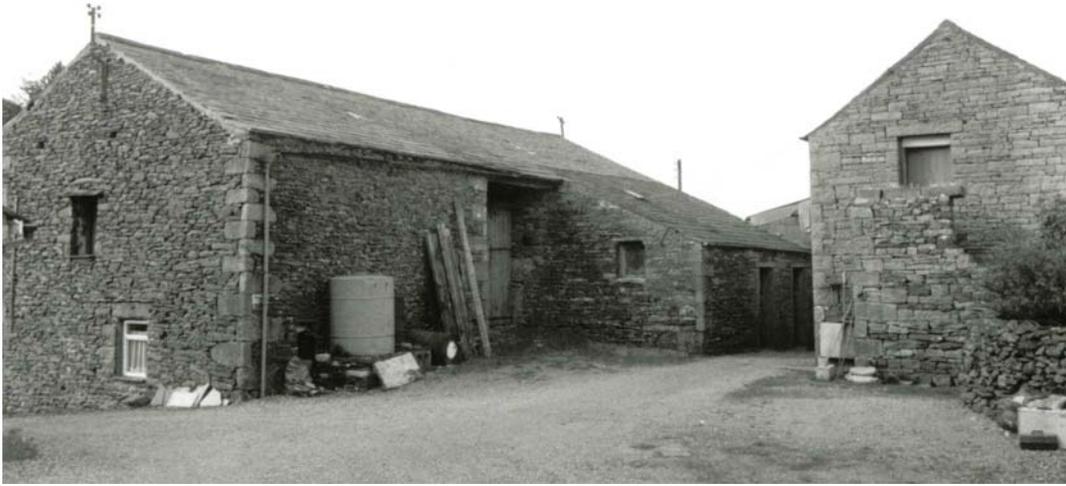
Plate 5 Barn 2 from the south-east

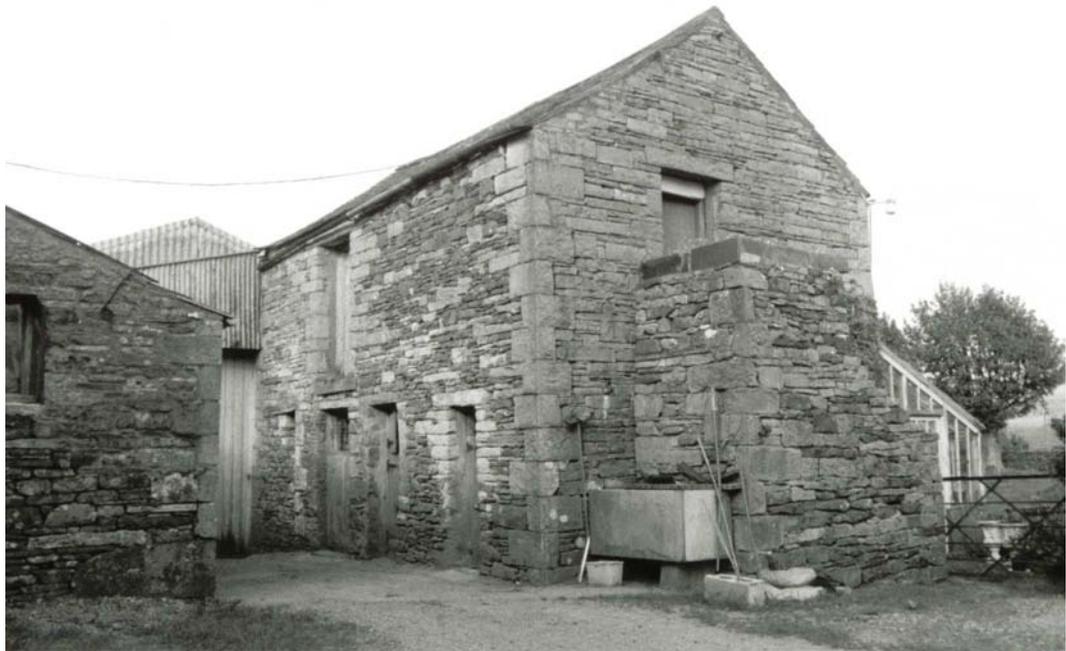
Plate 6 Barn 1 viewed from the south-west
