STATION HOTEL, GILSLAND

NORTHUMBERLAND

Archaeological Evaluation Report

Report no 1998-99/058/AUA7882

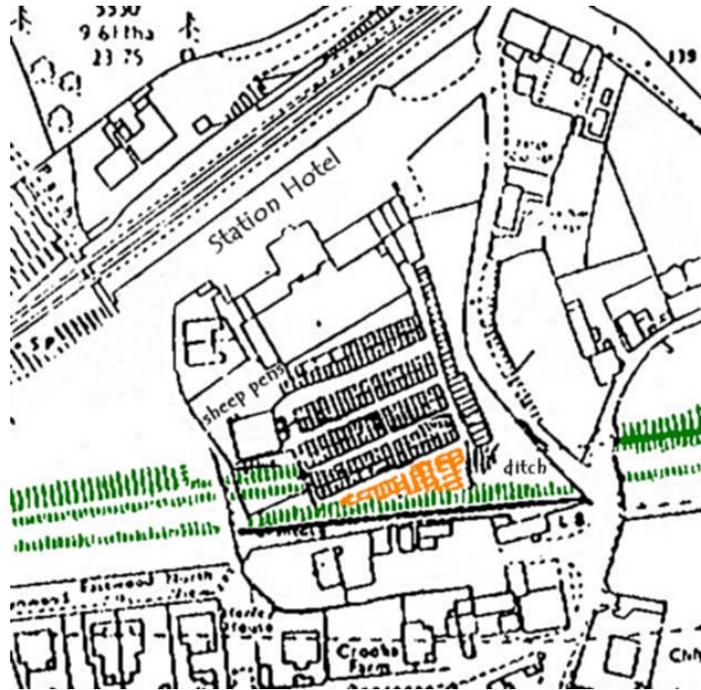
Fig 7 Correlation between map and magnetometry survey

The map indicates the location of holding pens for livestock and remnants of these pens were identified by the geophysical survey. The Correlation between anomalies from the magnetometry survey and map information is illustrated above (orange lines).

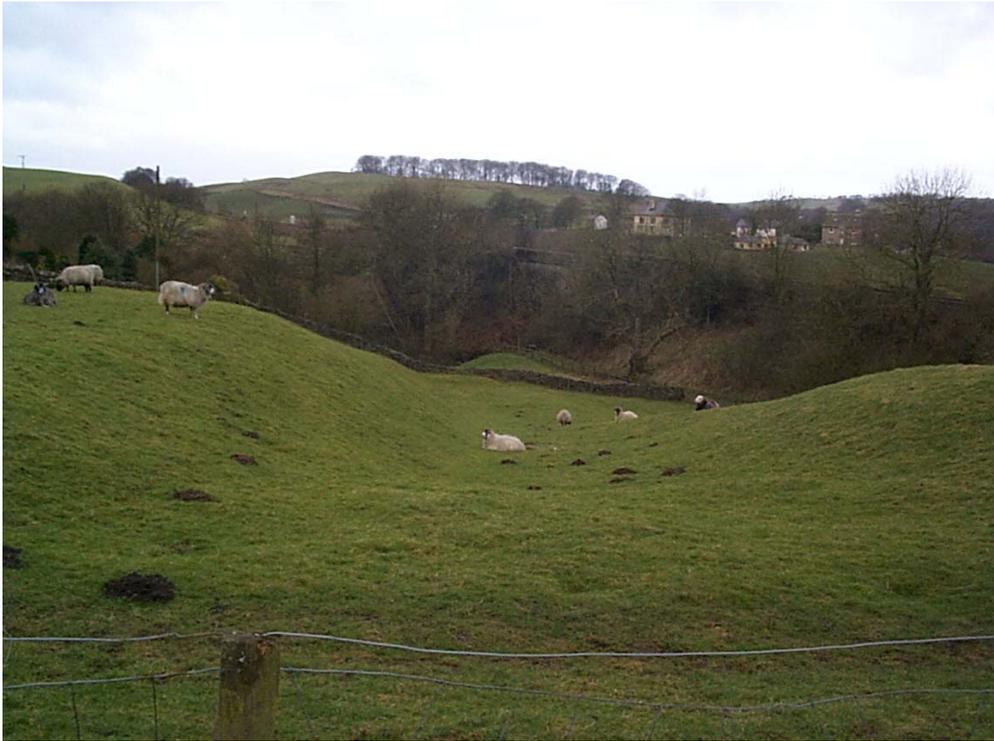
- 3.1.1 The preliminary site investigation demonstrated that there was a dramatic difference between the earthwork survival of the Wall ditch and counterscarp bank within the study area and those elements within areas immediately beyond. The Wall ditch did not survive and the south-western part of the proposed development area in particular appears to have been subjected to particularly severe terracing. In the south-eastern corner was a raised area (Fig 2 (iii)), which, on surface examination at least, appeared to be the northern remains (albeit very badly truncated) of the counterscarp bank. Along the southernmost end of the site was a terrace edge (Fig 2 (ii)), which broadly corresponded to the line of the southern side of the Wall ditch as defined by the surviving sections of ditch on either side of the study area (Plate 4).

Plate 1 Wall ditch and counterscarp bank immediately to the west of the study area > west

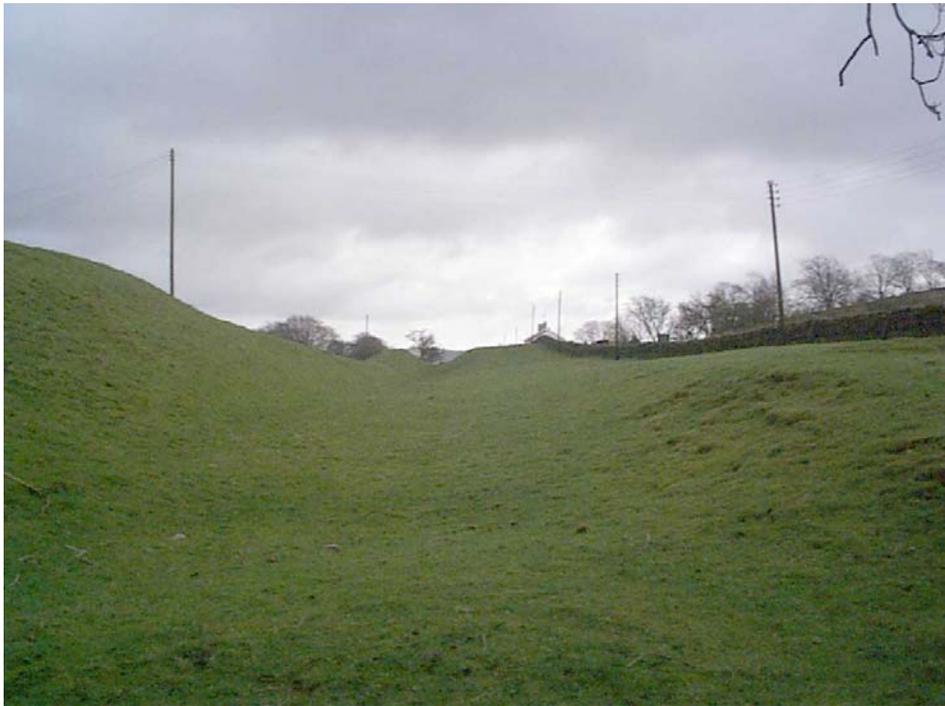
Plate 2 Wall ditch and counterscarp bank to the east of the study area > east

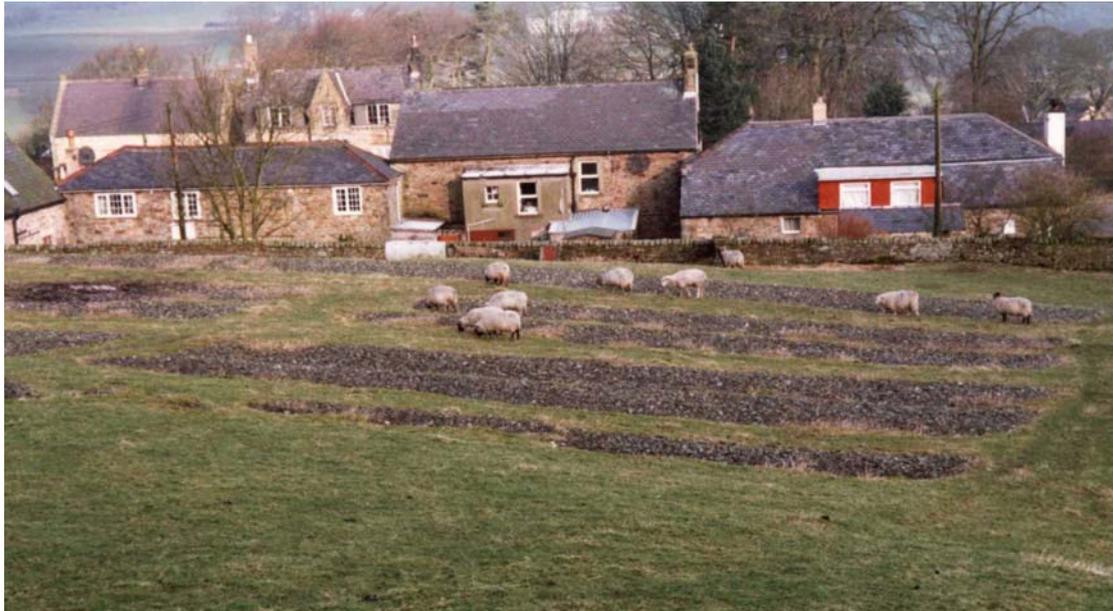
- 3.1.2 In the central part of the site, the layout of the former auction mart was still plainly visible on the ground, as lines of stony infill, and disturbed areas of turf (Plate 3). The western edge of the site appeared to have been affected by severe building disturbance, with concrete slabs, inset corrugated sheeting, and footing pads still in evidence. At the western edge of the site was a series of parallel, low, narrow banks (Fig 2 (i)), which would appear to correspond to the foundations of a recent structure in the area, and indeed are shown on the Ordnance Survey 2nd edition map.

Plate 3 Northern part of the study area, showing metal foundations for market pens

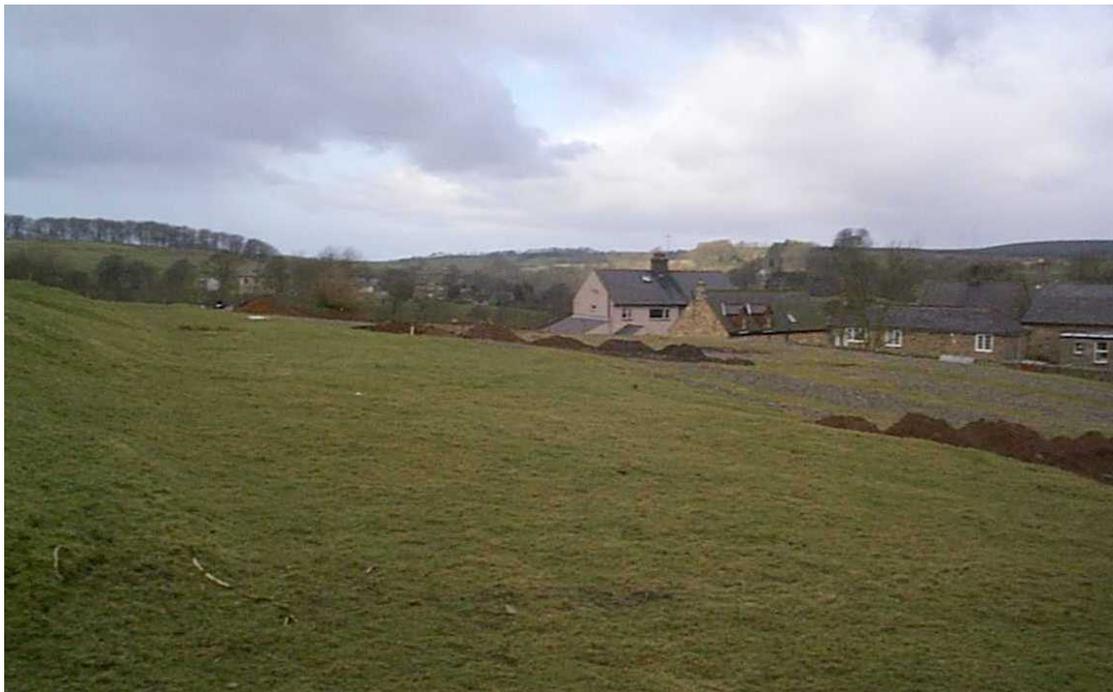
Plate 4 Terrace at the Southern end of site, which corresponds with the line of the filled north Wall ditch
