December 1999

MASON STREET, EDGE HILL
LIVERPOOL

Watching Brief Report

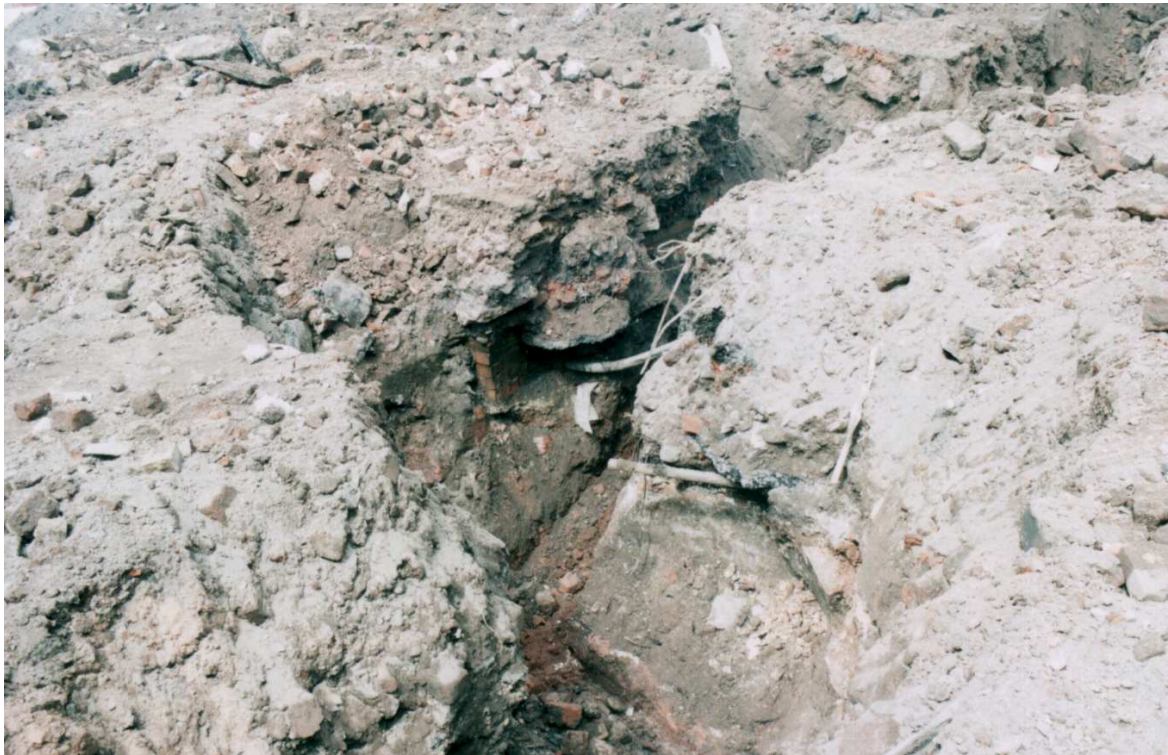
Plate 1 Cellar Walls (Feature i) in south-east corner of Unit 14 – looking north-east

3.4.3 In the south-eastern corner of Unit 14 (Fig 2) the north and west walls of a nineteenth century cellar with a modern concrete floor, were exposed (Plate 1). The walls were two courses thick, lime washed on the inside, and footed onto the bedrock.

- 4.1.2 The cellar (Feature i) in the south-eastern corner of the site (Fig 3) probably relates to the Raffles Public House constructed in the late eighteenth century (Friends of Williamson's Tunnels pers comm). The other nineteenth century cellar walls (Features iii-v) may relate to one of the detached houses in existence before Williamson built on the site, or to a cellar associated with one of the houses built by Williamson himself. These structures are shown on an 1823 estate map (Hf 912 1823).

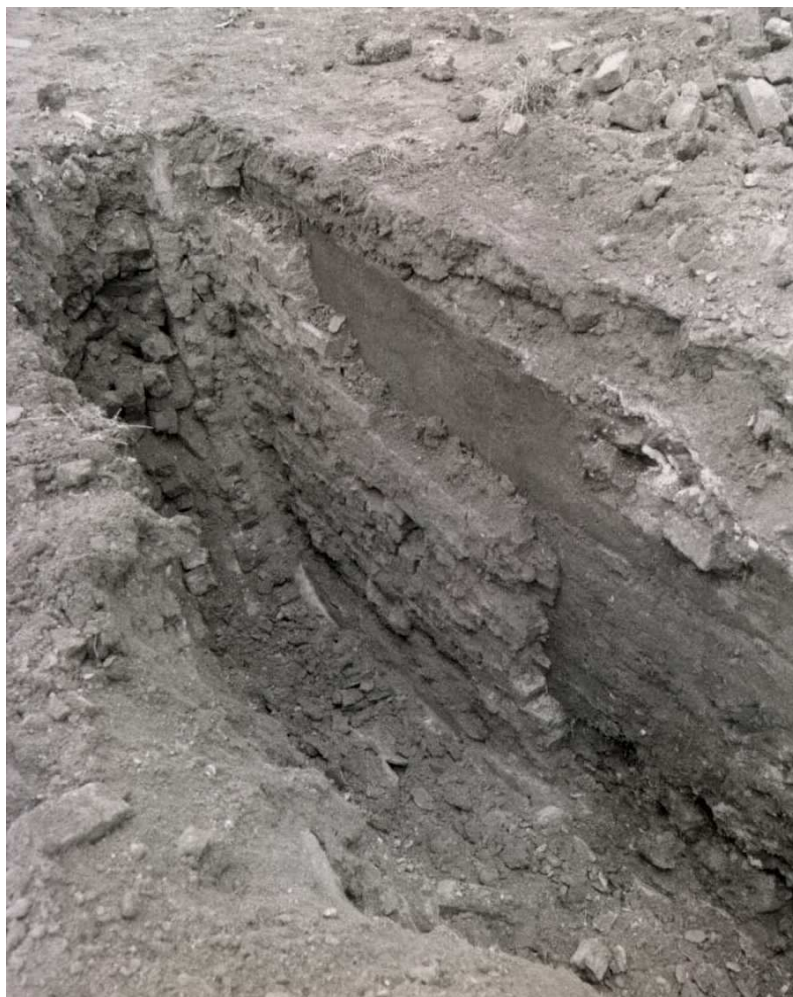
Plate 2 Cellar wall (Feature iii) at eastern end of Unit 16 – looking north

3.4.4 Part of a second nineteenth century cellar ((Feature iii) Plate 2) was revealed in the east side of the trench, which was excavated for the east wall of Unit 16 (Fig 2). The cellar wall was exposed almost directly below the surface, and was 2.1m in height and was again footed onto the bedrock. The wall extended 4.4m south from the north-eastern corner of unit 16 where the return of the south wall was exposed. The cellar was backfilled with nineteenth century brick (average size 240 x 70 x 120mm or 9.5 x

2.75 x 4.75"). The wall was 0.3m wide, with the bricks laid in bands of three courses of stretchers separated by single header courses. The outer face of the brickwork had been rendered as damp proofing.

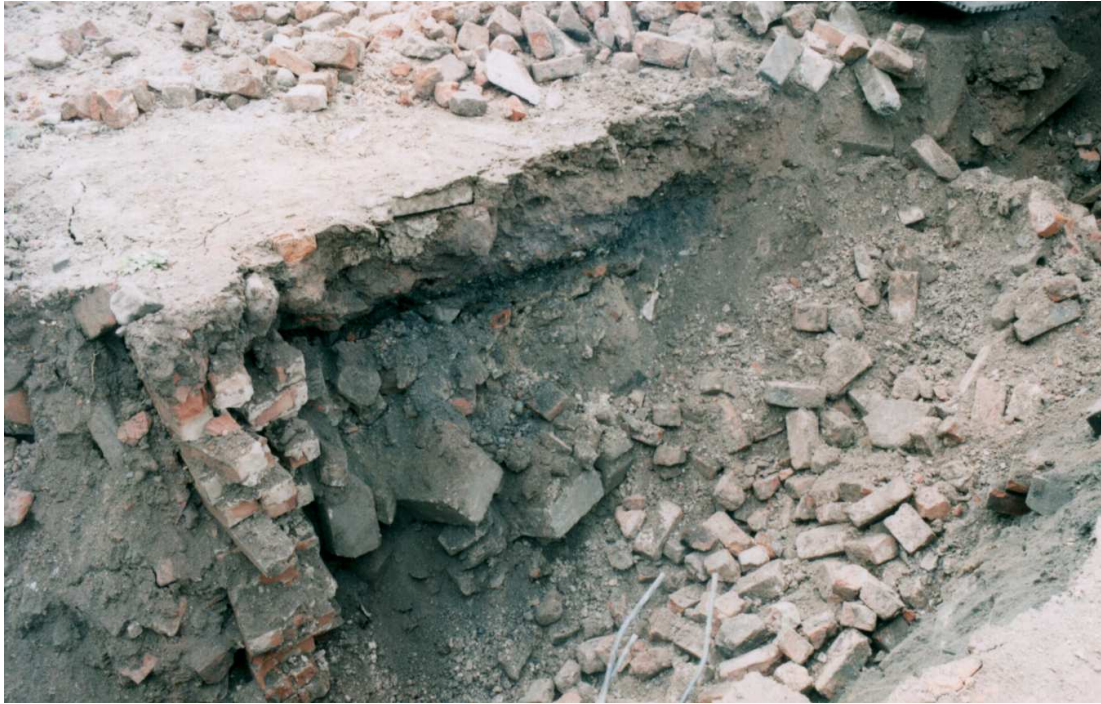
Plate 3 modern wall, and infill of former concrete moulding works (Feature ii) – looking east

- 3.4.5 Two modern brick walls (Feature ii), aligned north/south (Fig 3, Plate 3) were exposed extending across units 14, 15, 16 and 17. The walls had reinforced concrete footings set onto the bedrock with the remains of a cement floor above. The walls were 4m apart, and the space between was filled with concrete castings and demolition rubble above a concrete floor set directly onto the bedrock.

- 4.1.4 The modern walls and concrete raft (Feature ii) almost certainly relate to a factory which was producing reinforced concrete mouldings (friends of Williamson's tunnels pers comm), and appears to have occupied the area covered by units 14-18 (Fig 3).

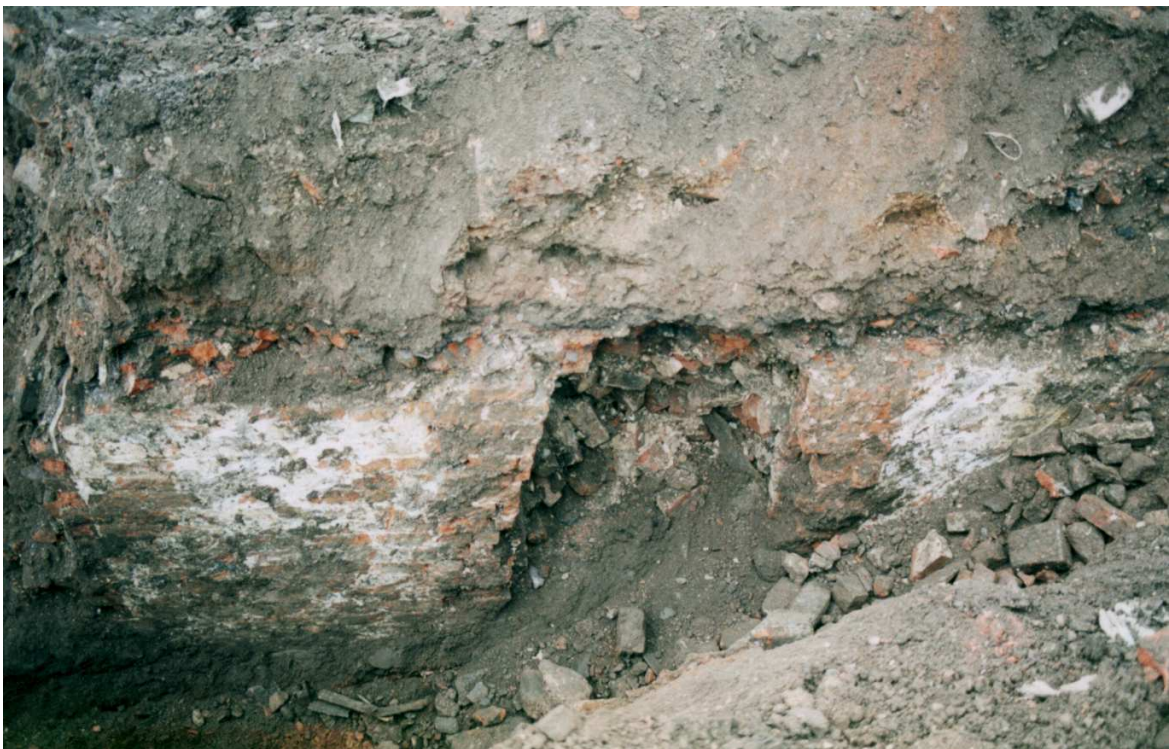
Plate 4 Cellar wall (Feature iv) between Units 17 and 18 looking north-east

- 3.5.1 A substantial nineteenth century cellar wall (Feature iv) (Fig 3, Plate 4) was exposed on the northern side of the trench which was excavated for the dividing wall between Units 17 and 18. The wall had an aperture in the centre exposing brick demolition rubble. A further nineteenth century cellar wall (Feature v) was exposed in the south-eastern corner of the trenches for Unit 19 (Fig 3). The excavation trench for the walls between Units 19, and 20 crossed the line of Tunnel 10, and although the trench was excavated to a maximum depth of 1.4m, the crown of the tunnel was not exposed.

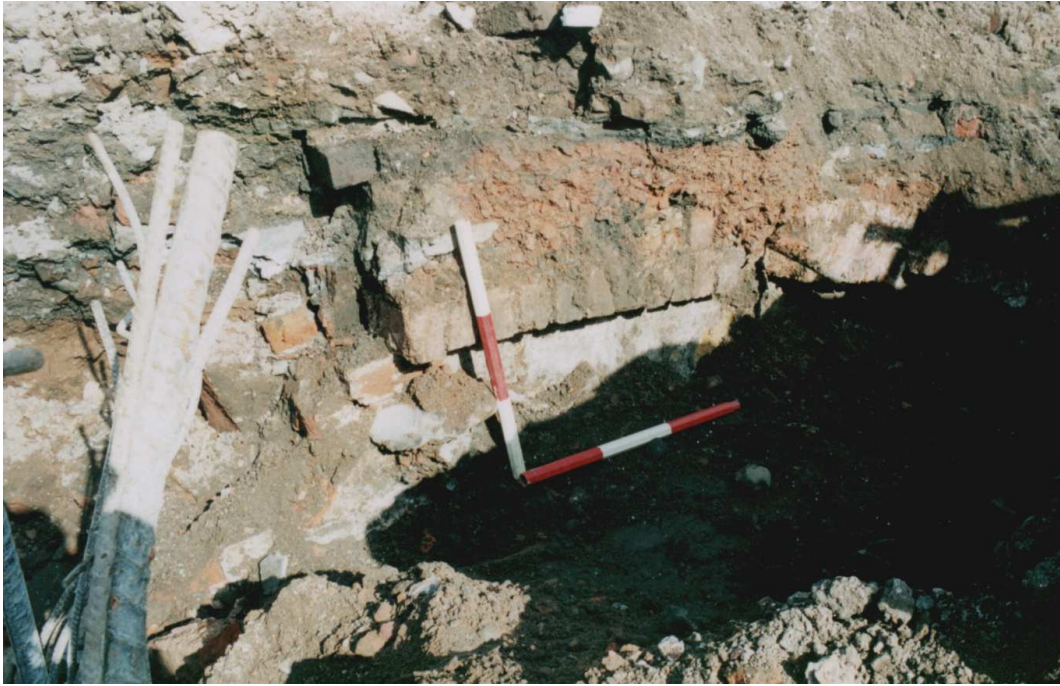
Plate 5 Upper part of vaulted cellar (Feature vi) after removal of the vault

- 3.5.2 Excavation of the trench for the dividing wall between Units 20 and 21 (Fig 2; Plates 5 and 6) exposed two brick lined voids (Features vi and vii) almost immediately below the ground surface. Further excavation of the voids showed them to connect with the two narrow passages in the northern side of the north passage, that leads from Tunnel 10.

- 3.5.3 The westernmost of the two small north/south passages had a flagstone roof with an opening at the level of the cut into the bedrock and above was a brick vaulted nineteenth century cellar (Feature vi) (Plate 5) with an entrance in its western side; the cellar was 3.5m long, and 2m wide. It is possible that the walls of the cellar were constructed as a partial lining to the cut in the bedrock. The passage extended only as far as the western end of the cellar (3.5m), and ended in a vertical face of bedrock. The depth from the base of the cellar vault to the passage floor was approximately 4.5m. It is clear that the short passages were constructed in order to connect the cellars of the buildings that formerly stood on the site with the main tunnel system (*Section 4.1.2*).

- 4.1.3 The two cellars (Features vi and vii) above the small passages probably relate to houses built by Williamson himself. Access from the cellars to the passages below would have been by ladder as there was no evidence for steps. The fact that the two short passages extended only as far as the cellars above, would seem to indicate that they were intended to provide discrete access between the cellars and the tunnel complex.

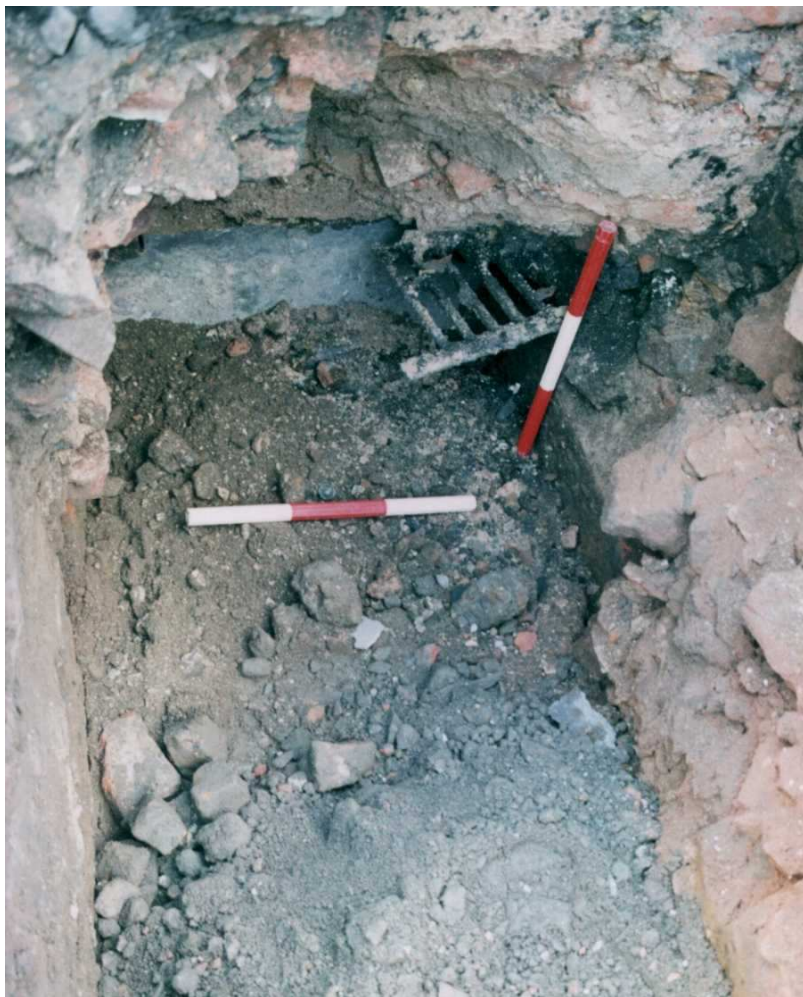
Plate 6 Upper part of cellar showing bedrock cut and metal grating (Feature vii)

- 3.5.4 The easternmost of the two north/south passages was accessed from a narrow arched doorway from the northern passage. Above the passage was the cellar (Feature vii) which extended beyond the western section of the foundation trench (Fig 4; Plate 6). This passage was the same length as that to the south, and also terminated in a vertical cut in the bedrock. The cellar was 1.2m wide, and over 2.1m in length. The brickwork of the cellar was internally rendered and whitewashed and there was a metal grating in the south-western corner. The top of the cellar had been previously truncated, and it was not possible to establish whether or not it had originally been vaulted. There was no visible evidence for a floor between the cellar and the base of the passage.

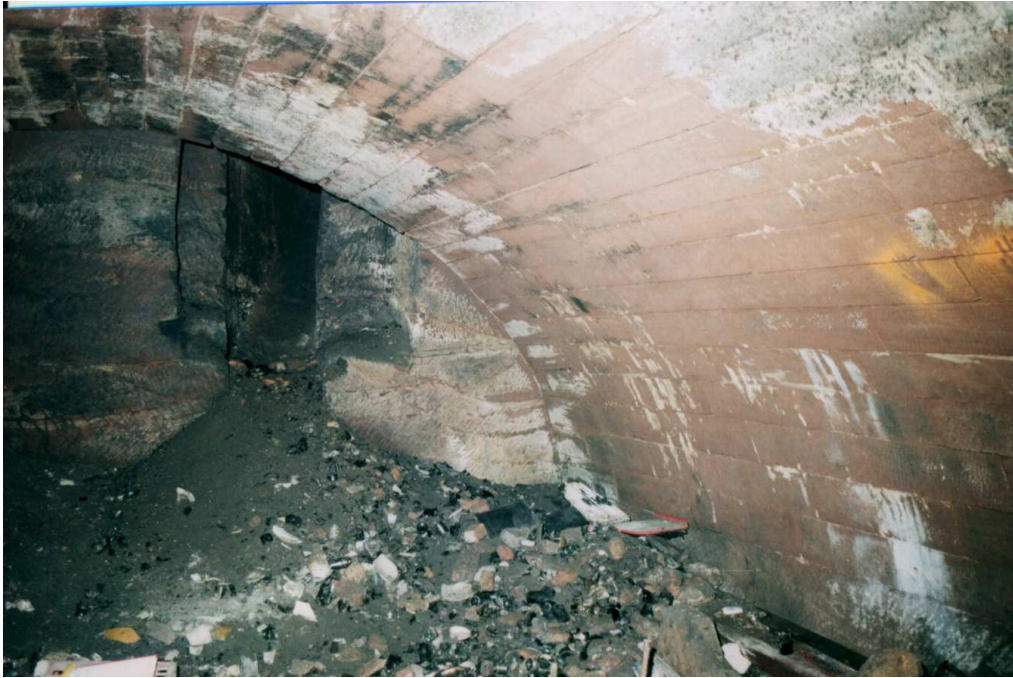
Plate 7 Interior of Tunnel 10, southern passage entrance, taken prior to the piling

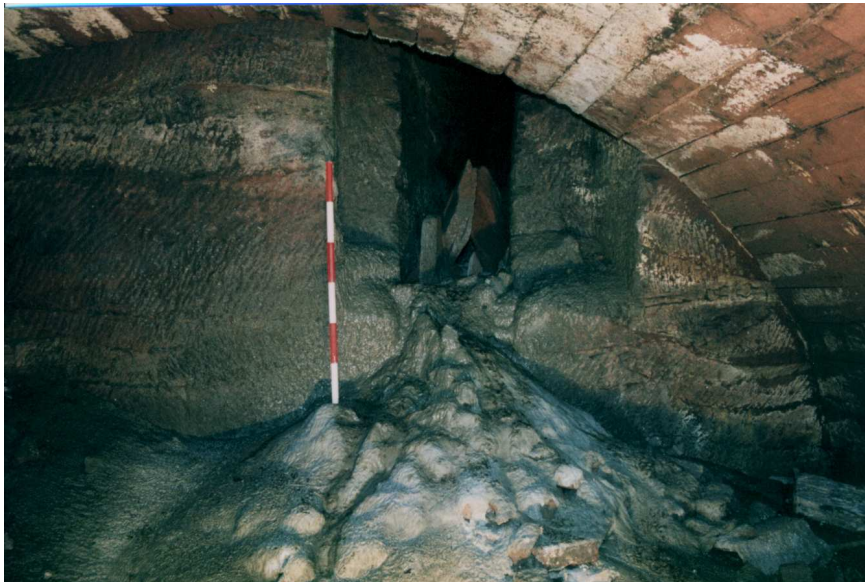
Plate 8 Interior of Tunnel 10, southern passage entrance, taken following the piling – looking east

- 4.2.1 Some disturbance was caused by the piling, a block on the northern side of the stone vault of Tunnel 10 (Plate 11) was moved out a short distance by one of the piles, and a pile drilled into the sandstone pier between the two narrow tunnel entrances (Tunnel 10) dislodged some pieces of sandstone into the entrance of the southern passage (Plates 7 and 8). In the northern passage of Tunnel 10 (Plates 9 and 10) were relatively minor amounts of grout penetrated into the passages, but a more substantial amount of penetration was observed from the entrance of the southern passage.

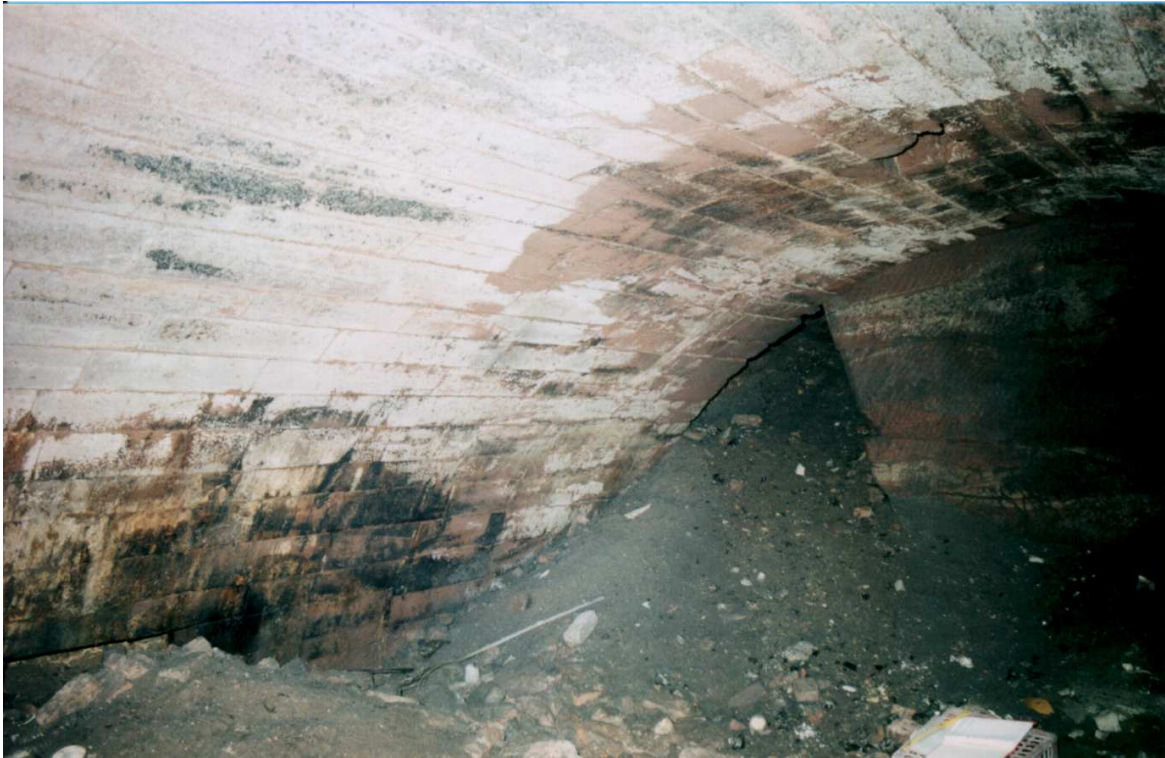
Plate 9 Tunnel 10, entrance to the northern passage prior to piling

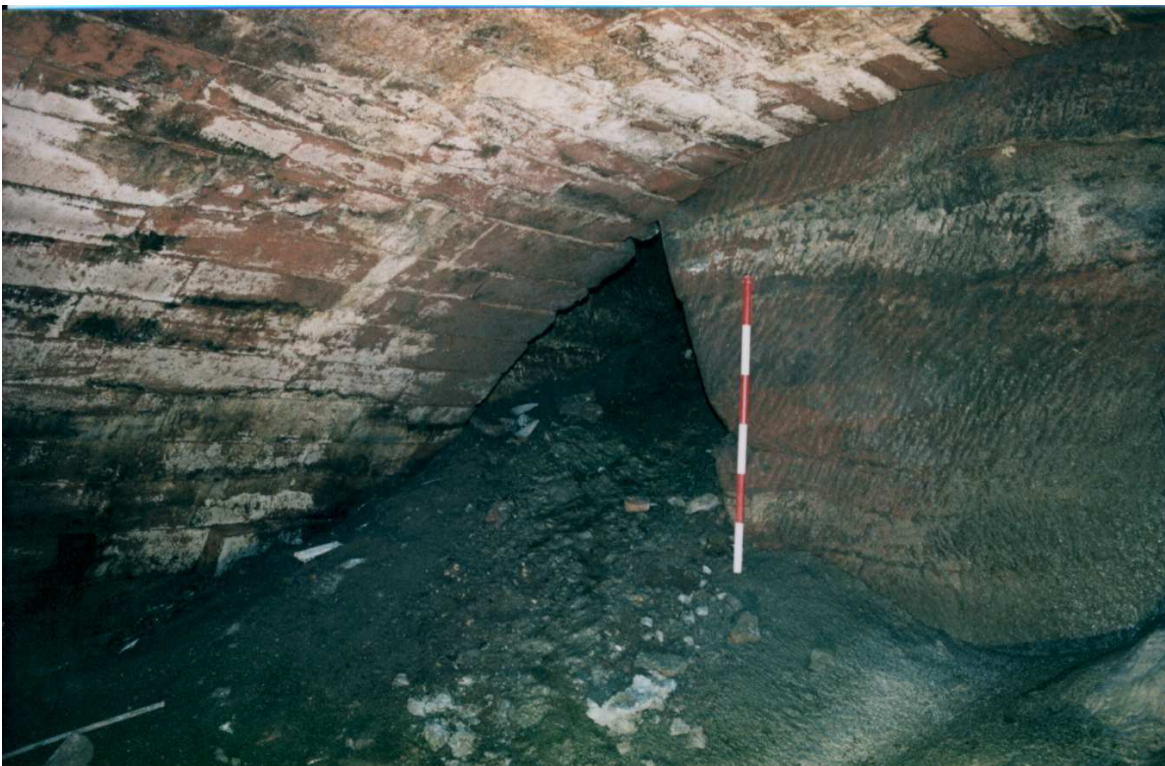
Plate 10 Tunnel 10, entrance to the northern passage after piling – looking east

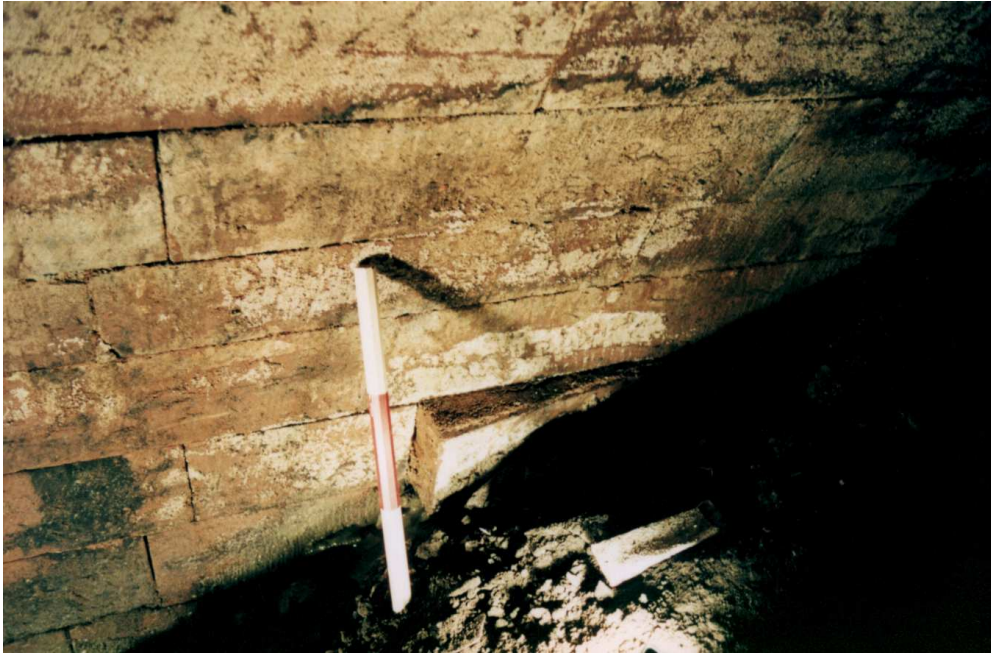
The piling slightly dislodged one of the lower sandstone blocks in the southern tunnel (10), and some pieces of sandstone bedrock were dislodged into the entrance of a small dead end passage at the end of this tunnel.

Plate 11 Dislodged block on the north side of Tunnel 10

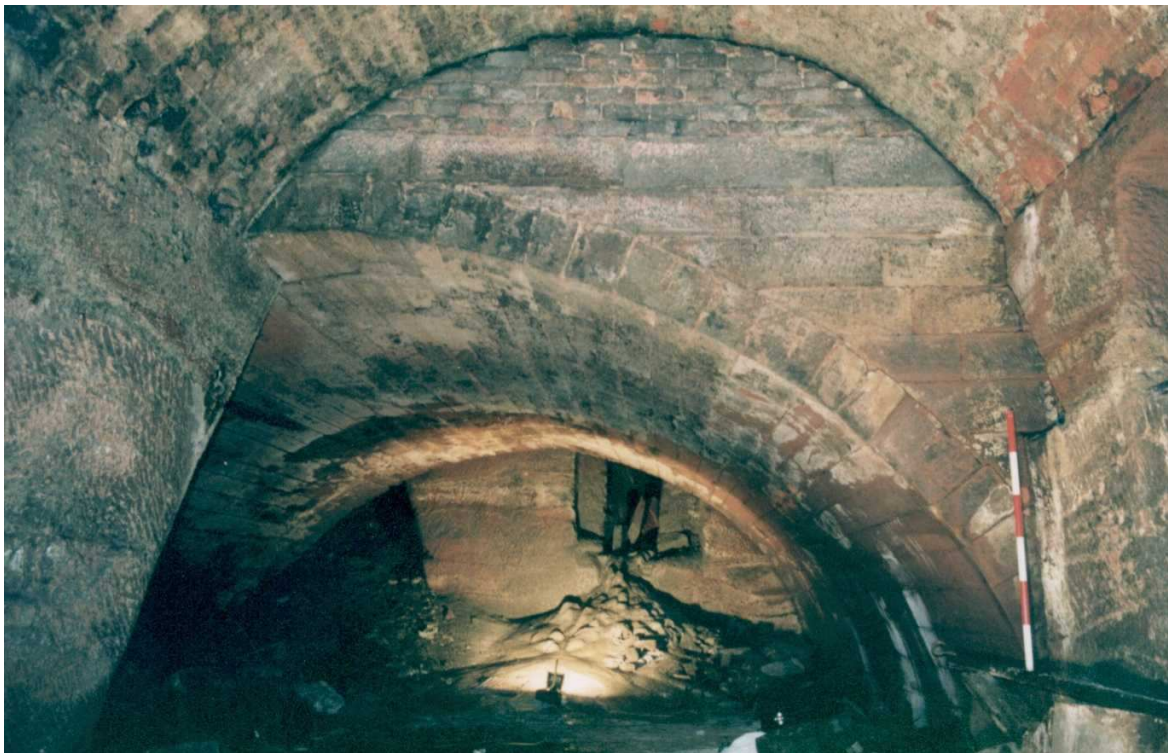
- 1.3.5 Constructed on top of the main tunnel vault is a second wide brick vault, but is accessible only from the eastern, internal end of the lower vault (Plate 12). A large section of the eastern end of the upper vault brickwork has collapsed, and a substantial tip of earth silt, broken glass bottles and other material has spread over the top of the lower vault.

Plate 12 General view of the Tunnel 10 and passages, post piling – looking east

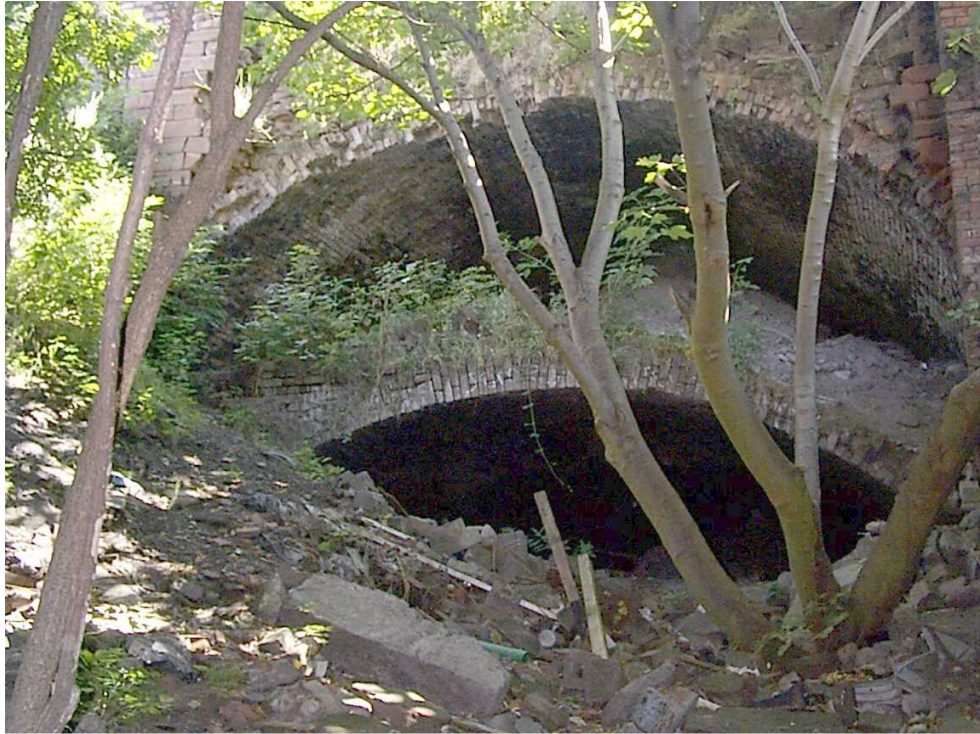
Plate 13 Entrance to double tunnel 9 – looking east

- 1.3.7 **Tunnel 9:** the northern tunnel (Tunnel 9; Fig 2) (known as the double tunnel) consists of a broad rock cutting with superimposed brick arches. Stonehouse on his plan (LRO 942 570 1/3) describes it as '*two tiers of vaults in a frightful labyrinth filled in*'. The apex of the top arch is relatively close to the existing ground surface and has fallen, or been broken through, causing a cone of spoil/building rubble to accumulate on top of the lower arch. This tunnel is also thought to continue beyond the boundary of the site, and to be connected with further tunnels. There is no visible direct connection with the north/south Tunnel 7, which is at a much lower level than either 9 and 10; it is possible that there is a deeper section of Tunnel 9, which although now buried, originally allowed a connection with Tunnel 7.

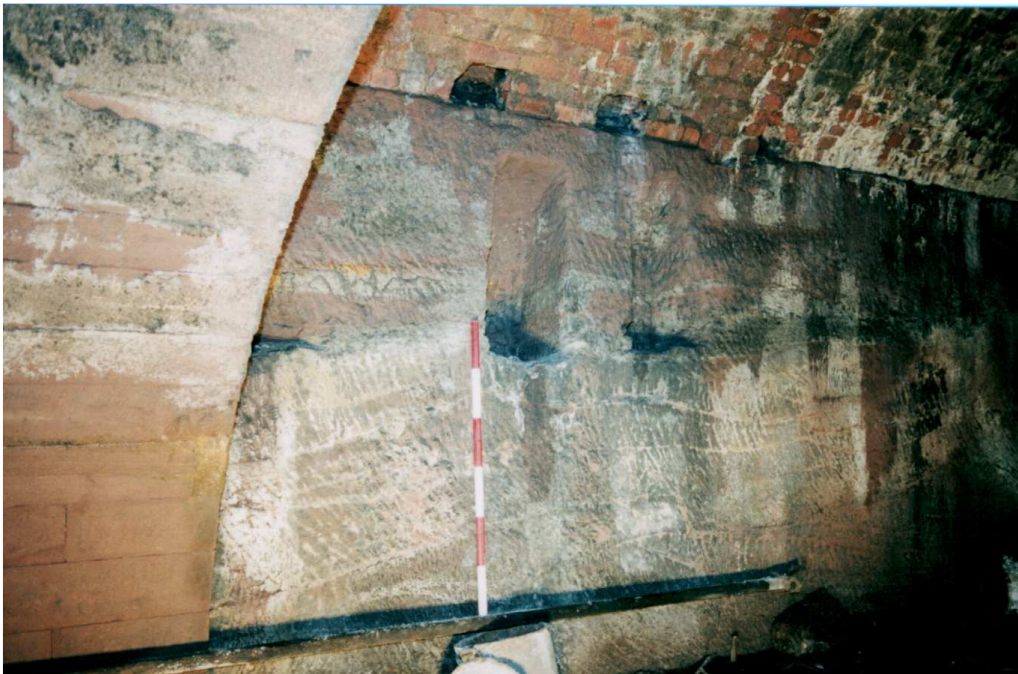
Plate 14 Arch former sockets in the south side of Tunnel 10

- 1.3.3 **Tunnel 10:** the southern tunnel (Tunnel 10, Fig 2) consists of a 20m long, 4.4m wide cut into the sandstone bedrock with a brick vault sprung from ledges at the top of the rock cutting. There are irregularly spaced sockets in the sides, which would have held

the wooden arch former for the vaulting. At its eastern end the tunnel widens to the north to a width of 7m and changes to a broad arch, constructed with large rectangular sandstone blocks. At the base of the vault, sockets for the arch former can be seen.

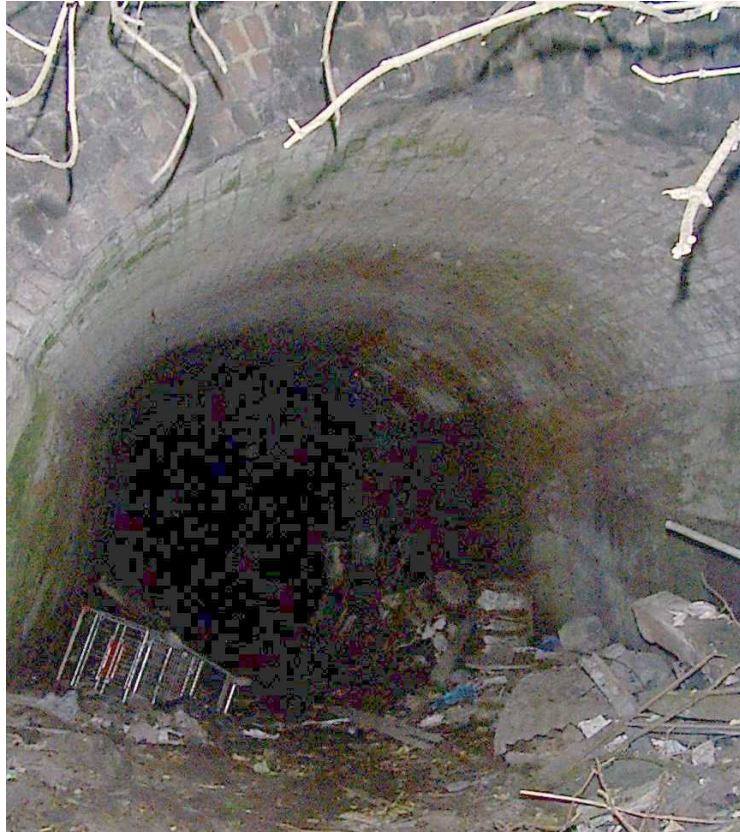
Plate 15 Entrance to Tunnel 10 – looking east
