**KEEKLE HEAD OPEN CAST
COAL SITE
CUMBRIA**

Archaeological Survey and Evaluation Report

Report no 1998-99/(016)/7832

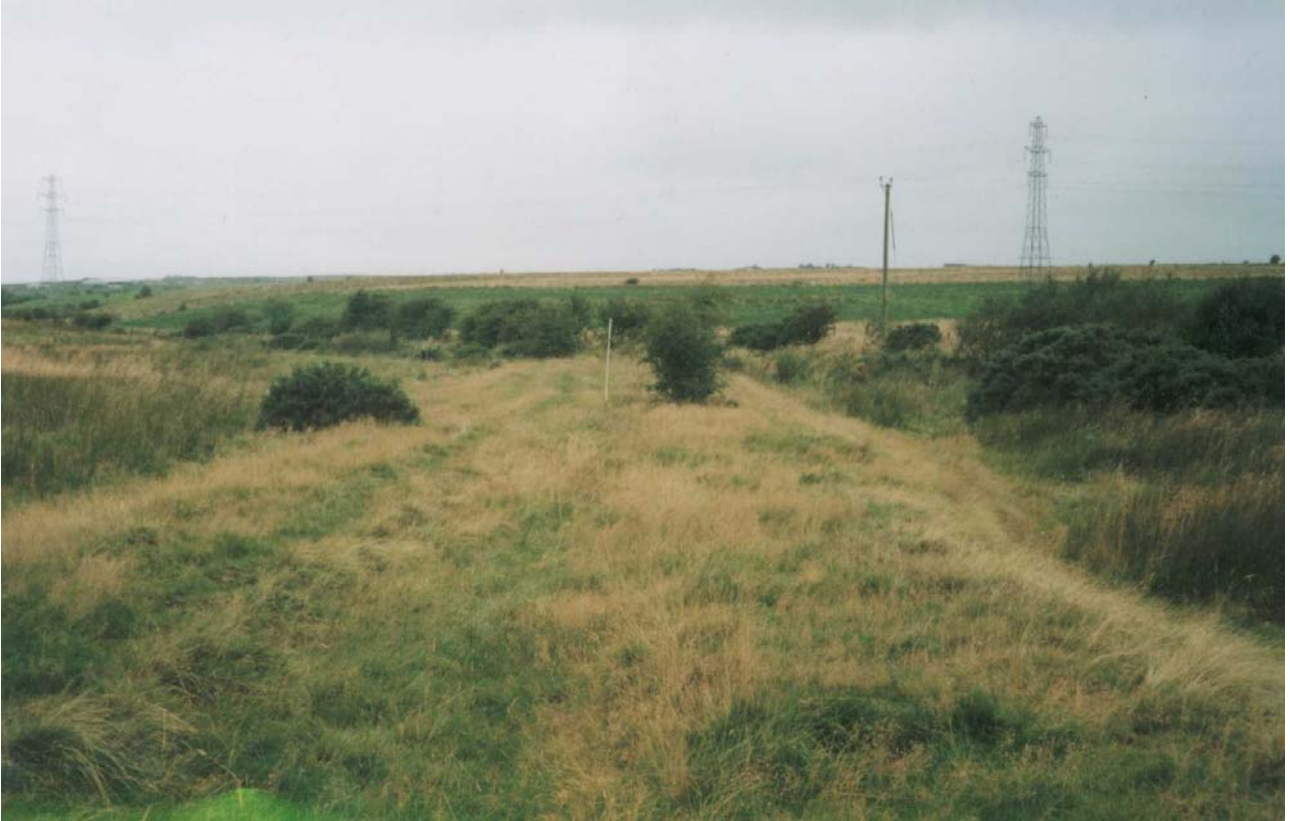
Plate 1 Venture Pit Tramway (Site 22.1)

- 3.3.7 **Tramway (Site 22.1):** the tramway (22.1) extended north-west from the Venture Pit to a crossing point of the River Keekle and then due north up to the road, following the line of the present field boundary. The northernmost section of the tramway was outside the study area. For the most part the tramway comprised a broad and very prominent, flat topped embankment, which was up to 1.7m high in places, the width of the tramway top was typically c5m and at the base it was c 9.5m. The tramway was almost entirely earthfast, but, localised exposures, particularly at the river crossing, show that it was composed of angular stones and loam interspersed with flecks of coal. It would appear to have been largely constructed of spoil, probably originating from the venture pit. The most prominent sections of the tramway were near the Venture Pit, and it was noticeably less substantial on the northern side of the river crossing. In particular there was one section which was relatively ill-defined (22.1a), to the south of the Wilson Park land holding, where it passes through an area of mire and only short sections of the eastern side of the embankment were discernible.

- 3.3.8 At the river crossing point there was a substantial gap between the two extant terminals of the tramway, which was, in part, a result of water erosion but may also reflect the span of the original bridge. Part of a bridge abutment survived in the northern face of the southern embankment terminal and comprises a short length of large earthfast stones (22.1b); there was, however, no evidence of any abutment on the northern side of the crossing.

- 3.3.9 The section to the south-east of the crossing was extremely well-defined and very prominent. It was extremely broad (9.8m across) and comprises two fairly level parallel tramway surfaces which were separated by a shallow ditch. It is evident that this section at least was intended for two-way traffic. The eastern end of this section of tramway has been cut back by a small stream which leads into the River Keekle to the north (22.1c). No evidence of any deliberate crossing of the stream was observed, and it would appear, therefore, that any bridge or conduit remains have been eroded away.

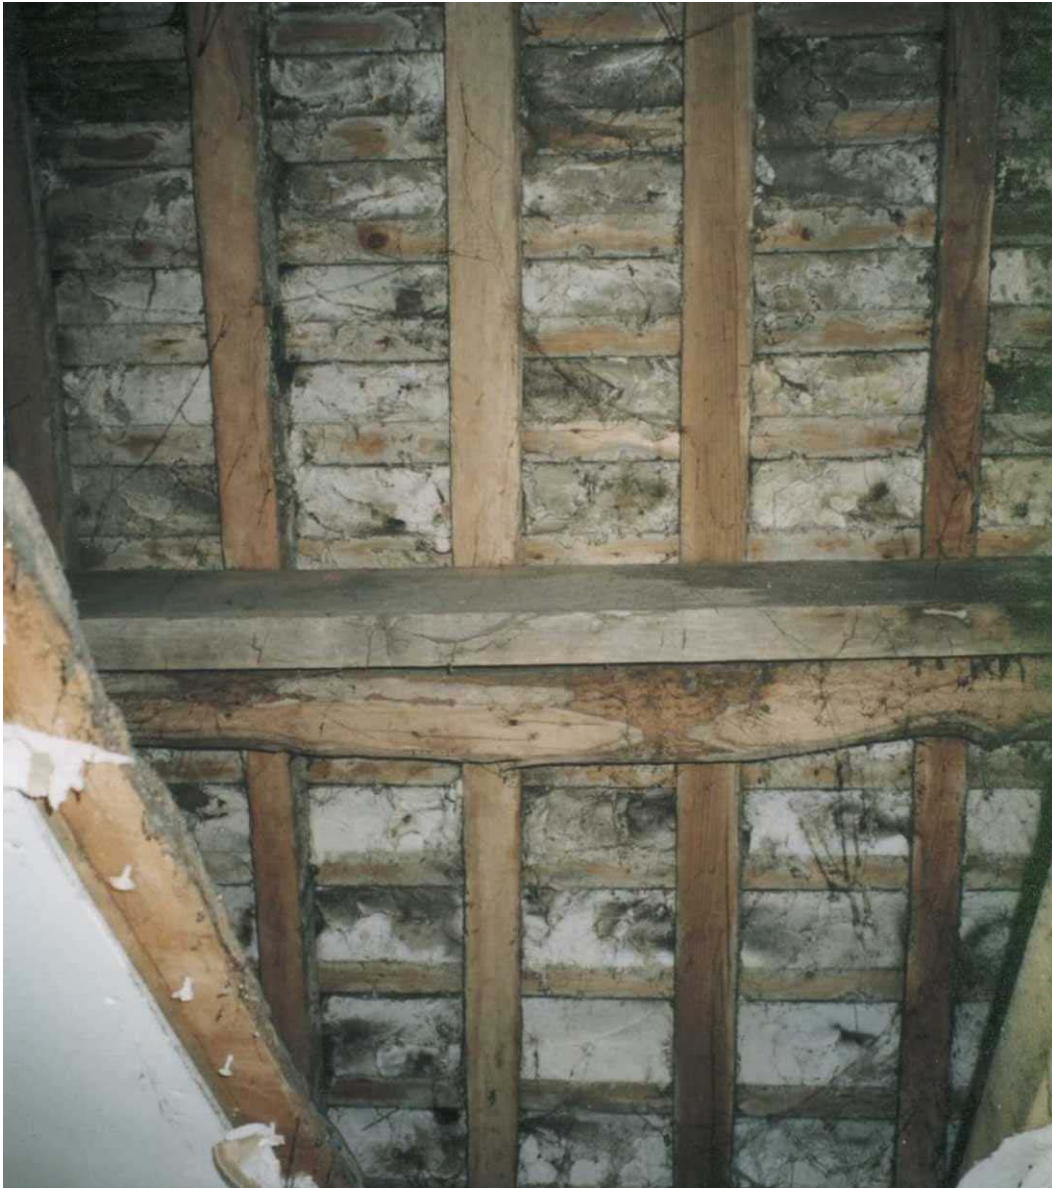
Plate 5 Sandbeds Farmhouse Roof, Showing Rough Sawn Purlin

4.2.10 **Farmhouse Roof Structure:** the roof of the farmhouse comprised a series of two side purlins to each side of a central ridge purlin, supported by the existing wall structure at either extreme and by the internal partition walls which extended above the level of the first floor ceiling. There were no trusses within the farmhouse, instead the purlins were supported by the gable and internal walls. The roof had been subject to recent repair with large-scale replacement of the original timbers; the recent timbers were generally of machine cut timber with little evidence of decay suggesting a recent date for insertion. Only one original timber was encountered and this was a roughly sawn purlin which had a sinuous shape, that reflected the shape of the original tree from which it was cut.
