Land adjacent to  
The Royal Oak, Blackthorn,  
Oxfordshire

Archaeological Watching Brief  
NGR 6228 1934

Oxford Archaeological Unit  
May 1996

## ARCHAEOLOGICAL WATCHING BRIEF REPORT

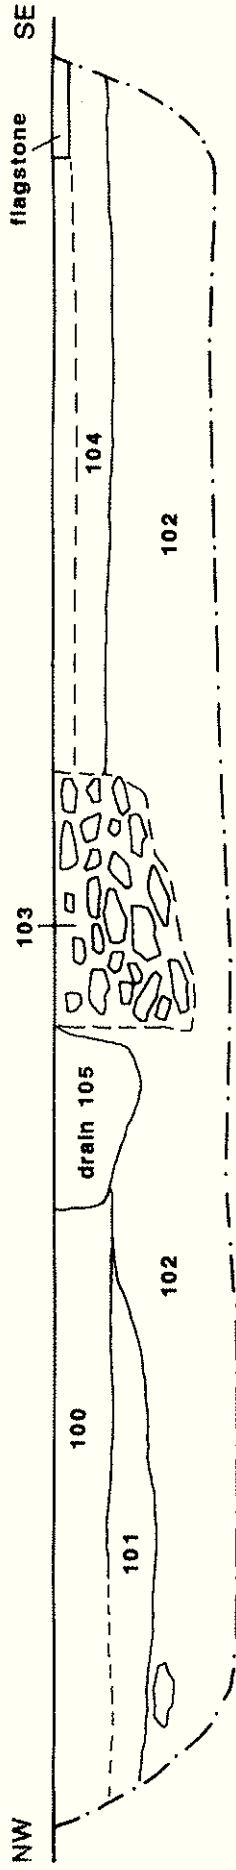
trench 7 section 1

The section showed the mid grey alluvial clay (102) cut by the construction of the wall footing (103), 0.80 m wide and 0.45 m deep. The interior of the building, south-east of the wall showed a flagstone floor resting on a rubble and brown clay make up layer (104), which itself overlaid 102. A fragment of clay pipe stem and a sherd of salt glazed 18th century pottery were recovered from the matrix of the wall context (103)

To the north-west of the wall the alluvial layer 102 was overlaid by a layer of pale brown clay (101), and the modern topsoil (100). Adjacent to the wall was a modern drain trench (105).

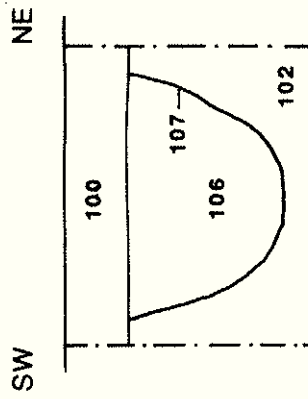
trench 8 section 2

The drainage trench was excavated to a depth of approximately 1.0 m at the N part of the site, shallowing to approximately 0.70 m at the south-east end of the site. Apart from the footing of Regina cottage, and the edge of the evaluation Trench 1, no archaeological features were noted in the main length of trench. In the section of the branch leading to Plot 2 a small feature was identified, probably a pit, cut into the brown alluvial clay (102) with a fill of dark grey brown silty clay. Two sherds of sand tempered 12th/13th century pottery were recovered from this fill.

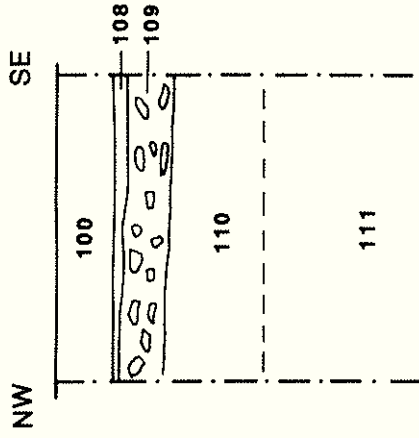
trench 9 section 3

Deposits in this profile section are similar to those seen in evaluation trench 4. A layer of stiff yellowish clay (111) was overlaid by a grey silty clay layer 0.30 m deep (110) [4/9]. This was overlaid by a 0.15 m deep layer of mixed limestone rubble and orange-brown sandy clay (109) [4/13]. This in turn was sealed by a thin layer of dark grey silty clay (108) [4/4] and a disturbed topsoil (100). The evaluation concluded that the layer 4/13 represented the make up or consolidation for a floor or yard surface. If so, the surface apparently extended at least three metres to the north-east. However, no dating material was recovered from these deposits during the watching brief, so the original conclusion that this represented post-medieval activity stands.
