September 1995

**KIRKBY STEPHEN BYPASS**  
**Cumbria**

**Archaeological Evaluation**

**Cumbria County Council**

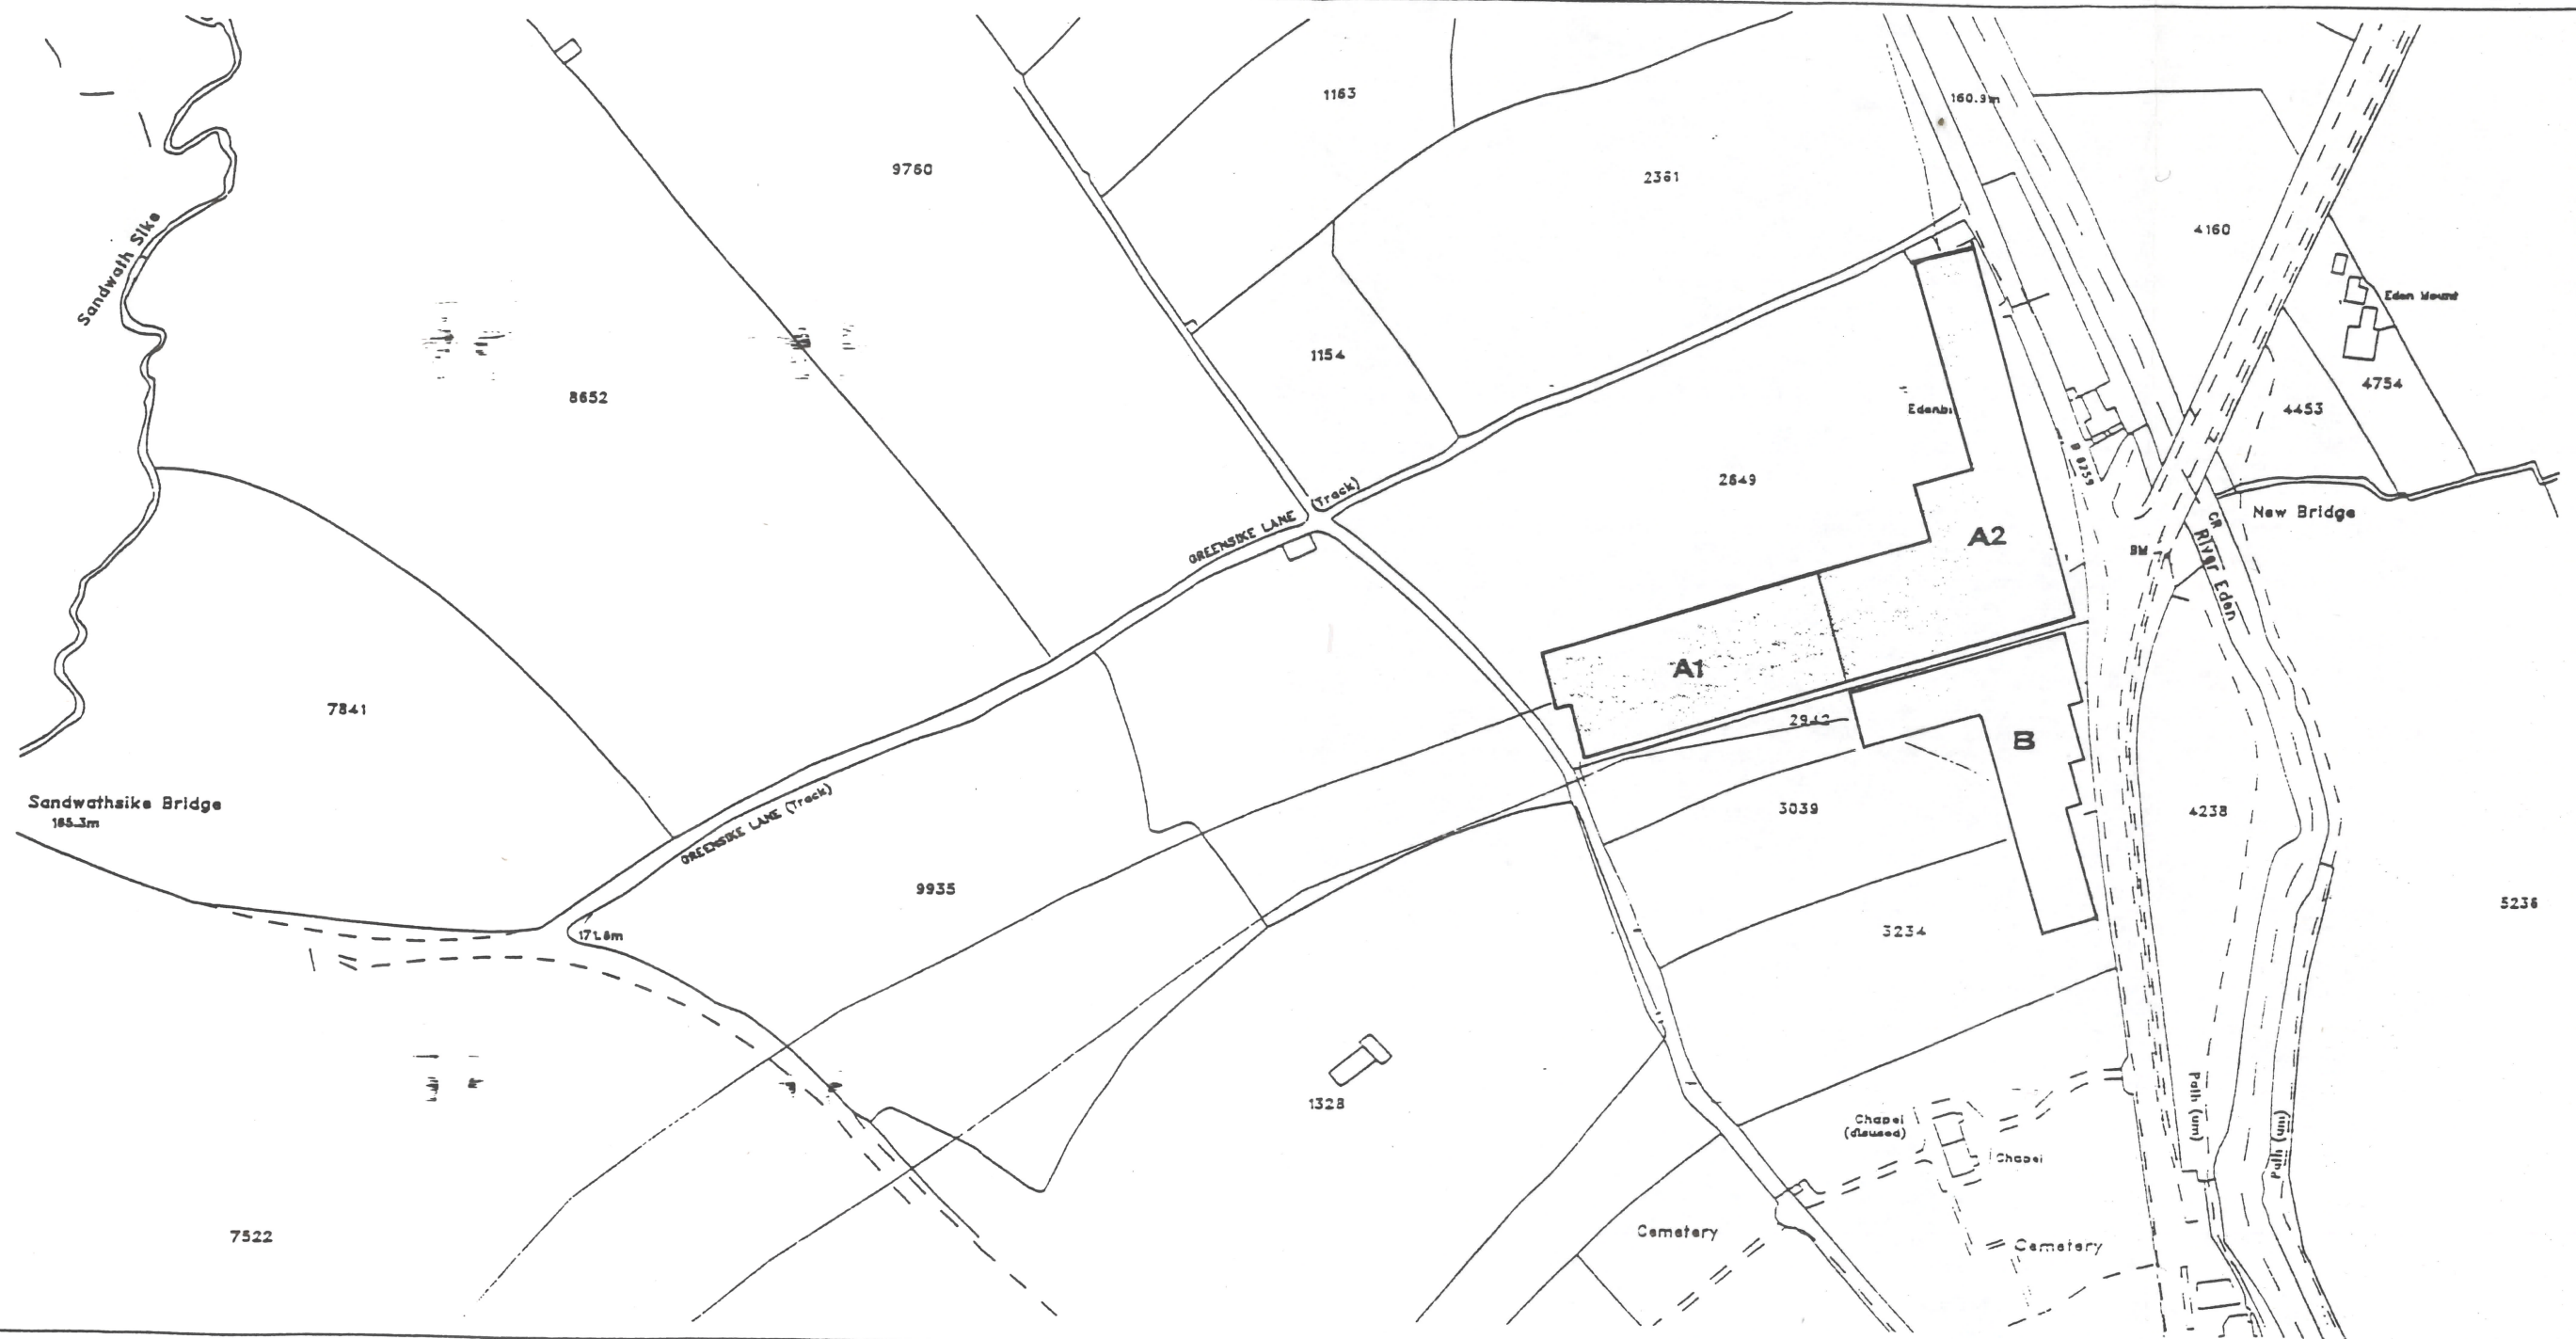
FIGURE 2

Bradford. The area was sub-divided by a hedge, and was surveyed as two blocks. The location of these areas, A and B, is shown in Figure 2 at a scale of 1:2500. The survey grid was established by Geophysical Surveys of Bradford, and tied in by staff of LUAU. Conditions were suitable for survey with the ground being gently undulating and under pasture.

## Location of Survey Areas

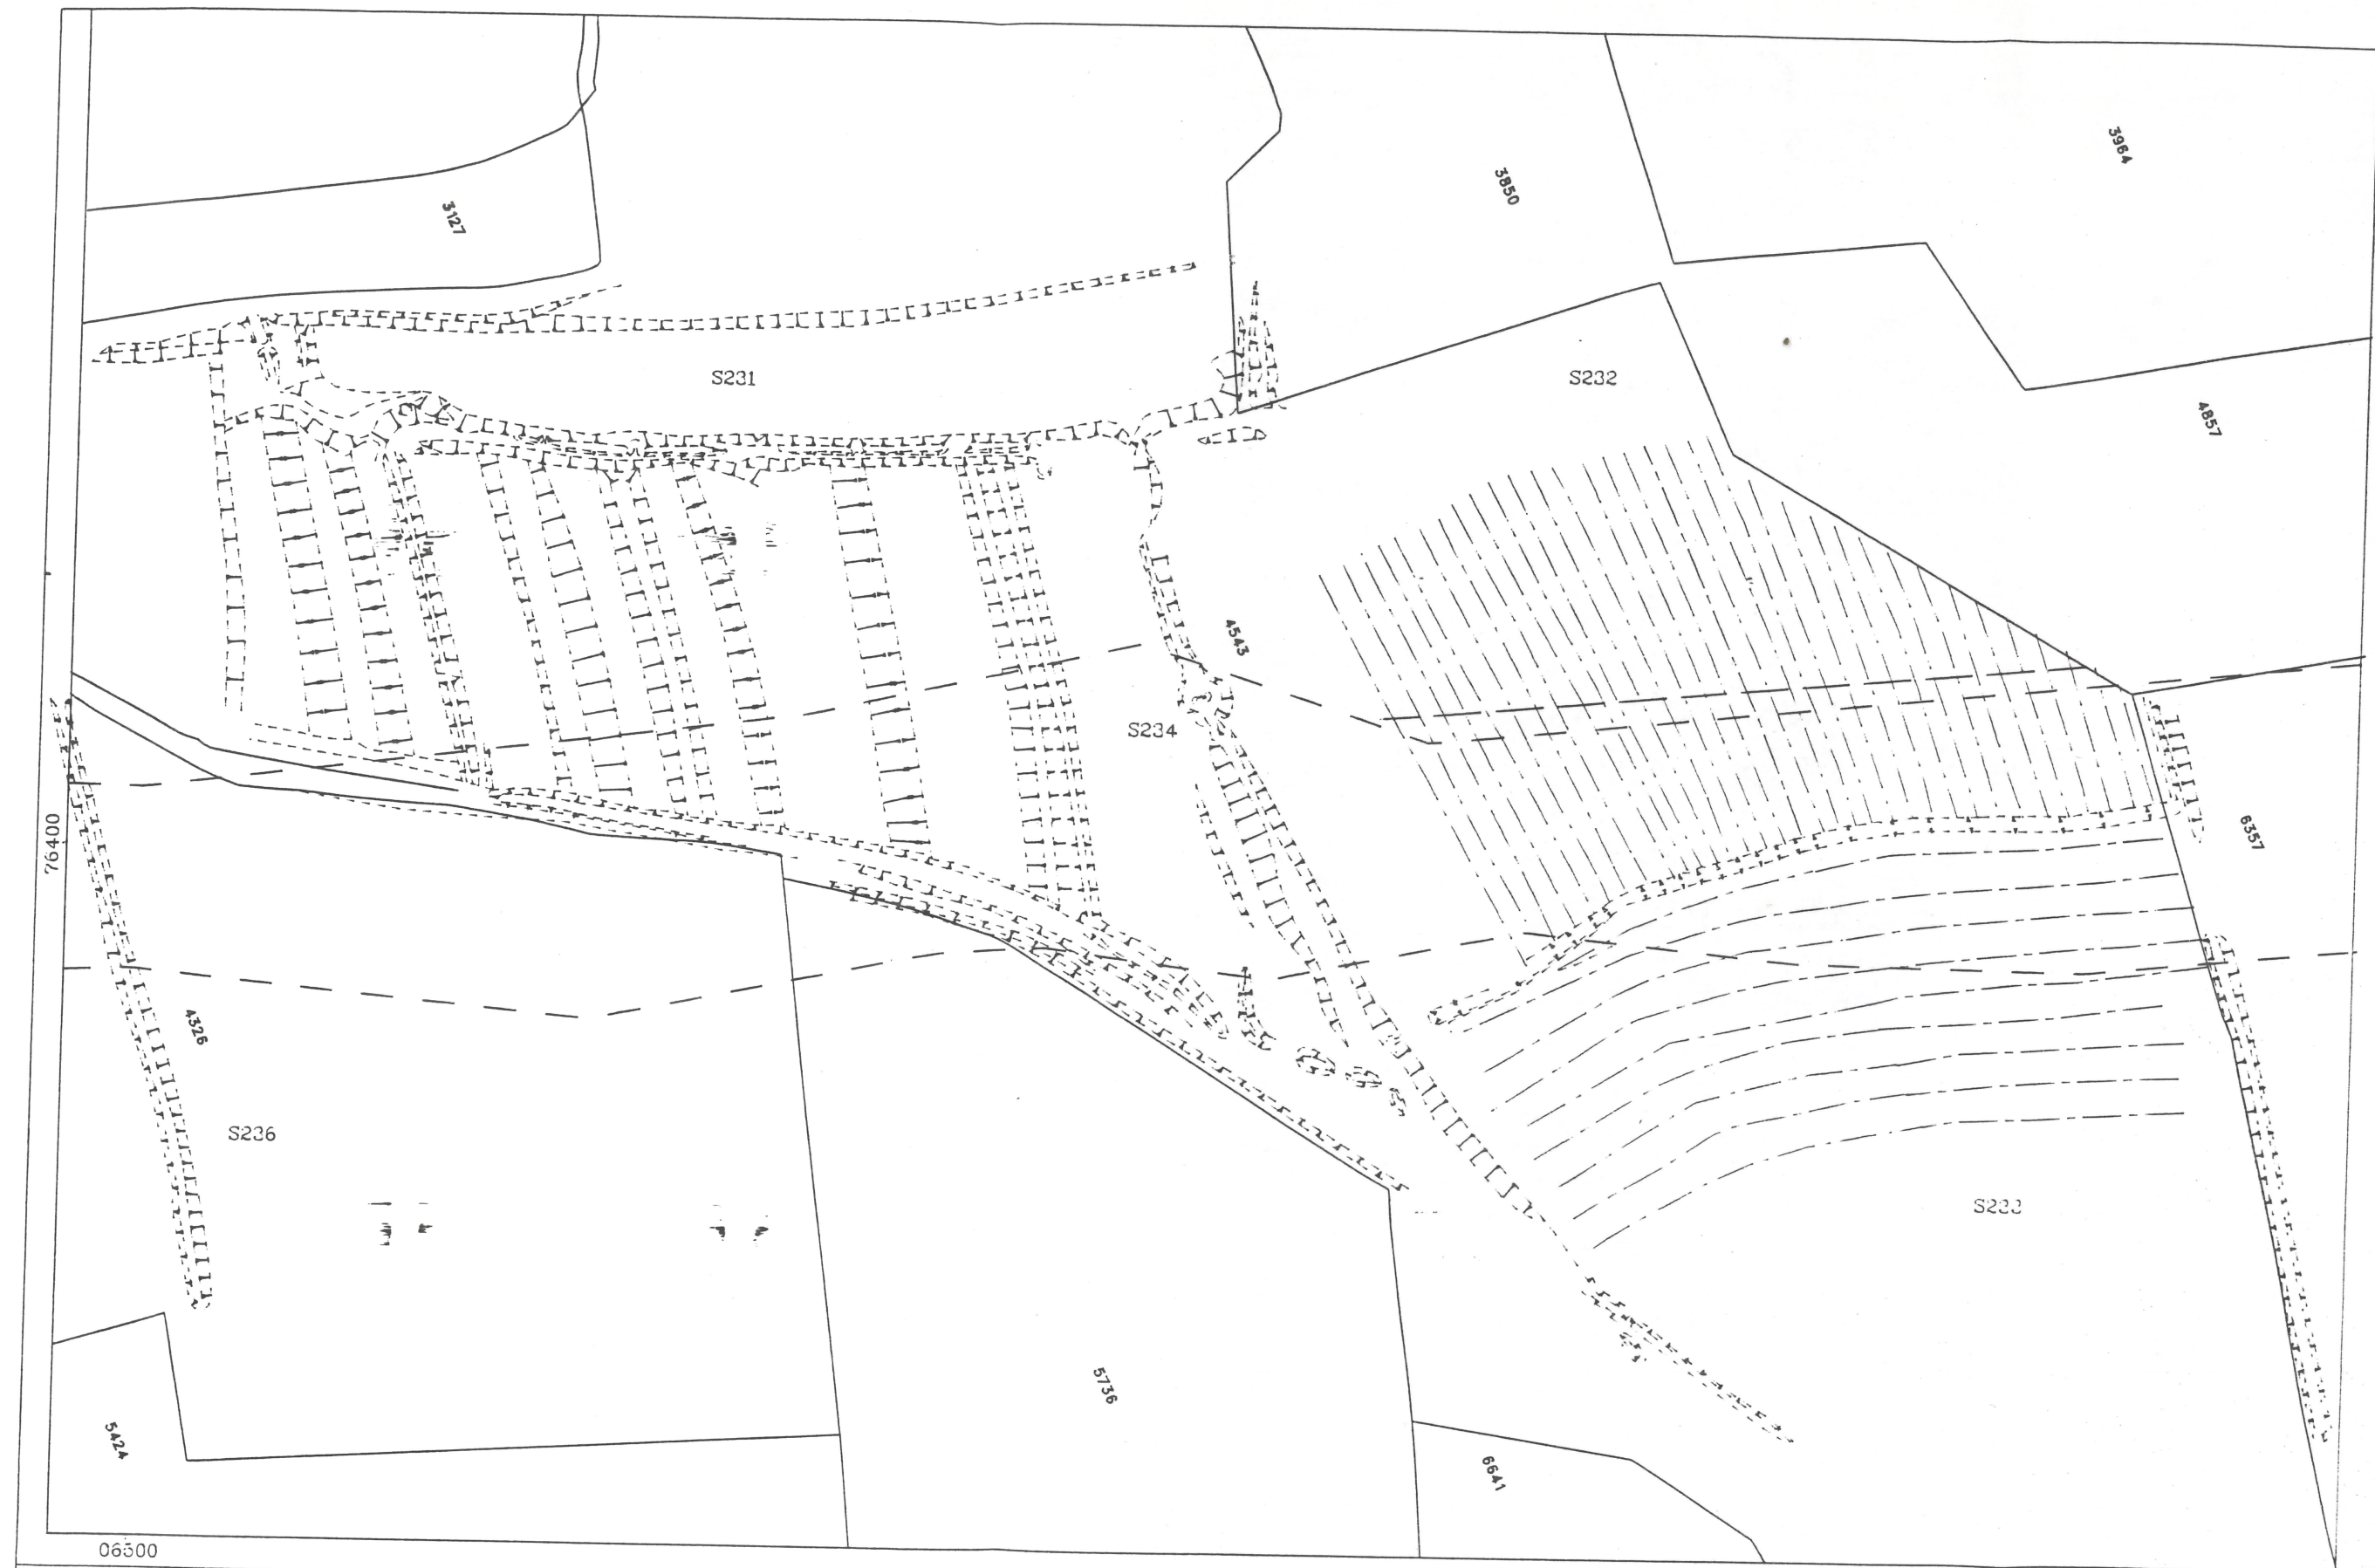
SCALE 1:1000  
FIGURE 18

PLAN NAME  
SITES 231, 232, 233  
234, 236

Sites 231 and 237 area field containing remarkable lynchet system. The corridor extends through the eastern section of site 231 and through the middle of site 237 and will result in significant destruction to the field system. The damage should be minimised by narrowing the corridor where possible.

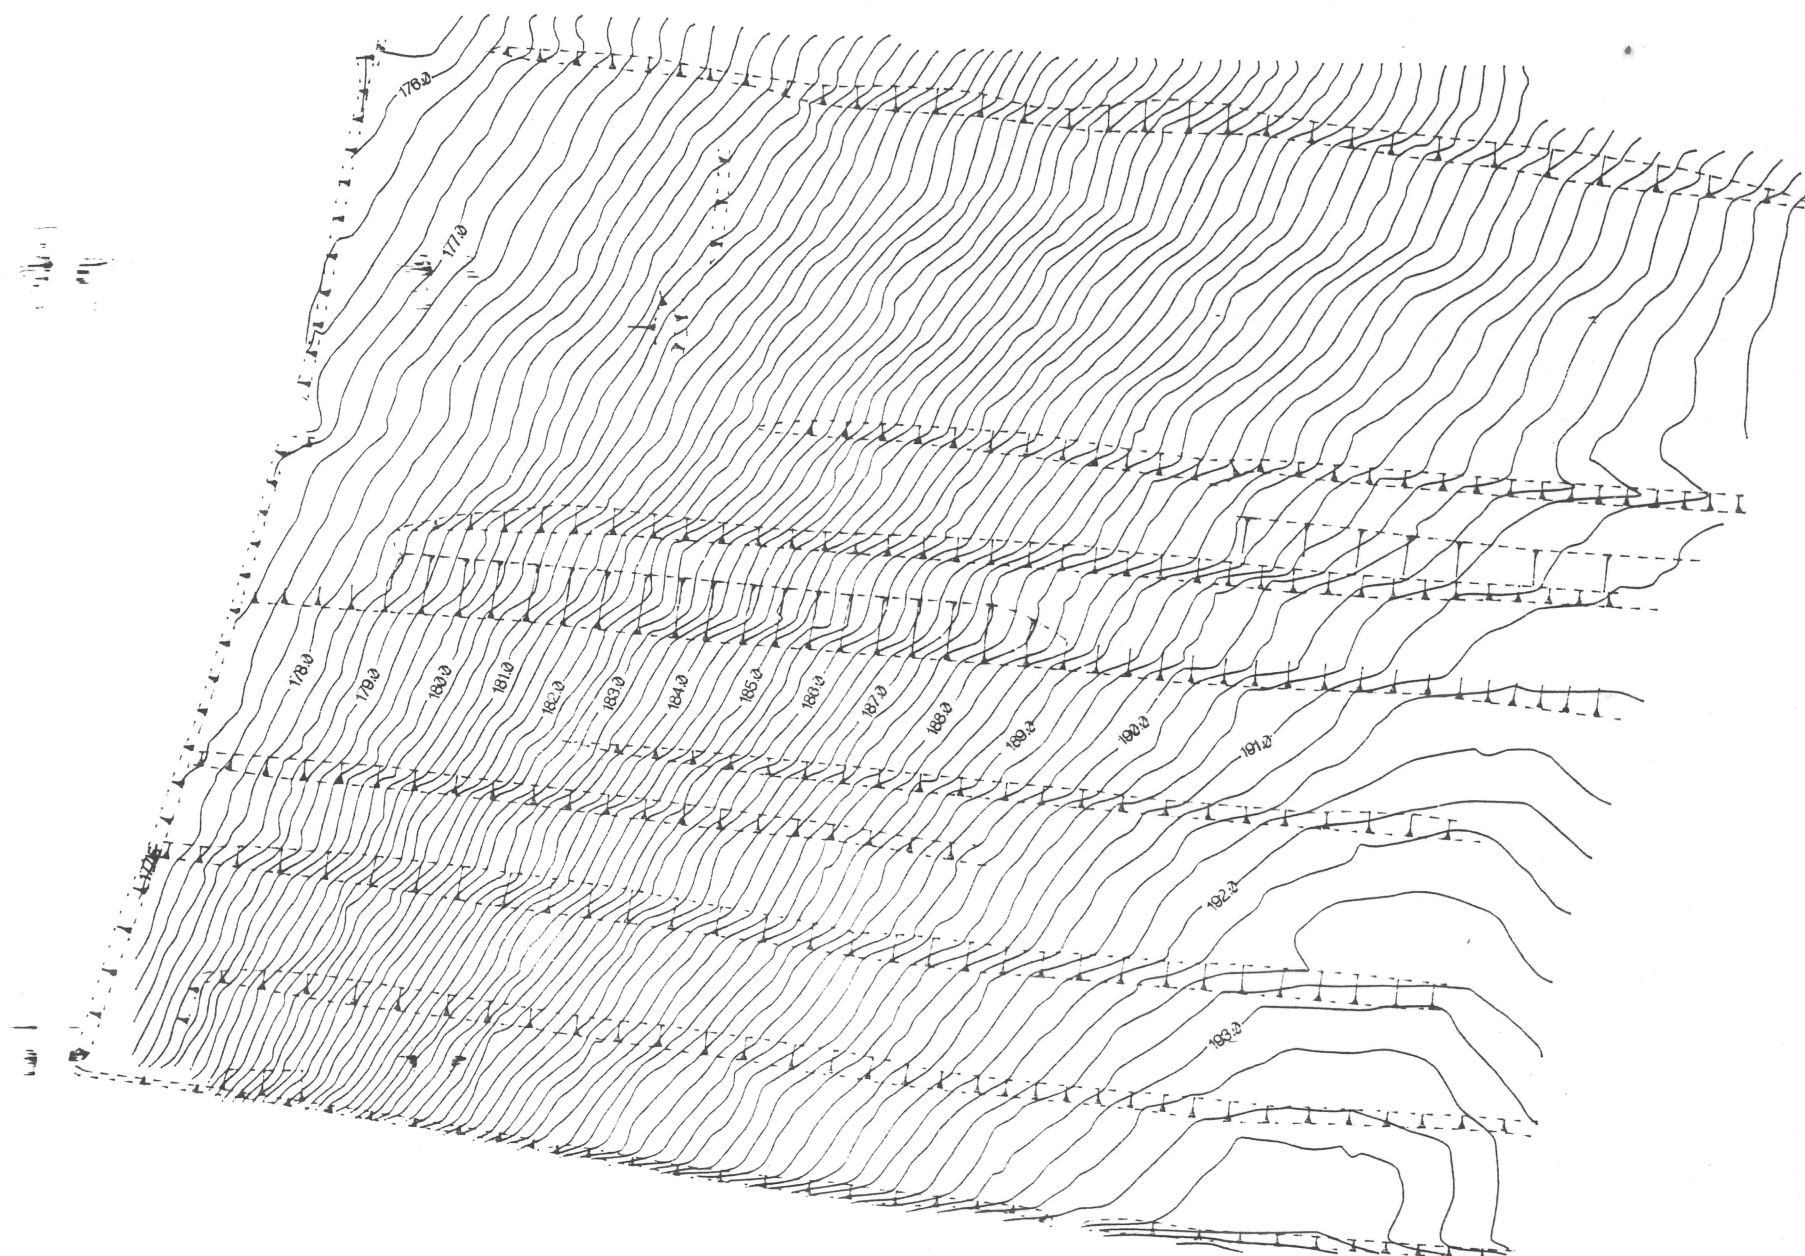
FIGURE 27

Site 237 reflects a further strip lynchets field, where again the lynchets are orientated down-slope. The separation between the lynchets is however slightly narrower, being only about 10m. The profile is not as distinct as those of site 231, which may reflect degradation of the earthworks by subsequent ploughing, particularly at the crown of the hill. Significantly two of the lynchets could not be identified by visual observation because of vegetation obscuration, but were mapped by the full contour system.
