# ST CATHERINE'S WINDERMERE CUMBRIA

# Historic Landscape Survey

**Oxford Archaeology North**

February 2005

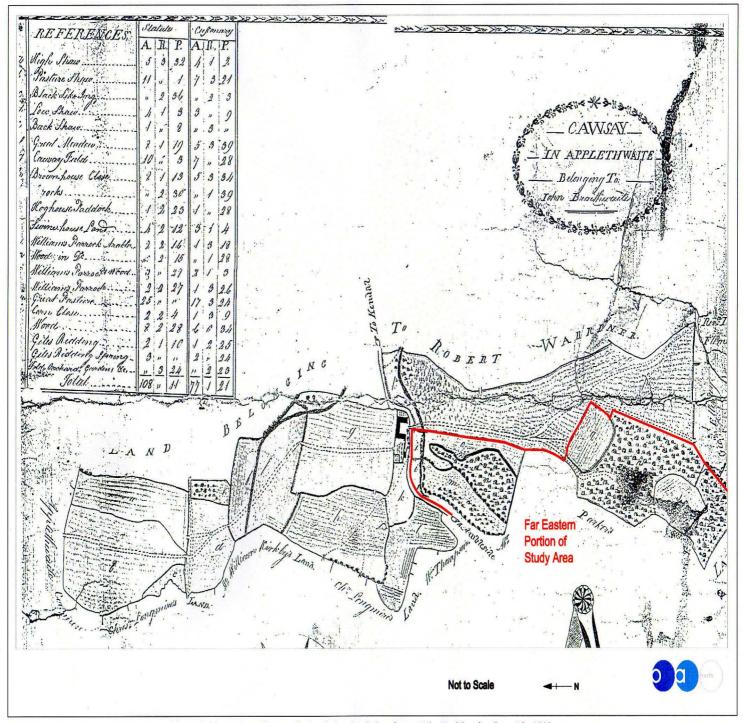
Figure 3: Estate map, Cawsay, in Applethwaite, belonging to John Braithwaite, June 4th, 1802

- 4.3.2 Causeway Estate Map 1802 (CRO(K) UncataloguedWD/NT): this map was produced for the Braithwaite family who owned the easternmost portion of what is now the St Catherine's Estate (Fig 3). The map names Mr Parker as being the owner of St Catherine's to the west. The fields to the north of the current estate are shown as being managed as pasture and woodland and survive like this today. What is more interesting are the southernmost fields. There are two enclosures of woodland and two smaller open fields called 'corn close' and 'hoghouse paddock'. This area in the south has subsequently been

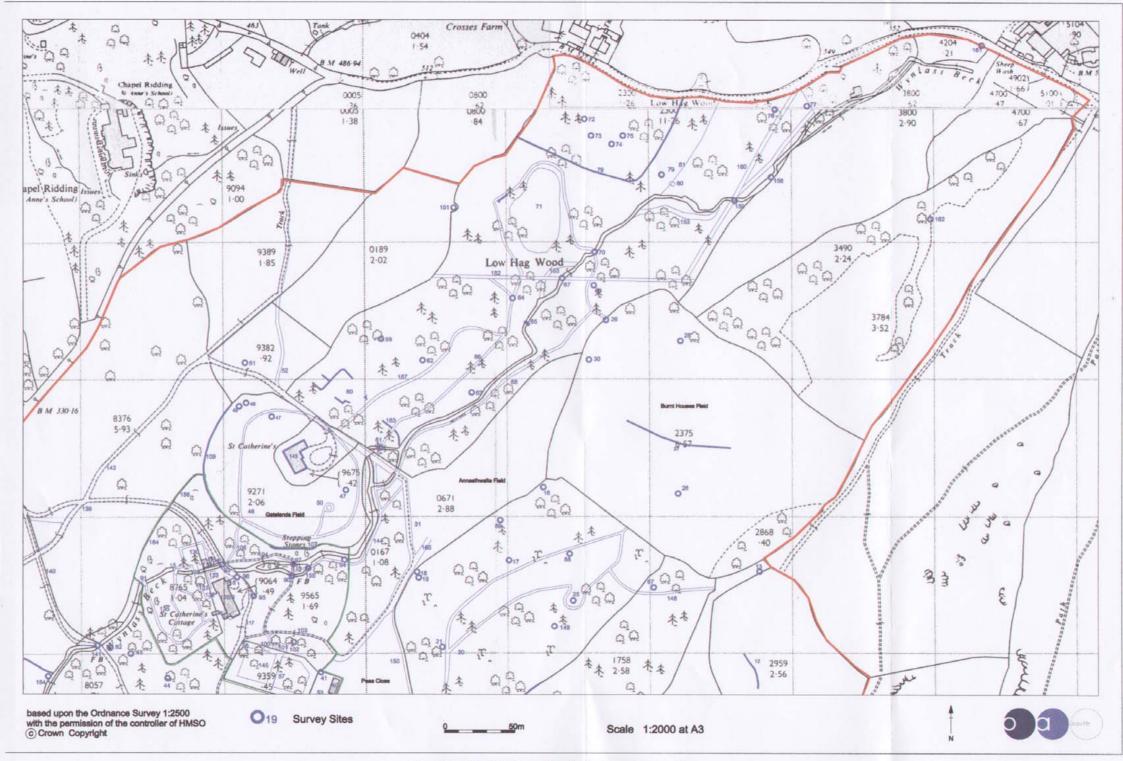
Figure 8: St Catherine's Estate, Identification Survey Map (North)

5.1.1 The identification survey was conducted throughout the entire extent of the St Catherine's Estate in order to both check the survival of features and structures observed in the documentary study and to identify new, previously unrecorded, monuments; including any formal garden features. The survey identified many new sites and these are discussed by theme and general area within the estate below, and are shown on Figures 8 and 9. Sites identified within the main garden complex (Fig 12) have been subject to an intensive topographic garden survey and, as such, are discussed in *Section 8*.

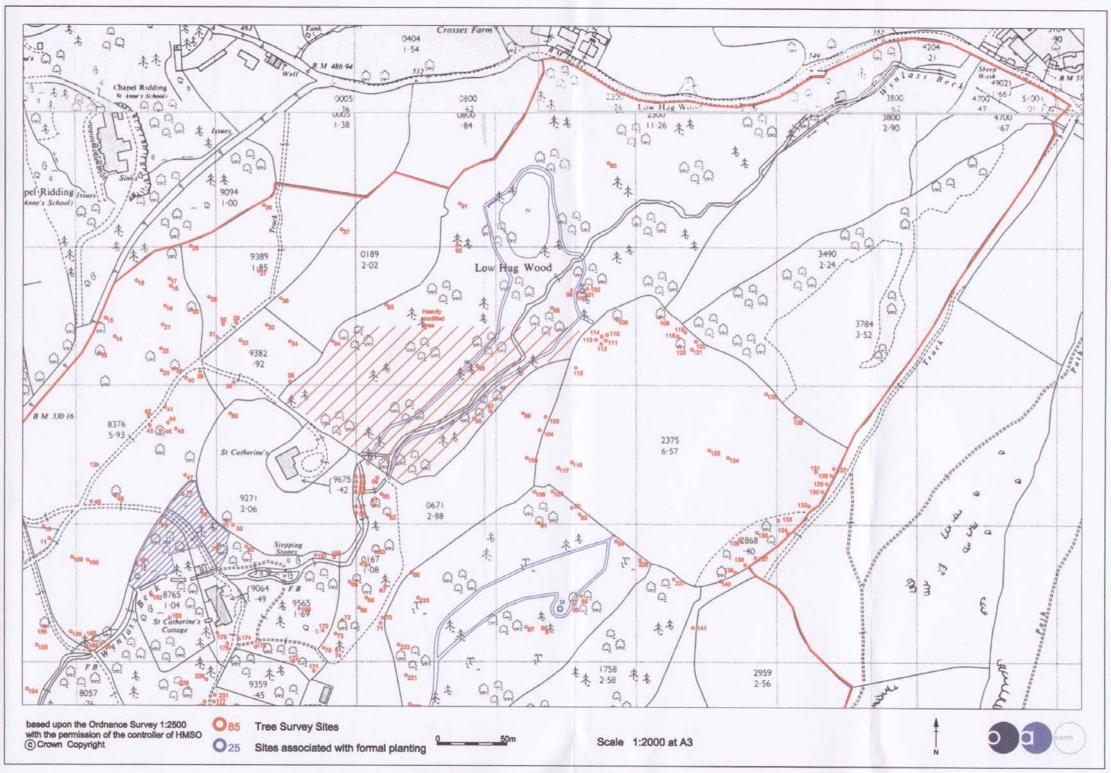
Figure 10: St Catherine's Estate, Tree Survey Map (North)

- 6.2.5 Pasture trees: the open pasture fields within the estate are mainly located to the east of Low and High Hag Woods. The majority of surviving trees are oak trees, although several examples of sycamore, rowan and beech are evident. The Burnt Houses Field is encircled by numerous extant trees and cleared stumps (although not many veteran trees), and it is shown, from the earliest OS mapping (c1860) (Fig 6), to have been an open field which was divided in two by a tree-lined field boundary (Site 27). The field may have, at some point, been woodland and have joined Low and High Hag Woods. To the south of Burnt Houses Field the open fields on the east of the study area were formerly part of the estate belonging to the Braithwaites of Causeway Farm and were seen on the early 1802 estate map (Fig 3) as being predominantly woodland with two cleared enclosures. The woodland and the southernmost enclosure have been cleared but a corner of the southernmost field has surviving veteran oak trees (Site 8; Trees 145-151) which may have once formed part of the woodland.

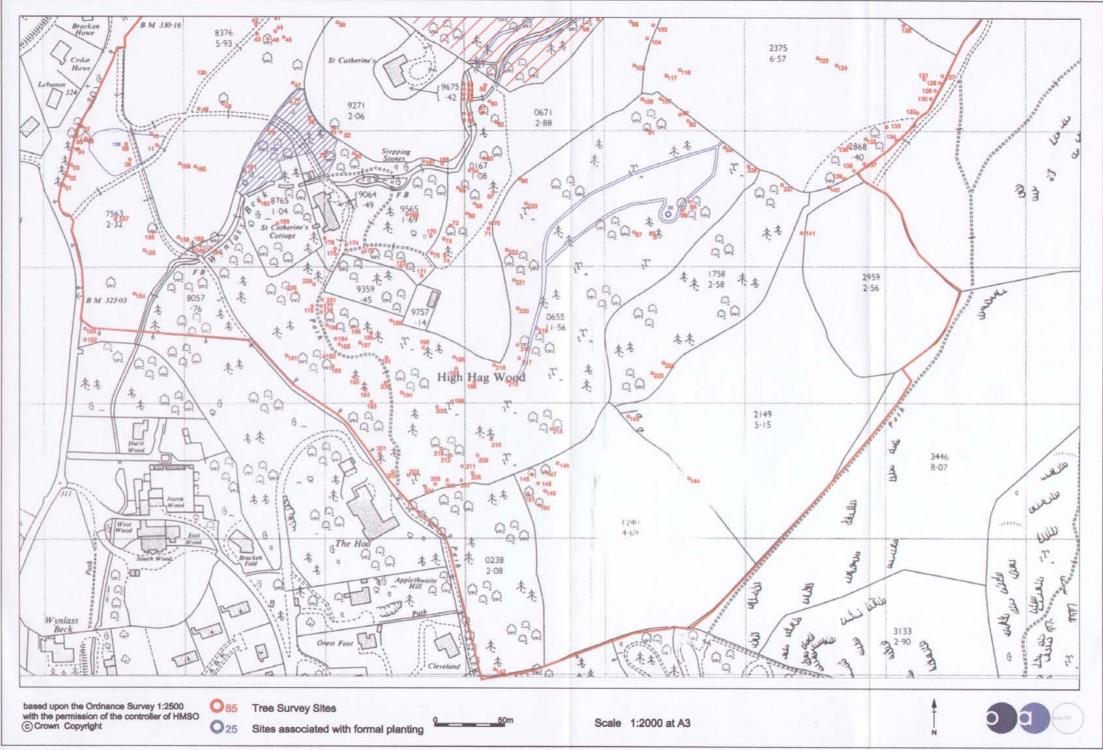
Figure 11: St Catherine's Estate, Tree Survey Map (South)

- 6.2.6 **Woodland trees:** the parkland trees can be divided up into the two main distinctive areas of High Hag and Low Hag Woods. Low Hag Wood has been subject to modern felling within the southern portion of the wood which has consequently affected the interpretation of the surviving trees. There are no obviously veteran trees within the wood and non-native trees are confined to dispersed examples of norway spruce (Trees 93-97). There is evidence that some of the native trees within the wood have been managed and pollarded, the most impressive of these is a clump of plane trees found within the wall gap on the eastern side of the wood (Site **158**). The only possible formal

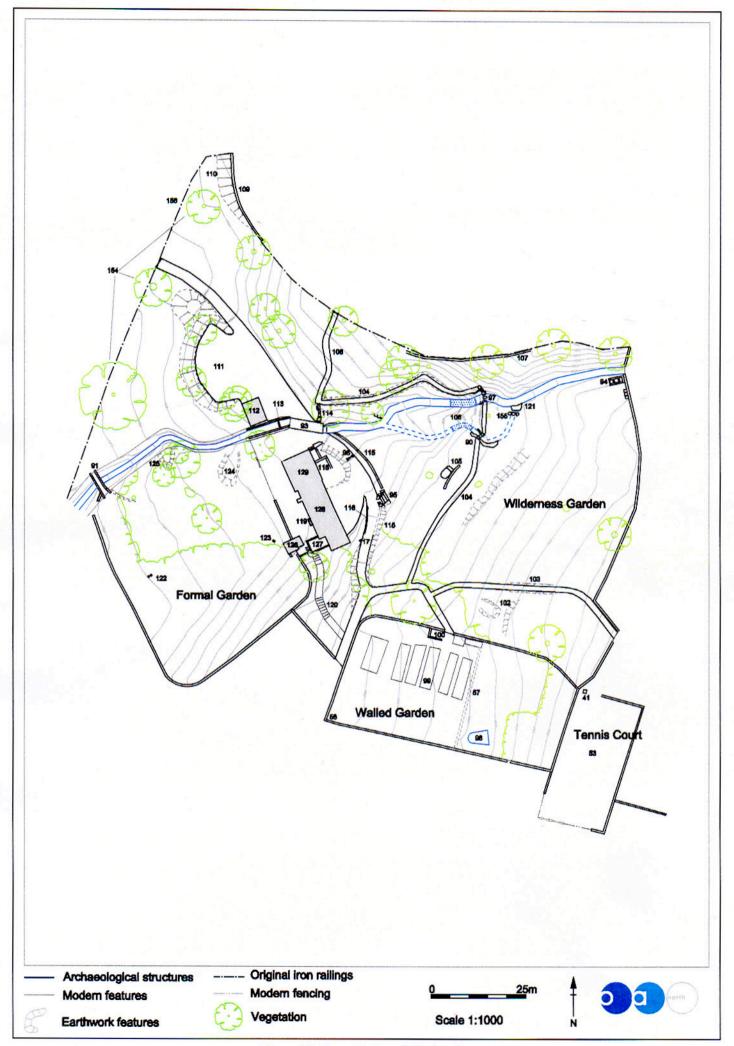
Figure 12: Overall plan of Garden Survey

- 7.2.1 The main complex of buildings at St Catherine's are located in a cluster, slightly off centre within the overall garden complex and sat on the west side of the carriageway running into the garden. The main cottage Orneé has been demolished and the foundations are covered by the current National Trust car park. Likewise, the kitchen range of buildings has been demolished and on the site there is now a re-used section of iron railing fence. The surviving coach house/stable block (Sites 128/129) is skirted by a small narrow yard on its west side. The yard is gravel covered but in the south, between two ancillary buildings (Sites 126/127), evidence of earlier cobbling is visible. The eastern side of the house is skirted by the gravel covered carriageway (Site 117) that continues in a southerly direction (through an iron gate - Site 96) to give access to pathways and farm tracks. There is a small open yard on this northeastern side of the house giving access to the first floor living accommodation and there is a relatively large rockery/flowerbed on the north-east corner of the coach house.

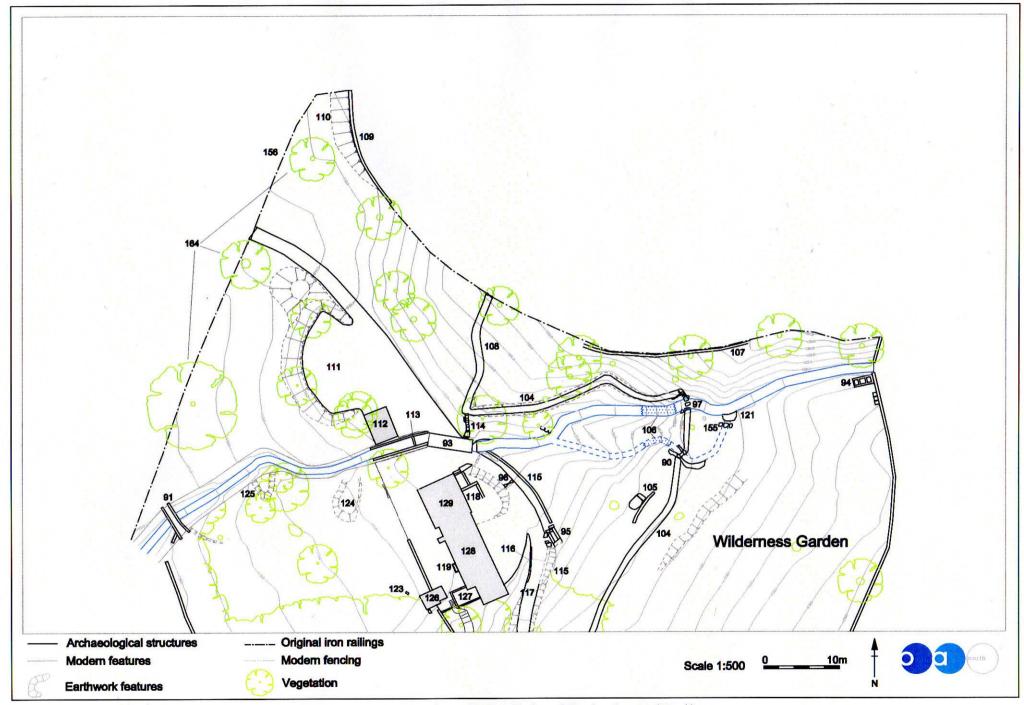
Figure 13: Detail plan of Garden Survey (North)

- 7.4.1 The wilderness garden consists of the eastern half of the core of the garden (excluding the walled garden). It is demarcated on the west by a pathway (Site 108) which separates it from the formal garden, and the eastern boundary of the garden consists of a drystone wall with coping stones on top. The northern boundary consists of a five bar iron railing fence which runs around the edge of Gatelands Field; the fence post-dates an earlier drystone wall foundation (Site 107) that survives in a much denuded and collapsed state.

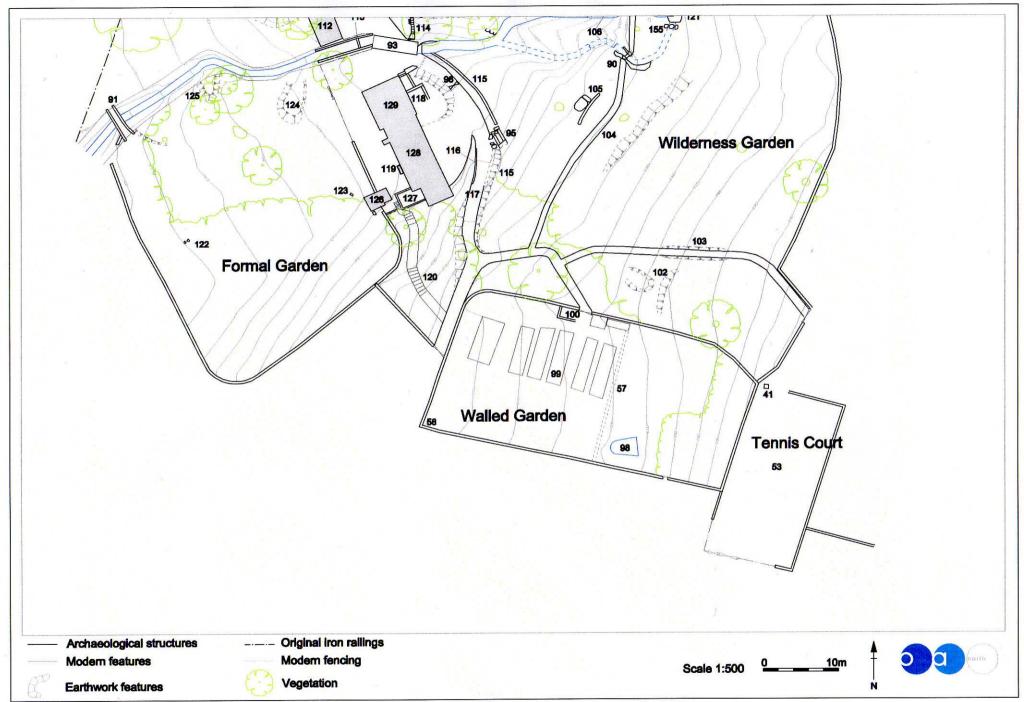
Figure 14: Detail plan of Garden Survey (South)

- 7.4.5 In the centre of the garden the main formal pathway (Site **104**) runs south-west to north-east along an area of possible terracing, which is immediately upslope of the path. The terrace consists of a modified natural stone ridge that is covered in holly bushes; there is a flattened area around the path and the western limit of the terrace consists of a small linear wall foundation. Two modified flat earthfast stones are located on the top break of slope before the ground falls away to the west.

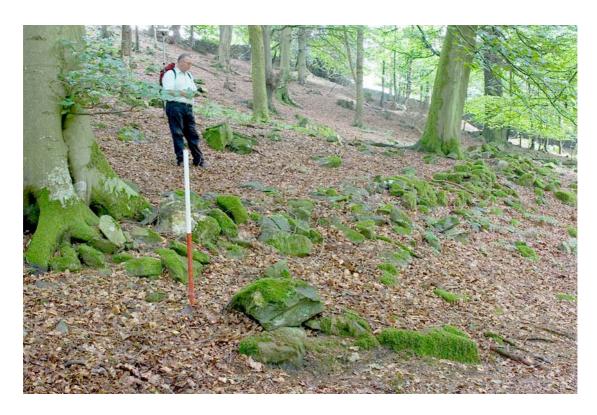
- 5.2.2 Further examples of woodland management features are mostly concentrated in the south-east of the wood and consist of the surviving foundation walls of probable coppicing compartments. The walls survive as linear and curvilinear sections of drystone wall surviving only to foundation level (Sites 24, 32, 36). The boundaries enclose land measuring approximately 120m long east to west by 95m wide which contain three of the charcoal burning platforms (Sites 23, 33 and 37), the first of which is sat astride one of the boundaries (Site 24) (Plate 14). There is no clear association of the coppice compartments with the present drystone walls enclosing the wood as a whole, but it is probable that the walls extended up to the edges of the former coppiced wood. Also it is not clear if the walls were ever constructed to a considerable height or were just used as merely markers of where particular stands of coppice trees ended. Further evidence of boundary markers within the wood include a possible marker cairn (Site 35). Coppied trees are still evident within the wood, and the majority of the best preserved are located in the enclosed woodland on the east side of High Hag Wood. This area was not originally part of the St Catherine's Estate and consists of a surviving portion of woodland which was formerly part of the Causeway Estate; the boundary between the two estates can be seen partially surviving within the woodland (Site 86). The woodland

Plate 14: Coppice compartment wall foundations (Site 24), in High Hag Wood, looking east

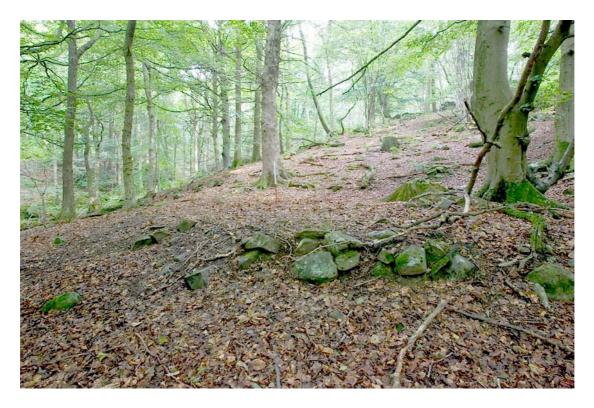
- 5.2.1 Woodland Management: the woodland is particularly rich in extant woodland management features; the most numerous and widespread being charcoal burning platforms. They are distributed widely, for the most part in the north and south-eastern parts of the wood, which strongly suggest that at least some of the formal pathways may be the later reworkings of long established pathways. There are at least nine possible examples of platforms within the wood (Sites 21-23, 33, 37, 43, 45, 88 and 149). The most impressive of these consist of a circular platform measuring approximately 6m in diameter, which has been set into the hillside and is supported by rough stone revetment on the downslope side (eg Site 22, Plate 15). One of the platforms (Site 21) has been crossed by a formal pathway (Site 20, Plate 16), which indicates that the platforms are of at least some antiquity, as the pathway is one of the earliest formal nineteenth century elements within the wood, and that this particular pathway did not previously serve charcoal burning.

Plate 15: Charcoal burning platform (Site 22) in High Hag Wood, looking north

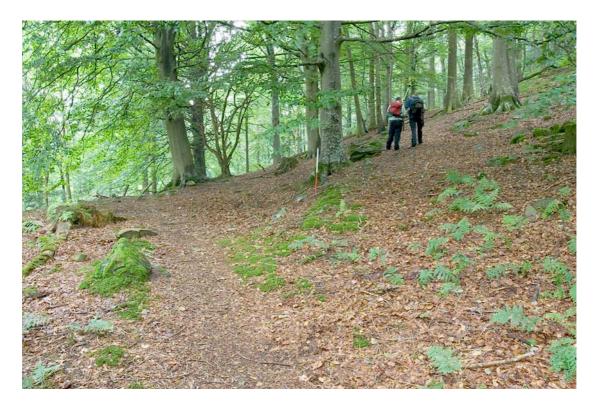
- **Pathways and Formal Garden Features:** the majority of the formal pathways within the wood were identified from map evidence, and form a distinct pattern of elaboration over time. The pathways that survive with distinct formal characteristics (predominantly with formal stone lined edging) are the pathway linking the garden with the public footpath (Site 83/84), the perambulatory path running from Peas Close to Burnt Houses fields (Site 20, Plate 16) and the later pathway that joined both of these together (Site 147). An unmapped later formal pathway runs between a formal pathway in the south (Site 84) and the tennis courts (Site 53) and includes a small flight of steps (Site 39). The formal edging on the pathways is intermittent at best, but the paths are well established and the majority of the layout first seen on the early mapping can be traced on the ground. The only other formal feature located within the wood is the site of a possible arbor (Site 25). It is located in the dog-leg of a formal pathway (Site 20, Plate 16) that rises up to the highest part of the wood and runs around the bottom of a rocky outcrop. The outcrop has ornamental yew trees placed atop it and has been deliberately incorporated into the layout of the formal pathway within the wood.

Plate 16: Formal pathway (Site 20) in High Hag Wood, looking north

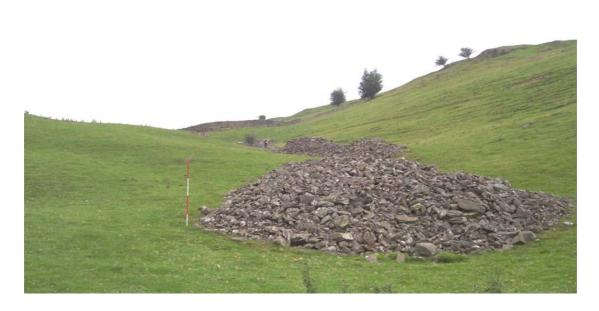
Plate 17: Clearance cairn (Site 11) in Hoghouse Paddock, Looking north.

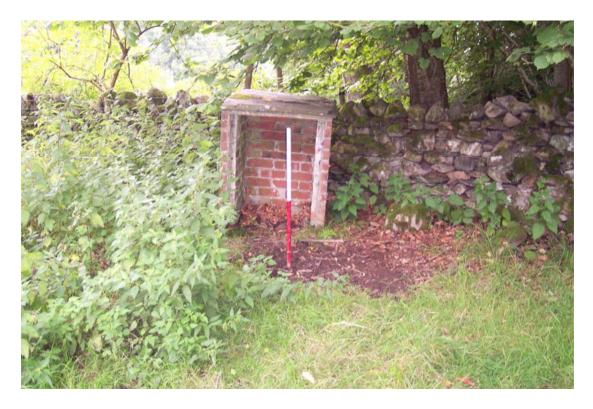
Plate 18: Enclosed water tap (Site 41), for use on the tennis court, looking west

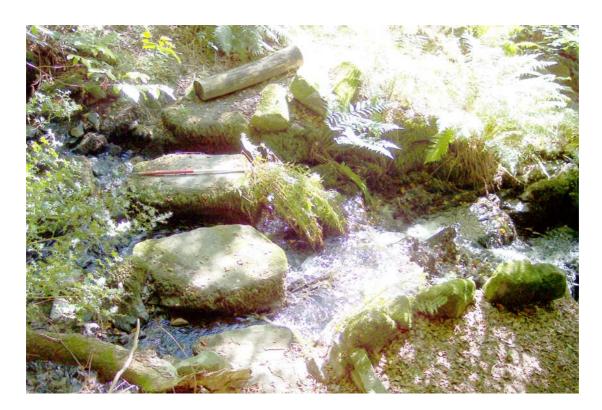
Plate 19: The foundation stones of rustic bridge (Site 97), in the wilderness garden, looking south

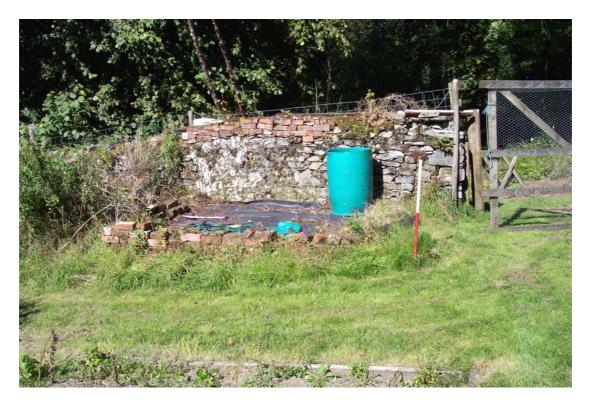
- 7.5.3 The only surviving early feature found within the garden are the brick-built footings for a greenhouse (Site **100**, Plate 20) that are located on the internal face of the northern wall of the garden, to the west side of the entrance gate. The footings measure approximately 3.7m long by 2.5m wide, consisting of a double thickness of bricks built up to three courses in height. The internal face of the walled garden has been whitewashed at this point and the coping has been replaced by supporting bricks.

Plate 20: Brick foundations of greenhouse (Site 100), in walled garden, looking north

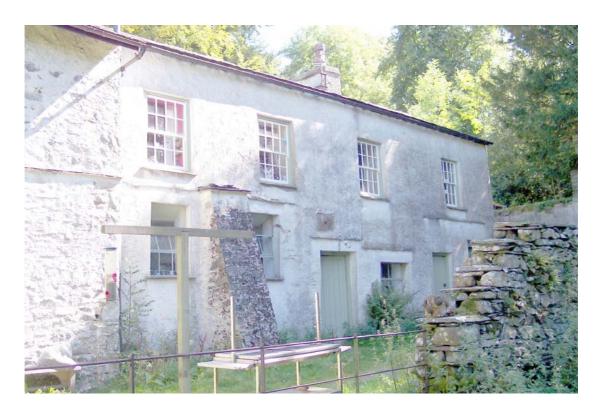
- 7.2.3 The surviving range of buildings from the original house consist of the coach house on the north end (Site 129, Plate 22) and the stable block to the south (Site 128, Plate 21). The coach house was the earlier as the stable block butts against it and its north-west corner turns inwards in order to avoid a window on the corner of the south elevation of the coach house. The coach house has rustic plaster rendering partially covering details such as the quoin stones. The stable block has a large buttress on the western elevation in order to offset the raised yard on the eastern side of the building, from where there was the main access to the first floor domestic quarters. The coach house has a pair of large

Plate 21: The surviving stable range (Site 128), Looking east.

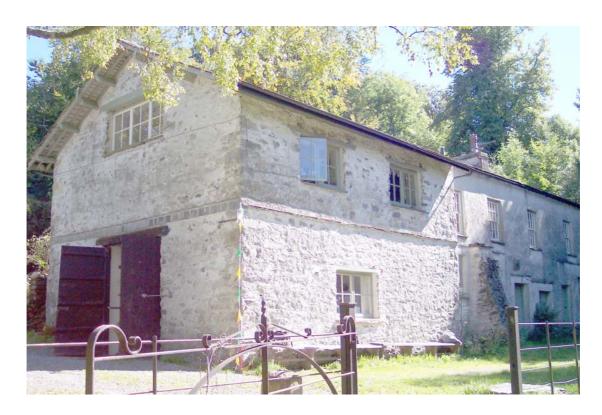
Plate 22: The surviving coach house range (Site 129), Looking east.
