# **LAND AT MELKINTHORPE**

## **CUMBRIA**

### **Evaluation Report**

Report no 1999-2000/061/AUA8966

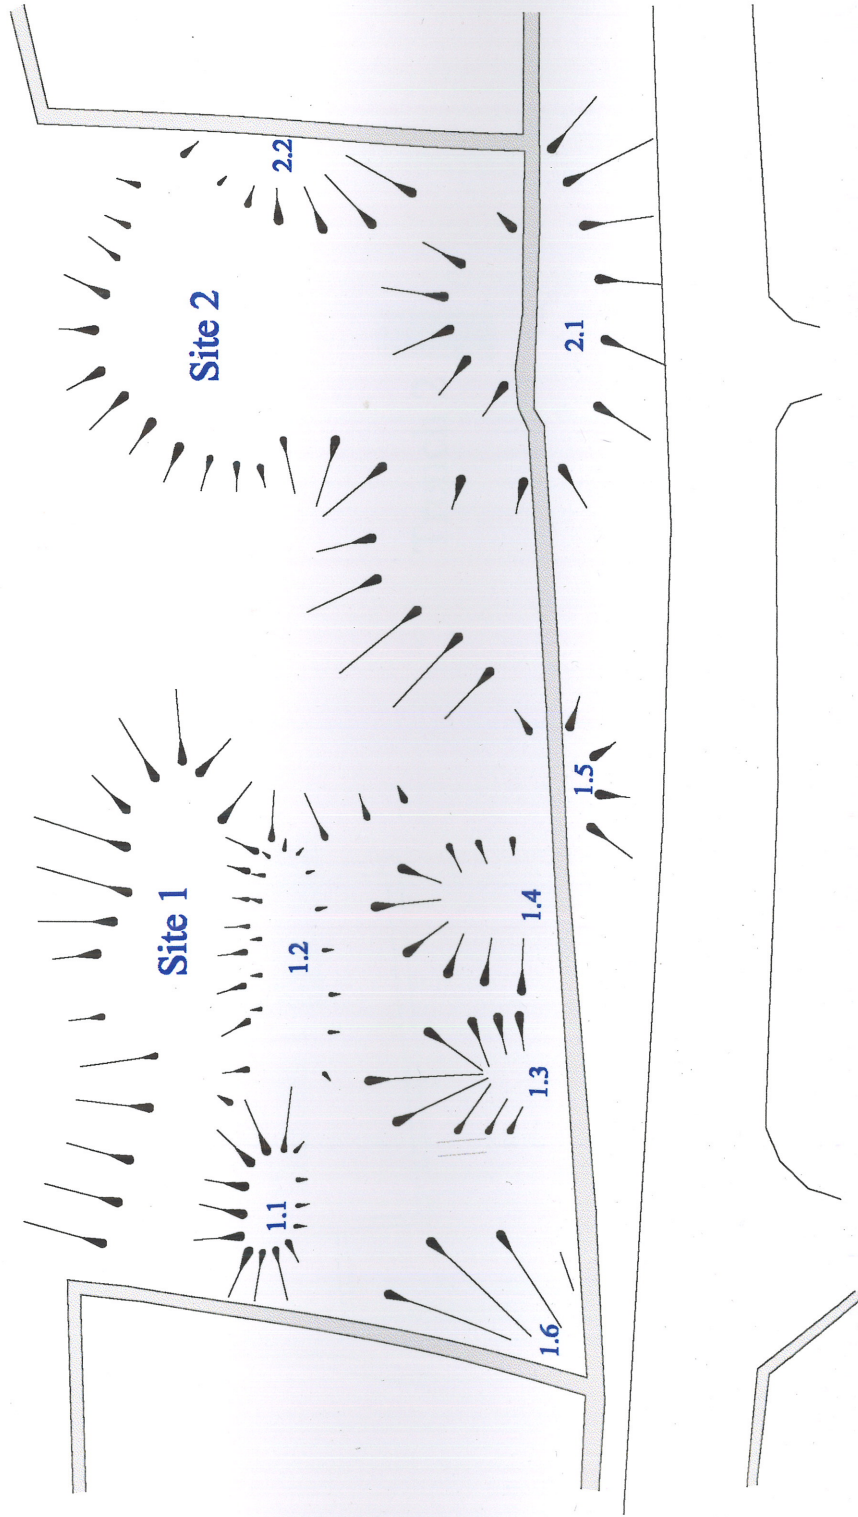
Fig. 2: Earthwork Survey Plan

- 3.1.1 At the time of the survey the study area was in pastoral use and covered with short grass. The surface morphology revealed a series of shallow earthworks, which were potentially indicative of relict structures. There were two principal sites (1 and 2), each a sub-rectangular platform, on either side of the plot (Fig 2).

- 3.1.2 **Site 1:** the platform comprised a slightly prominent flat-topped mound, which rises up to 0.2m above the surrounding ground surface of the north-east side. It is most prominently defined along the northern-eastern side, which follows a slightly sinuous course. The south-eastern edge is similarly sinuous, but less well-defined. The south-western and north-western edges, approximately correspond to the lines of the respective modern plot boundary walls. There is a very limited continuation (1.5) of the feature to the south of the boundary wall, which extends almost up to the line of the present road. This would suggest that the boundary wall post-dates the feature, and that the feature was edged by the road. The ground to the north-east of the platform is uniformly level and contrasts with the undulating morphology of the platform.

- 3.1.3 The surface of the platform is slightly undulating with a notable broad bank (1.1 and 1.2), extending north-west/south-east across the platform. This does not have a uniform shape, being more prominent and mound-like at the north-west end. At the south-western side is a series of three shallow hollows (1.3, 1.4 and 1.6) set against the boundary wall. There is no evidence of these hollows to the south of the boundary wall, and it is possible that they post-date the wall.

- 3.1.4 **Site 2:** this is the more prominent of the two platforms, and has a well-defined north-eastern edge that rises up to 0.25m above the ground surface. It has a moderately defined, albeit sinuously shaped, north-western side, and the south-western edge is set against the present road line; the feature is clearly overlain by the present boundary wall. The south-eastern side corresponds to the line of the farm boundary wall, and it was not possible to discern reliably the relationship between this boundary and the earthwork.

- 3.1.5 In general the upper surface of the platform is fairly level, and certainly more so than site 1; however, there is one semi-circular hollow against the south-eastern boundary wall, and there is a mound up against the south-western boundary wall.

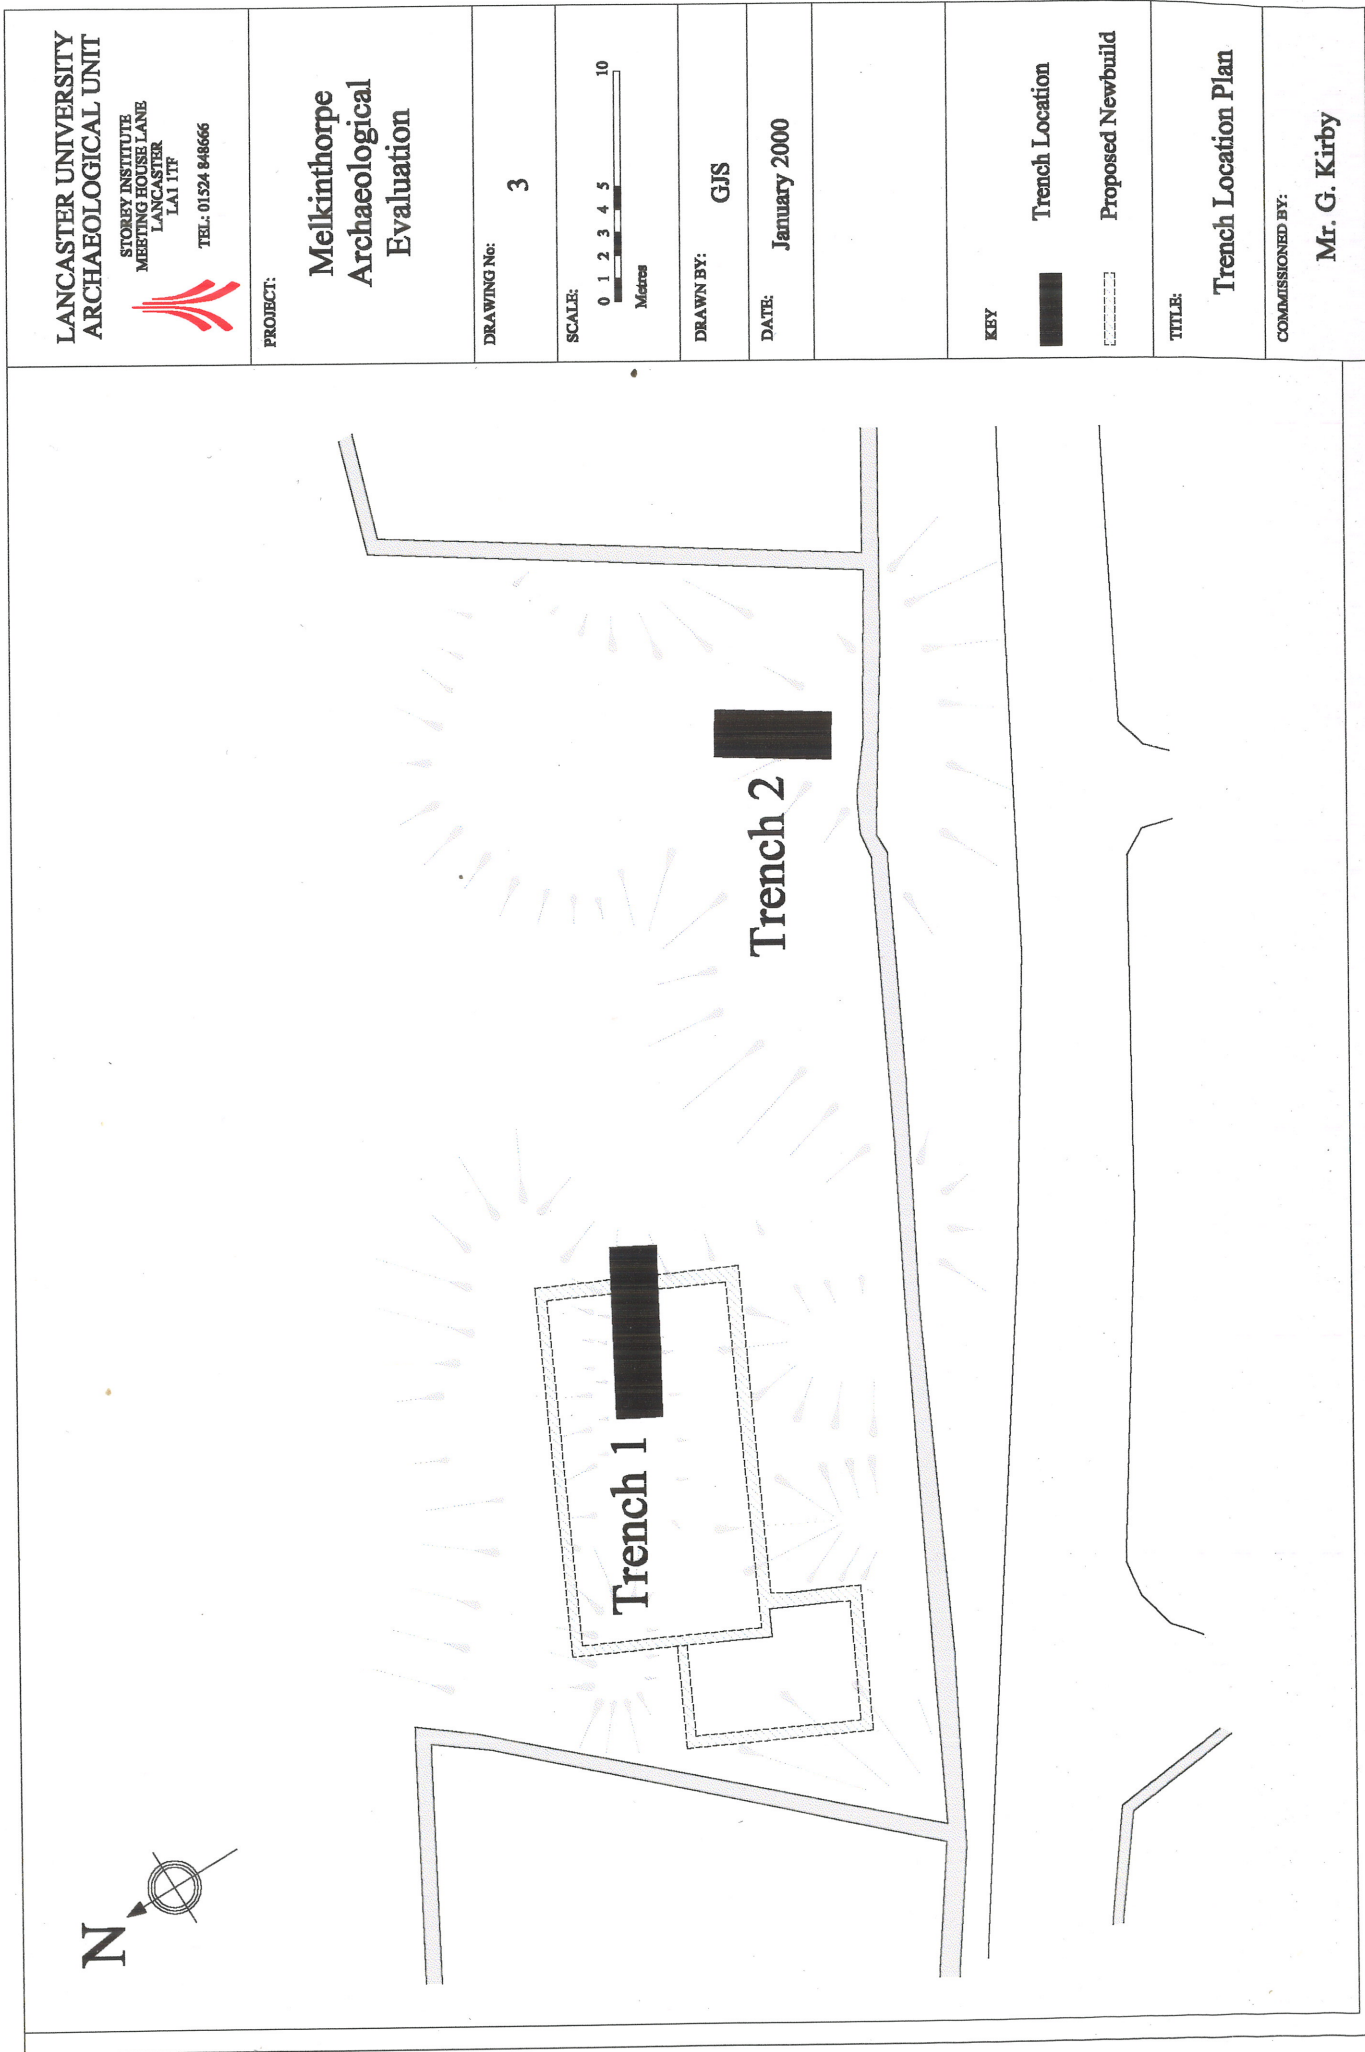
Fig. 3: Trench Location Plan

- 2.3.1 Two trenches (7m x 2m and 5m x 2m) were excavated, which were situated in the centre of each of the two putative platforms; the westernmost of these corresponded also to the centre of the proposed new-build. The arrangement of the trenches is shown in Figure 3 and was accurately located by total station surveying.

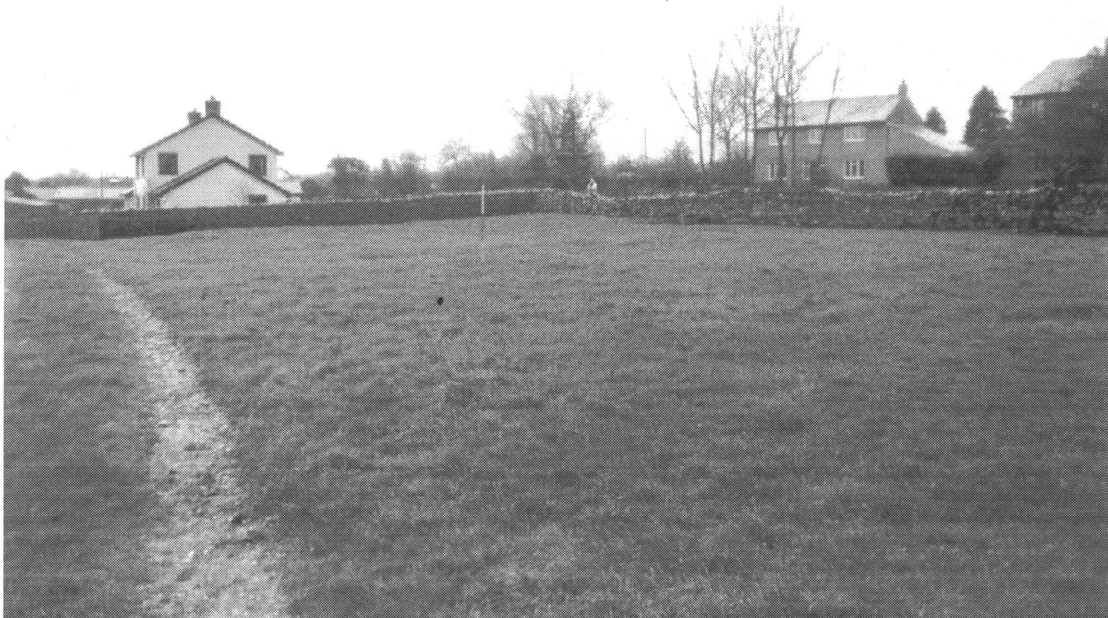
Plate 1 Study Area plot looking towards Platform 2

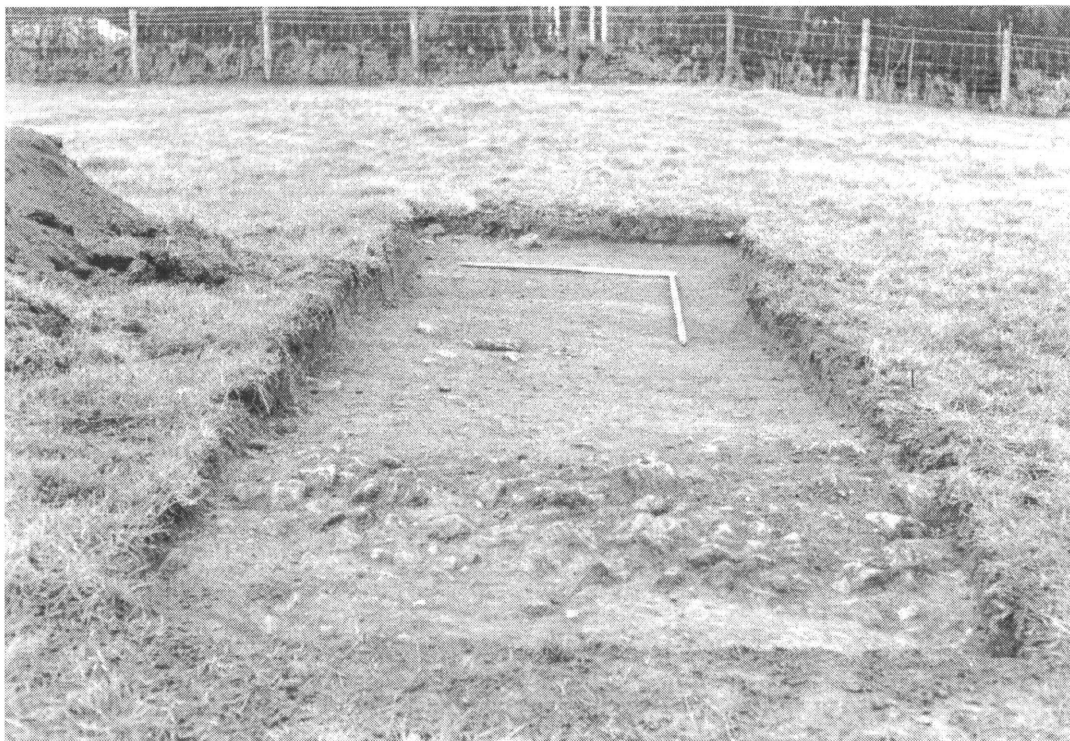
- 4.1.2 The uppermost deposit was a 0.15m thick layer of black/dark brown friable organic topsoil [11], containing post-medieval pottery and a simple animal bone. This overlay a sandy clay layer [6], a drain [8], and a band of cobbles [7]. The band of cobbles [7] was in the south of the trench, and overlay layer [6]; this band comprised stones between 0.03m and 0.15m in diameter. The cobbles extended across the width of the trench and formed a 1m wide band, and were situated to the immediate north of a break of slope marking the edge of the putative platform. A few sherds of nineteenth century pottery were recovered from within it. Whilst it is possible that the cobbles represent the remains of a very degraded wall, excavation revealed no foundation trench associated with them. It is perhaps more probable that they represent the remains of a narrow metalled trackway.

- 5.1.2 Trench 1, which was positioned over a potential house platform (1), revealed a cobble spread [7], which contained nineteenth century pottery and perhaps represented a narrow trackway. It is possible that the putative building platforms may have been designed to accommodate timber structures; however, no evidence of associated features, such as beam-slots or post-holes, was recorded during the evaluation.

Plate 2 Trench 1 showing cobbled surface [7] in the foreground > north-west
