**CROMWELL'S BRIDGE**  
**CLITHEROE**  
**LANCASHIRE**

**Fabric Survey Report**

Report no 1999-2000/34/AUA8914

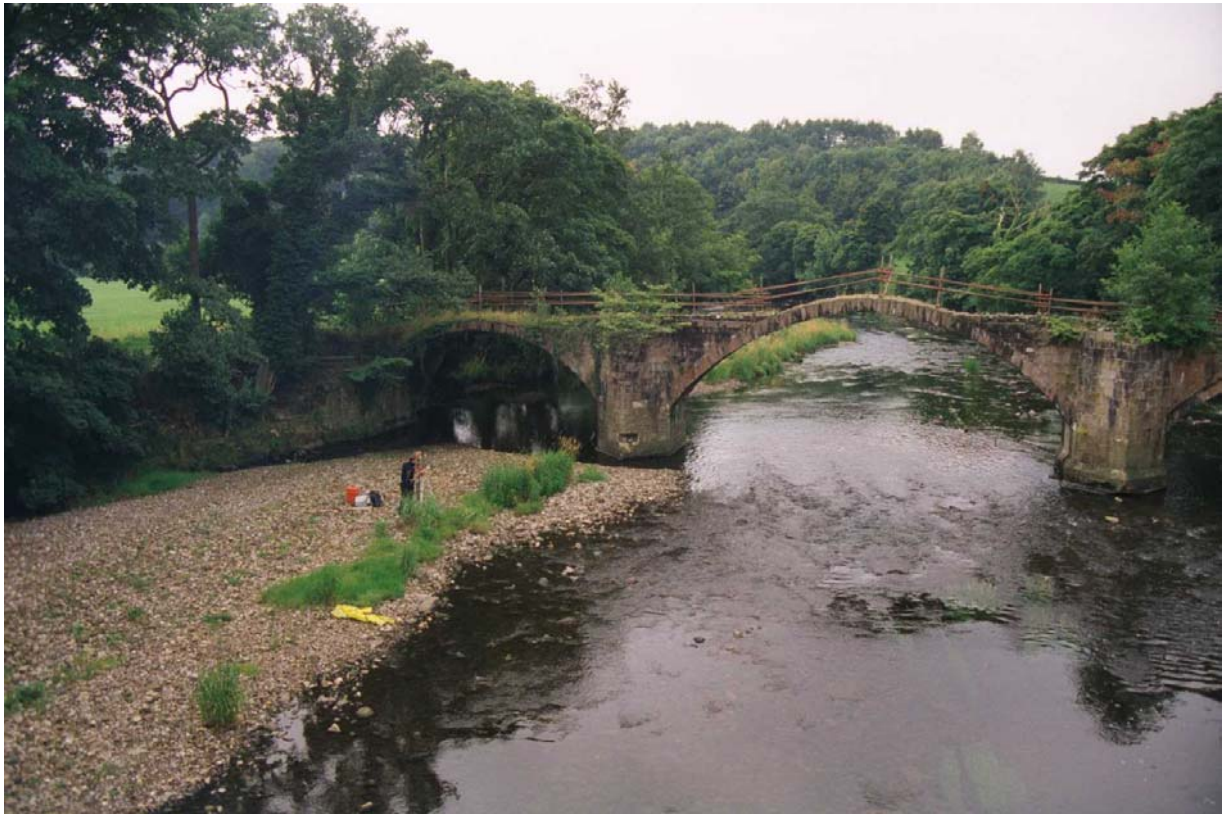
Plate 1 General view of Cromwell's Bridge looking south-west

- 3.1.1 The bridge comprises three segmented arches spanning approximately 40m; the outer arches span just over 10m each and the centre arch spans 15.4m. The bridge is 3.8m wide and was constructed of coursed ashlar masonry with a rubble core. The parapets and the roadway have been removed, probably robbed for re-use elsewhere, leaving very little material above the voussoirs. The central arch is flanked by two triangular cutwaters, both of different styles. That to the west has a broad plinth extending above normal water level; this western pier is supported at its base by a concrete bench, which was constructed prior to 1970. The eastern pier base and eastern abutment base are of broadly similar type, with a stepped kerb, which is five steps deep on the eastern pier. Above the water level the eastern pier and eastern abutment are also of broadly similar construction style, with the segmental arches flush with the ashlar masonry of the face of the bridge. At the time of the survey the eastern pier was damaged on the northern face with several hungry joints and one area of missing ashlar face at the lower front part of the cutwater.

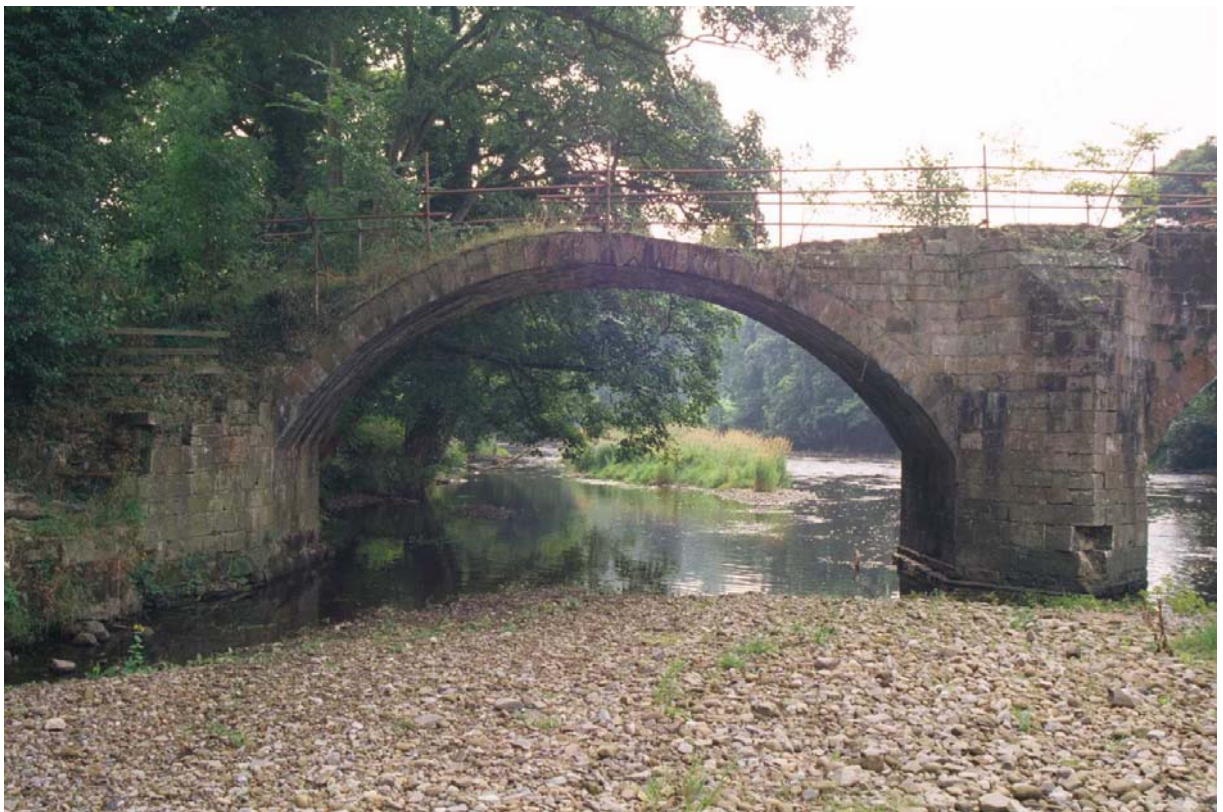
Plate 2 East arch of bridge looking south-west

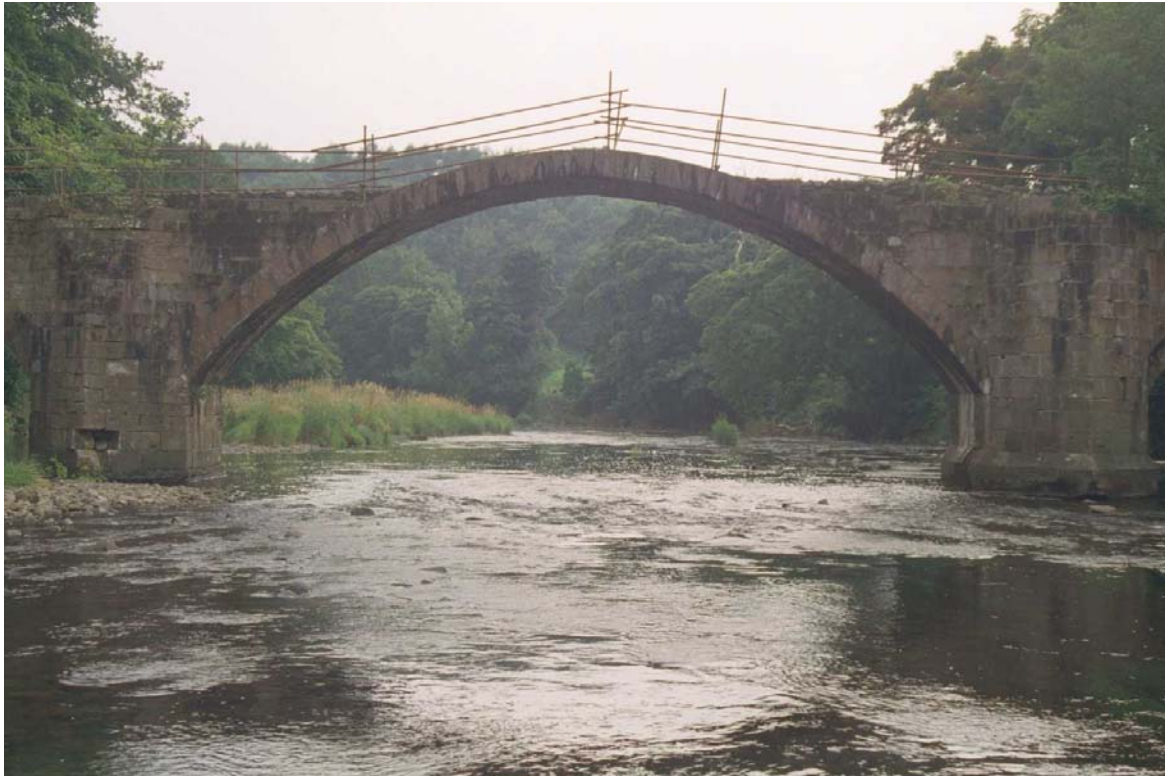
Plate 3 Central arch of bridge looking south-west

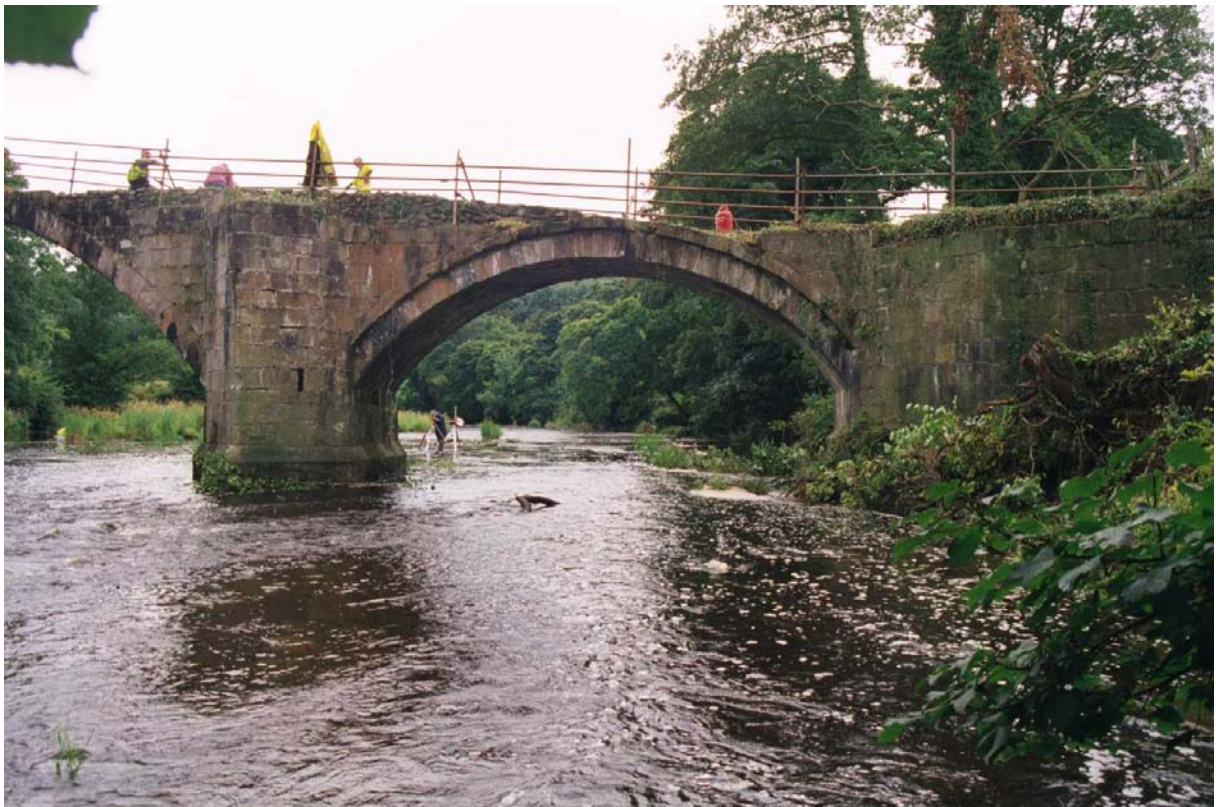
Plate 4 West arch of bridge looking south-west

- 3.1.2 The western arch comprised two sets of voussoirs. The lower set comprised voussoirs of a similar size and shape to those of the central and eastern arches; it is, however, set in from the principal face of the arch. The higher set comprised long flat voussoirs which were in the same plane as the rest of the arch. The upper set of voussoirs would appear, by virtue of their insubstantial form, to be of principally ornamental function.

- 3.2.1 The differential character of the bridge demonstrates that the present structure is a product of more than one phase of construction. In particular the design of the western arch, western pier and western abutment suggest that these elements were constructed at a different date from the rest of the bridge. The character of the design, incorporates decorative embellishments that are not found elsewhere, such as the pier plinths and recessed voussoirs, and the implication is that these were rebuilt or modified at a later date to the eastern and central elements of the bridge. If this were demonstrably the case, then it would imply that the western pier was a modification of the original, as the central arch would not have survived had the pier been removed or lost. The probability is that this reflects the refacing of the western part of the bridge, at some unknown date, possible in response to storm damage.
