**WEST BARN, HORNBY ROAD**  
**WRAY**  
**LANCASHIRE**

**Building Investigation Report**

Report no 2000-2001/104/AUA8192

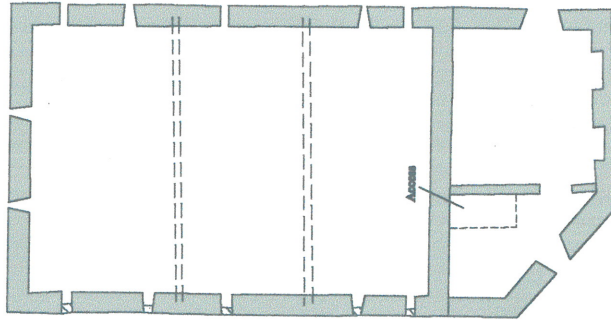
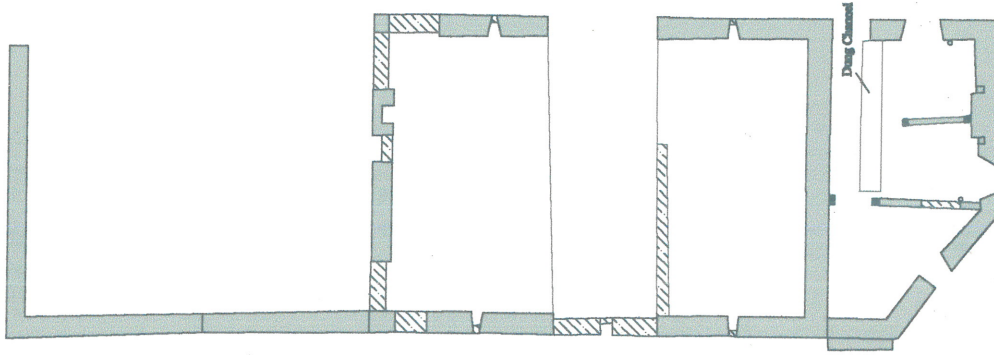
Figure 3 : Ground and First Floor Plans

- 3.1.2 **Plan:** the barn consists of a large main building, with an extension at the south end. Access into the main building is via two wagon doors through the eastern wall, leading into a central passage, with a brick partition separating it from a stable area to the south. The southern extension incorporates two small rooms with large domestic windows, and a fireplace/flue, and formerly had a domestic function. At the north end of the barn is a low, L-shaped stone wall forming a small enclosure. On the OS 1st edition map the barn had a different plan; was 'L' shaped, with a further extension to the west, extending into the Hornby Road; this west extension no longer survives and the south-west corner of the south extension has a diagonal chamfered plan respecting the line of the road.

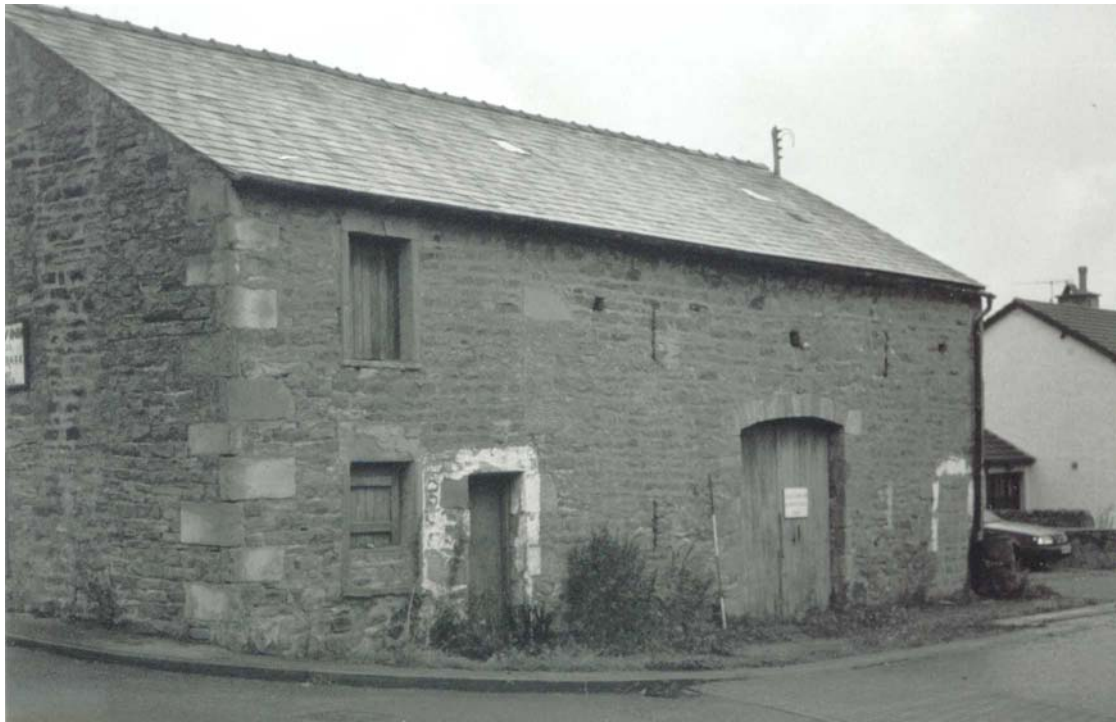
Plate 1: South and East External Elevations from the south-east

- 3.2.6 **East Elevation** (Plate 1): the eastern elevation has dressed quoins at the north and south end of the main barn. At the northern end there is a pedestrian doorway, which has been blocked with stone, and has a stone lintel, with quoins doubling as door jambs on its northern side. In the centre is a wagon doorway, which has slit vents on either side and two directly above them. There are also three square vents, across the elevation, below the roof line. The wagon doorway itself is similar to that on the west side with stone, quoined jambs and a segmented stone arch.

- 3.2.7 The southern end of the building comprises the extension. There is a single pedestrian door with a stone lintel and the quoins of the main barn have been used as jambs on its north side. There are also two windows, one above the other at the southern end, both with stone jambs, sill and lintel. The lower window has had the bottom 0.35m blocked with stone, leaving an opening 0.85m square, while the upper is 1m high by 0.85m wide. The extreme south end has been finished with

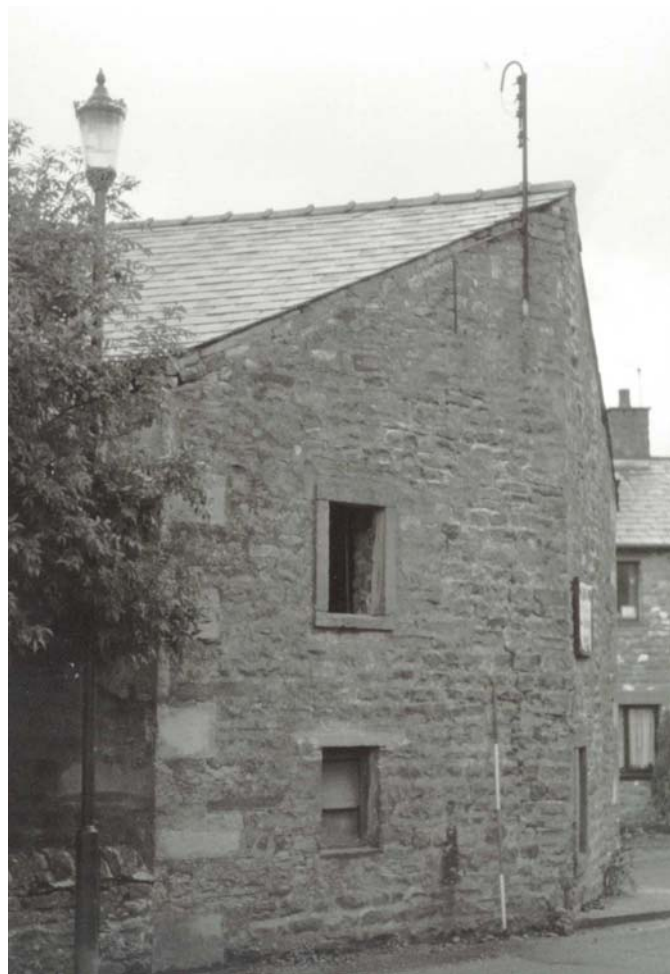
Plate 2: South External Elevation from the south-west

- 3.2.3 **South Elevation** (Plate 2): the southern gable wall has been built as an extension to the original barn, forming an irregular angle (of approximately 40°) respecting the position of the road; despite this angle the wall appears to be of a single build. The eastern half has quoins at the north-east corner and has a single window on the lower west side (approximately in the centre of the south elevation) which is 0.94m high, 0.6m wide and has a stone lintel, jambs and sill. There has been a large amount of repointing across the whole of the centre of the east side, extending in a 0.95m wide band up to the roof. The western half of the southern elevation has two windows, one above the other; both are 0.55m wide by 0.8m high, with stone jambs, sill and lintel. There are also quoins at the north-west corner and some repointing towards the east side. An iron pole or bracket is attached to the top connecting electricity and/or telephone lines to the building.

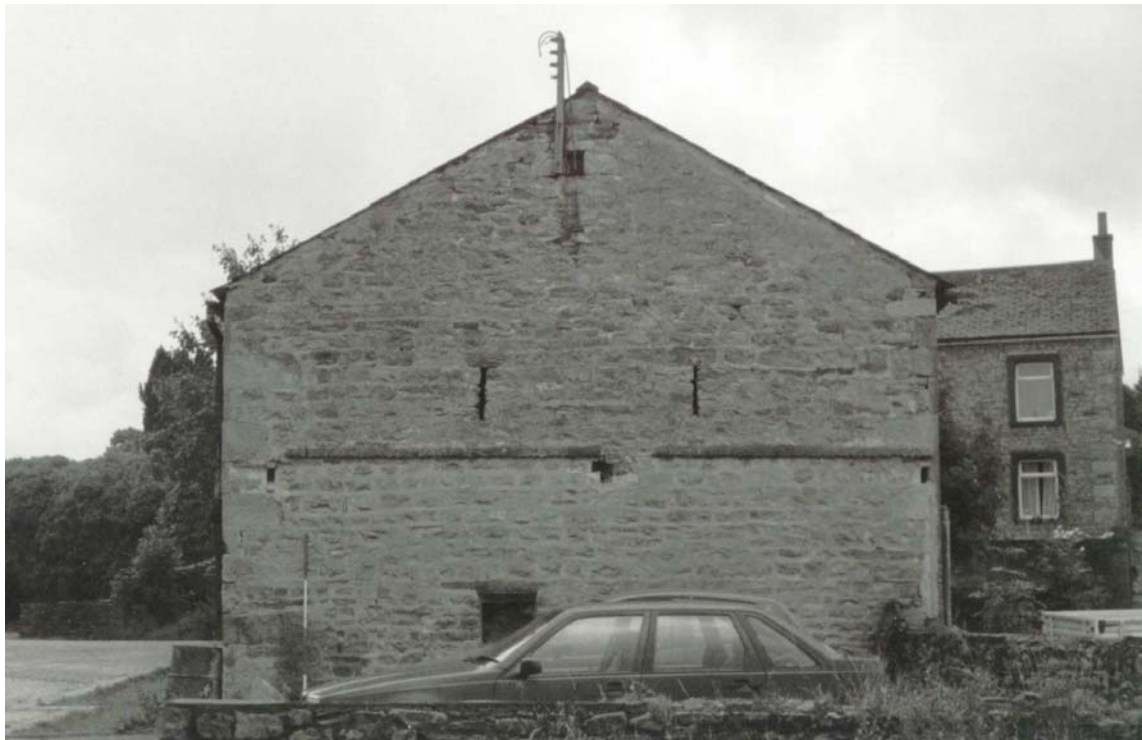
Plate 3: North External Elevation from the north

- 3.2.2 **North Elevation** (Plate 3): the northern gable wall of the barn is of coarse dressed masonry with large dressed quoins at the corners. There is a small aperture at the base of the wall, slightly east of the centre, which is 0.64m wide and 0.6m high with a stone lintel. This is blocked with brick on the inside leaving a recess 0.4m deep on the outside. There are two slit ventilation openings higher up the wall, and a rectangular vent below the apex. Across the centre is a concrete roof scar formed by a corrugated-iron roof from a former lean-to outshut set against the north end of the building. There are three joist slots below this and the area below it has been entirely repointed. The extent of the outshut may correspond to the yard at the north end, formed by a wall, no more than 1.15m high, which was built in the same style as the rest of the building, although a 3.85m long section at the southern end, had either been rebuilt or was the blocking of an aperture (Fig 3). On the west side of the north elevation is an iron hinge pin, which would reinforce the supposition that there was a doorway between the yard and the barn's north

end. Through the east and west sides of the north wall of the barn are two apertures, which have now been blocked; that to the east is 0.94m wide and has been blocked with stone, while that to the west is 1.37m wide and has been blocked with brick. These had been doors which would have provided access to the lean-to building to the north. A piece of timber has been attached to the top of the wall for telephone / power cables.

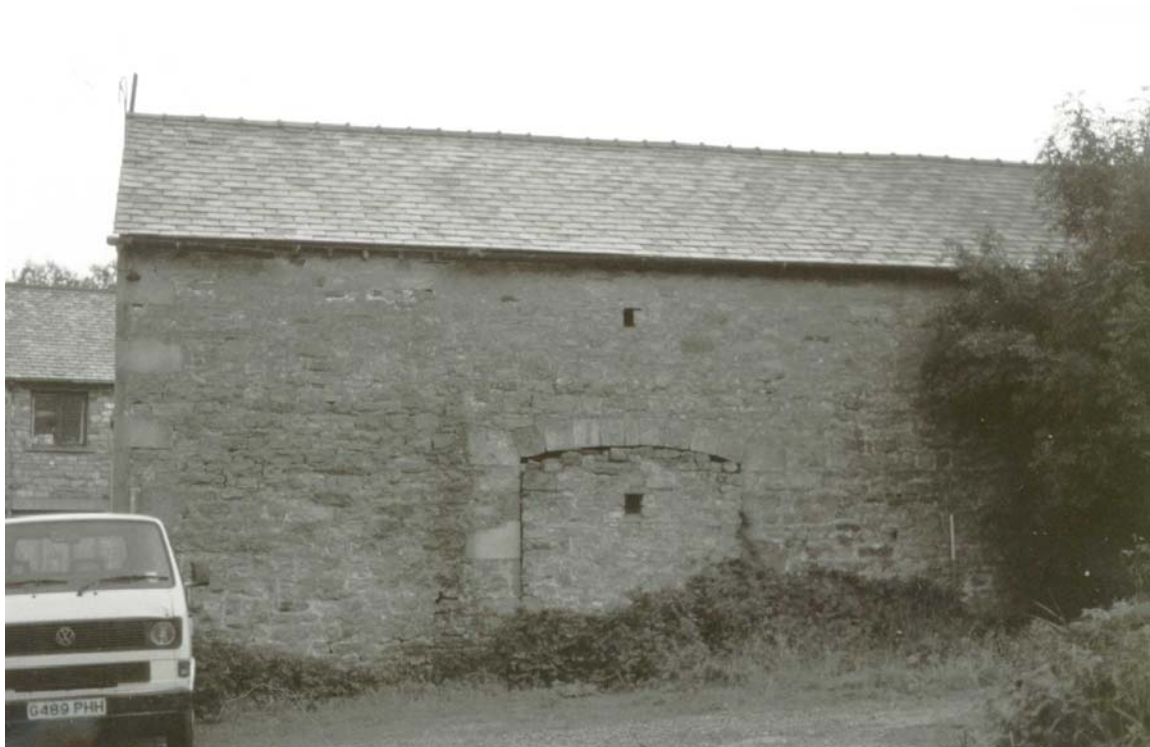
Plate 4: West External Elevation from the west

- 3.2.4 **West Elevation** (Plate 4): the west elevation comprises the barn and its southern extension; there are dressed quoins at the north and south corners of the barn, which, at the south end, define the northern edge of the extension. There is a single wagon doorway in the centre of the elevation with quoined jambs and a segmented stone arch; this has been roughly blocked with stone, leaving only a small vent, 0.25m high by 0.2m wide, in the centre. This in turn has been blocked with brick on the inside, leaving a slight recess. There is a further small vent above this, of a similar size, and there are four blocked slit vents spread across the upper part of the elevation, although these are not visually obvious (the lower slit vents seen internally were almost impossible to identify externally). There is also a small blocked aperture at the north end, 0.7m high by 0.44m wide, with a stone lintel.

- 3.2.5 The extension at the south end is butted onto the main building with a thick layer of mortar. It has been repointed throughout and there is a string-course at a height of approximately 2m, which was 0.05m thick and projected by 0.2m. The wall plate and common rafters are also exposed below the roof line.

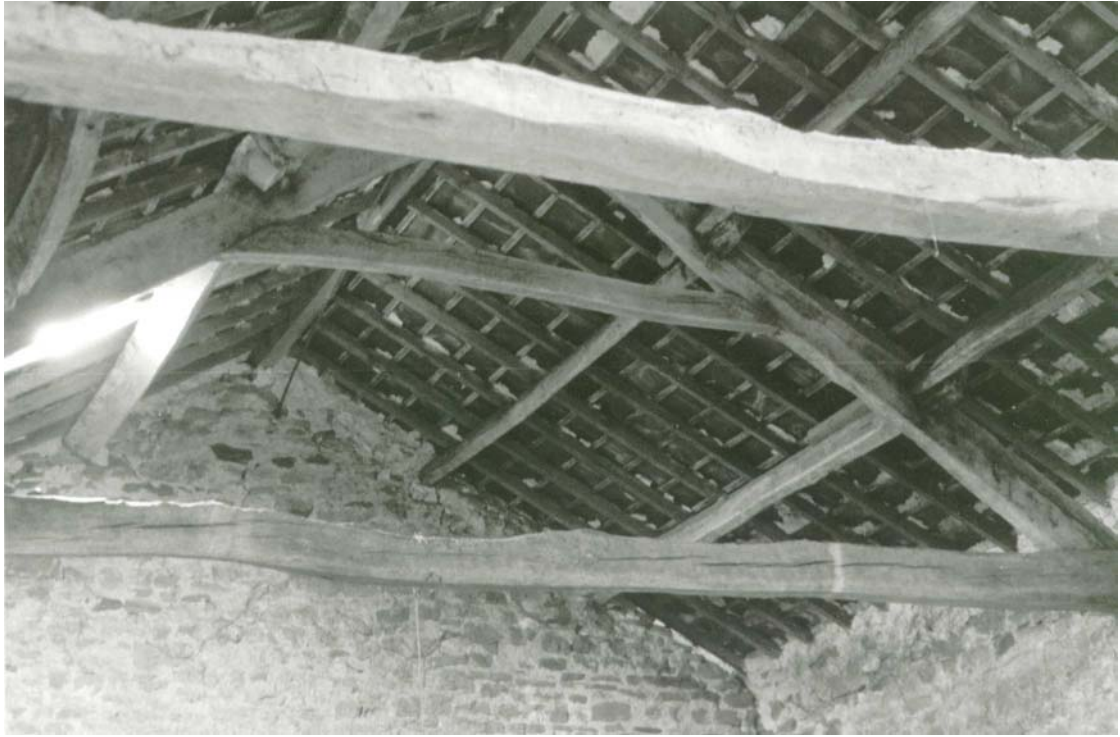
Plate 5: Southern Truss in the Barn from the south-west

- 3.3.2 The roof consists of two trusses, forming three bays. The trusses consist of a simple tie beam, supporting principal rafters, which overlap west on to east, with a pegged joint (Plate 5). There is a single collar on each with a pegged mortise and tenon joint and the principal rafters are trenched to fit the purlins. All of the principle pieces of timber are hand finished and the tie beam is built into the wall just below wall head height. There are chiselled carpenters' marks (Brunskill 1987) on the collar and tie beam of each truss: 'II' on the northern and 'I' on the southern. The letters R.H.H. are also gouged into the collar of the southern truss.

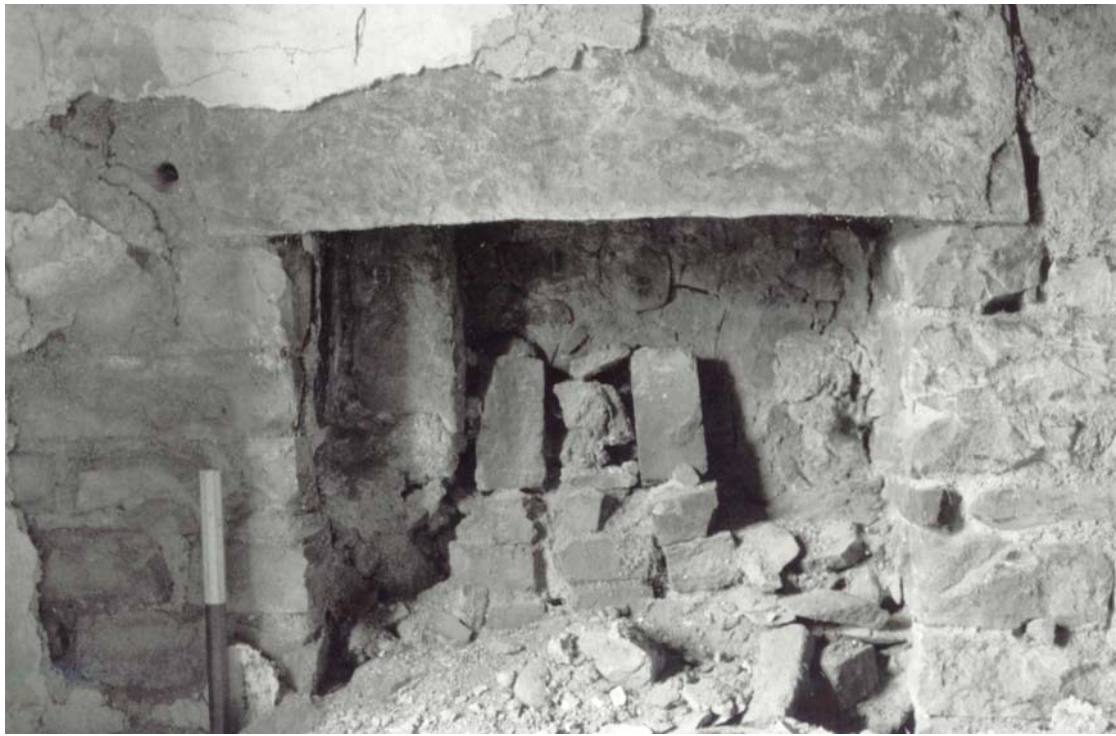
Plate 7: Fireplace in Room 4 from the north

- 3.4.15 **South Elevation - Room 4:** the majority of the whitewash has come away from this wall, revealing a low fireplace on the east side, 0.9m high and 0.9m wide, with a stone lintel (Plate 7). Some elements of the structure of the fireplace survive, built in brick and cement, although this may be blocking material. At the west side is a tall, built-in cupboard, 1.93m tall and 0.8m wide, with scars for at least three shelves (Plate 8). The lintel is of timber and shows signs of quite extensive fire damage.
