**HENLLYS HALL**  
**BEAUMARIS**  
**ANGLESEY**

**Evaluation Report**

Archaeological Evaluation Report

Report no 2000-2001/090/AUA 8148

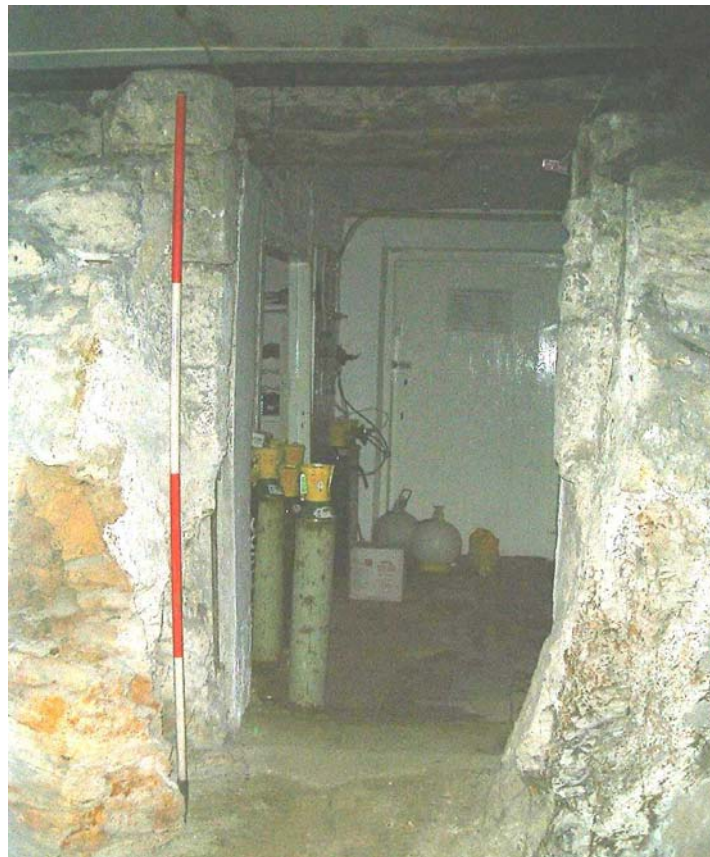
Plate 2 Relict Doorway looking south-east

- 4.2.1 The elevation shows two door jambs which are keyed into blocks of masonry which appear to be earlier than the present building (**168** and **169**). Both blocks of masonry appear to have been cut through, so that the only definite faces to survive are on the inside of the doorway, where the jambs are located. The bases of the jambs stand c1.1m above present floor level, and are now supported on upstanding pillars of bedrock, the implication being that the floor level relating to the doorway was 1.1m higher than the present basement floor. The north-west face of each jamb is slightly chamfered, suggesting that the contemporary door opened to the south-east. The jambs belong to a basic form of frameless door, which is not closely datable, but is consistent with a broad medieval to early post-medieval date range (Brunskill 1978, 132-4).

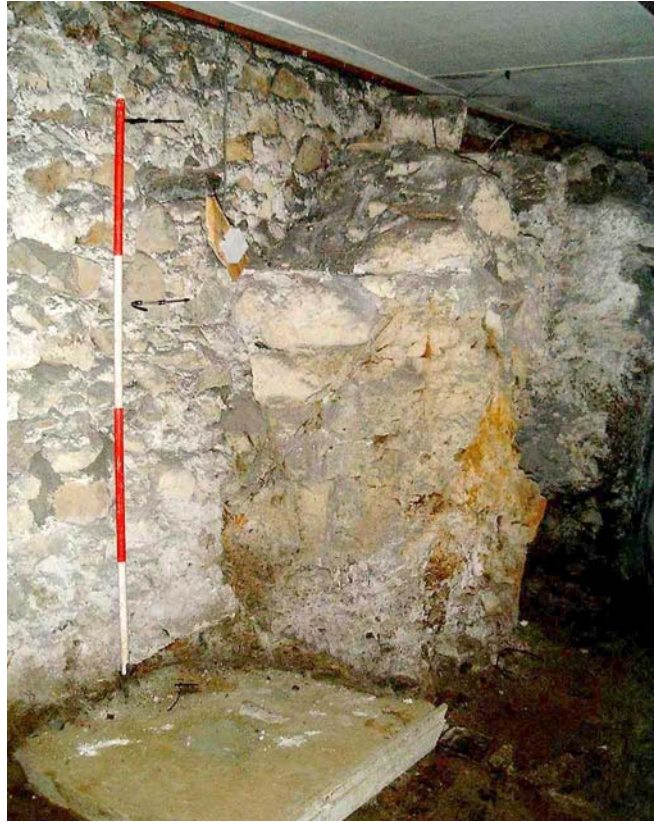
Plate 3 Relict Doorway and pillar of bedrock viewed from the north

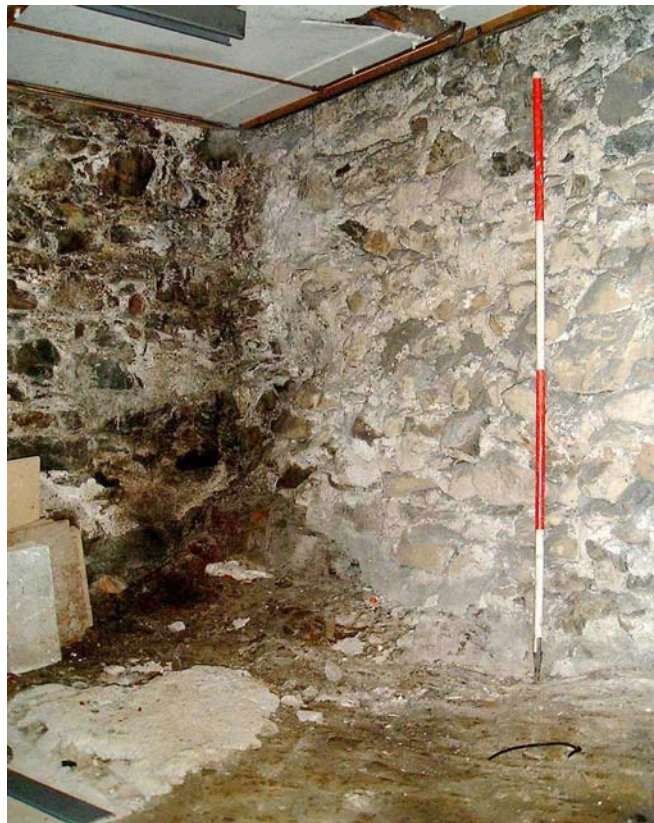
Plate 4 Interface of walls 170 and 171 in the basement

- 4.2.2 A second phase of building is represented by the wall aligned north-east / south-west through which the relict doorway now provides access (**170**). This wall appears to have cut through masonry associated with the door jambs to the south-west of the doorway. The wall is of a generally uniform style, without apparent breaks, which extends between the present ceiling and floor of the basement. This would indicate that the wall relates to a lower floored room than that of the door jambs. The wall is interesting because it is completely unpointed on its north-west face; this suggests that it was a retaining wall, built from the south-east side against bedrock and earth to the north-west. This would imply that the wall was built before the present cellar room to the north of the relict doorway was excavated.

- 4.2.3 The third phase of construction is represented by the external wall of the present hall (**171**), which is dressed and pointed internally and butts against and the retaining wall (**170**). The wall contains a light well, confirming that it post-dates the excavation of the basement. It appears integral with the north-east façade of the hall, and is therefore likely to date from the rebuilding of 1852-3.

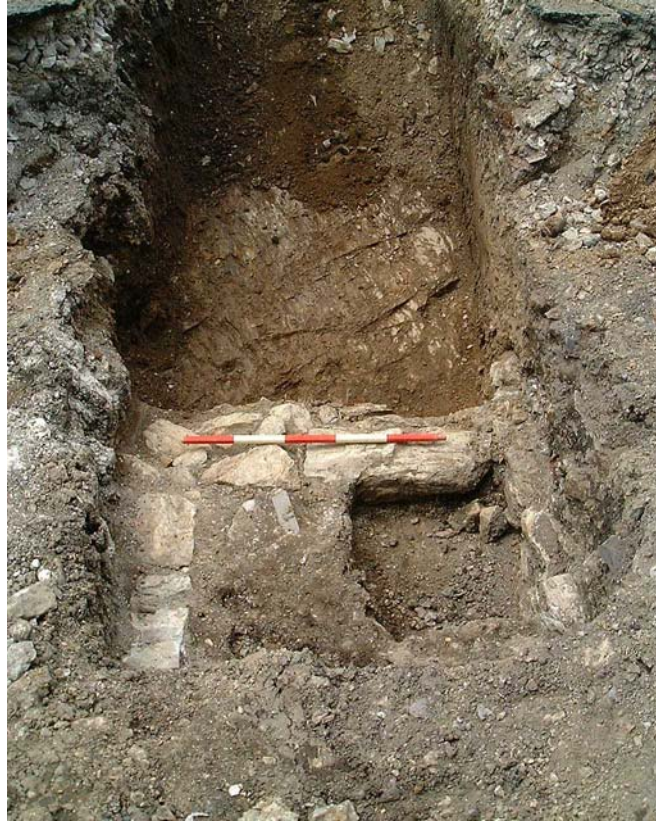
Plate 5 Pit 105 in Trench 1 viewed from the south-west

6.2.3 A single cut feature (**105**) was present within Trench 1, which extended beyond the northern, eastern, and western limits of excavation, but appeared to be the cut of a stone-lined pit. In section, the feature could clearly be seen to post-date deposits **102** and **103**, but was also tentatively identified truncating deposit **101**. Cut **105** measured at least 1.6m x 1.6m x 1.2m deep, and was near vertical with a flat base. A rough dry stone lining remained in the base of the cut on the western, southern, and eastern sides, but was only one to two courses deep; it seems likely that the lining had once extended higher up the cut, but had been removed by robbing. A single fill was recorded, **104**, which sealed the upper surface of the extant lining, and may represent post-abandonment deposition. Fill **104** contained

several sherds of late nineteenth to twentieth century pottery and glass, fragments of animal bone and oyster shell, and a fragment from a leather boot sole, potentially of the same date as the pottery and glass. The form of the feature suggested a possible function as a cess pit, but no cess-like deposits were found *in situ*.

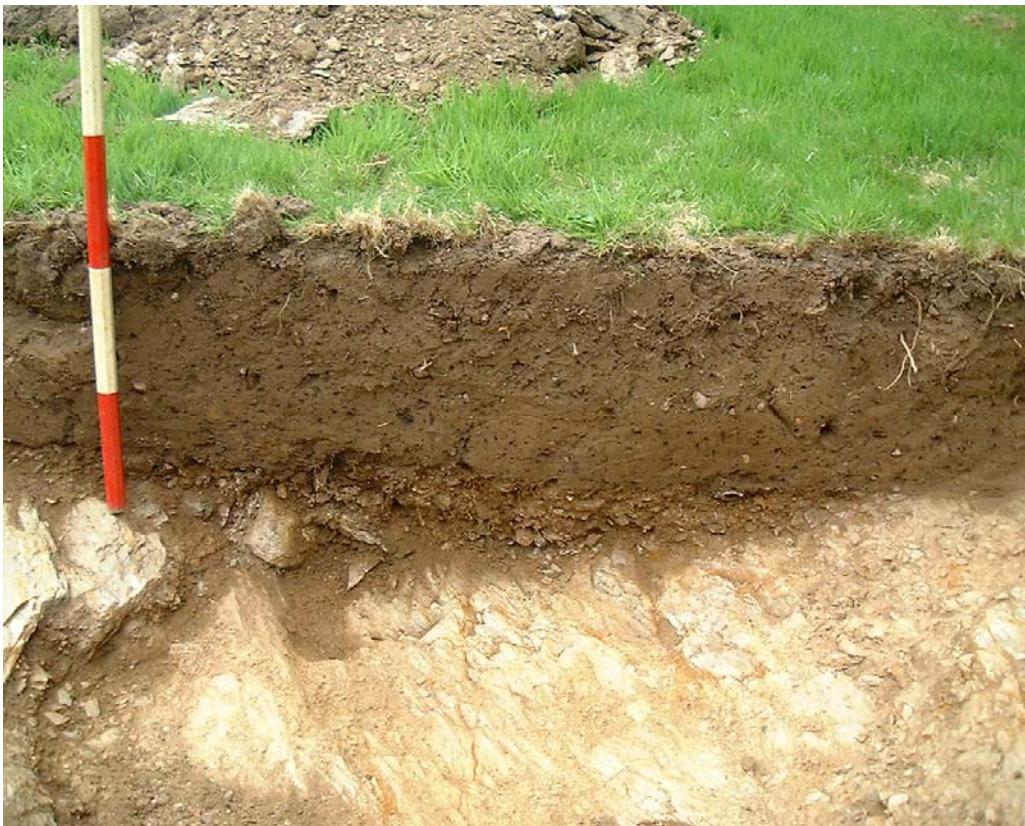
Plate 6 Rock cut ditch in Trench 3 looking south-west

- 6.4.1 Trench 3 was excavated within the footprint of the proposed apartment block to be sited to the south-west of the main hall buildings. It was also positioned with the aim of examining the external wall-line of a building, which predated the present hall, depicted on the estate plan of 1830 (UWB Henllys ms 1191). Trench 3 was aligned north-west / south-east, and measured 11.3m long; it was excavated to a maximum depth of 0.65m.
- 6.4.2 A thick deposit of turf and topsoil was removed by machine to reveal the surface of the bedrock immediately below, at a height of 53.11m OD. A single linear feature was identified, cut into the bedrock (**115**), which was aligned north-east / south-west, and extended for the full 1.6m width of the trench. It was 1.5m wide

and 0.24m deep, with gently sloping sides and a relatively flat base, and contained a single fill of orange brown clay sand with 80% shattered rock fragments. The position of cut **115** corresponds to the north-west wall of the structure depicted on the 1830 estate map, and it is suggested that the feature may represent a shallow rock-cut foundation trench. One sherd of late nineteenth to twentieth century pottery was recovered from the topsoil, but there were no other finds from Trench 3.

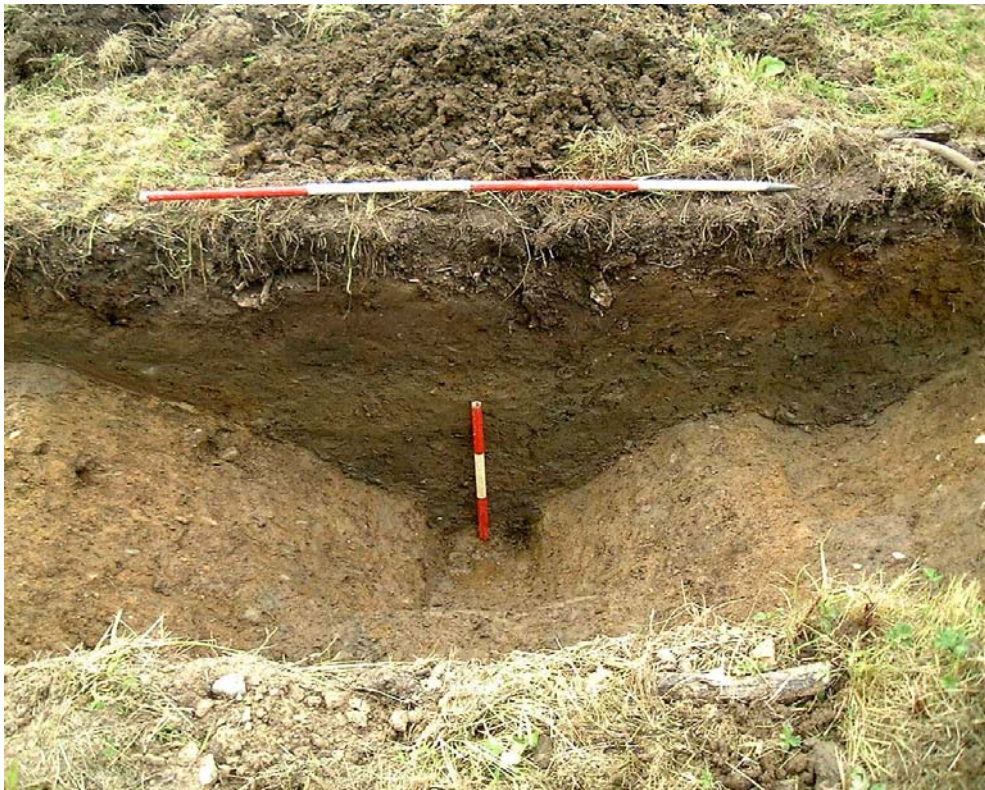
Plate 8 Ditch 160, Trench 14 looking north-west

- 6.15.5 The linear feature recorded as Site 32 corresponds to the position of ditch **I60**, and may represent a surviving physical trace of this ditch. The magnetic anomaly was undoubtedly caused by the dumping of ferrous rubbish and burnt materials in a depression over the top of culvert **I38**; the rubbish included the remains of a sprung mattress.
