November 1998

VALE ROYAL SCHEDULED AREA

Archaeological Evaluation and Excavation Report

Report no 1998-99/(023)/7811

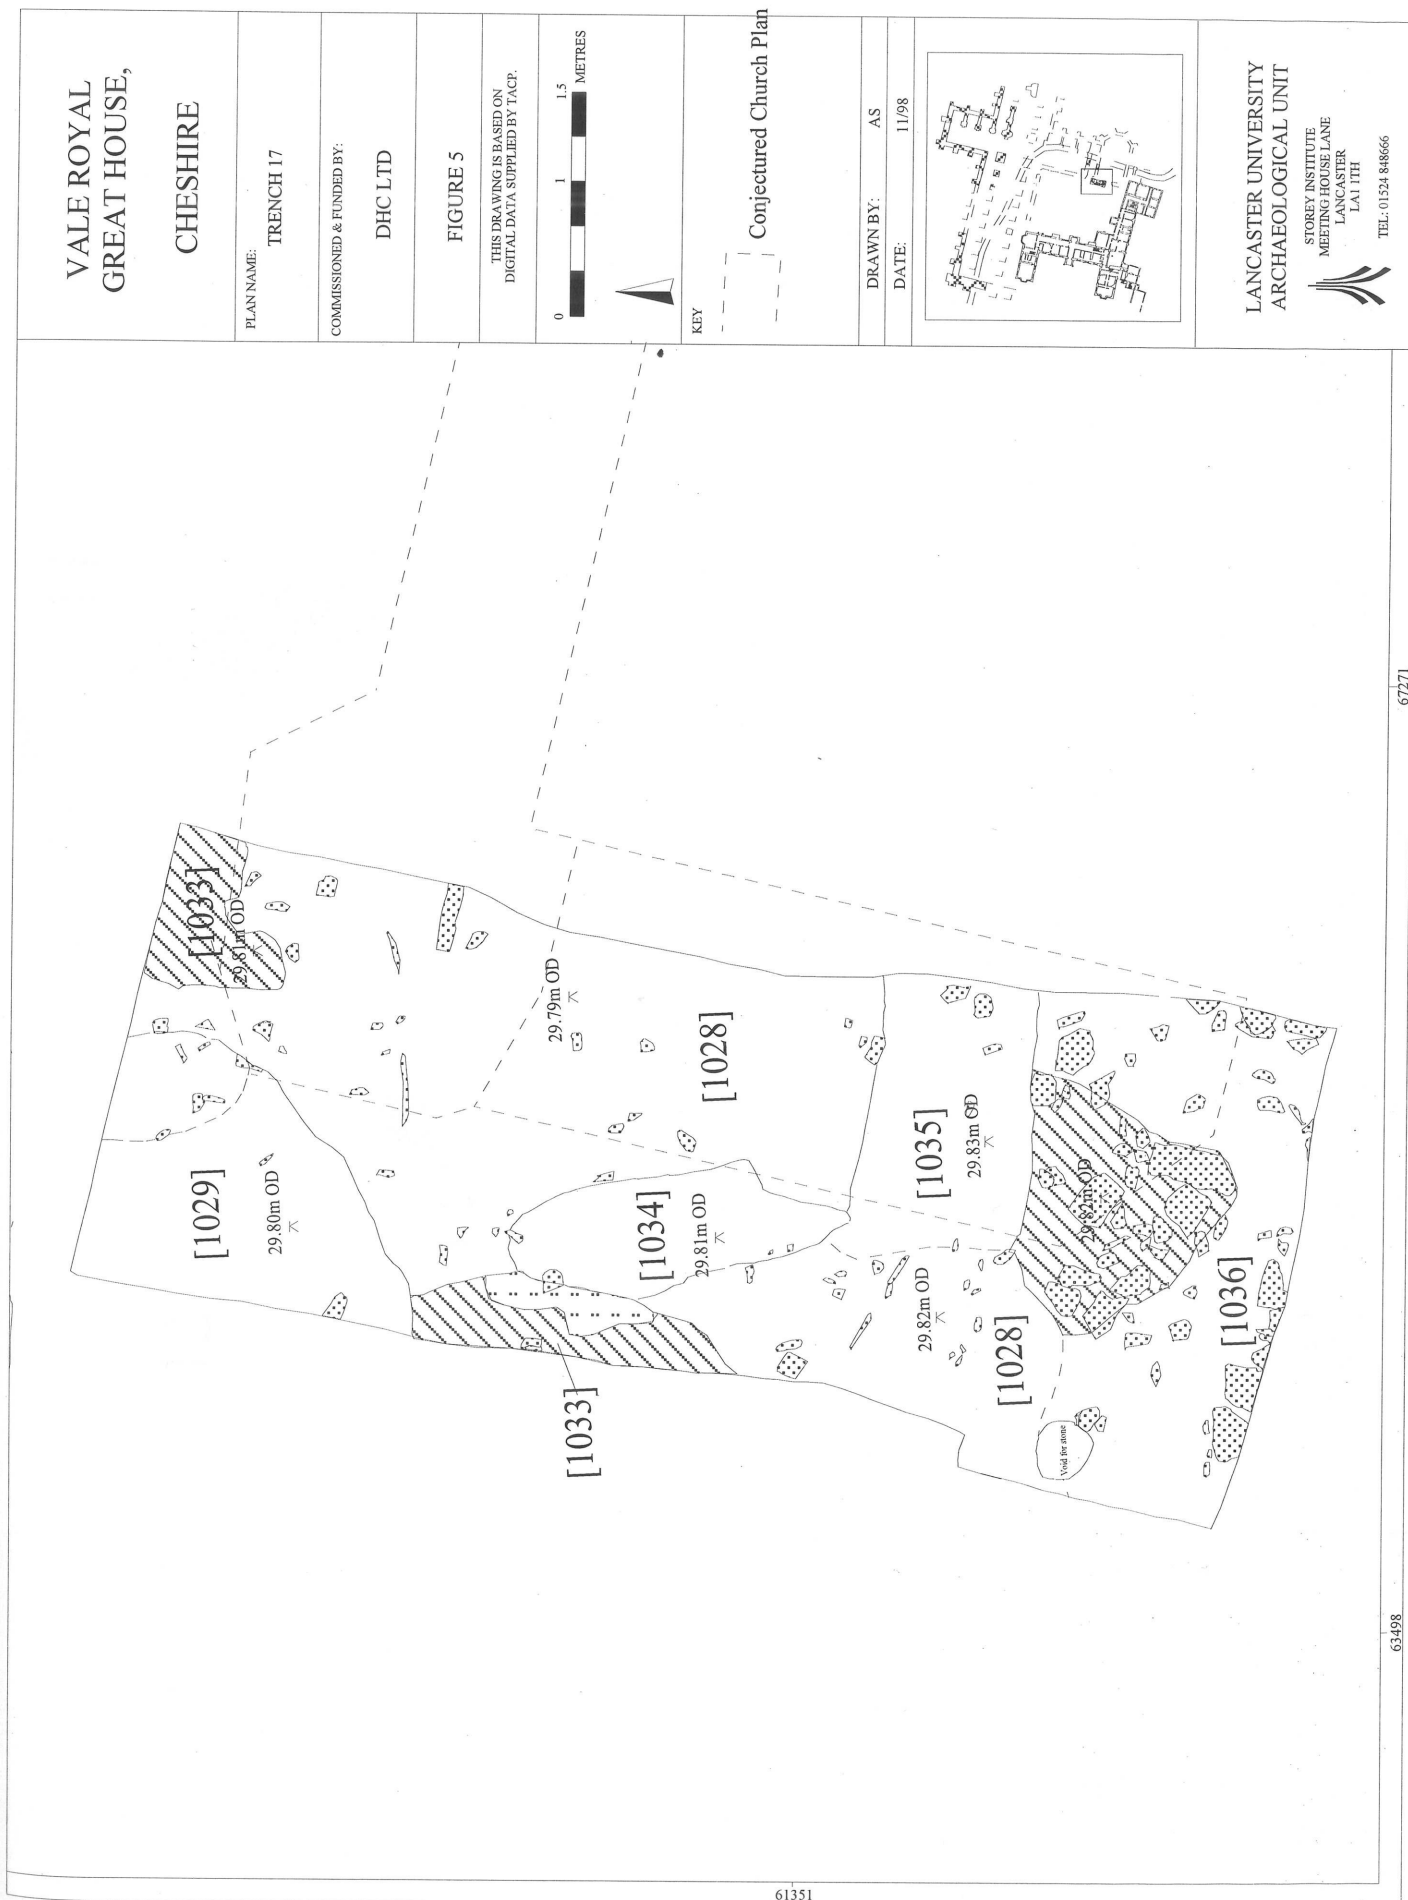
Fig 5 Trench 17 Plan

- 8.1.3 The mortared sandstone revealed at the southern end of Trench 17 also seems likely to be a partially robbed foundation. Its position in plan almost exactly coincides with the suggested location of a pier within the west wall of the chapter house and thus this deposit may also represent an element of monastic foundation.

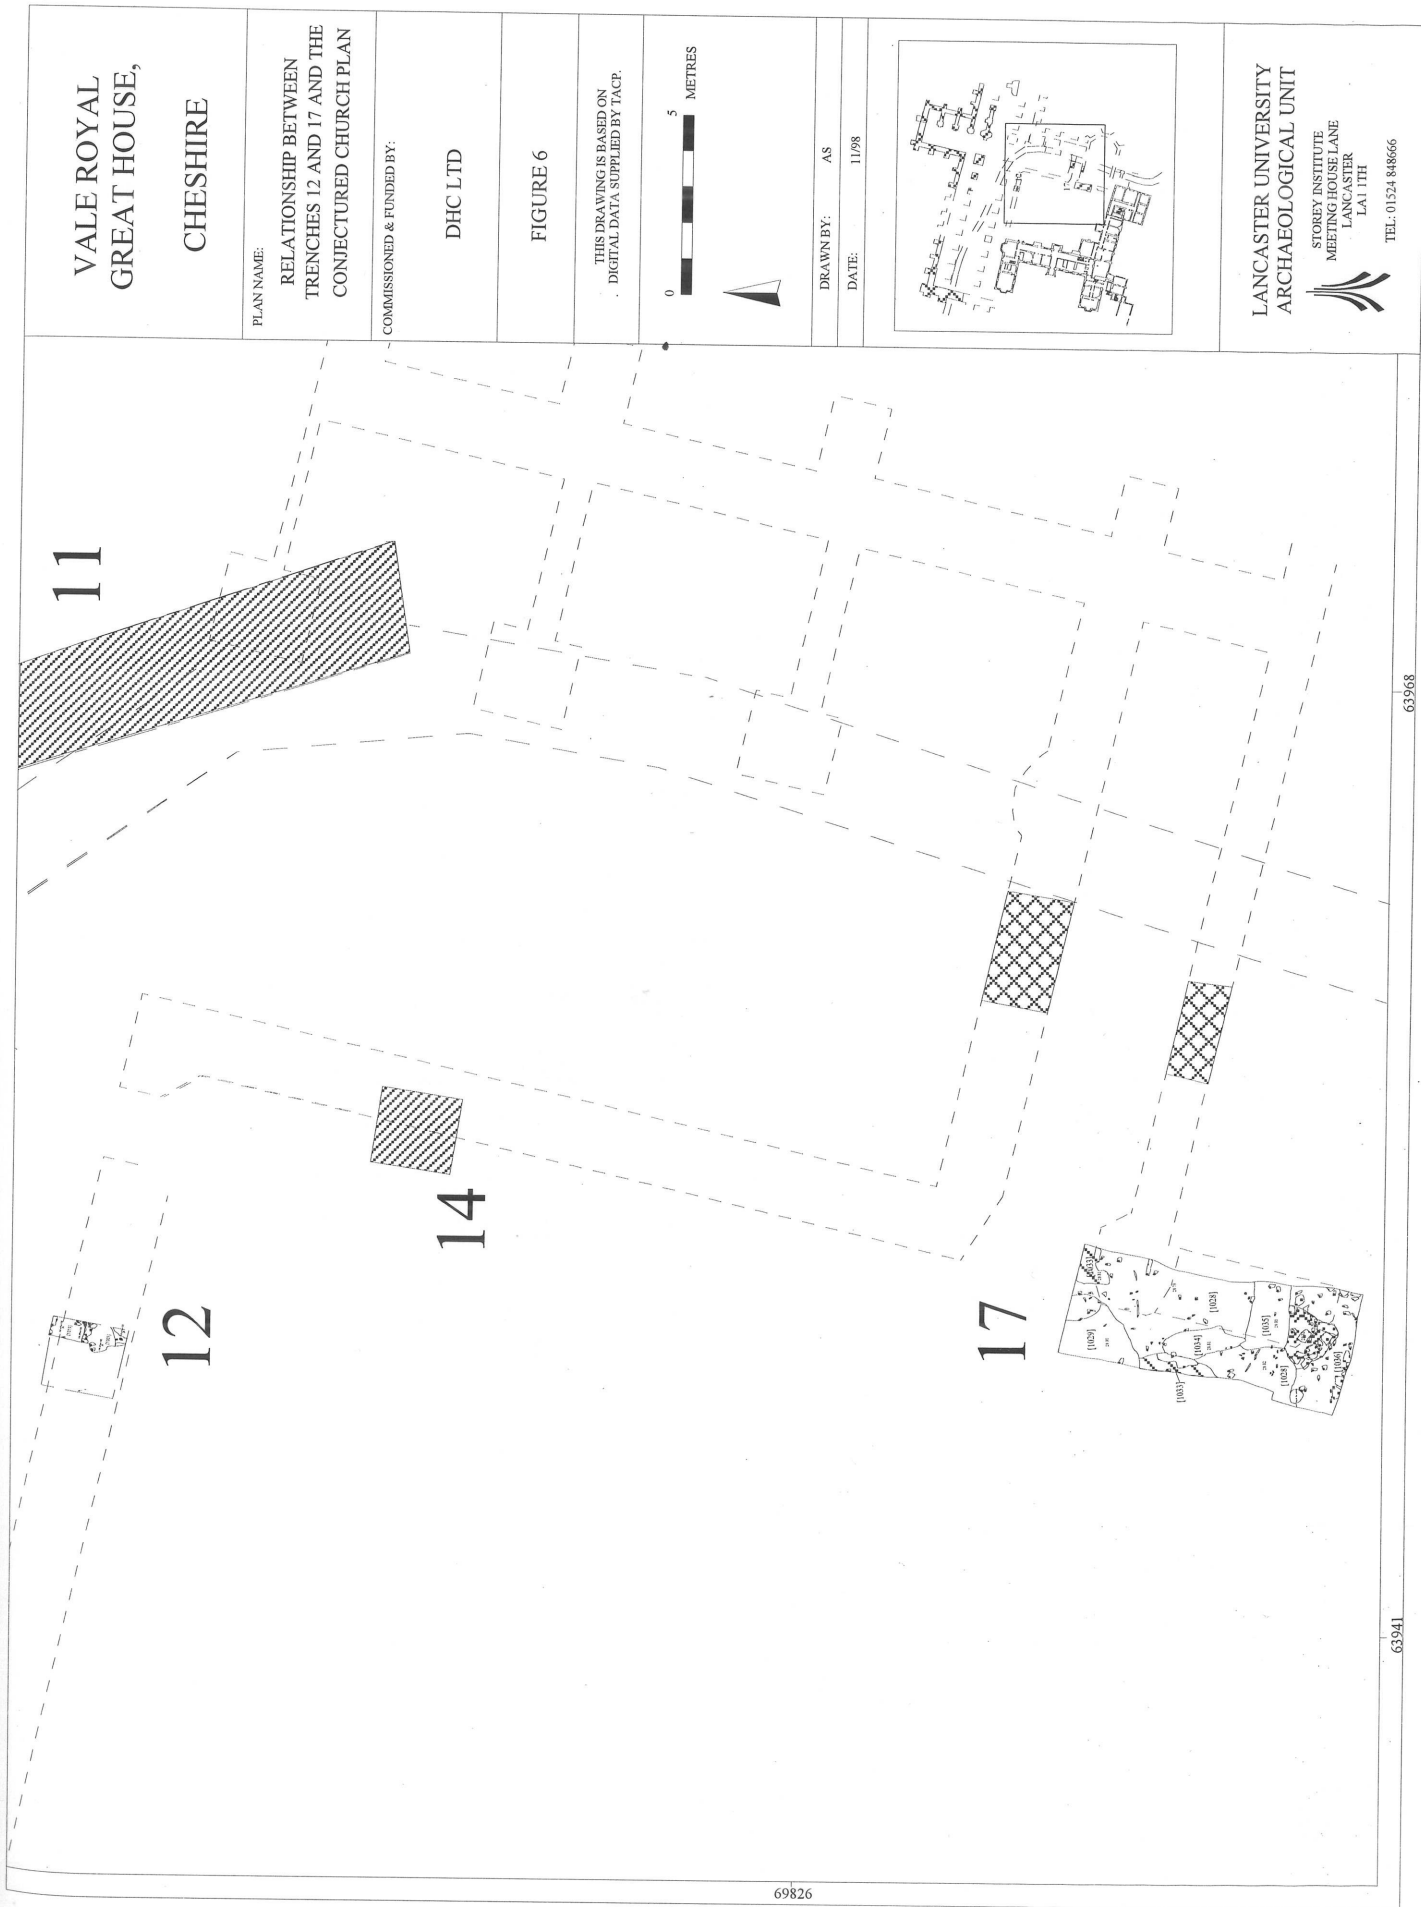
Fig 6 Relationship Between Trenches 12 and 17, and the conjectured Church Plan

- 8.1.1 The mortared foundations revealed in Trenches 1 and 12 shared the same alignment, and appeared closely comparable in terms of form and bonding material. Both lay very close to the putative position of the south wall of the nave of the abbey church, part of which was revealed by an excavation earlier this century (Thompson 1962), c5m to the east of Trench 12 (Fig 3). It is probable that these foundations do indeed relate to the nave of the abbey church, although no artefactual dating evidence was available. The foundation in Trench 12 was sealed by a deposit of sandy silt containing a scatter of loose stone and late post-medieval and modern finds. This may indicate robbing in the nineteenth century, although the absence of ruins on early depictions of the house suggests that the initial robbing out of the wall fabric must have occurred much earlier.

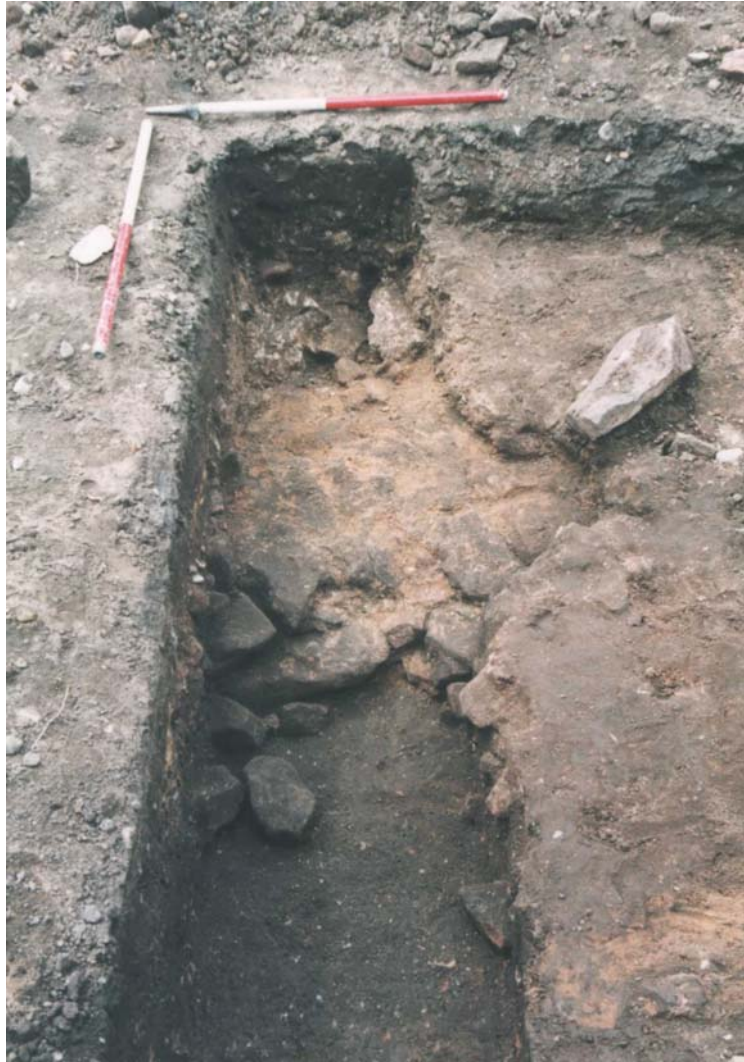
The mitigation excavation for the barrel drop (Trench 1) revealed a mortared wall foundation beneath that for the North West Wing; this is in line with that observed in Trench 12 and was probably the foundation of the nave wall.

Plate 1 Trench 12 – Mortared wall foundation, looking south

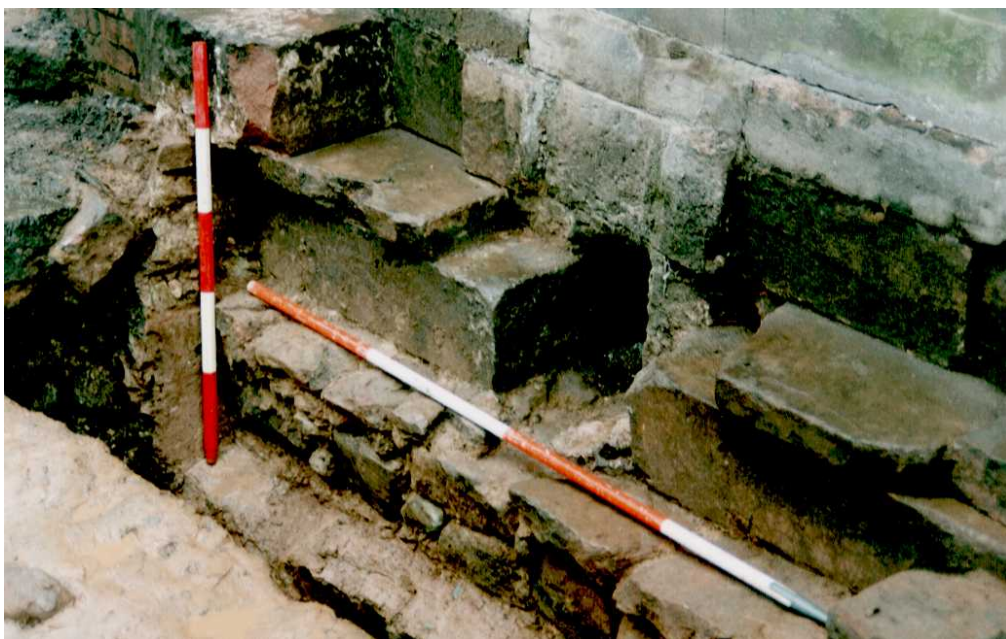
- 4.1.7 The ashlar foundation was in turn built upon an earlier foundation [1042] which projected out an additional 0.25m to the north. This earlier foundation had been built flush against a vertical-sided construction cut which was recorded to the north cutting through natural clay. The foundation was not excavated as it underlay the wall of the present North West Wing, but the natural clay, through which it was cut, was removed for a 2.2m length in the area where the barrel drop was to be constructed so that the foundation's north-facing elevation could be recorded. Foundation [1042] consisted of sub-rounded and sub-angular stones with the appearance of fieldstone cobbles, and roughly hewn sub-rectangular sandstone slabs. They varied in size from c160mm x 160mm x 160mm to c400mm x 300mm x 150mm. The foundation was uncoursed, but the stones were bonded with a very weakly cemented, degraded yellowish brown sandy mortar with frequent small pebbles. This mortar was found to be closely

Plate 4 Trench 1 – Monastic Foundation [1042] looking south-east

- 8.1.2 The foundation in Trench 1 was overlain at a depth of c0.80m by an ashlar foundation apparently relating to the present North West Wing of the Great House, which was probably rebuilt in 1798. The presence of a marked change in building materials so far below ground level suggests that the two foundations related to different structures. Moreover, the mortared lower foundation differed completely from a small area of the foundations of the North West Wing of the house, viewed whilst work was being conducted on the upper side of the vault of the cellar in room G1 (LUAU 1998, Fig 7) and again during the watching brief (*Section 5.2*). Here the foundation of the North West Wing consisted of large roughly squared sandstone blocks loosely bonded with clay. The divergence from the foundations of other parts of the house, and similarity to the foundation revealed in Trench 12, suggests that the masonry at the base of the North West Wing originally related not to an early build of the Great House, but to a structure that continued east of the North West Wing towards Trench 12. The south nave wall of the abbey church is the most likely structure for such a foundation.

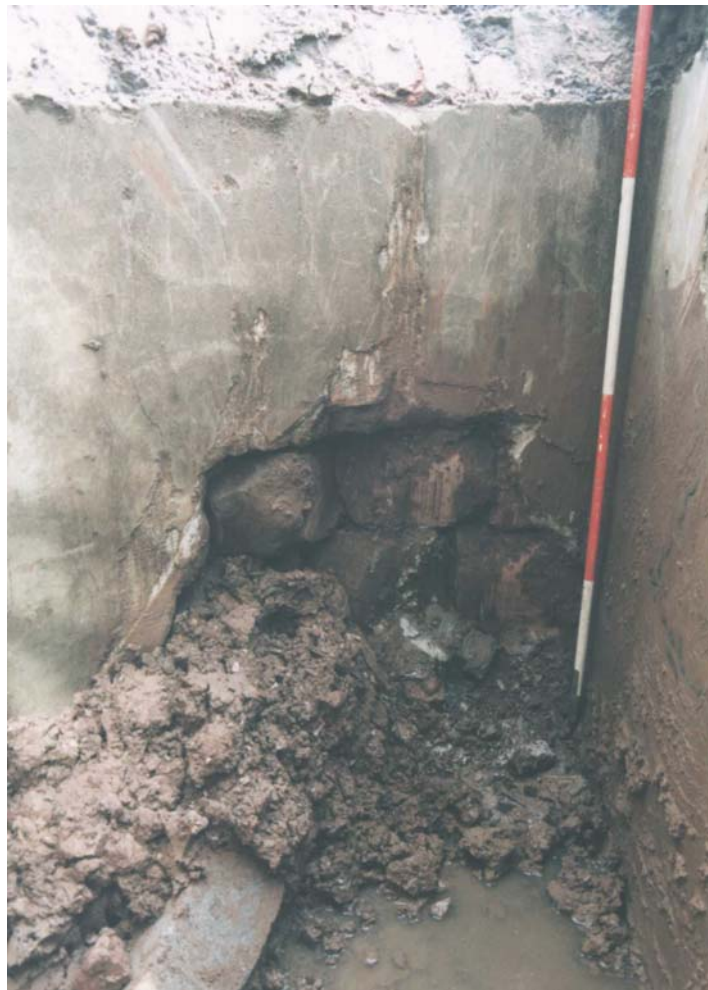
- 4.2.2 An area of sandstone masonry was observed in a hole through the eastern concrete wall of the existing chamber projecting out from the cellar on the site of the proposed staircase. It lay at least 1m below present ground surface, and in theory the masonry should not be disturbed by the insertion of the west end of the staircase at a higher level. The masonry was recorded photographically.

Plate 6 Trench 16 - Sandstone masonry exposed in eastern concrete wall

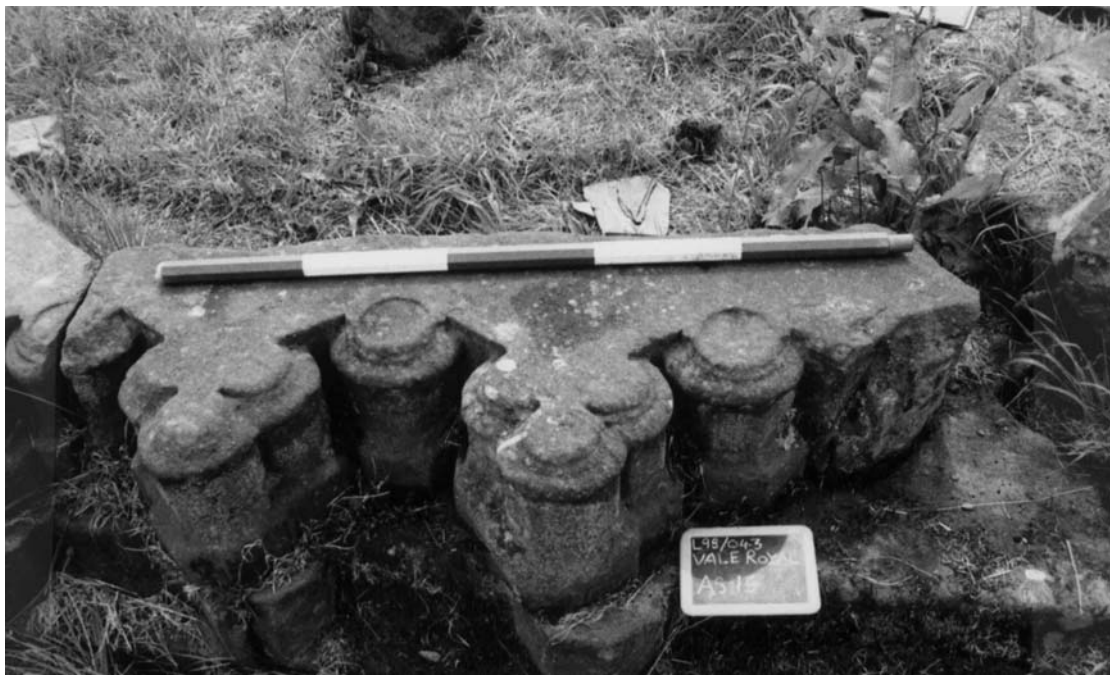
Plate 7 Stone 15 - moulded plinth from Nun's Grave

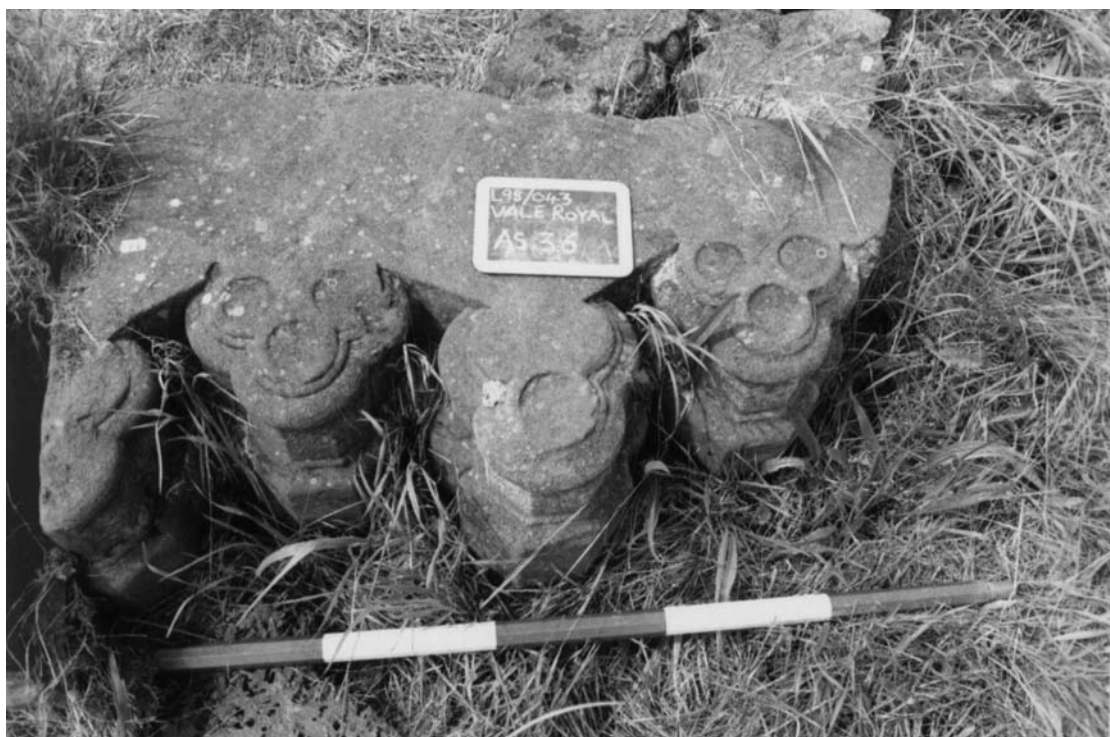
- 7.2.5 There are three further blocks [28, 31 and 32] with mouldings for a variety of composite trefoil and narrow independent columns of various dimensions. Other stones represent a variety of details: [2] is part of a plain chamfered cill; [13] has a part octagonal moulding on one corner; [19] and [21] are very worn pilaster fragments.

Plate 8 Stone 36 - moulded block for trefoil columns from Nun's Grave

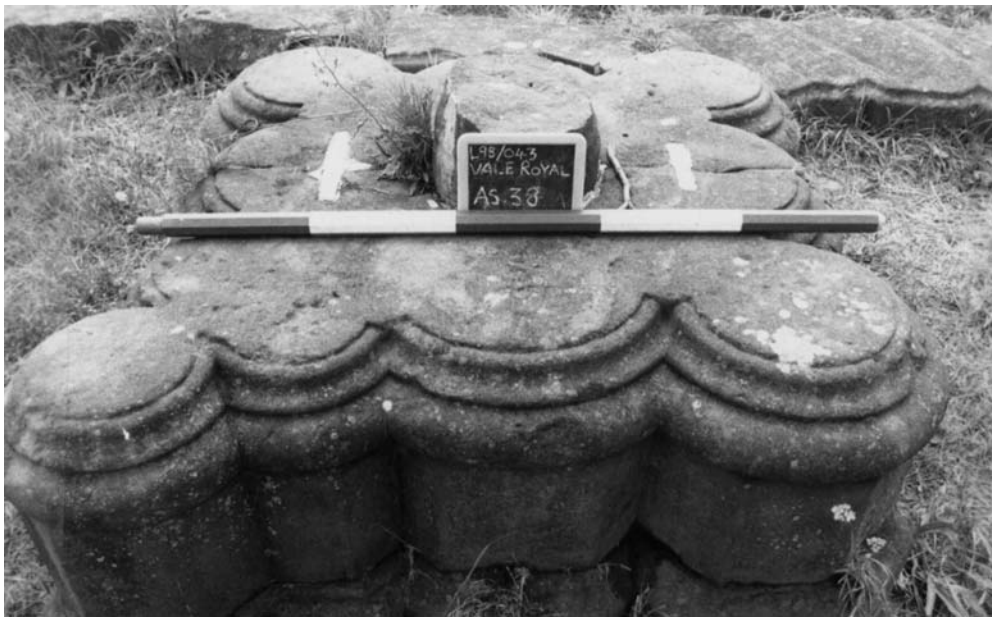
- 7.2.2 The group includes the base of a former cross which had been constructed from four reassembled stones [38-41]. The base was formed from two joining blocks [40 and 41] with angular faceted sides and a worn roll moulding on the torus. The upper section was formed with two further blocks joined with lead clamps [38 and 39]. One stone [38] had bases for two composite columns with a diameter of 268mm, and a base for a trefoil arrangement of composite columns on one corner (Plate XX). The other block [39] had bases for three 268mm composite columns. In the centre of the upper two stones was the broken base of the inserted cross shaft, which had an oval rather than a circular profile.

Plate 9 Stone 38 - Half column plinth with (upper) cushion mouldings on the Torus

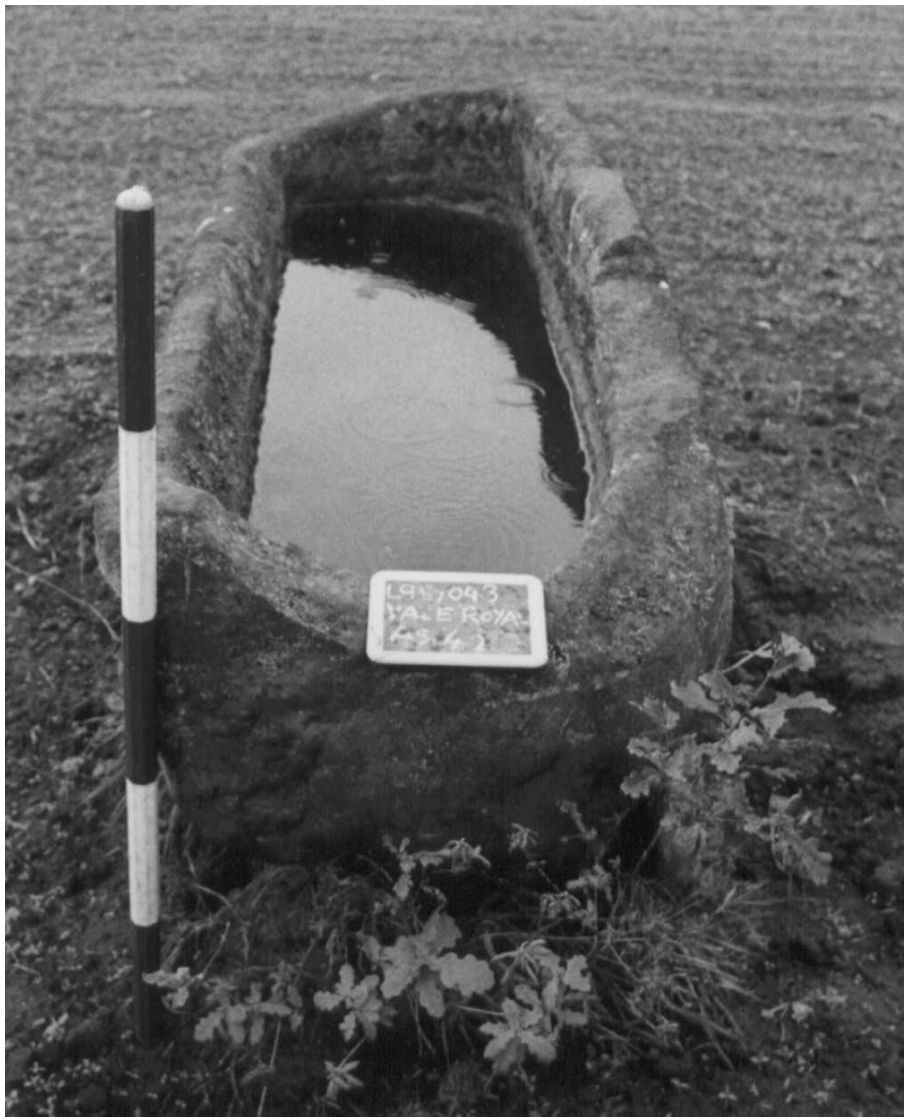
42	Stone Trough (SJ 64015 69801)	Stone trough in field; date uncertain; possibly originally a coffin
43	Stone Trough (SJ 64015 69801)	Cylindrical block with rosettes to outer faces. 360mm diameter narrow grooves in centre of block on opposing faces
44	Stone Trough (SJ 64015 69801)	As 43, these blocks have been used as supports for trough 42
45	Trench 16	Voussoir with identical chamfered and rebated sides
46	Trench 16	Jamb badly damaged remains of roll and hollow moulding to one face
47	Main Entrance	Half barrel section of column shaft 210 diameter
48	Main Entrance	Broken rosette fragment part of block as 43/44
49	Main Entrance	Section of tracery with opposed glazing slots, and dividing rib moulding on one face
50	Main Entrance	Damaged moulded block, remains of moulding to two faces, possibly recut for ashlar
51	Main Entrance	Lower section of chimney stack, square form with concave chamfered corners, octagonal convex chamfered top, circular flue in centre, 260mm diameter

Plate 10 Stone 42 - Stone Trough

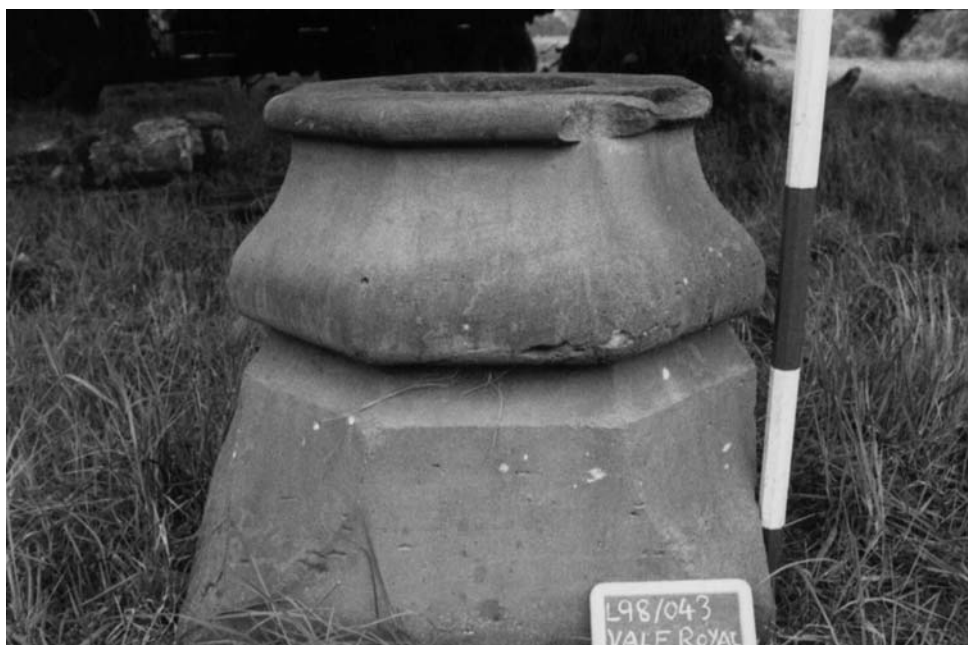
Plate 11 Stone 52 - Upper section of chimney stack

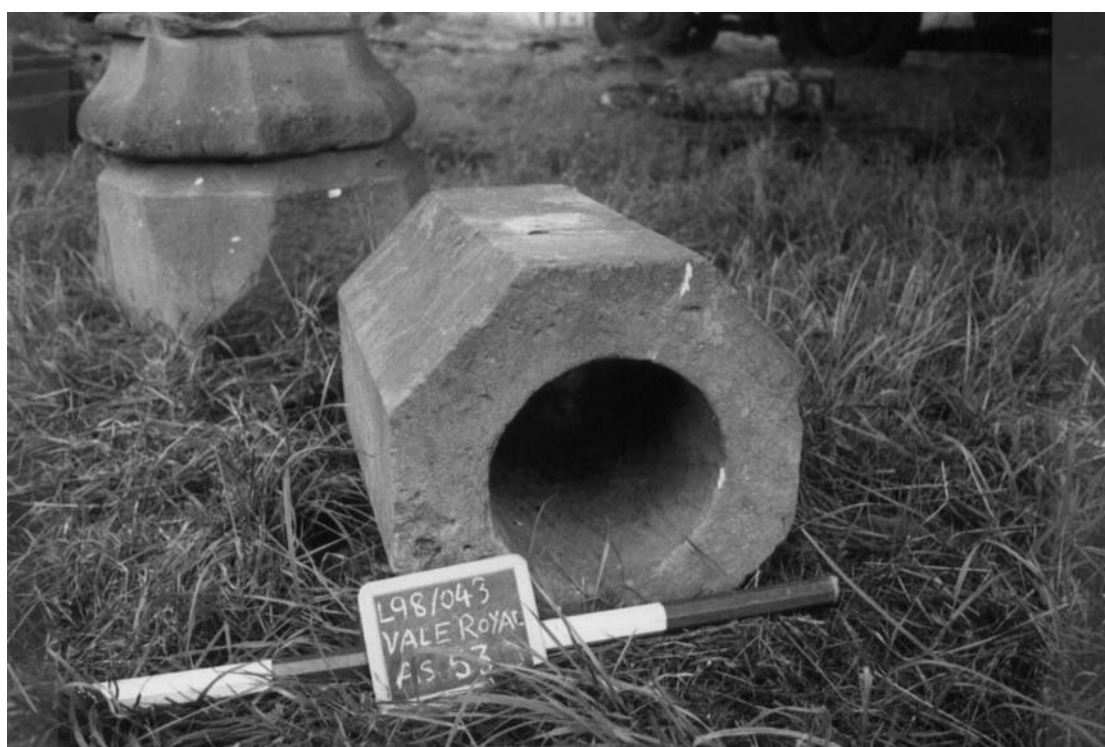
Plate 12 Stone 53 - Octagonal Chimney Pot
