Adeline Genee Theatre
East Grinstead
Surrey

**Historic Building Recording
and Investigation**

Historic Building Recording

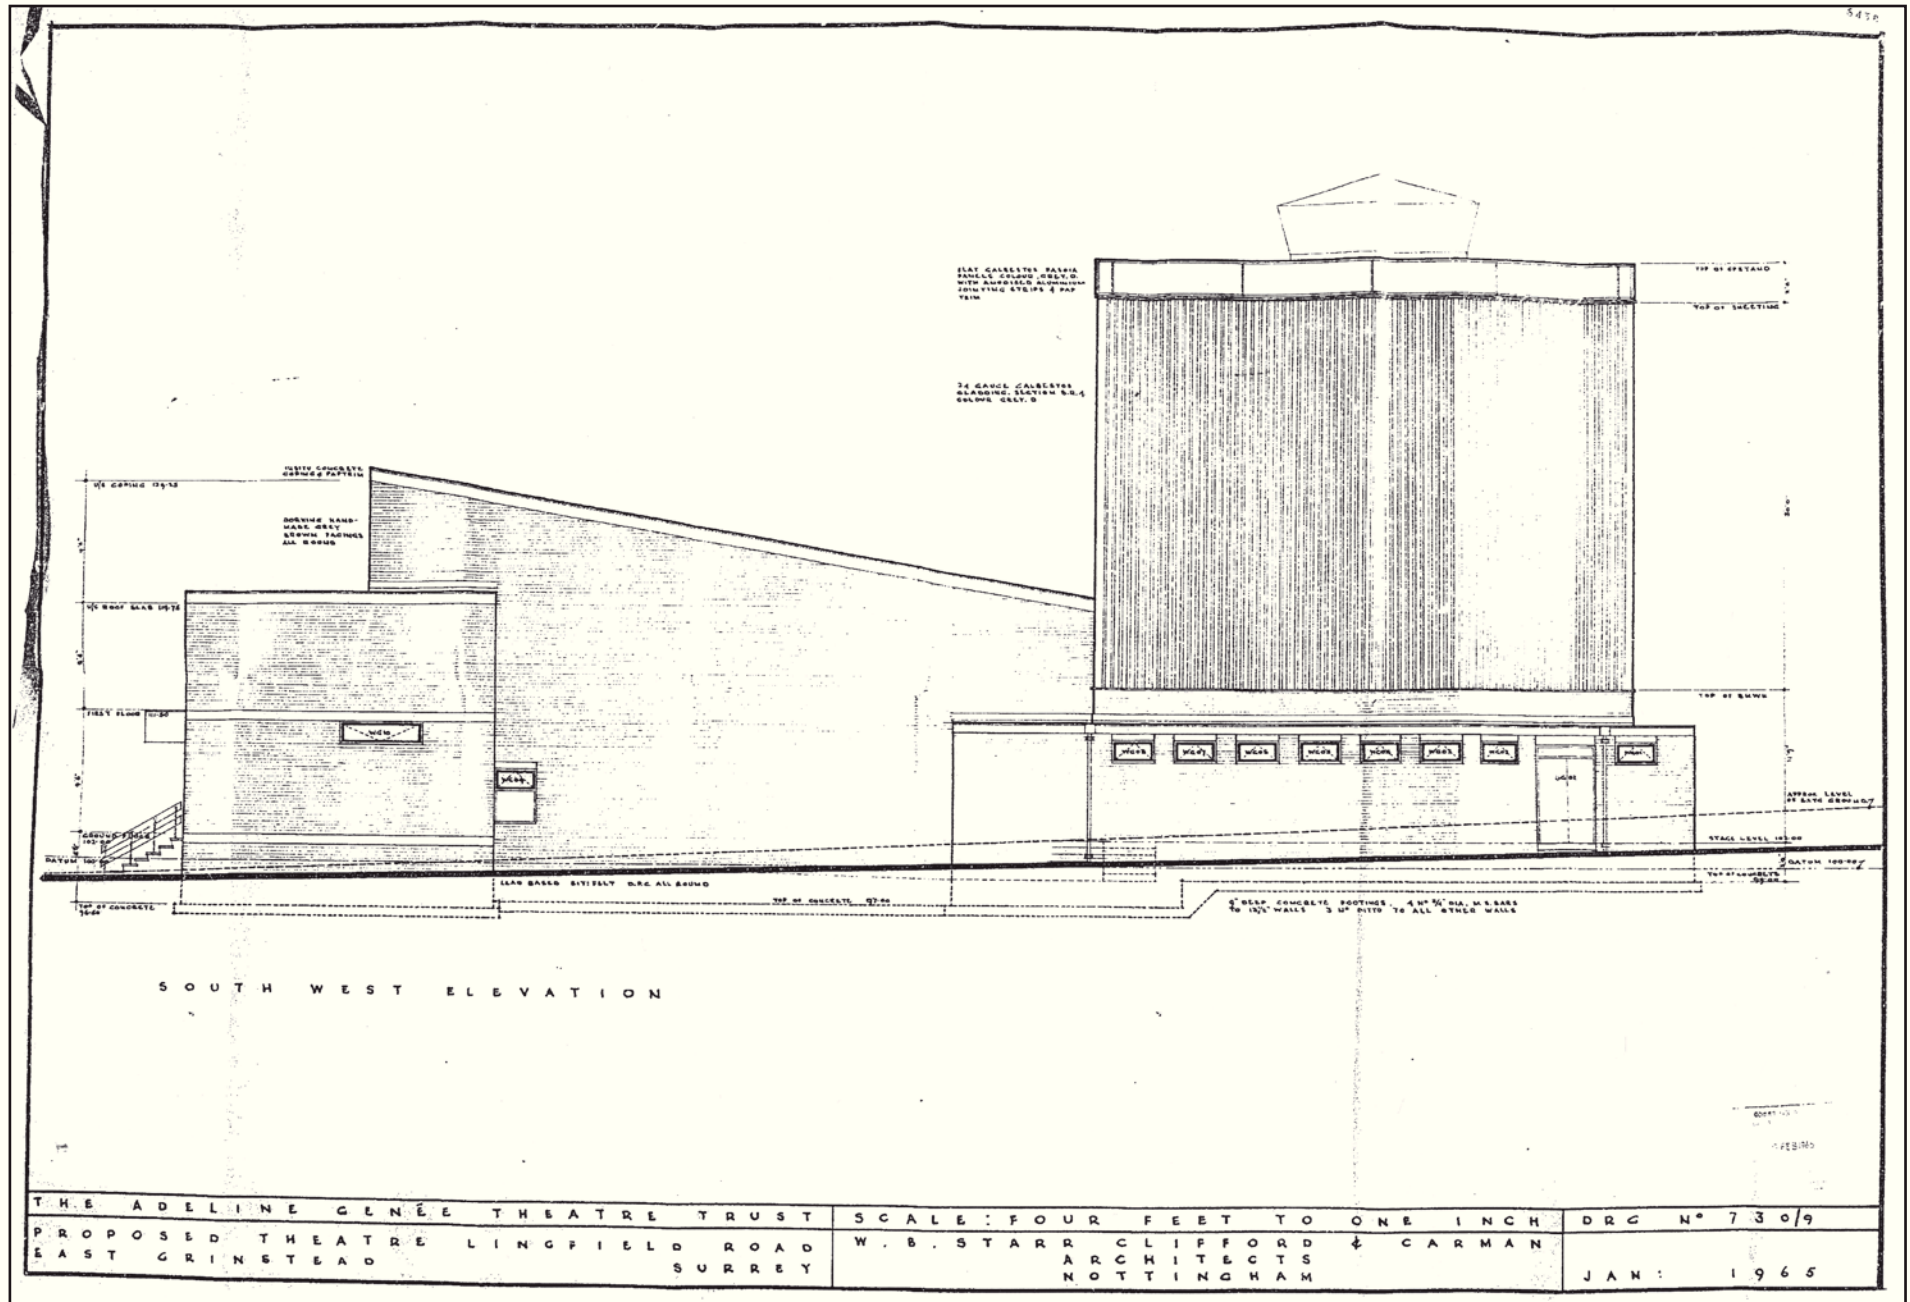
Figure 6: The Adeline Genee Theatre, south-west elevation (prior to extension) (W.B Starr Clifford & Carman Architects, drg no.730/9) (January 1965)

- 4.1.6 The **south-west elevation** provided access to the performers entrance at the south-east end of the elevation and this has '*The adventure begins*' printed in black above the door (Fig. 6) (Plates 2 and 3). The elevation is dominated by a large white fly tower, which is clad in corrugated metal with twelve square windows at its height in three sections below the flat roof. This accommodates the internal stage, dwarfing the single storey brick projection at the south-west half of the elevation, which has a flat asphalt roof above seven small rectangular windows (Plate 4). Internally, this is used as sanitary areas and dressing rooms for the performers. At the south-east end of the elevation is a large rectangular steel roller shutter with a concrete lintel which provides access to the store (see Plate 3). This is an addition to the elevation which was constructed with the linear extension to the south-east elevation, at the rear of the fly passage. Figure 6 illustrates the elevation prior to this extension, whilst Figures 7 and 8 illustrate the later addition.

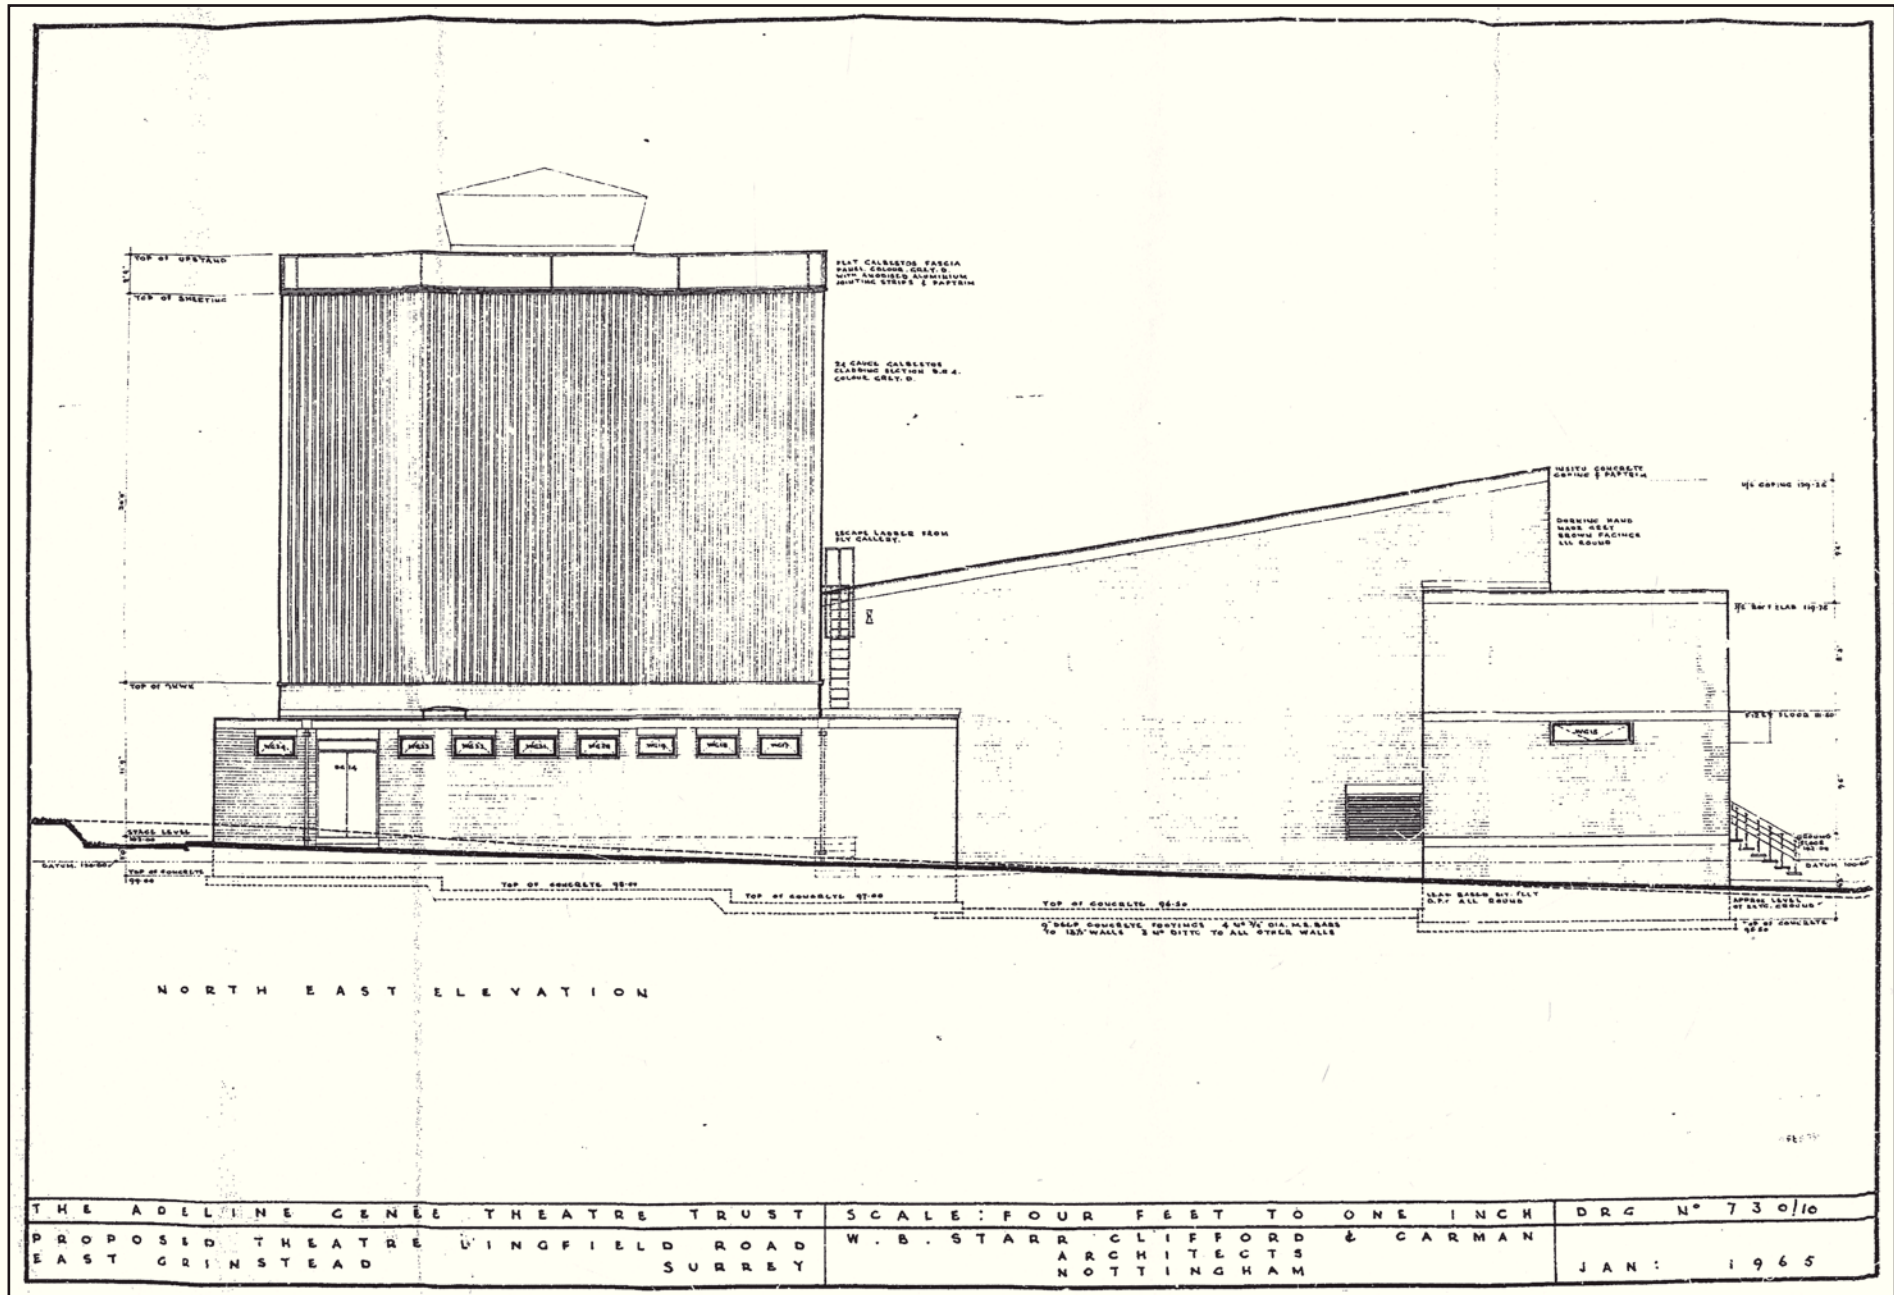
Figure 9: The Adeline Genee Theatre, north-east elevation (prior to extension) (W.B Starr Clifford & Carman Architects, drg no.730/10) (January 1965)

- 4.1.8 The **north-east elevation** was not constructed to be seen as it did not provide access for performers or the audience, it therefore in some respects lacks the uniformity of the other elevations with for example a small boiler room projecting from the elevation (Fig. 9) (Plate 6). It does however have the white horizontal bands, which is the main decorative feature of the theatre. The south-east end of the elevation is similar to the south-west elevation in having an entrance door within a single storey projection, which also accommodates the toilets and dressing rooms (Plate 7). It is of the same form with seven windows over which looms the fly tower above. The north-west end of the building is also of the same form as the south-west elevation, with the projecting entrance lobby extending around the structure to the east elevation. The south-east end of the elevation has been extended to the rear of the fly passage; Figure 9 illustrates the elevation prior to the extension at ground and first floor levels, Figures 7 and 8 show the later addition (Plate 8).

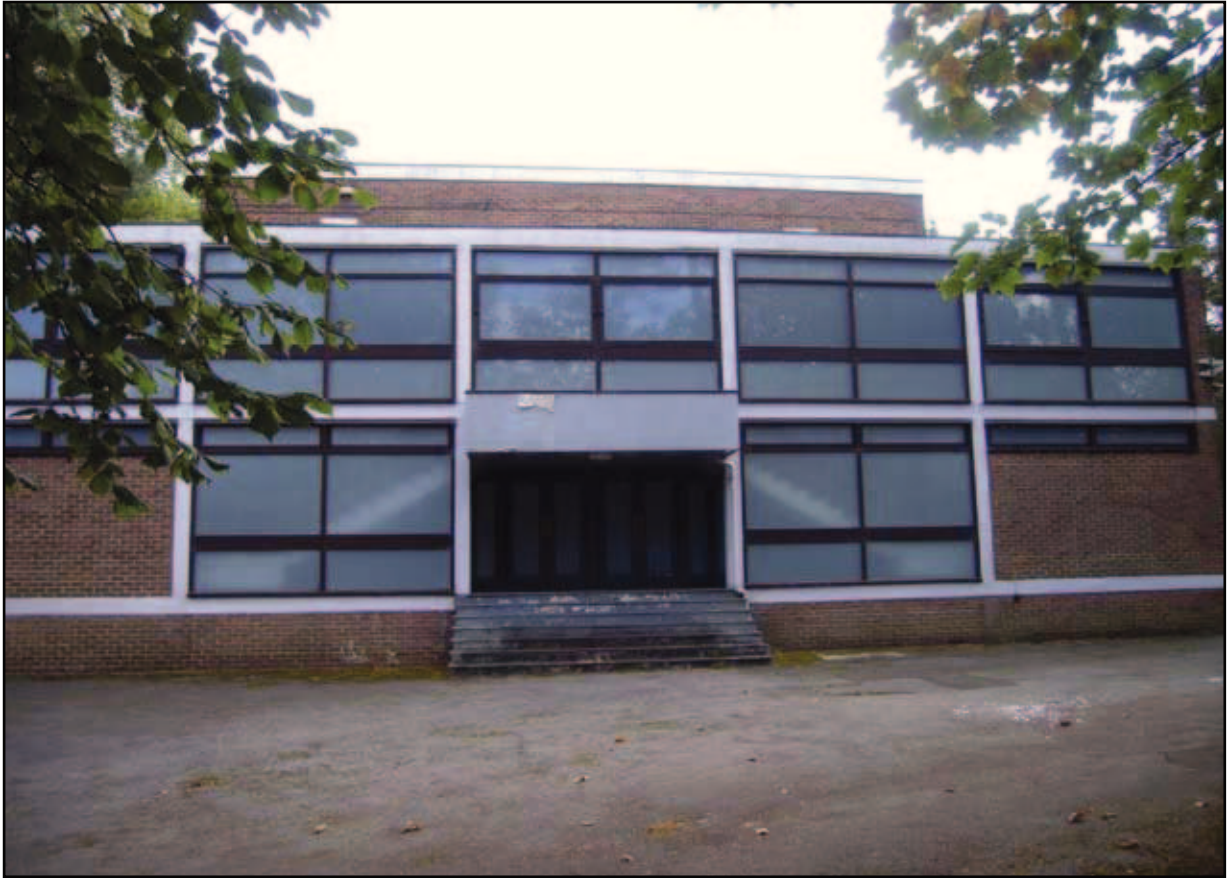
- 4.1.5 The *north-west elevation* would have been the main public entrance to the theatre. It has a mainly glazed façade with a canopy over steps leading up to double doors at the entrance and a narrower set back upper storey (Fig. 5) (see Plate 1). The double entrance doors consist of two sets of doors with single glass rectangular panes, with further decorative static glass panes to each side. The elevation consists of six rectangular glazed

sections defined by concrete bands painted white. This detailing also runs along the top of the elevation and towards its base. Each of the six sections is subdivided into six smaller rectangular sections divided by timber frames, which are mainly decorative as the majority of the sections do not function as windows.

Plate 1: Adeline Genee Theatre, north-west elevation

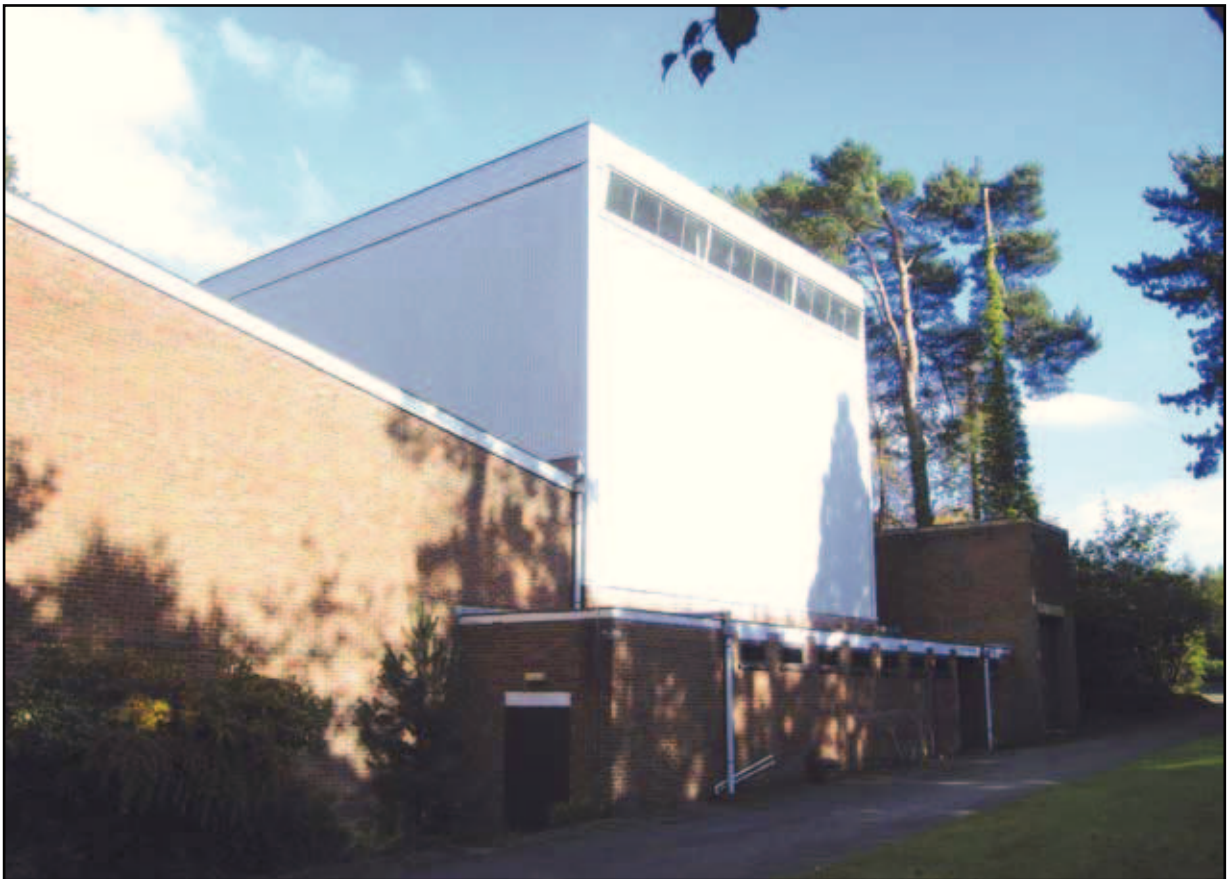
Plate 2: Adeline Genee Theatre, south-west elevation

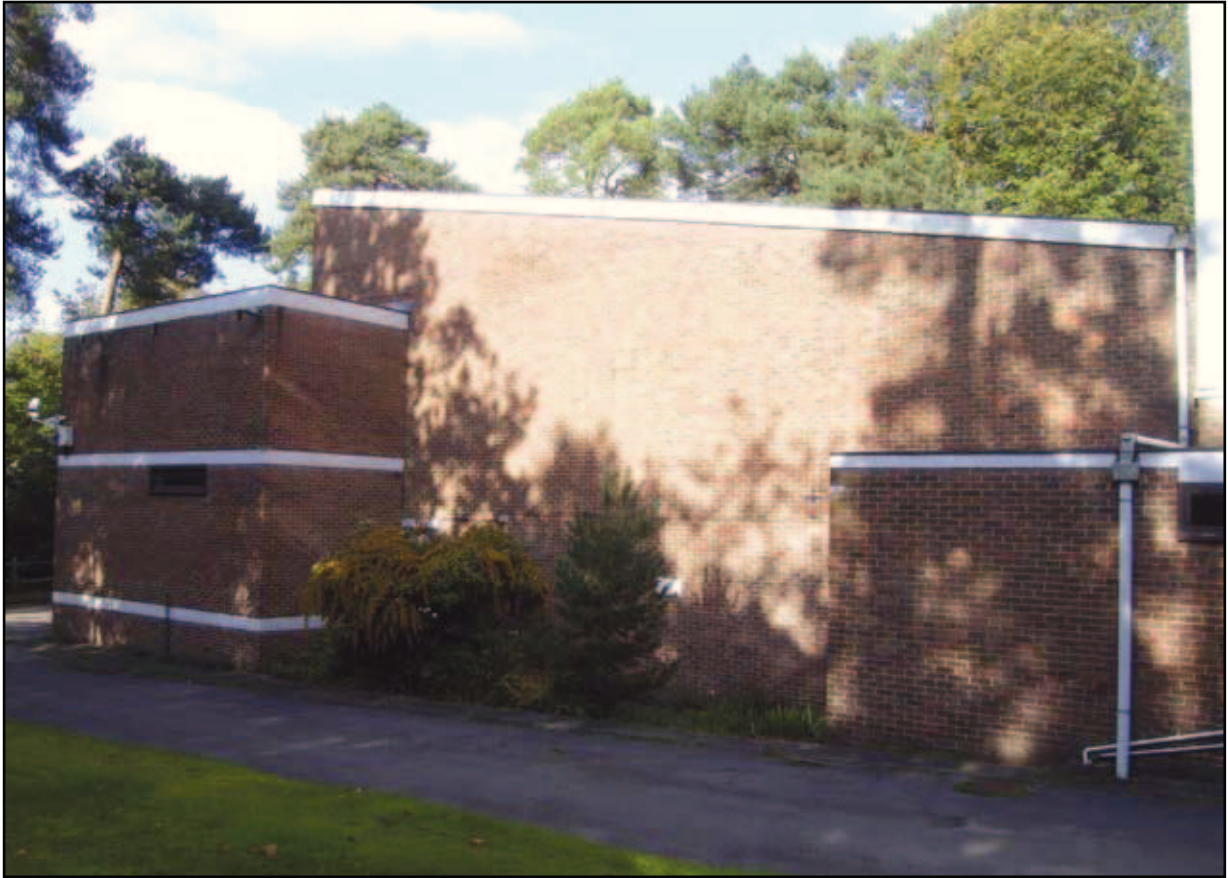
- 4.1.7 At the same alignment and adjacent to the tower is a large windowless section with a sloping asphalt roof which accommodates the auditorium (Plate 5). At the north-west end of the elevation, the entrance lobby wraps around the building in the same alignment as the single storey entrance/ fitting room area described above. This is featureless with the exception of three concrete white horizontal bands.

Plate 5: Adeline Genee Theatre, north view of south-west elevation, depicting auditorium and north-west end

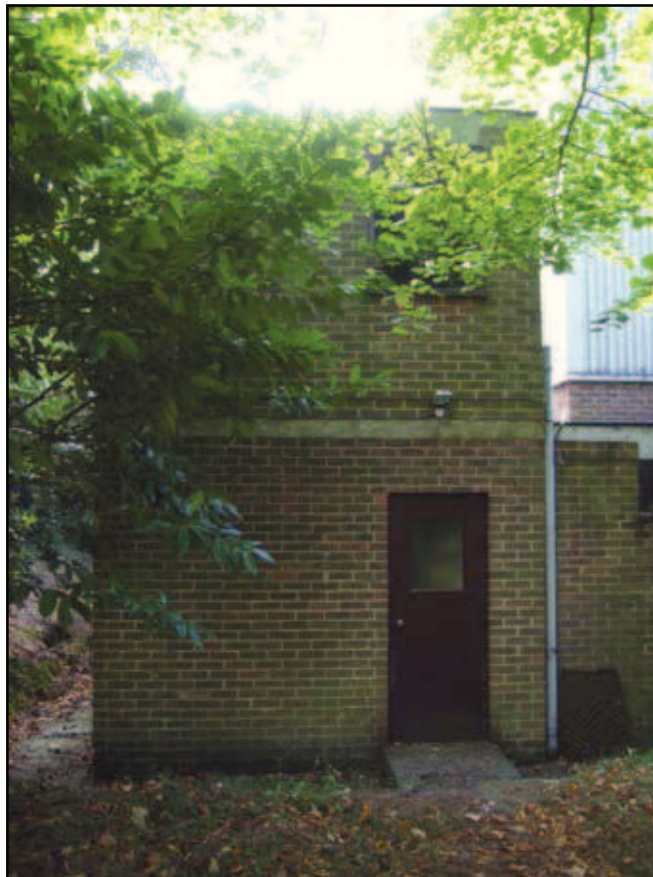
Plate 8: Adeline Genee Theatre, north-east elevation, south-west view showing extension at south-east end to rear of Fly Passage

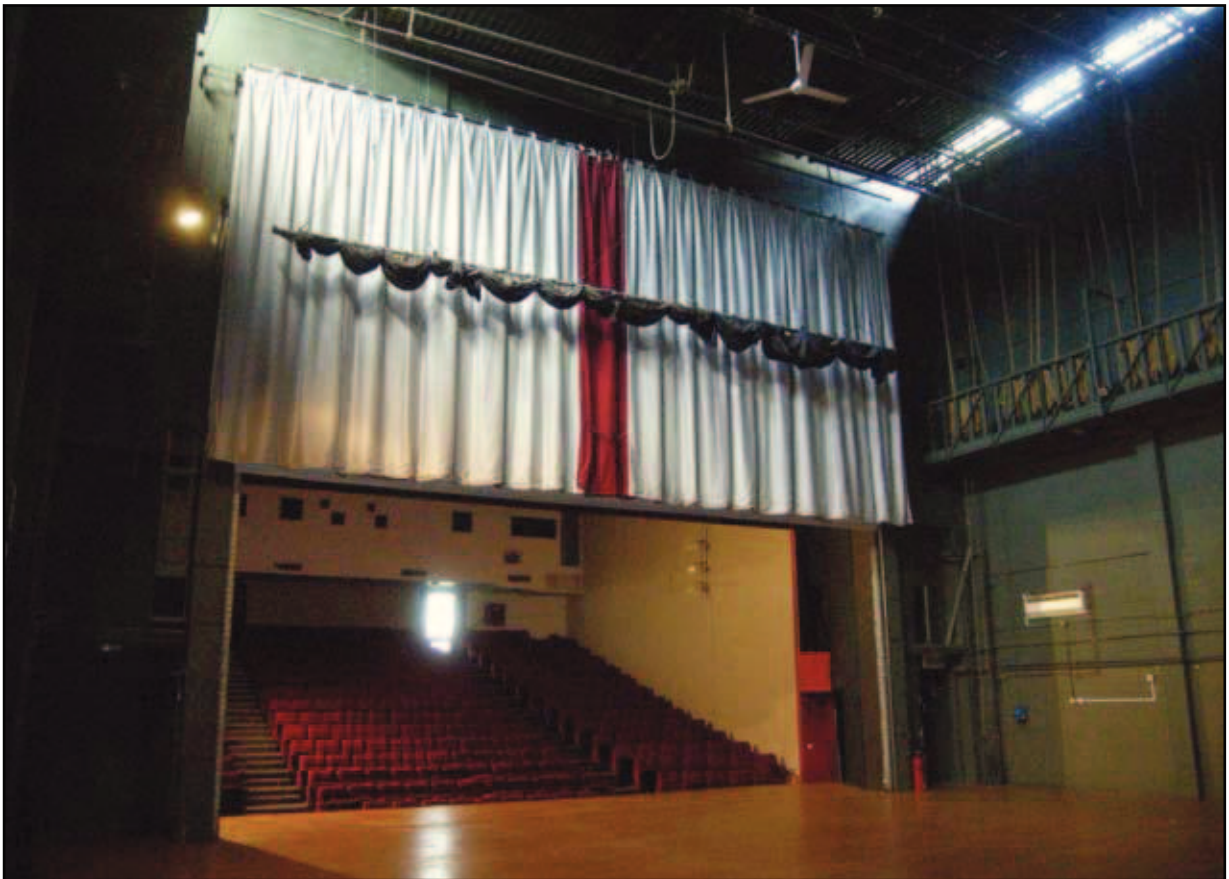
4.1.21 The *stage* is situated centrally within the building with the service areas such as dressing rooms, toilets and foyer situated around these two substantial areas (Plate 10). The stage is a basic open space with bare brick walls painted green/ grey. A balcony extends mid-height on the east and west elevations which are accessed by two metal ladders along the north-east elevation (Plate 11). A circular ladder in the east corner extends the full height

Plate 10: Adeline Genee Theatre, internal north view of the stage and auditorium

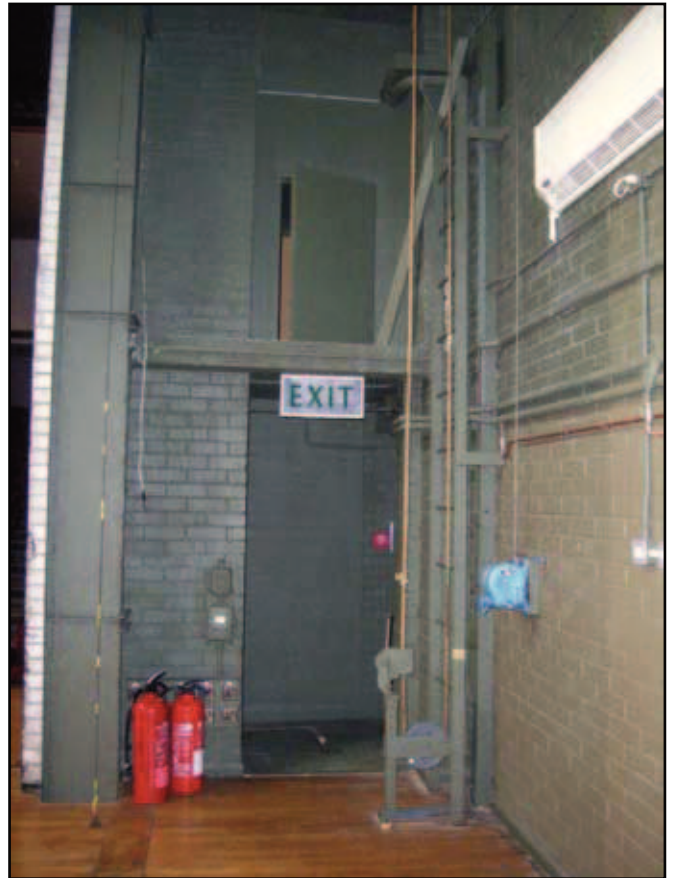
of the elevation, whilst a shorter ladder in the north corner is situated next to the curtain pulley (Plate 12). A balcony running along the north-east elevation holds the ropes used to manoeuvre the fly gallery, which would have been lowered/ heightened as necessary for performances. Along the rear (south-east) wall is a black projection curtain above three fans at the north-east end, otherwise the elevation is of bare bricks painted green/grey (Plate 13).

Plate 12: Adeline Genee Theatre, north-west view of north corner of stage showing curtain pulley and exit

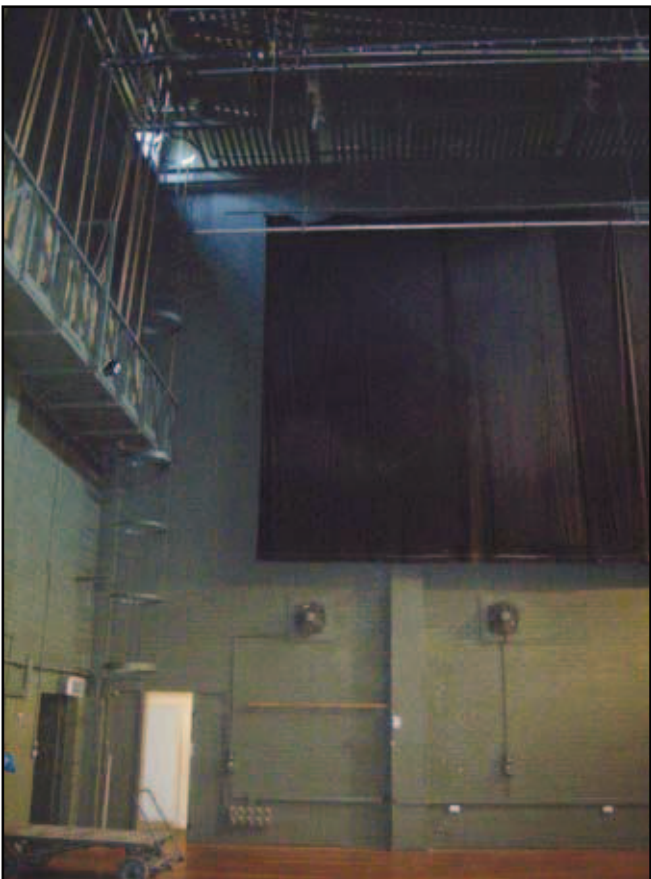
Plate 13: Adeline Genee Theatre, south-east view of stage area showing projection curtain, balcony and exits

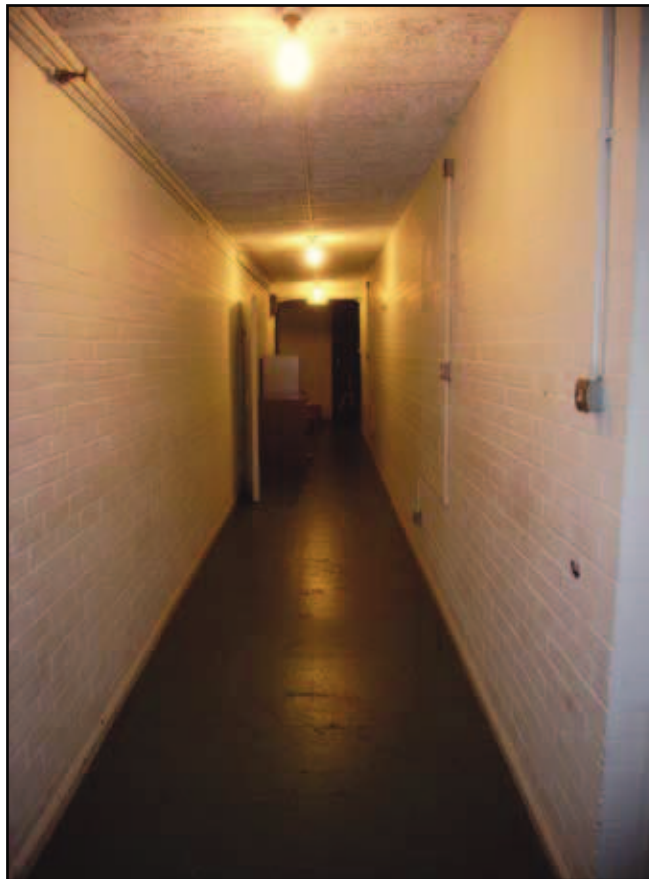
- 4.1.24 There is a fly passage running along the south-east end of the stage with a green concrete floor, white painted bricks walls and light bulbs hanging from the ceiling (Plate 16). This is accessed from the stage area by two doors with two additional doors to the rear of these providing access to a series of rooms at the south-east end of the building. The rooms to the rear (south-east) of the fly passage are a later addition as illustrated on Figures 7 and 8. These include *offices* at the north-east end of the building which are plain empty rooms used (north-east to south-west) as offices for the Stage Manager, Production Manager and Staff Room (Fig 8). These are basically decorated with white painted brick walls and carpeted floors.

Plate 16: Adeline Genee Theatre, south-west view of Fly Passage

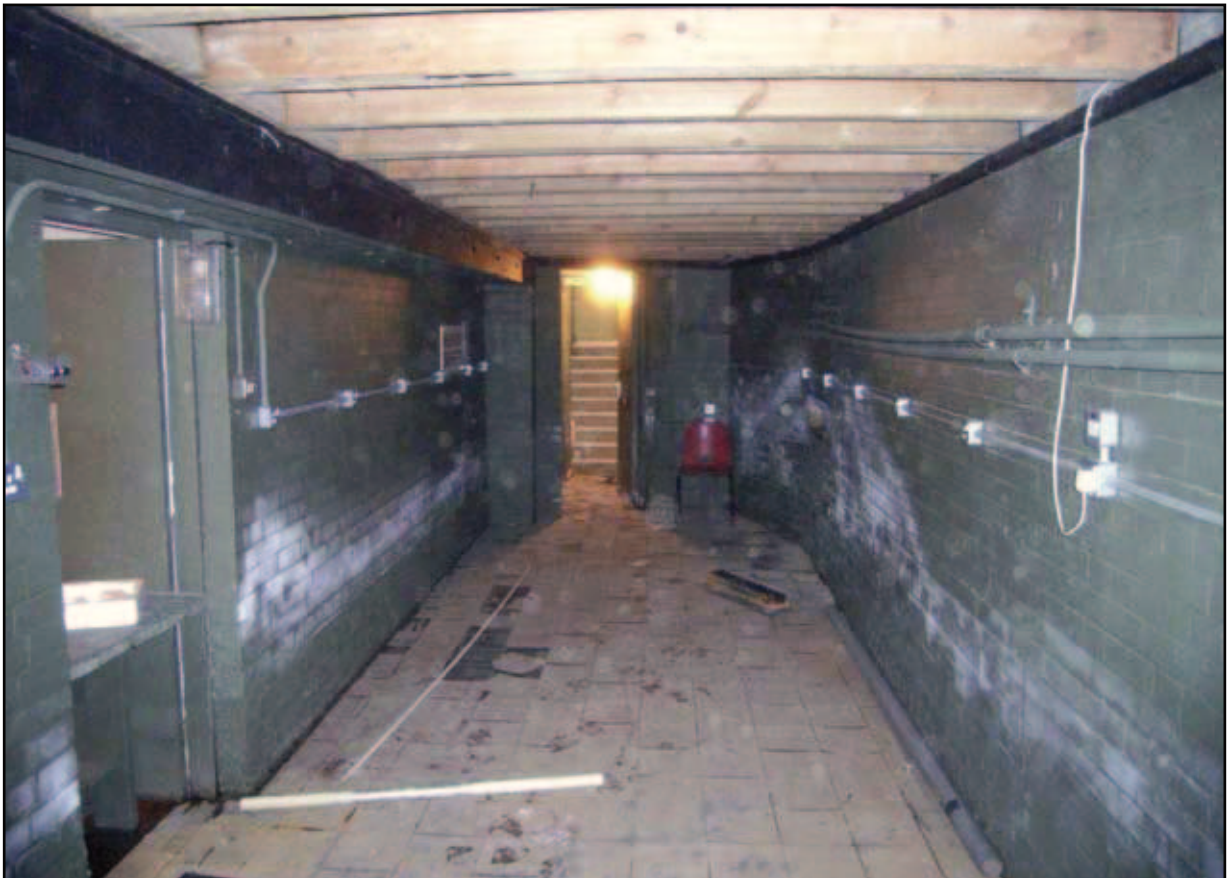
4.1.15 The main orchestra pit (Room A) is c.11.75 m long by 2.37 m wide and although it is broadly rectangular the plan tapers slightly at each end. The room is c.2.1 m tall up to the underside of the secondary floor joists which must have been added in recent years and which greatly alter the character and understanding of this space as a part of the auditorium. These secondary joists are of unpainted softwood while the floor of the pit is a concrete slab, covered in floor tiles which have partially peeled away due to the damp. The walls are of unplastered English bond brick, painted green, and at the top of the two long walls there is a band of concrete. The concrete at the top of the south-east wall would have formed the edge of the stage and it cantilevers over the wall between orchestra pit and band room by c.30 cm.

Plate 27: Orchestra pit from north-east

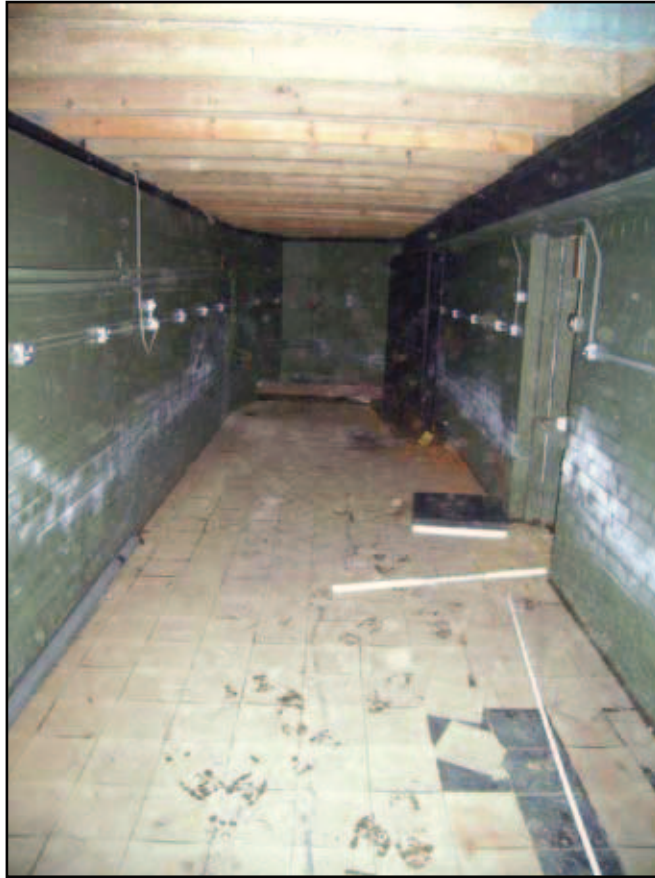
Plate 28: Orchestra pit from south-west

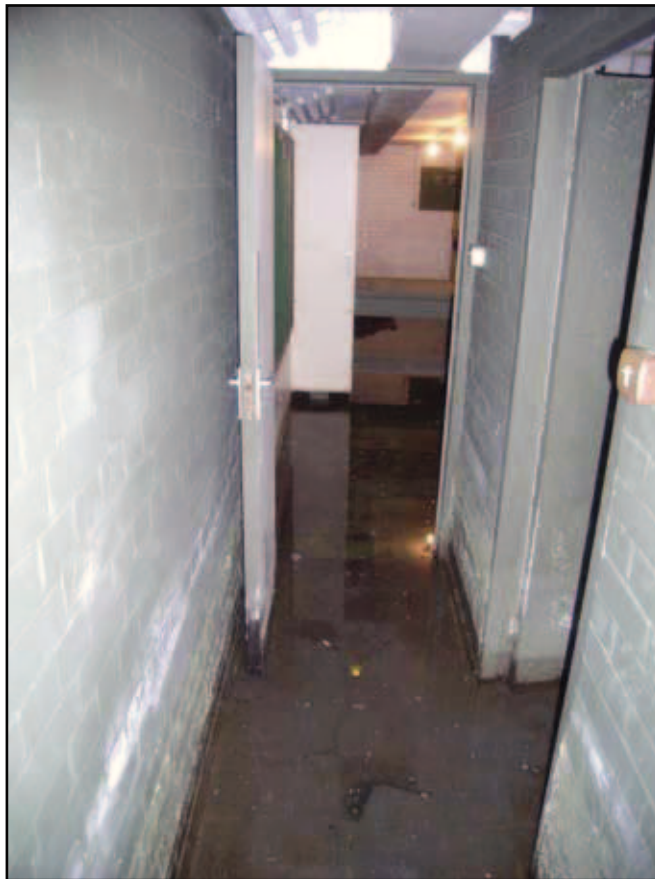
4.1.17 The Band Room (Room B) is in the south-eastern half of the basement and is either reached from the stairs to the south-west or through the interconnecting door in the wall adjoining the orchestra pit. The main body of the Band Room is 7.75 m long by 2.77 m wide although at the south-western end there is also a narrower corridor. The floor of the Band Room is c.15 cm below that of the orchestra pit and the room has therefore suffered more than the Orchestra Pit from flooding. It has a concrete slab ceiling (the underside of the stage) which is supported by brick walls painted white and there are traces of floor tiles on the concrete floor.

Plate 29: Towards Band Room from south-west

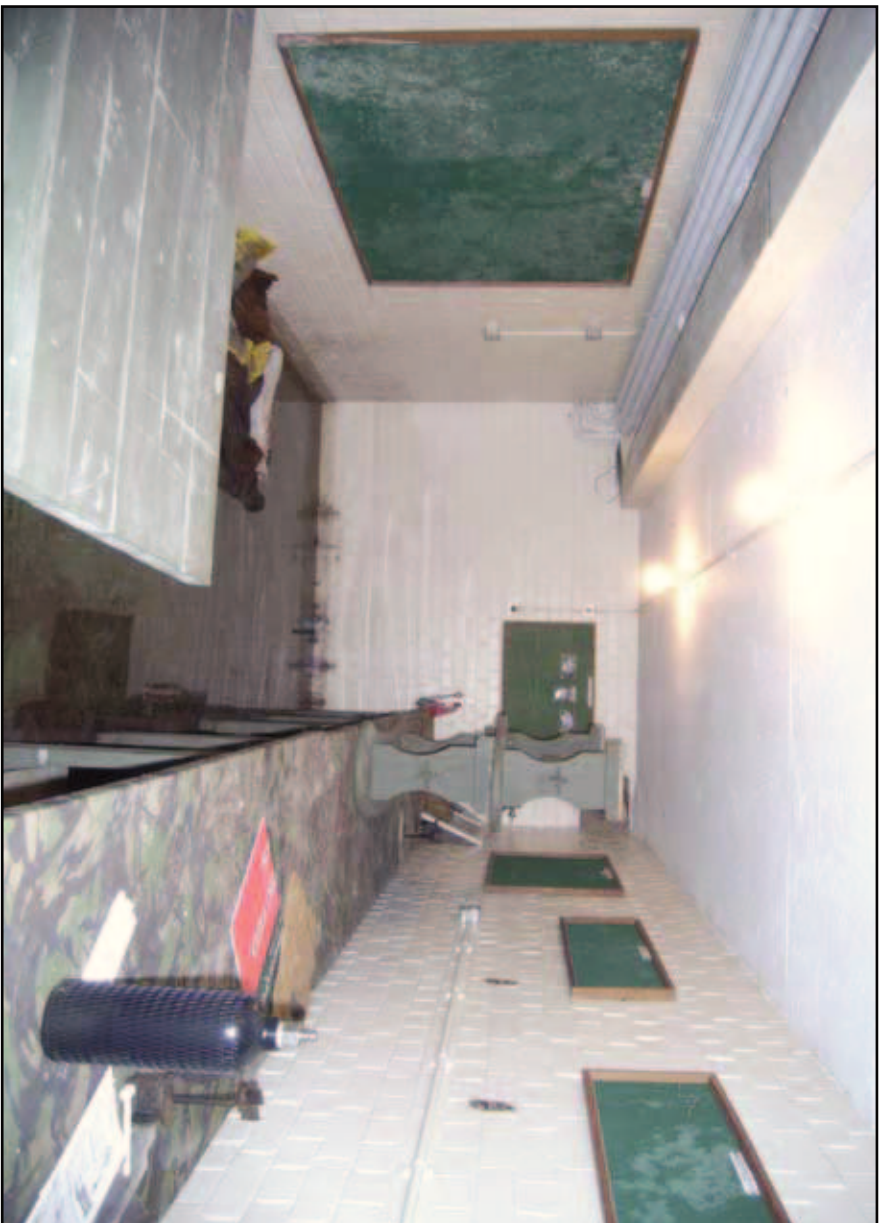
4.1.18 This room appears to have been used in recent years for some form of pseudo-military 'war games'. There are seven notice boards with signs for 'small arms USA', 'Small arms; edged weapons', 'protected weapons' etc written on. There is also a long work bench with a camouflage design material over it and there are various pamphlets in the room relating to ammo reloading. There is also a reloading machine fixed to the bench.

Plate 30: Band Room general from south-west
