**ASH GROVE COTTAGE**  
**NETHER KELLET**  
**LANCASHIRE**

**Interim Fabric Survey Report**

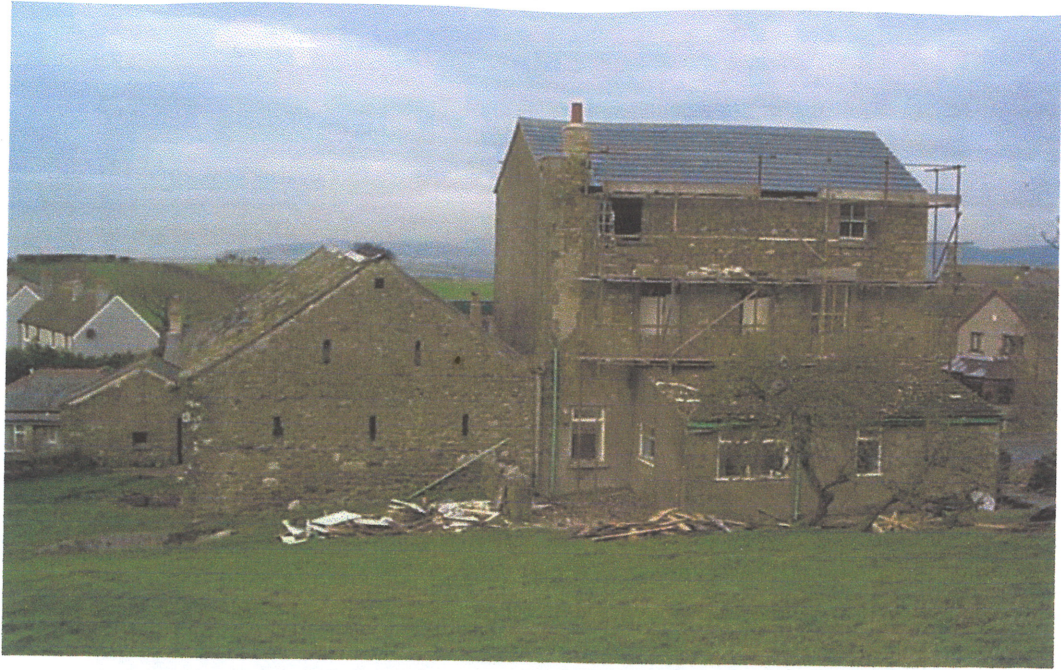
Plate 1 Cottage and Barn exteriors looking north-west

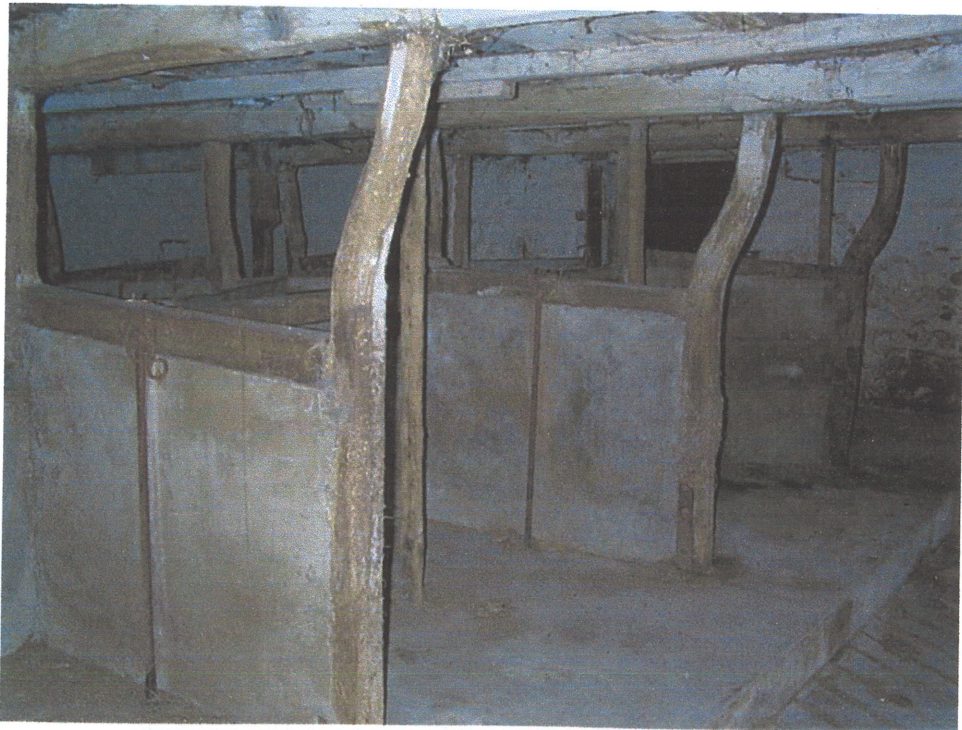
- 3.1.5 Internally the barn was little altered, except that the floor to the cowhouse had been concreted. The cowhouse comprised a central feeding passage with flanking manuring passages, each split into four double stalls (1.9m wide) with a central timber stanchion in each as well as tether rings on the stalls. The area above was used as a loft. The eastern part of the barn was a threshing barn with a flagstone threshing floor located across the centre of the barn.

Plate 2 Cattle stalls within the western end of the barn

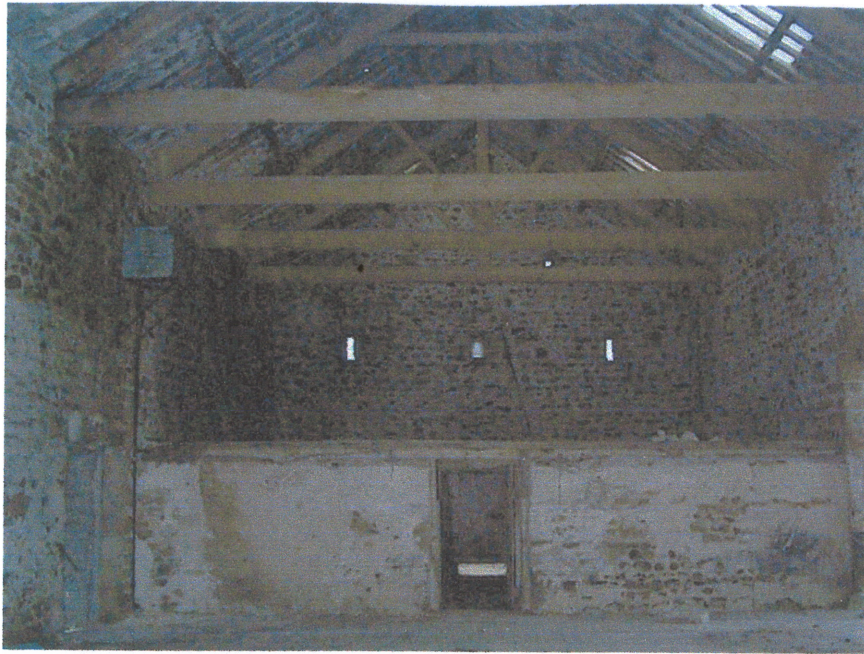
Plate 3 Eastern interior of the barn

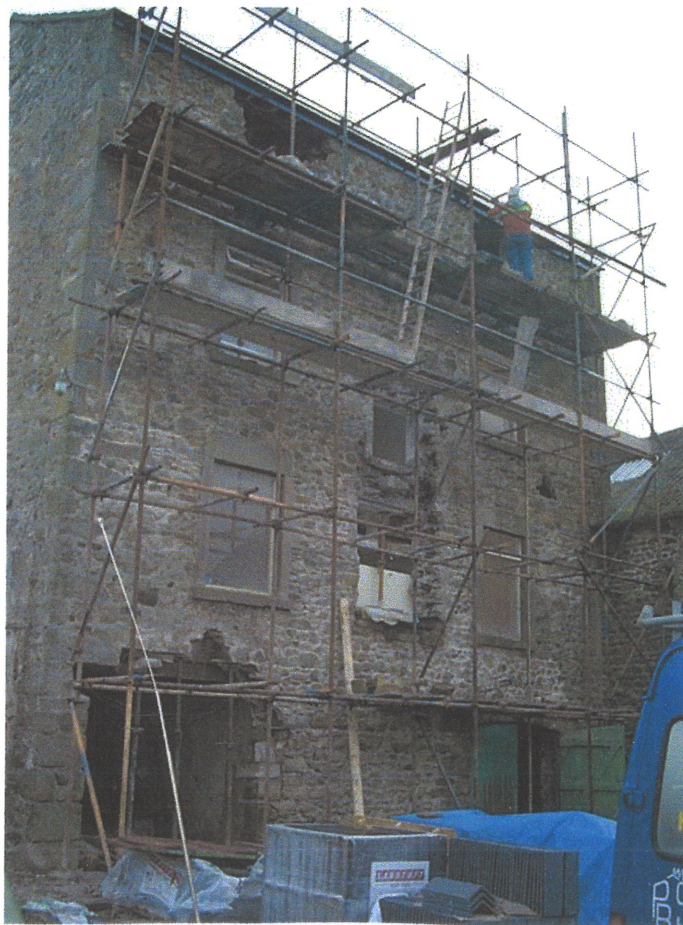
- 3.2.5 Externally, the house was quoined on all corners, with all original windows having stone lintels, sills and jambs. The southern elevation and part of the eastern elevation and outshut were rendered, and, although the quoin stones on the eastern elevation were continuous with the eastern elevation of the barn, there was a possibility of a rebuild *c* 1m to the south, suggesting that the barn may predate the main house. A mortar wall scar was also observed on the northern elevation of the house, suggesting that there was, at some point, a small structure attached to the lowest storey to the west of the main door.

Plate 4 Western external elevation of the farmhouse

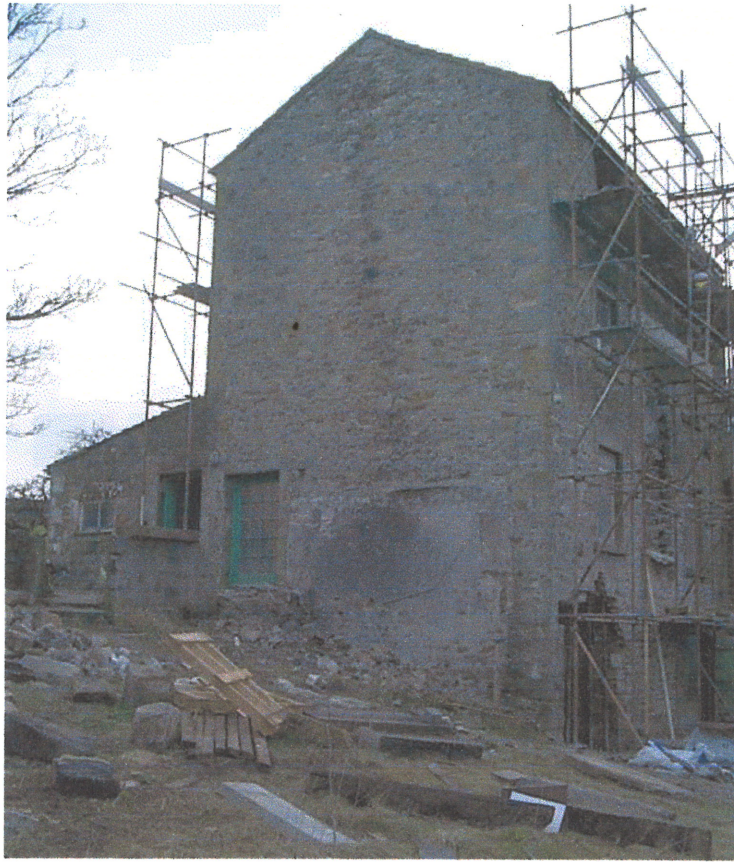
Plate 5 Northern external gable elevation of the farmhouse

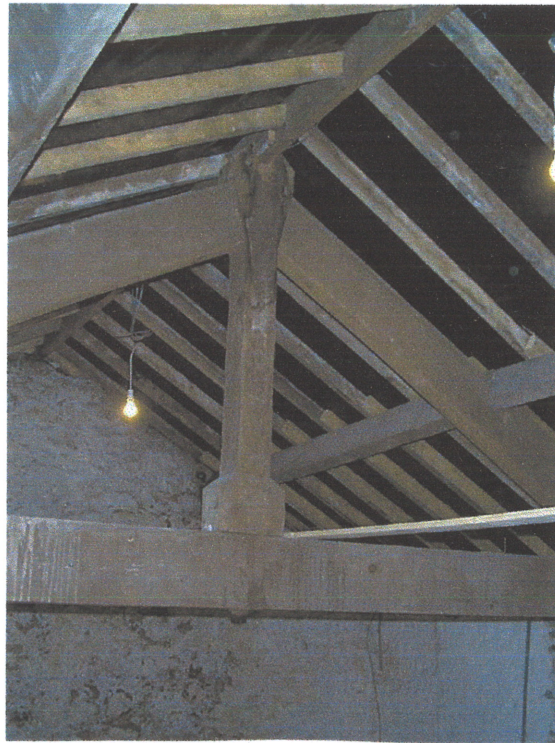
- 3.2.4 The attic comprised a single room, with four windows at the top of the front and rear elevations. The entire roof had been replaced at sometime during the twentieth century, probably at the time of the structural collapse of the upper two storey window lintels, but both king posts had been reused and the position of the trusses, on either side of the central staircase, remained the same. The roof sat directly on the wall tops without the use of timber wall plates. Both king posts had ornamental, but crude, chamfers, mimicking the earlier tradition of attaching the braces to the king post, though neither were socketed. It is probable that the original trusses had offset braces, as seen in the barn.

Plate 6 Kingpost truss within the farmhouse
